**EVALUATION OF SAW-CUT SEALANTS FOR THE
PREVENTION OF REFLECTIVE CRACKING IN
HOT MIX ASPHALT
(A CASE STUDY ON NORTH CAPITOL STREET, NW)**

DRAFT FINAL REPORT

Dr. Stephen Arhin, P.E., PTOE and Dr. Errol C. Noel, P.E.

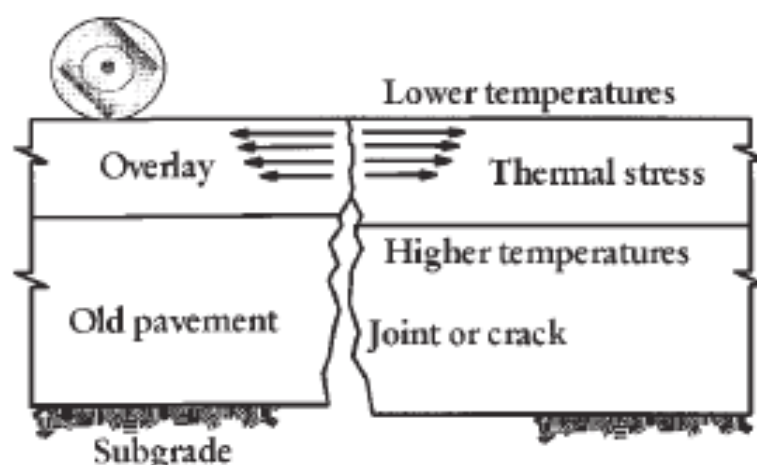
Figure 1: Tensile Stresses due to Traffic loading and Temperature Variation

Reflective cracks occur due to a coupled effect of repetitive horizontal and vertical deflections at the underlying joints in composite (jointed) pavements or at the underlying cracks in original HMA layer that has been overlaid with additional HMA [9]. Figure 1 depicts the commonly accepted mechanisms of reflective cracking [8].

Horizontal movements are caused by the expansion and contraction of the Portland Concrete Cement (PCC) slabs that are concentrated at the joints and cracks, while vertical movements occur due to traffic loading. The most documented cause or initiation of reflective cracking is horizontal movements, which results in transverse cracking. Contraction and expansion of the PCC slab, which occurs due to changes in temperature, cause the opening and closing of joints or cracks and consequently induces horizontal stresses in the HMA overlay [2]. When these horizontal stresses exceed the horizontal tensile strength of the HMA overlay a crack is formed at the interface of the PCC slab and HMA overlay [8, 10]. Continuous horizontal movements over time result in upward crack propagation that becomes visible at the driving surface as a transverse reflective crack. Reflective cracking caused by such temperature cycling is referred to as thermally-induced cracking. It must be noted that the extent of contraction and expansion of the PCC slab (the underlying concrete base) is based on its coefficient of thermal expansion (CTE). Even though horizontal movements are the most documented cause for reflective cracking, several other factors help in crack progression [2]. Slab geometry, properties of the HMA overlay, curling and warping of the slab during curing after placement, gauge length across the joint or crack are all factors to be considered in evaluating environmental effects on HMA overlays.

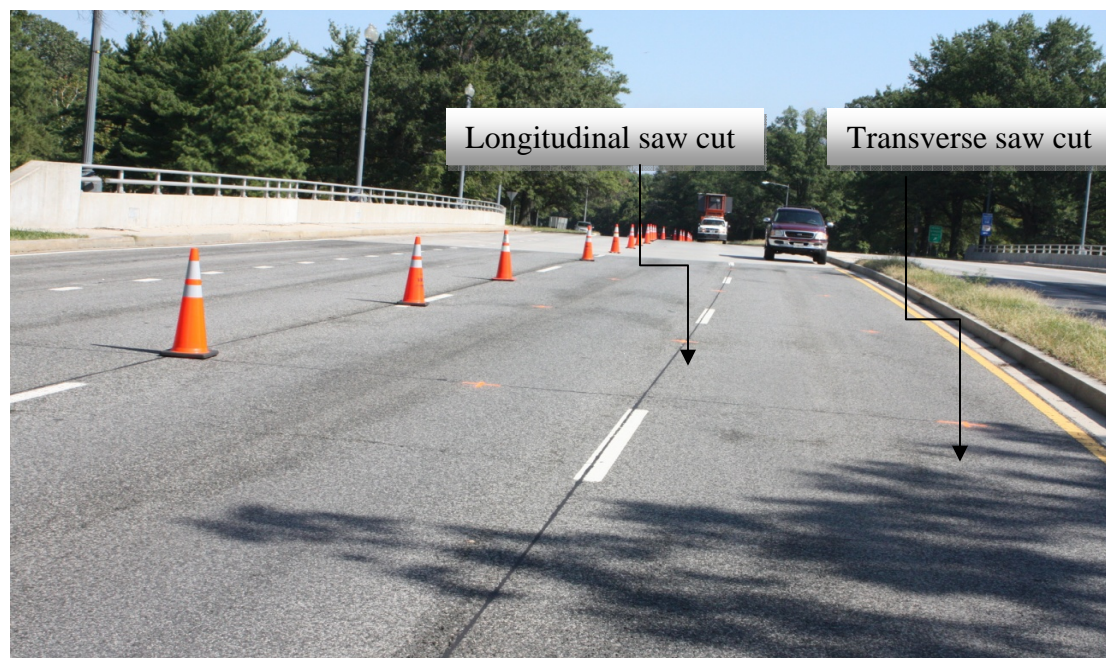
Figure 4: Experimental Pavement Section showing Sawed and Sealed HMA Saw-Cuts with Sealants

The experimental section shown in Figure 4 is located along the southbound direction of North Capitol Street NW at the interchange with Irving St. It is approximately 150 feet long and consists of fifteen transverse saw-cuts and seven longitudinal saw-cuts respectively. The transverse saw cuts cover all three lanes and are equally spaced at 30 feet and placed directly above the transverse underlying concrete joints. The longitudinal saw-cuts are located directly above the longitudinal joints between the concrete slabs, which coincides with the dashed white lines that separate each lane in the HMA overlay. The HMA saw-cuts are neatly filled with sealant to the exact level of the pavement.

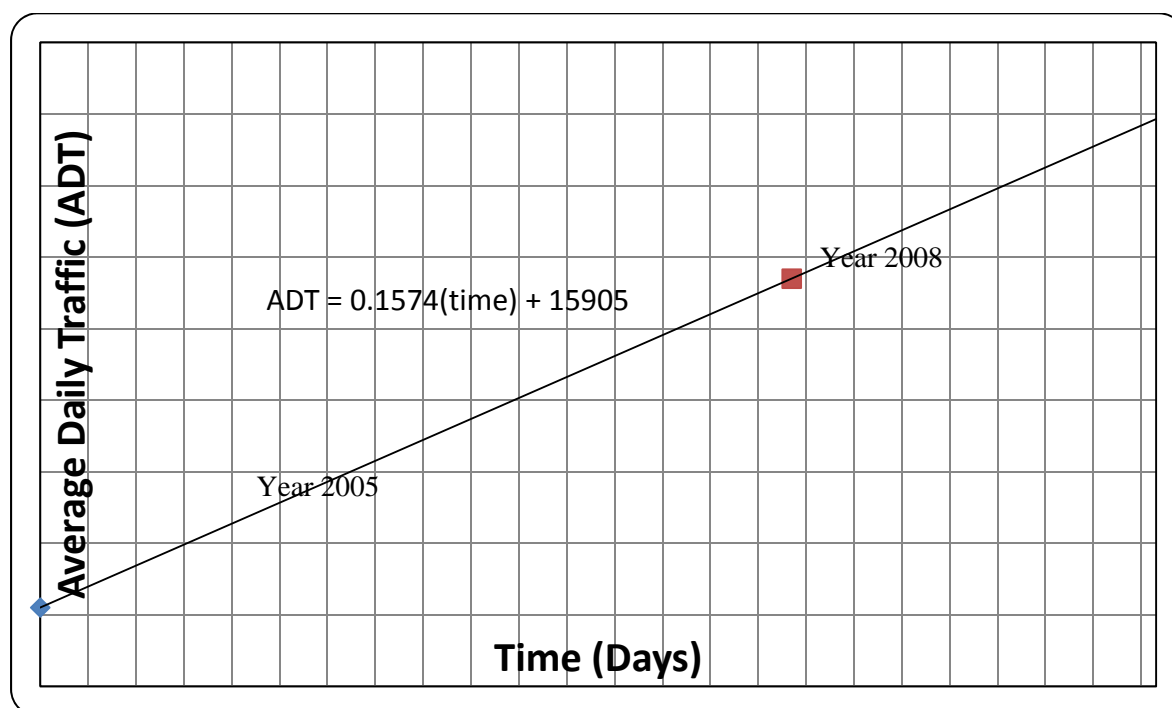
Figure 6: Relationship between ADT and Time between Years 2005 and Projected Year 2010

The Average Daily Traffic (ADT) of the pavement test section for each quarter was estimated by extrapolating from a linear relationship created between previous traffic data counts that were performed in 2005 and 2008 for the District of Columbia Department of Transportation (DDOT). The traffic data counts were recorded in 15-minute increments for 24 hours on 5 consecutive weekdays (Monday to Friday) of both years. An estimated ADT for each year (2005 and 2008) was determined by finding the average of the total traffic recorded for all five days after which a scatter plot of both points and their subsequent relationship was developed (Figure 6).

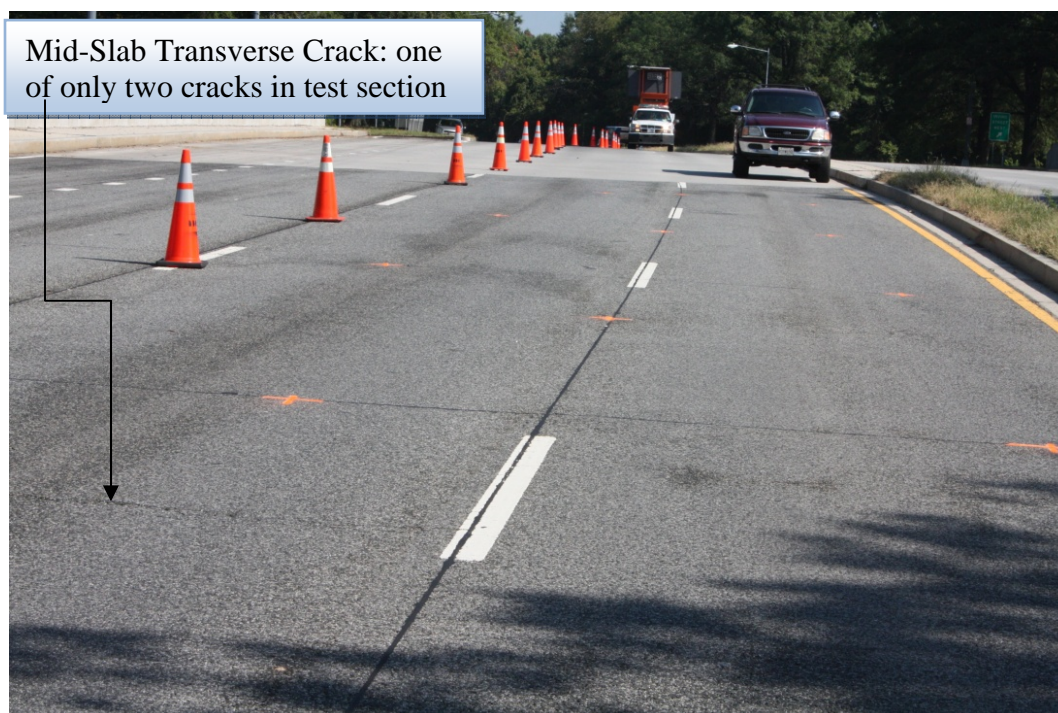
Figure 8: Condition of the Sawed and Sealed Section

A final visual inspection of the treated pavement was conducted after fifty-four (54) months, as depicted in Figure 8 it was generally in good physical condition, containing only two cracks. One of these cracks is shown in Figure 9; located approximately one foot away from a transverse saw-cut, is of a low severity, and has an estimated length of five feet.

The second crack in the test section, shown in Figure 8, occurred in the center lane and mid-slab between transverse saw cuts. It spanned the entire middle lane with a length of approximately twelve feet. Generally, the test section, with the exception of the two cracks previously described, did not experience reflective cracking.

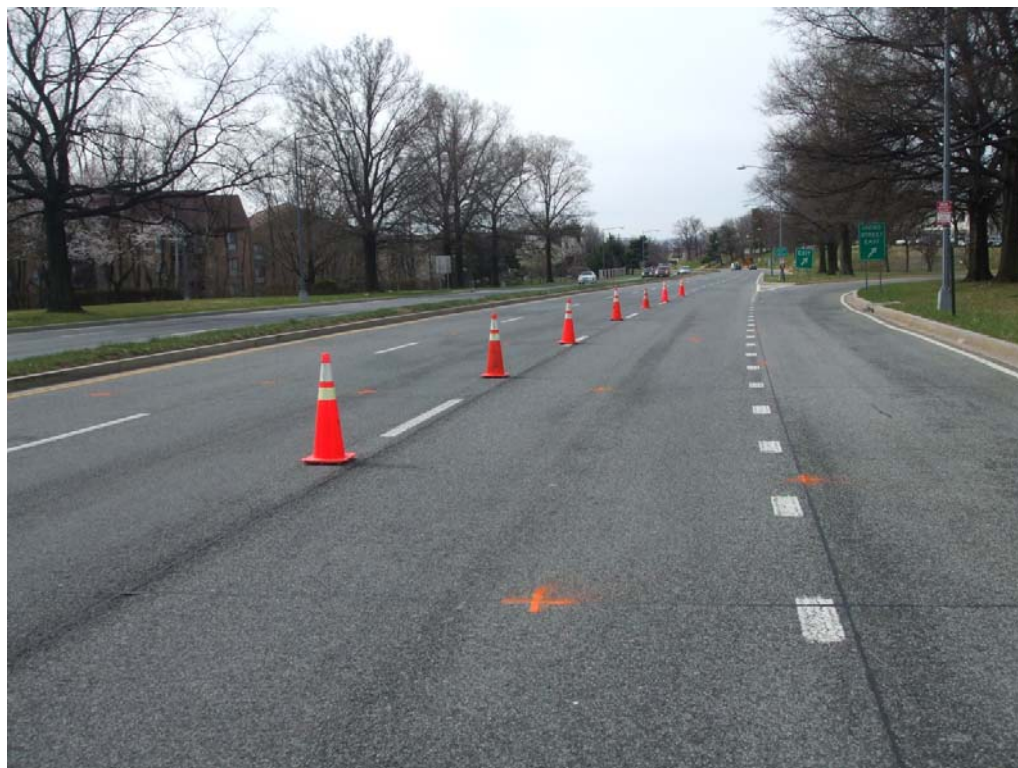
Figure 10: Condition of Treated Pavement Section

Figure 10 shows the overall condition of the sawed and sealed pavement section. Relative to the conditions of the untreated pavement section shown in Figures 11 and 12, it is apparent that the sawed and sealed section considerably outperformed its counterpart.

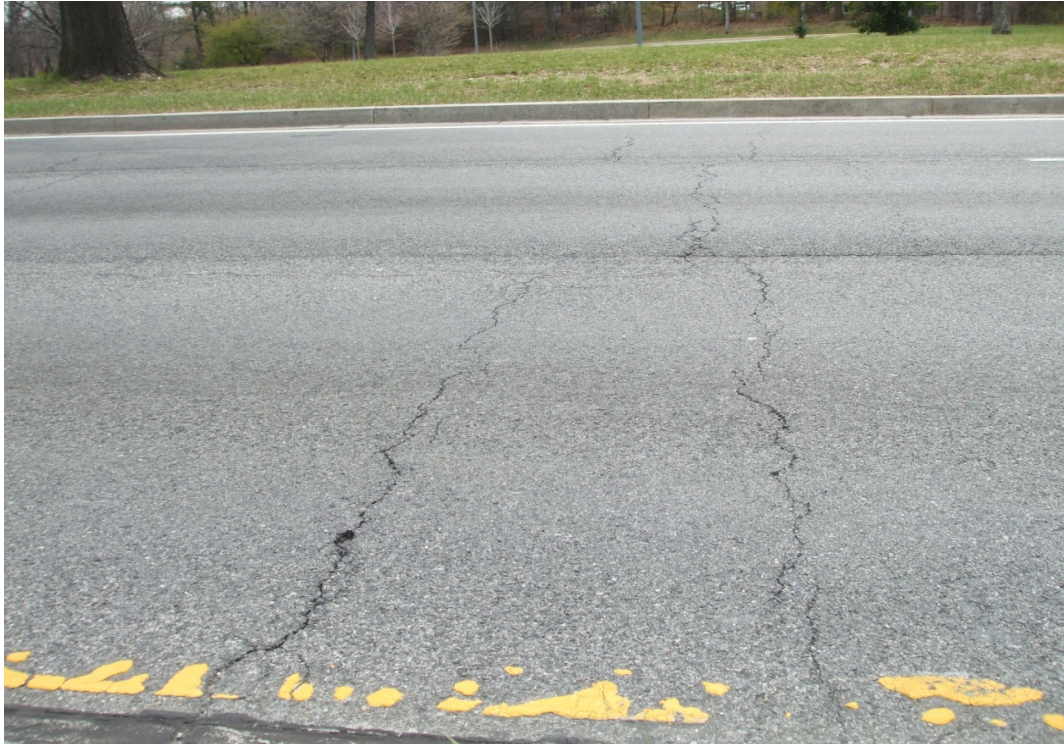
Figure 13: Major Cracking Area in the Untreated Pavement Section

Visual assessments of the control sites showed extensive transverse and longitudinal reflective cracking. Severe longitudinal cracks were present along all lanes and transverse reflective cracking occurred at all transverse joint locations. Figure 11 shows a considerable number of longitudinal and transverse reflective cracks in the untreated section. The severities of these cracks are shown in Figure 12, which provides an example of the damaging effects of reflective crack progression. The untreated pavement at this point (shown in Figure 13) has experienced pavement “blow-up” and stripping. It is expected that, if left untreated, the pavement will experience compromised foundation strength to support traffic loads. Figure 14 provides an example of the inevitability of reflective cracking in a jointed composite pavement, as it represents the condition of the untreated pavement section located at all the transverse joints. The comparison results are magnified by the conditions of the sawed and sealed section and untreated section shown in (Figure 14).

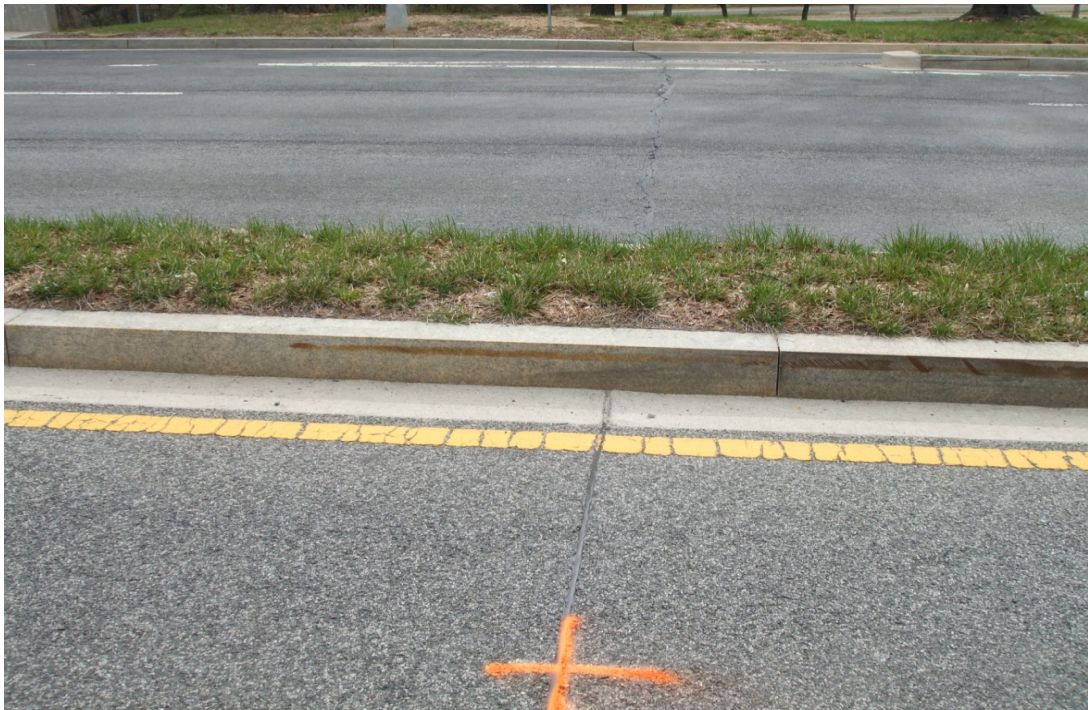
Figure 14: Typical Reflective Cracking Experienced at all Joint Locations in Untreated Pavement Section Adjacent to Corresponding Saw Cuts in Test Section.

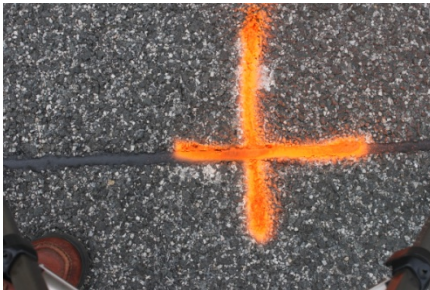
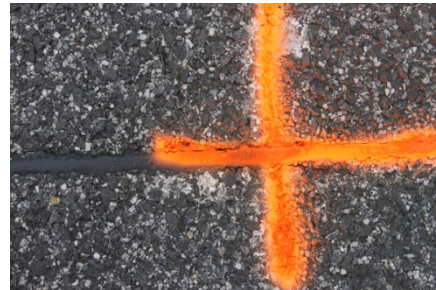
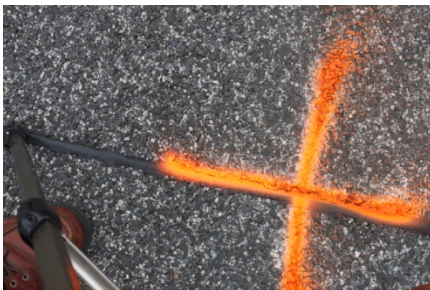
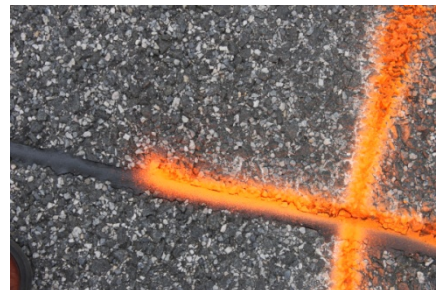
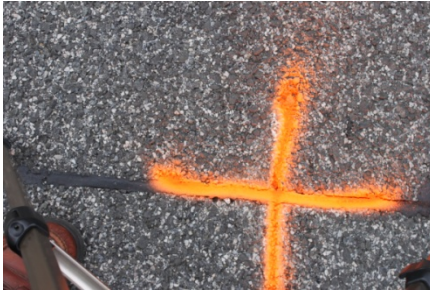
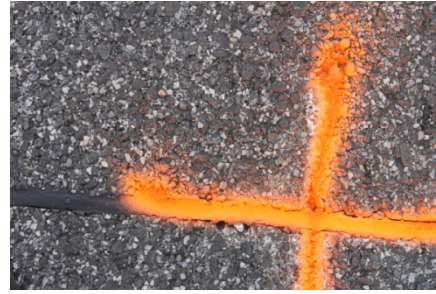
Figure 8.9 (a – o): Conditions of HMA Overlay Transverse Saw-Cuts

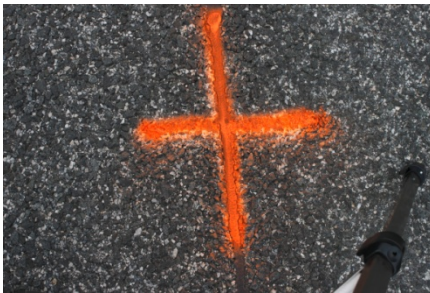
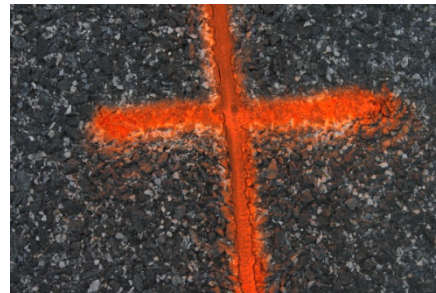
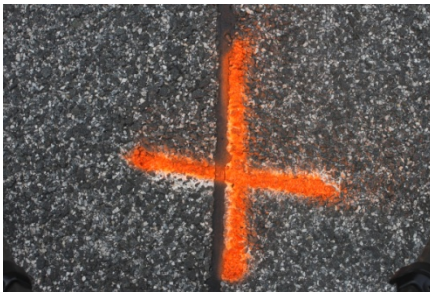
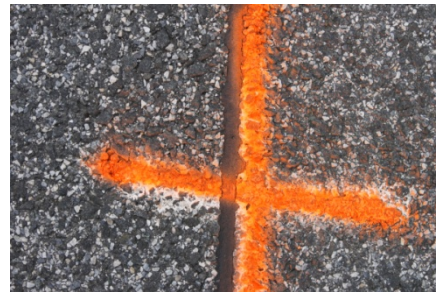
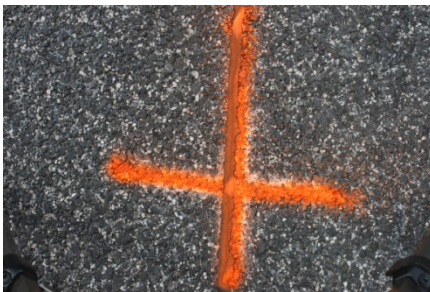
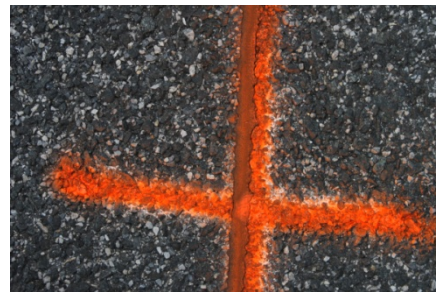
Figure 8.10 (i – vii): Conditions of HMA Overlay Longitudinal Saw-Cuts
