U.S. Department
of Transportation
Federal Railroad
Administration

Commuter Rail Seat Testing in Open-Bay Configuration

| 1. REPORT DATE (DD-MM-YYYY) 07/31/2021 | | 2. REPORT TYPE Technical Report | | 3. DATES COVERED (From - To) October 2020-July 2021 | |

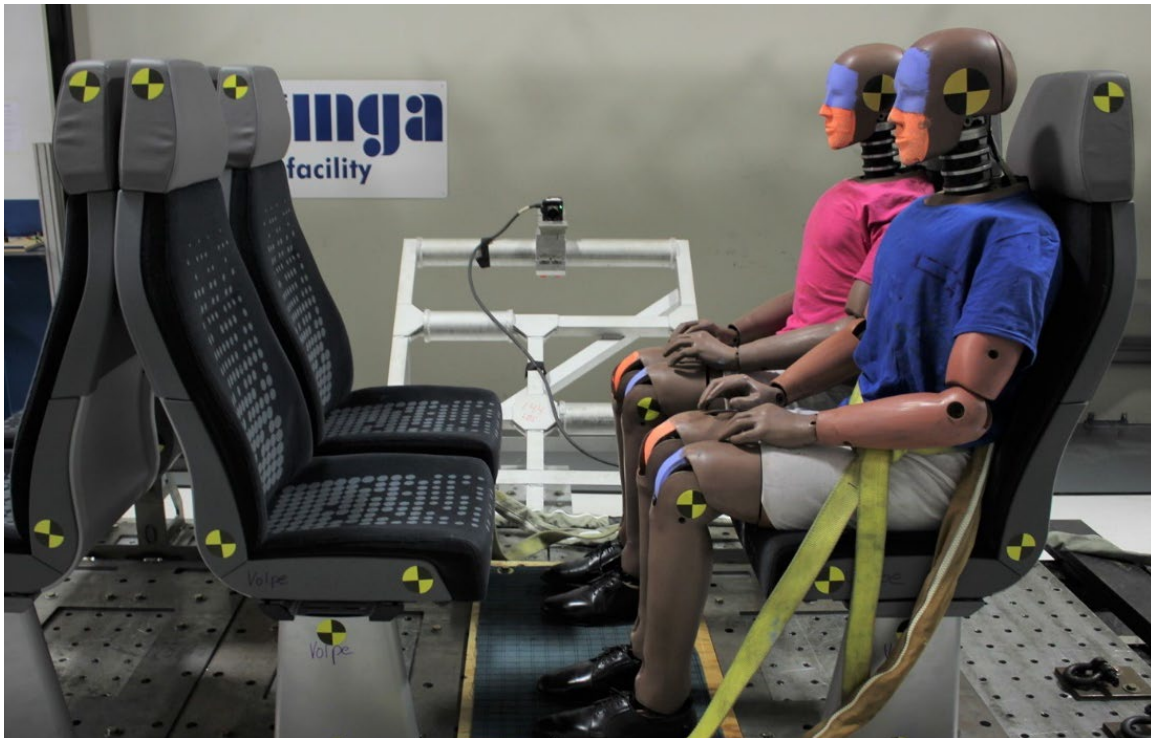
Figure 4: Test 1 Lateral Pre-Test Photo

The test setup is depicted in [Figure 4](#) and [Figure 5](#) below. The corresponding post-test photos are shown in [Figure 6](#), [Figure 7](#), and [Figure 8](#). The test pulse is shown in [Figure 9](#).

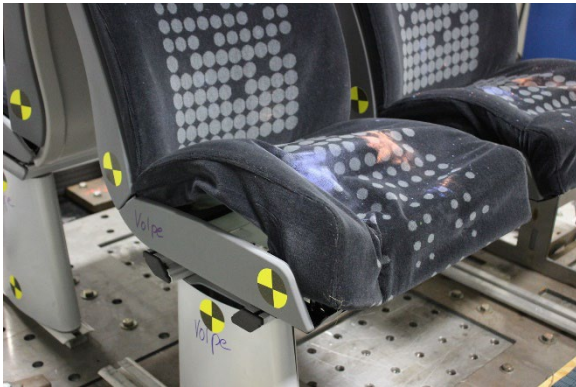
Figure 10: Test 1 Impact Seat Pan

Impact seat pan structure deformed during the event.

| APTA Requirement | Assessment |
|--|--|
| Seats may deform but shall not tear loose from their mountings. | Seats deformed but stayed attached during the event. |

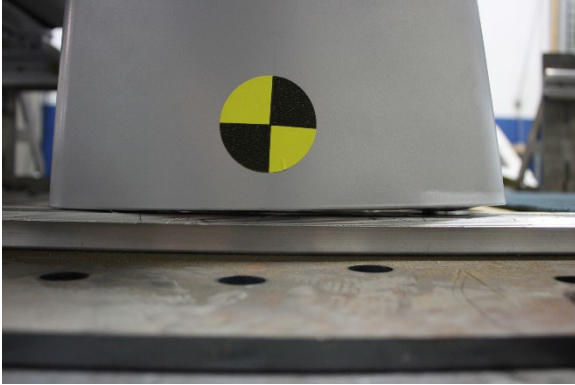
Figure 11: Test 1 Impact Seat Pedestal

Impact seat pedestal deformed at floor mounting.

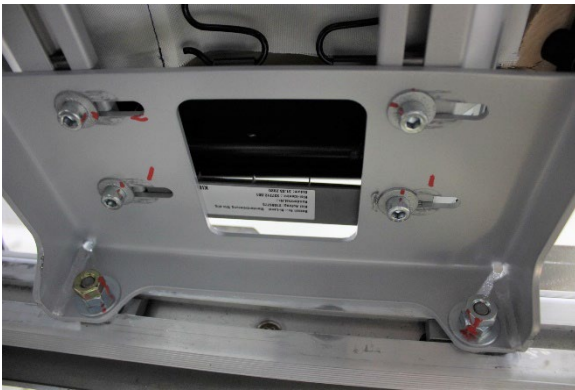
Figure 12: Test 1 Impact Seat Wall Mount Bracket

Impact seat slid at the interface between the seat and wall mount bracket.

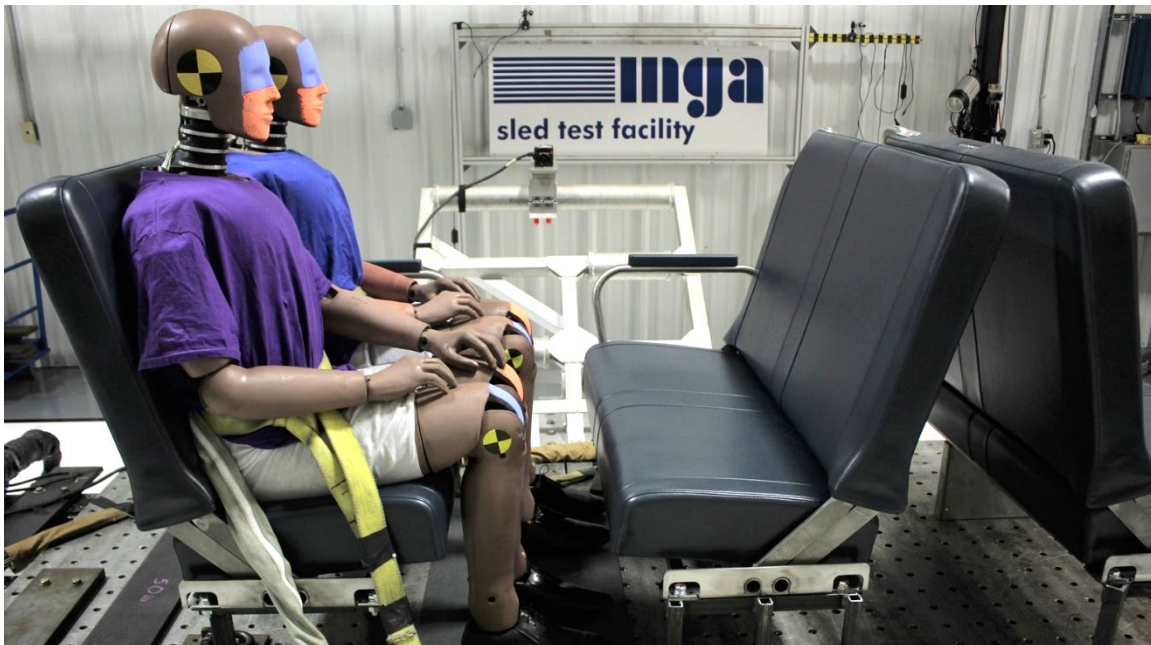
Figure 18: Test 2 Lateral Pre-Test Photo

The test setup is depicted in [Figure 18](#) and [Figure 19](#) below. The corresponding post-test photos are shown in [Figure 20](#), [Figure 21](#), and [Figure 22](#). The test pulse is shown in [Figure 23](#).

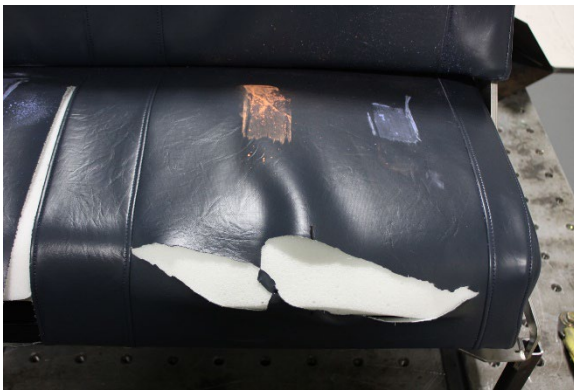
Figure 24: Test 2 Impact Seat Vinyl

ATDs' knees contacted the impact seat cushion during the event. The friction from the ATDs' knees moving across the top of the cushion caused the vinyl to tear.

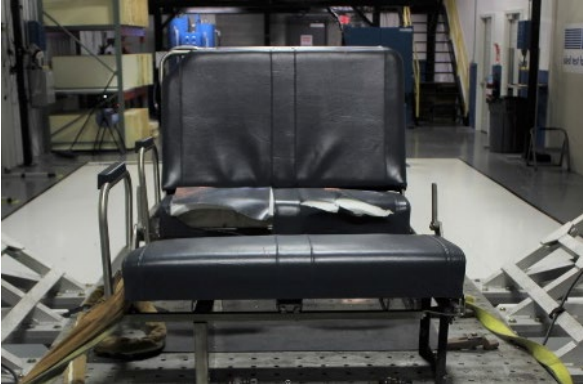
Figure 25: Test 2 Launch Seat Seatback

Inertial lock on launch seat did not properly engage, allowing the seatback to rotate and detach during the event.

| APTA Requirement | Assessment |
|---|---|
| Seat components shall not tear loose and become separated from the seat assembly. | Launch seatback separated from seat assembly and became a projectile. |
| The anti-rotational lock mechanism in rotating seats shall not fail, and the seat shall be retained in the locked position. | The anti-rotational lock on the launch seatback failed allowing the seatback to rotate during the event. |

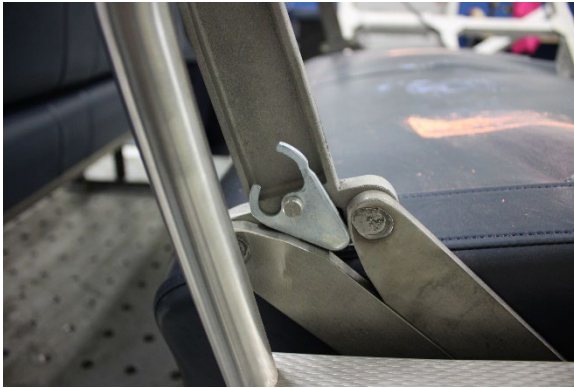
Figure 26: Test 2 Impact Seatback Rotational Lock

Impact seat seatback's rotational lock bent during the event.

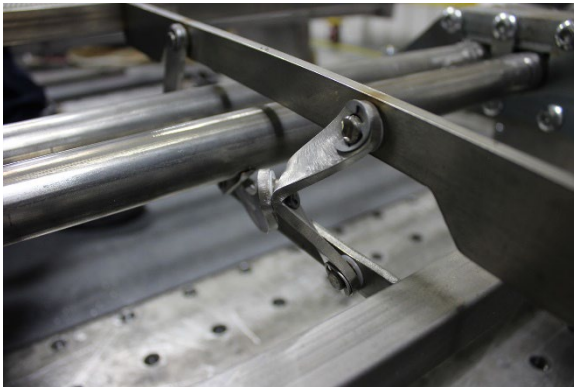
Figure 27: Test 2 Impact Seat Pan Structure

Impact seat pan structure bent during event.

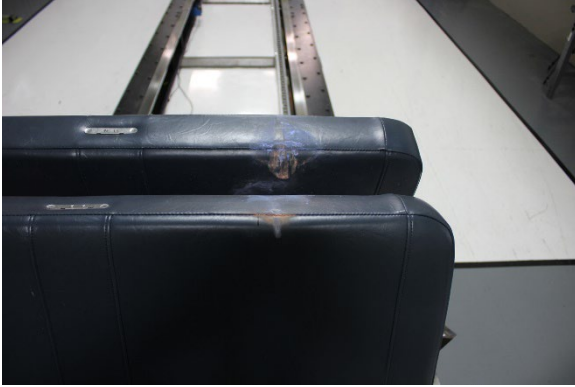
Figure 28: Test 2 ATD Head Impact Region

ATDs' heads impacted the backing seat. The ATDs' momentum carried their torsos over the impact seatback.

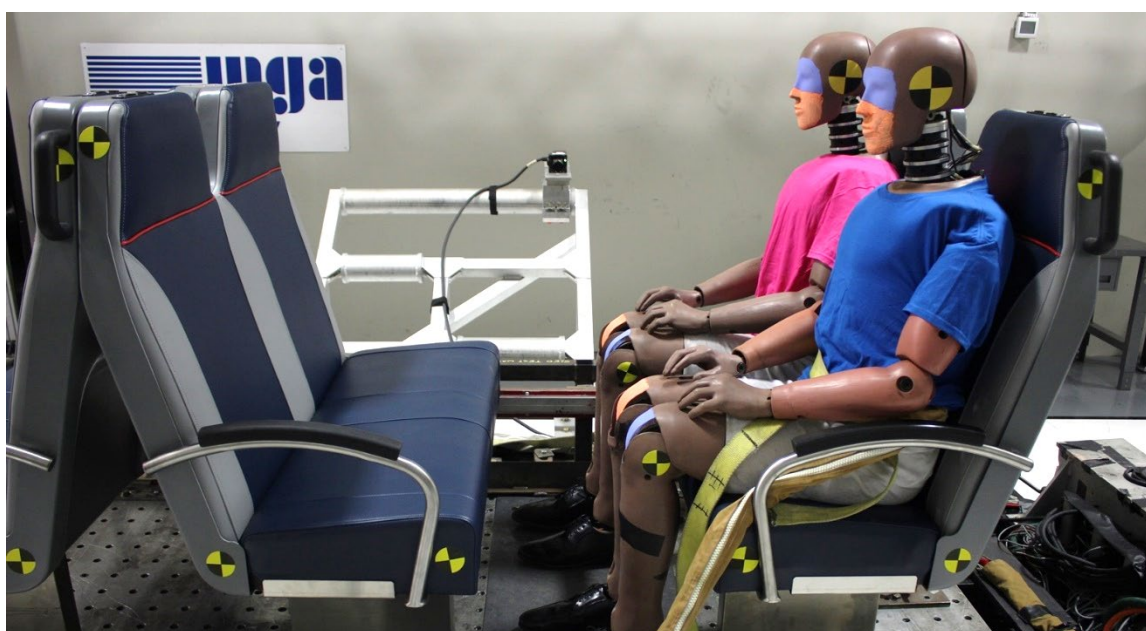
Figure 33: Test 3 Lateral Pre-Test Photo

The test setup is depicted in [Figure 33](#) and [Figure 34](#) below. The corresponding post-test photos are shown in [Figure 35](#), [Figure 36](#), and [Figure 37](#). The test pulse is shown in [Figure 38](#).

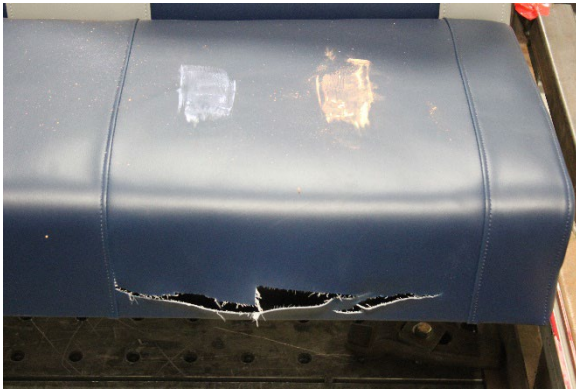
Figure 39: Test 3 Impact Seat Vinyl

ATDs' knees contacted the impact seat cushion during the event. The friction from the ATDs' knees moving across the top of the cushion caused the vinyl to tear.

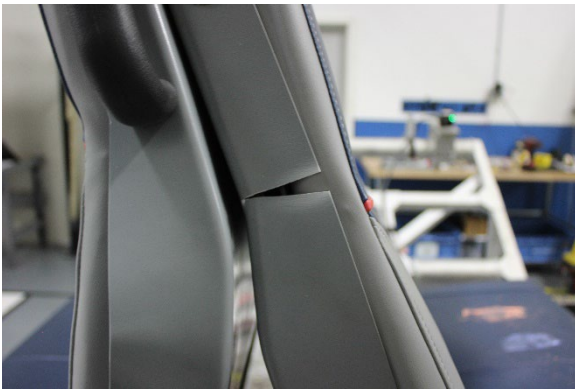
Figure 41: Test 3 Impact Seatback Plastic Cover

Impact seatback cover cracked on both sides during the event.

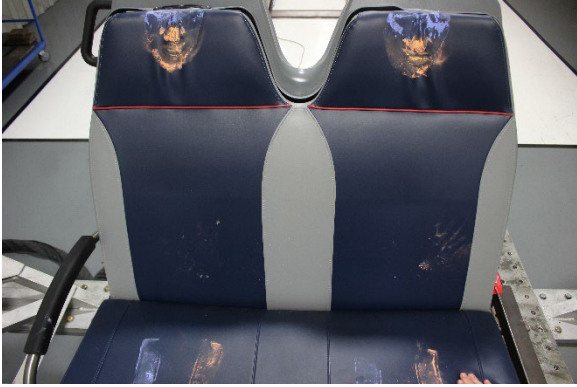
Figure 43: Test 3 ATD Head Impact Region

ATDs' heads contacted the impact seat's headrest, aiding in their compartmentalization.

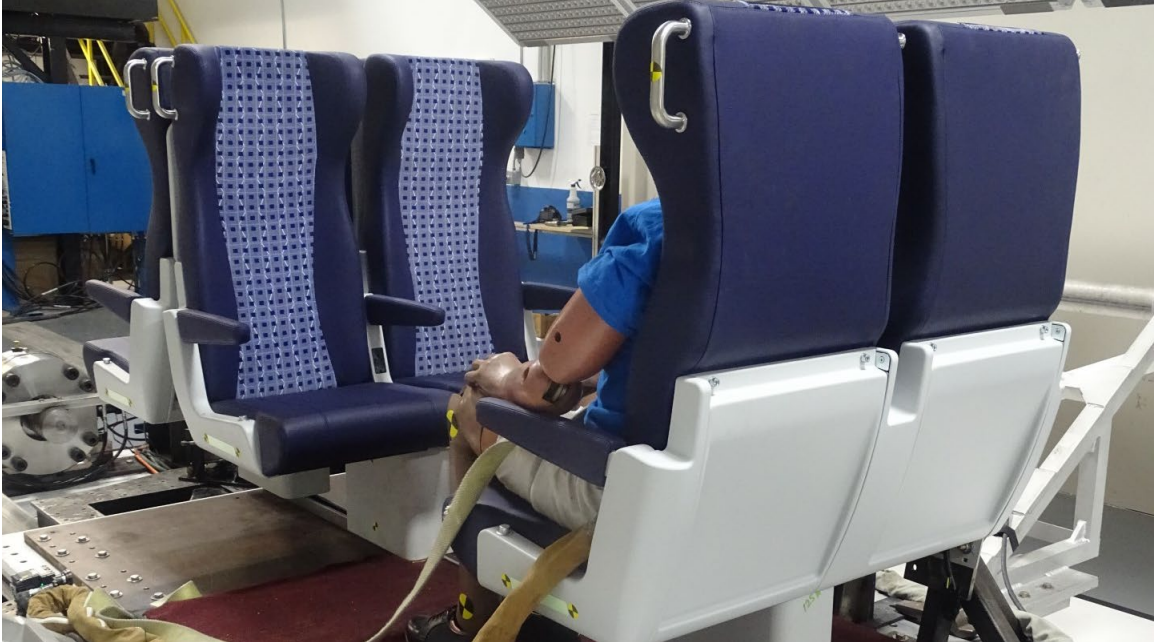
Figure 49: Test 4 Isometric Pre-Test Photo

The test setup is depicted in [Figure 48](#) and [Figure 49](#) below. The corresponding post-test photos are shown in [Figure 50](#), [Figure 51](#), and [Figure 52](#). The test pulse is shown in [Figure 53](#).

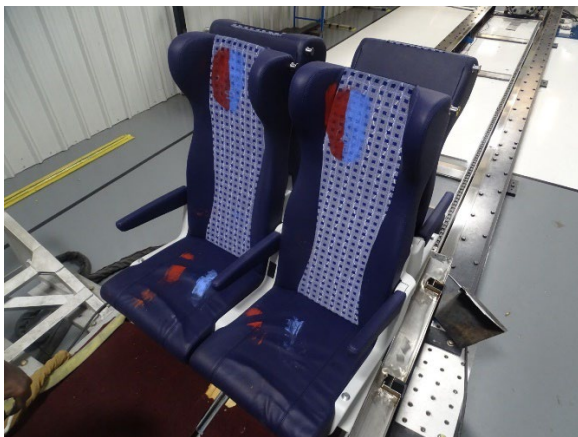
Figure 54: Test 4 Impact Seat

ATDs' faces contacted the impact seat's headrest cushions during the event. The impact seat rotated and deformed the backing seat.

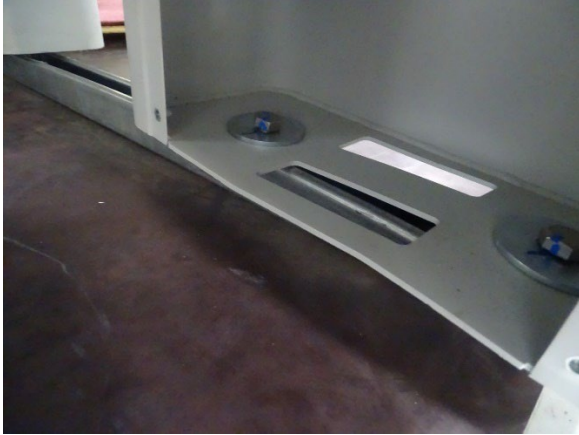
Figure 56: Test 4 Impact Seat Pedestal

Impact seat pedestal deformed at floor mounting points.

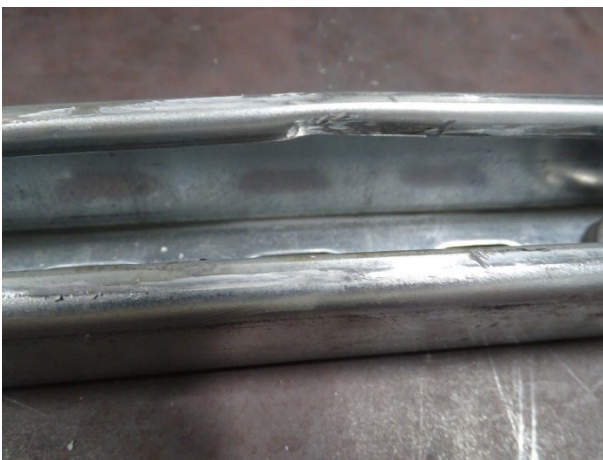
Figure 58: Test 4 Seat Track

The track supporting the impact and forward-facing seats deformed. The bolts and spring nuts pulled through the track. This likely occurred because an incorrect floor rail was used during setup. The rail used was made of galvanized steel rather than stainless steel.

| APTA Requirement | Assessment |
|---|---|
| Seats may deform but shall not tear loose from their mountings. | Impact seat and forward-facing seat pulled out of seat track due to incorrect material used for floor track. |

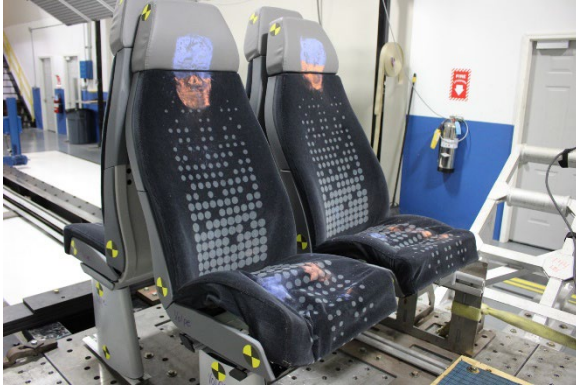
Figure 63: Test 1 Impact Seat

The thick foam and thinner structural members in the headrest for Test 1 limited contact forces and resulted in compliant head injury values.

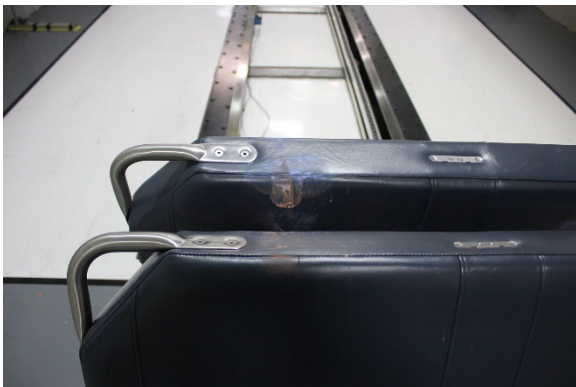
Figure 64: Test 2 Impact Seat

The lower seatback in Test 2 resulted in the ATDs' heads impacting the top of the seatback where there is a stiff frame member leading to higher HIC15 values.

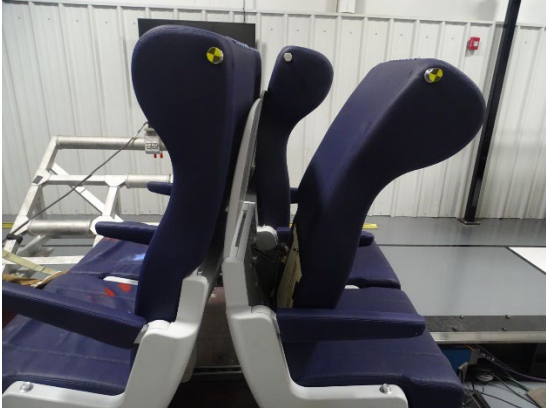
Figure 66: Test 4 Impact Seat

The thick foam and thinner structural members in the headrest for Test 4 allowed for lower contact forces and compliant head injury values.
