An automated system for inspecting rock faces and detecting potential rock falls using machine learning

Project No. 20GTUNM31

Lead University: The University of New Mexico

Final Report
August 2021

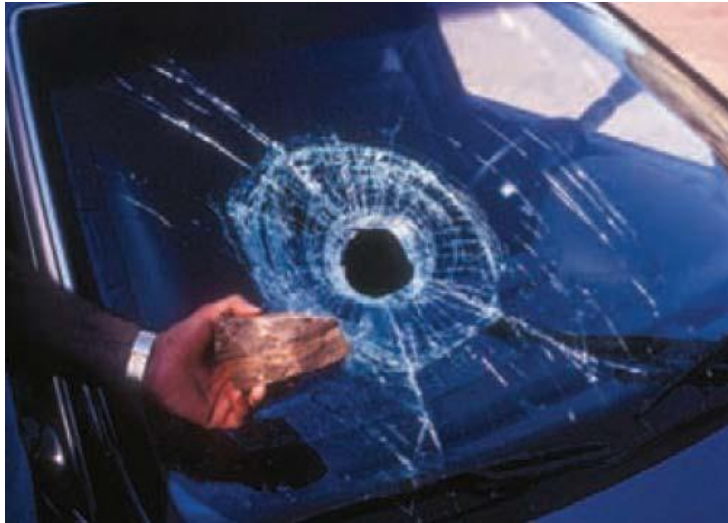
Figure 1. Windshield damage from hand-sized rock fall in in Glenwood Canyon, CO (2).

Rock falls are a threat to the safety of residents, drivers, and transportation infrastructure at locations adjacent to steep rock cuts, including the South-Central states of Region 6. For example, on September 13, 1988, a rock fall occurred in 50 miles north of Santa Fe, NM that killed 5 people and injured 14 people (1). Beyond the potential for fatalities and injuries, rock falls result in property damage, traffic delays, and road closures. Even small rock falls can be hazardous; for example, a hand-sized piece of rock severely damaged a windshield in Colorado (Figure 1).

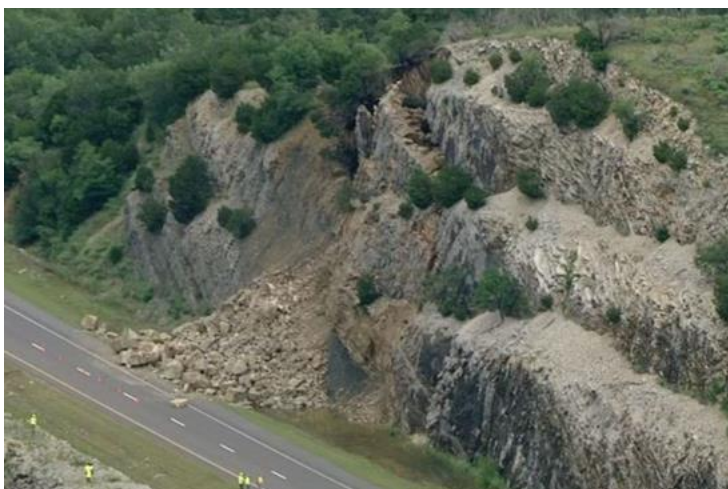
Figure 2. Rockfall in interstate Oklahoma, June 2015.

Furthermore, rehabilitation of transportation infrastructure after a rock fall is costly. For example, a rock fall in June of 2015 along Interstate 35 (Figure 2) resulted in road closure for seven weeks while the Oklahoma Department of Transportation stabilized the rock face and moved 14,000 tons of fallen rock away to a local quarry at an estimated cost of \$2M (3,4). Within the last year, there have been 3 rockslides on Loop 360 near Austin, Texas that resulted in multiple road closures and property damage (5,6). A rockslide blocked Arkansas Highway 220 south of Devil's Den State Park last summer (7).

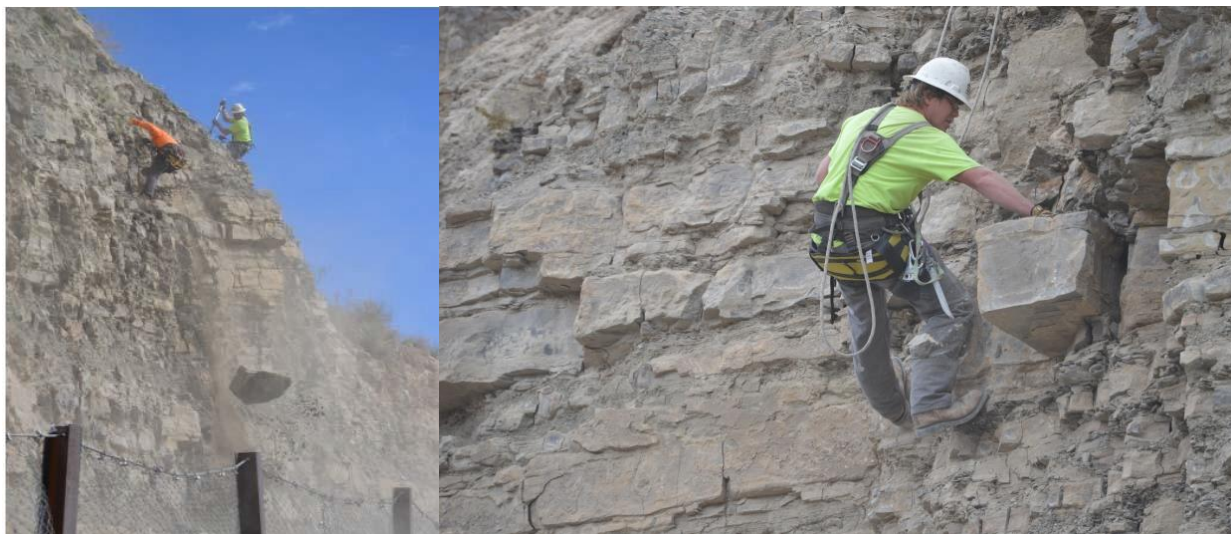
Figure 5. Rock fall mitigation Otero County, New Mexico (17).

A principal means to mitigate rock fall hazards is to detect and remove rocks that are prone to fall by manually inspecting and scaling existing exposed rock surfaces. Trained crews access the rock faces - often by rappelling over the edge from above (see Figure 5) or via portable lifts - and use pry-bars to strike the rock.

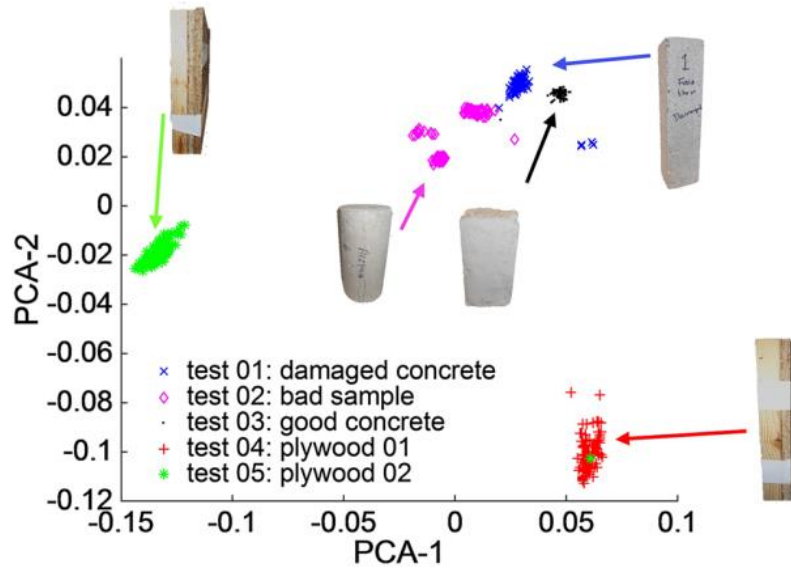
Figure 6. PCA analysis of impact responses of bridge concrete and plywood collected using a mechanical tap testing device (18).

In past research, acoustic response was used in conjunction with a machine learning algorithm to classify bridge concrete and plywood (see Figure 6). However, this research did not delve further to other materials such as limestone, sandstone, and cement.

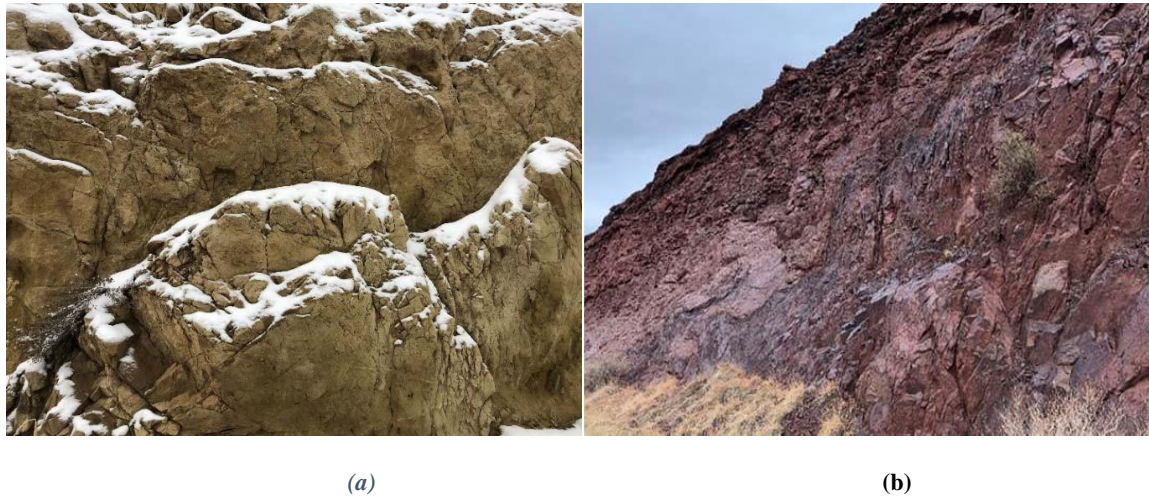
Figure 11. Rock cut Turquoise Trail 4 miles north of Tijeras, and (b) rock cut near Grand Rd, Socorro, NM.

We identified several potential sites for this work. There are many rock cuts along NM 333 close to the town of Tijeras that meet the selection criteria. One site is shown in Figure 11a. Another potential area for preliminary field testing is Grand Rd, Socorro, NM (Figure 11b).

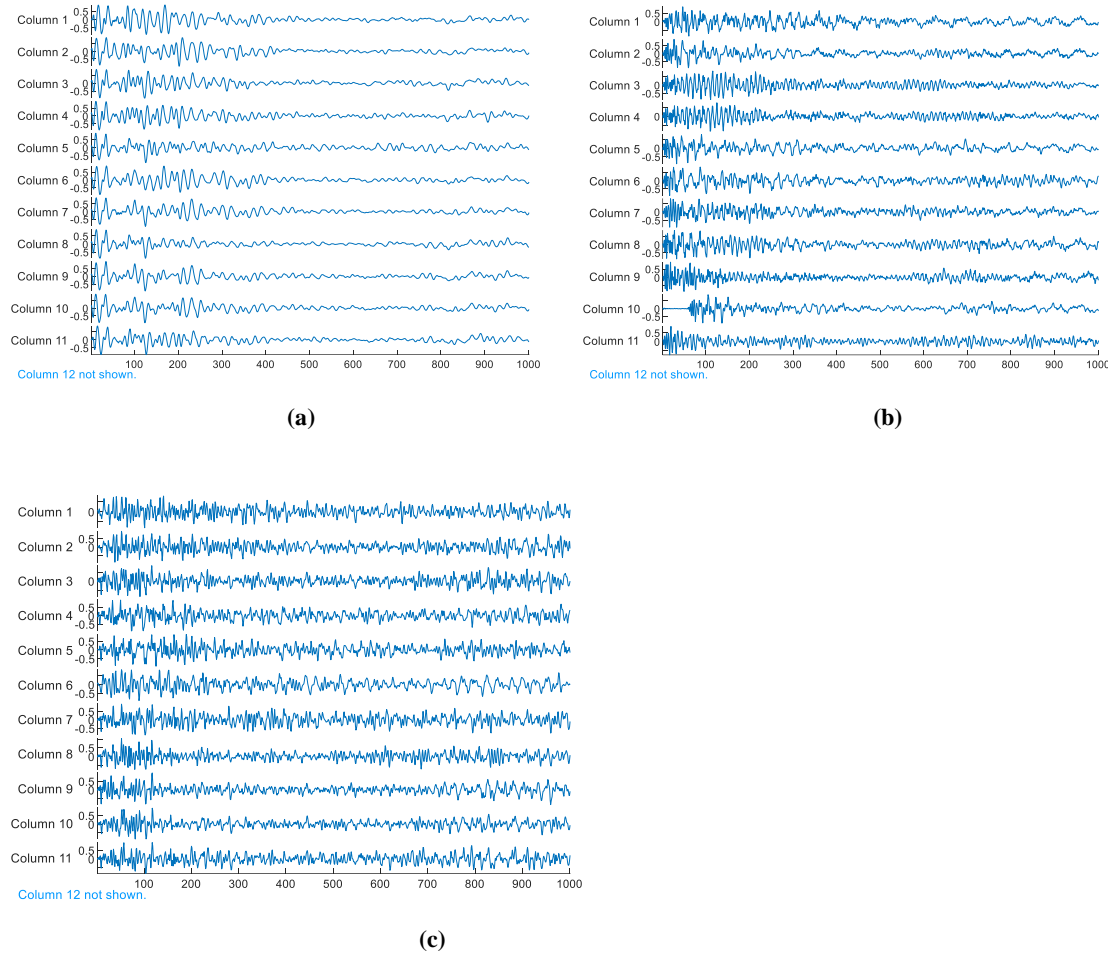
Figure 15. tap data extracted from the sound signal to do PCA analysis on; (a) 12 taps on the board; (b) 12 taps on the shelf; (c) 12 taps on the metal.

The time history of the experiment was divided in short time steps in a way that there is one hit for each time step. Authors selected a threshold value of 0.0.4 dB, which helped to get rid of the noisy data that lack valuable information during the analysis. 1000 data points were selected for each tap after that the amplitude reaches to threshold value of 0.4 and the PCA analysis was conducted on the new data file. Figure 15 shows the tap data for each hit after processing the sound signal.

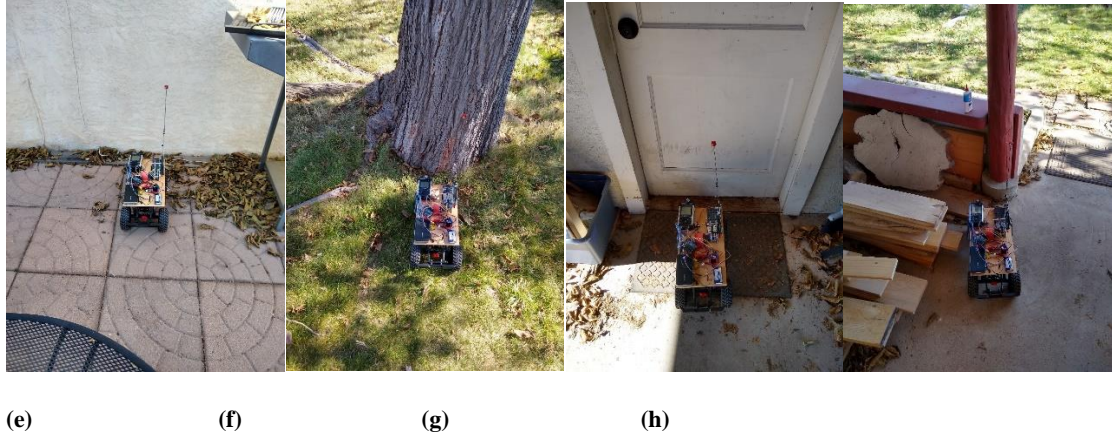
Figure 19. Different surfaces tastes using Brutus 1 in outdoors; (a) Barbeque metal panel; (b) Cement block wall; (c) Plastic hose reel; (d) Sandstone block; (e) Stucco wall; (f) Tree trunk; (g) Wood door; (h) Wood post.

Figure 19 shows the surfaces that were used to collect data using Brutus 1. The authors used 8 different surfaces to conduct tap testing on. For each test there were 25 hits on each surface and every test was conducted twice.
