EVALUATION OF HAWK SIGNAL AT GEORGIA AVENUE AND HEMLOCK DRIVE, NW IN THE DISTRICT OF COLUMBIA

DRAFT FINAL REPORT

August 20, 2010

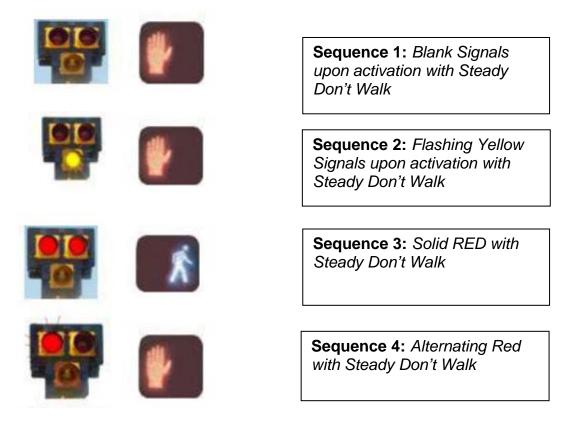
Figure 1: HAWK Signal Sequence

A <u>High-intensity Activated crossWalK</u> signal, known as HAWK, was installed at the intersection of Georgia Avenue and Hemlock Drive in Washington DC to reduce incidences of pedestrian-vehicle conflicts as well as overall crashes involving pedestrians. The HAWK signal, originally developed by the City of Tucson in Arizona, is only activated when a pedestrian approaches the signal and presses a button, like they would at a traditional signalized crosswalk. The HAWK remains dark for vehicular traffic on the major road unless a pedestrian activates it using the pushbutton. The signal sequence is presented in Figure 1.

When the pedestrian activates the signal, approaching drivers will see a FLASHING YELLOW for a number of seconds, indicating that they should reduce speed and be prepared to stop for a pedestrian in the crosswalk. The FLASHING YELLOW is followed by a SOLID YELLOW and then by a solid RED, requiring them to STOP at the stop line. During the solid RED for motorists, the pedestrian receives a WALK indication

(with an associated countdown timer, if available). In some cases, visually impaired pedestrians will hear the signal indicate that it is safe to cross. At the end of the WALK interval, the FLASHING DON'T WALK interval begins, and motorists see an ALTERNATING FLASHING RED. During the latter interval, motorists are required to STOP or remain stopped until pedestrians have finished crossing the street, and then may proceed.

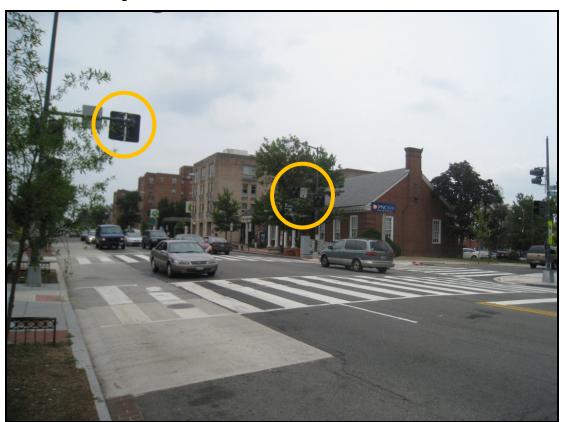
Figure 2: Georgia Avenue and Hemlock Drive, NW

Figure 1 shows an inactive HAWK signals facing the south-bound and north-bound traffic on Georgia Avenue.

Georgia Avenue and Hemlock Drive, NW, forms a T-intersection that is located in Washington D.C, approximately four blocks south of the Washington, DC – Maryland border. Georgia Avenue is a four-lane undivided roadway oriented in the north-south direction, and Hemlock Drive, the stem of the T-intersection, is a two-lane undivided

roadway with an orientation to the east of Georgia Avenue. Georgia Avenue is the major of the two roadways and provides connectivity between Silver Spring, Maryland and Washington, DC. West of the intersection is a private driveway, which serves an office and residential development. In addition to the PNC Bank, located on the north-eastern quadrant, other notable pedestrian traffic generators are the Ledo Pizza restaurant, KBC Nursing Agency and Home Health Care, and a relatively small 3-story apartment building. Bus stops are located on both approaches of Georgia Avenue. There are marked crosswalks on all approaches of the T-intersection. In addition to the HAWK signals, other regulatory signs including "Crosswalk, STOP ON RED", and pedestrian crossing signs mounted on the HAWK signal posts located at the corners of the intersection.

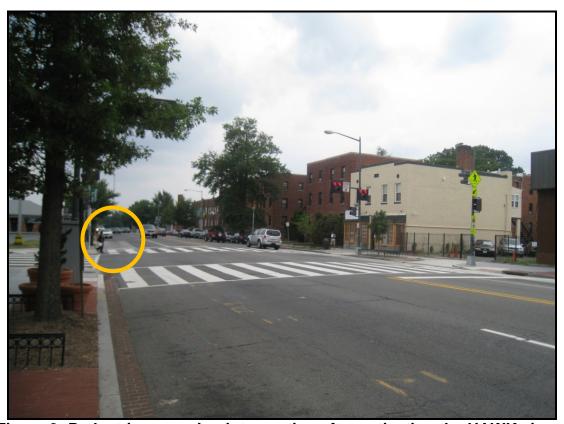
Figure 3: Pedestrian crossing intersection after activating the HAWK signal

Figure 3 depicts a typical pedestrian crossing event across Georgia Avenue as a result of activating the HAWK signal.
