Safety of Vulnerable Road Users in Light-Rail Transit Environment

Project No. 20SAOSU06

Lead University: Oklahoma State University

Final Report
July 2021

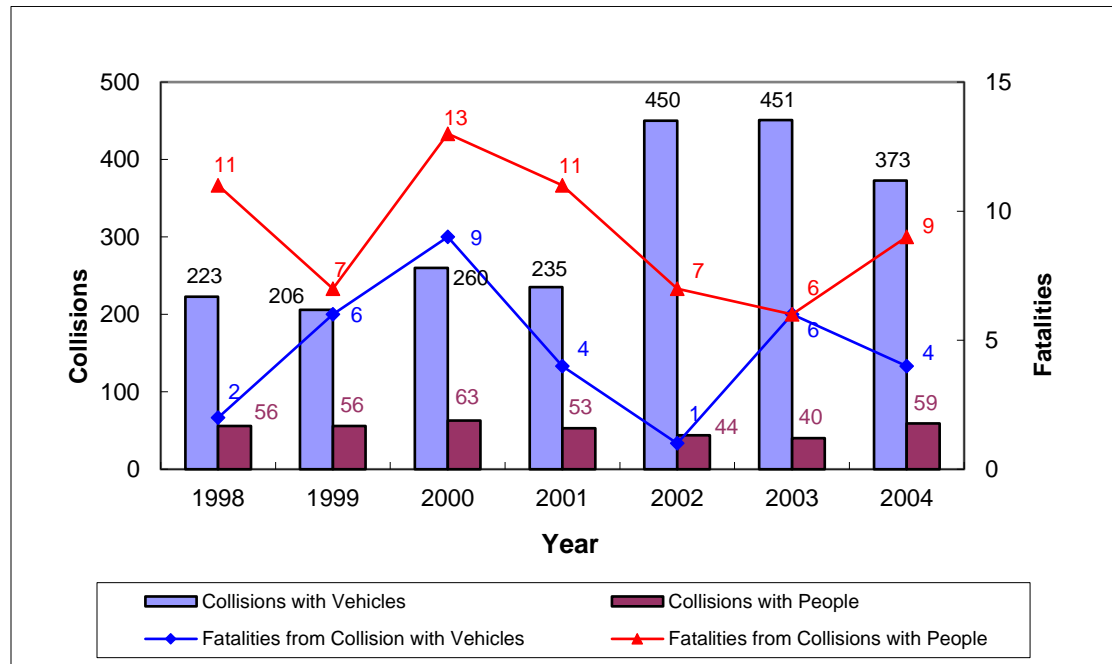
Figure 3 illustrates the number of LRV collisions with people and other vehicles that occurred between 1998 and 2004 and the resulting number of fatalities. During this seven-year time period, collisions with other vehicles averaged 314 per year whereas collisions with people averaged 53 per year, excluding suicides. The available data do not distinguish between pedestrians, bicyclists, trespassers, patrons, or employees. The average number of fatalities resulting from collisions with vehicles was 4.57 per year and the average number of fatalities resulting from collisions with people was 9.14 per year.

Figure 3. LRT Collisions and Fatalities (No Suicides), 1998-2004

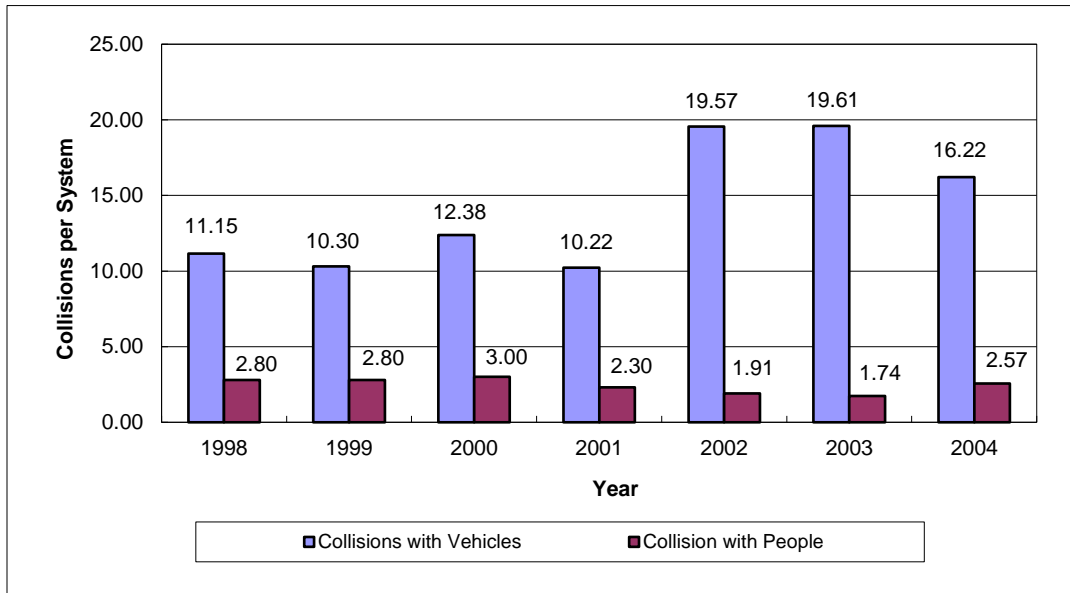
To account for the increase in the number of LRT systems and passenger-miles, Figures 4 and 5 present the average number of collisions per system and the rate of collisions per 100 million passenger-miles. Between 1998 and 2004, LRT systems averaged 14.21 vehicle-LRV collisions and 2.45 pedestrian-LRV collisions per year per system. Using passenger-miles as a measure of exposure, the rate of vehicle-LRV collisions averaged 23.99 and the rate of pedestrian-LRV collisions averaged 4.23 per 100 million passenger-miles per year. It should be noted that substantial variability exists in collision rates among individual LRT systems.

Figure 4. LRT average collisions per system (no suicides), 1998-2004

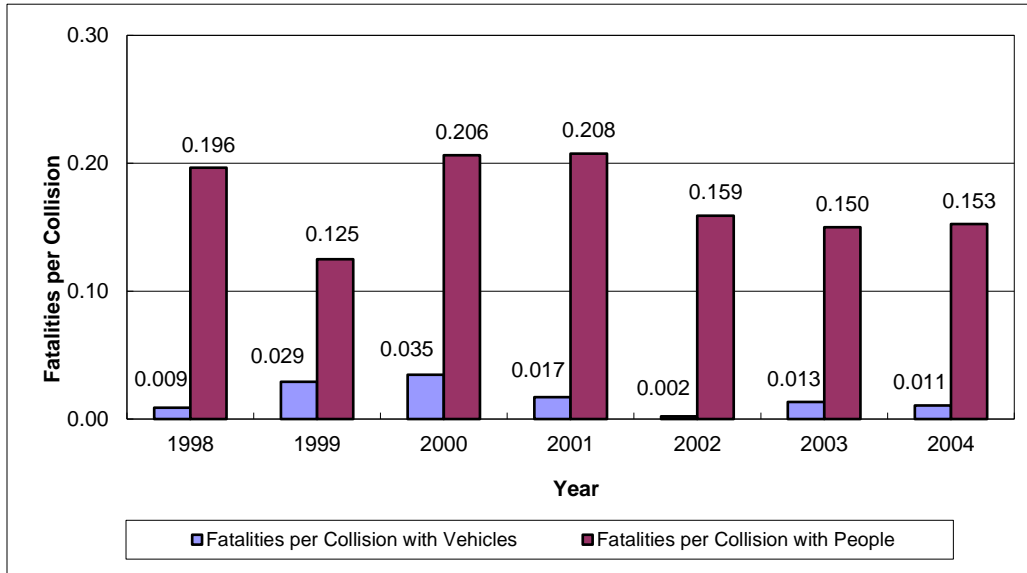
Although collisions between LRVs and pedestrians are the least common of all LRV collisions, they are more likely to result in fatalities or serious injuries. Figure 6 presents the trend in lethality of LRV collisions between 1998 and 2004. On the average, 17% of pedestrian-LRV collisions were fatal, whereas only 2% of vehicle-LRV collisions involved fatalities.

Figure 6. LRT fatalities per collision (no suicides), 1998-2004

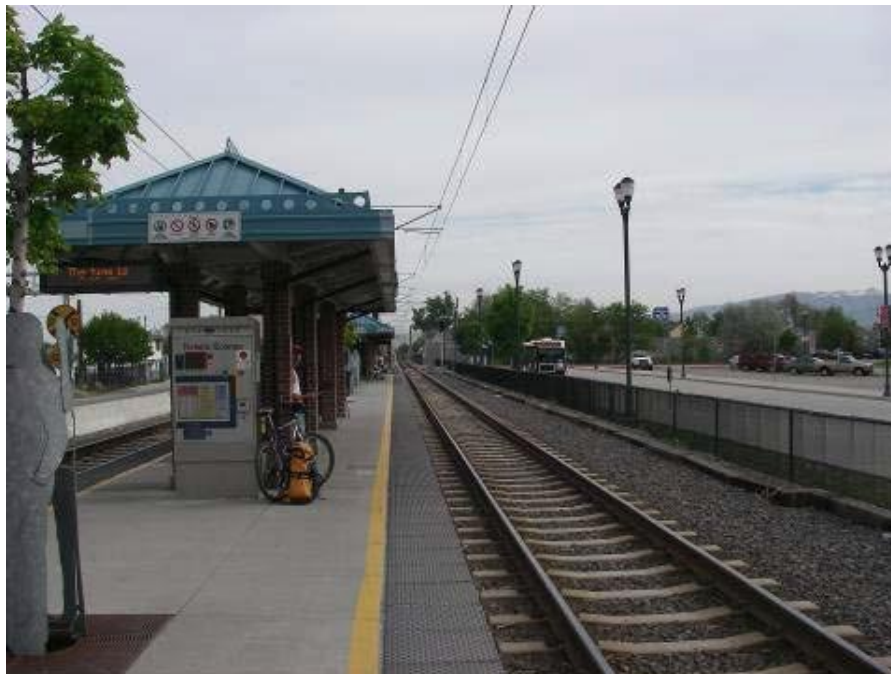
**Figure 7. Example of type-a exclusive alignment
Salt Lake City, Sandy Line, UT**

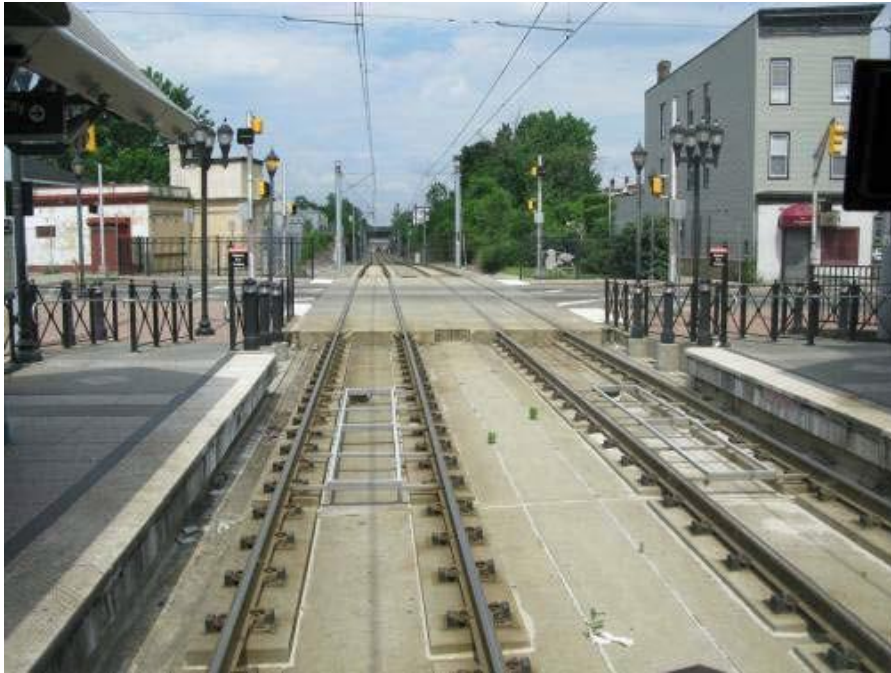
**Figure 8. Typical type b.1 alignment
New Jersey Transit, NJ**

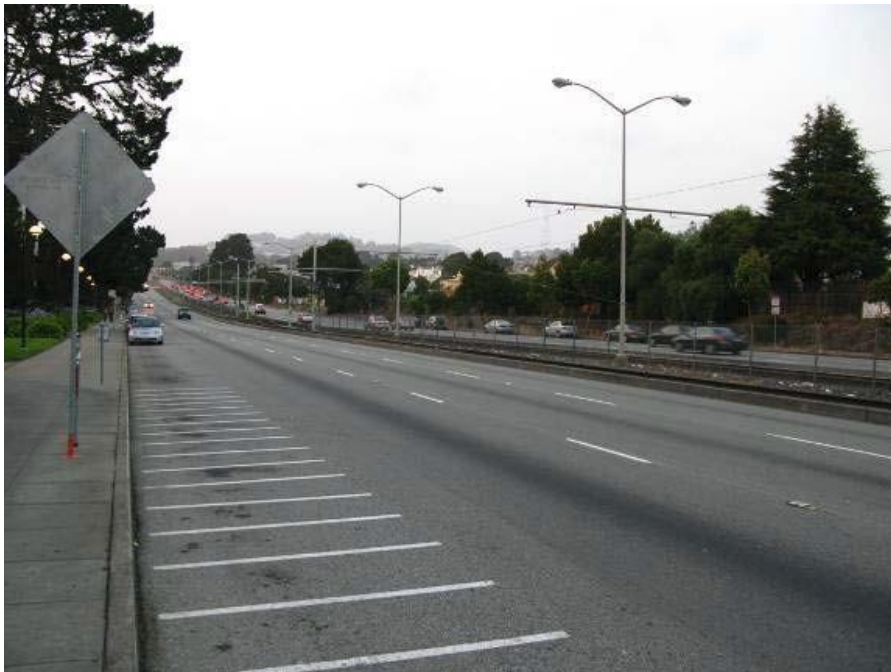
**Figure 9. Median running type b.2 semi-exclusive alignment
M-line, San Francisco MUNI, CA**

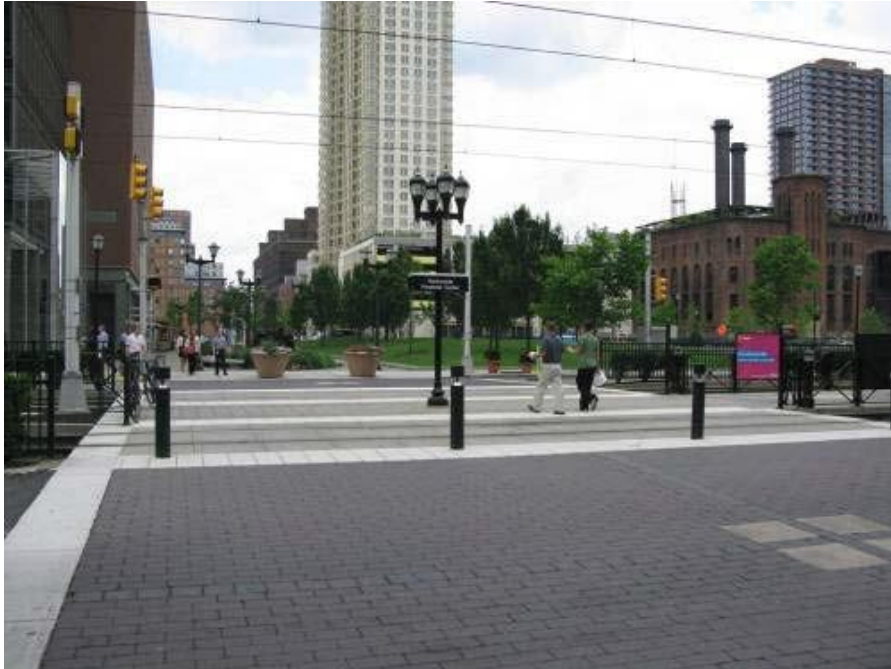
**Figure 11. Pedestrian Crossing of Type b.2 Median Running Alignment
New Jersey Transit, NJ**

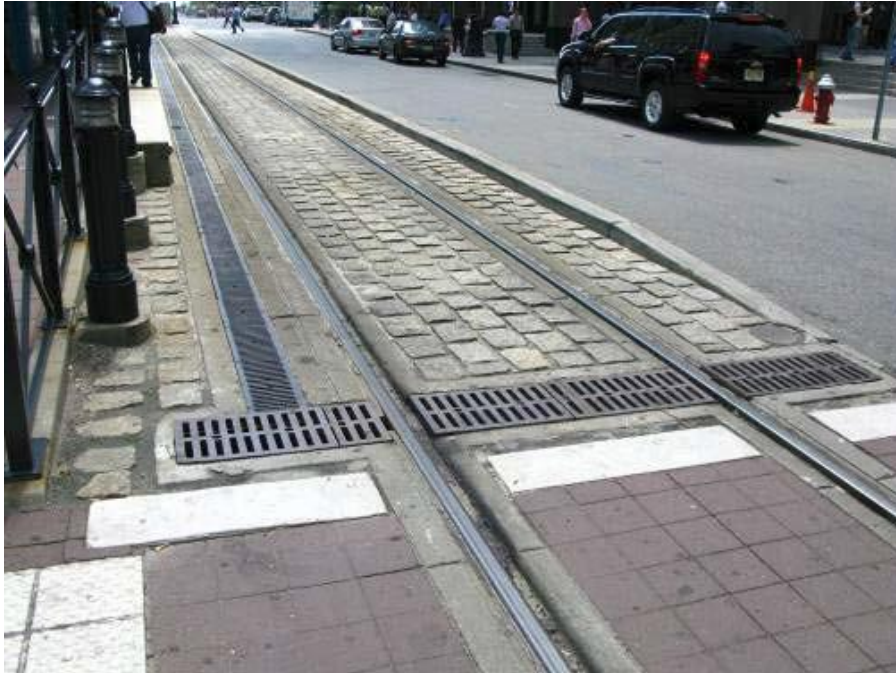
Figure 12. Type b.3 Alignment with Textured Surface and Drainage
New Jersey Transit, NJ

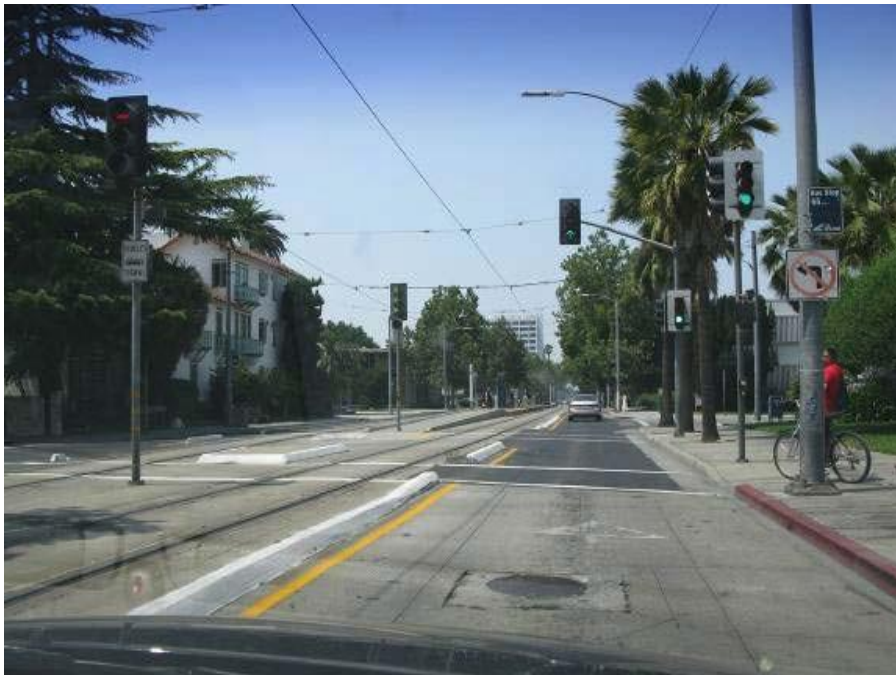
Figure 13. Type b.3 Alignment with Barrier Curbs
Santa Clara SCVTA, CA

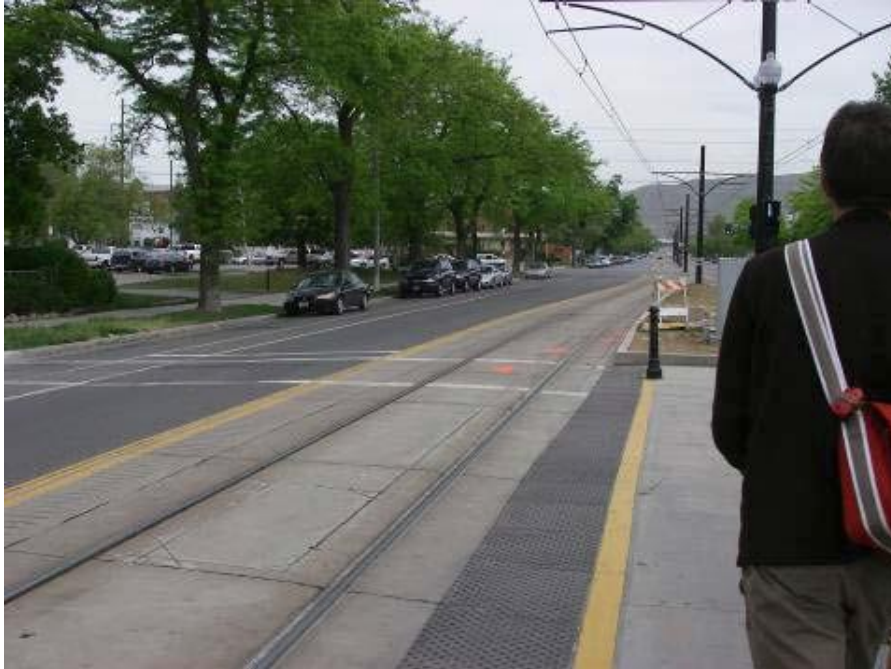
**Figure 14. Type b-4 Semi-exclusive Alignment - Rumble Strip and Pavement Markings
Salt Lake City, UT**

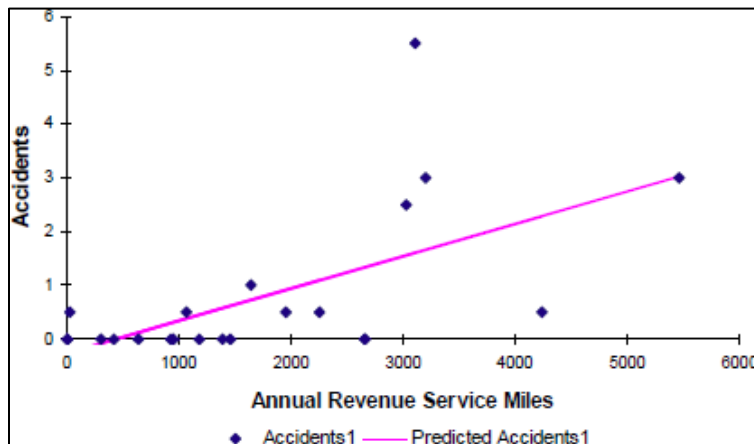
Figure 22. Linear regression of pedestrian-LRT collisions and annual revenue service miles (7)

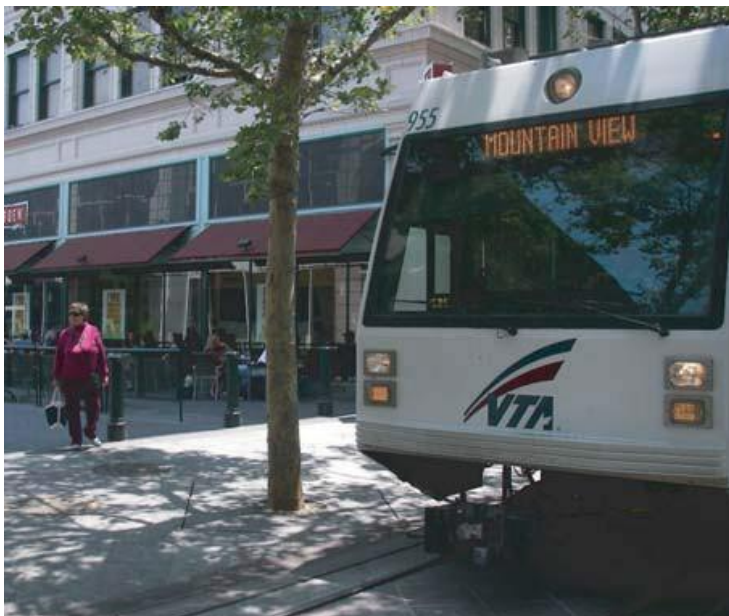
Depending on their location, audible warning devices can be divided into two groupings: on-board the LRV, and wayside along the tracks. TCRP research results Digest 84 (7) presents guidance on practices that should be considered when designing or developing operating procedures for audible warning devices. Operating procedures on use of on-board horns are usually included in the LRT agency's rulebook. Figure 26 shows an on-board LRV-mounted audible warning device.

Figure 26. On-board LRV-mounted audible warning device, Santa Clara, CA

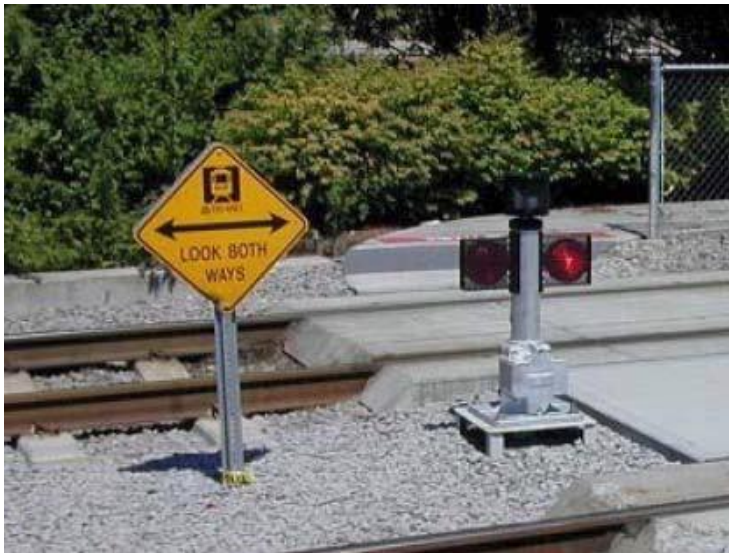
tend to look down not up while walking. Figure 28 shows a low-mount warning device installed in Portland’s Tri- Met system. This alternative treatment addresses the issues of height compatibility with pedestrians’ field of view and noise spillover into the surrounding community.

Figure 28. Low-mount flashing light signal, Tri-Met, Portland, OR

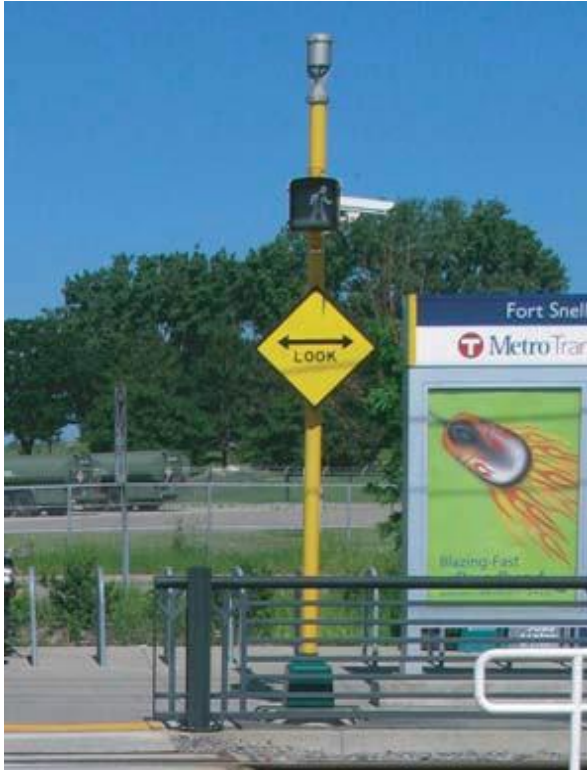
Audible devices are not always provided at pedestrian-only crossings with traffic signal controls (21). Other treatments may consist solely of a verbal warning (e.g., some systems have audible announcements on the station platforms, such as “train approaching, stand back”). Figure 29 illustrates a pedestrian signal on the Hiawatha line, Minneapolis that incorporates an audible crossing warning device and “LOOK BOTH WAYS” sign.

Figure 29. Pedestrian signal with audible crossing warning device and “LOOK BOTH WAYS” sign, Hiawatha line, Minneapolis, MN

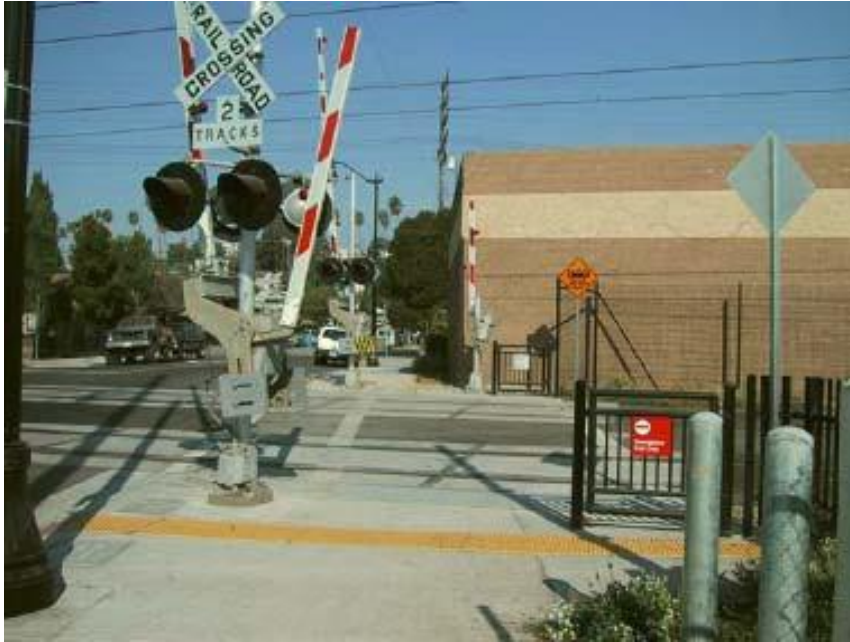
Several types of flashing light signals are used by transit agencies to warn motorists, pedestrians, and bicyclists at LRV crossing area. The most common type is the standard railroad-type crossing lights shown in Figure 30.

Figure 30. Standard railroad crossing flashing-light signals with gate arm, Gold Line LRT, Pasadena, CA

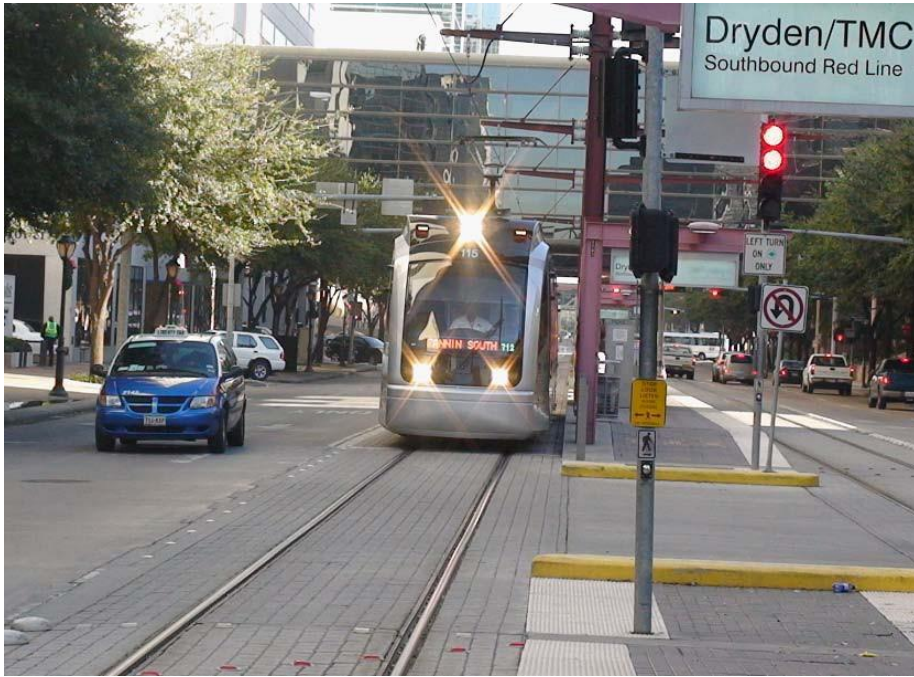
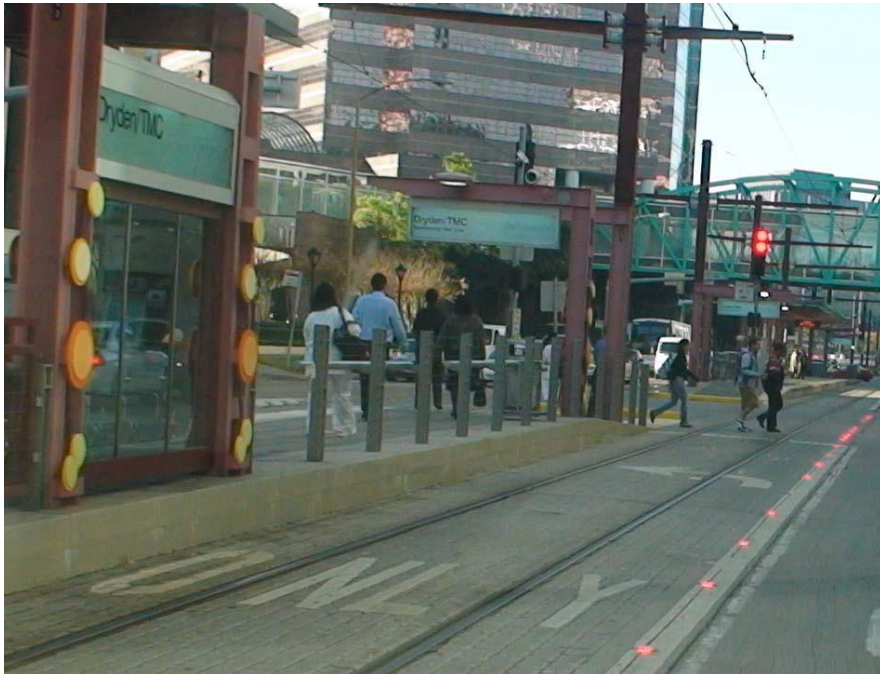
Markers can be recessed in the pavement through coring or milling methods or affixed directly to the pavement surface. Recessed markers are less prone to “pop-offs” but require additional work during the installation process. In cold regions, where snowplowing is frequent during the winter months, use of recessed markers is necessary. Also, the performance of marker adhesives, particularly in unusually cold or hot temperatures, can have a significant effect on pop-off frequency. Figure 31 illustrates the illuminated IPM systems installed in Houston Metro.

(a) IPM system – Status: Not active

(b) IPM system – Status: active

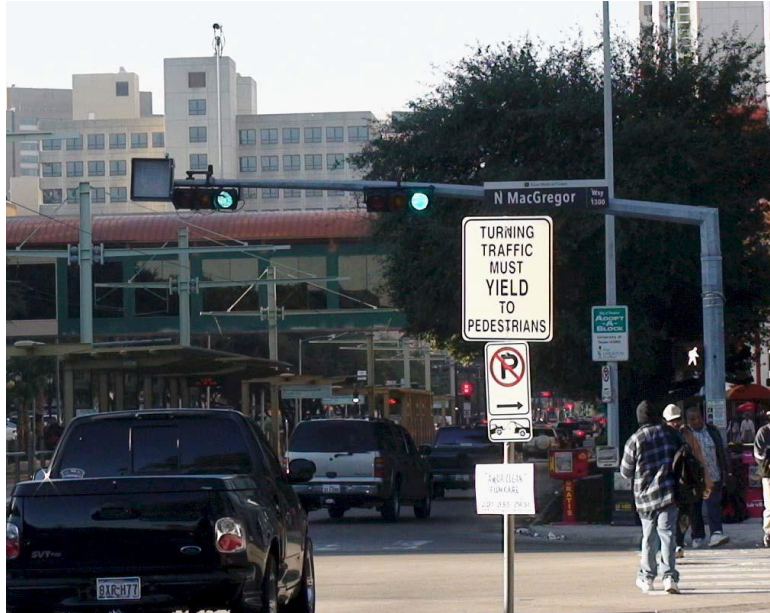
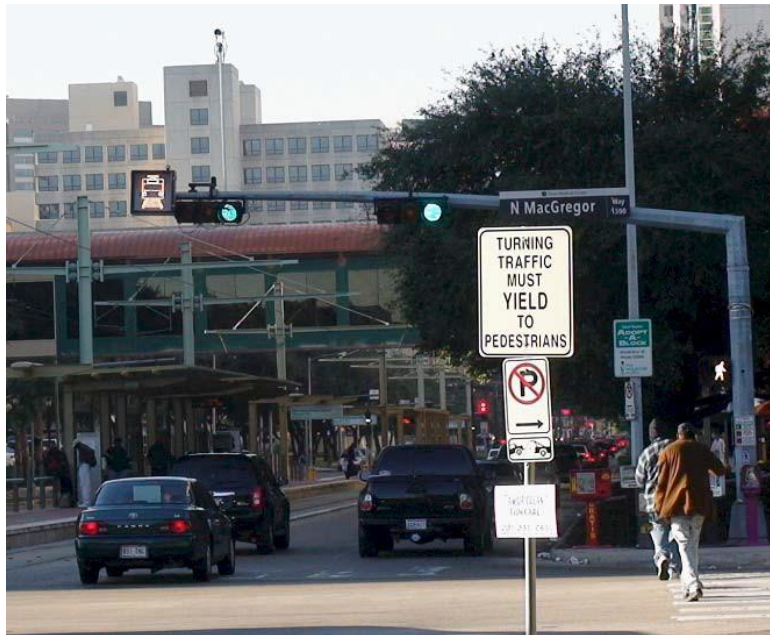
approaching. LRV-activated blank-out warning signs may be used at signalized intersections near highway-LRT grade crossings or at crossings controlled by STOP signs or automatic gates. Figure 32 shows example of LRV-activated sign installed at a signalized intersection in Houston, TX.

(a) Blank-out sign – Status: not active

(b) Blank-out sign – Status: active

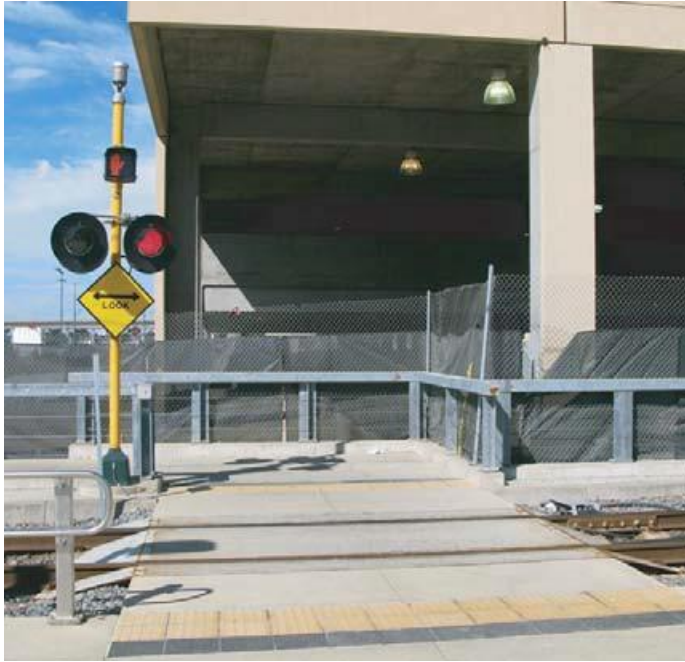
Figure 34. Pedestrian signal with “LOOK” sign and flashing lights, Metro Transit’s Hiawatha line, Minneapolis, MN

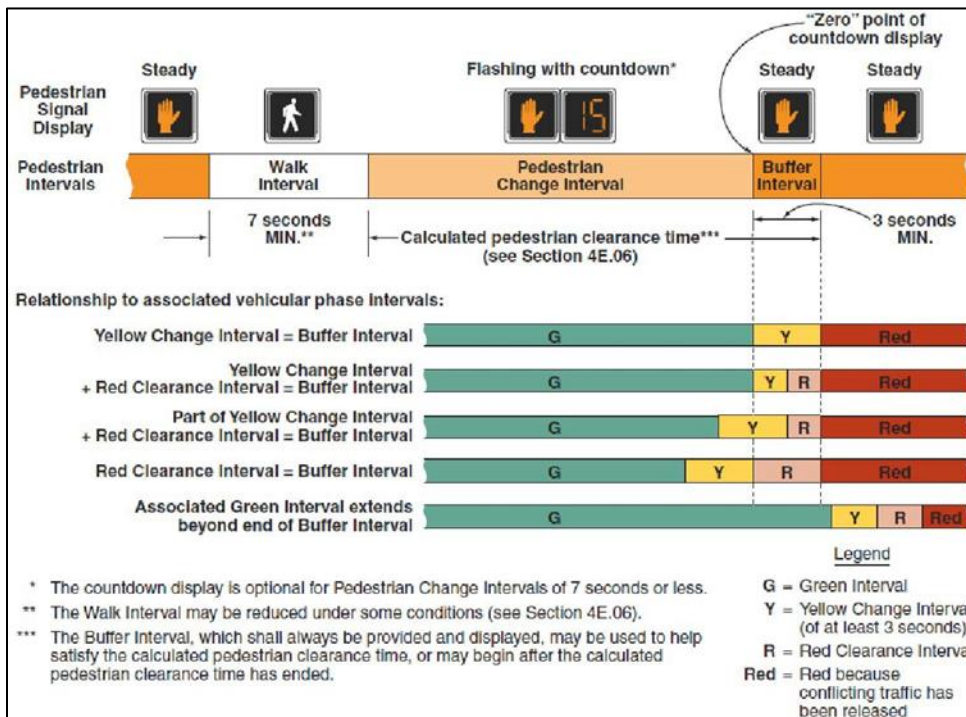
Pedestrian Intervals. Pedestrians should be provided with sufficient time to cross the roadway or right-of-way every signal cycle unless pedestrian detectors are installed. Figure 37 illustrates the pedestrian intervals and their possible relationships with associated vehicular signal phase intervals.

Figure 37. Pedestrian intervals (MUTCD figure 4E-2)

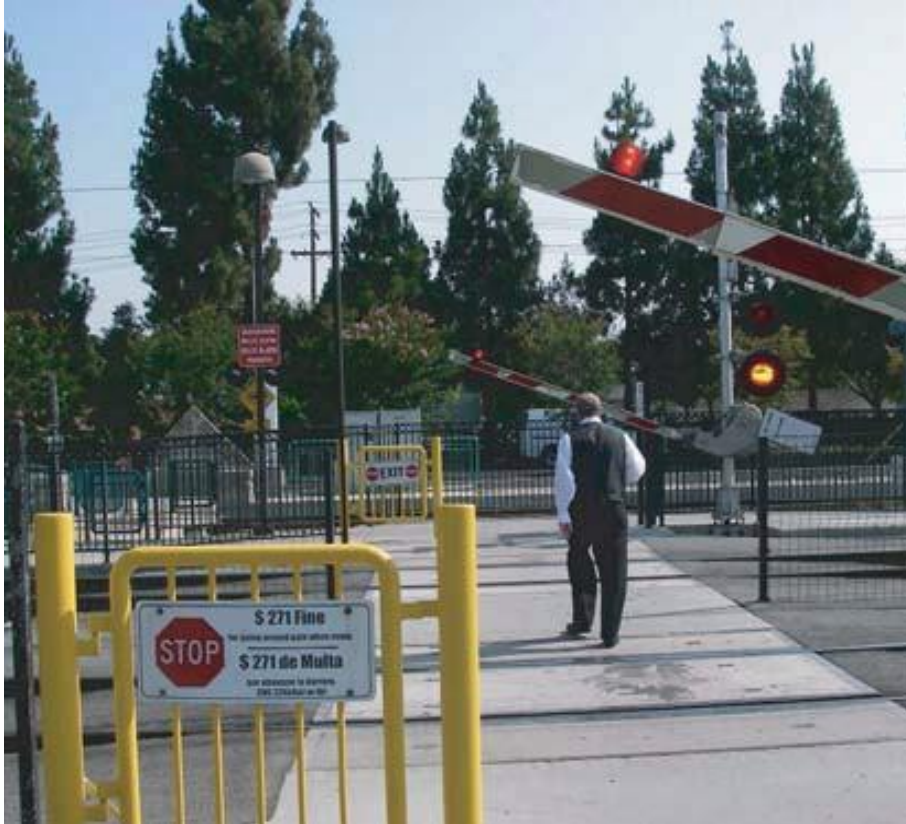
Figure 46. Pedestrian automatic gates in combination with pedestrian swing gates, Mountain View, CA

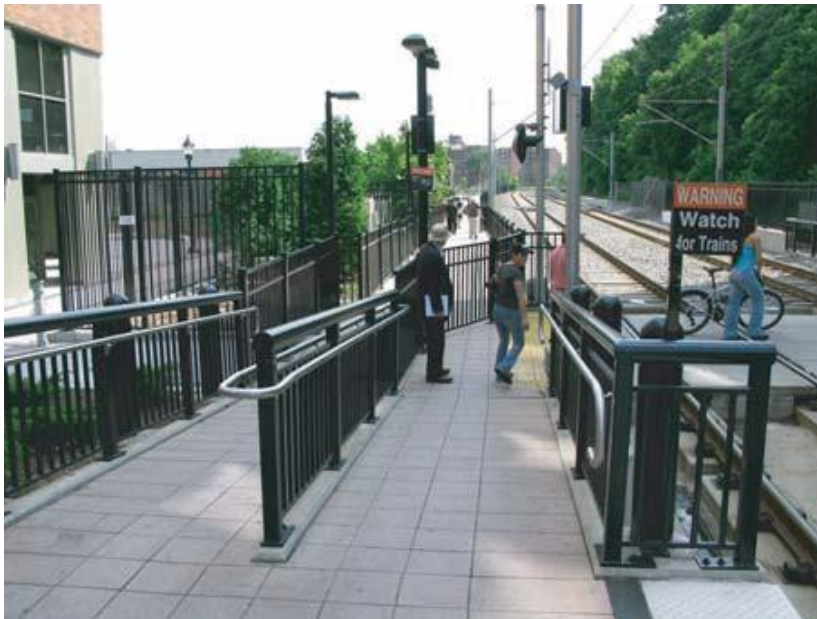
Offset crossings should be used only at pedestrian crossings with adequate sight distance. If pedestrians are turned to face approaching LRVs but cannot see them because of obstructions, the Z-crossing becomes useless. Furthermore, Z-crossings should not be used if LRVs operate in both directions on a single track because pedestrians may be looking the wrong way. Therefore, Z-crossings are not suitable near end-of-the-line (terminal) LRT stations, beyond the track crossover, or where LRVs routinely reverse-run into or out of a station. Examples of offset pedestrian crossings are shown in Figures 53 and 54.

Figure 53. Offset pedestrian crossing at an LRT station Hudson-Bergen Line, NJ

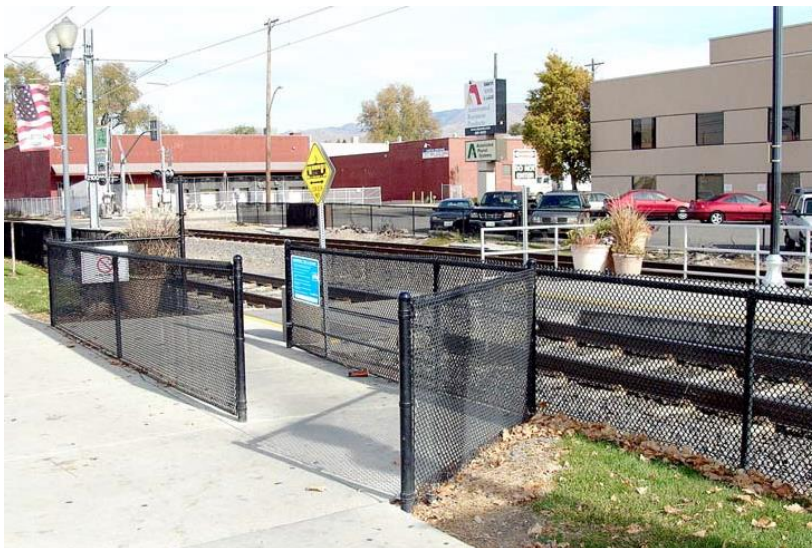
Figure 54. Offset pedestrian crossing, UTA Metro Salt Lake City, UT

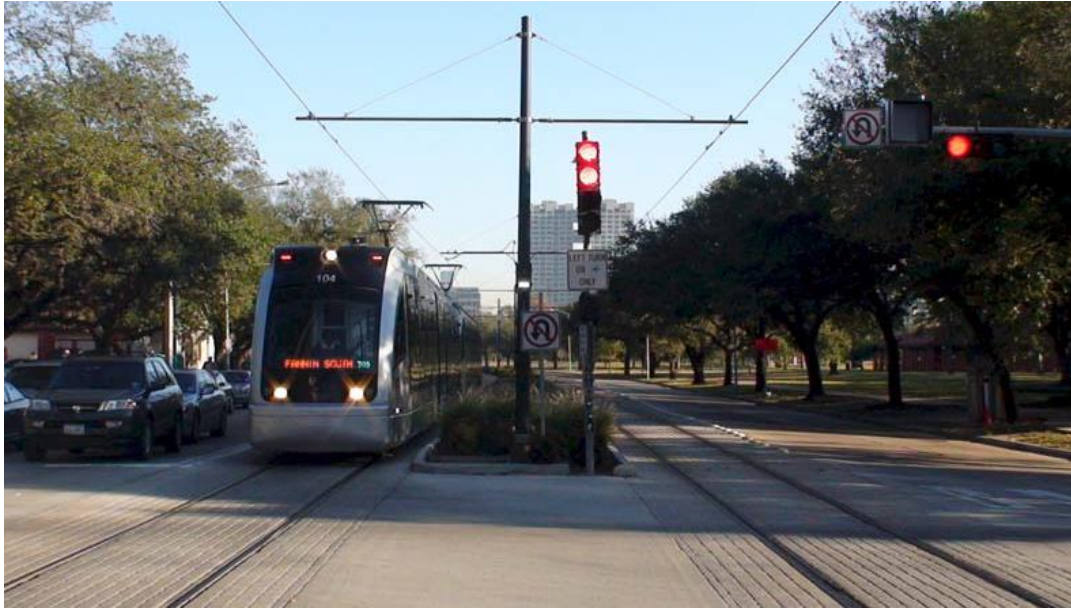
Figure 58. Textured concrete marking of LRV track area, Houston Metro, TX

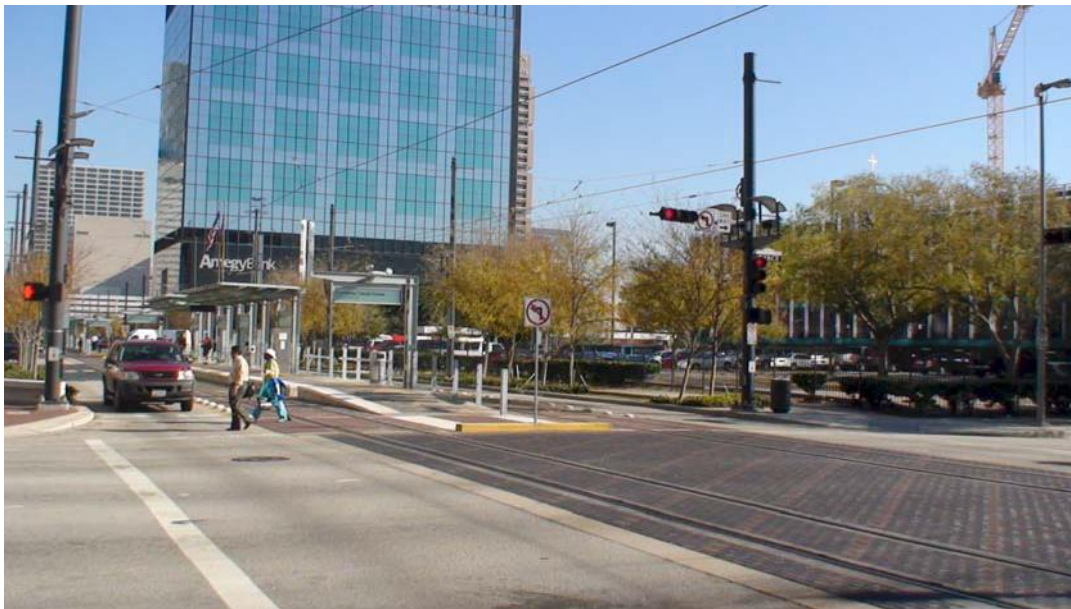
Figure 59. Colored, textured concrete marking of LRV track area, Houston Metro, TX

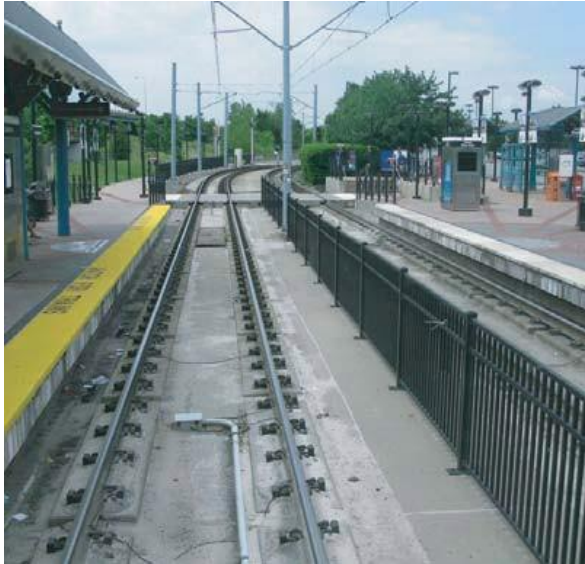
Figure 63. Paint and texture on station platform edges, Hudson-Bergen line, NJ

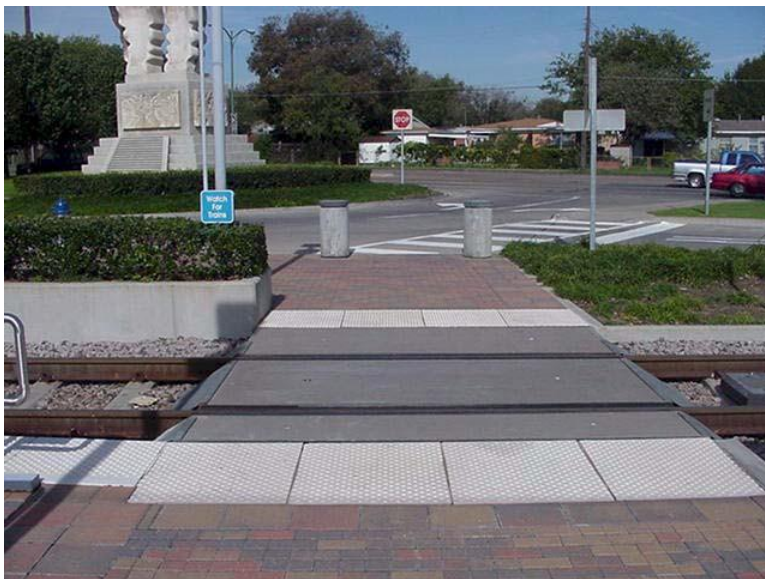
Figure 64. Textured concrete and tactile strips marking the pedestrian crossing area, DART, Dallas, TX

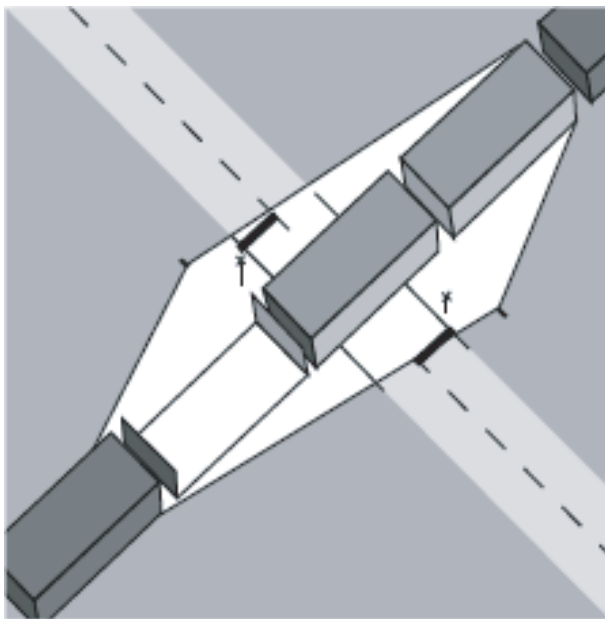
Figure 68. Schematic of rail-highway grade crossing illumination

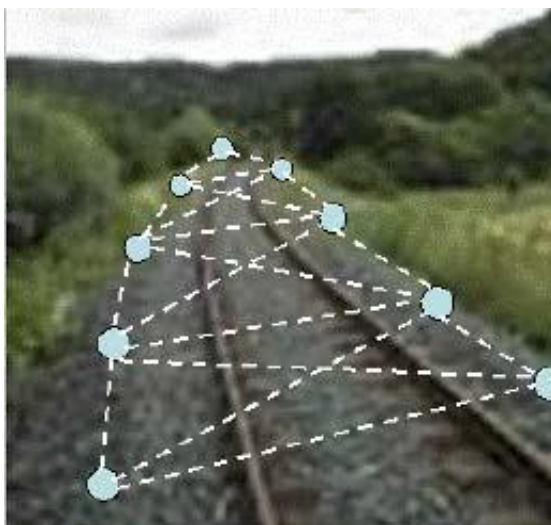
Figure 70. A wireless sensor network along trackway
