# Development and Regionalization of *In Situ* Bioslopes and Bioswales

**July 2019**

Research Report

Final Report 2019-31

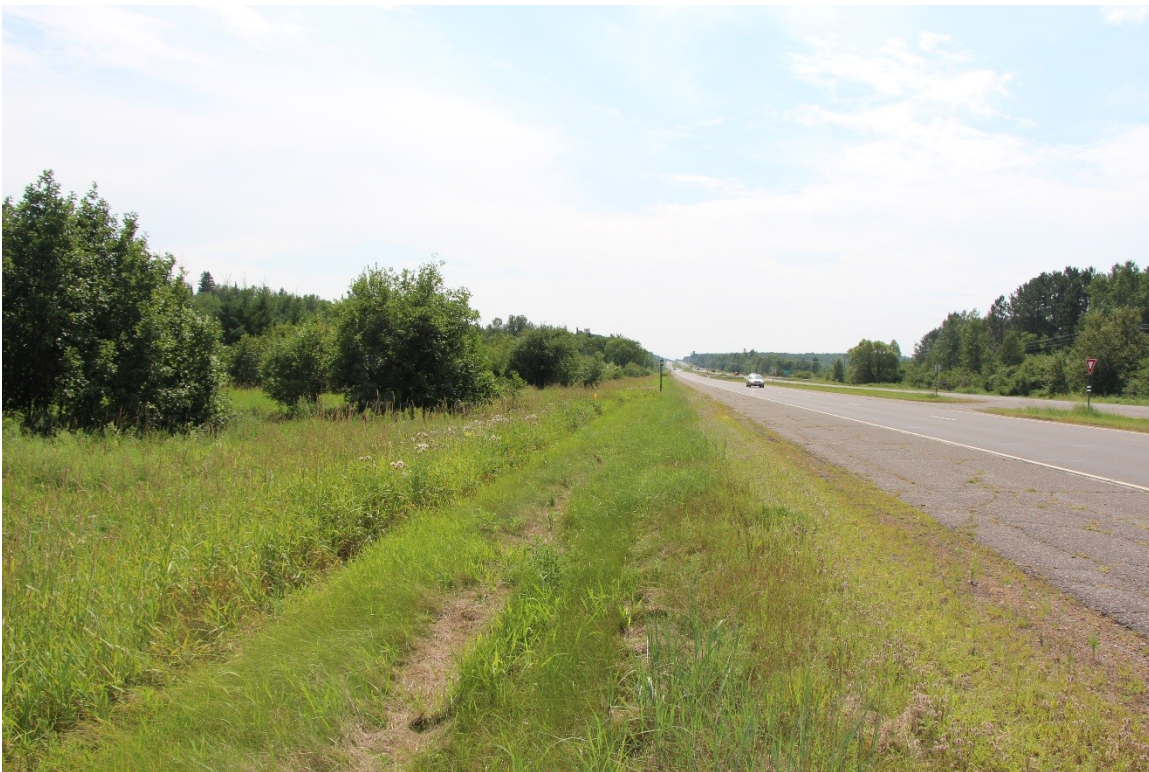
**Figure 2.1 Existing bioslope in place along a highway in northern Minnesota.**

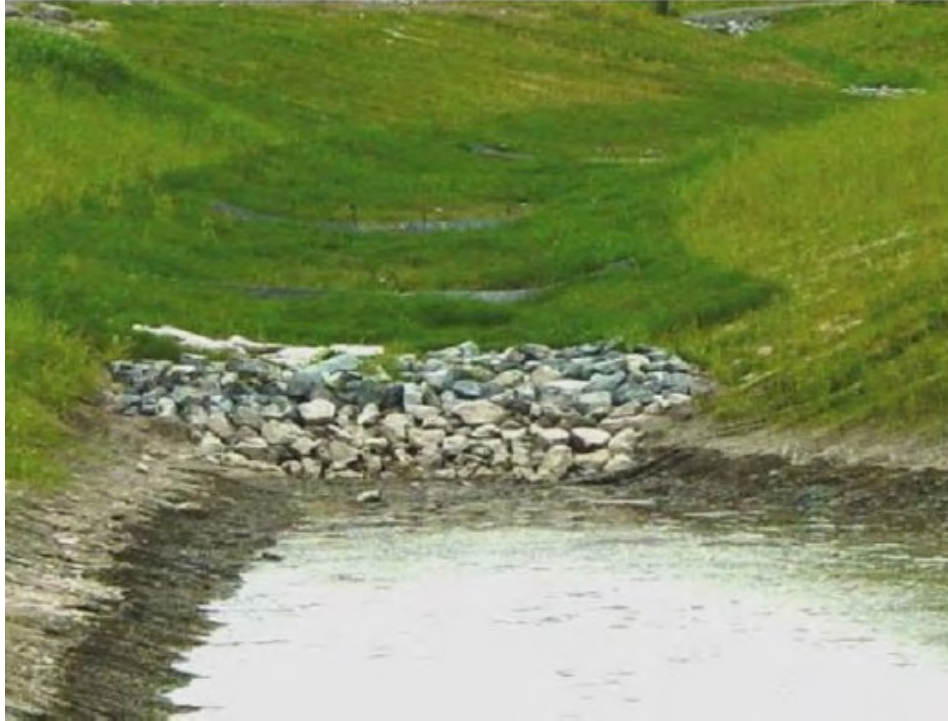
**Figure 2.14. Bioswale with designed outflow into a detention pond (adapted from ODOT, 2014).**

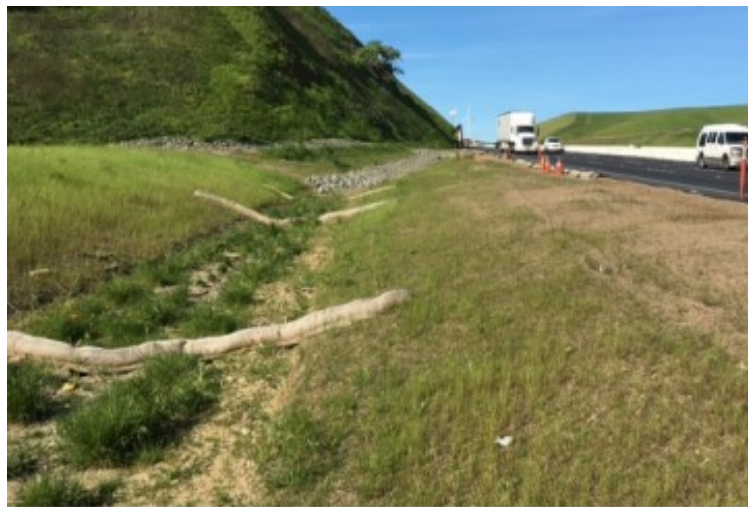
**Figure 2.16. Vegetated swale with temporary check dam (Caltrans, 2017).**

There are several optional bioswale design features to control flow including check dams, inlet flow spreaders and underdrains. Check dams, shown in Figure 16, can be constructed of concrete, rock, mounded soil, boards, or nailed compost logs (Caltrans, 2011; Jurries, 2003; WSDOT, 2014). Check dams are used to cause water to pool in sections of the bioswale, decreasing flow velocity and increasing residence time (Jurries, 2003). Inlet flow spreaders, shown in Figure 17, are also recommended to control incoming flow velocity and produce sheet flow. Inlet flow spreaders are used in systems that have directed flow into the bioswale via pipes or curbs (Caltrans, 2011; Jurries, 2003; ODOT, 2014). Bioswales may also utilize an underdrain to help water flow through the swale media and reduce ponding. ODOT (2014) recommends the use of an underdrain for bioswales placed in poor draining media or with a slope less than 1.5%.

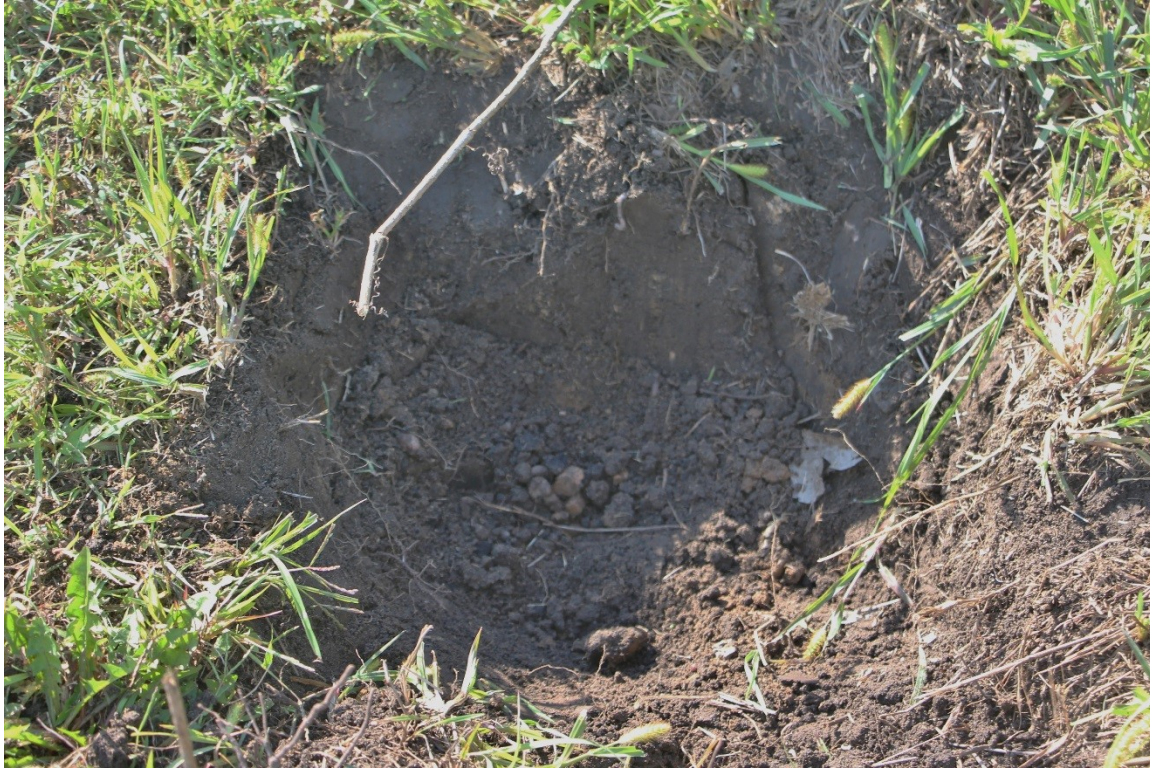
**Figure 3.4. Characteristic soil profile from the Chaska biofilter.**

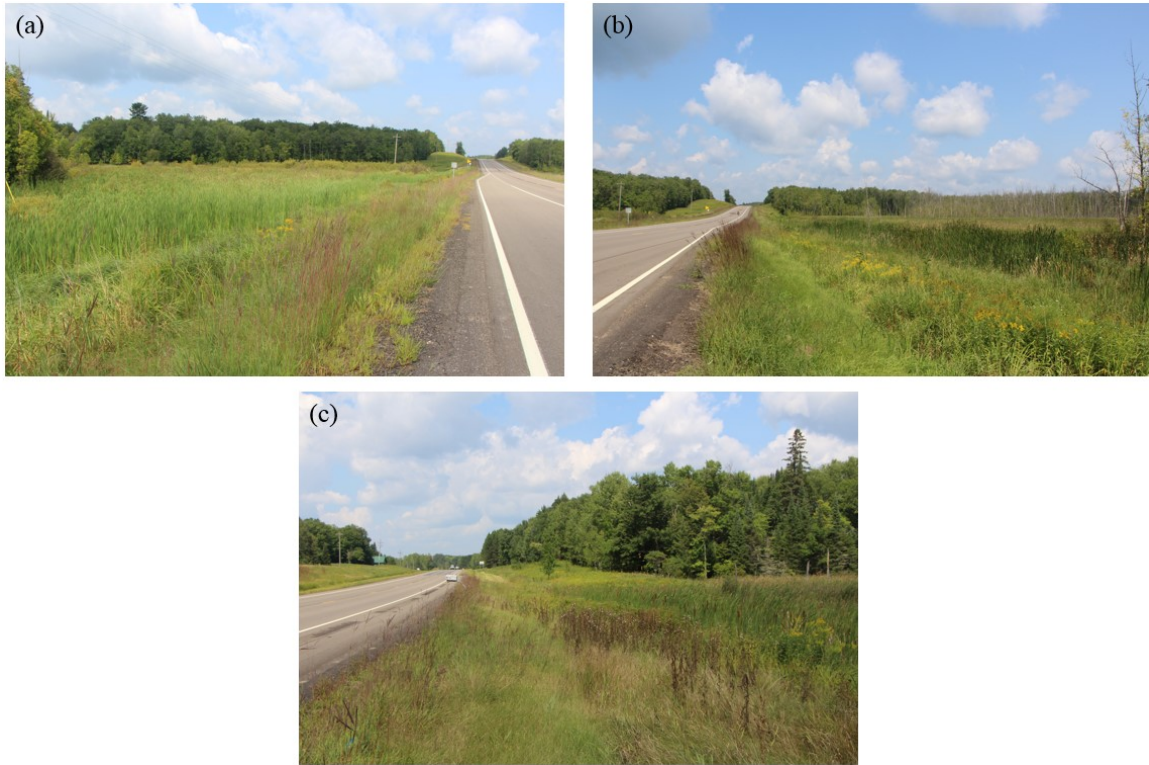
**Figure 3.12. (a) West portion of Crosby Site 1. (b) East portion of Crosby Site 1. (c) Crosby Site 2.**

*In situ* testing was conducted at the Crosby biofilters in August of 2018. Both biofilters had a moderate slope and were vegetated with un-maintained grass that extended from the shoulder of the road for approximately 15 feet. The sloped sections of both sites ran into a wetland area which could be identified by the cattails and reeds as shown in Figure 29. Test plots were prepared in the biofilter by trimming grass to a height of several inches, followed by the removal of the debris. Soil sampled from the biofilters were uniform and sandy as shown in Figure 30.

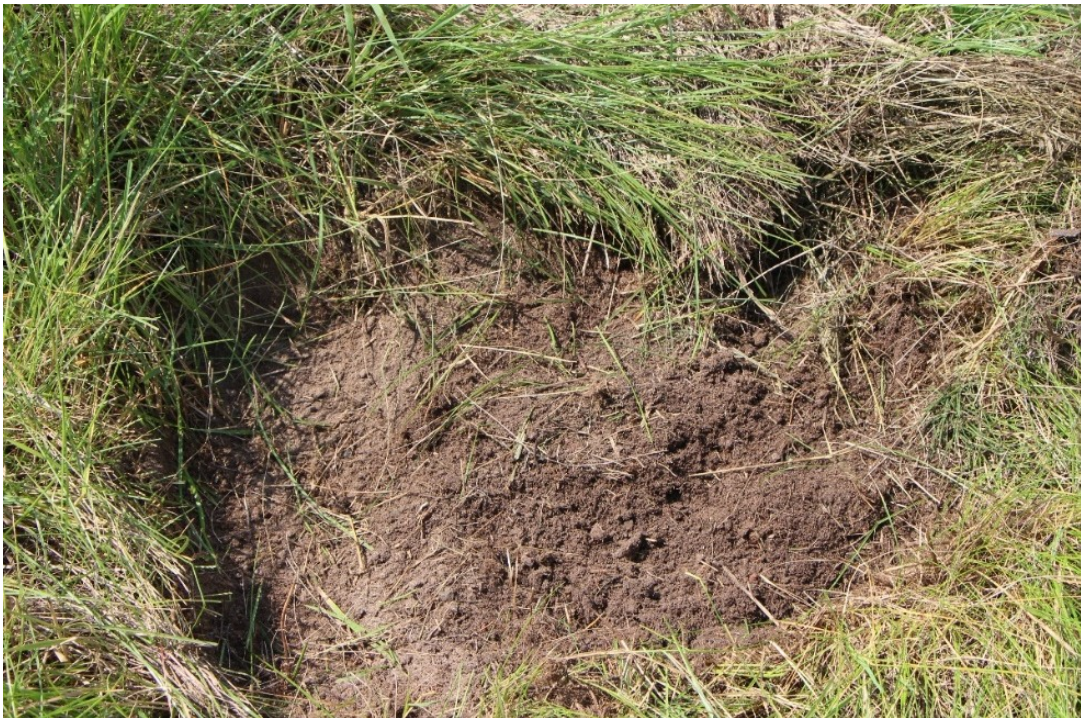
**Figure 3.13. Characteristic soil profile from the Crosby biofilters.**

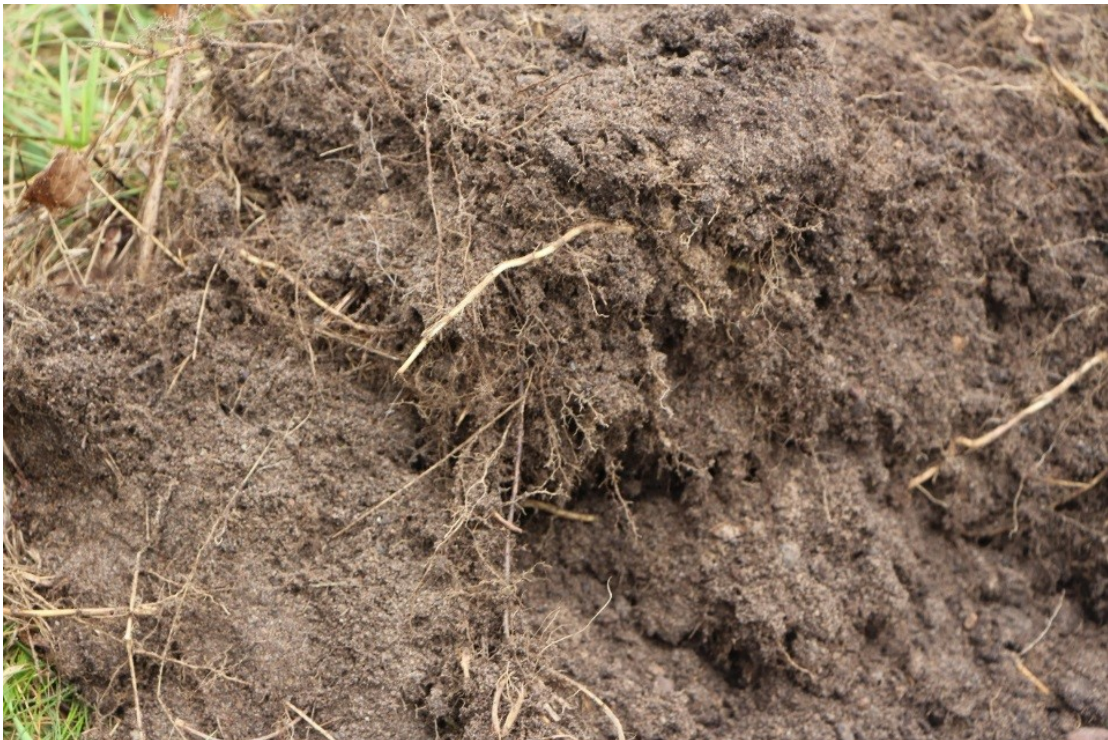
Figure 3.16. Characteristic soil profile from the Gilbert Lake biofilter.

Field investigation and testing was conducted in August of 2018. Much of the biofilter was found to have a steep slope (between approximately 60 to 70 degrees) and was deemed unsafe for testing. A section of the biofilter towards the southeast shore of Lake Gilbert, shown in Figure 32, and several sites near the road with moderate slopes were selected for field testing. Although grass was maintained along the road, the sites were initially prepped for testing by trimming grass to several inches in height and then removing debris. Soil samples taken at the site included sands with some larger sized aggregate as shown in Figure 33.

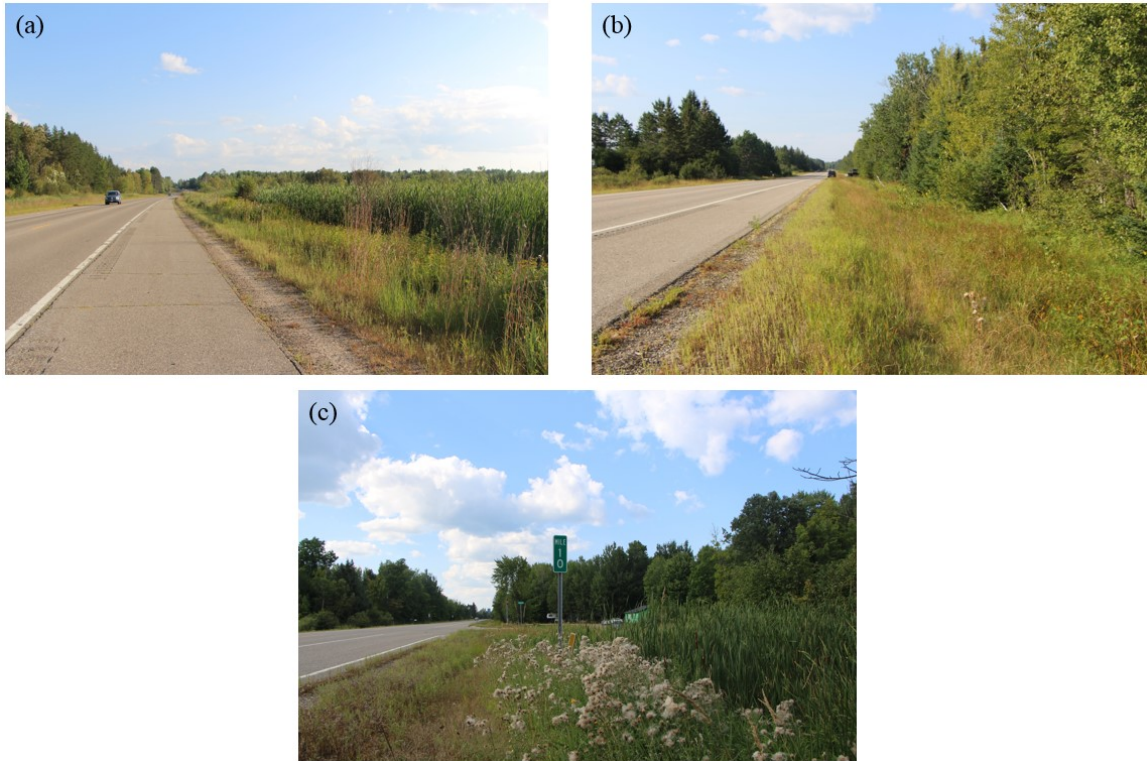
**Figure 3.18. (a) Grand Rapids Site 1. (b) Grand Rapids Site 2. (c) Grand Rapids Site 3.**

Field testing was conducted at the Grand Rapids sites in August of 2018. The 3 sites all had mild slopes and a grassed section that extended for approximately 10 feet from the road as shown in Figure 34. Prior to testing, grassed sections of the slope were cut to several inches in height and debris was cleared. Soils sampled at the site were uniform and sandy as shown in Figure 35.

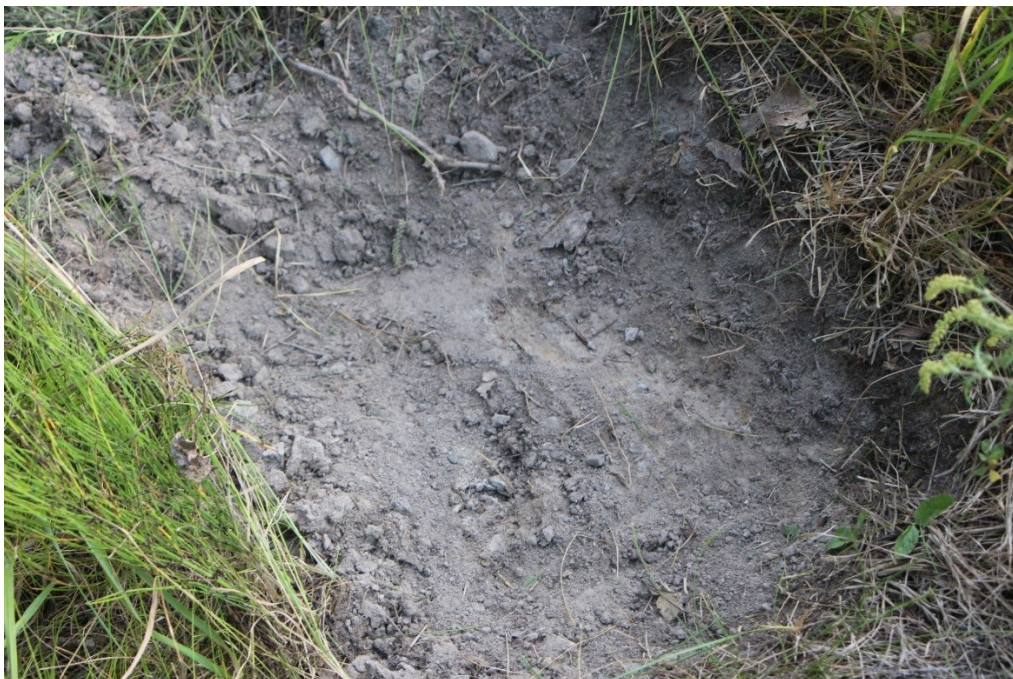
**Figure 3.19. Characteristic soil profile from the Grand Rapids biofilters.**

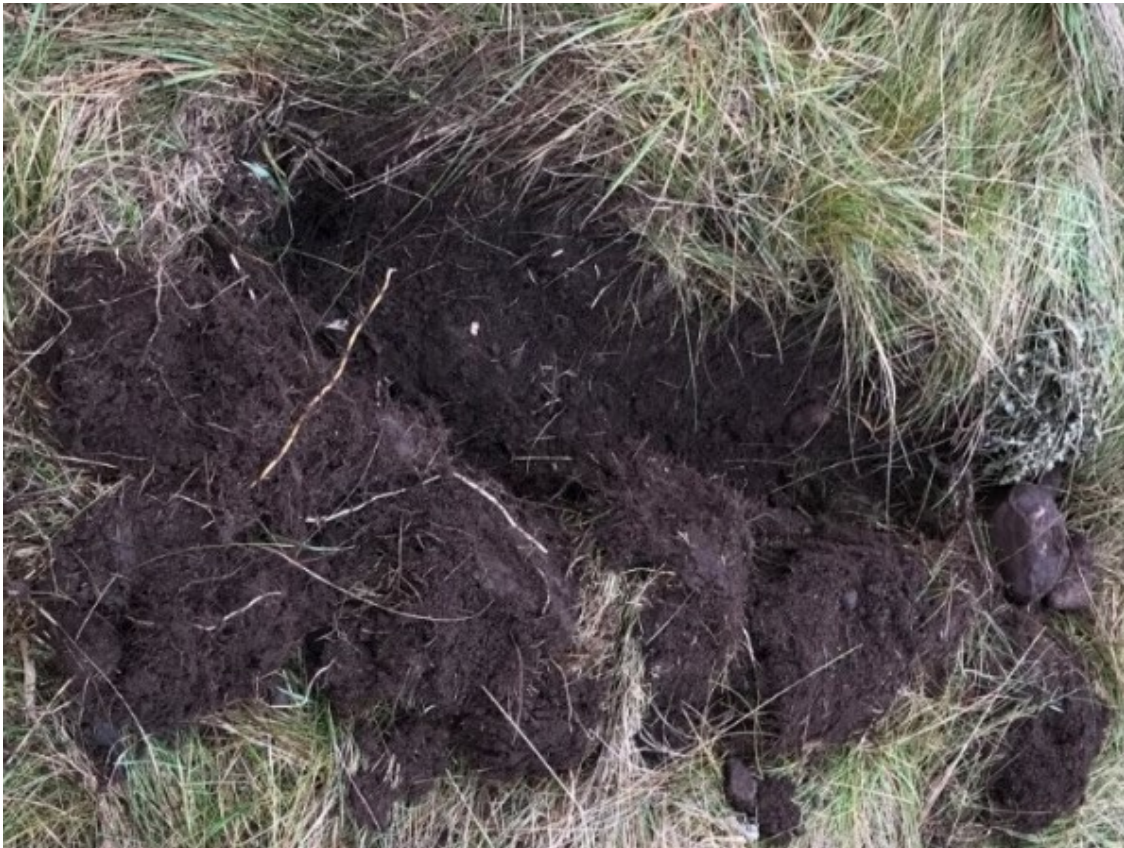
Figure 3.25. Characteristic soil profile from the Silver Creek Cliff biofilter.

Field testing was conducted at the Silver Creek Cliff biofilter site in August of 2018. The biofilter extends over approximately a half of a mile along both trail sections and a short section of roadway as seen in Figure 41. The broader section of the biofilter has a moderate slope, sections along the trail are relatively flat. Sections of the biofilter along the trail and further north by the parking lot contained high amounts of gravel that made testing difficult. Sampling was carried out at the trail access point. Vegetation was initially cut to several inches in height and cleared from locations prior to testing. Soils from the site were sandy and contained some coarse aggregate as shown in Figure 42.

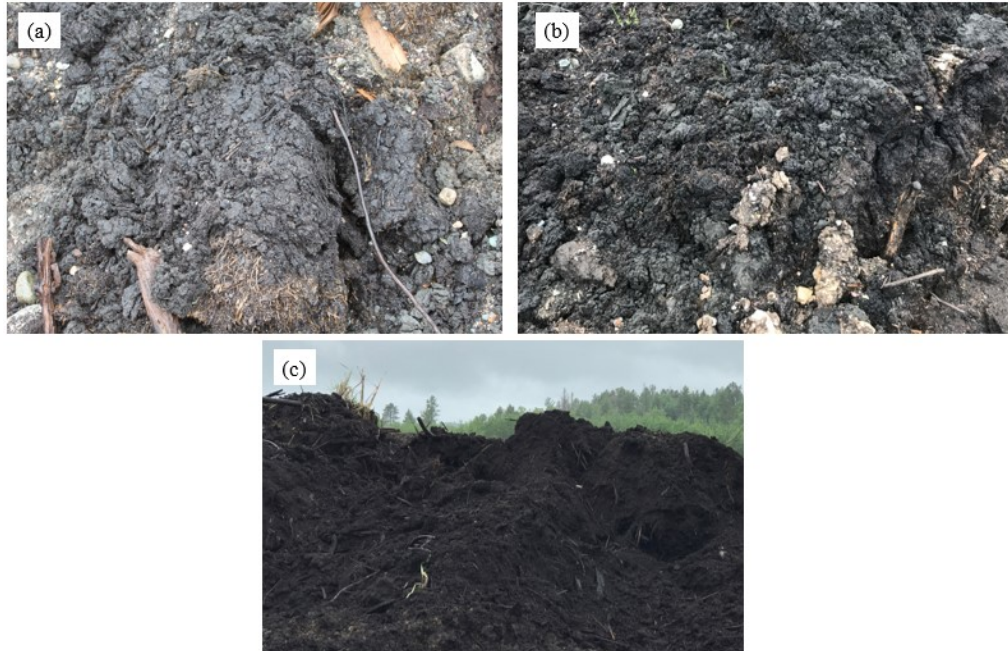
Figure 4.2. (a) Site 1 peat sample. (b) Site 2 peat sample. (c) Site 3 peat sample.

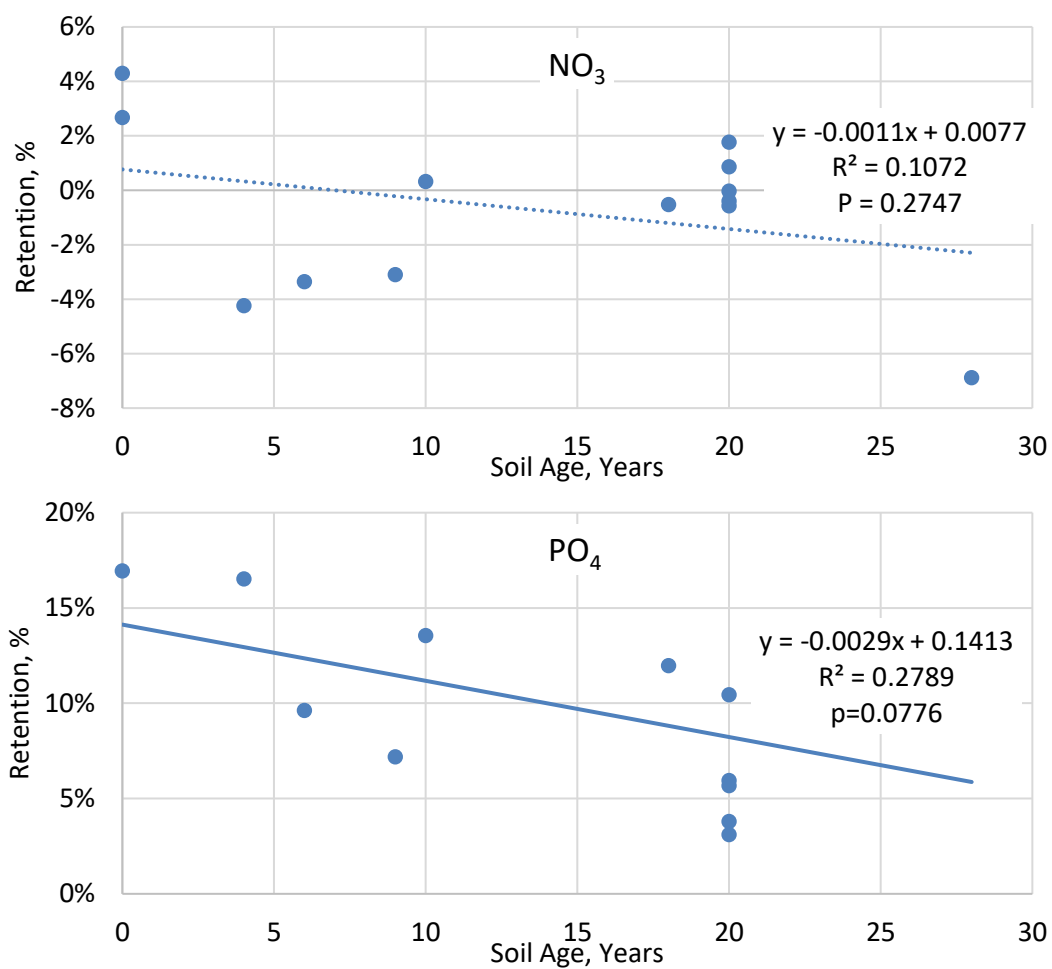
Figure 5.16. The linear fit between the percent of chemical retained and soil age. The significant ( $p < 0.1$ ) fit is shown in a solid line and the dashed line represents the insignificant fit.

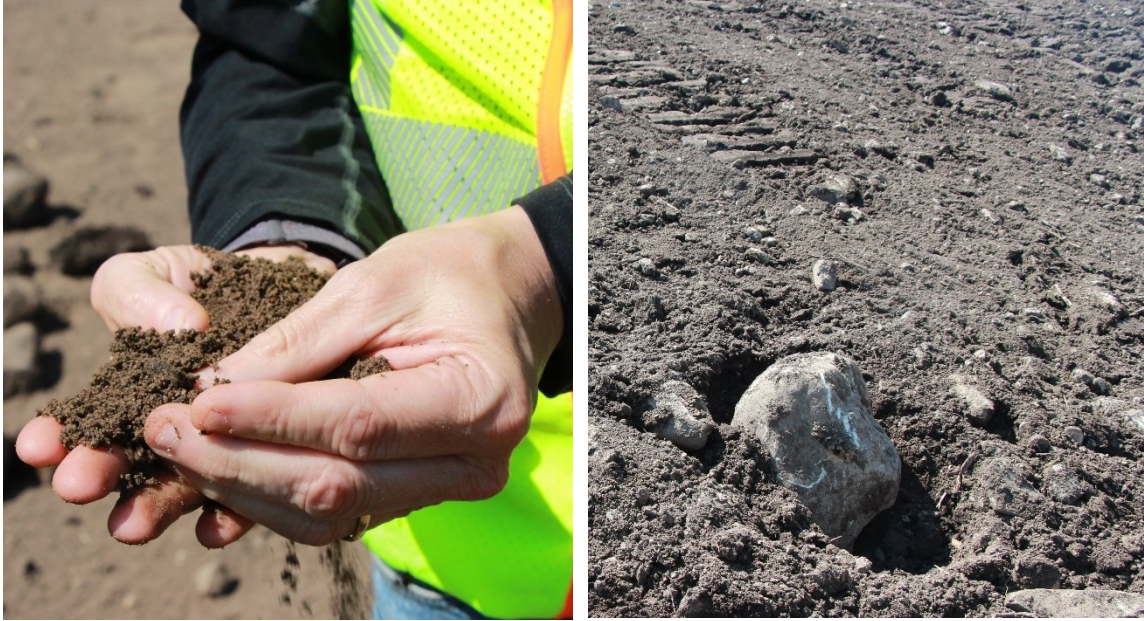
**Figure 6.2. Typical sample of peat used at the Eagles Nest Project site.**

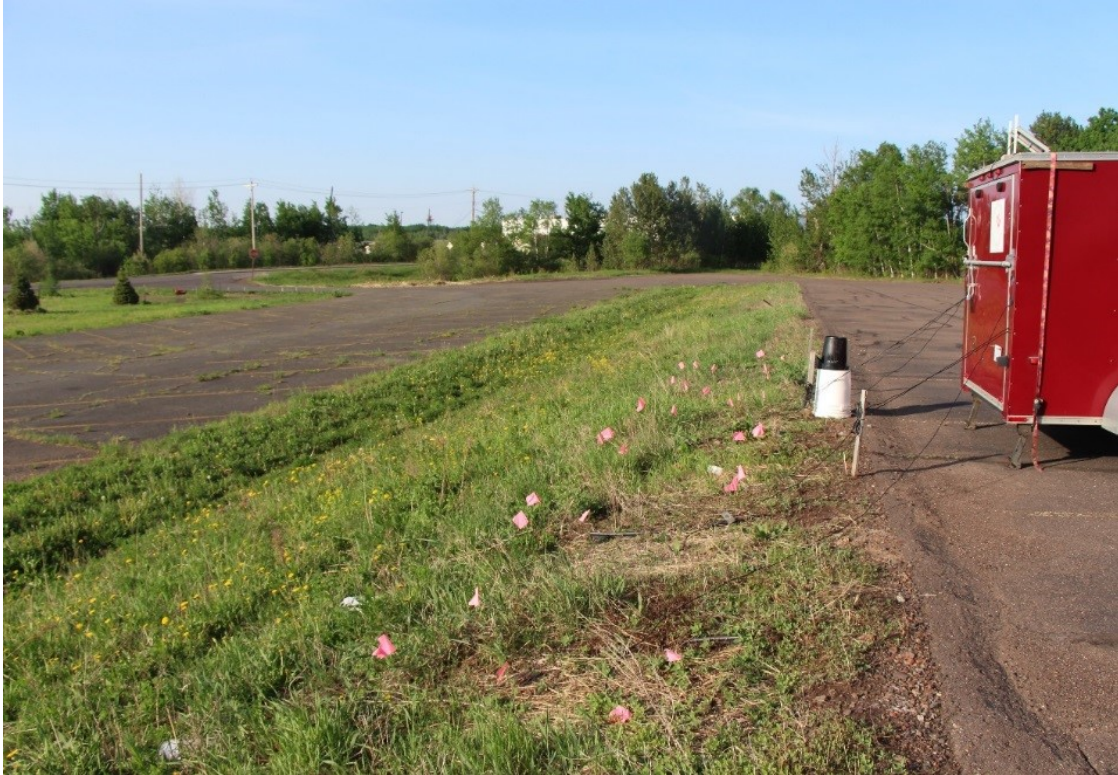
Figure 6.5. Field pilot test plot at NRRI.

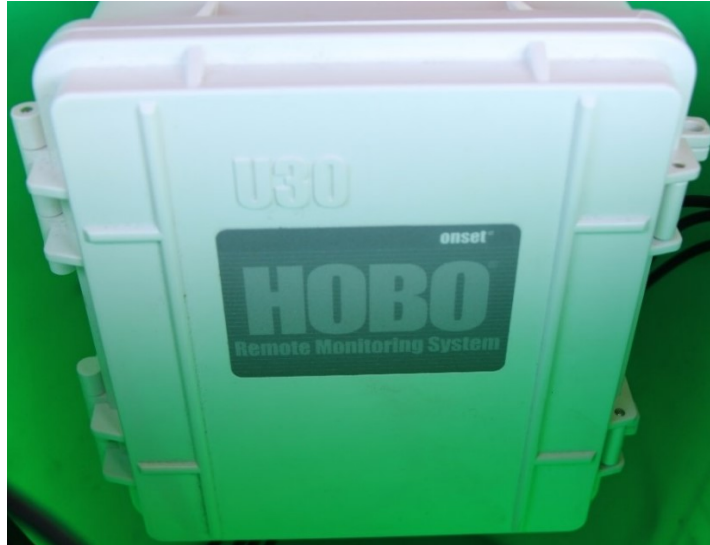
Figure 6.7. Data acquisition unit used to record soil moisture, rainfall and temperature during monitoring.

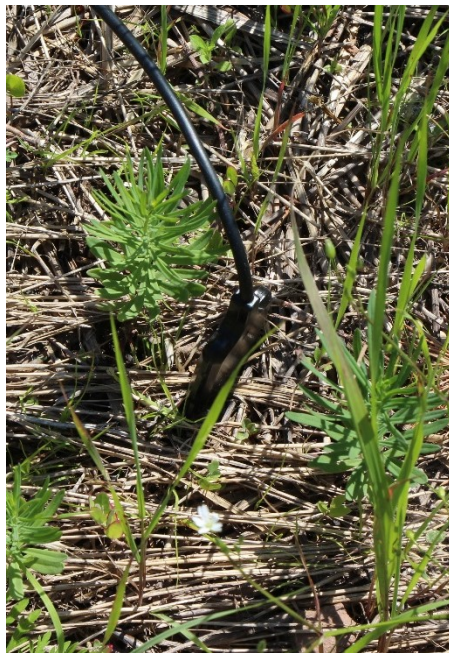
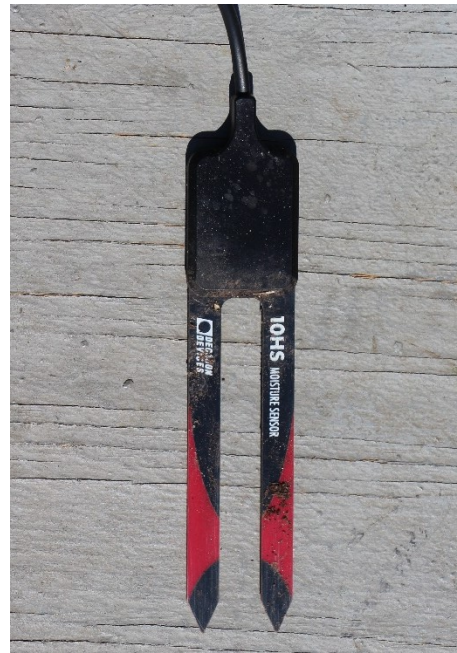
Figure 6.8. Typical soil moisture probe used for monitoring.

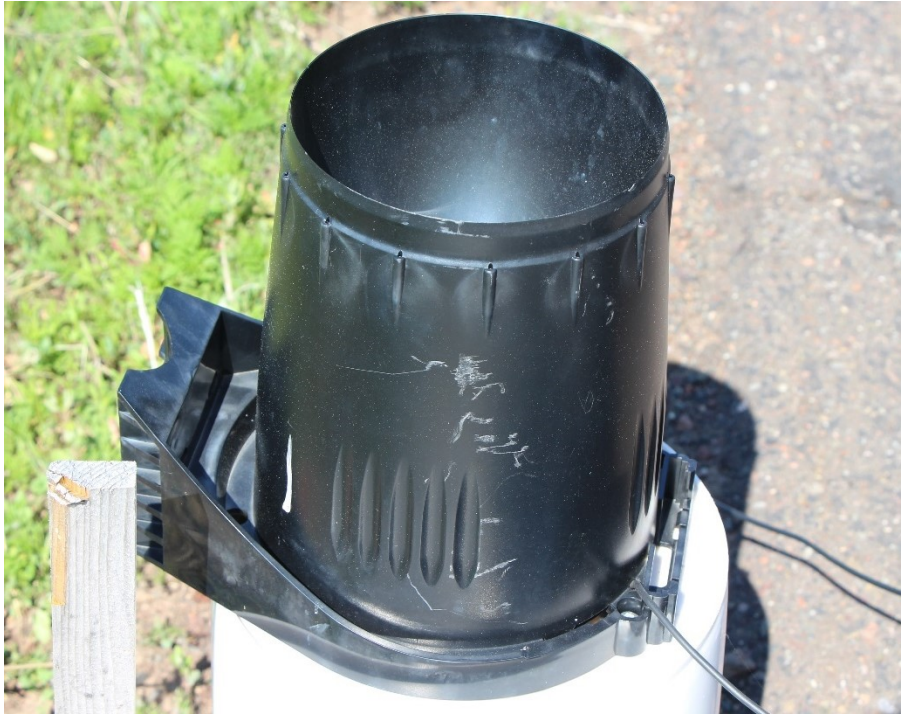
**Figure 6.9. Rain gauge monitoring unit.**

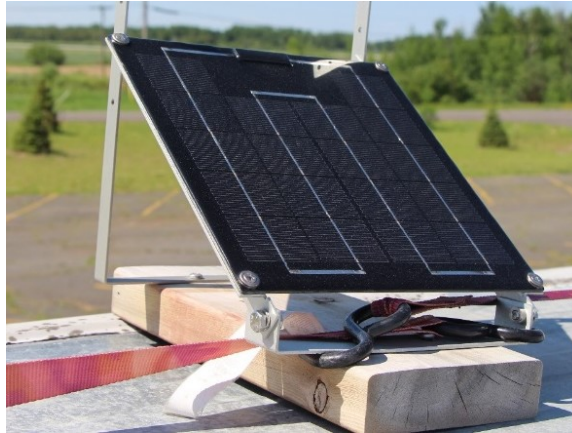
**Figure 6.11. Solar panel used to sustain long term monitoring.**

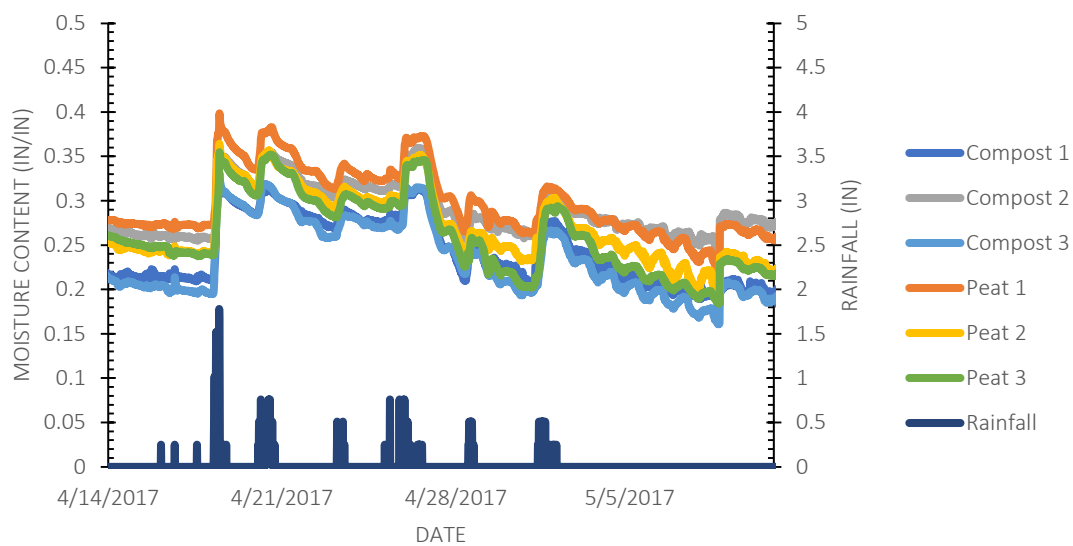
Figure 6.12. Soil moisture and rainfall event data for the NRRI test plot during the spring of 2017.

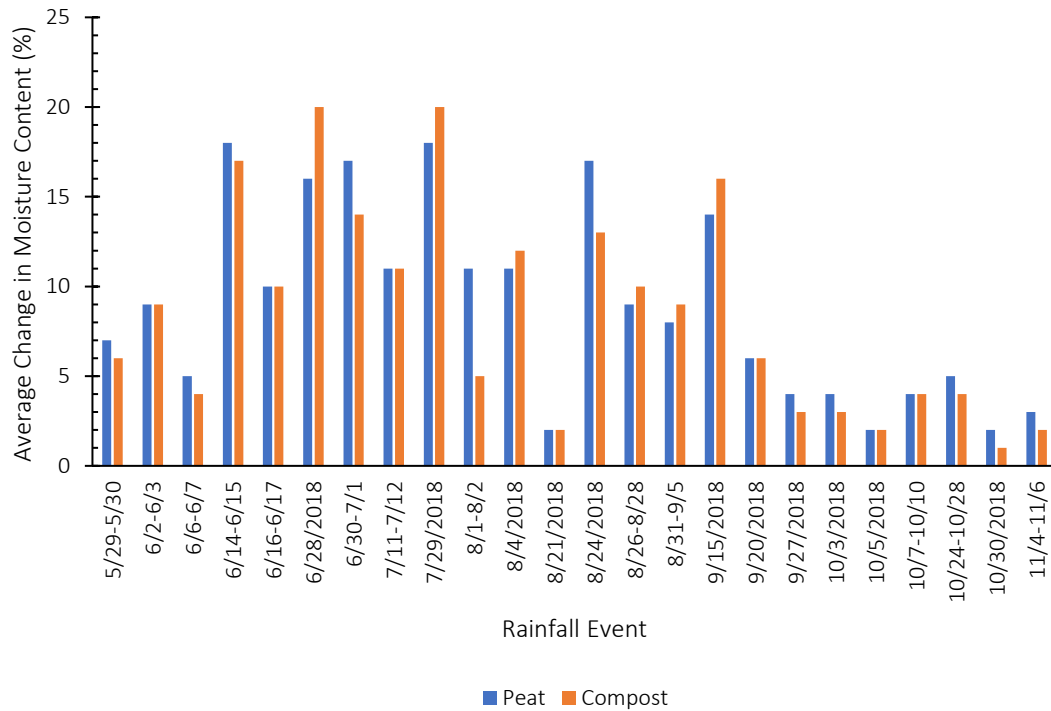
**Figure 6.14. Comparison of water absorption for the NRRi pilot plot for 2018.**

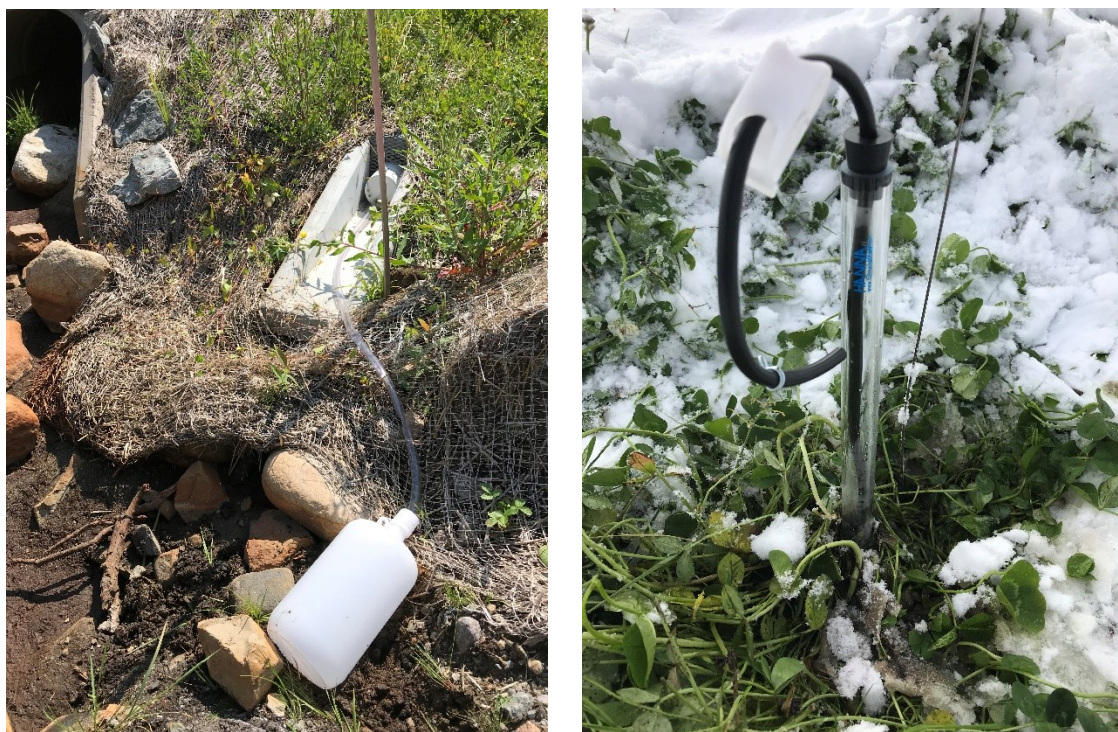
**Figure 6.27. Leachate collection from Eagles Nest trench (left) and lysimeters installed in Eagles Nest slope (right).**
