# Cost/Benefit Analysis of the Effectiveness of Crack Sealing Techniques

University of Minnesota Duluth

Research Report

Final Report 2019-26

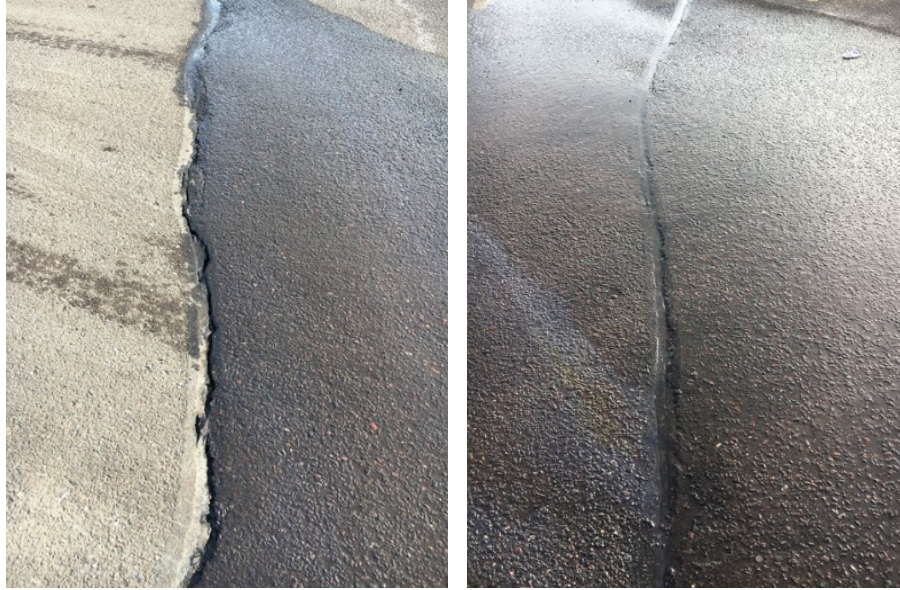
(a) Failed Crack Seal

(b) Intact Crack Seal

**Figure 1.1 Photographs Show the Benefits of Effective Crack Seal**

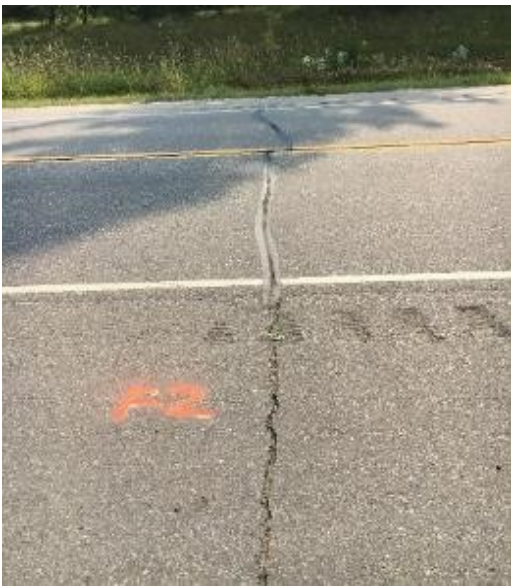
**Figure 1.2 Photograph of a Transverse Crack**

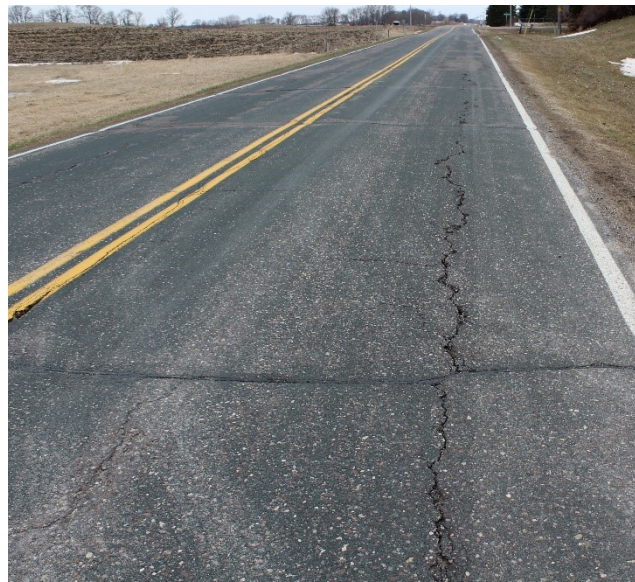
**Figure 1.3 Photograph of a Longitudinal Crack**

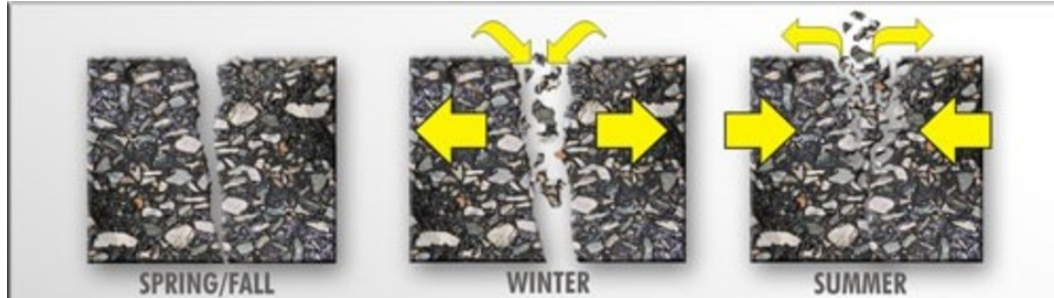
Figure 2.2: Incompressibles Intrusion Related Damage (after, Stoikes, 2017)

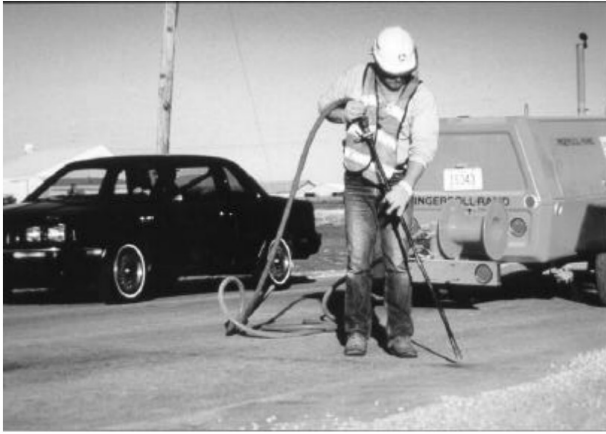
Figure 2.4: Airblaster Being used to Clean a Crack (after, Smith and Romine, 1999)

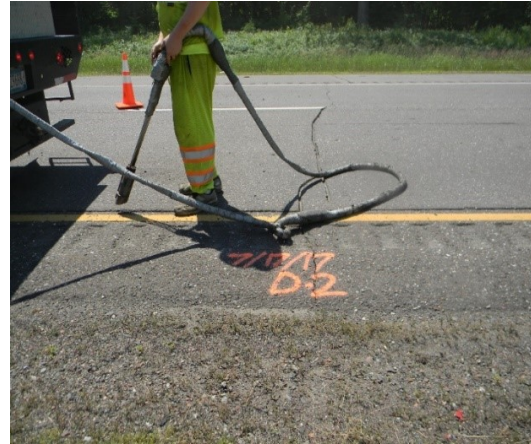
Figure 2.5: Air lance being used to Clean a Crack

**Air Lance:** Hot air blasting uses air that is heated to a minimum of 1,370° Celsius as defined by the Smith and Romine (1999). This form of cleaning is effective at removing dirt and debris. It also creates a dry and hot crack surface for a sealant to bond to. A hot surface will likely create a better bond for the sealant by activating the binder in the pavement itself. Caution must be used, however, as it is possible to burn the asphalt concrete pavement with a lance. For this reason, an open flame torch should never be used for this procedure. Figure 2.5 shows an example of an air lancing to clean a crack.

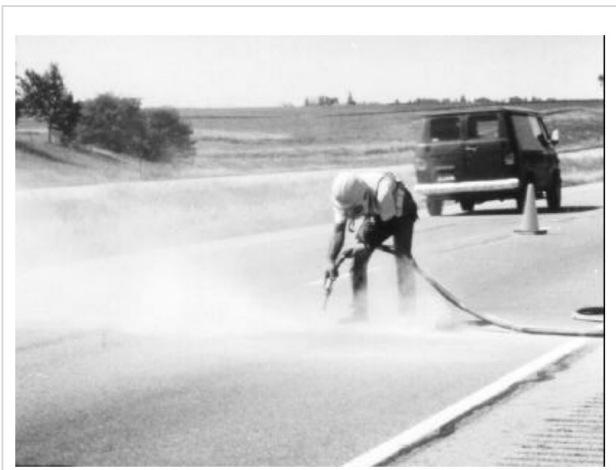
Figure 2.6: Sandblaster Being Used to Clean a Crack (after, Smith and Romine, 1999)

**Sandblaster:** Sandblasting is a highly effective way of removing debris and loosened fragments from the channel of a crack. One pass of the sandblaster should be made on each side of a routed reservoir. The procedure leaves a smooth and textured surface that is ideal for the sealant to bond to. Sandblasting consists of a compressed air unit, sandblaster machine, hoses, and a wand. A second pass with an air compressor is typically necessary to clean any debris that was left during the sand blast. Due to the number of passes needed, sand blasting requires a great deal of equipment, is labor-intensive, and time-consuming. Figure 2.6 shows an example of sand blaster being used to clean a crack.

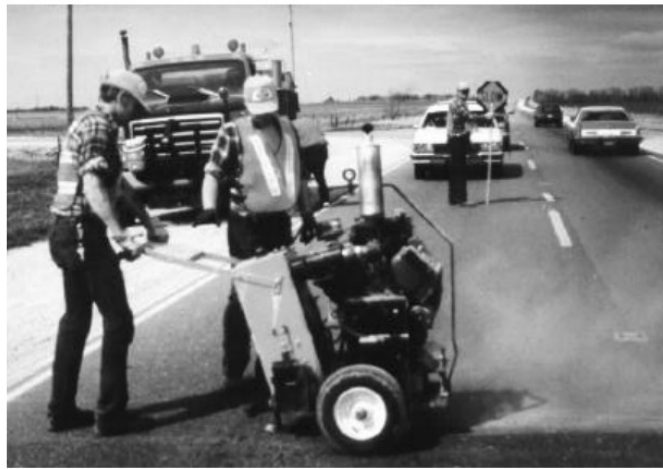
Figure 2.8: Routing Machine (after, Smith and Romine, 1999)

**Routing Machine:** Crack routing is performed by a worker using a router or saw unit mounted onto a cart. The operator uses his/her eyes and best judgment to follow the path of the crack with the routing or sawing machine. Smith and Romine (1999) noted that although a saw with a 150-200 mm diameter diamond blade can follow the meanders of cracks fairly well, the high cutting rate of an impact router creates smoother reservoir walls with a higher percentage of aggregate area for the sealant to bond to. Most companies require that employees operating routing equipment wear some type of respirator mask. The most modern routing machines have air and dust control systems built into them. Figure 2.8 shows an example of a router in operation.

The first step of performing the rout-and-seal crack treatment is routing the cracks. Routing machinery comparable to that shown in Figure 2.8 is used for this. Figure 2.15 shows a crack before and after being routed.

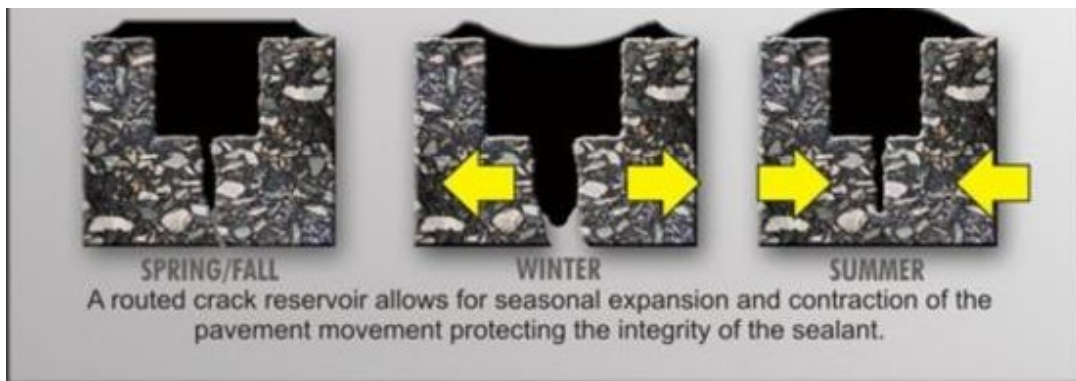
Figure 2.14: Routed Seal Expanding and Contracting Without Failure (after, Stoikes, 2017)

There are three major benefits of creating the reservoir. One benefit is that the saw routing machine removes a percentage of deteriorated material from the immediate area around the existing crack. This reduces the possibility of water entering hairline secondary cracks around the existing crack and causing continues deterioration. The second benefit of cutting a reservoir is that it creates a very cleanable and sealable surface. It is much easier for workers to blow debris out of a fresh cut reservoir than an existing crack with various irregularities in its geometric shape. The consistently clean sidewalls made by routing are a good surface for a sealant to bond to. The third and largest benefit of routing cracks is that the reservoir holds a large pool of sealant that has a larger ability to expand and contract with the pavement due to thermal fluctuations. See Figure 2.14.

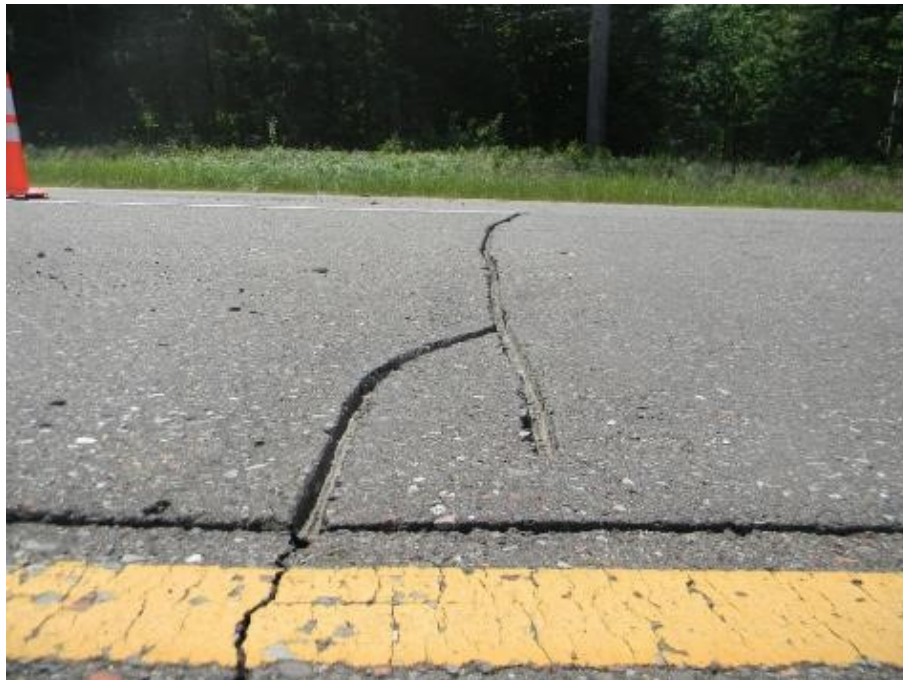
**Figure 2.16: Routed Crack After Cleaning**

Upon a crack being routed, air blasters, air lances, or wire rushes must be used to clean the crack prior to application of sealant. Figure 2.16 shows a routed crack after being air blasted and heat lanced.

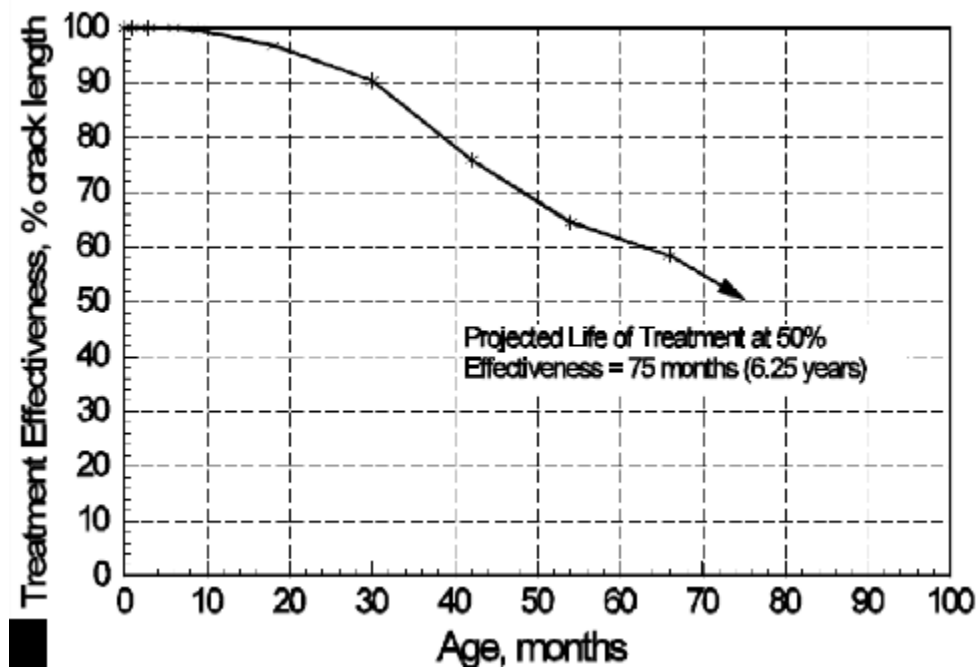
Figure 3.1: Trend of Seal Deterioration over Time (after, Smith and Romine, 1999)

Smith and Romine (1999) suggested that sealant performance can be measured by summing the lengths of failed segments and dividing by the total length of treated cracks inspected. After multiple field inspections, a graph can be made that shows the treatment effectiveness over time. Also, by defining a minimum threshold of effectiveness, the project lifespan can be determined. Figure 3.1 shows such a graph, with treatment effectiveness (%) on the y-axis and age (months) on the x-axis. In addition, the author recommended that at least one inspection be performed each year on treated cracks to document the failure rates and plan for future maintenance operations. It is also recommended that a mid-winter evaluation shall be conducted in order to evaluate the performance of crack treatments during maximum crack expansions. Caltrans (2008) provided a guideline on the crack sealant distresses and their likely cause and remedial measures. See Table 1 and Table 2.

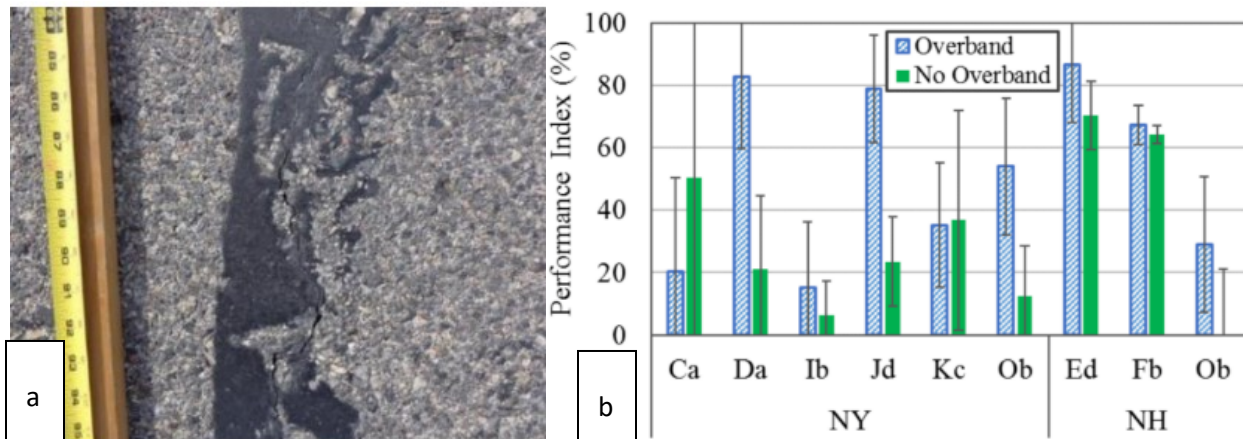
Figure 3.5: (a) Overband Failure and (b) PI Comparison of Overband vs no-overband seals (after, Al-Quadi et al., 2017)

In that study, in order to observe the influence of the overband, two roadway sections in New York (NY) and New Hampshire (NH), were used; both overband and no-overband placement configurations of sealant were also considered. As shown in Figure 3.5, it was found that the overband seals out-performed the no-overband seals for all sealant types in most cases.

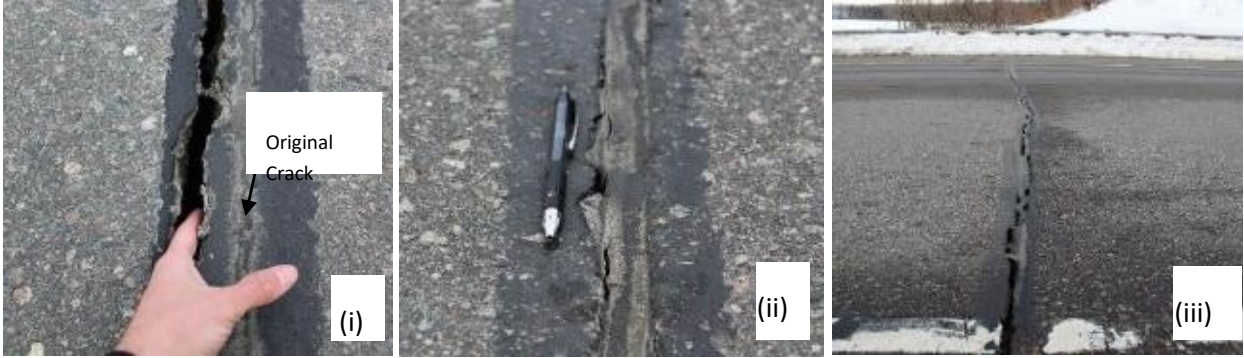
Figure 4.28: Examples of Seal Failures (i) Spalling, (ii) Partial Adhesion Loss, (iii) Full-depth Adhesion Loss.)

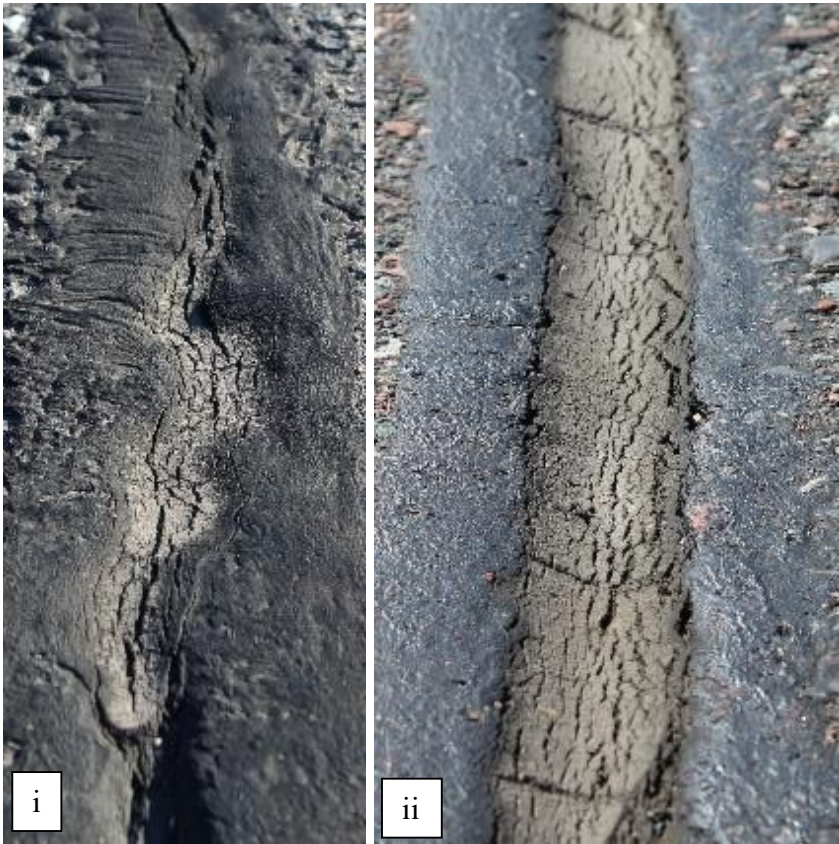
Figure 4.29: (i) Cohesion Failure of Clean-and-Seal Crack (ii) Early Signs of Cohesion Failure on Rout-and-Seal Crack

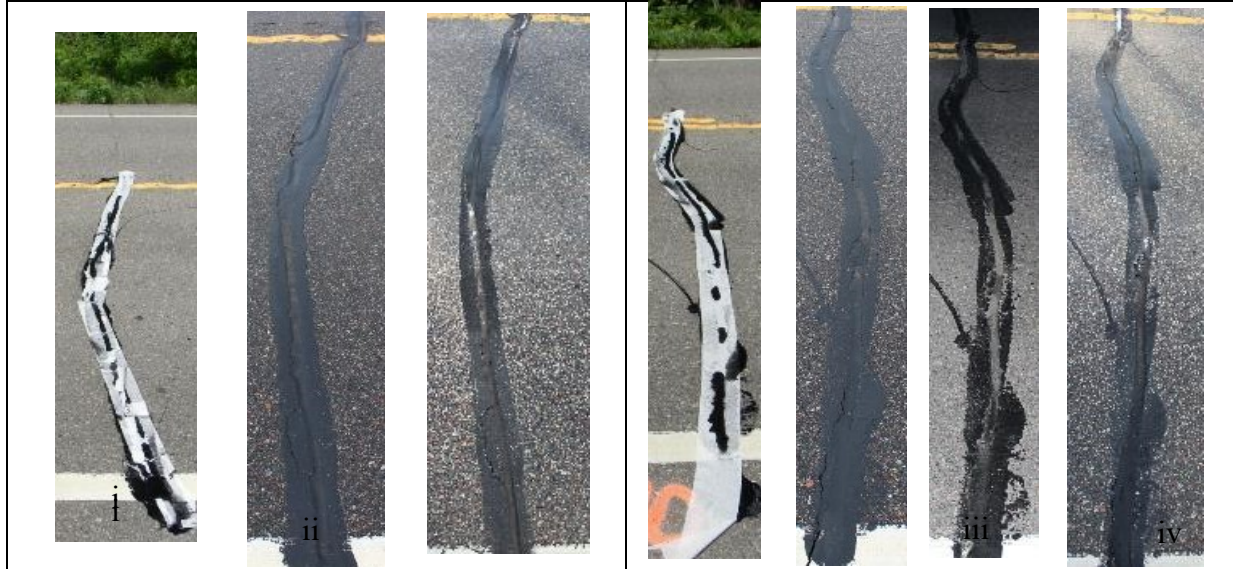
**Figure 4.32: Photographic Performance Documentation of Site E. E-1-i Shows Crack E-1 upon being sealed. E-1-ii and E-1-iii show Crack E-1 at the end of its first winter and during the second winter after being sealed. This same sequence of photos follows for cracks E-2, E-3, E-4, E-5, E-6, E-7, E-8, E-9, and E-10. E-10-iv shows the seal performance at the end of the first winter compared to the mid-winter performance presented in E-10-iii.**

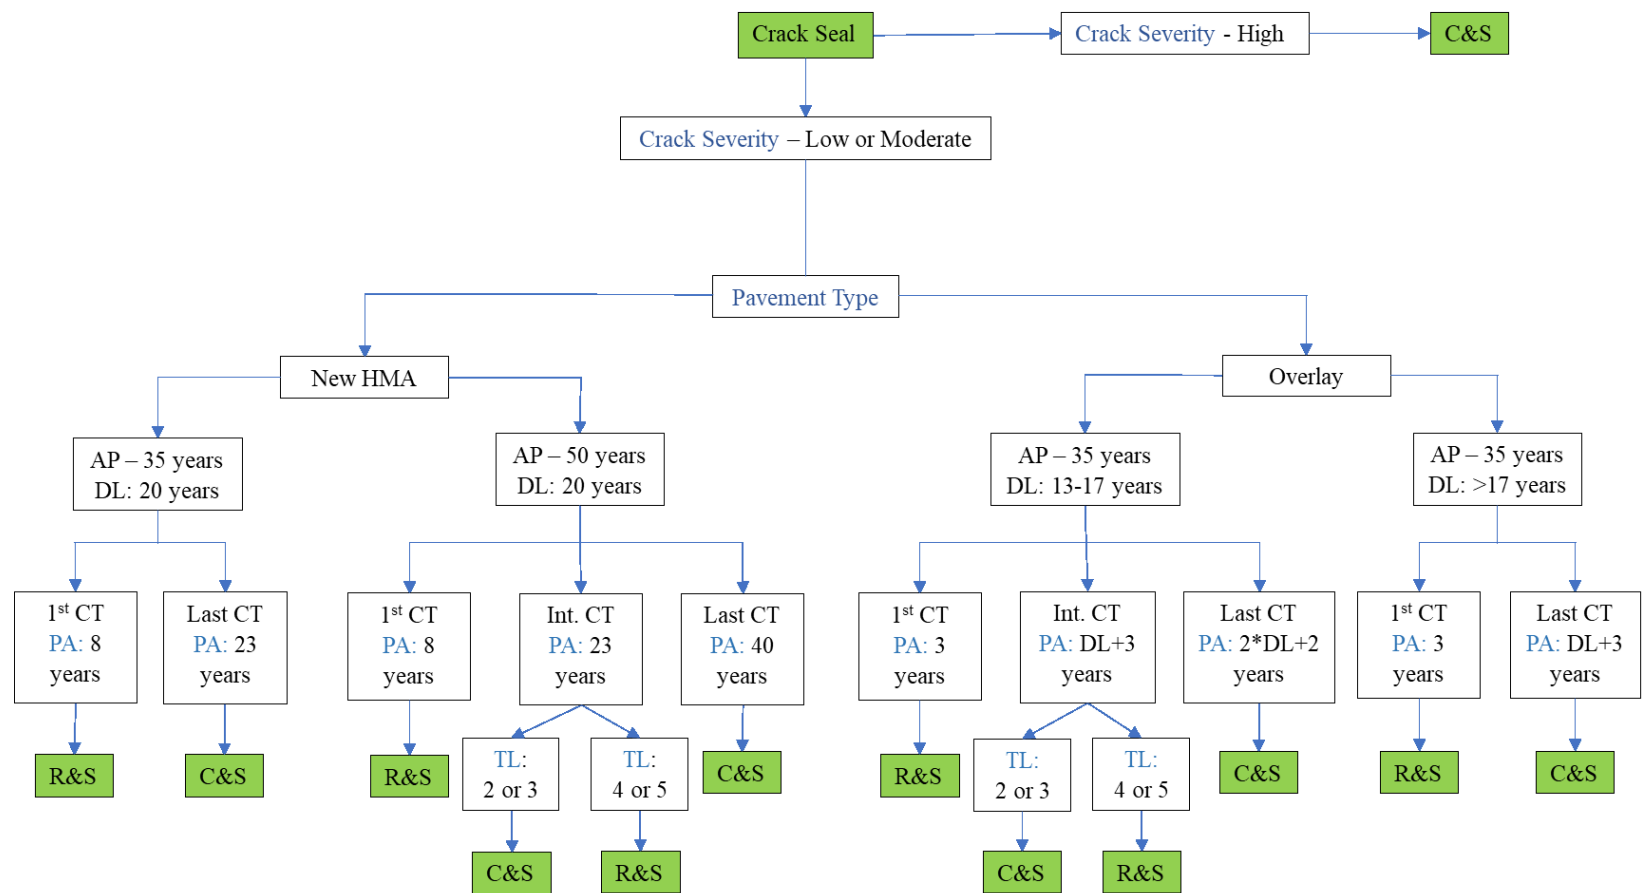
**Crack Severity = Low:  $CW < 1/4"$ , Medium:  $1/4" < CW \leq 3/4"$ , High:  $CW > 3/4"$ ;  $CW$  = Crack Width  
 AP = Analysis Period; DL = Design Life; CT = Crack Treatment; PA = Pavement Age; TL = Traffic Level; R&S = Rout-and-seal; C&S = Clean-and-seal**

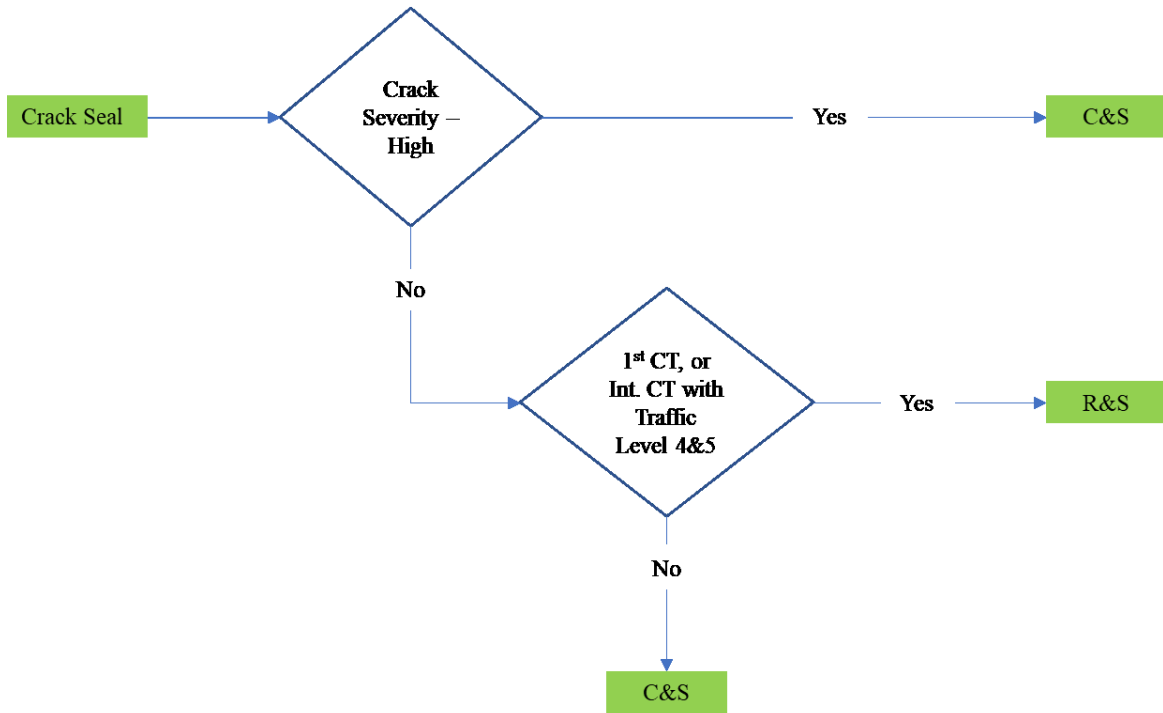
Crack Severity = Low:  $CW < 1/4"$ , Medium:  $1/4" < CW \leq 3/4"$ , High:  $CW > 3/4"$ ; CW = Crack Width  
 1<sup>st</sup> CT = 1<sup>st</sup> Crack Treatment; Int. CT = Intermediate Crack Treatment; R&S = Rout-and-seal; C&S = Clean-and-seal
