Iron-Enhanced Swale Ditch Checks for Phosphorus Retention

July 2019

Research Report
Final Report 2019-27

IRON-ENHANCED SWALE DITCH CHECKS FOR PHOSPHORUS RETENTION

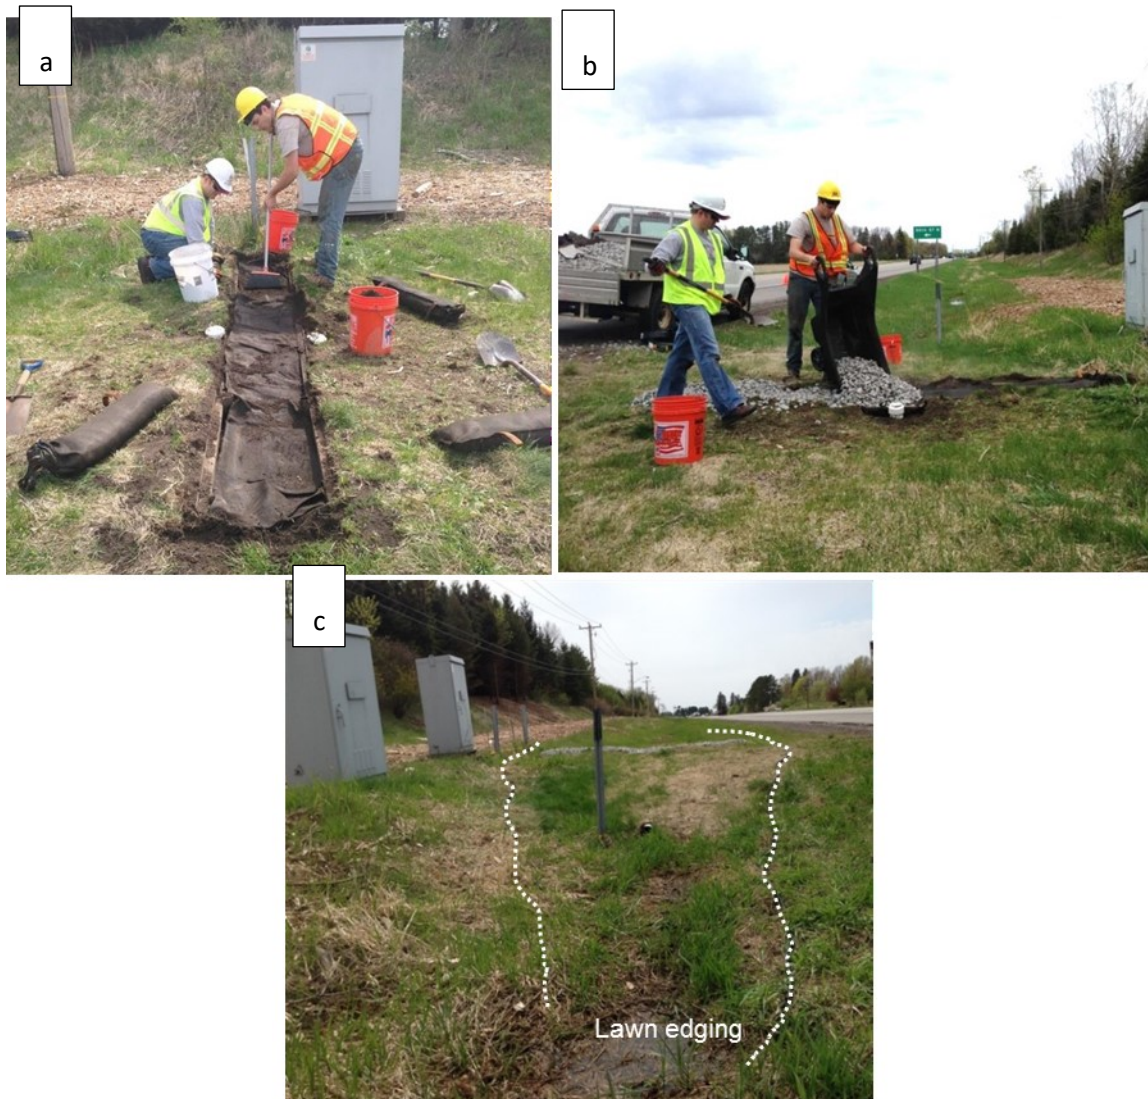
Figure 4.1. Maintenance performed at the ditch check site in May 2017. The topsoil and sod covering the filter insert section were removed (a & b), and lawn edging (highlighted by white dashed line) was installed along the ditch check (c).

In May 2017, the sod and topsoil covering the filter insert section was removed and replaced with washed river rock (~2.54 cm or 1 inch size) (Figure 4.1a, b). The sod cover on the remaining surface of the ditch check was not disturbed. Second, lawn edging was installed along the entire length of the ditch check feature on the roadway side (in-slope) and the back-slope to divert sheet flow away from the ditch check (Figure 4.1c). Monitoring began after these maintenance actions.

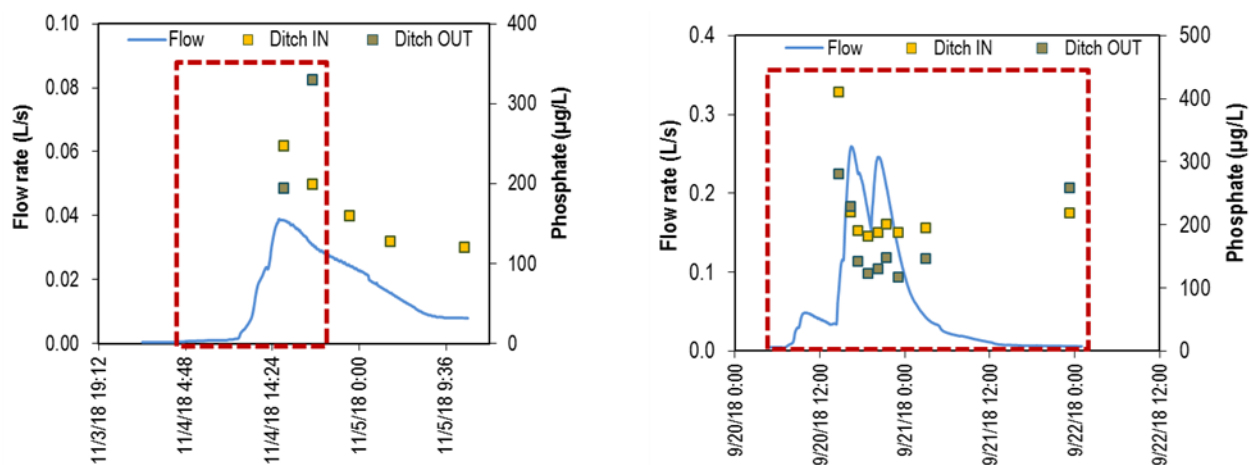
Figure 4.3. Inflow and outflow phosphorus concentrations at the ditch check during the (a) November 4, 2018, and (b) September 20, 2018, rainfall event. Red dashed box in each graph represents the sampling window considered for the EMC calculation.

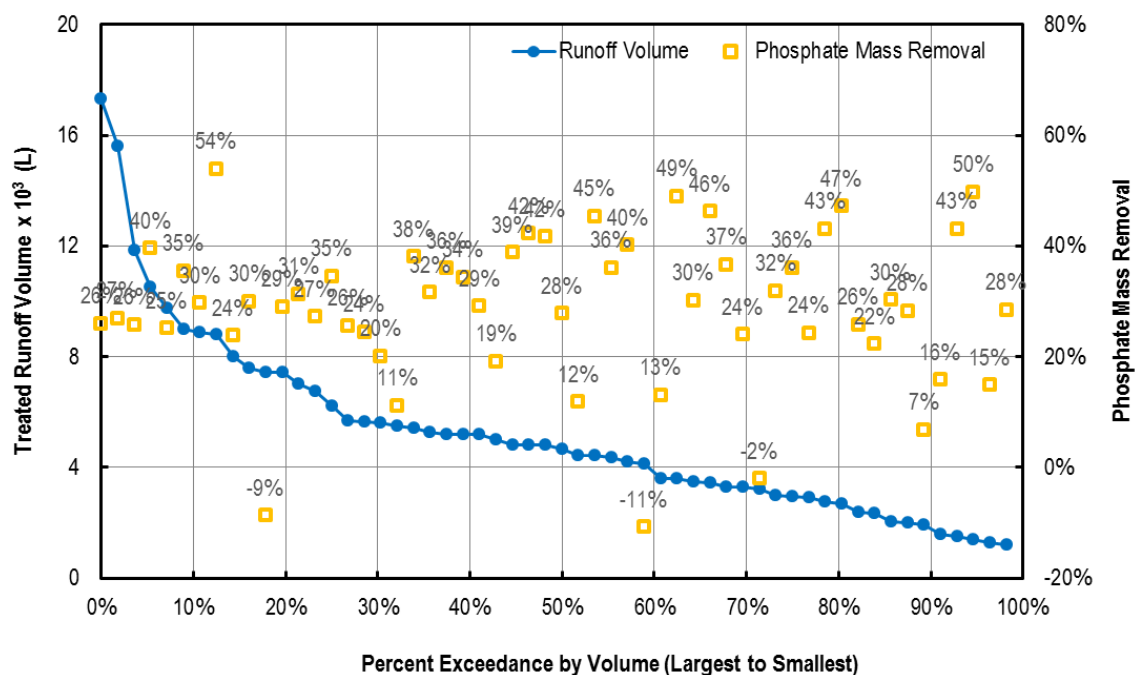
Figure 6.2. Phosphate mass reductions by the filter insert as a function of treated flow volume exceedances at the iron-enhanced ditch check from 2015 to 2018. The largest runoff volume (17,318 L) is plotted at 0% exceedance since this volume was not exceeded during the entire monitoring period. The 2015 data are from Natarajan and Gulliver (2015).

The relationship between phosphorus retention and various independent parameters was considered to explain the differences in performance of the filter insert. The flow exceedance probability plot in Figure 6.2 shows the variation in event-based phosphate mass reductions by the filter insert as a function of the treated flow volumes from 2015 to 2018, to determine if a trend associated with removal during large storm event vis-à-vis small or medium storm event was possible. The scatter in the data indicates a lack of significant effect of treated volume on the phosphate reduction achieved by the filter insert for the entire monitoring duration. TP reduction also did not exhibit any trends for the flow volume exceedances (data not shown).

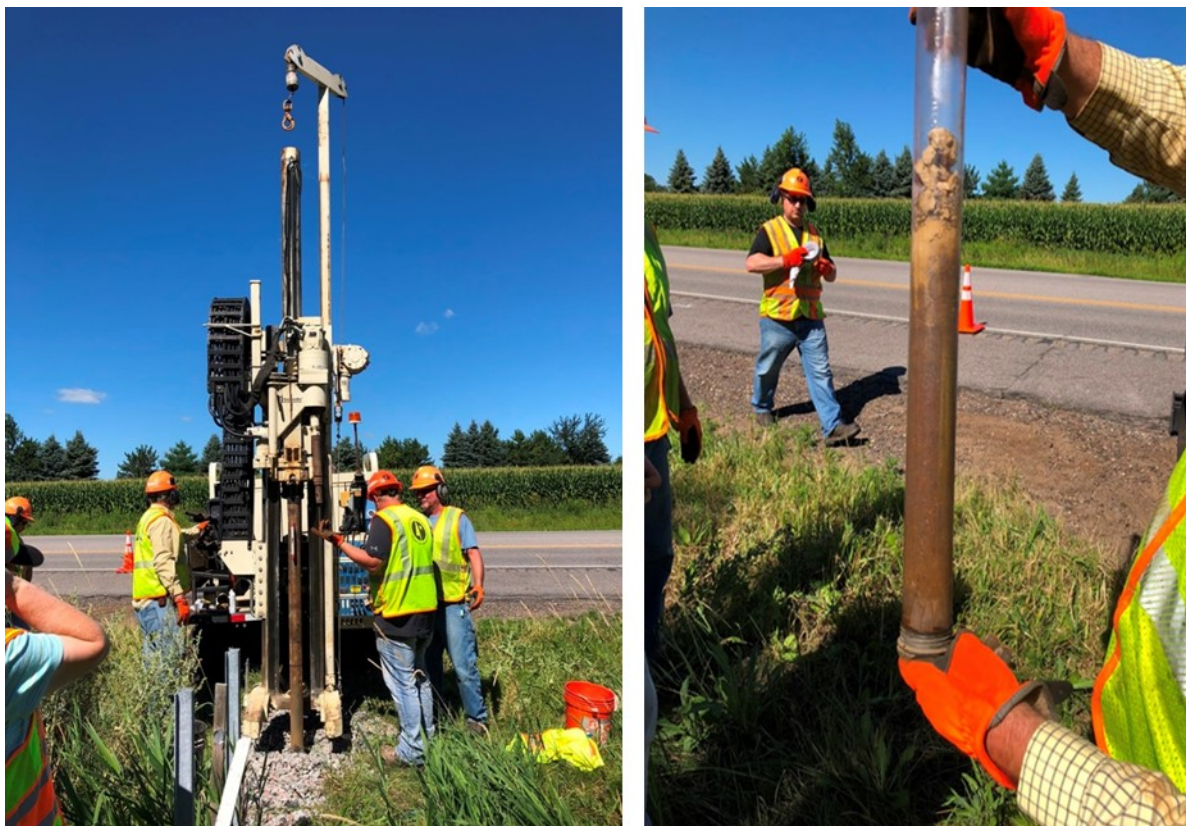
Figure 6.5. Filter media core collection using a Geoprobe® at the iron-enhanced ditch check in July 2018.

To further investigate the hypothesis that the phosphorus sorption capacity of the media has diminished over time, the filter insert's sand-iron media was cored for testing. Three cores were collected in July 2018 with the help of MnDOT's Materials Group (Figure 6.5). After clearing the riprap, uncovering the geotextile fabric over the filter insert surface and using a Geoprobe®, two cores were taken ~0.61 m (2 ft) on either side of the approximate center of the filter insert (i.e., 0.61 m or 2 ft from the monitoring wells), and one core was taken ~1.5 m (5 ft) from the filter's center on the in-slope side. The geotextile fabric was closed and the riprap replaced on the filter surface afterwards.
