# Florida ATMA Pilot Demonstration and Evaluation

## Final Report

Prepared by:  
University of Florida

March 2021

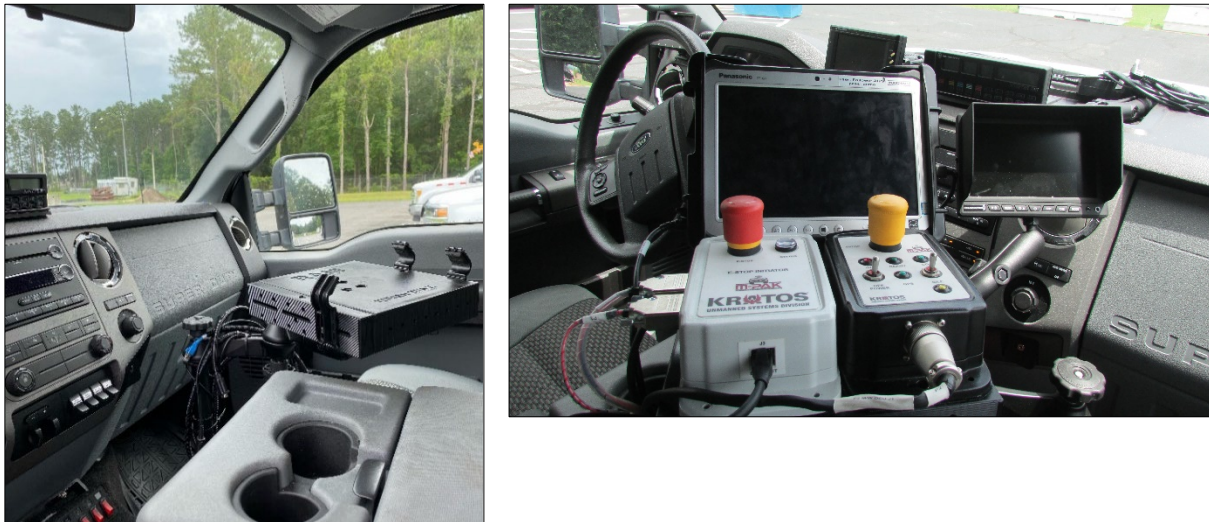
Figure 3-1. Before and after leader kit installation on FDOT F350 leader vehicle center console

Royal Truck, in partnership with Kratos Defense, was contracted for the leasing of an ATMA system. An FDOT F350 truck was delivered to the Kratos facility in Fort Walton Beach on Tuesday, June 23, 2020. Kratos technicians installed the leader kit. The kit included an operator control unit, a PC-based system for system activation, navigation, and emergency stop functions. External components of the kit included a V2V communications system, GPS receivers, a rear-facing video camera, and other components. The system is powered through a connection to the truck's battery. System integration, calibration, and testing were conducted from June 23 through July 12. Figure 3-1 below shows the interior center console of FDOT F350 before and after the instrumentation. Figure 3-2 shows the modification to retrieve power from the F350 battery. Figure 3-3 shows the before and after of the exterior with the custom-fitted antenna and other equipment. Detailed description is provided in Section 3.3 of this report, which provides the overview of ATMA Demonstration.

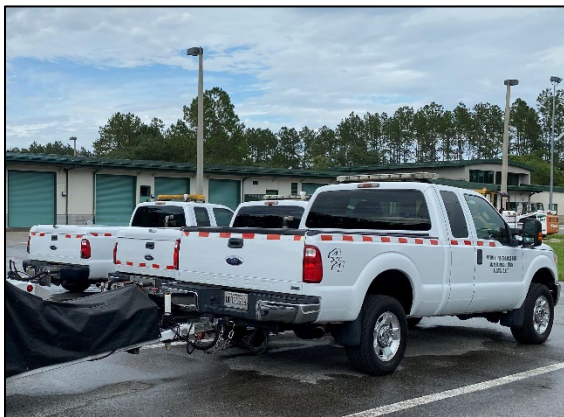
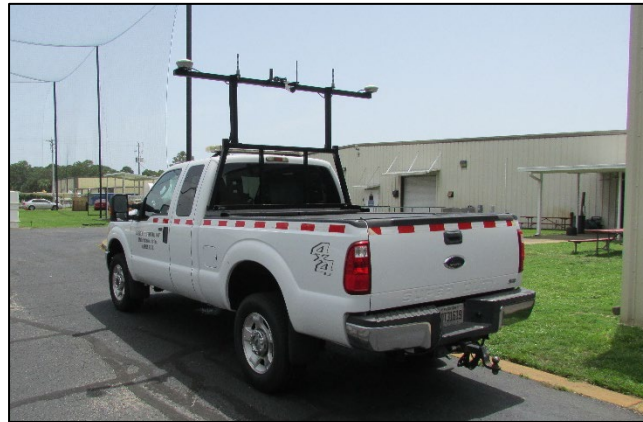
Figure 3-3. Before and after installation of the exterior mount and equipment on FDOT leader vehicle

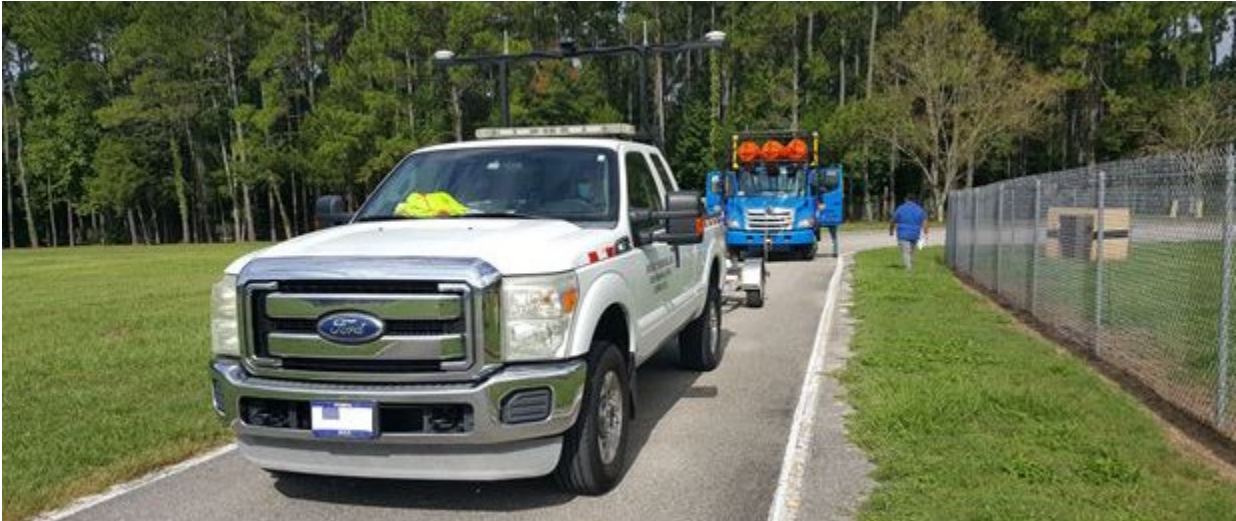
**Figure 3-6. ATMA trucks in demonstration configuration. The white truck in the foreground is the FDOT F350 truck retrofitted with the Kratos leader kit. In the background in the blue follower truck, rented from Kratos.**

Figure 3-6 shows the leader truck and follower truck in demonstration configuration. The FDOT leader truck is in the foreground with trailer attached. The trailer carries a falling weight deflectometer (FWD). The Kratos follower truck is in the background. The follower carries a Scorpion attenuator, shown in Figure 3-7.

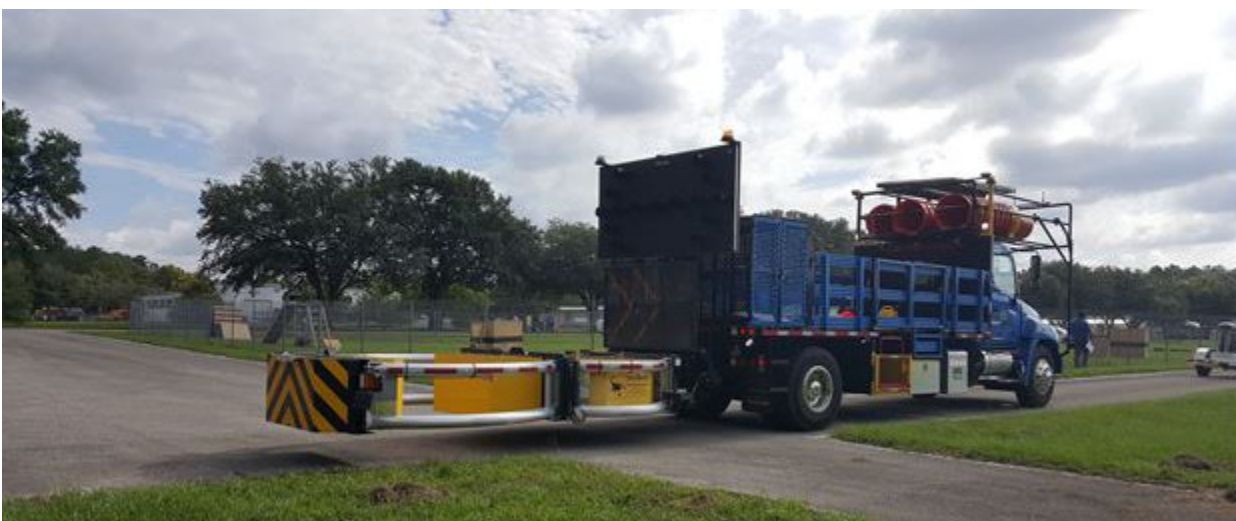
**Figure 3-7. Follower vehicle showing Scorpion impact-absorbing device extended to the rear**

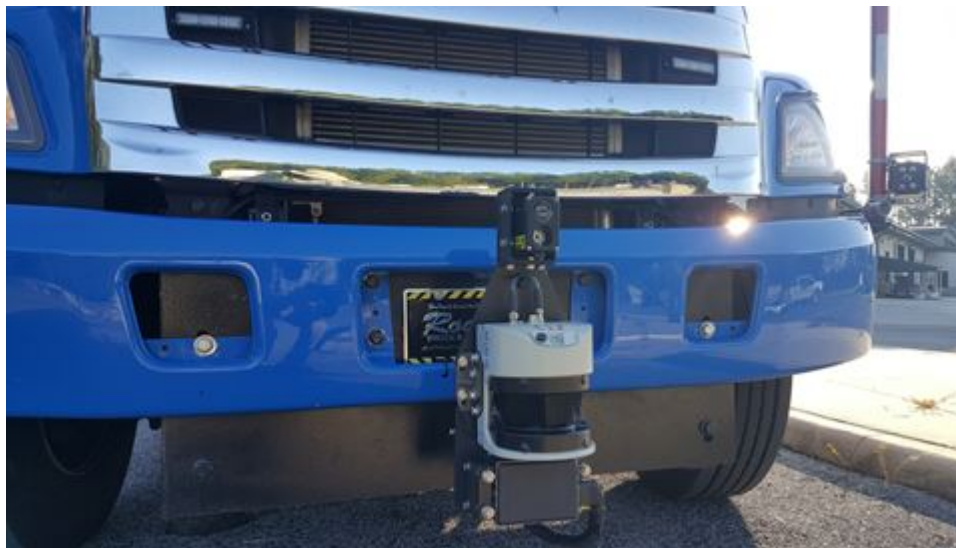
**Figure 3-8. Follower truck – External sensors: The forward-facing obstacle detection system is attached to the front bumper of the follower vehicle. (1) The large device in the white housing is an off-the-shelf lidar (SICK, Inc.) which has a 190° view. During autonomous operation, the lidar narrows its field of view to the leader vehicle so that during a turn or in a roundabout, the follower vehicle will not respond to objects that are in its line of sight but not in its path of motion. Otherwise, the follower vehicle would detect, for example, a street light on the opposite corner and execute an automatic stop (A-stop). (2) The rectangular black device below the white housing is a standard automotive radar (Delphi, Inc.). The radar can detect objects out to 150 ft. If the radar detects an object in the range of 100 ft to 150 ft, the follower truck will automatically slow to 7 mph. If the radar detects an object within 100 feet, the follower truck will execute an A-stop. (3) The lensed device above the white lidar housing is a legacy lidar. It is no longer used and will be not be included in future versions of the system.**

The follower truck is guided by digital “crumbs,” a series of GPS locations provided by the leader truck. Cameras on the follower vehicle provide visual feedback to the leader driver, who can also monitor aspects of the follower’s performance on the operator control unit. However, the follower does not blindly follow; it is equipped with a variety of sensors to detect vehicles or other possible interferences. The sensors can cause the follower to stop in order to prevent a collision if, for example, a vehicle should enter the space between the leader and follower. The following images show the external devices attached to the follower vehicle, including external sensors, front-facing lidar and front-facing radar (Figure 3-8), and lateral-facing lidar (Figure 3-9)

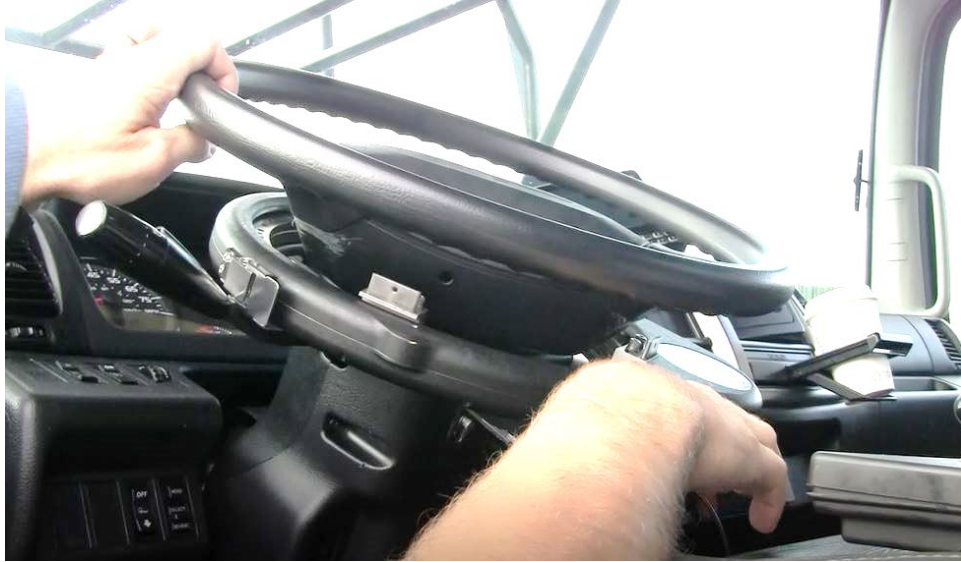
**Figure 3-11. Follower truck – Internal controls:** Steering in the follower truck is controlled by an actuator ring, seen in the image as a heavy black ring on the steering column below the steering wheel. The silver tab sticking up from the actuator ring is a steering tab. There are two steering tabs on the steering actuator ring.

- External control: emergency stop (E-stop) activator (Figure 3-10)
- Internal controls: steering actuator ring, steering tabs, and steering fingers (Figures 3-11 and 3-12); brake and accelerator cable system (Figure 3-13); and operator control unit (Figure 3-14)

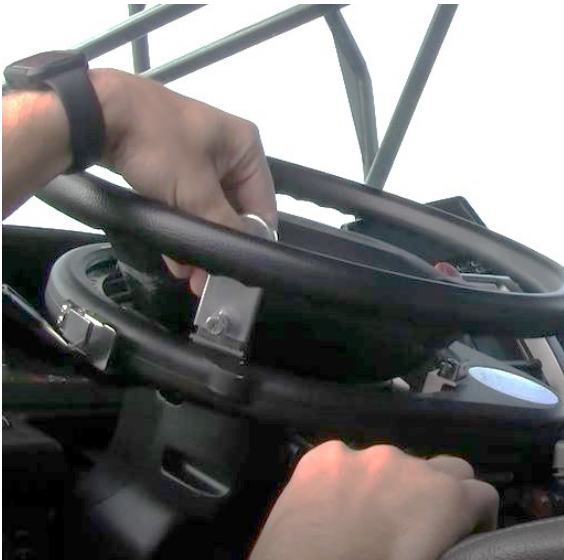
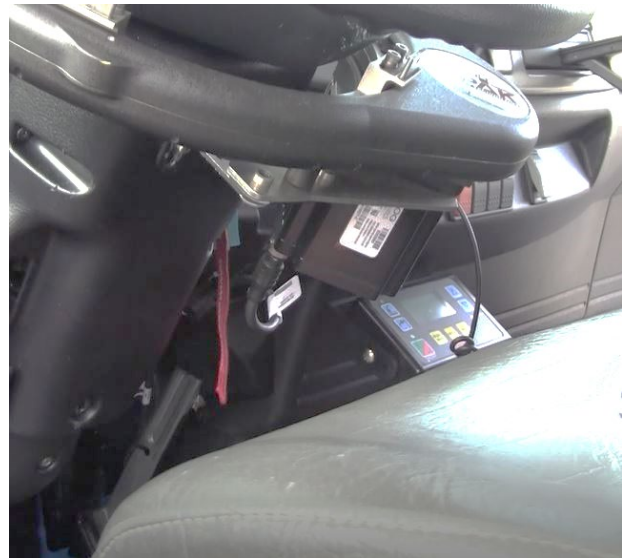
**Figure 3-12. Follower truck – Internal controls (left):** The steering actuator ring is linked to the steering wheel when the “steering fingers” are mounted on the two steering tabs. When the set screws are tightened, the steering fingers form a secure and tight connection between the steering actuator ring and the steering wheel. **Internal controls (right):** The steering actuator ring appears in the upper part of the image, with the servo housing at the right. Beneath the servo is the junction box and CAN bus that connects the steering controls to the follower vehicle’s on-board systems control unit (SCU).

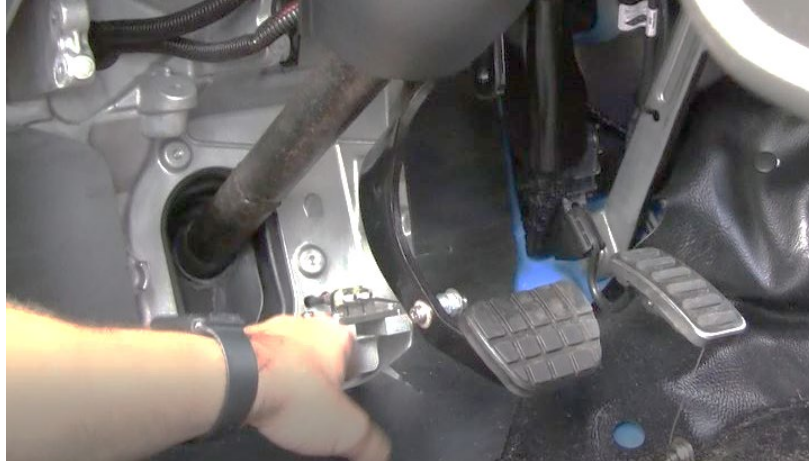
**Figure 3-13. Follower truck – Internal controls:** The Kratos demonstrator points to the custom cable system that operates the brake and accelerator in the follower vehicle. There are two cable linkages to the brake pedal: one provides a range of motion for normal operations and A-stops; the other one provides full braking during an E-stop.

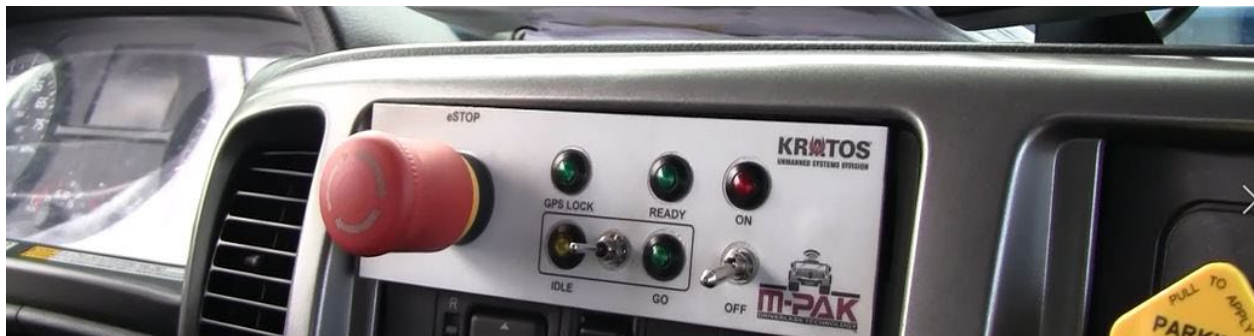
**Figure 3-14. Follower truck – Internal controls:** In the center of the dash is the follower truck version of the operator control unit (OCU). Near the right of the panel is the on/off switch which engages the OCU in preparation for autonomous operation. The light above the switch verifies that the system is on and operational. When the OCU is switched on, the system will attempt to locate GPS signals. When 6-7 satellite signals have been located, the GPS Lock light illuminates. When the system is powered on, initialized, and GPS lock is achieved, the Ready light lights up to show that the follower vehicle is ready for autonomous mode. The switch in the black rectangle switches the follower vehicle between idle mode and GO mode: in idle mode, the follower truck is ready for autonomous mode but still under manual steering, braking, and accelerating control; in GO mode, the follower truck is in autonomous mode and under control from the leader truck. When leader driver has completed the leader vehicle checklist, the follower driver will be instructed to enter “Go” mode, and the GO light illuminates. The follower driver will then exit the follower vehicle and enter the passenger seat in the leader vehicle to act as system monitor. The follower driver can return to the follower vehicle at any time it is stopped, switch to idle mode, and take manual control of the follower vehicle. The big red button on the OCU panel is an E-stop (only active when the OCU is on). An E-stop will be activated automatically if the follower vehicle loses contact with the leader.

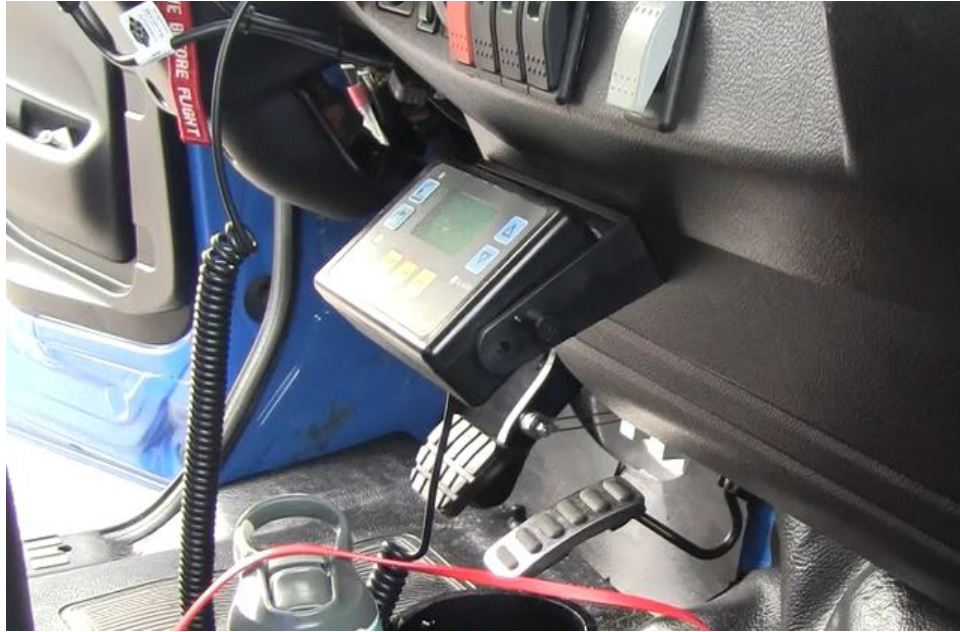
**Figure 3-15.** Low on the dash are the controls that lower and raise the Scorpion tail and the arrow board on the rear of the follower truck. There is also a port on the Scorpion tail that allows it to be raised and lowered with a plug-in controller (not shown).

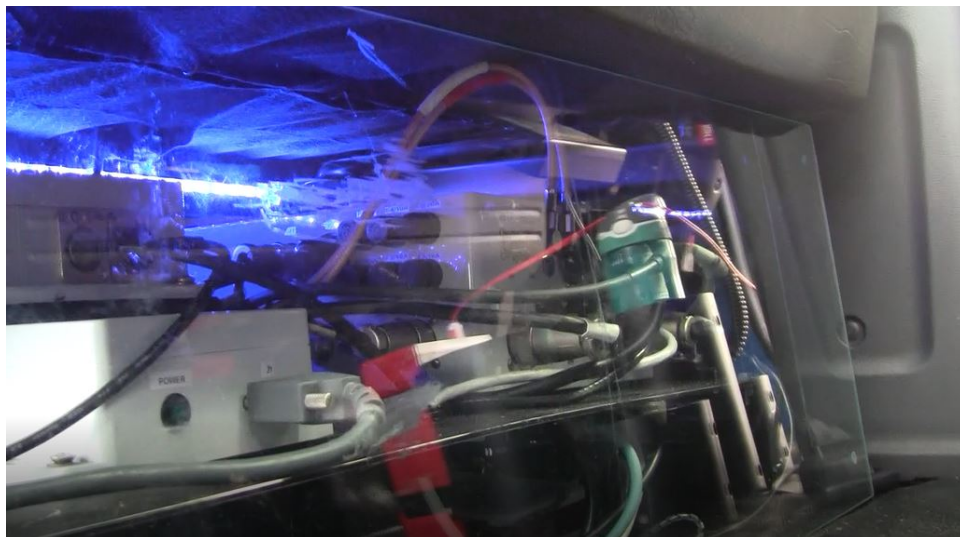
**Figure 3-16.** Follower truck – Internal controls: Hardware including RS232 hub, gyro, CAN bus hub, video amplifier, and wireless video link are located under the passenger seat. Communications are protected from hacking during operation with military-grade encryption.

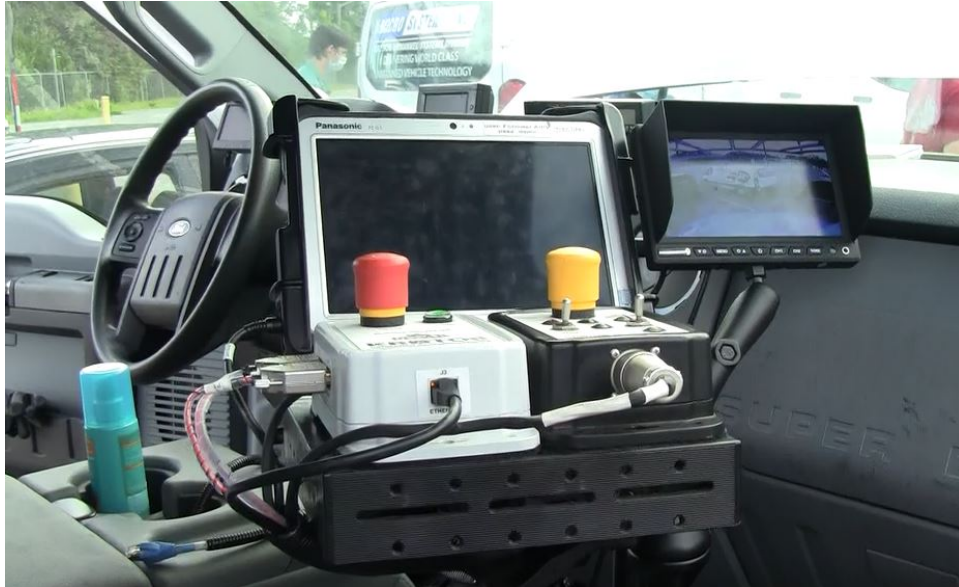
Figure 3-19. The leader vehicle OCU includes a laptop computer screen that displays the control user interface, two control panels in front of the screen, and a viewer that displays the signal from the follower truck's front-facing camera. The OCU is held on a pivoting arm that is pulled out for a clearer view. Through the user interface, the follower truck operator can enable the system, view warnings, adjust offset and gap, and more.

The retrofit included four components: a power link to the leader truck's battery (Figure 3-17); an antenna array (Figure 3-18); an OCU (Figures 3-19 and 3-20); and the system hardware (Figure 3-21), as shown in the following images.

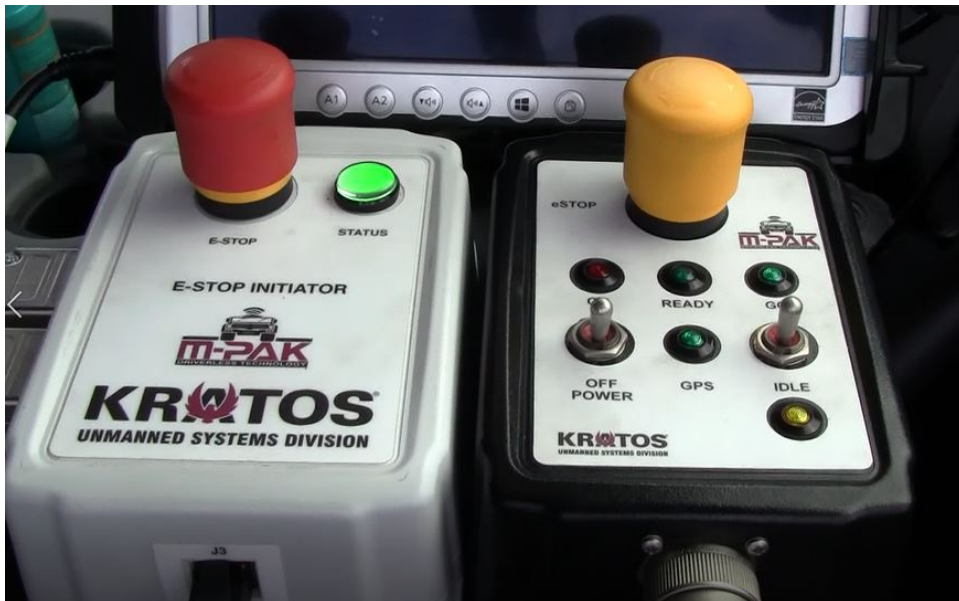
Figure 3-20. The control panels are the same as the dashboard OCU panel in the follower truck. On the left is an E-stop activator. On the right are the on/off and idle/GO switches and the GPS Lock and Ready lights. The big yellow button is an A-stop.

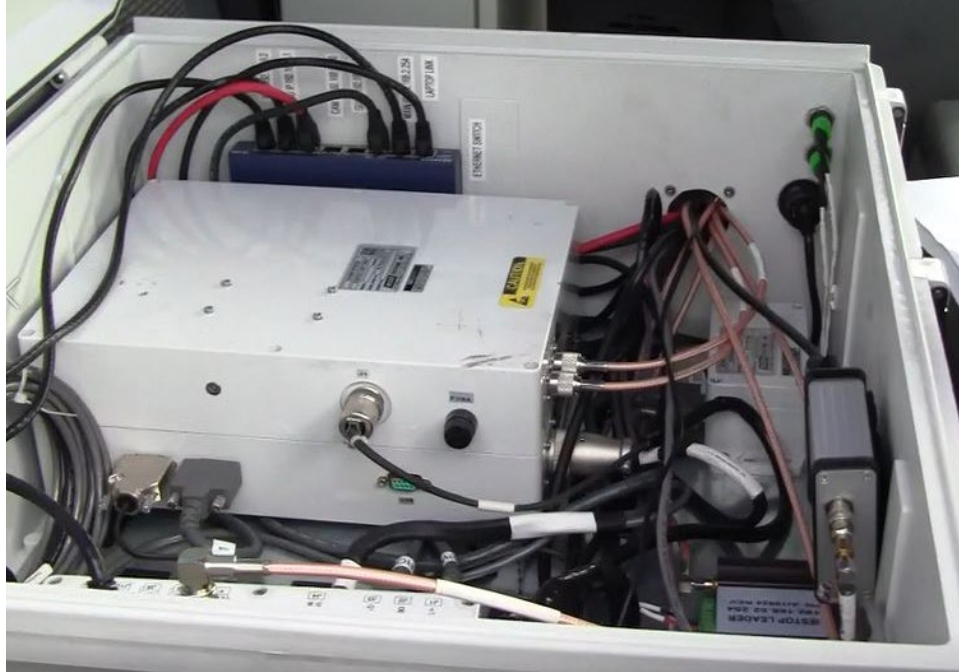
**Figure 3-21. Leader vehicle: System hardware – “The brain of the system” is located behind the passenger seat. It draws power from battery as shown previously and includes the GPS receiver, interfaces to the OCU and I/O computer, the vehicle interface, radios, fiber optic gyro, and receiver for analog video.**

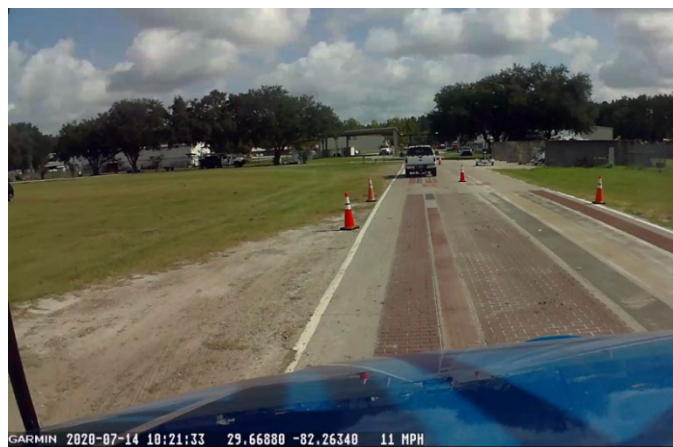
Figure 5-1 shows the screen capture of the GARMIN dash cam. At the bottom of the picture, the date, time stamp, latitude and longitude, and speed information can be seen. This was used as ground truth for validating the data retrieved from ATMA log files by developing a time-space diagram.

**Figure 5-1. Screenshot from dashcam used for data collection**

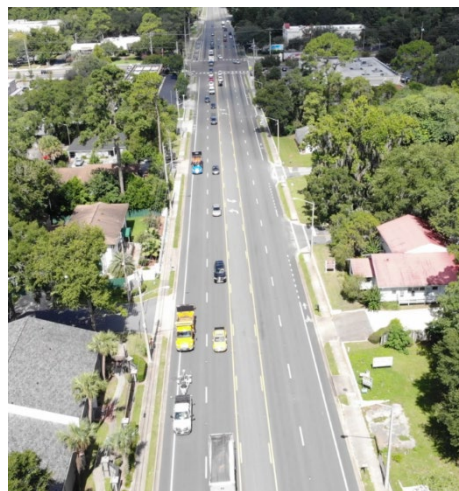
Figure 5-3. Screenshot of drone video data

For selected roadways, aerial video was captured using a drone to understand the effect of the ATMA on general traffic characteristics of the corridor by visual inspection. These data were helpful in visually reviewing several items, including lane-changing behavior of vehicles following the work platoon (Figure 5-3) and driver behavior in between leader and follower vehicle. The aerial video data were also helpful in proposing driver training techniques – for example, the effect of an ATMA stop in the vicinity of intersections.

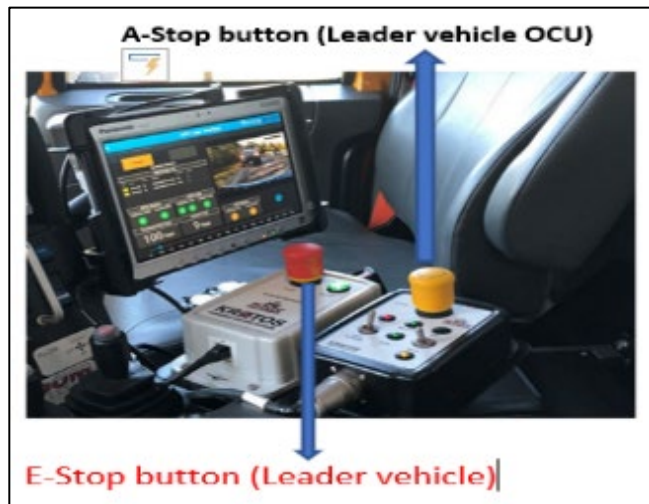
**Figure 6-1. Leader vehicle A-stop and E-stop**

The safety tests were designed to evaluate the functionality of various stop buttons on the leader and ATMA vehicles, including: leader vehicle A-stop button on the operator control unit (OCU) and the leader E-stop button (Figure 6-1); ATMA follower emergency stop (E-stop; Figure 6-2); and the ATMA follower external button (Figure 6-3).

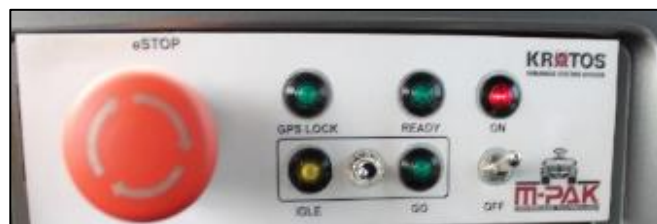
**Figure 6-2. ATMA follower E-stop button**

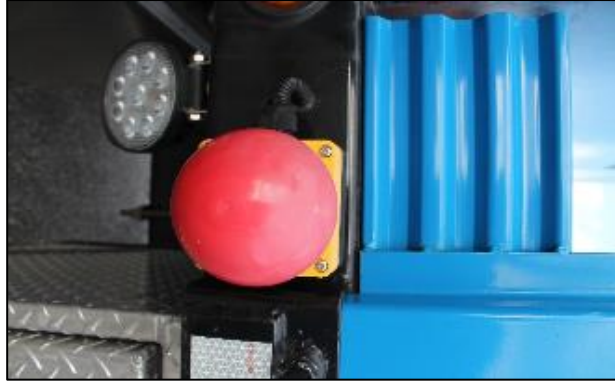
**Figure 6-3. Emergency stop ATMA follower external button**

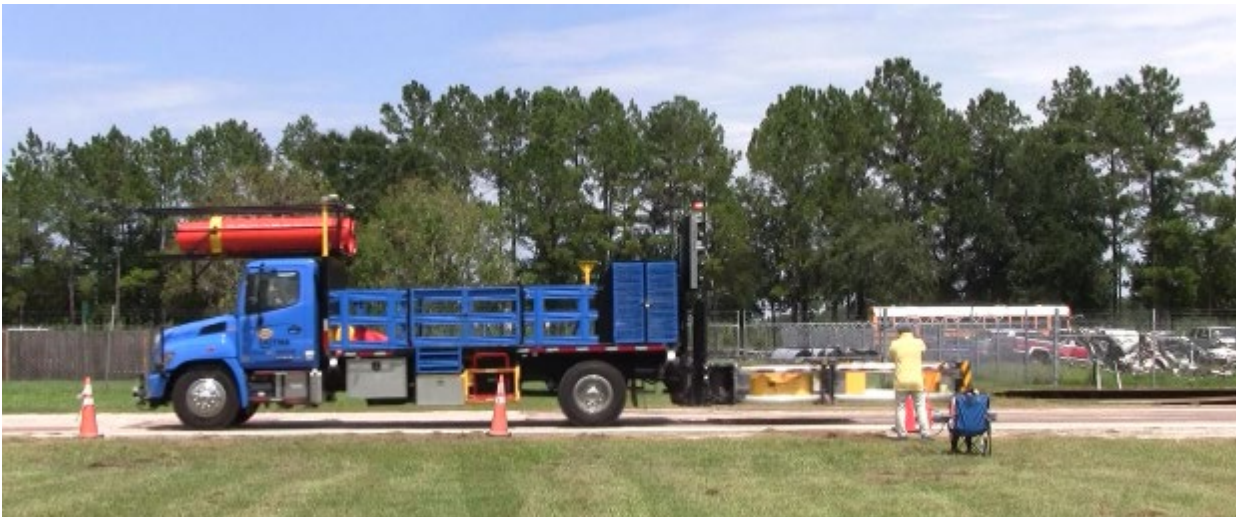
**Figure 6-5. Test Case 1 external camera view**

Figure 6-4 shows the field setup for this test case. The cones were set at a 20-ft spacing to mark the A-stop activation location and establish a reference point for video reviews (Figure 6-5). The stopping distance was measured after the ATMA stopped, using a measuring wheel.

For this test (as well as the other tests), cameras were installed outside and inside the vehicle for data collection. For instance, Figure 6-5 and Figure 6-6, respectively, show the external camera and ATMA dashcam views.

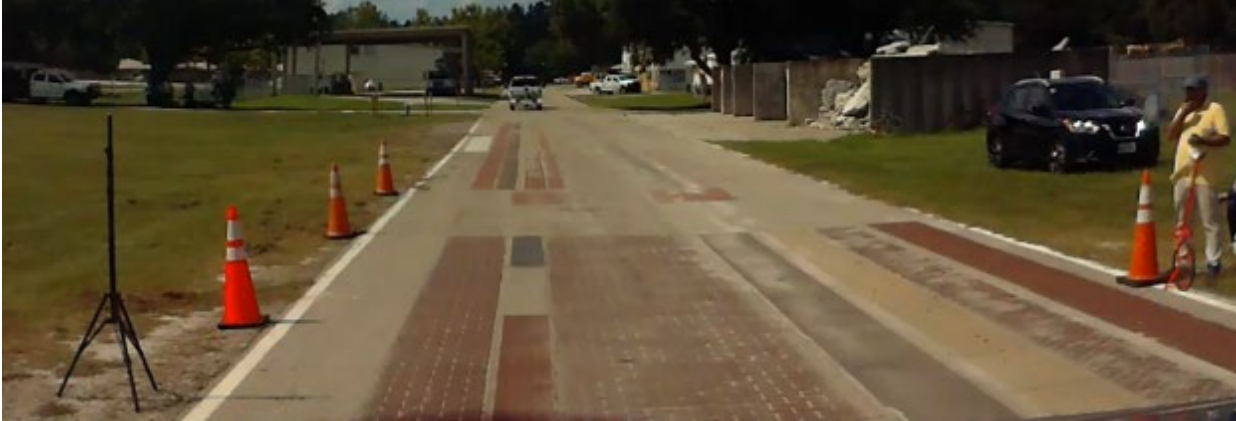
**Figure 6-6. Test Case 1, follower dashcam view**

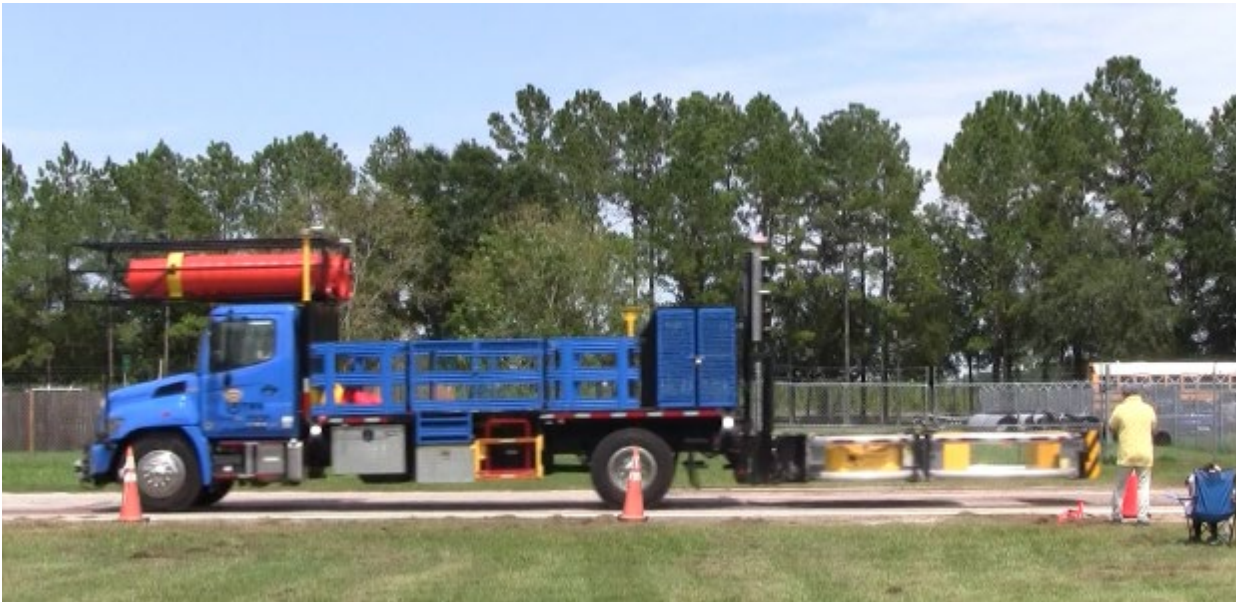
Figure 6-11. External camera view

Figure 6-11 shows the field setup for this test case, which was similar to A-stop setup. The cones were set at a 20-ft spacing to mark E-stop locations and provide a reference point for video reviews. The stopping distance was measured after the ATMA stopped using a measuring wheel.

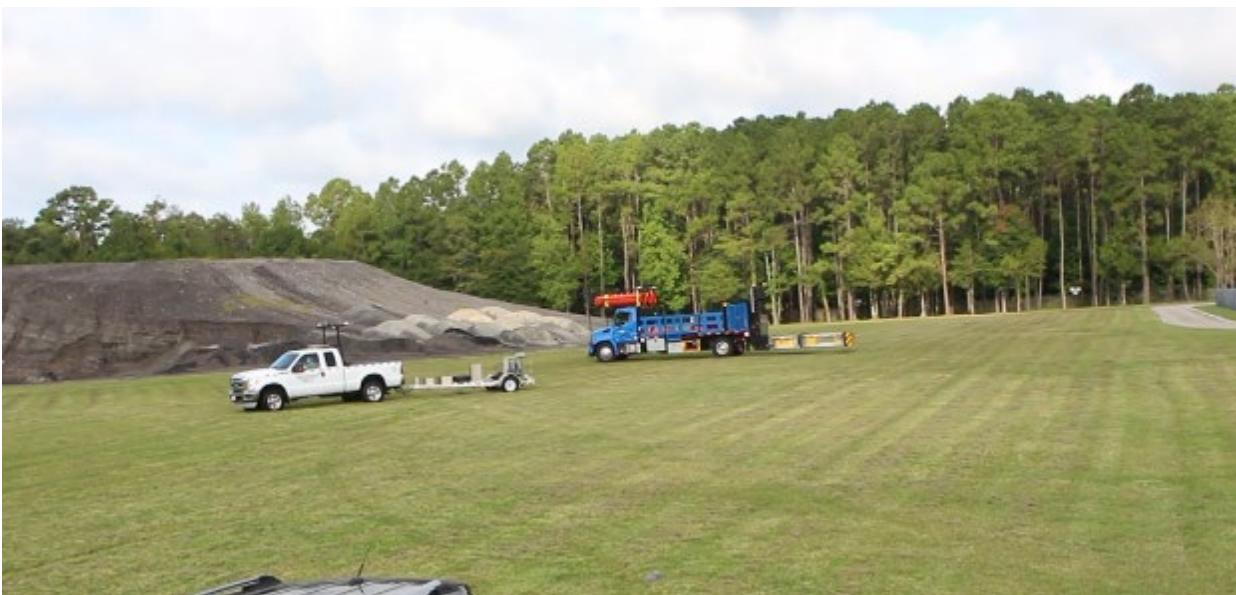
**Figure 6-17. Insufficient test track in closed loop location for Test Case 5 (closed loop), external camera view**

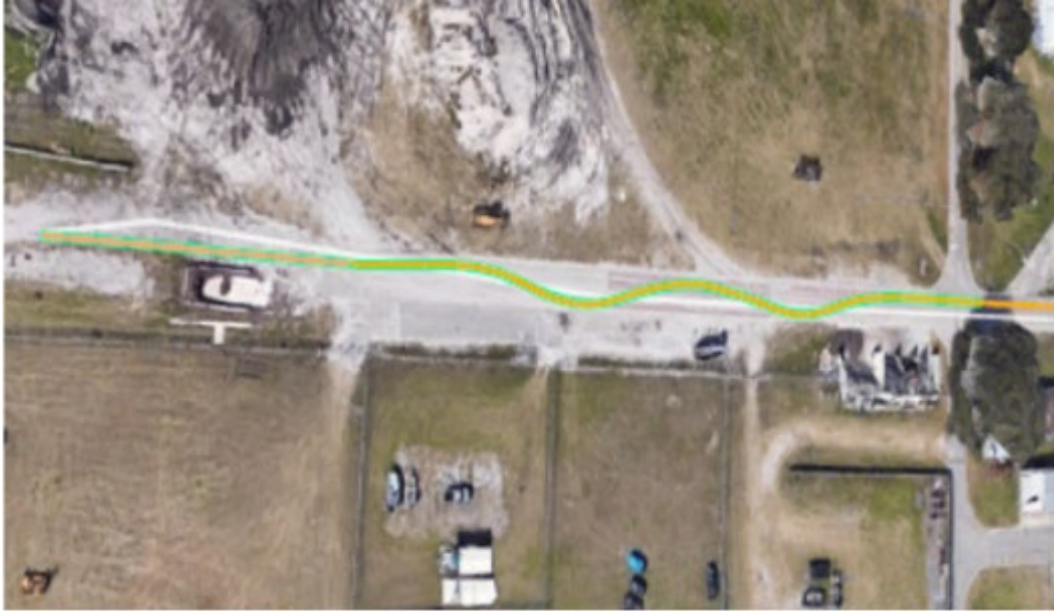
In addition to the visual inspection and field data collected, the ATMA log files were analyzed. Figure 6-35 shows the overlay of the leader vehicle trajectory (in orange) with the follower ATMA (in green). As can be seen, the follower ATMA maintained a consistent path based on the GPS trajectory data. Figures

**Figure 6-35. Path of the follower vehicle on the slalom course**

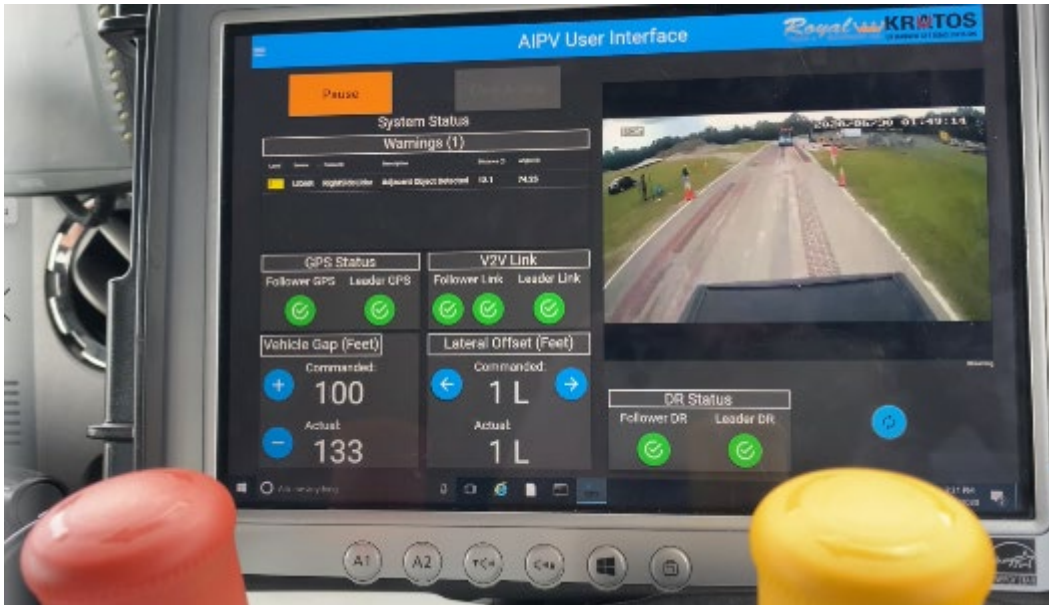
Figure 6-56. User interface view of lateral offset test showing 1-ft offset towards left

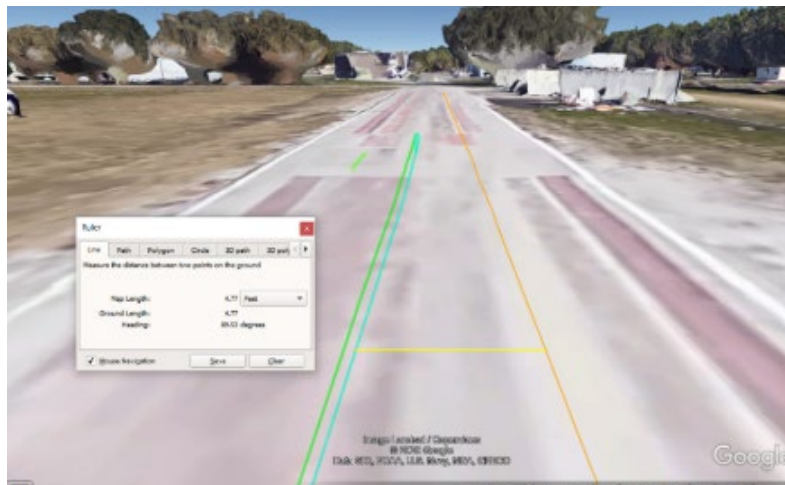
The ATMA log files were analyzed to validate the lateral offset through the CTE data. The research team verified and validated the 1-ft, 5-ft, and 12-ft lateral offsets by visual inspection in the field as well as geospatially by using the trajectory data. The time for ATMA to achieve an offset of 12 feet (from 0 feet initial) is about 7.5 seconds.

Figure 6-59. Image of recorded video of 5-ft offset test

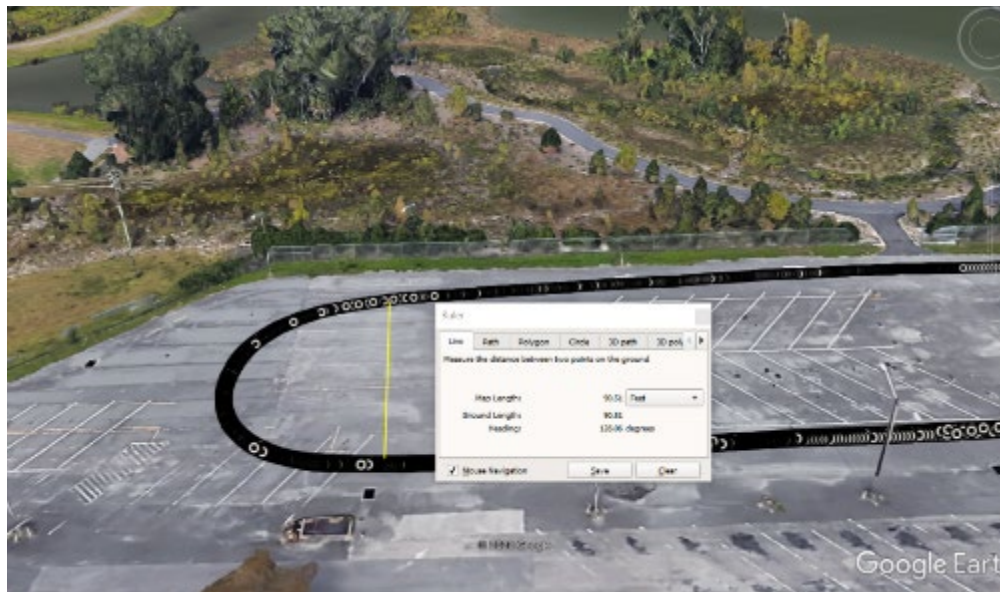
Table 6-26 shows the field observations for Test Case 10. For three out of four runs ATMA successfully negotiated the curve with the internal radius of 45 ft and lane width of 12 ft.

**Figure 6-63. Trajectory from log file results that shows two of the successful turns with radius of 45 ft**

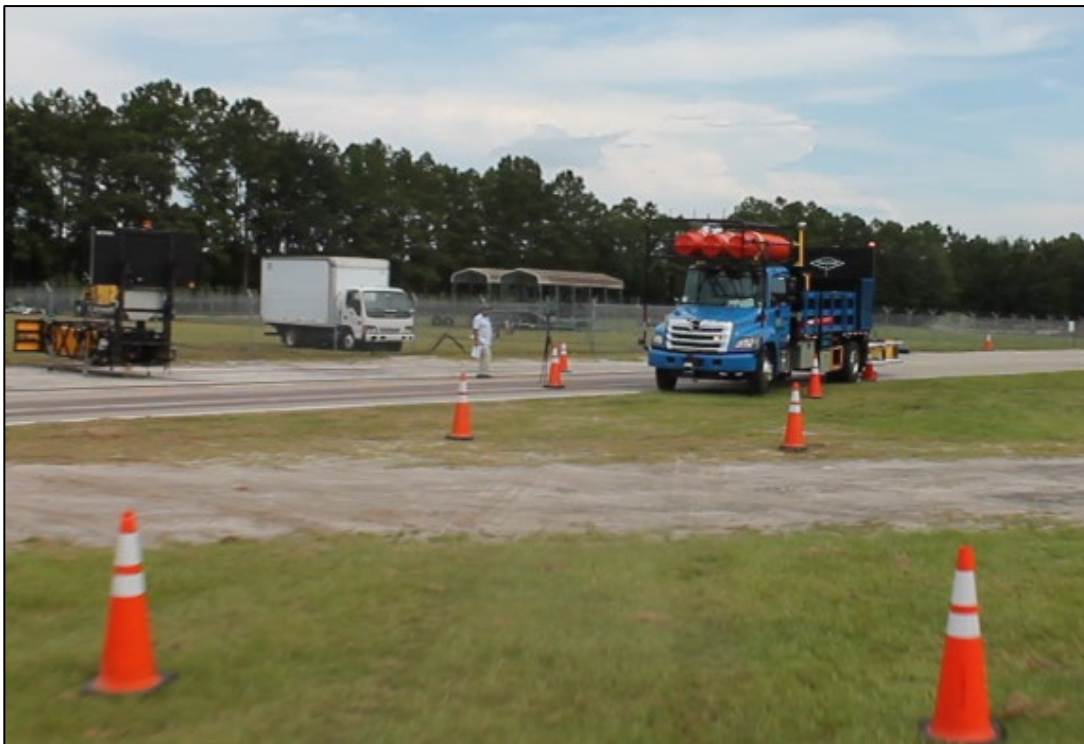
**Figure 6-64. External camera view of simple curve test. The follower vehicle hits a cone.**

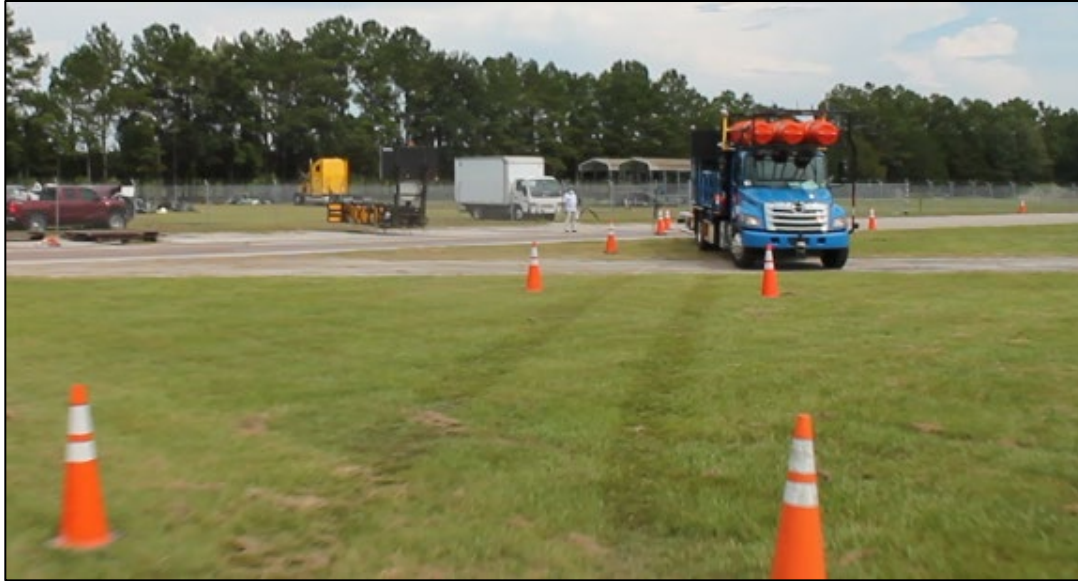
**Figure 6-65. External camera view of follower truck turning. The follower vehicle unexpectedly leaves its course.**

encountered the bump, it unexpectedly left its path (Figure 6-67). In addition to the bump, the Kratos staff explained that the system was not restarted between the tests and that potentially caused some issues with the e-crumb data. The test was executed two more times with 15 mph, with the ATMA successfully negotiating the curve. Table 6-28 summarizes the field observations for this test.

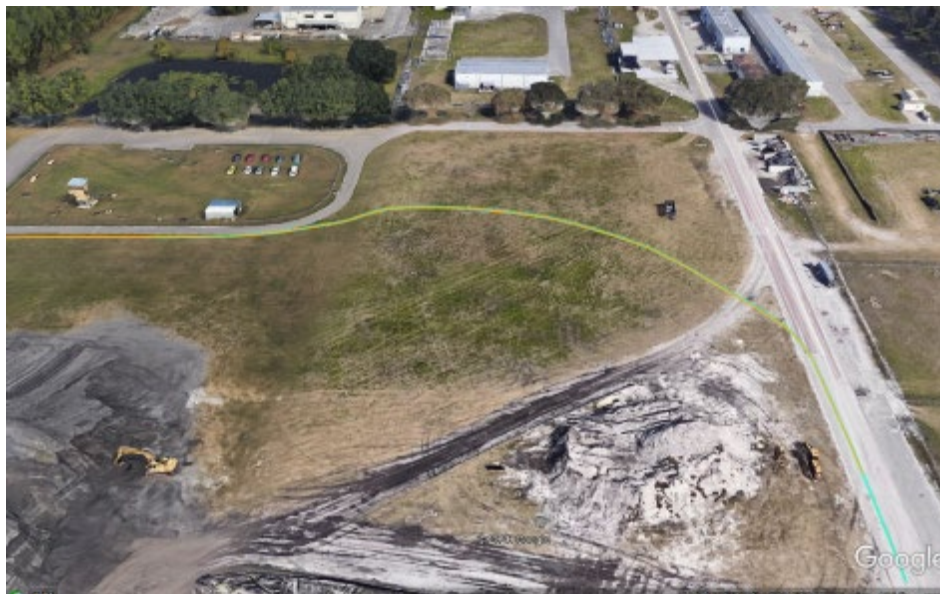
**Figure 6-67. The trajectory of the vehicle from the pavement to the grass for Test Case 11**

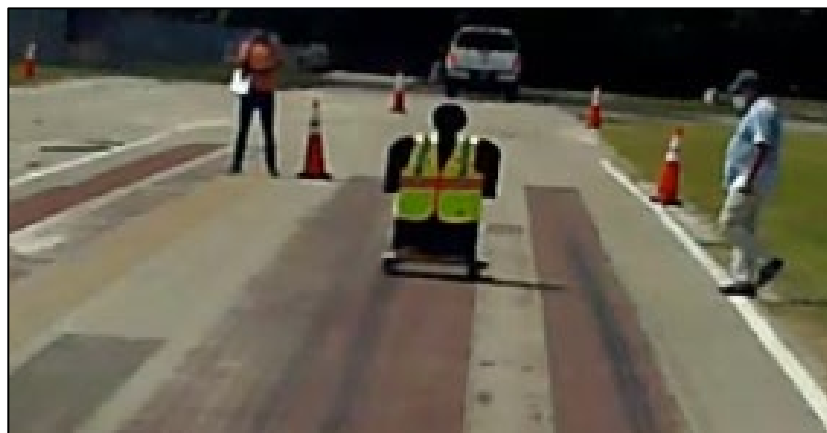
This test aimed to quantify the ATMA performance when there is an obstacle on the roadway. In this test, two different obstacles were tested. The first obstacle's dimensions were 2'7" wide and 4'5" high (as shown in Figure 6-78). The second obstacle was a regular traffic barrel (Figure 6-82) with dimensions of 1'8" diameter and 3' height. The obstacle was located on the adjacent lane and was pulled into the ATMA lane by a rope, after the leader passed the obstacle location. Table 33 shows the operation procedure, data collection, and expected results.

Figure 6-78. Dashcam view of the first obstacle

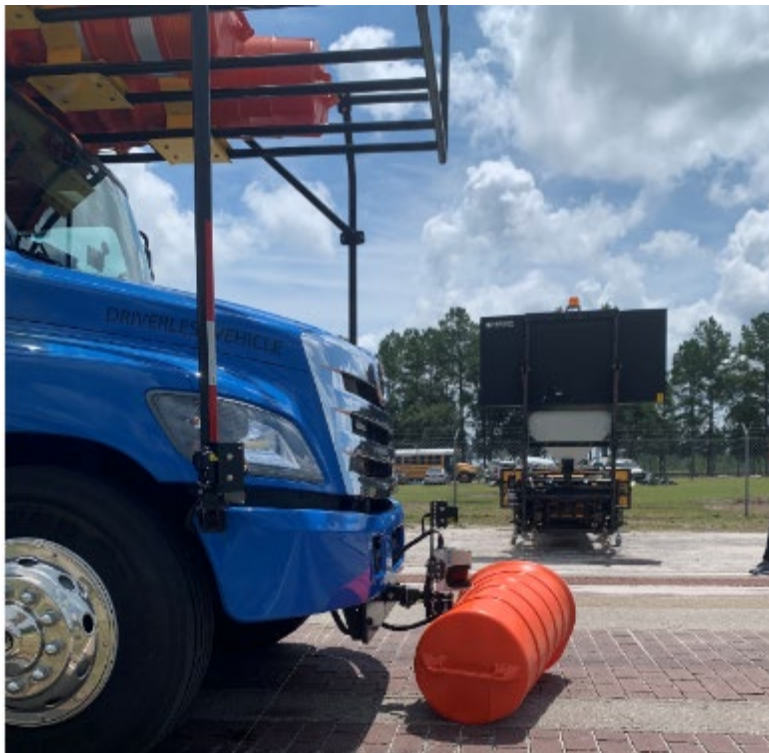
Figure 6-82. External camera view when traffic barrel was struck

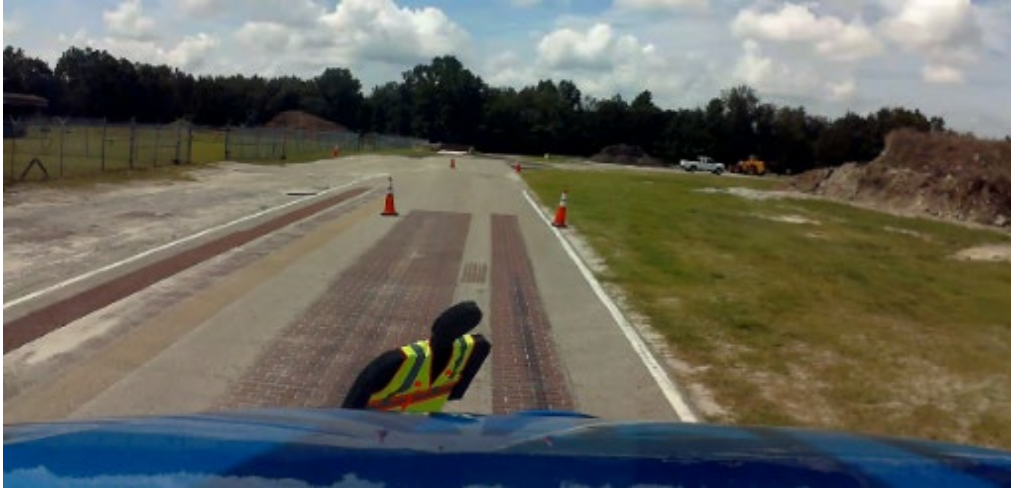
**Figure 6-83. Dashcam view when the obstacle was almost hit**

The test with this obstacle was executed two times for each speed of 5, 10, 15, and 20 mph. Table 6-34 shows the field observations of Test Case 15. For the speeds of 5, 10, and 15 mph, the ATMA recognized the obstacle and stopped. At a speed of 20 mph, in both runs, the obstacle was detected, and the ATMA applied brakes. In Run 7, the ATMA stopped, but in Run 8, the safety operator in ATMA (driver) applied brakes to avoid hitting the obstacle because there was not enough stopping distance available.

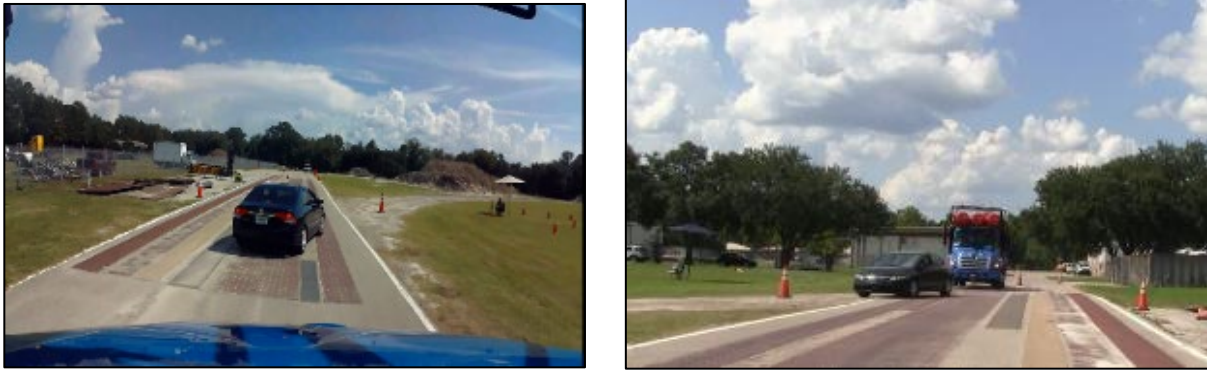
This test was performed to evaluate the ATMA performance in the event a vehicle intrudes between the leader and follower vehicles. It is expected that the ATMA would stop. The test was executed on a closed loop. For this test, the leader and ATMA operated at 10 and 15 mph, with a 300-ft gap. Another passenger vehicle (black sedan) operated beside the ATMA on adjacent lane. After a marked point, the vehicle in the adjacent lane changed its lane to cut the ATMA’s path and then left the lane (to replicate a last-minute exit maneuver) (Figure 6-85). Table 35 includes the operation procedure, data collection, and expected results.

Figure 6-85. Dashcam view(left) and external cam view (right) of vehicle intrusion test

Table 6-36 shows the field observations for Test Case 16. ATMA successfully stopped in all test runs after the vehicle intruded into its lane. The engine status was on after the stop.

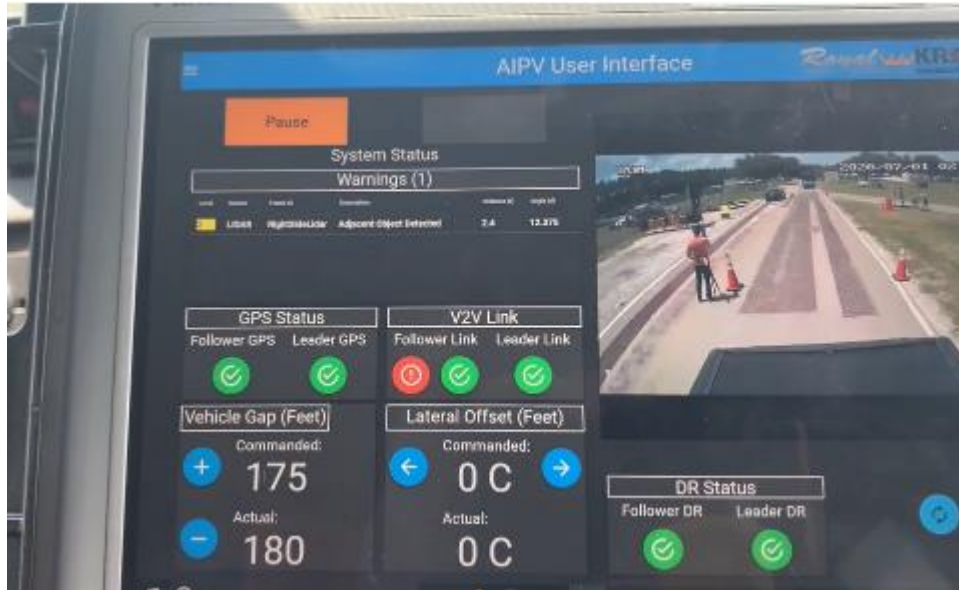
Figure 6-90. User interface view showing the warning as it recognized the object

In each case, the system was successful in recognizing the object.
