# Florida ATMA Pilot Demonstration and Evaluation

## Final Report

Prepared by:  
University of Florida

March 2021

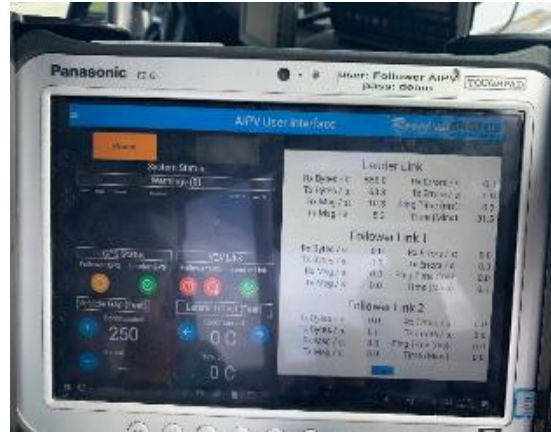
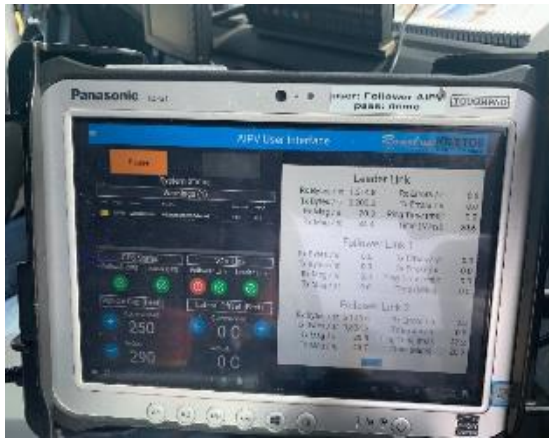
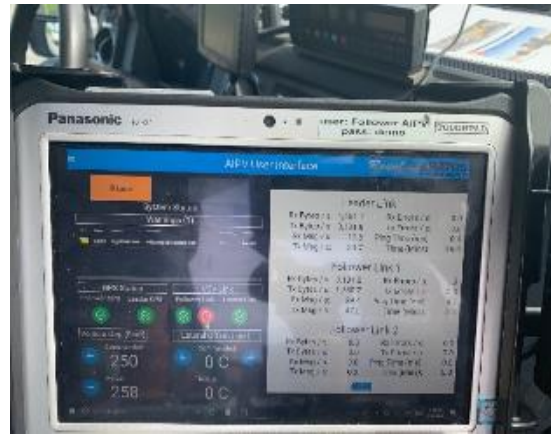
Figure 6-113. User interface showing status of communication link during loss of communication test

Figure 6-113 below shows the status of follower link: first, when both indicators were active; then both communication links were disconnected, which was confirmed in the UI as shown in the figure. For the second test, only one of the communication links was disconnected (confirmed in the UI).

Both Follower Link

One Follower Link Active

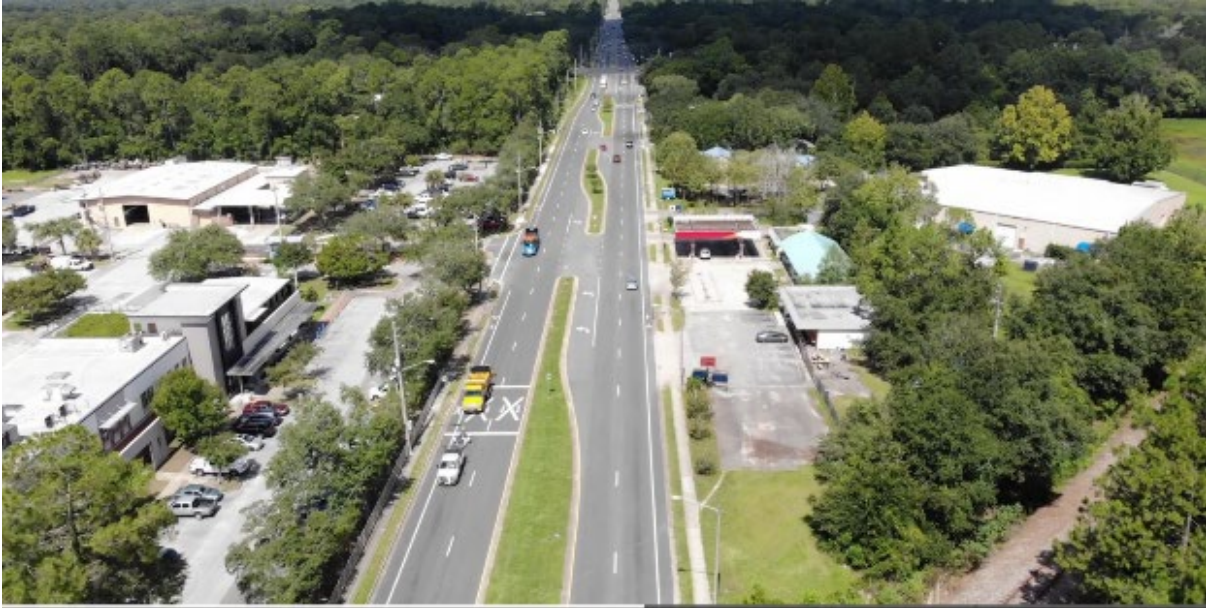
**Figure 6-114. Location of Test Site 3 on SR-222 in the Gainesville area**

Figure 6-114 below shows an aerial view of the Field Test 1 (FT-1) test section on SR-222, a multilane, high traffic (average AADT of 22,914), low-speed (speed limit: 45mph) urban environment with three signalized intersections and multiple access points on corridors. Historical AADT is provided in Table 6-57. The testing was conducted under daylight conditions on both EB and WB directions. This was a three-vehicle operation with the offset distance between the leader (FWD) and TMA being 50 feet, and between the TMA and ATMA follower vehicle, the gap was set at 200 feet. The overall testing took about 4 hours. The FWD made stops every 375 feet for a couple of minutes and moved to the following test location. Overall, the testing was performed as expected with one issue as documented below.

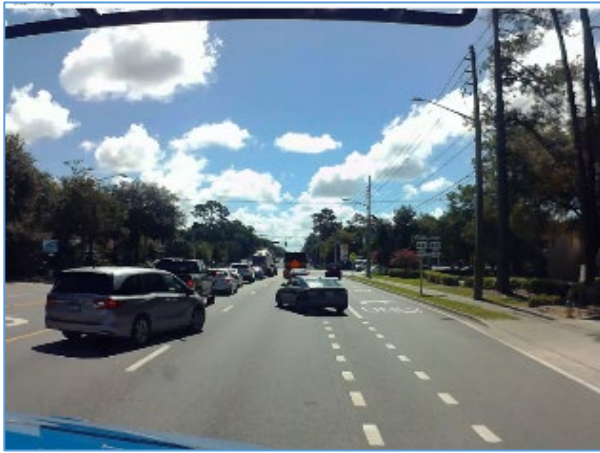
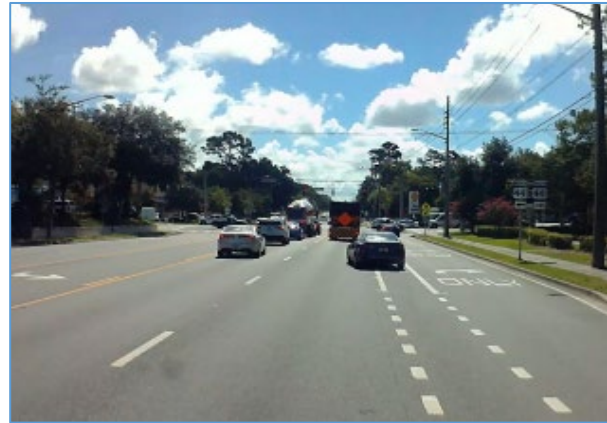
**Figure 6-115. Multiple vehicle intrusions in front of ATMA that caused frequent A-stops**

- The camera in the leader unit could not differentiate the signal light color due to sun glare.
- In one instance, the ATMA follower drifted towards the outside lane, and the control was overridden by the Kratos safety officer. The cause could not be determined.
- At 11:48 AM, the system operated on Idle because it did not receive the leader message.
- At 12:03 PM, due to a hard break, the system misreported a collision, and the safety operator (Kratos staff) was required to change to Idle mode.
- At intersections, driver training is critical to understand the implications of ATMA operation, for example, stop the work platoon downstream of the intersection to avoid a traffic bottleneck at the intersection (Figure 6-117).

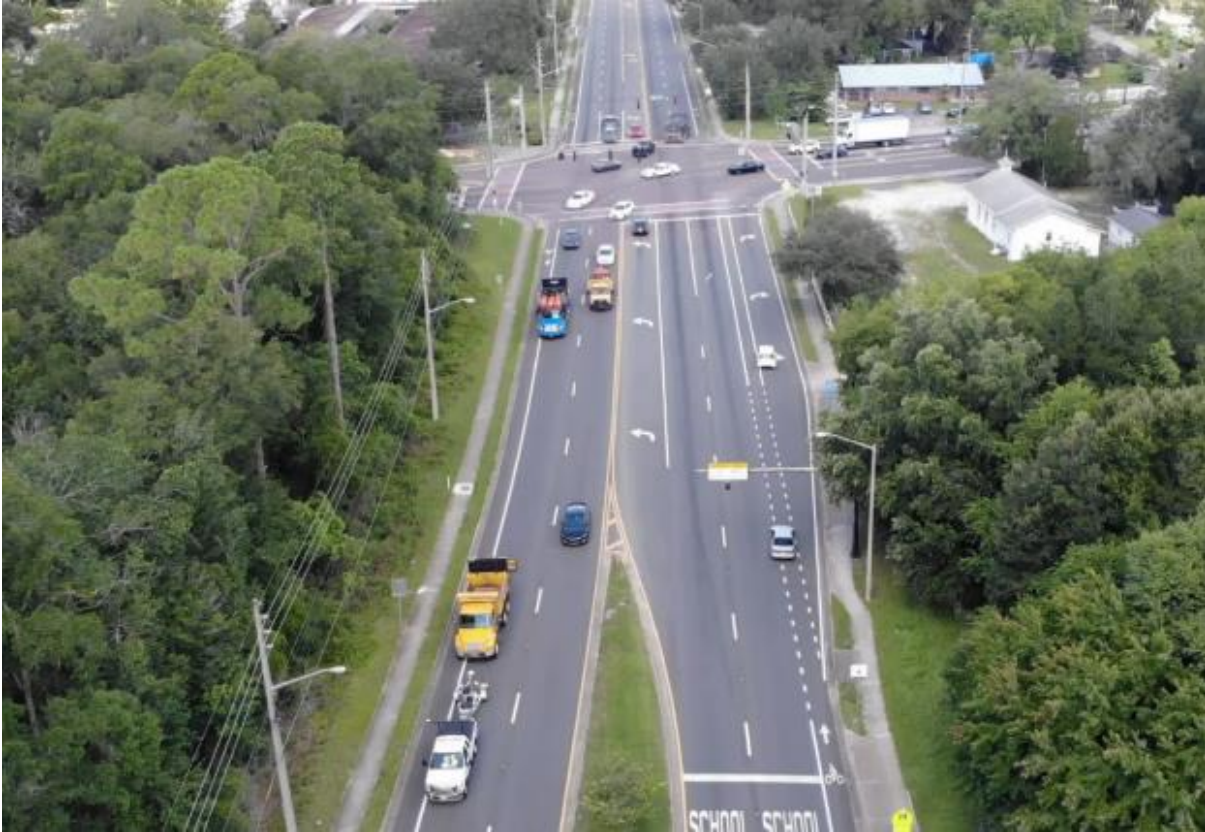
**Figure 6-117. ATMA stop too close to intersection caused traffic backup for left-turning traffic at intersection**

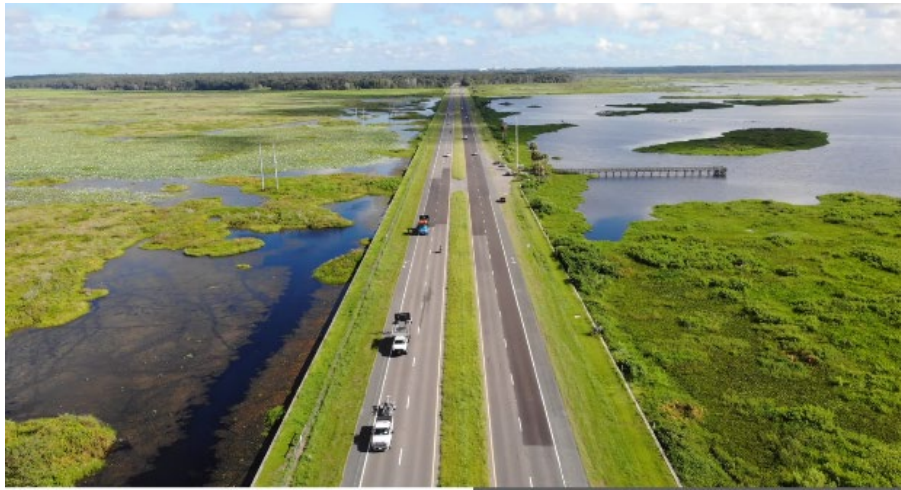
**Figure 6-125. Front view showing upstream vehicles changing lanes before approaching the work platoon section**

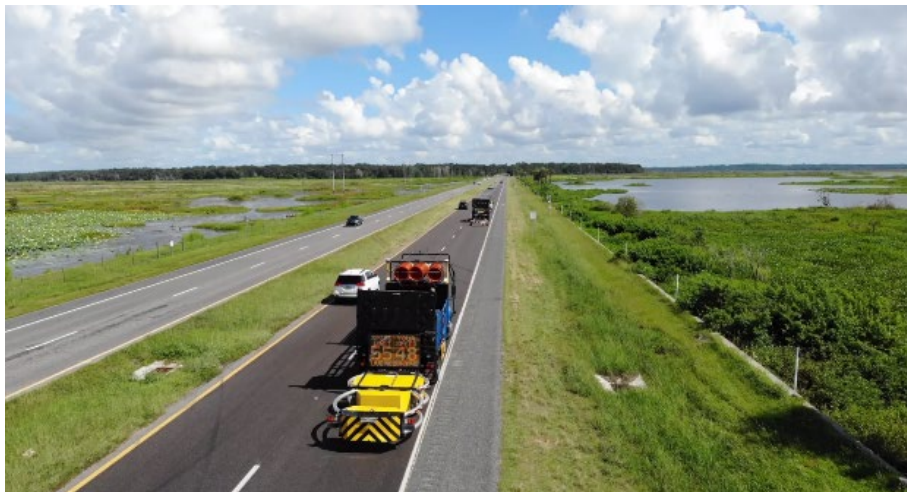
**Figure 6-126. View from the back of the work platoon**

Figure 6-123 shows the Field Test 3 test section on US-441, which is a four-lane, semi-urban, high-speed (65 mph speed limit) roadway with grass median. The roadway carries moderate traffic with AADT shown in Table 6-61 below. The FWD testing was performed in both NB and SB directions. Figure 6-126 shows the aerial views of the offset distance between FWD truck and lead TMA (50 feet), and between the TMA and ATMA, the gap was set at 300 ft. The staging was done in the grass shoulder where the attenuators were positioned, and safety checks were performed for all vehicles. After radio checks, the rollout was initiated until the command gap was achieved. Initially, the ATMA detected the middle TMA vehicle as an obstacle, but after minor adjustment in the gap from the TMA vehicle (closer to leader), the ATMA follower went into autonomous mode. The total testing duration was about 4 hours. The FWD made stops every 375 feet for a couple of minutes and moved to the following test location. Overall, the testing was performed as expected without any significant issues to report.

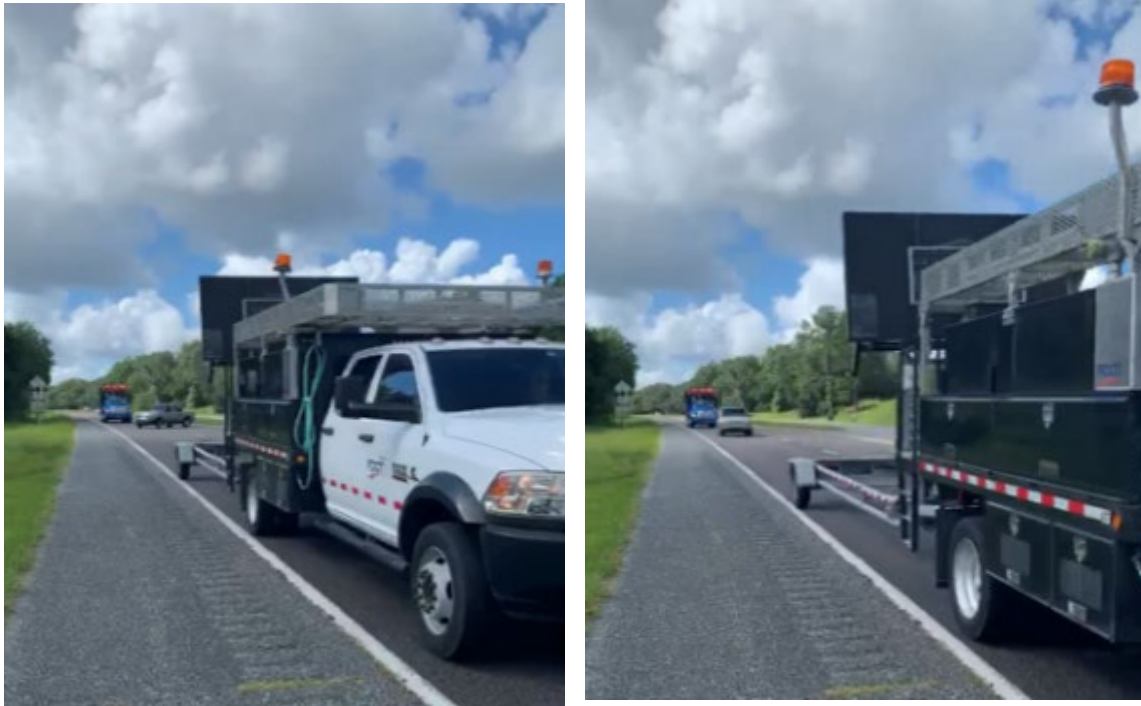
**Figure 6-129. Vehicle making a U-turn and cutting the path of ATMA follower vehicle**

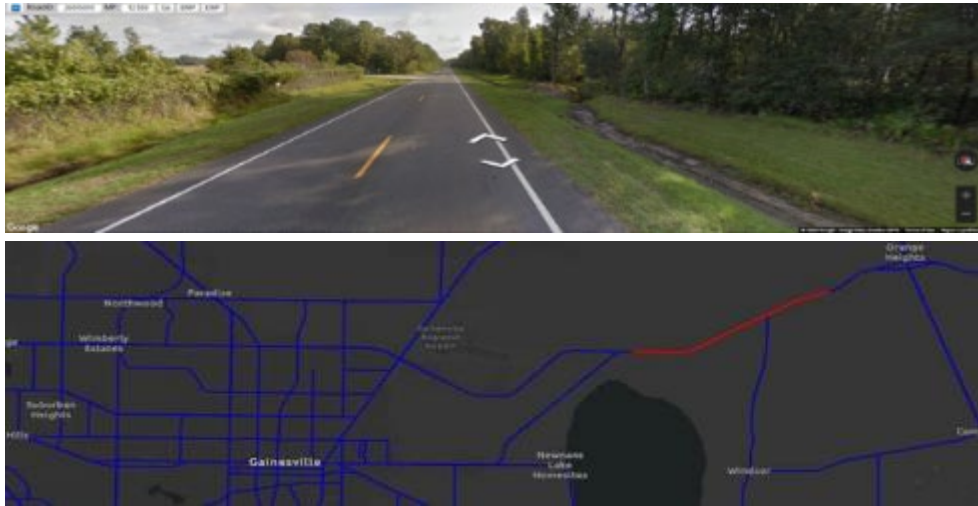
**Figure 6-130. Location of Test Site 4 on SR-26, east of SMO in the Gainesville area**

SR-26 is a high speed, rural, two-lane roadway with high traffic volume (Table 6-63). The FWD testing was conducted under daylight conditions. The testing was performed in the EB direction only; however, it was terminated early due to increased traffic and safety reasons. This was a two-vehicle operation. The offset distance between FWD leader and ATMA follower was 300 ft.

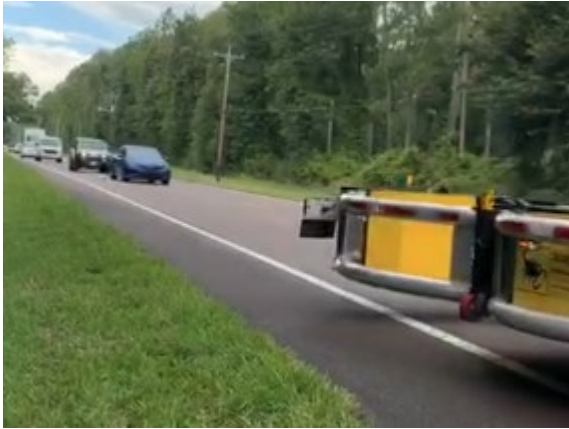
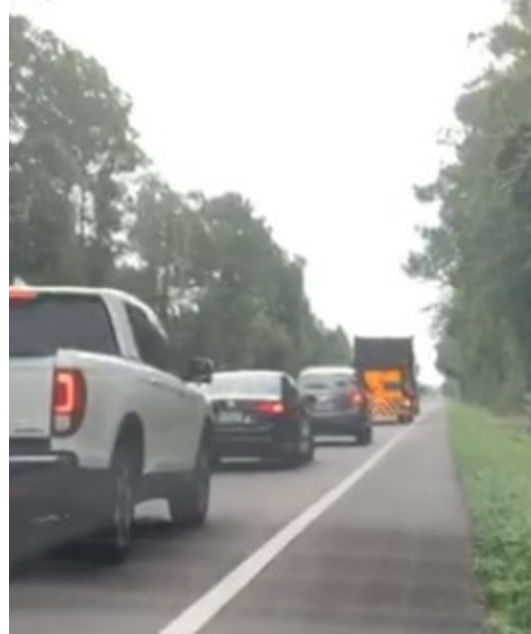
**Figure 6-131. Traffic backed up due to slow moving operation on two-lane roadway**

- Similar observations as the leader vehicle operator, with increased traffic causing safety concerns
- Figure below shows the traffic backing up behind the ATMA follower. With the ATMA follower being a large vehicle, it obstructs the passing sight distance of the vehicle behind, which caused an unsafe condition in the field.
- When the ATMA follower went into DR mode, the platoon had to pull over in order to clear the traffic behind.
- The team decided to terminate the test due to safety concerns.

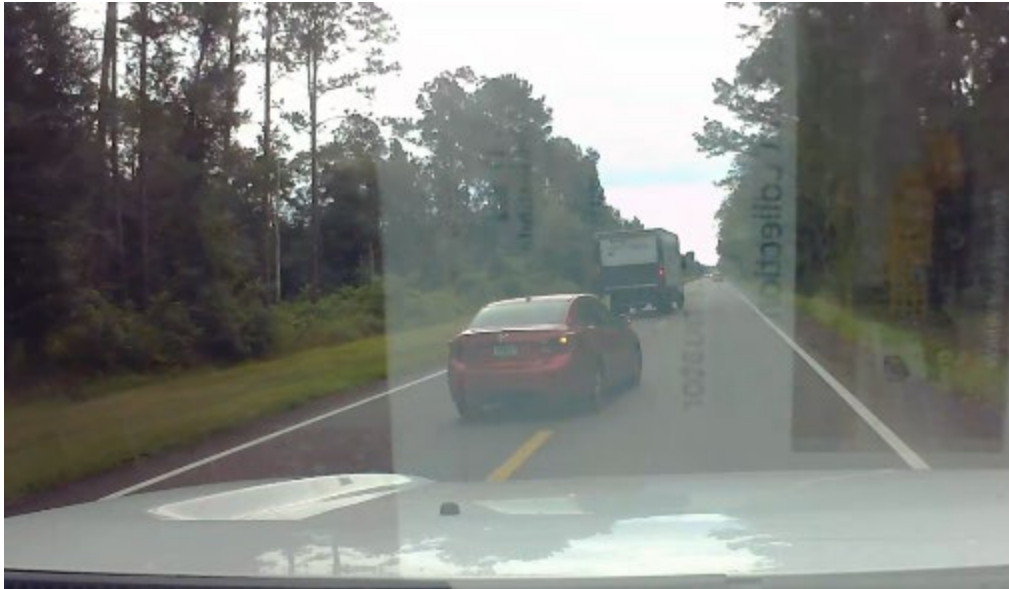
**Figure 6-132. Traffic overtaking the work platoon**

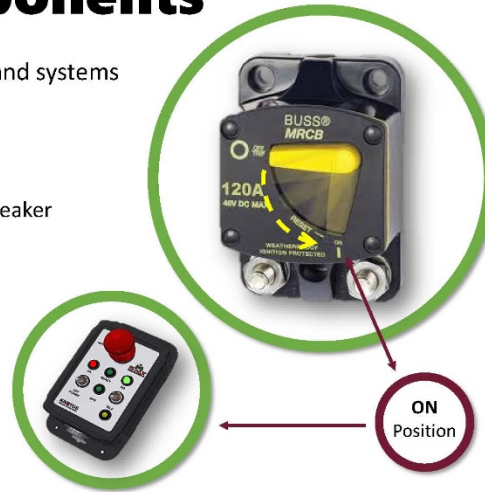
- Battery Breaker – Powers and protects AIPV components and systems

- Connected directly to vehicle’s battery
- Typically mounted near the battery
- Leader Vehicle components are connected to the battery breaker
- Design prevents accidental discharge of the vehicle’s battery when not in use
- Switch must be turned to ON position before operating AIPV system components
- Turn switch to OFF when system is not in use
- Do not switch to OFF while system is on GO

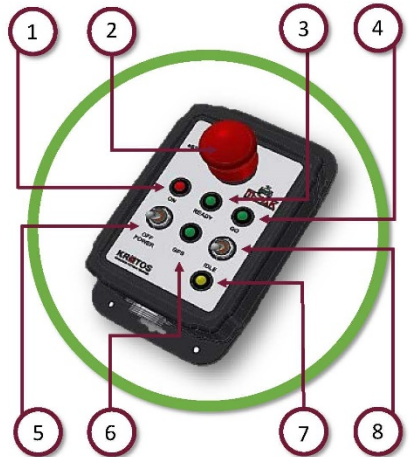
8 - GO / IDLE Control	Toggle Switch	Placing SCU in the GO mode transitions AIPV system into AIPV operations; placing AIPV SCU in IDLE position releases steering, brake, and accelerator controls to the operator.

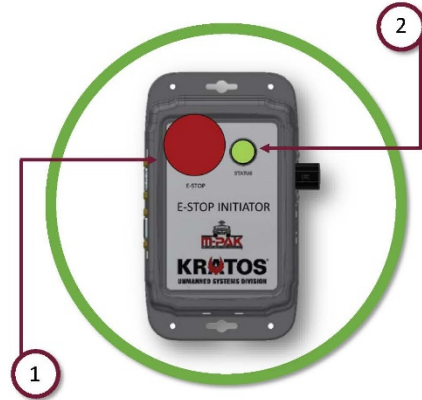
Independent E-Stop Indicators / Controls		
1 - E-Stop Control	Emergency Stop	Depressing the E-Stop Control stops the AIPV and kills the AIPV engine. Turning the E-Stop Control clockwise causes the E-Stop Control to reset to its original position.
2 - Status Light	Green / Red Light	When green light is illuminated, indicates that system is ON and operational. When red light is illuminated, that means an Emergency Stop was initiated and is active.

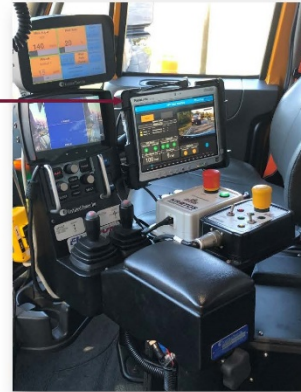
- User Interface – Enables user to conduct and monitor AIPV operations

- Must be installed / powered to start AIPV operations
- Enables Gap Control
- Displays system warnings and cautions
- Provides user with video feed for Leader rear looking camera

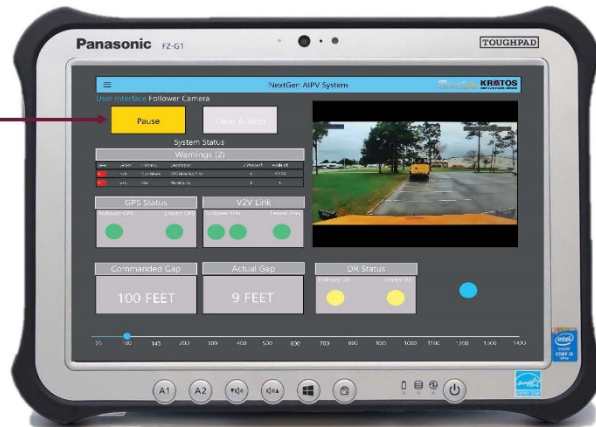
Pause Button

- The Pause button is orange and displays “Pause” as the text under normal operations
- If the vehicle is paused, then the text changes to “Clear Pause”
- If the vehicle is in A-Stop or an error state, then the Pause button is disabled
- Pause will stop AIPV and will keep track of the E-Crumbs for up to 1,500 feet
- When the pause is cleared, AIPV will follow the E-Crumbs that it collected to catch up slowly to the commanded gap
- Not recommended to use the Pause function for more than 1,500 feet and / or for a very long time

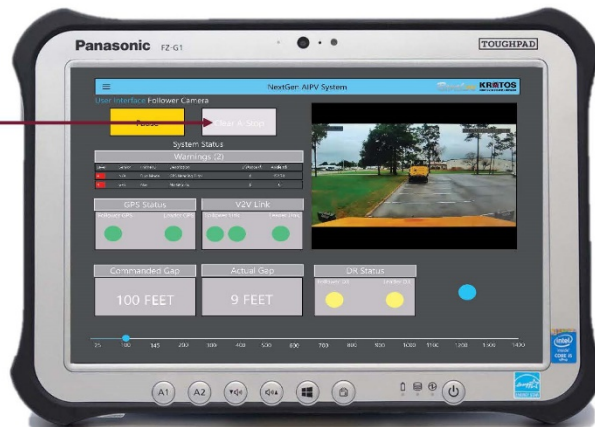
Clear  
A-Stop  
Button

This button is used to clear an A-Stop once the obstacle is no longer in the path of the AIPV. Once cleared, AIPV operations can resume.

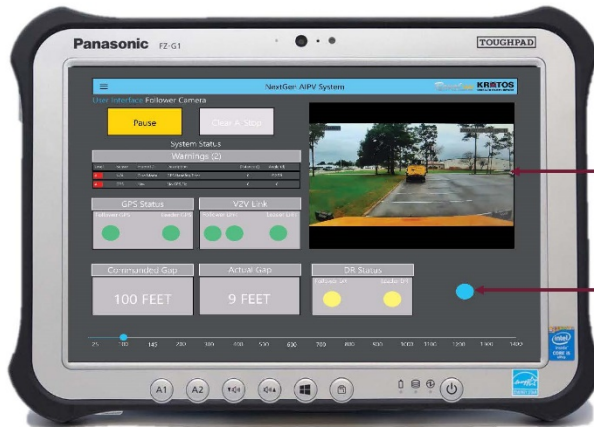
## Rear Looking Video

This displays the video looking backwards from the leader

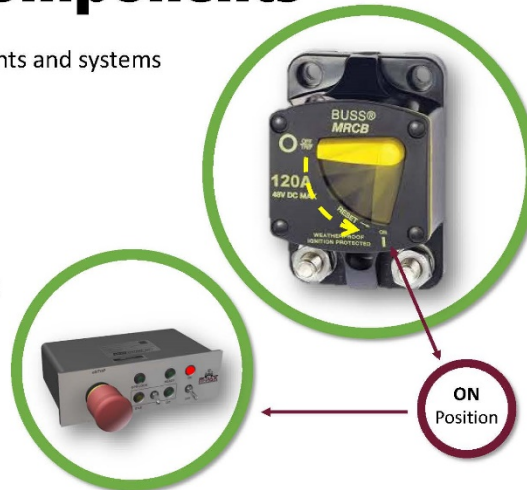
• Battery Breaker – Powers and protects AIPV components and systems

- Connected directly to vehicle’s battery
- Typically mounted near the battery
- AIPV SCU connected to the battery breaker
- Design prevents accidental discharge of the vehicle’s battery when not in use
- Switch must be turned to ON position before operating AIPV system components
- Turn switch to OFF when system is not in use
- Do not switch to OFF while system is on GO

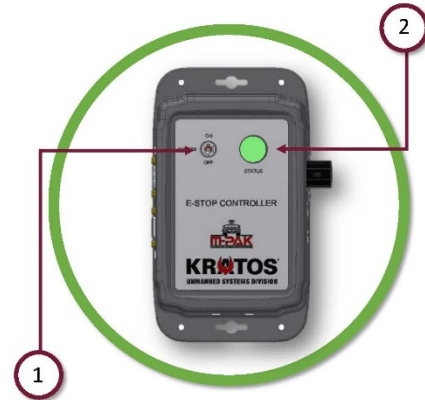
Indicators / Controls		
1 - ON / OFF Bypass	Toggle Switch	Used to put the Independent E-Stop Controller in Bypass mode.
2 - Status Indicator	Green / Red Light	When green light is illuminated, that means the system is ON and operational. When red light is illuminated, that means the system is a "no-go" due to E-Stop button engaged or no V2V communication.
