MPC 19-398 | L. Bohn, M. Tazarv and N. Wehbe

## Rehabilitation of Longitudinal Joints in Double-Tee Girder Bridges

August 2019

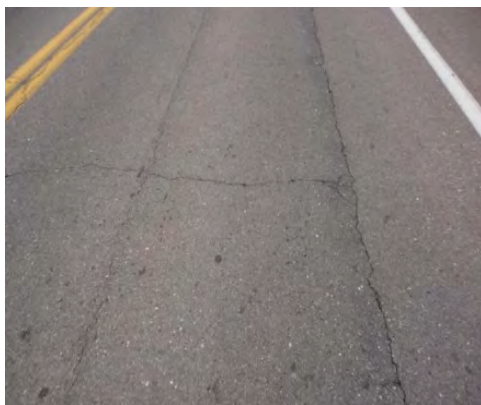
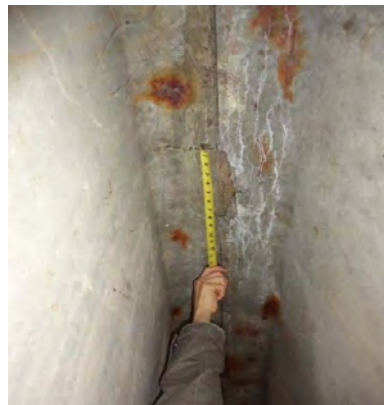
a. Reflective Cracking of Asphalt Overlay

b. Spalling and Corrosion from Underside of a Girder

**Figure 2.2** Reflective Cracking and Deterioration of Double-Tee Girder Bridges (Konrad, 2014)

A common problem with existing double-tee bridges is the deterioration of the girder longitudinal joints. The inspection of bridges built less than 40 years ago revealed there are large reflective cracks along these joints causing corrosion of the reinforcement and the welded connections. The corrosion usually expedites the double-tee girder's rate of deterioration (Fig. 2.2).

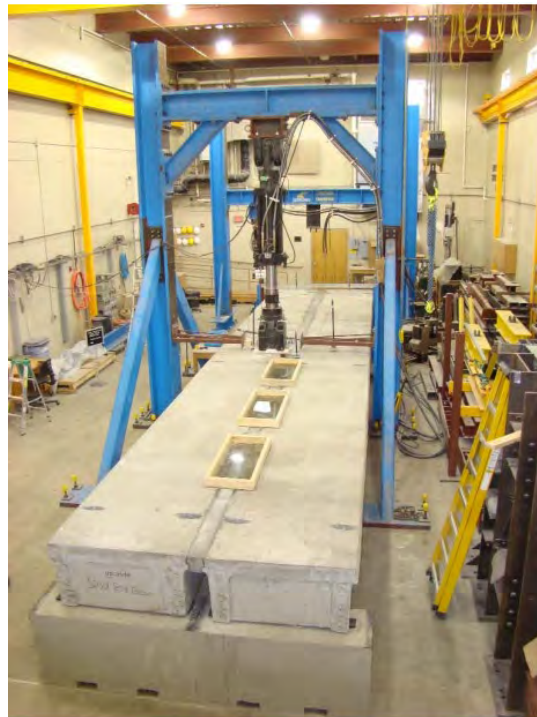
**Figure 2.3** Full-Scale Conventional Double-Tee Girder Test Specimen (Konrad, 2014)

Wehbe et al. (2016) experimentally investigated the behavior of a full-scale conventional double-tee bridge under fatigue and strength loading (Fig. 2.3). The bridge test specimen consisted of two, 40-ft-long interior double-tee girders connected longitudinally using the conventional joint detailing discussed above. The fatigue test was carried out by applying a 21-kip half-cycle loading at a frequency of one cycle per second at the mid-span with a slight offset to maximize the shear force demand on the joint. The strength testing was done by applying an increasing monotonic loading to the girders to failure. Water leaked through the girder-to-girder joint at a load cycle of 19,500 during the fatigue testing (equivalent to 3.5 years of service). The welded connections failed near the mid-span at 62,000 cycles of the fatigue loading (equivalent to 11 years of service). Furthermore, the two girders acted as individual members under the strength testing, indicating the girder-to-girder joint is the weak link in the system. The study concluded that the current double-tee joint detailing is insufficient and does not meet current AASHTO service, fatigue, and strength limit state requirements.

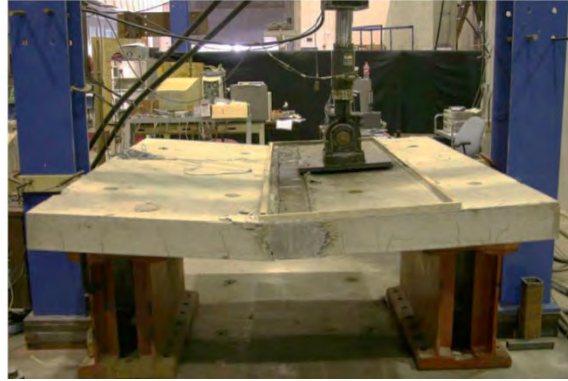
**Figure 3.5** Failure of Longitudinal Deck Panel-to-Panel Joint with Straight Bars under Fatigue Loading (Graybeal, 2010)

The specimens with the headed bar in the longitudinal connection withstood two million load cycles under 2- and 16-kip loads and nearly seven million cycles of 2- and 21.3-kip loads. Throughout the cyclic testing, no cracks or leaks were observed in the UHPC connections. The same result was observed for the longitudinal joints with the straight bars. However, additional cyclic loading was applied to fail the specimen. More than 10.5 million load cycles were applied before the bar crossing the connection interface fractured (Fig. 3.5). No evidence was observed of bond failure of the UHPC to concrete or UHPC to rebar.

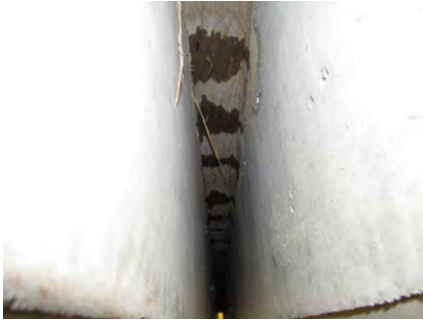
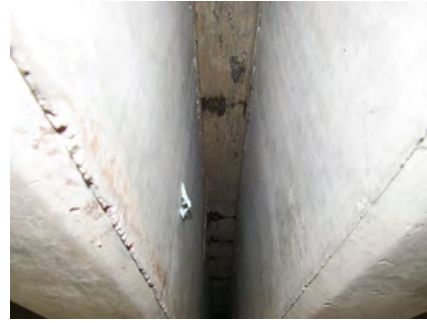
a. Leak in LMC before Testing

b. Leak in LMC after Fatigue Testing

c. Before Testing – Top of Bridge

d. After Testing – Top of Bridge

**Figure 6.13** Damage of Continuous Joint of Rehabilitated Double-Tee Bridge Specimen during Fatigue II Testing

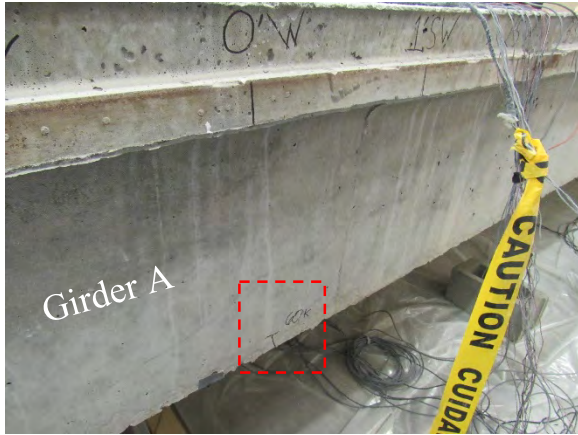
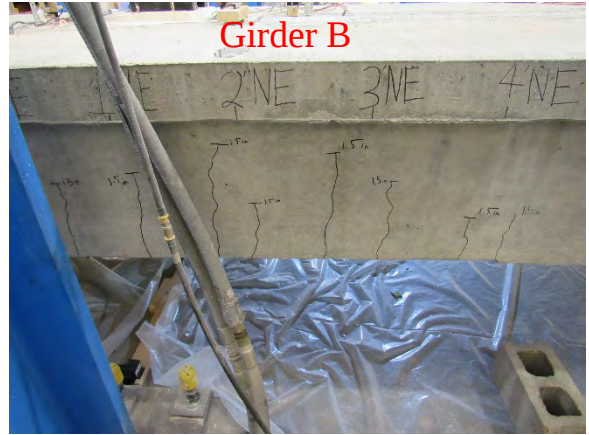
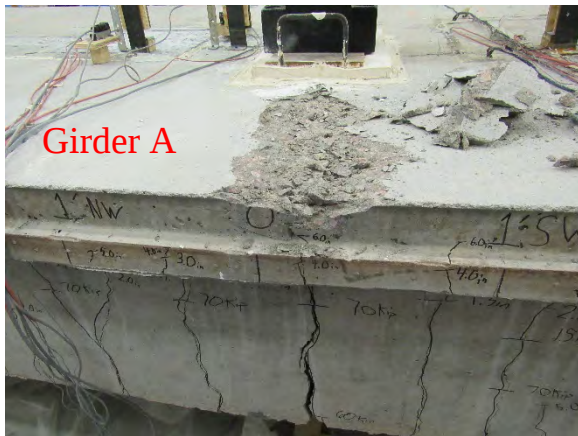
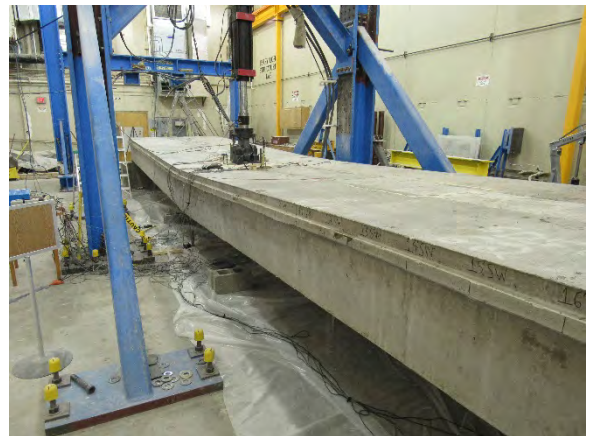
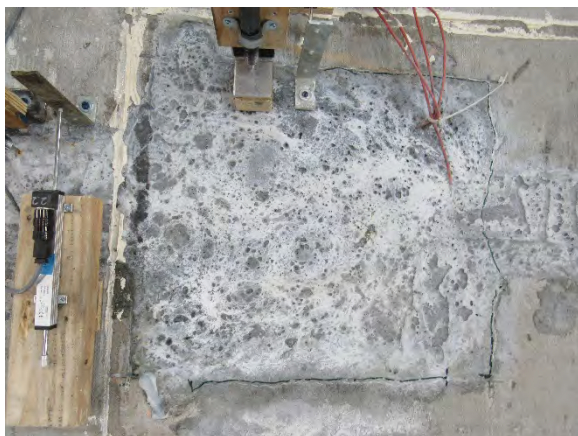
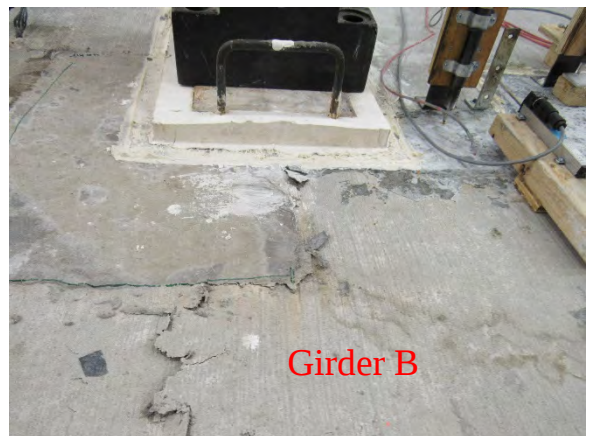
a. First Crack During Loading to 60 kips on West Girder

b. East Side of Girder B Damage at 1.5-in. Deflection

c. Compressive Failure of Concrete at 9.5-in. Deflection

d. Bridge Condition at Failure

e. UHPC Pocket Joint after Testing

f. LMC Continuous Joint after Testing
