**March 2022**  
**Report No. 21-028**

# Development of Comprehensive Inspection Protocols for Deteriorated Steel Beam Ends

# Technical Report Document Page

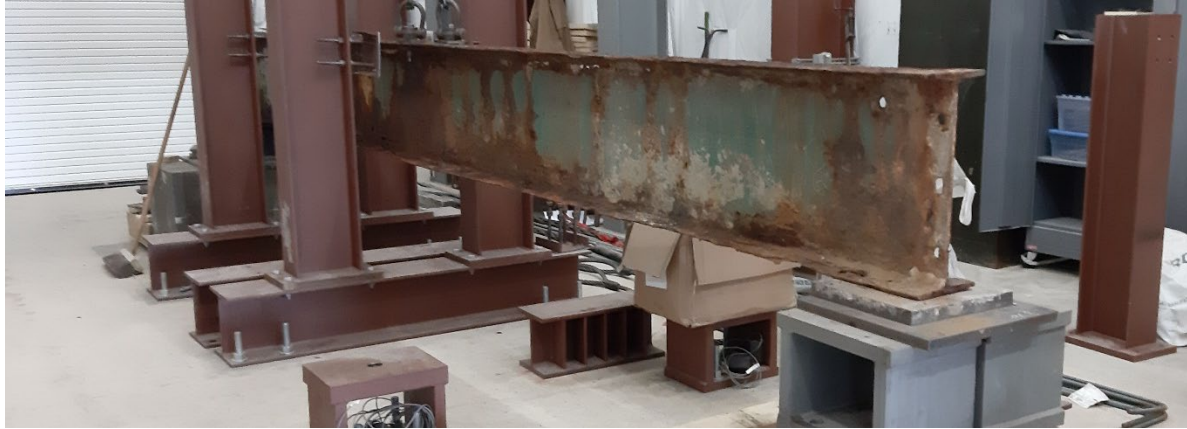
**Figure 3.1: Field corroded girder used for the study**

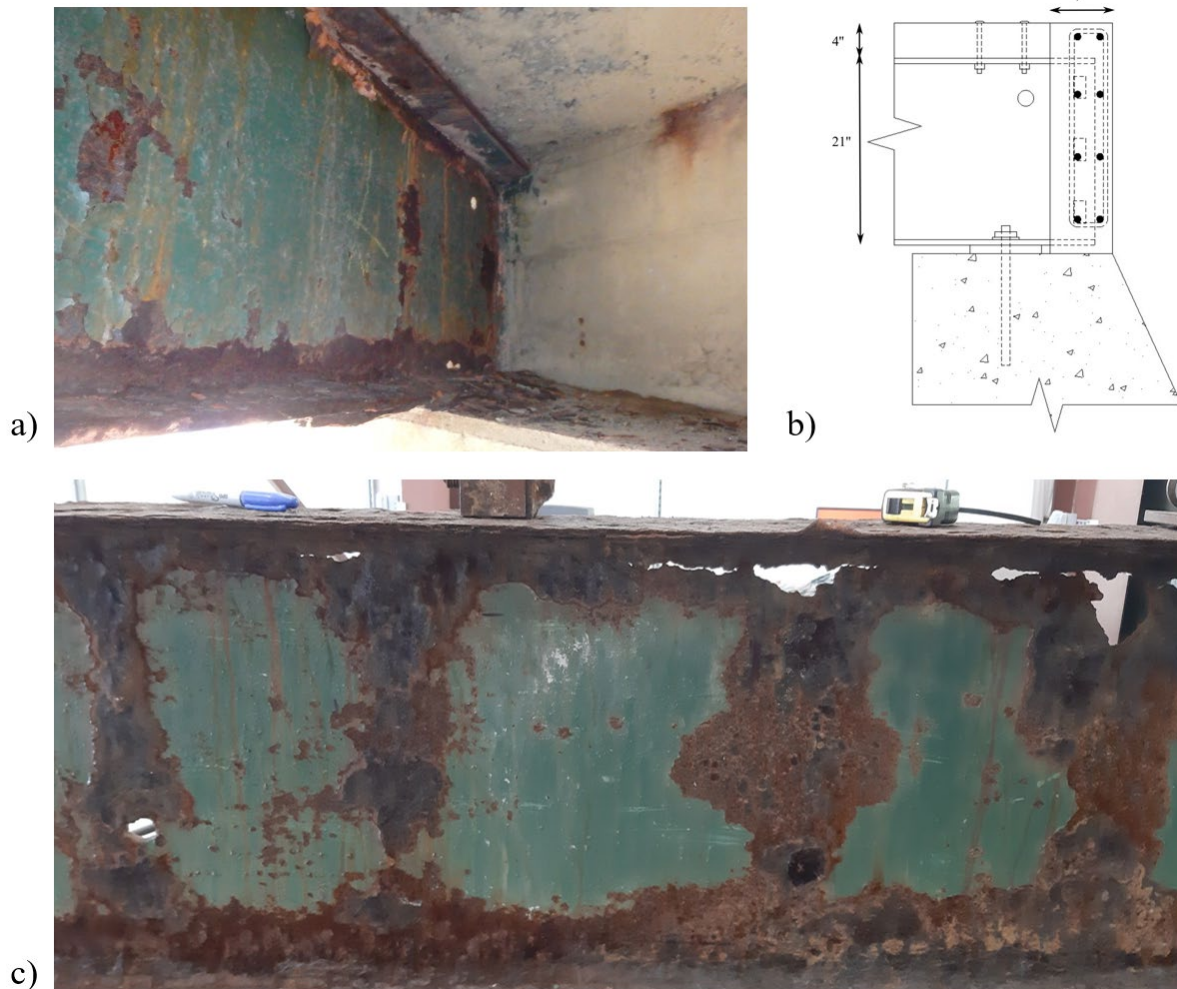
**Figure 3.2: (a) In-service configuration, (b) construction details for the support, and (c) web condition at midspan**

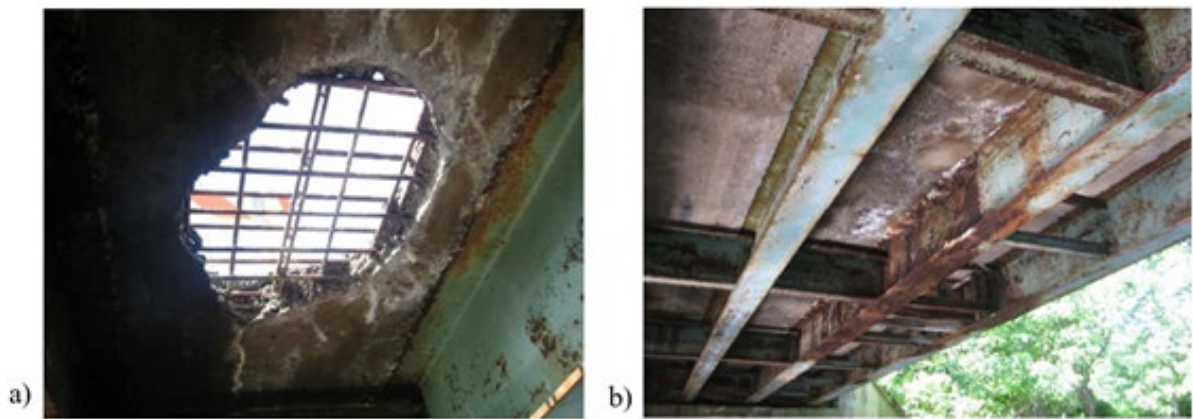
**Figure 3.7: a) Hole through the deck, and b) map cracking with heavy efflorescence at the O-03-009 bridge**

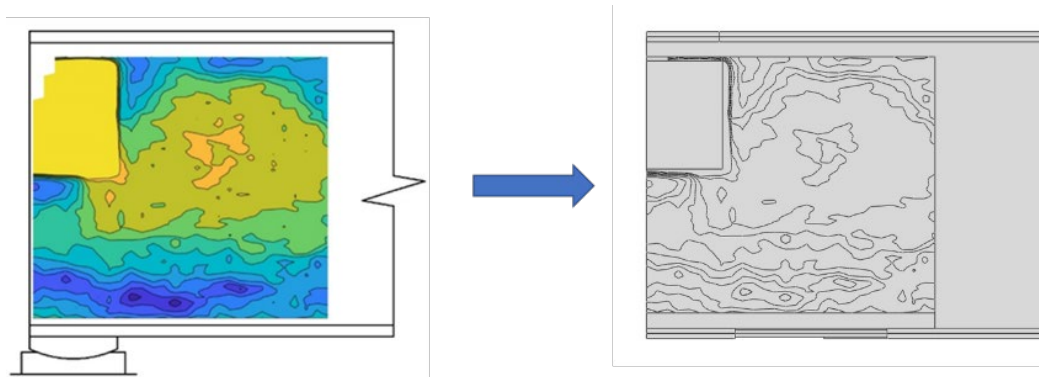
**Figure 3.11: Section loss simulation at the finite-element model**

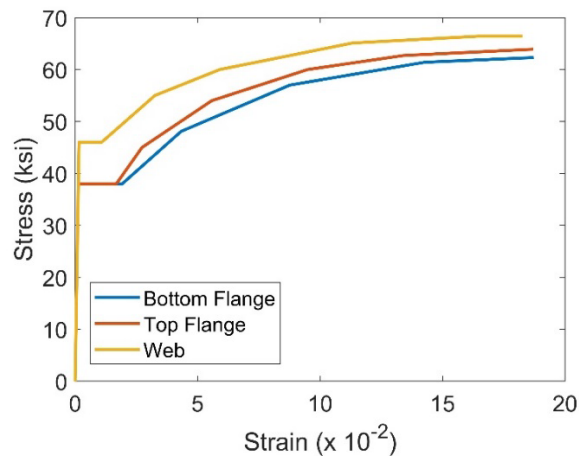
Figure 3.12: Material properties

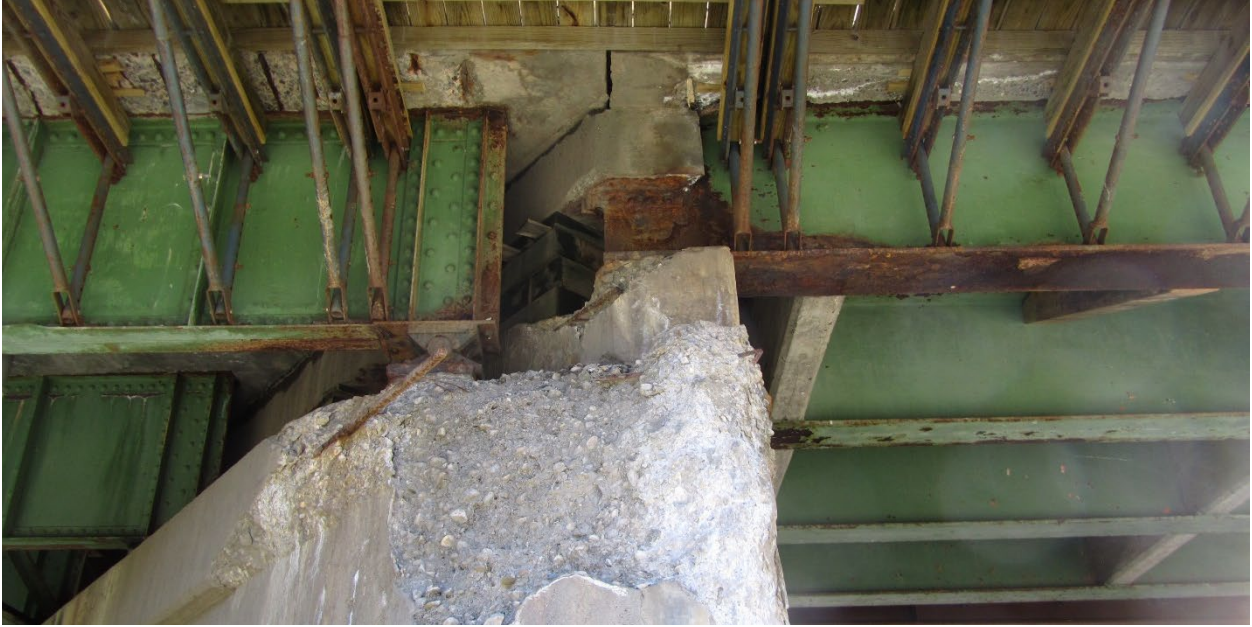
**Figure 4.19: Typical condition of aged bridges**

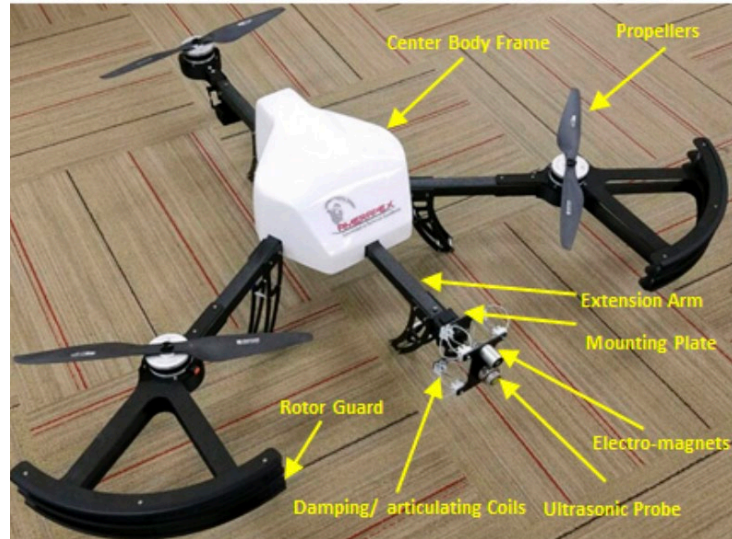
**Figure 4.22: Amerapex drone with UT equipment**
