**DEVELOPMENT OF STANDARD METHODOLOGY TO MEASURE SULFATE
IONS IN POST-TENSIONED GROUTS**

FINAL REPORT

**Project BDV29 977-43
(800002803)**

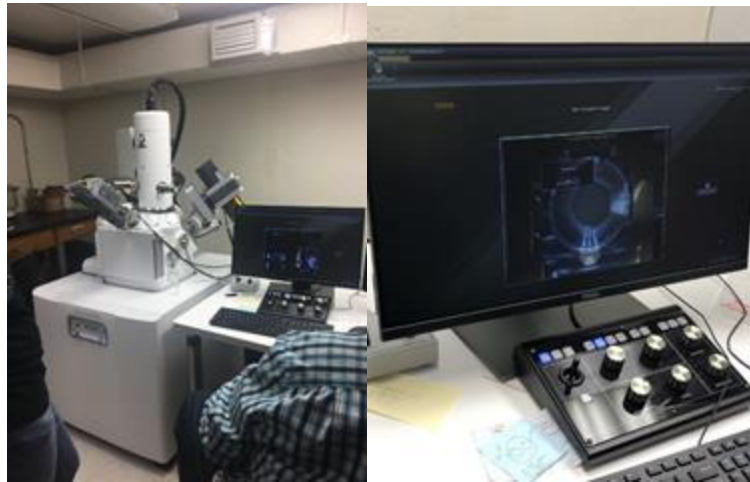
Figure 3.1. Jeol SEM with XRF

X-Ray Fluorescence (XRF) analysis was made for Grout A, B, C, Expired Grout C, Expired Grout D, and a neat grout. This testing was initially made to identify the incipient presence of sulfur-bearing species in the raw material for consideration of the development of the sulfate ions in grout pore water after casting and cement hydration. The raw grout powder was placed on the sample holder. A Jeol SEM with EDS-XRF located in the FCAEM/Dept. of Earth and Env. Sciences at the Florida International University Environmental Science Lab was used (Figure 3.1).

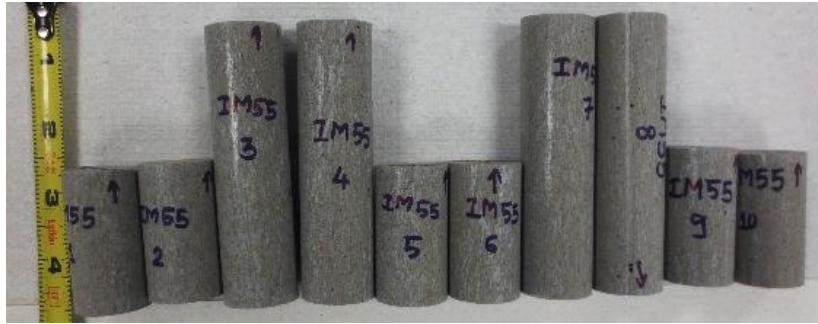
Figure 4.6. INT Test specimen fabrication.

After 28 days curing within the INT mold, the PVC was cut at each partition mark for each specimen with an electric chop saw. The PVC pipe mold was removed by making two circumferential cuts at the top and bottom of the specimen (~1 cm distance from each end) and two longitudinal slits. An example of a set of INT test specimens is shown in Figure 4.6.

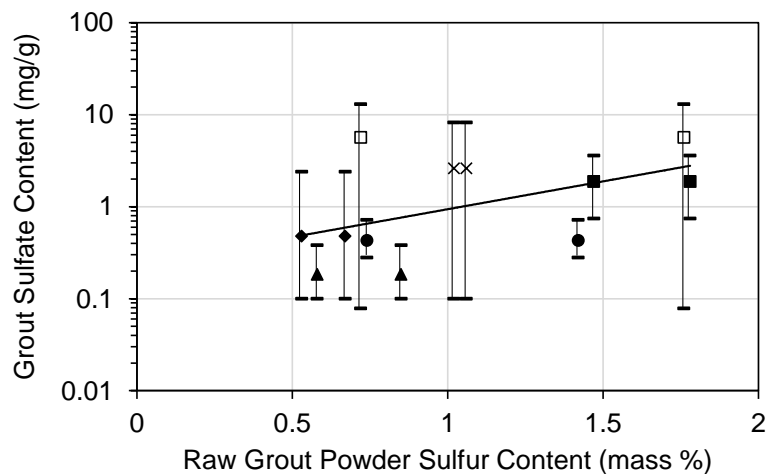
Figure 4.11. Correlation of sulfate content in hardened grout and grout powder. Triangle: Grout A. Diamond: Grout B. Square: Grout C. Cross: Grout D. Circle: Neat grout

Drying the grout samples is necessary for practicality to reduce the level of test preparation (to minimize the gumming of the pulverizing equipment) and to normalize the mass of test specimens (such as samples with high moisture content that can quickly dry in test preparation and transport). Drying of the grout samples to 100°C yielded low sulfate content likely due to evaporative processes and is not recommended.

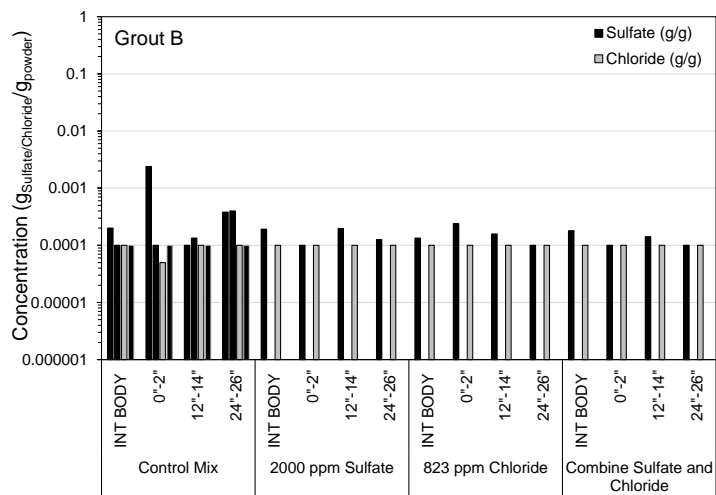
Figure 4.14. Sulfate ion concentration in grouts A and B subjected to external contamination.

Figures 4.13 and 4.14 show the resolved sulfate concentrations in grouts subjected to sulfate contamination. Consistent with previous research, it was shown that the sulfate ion accumulation in the deficient grout (here in the tee header) can develop without external contamination. In the test conditions with an additional 2,000 ppm sulfate, the resolved sulfate concentrations were lower than the control mix. It was observed that when the additional sodium sulfate was added to the mix water, the grout mix was thicker where less water per solids was present. This would create a lower water-to-cement ratio and overall less water availability to be involved in the material segregation.

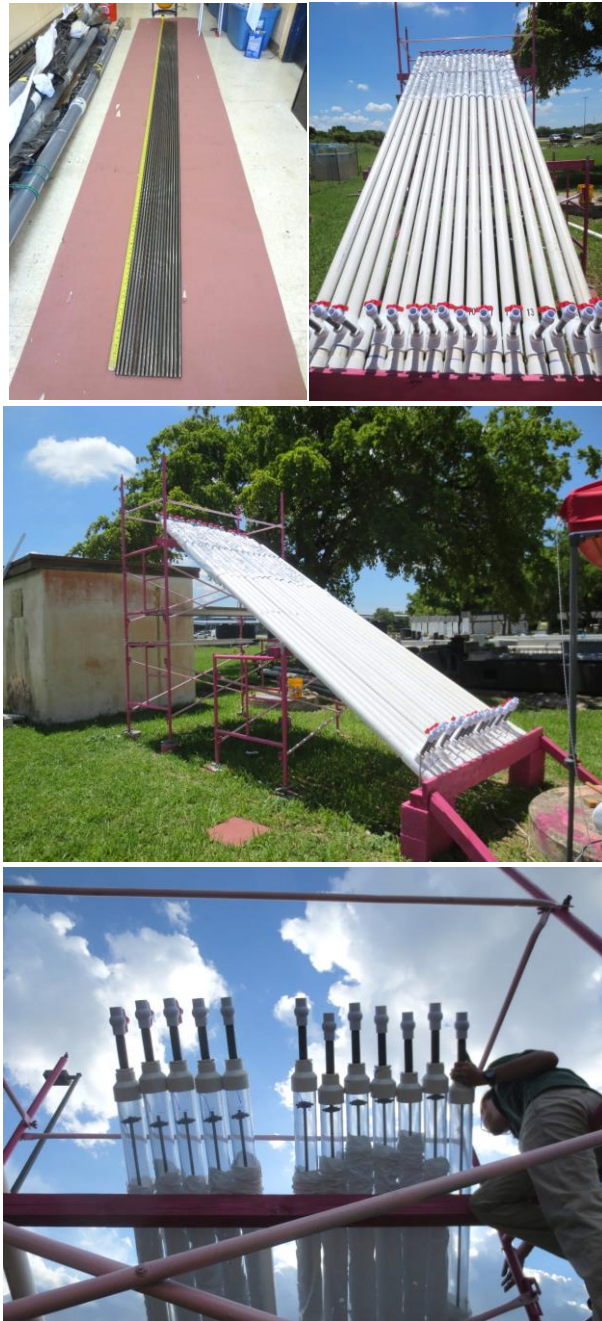
Figure 5.2. MIT assembly.

A. Steel bar. B. Front view of assembly. C. Side view of assembly. D. View of steel bar near MIT outlet.

A 15-foot 0.5-inch diameter steel bar was placed in the MIT for additional corrosion testing as part of the sister project, “Accelerated Corrosion Testing of Grouts for PT Steel Strand.” The steel bar was cut to length and cleaned with acetone (Figure 2A). The PVC components were assembled according to Figure 5.1 and the steel bar was placed within the pipe, centered with rebar spacers. The specimens were placed on a steel frame with a 30 degree incline, as shown in Figure 5.2B-D.

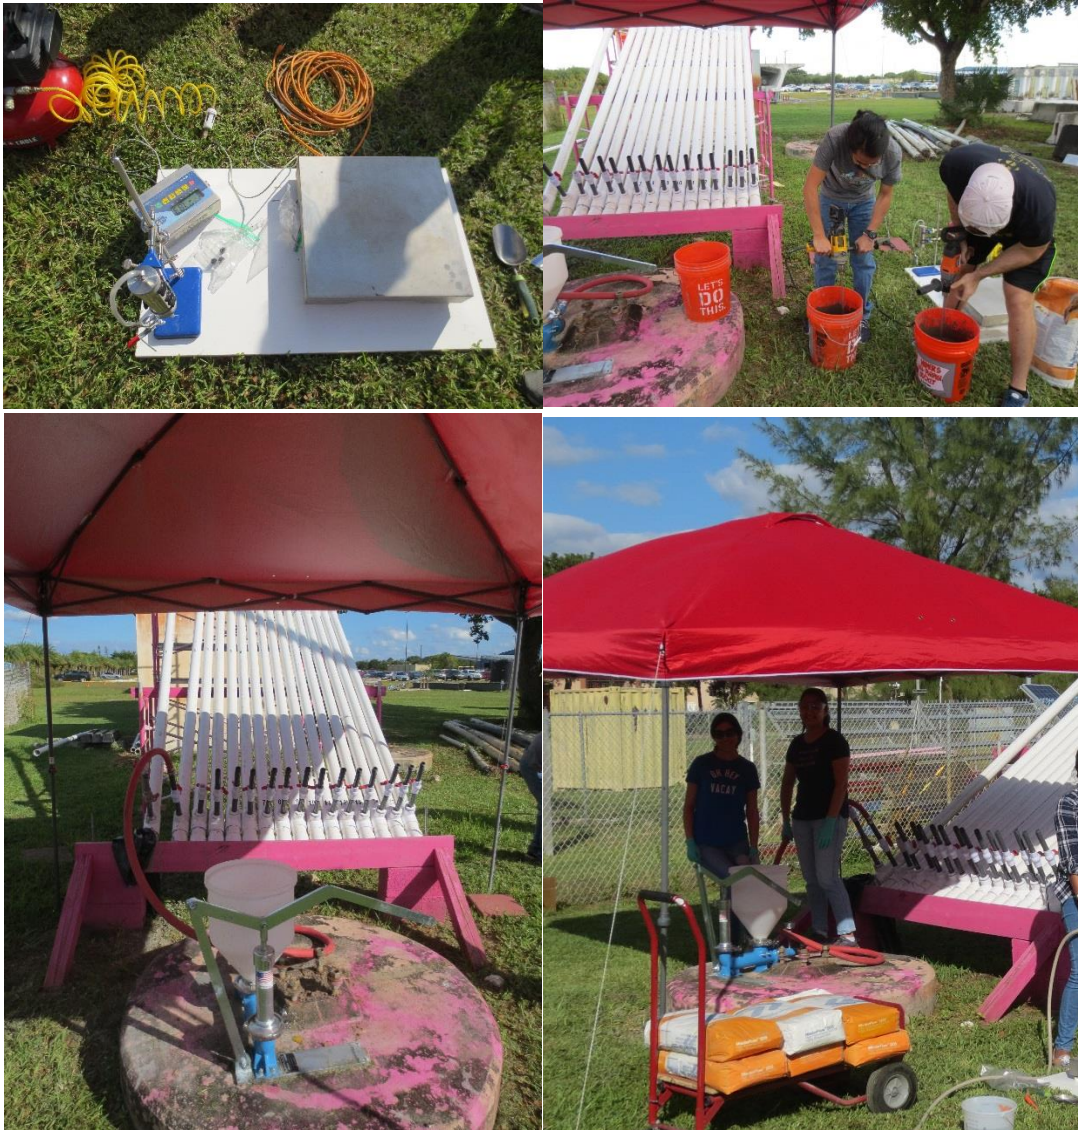
Figure 5.3. MIT grout mixing and injection

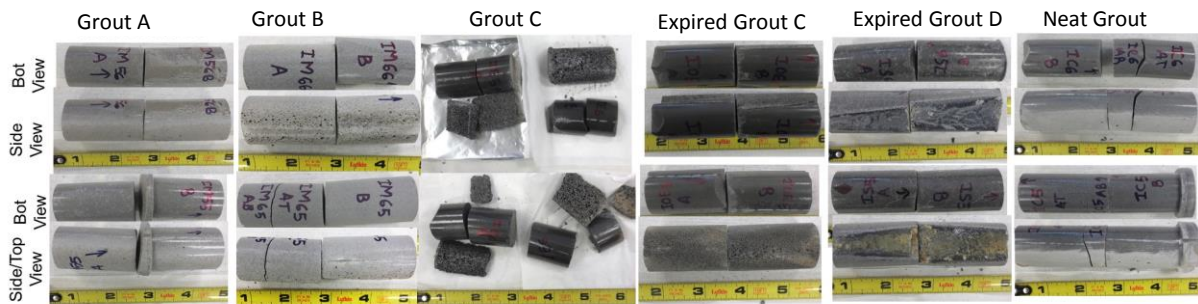
Figure A2. INT Tee-body test specimen after opening, cast with extra 10% mix water
