# Innovative Coating Removal Techniques for Coated Bridge Steel

Final Report VTRC 20-R1

14. Sponsoring Agency Code:	
15. Supplementary Notes: This is an SPR-B report.			
16. Abstract: <p>The purpose of this study was to determine if the use of a laser ablation coating removal (LACR) system would provide the Virginia Department of Transportation (VDOT) with an acceptable new alternative for removing existing coatings. In this study, the LACR process was documented in the laboratory and in the field to determine the feasibility of implementing LACR for VDOT bridges. All LACR work was performed on actual structural steel features from Virginia bridges. Industrial hygiene surveys of the LACR process were used to determine the environmental and worker safety of LACR. Laboratory material analysis of samples evaluated the effects on the properties of steel bridge components.</p> <p>This work led to the following conclusions.</p> <ul style="list-style-type: none"> <li>• LACR effectively removes the coatings investigated, including lead-based coatings. Although microscopic investigation revealed that small coating particles remained on the surface after cleaning (which were not visible to

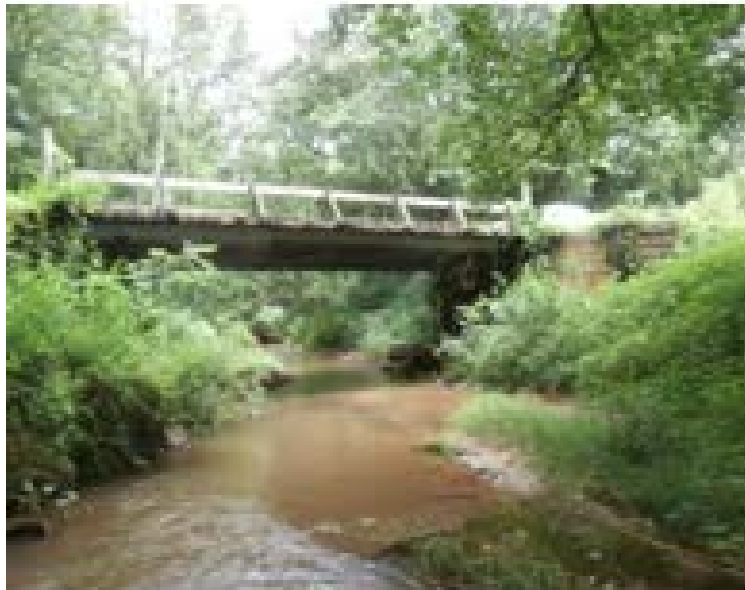
**Figure 1. Bridge From Which the 20 I-Beam Samples Were Taken**

Phase 1 consisted of sample generation and the initial test to laser clean bridge components. Several bridge I-beams were removed by VDOT from the bridge on Route 685 (Telegraph Road) over Stinking River in Pittsylvania County, VDOT Structure No. 6096 (Figure 1); sectioned into 1-ft or 5-ft sections; and transported to the facility of the LACR representative for the LACR demonstration. Along with the documentation and observations made of the LACR process, an IH survey was conducted to monitor and report on the worker health and safety and environmental protection of the process. Phase I took place in an indoor office setting, further demonstrating the cleanness of the process because of the vacuum and filtration system on the laser.

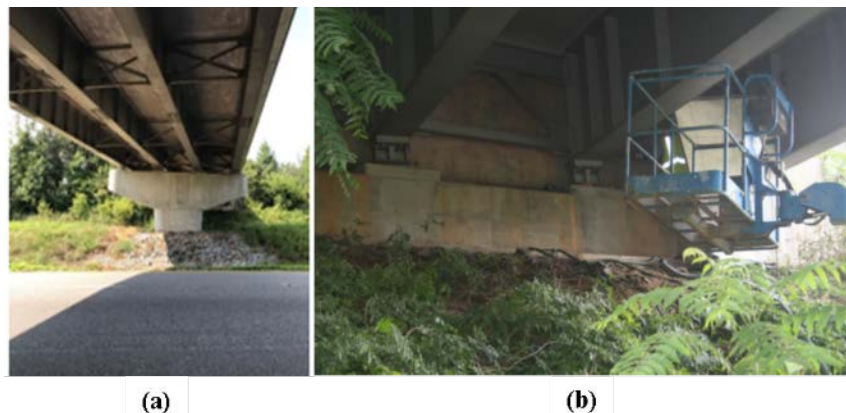
**Figure 5. On-site Demonstration of LACR: (a) underside of Route 695 Bridge in Farmville, Virginia, where the on-site LACR testing took place; (b) boom lift used to elevate the operator to the cleaning area. LACR = laser ablation coating removal.**

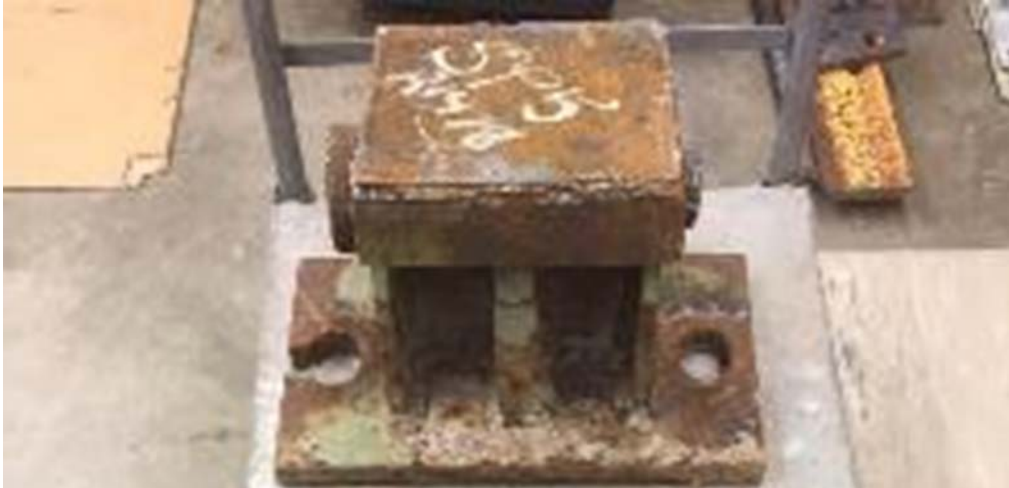
**Figure 6. Bridge Bearing Component Used in Phase 3**

In order to evaluate the ability for the laser to clean tighter areas, the 500W system was used with the CleanCUBE H15 head, which consists of a laser optic head with a light aperture that is 90 degrees to the incoming optic cable line, allowing for a more maneuverable optic that also takes up less space (Figure 7). The targeted area for the laser test was one of the recessed areas underneath the bearing pin because it was the toughest part of the bearing to access with the laser. After surface scale and dirt were removed by hand with a metal scraper and wire brush, the first attempt at laser ablation used the 500 Watt laser and CleanCUBE H15 optic.

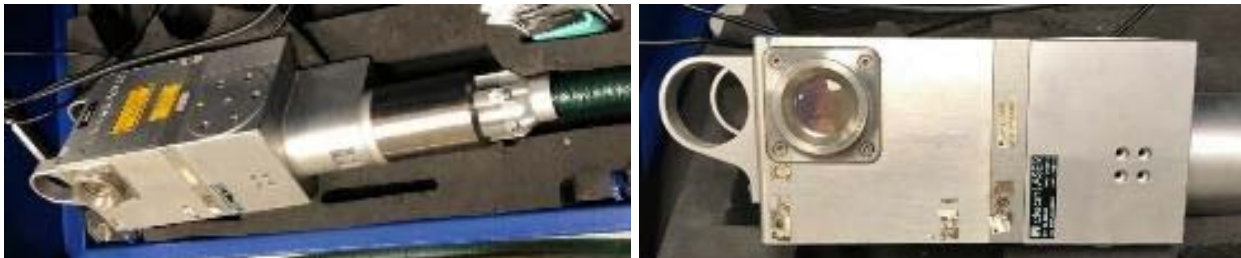
**Figure 7. CleanCUBE H15 Optic Head Used With the 500 Watt Laser. The optical cable (green) enters the head from the laser power supply. The cleaning lens is on the left in both images.**

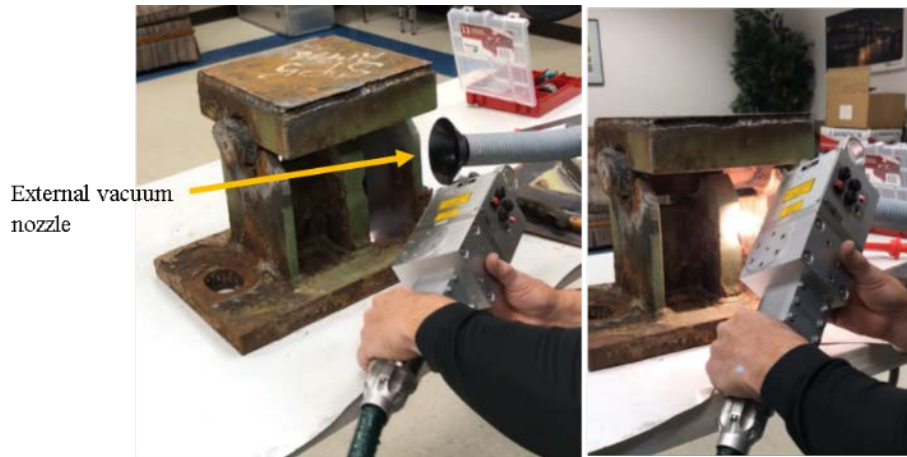
**Figure 8. Images of Right-Angle CleanCUBE Head Geometry Processing in Tight Geometric Areas**

Various apertures with different corresponding laser focal lengths can be used with the 500W system, and different combinations of lenses and laser parameters were tested until an optimal setup was found. The first laser setup used the 150 mm lens, which has a focal length of 6 in. This was later replaced with the 250 mm lens, which increased the focal length to 10 in. Various laser parameters such as pulse frequency and scan width were adjusted until optimal settings were found. After the settings on the laser were adjusted, a test scan was performed on a sample piece of scrap metal to determine the characteristics of the beam before the laser was used on the bearing.

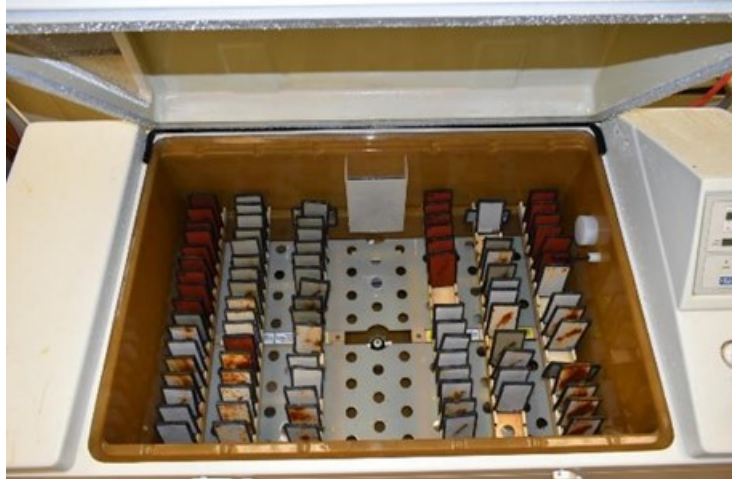
**Figure 12. Coated Panels in Salt/Fog Chamber of Test Cabinet**

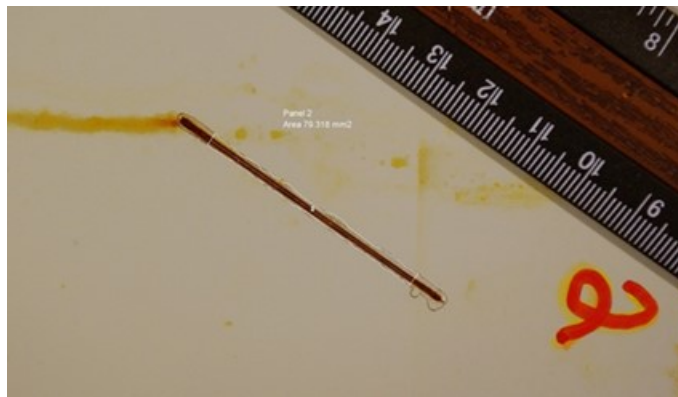
**Figure 15. Sketching Rust Creepage Outline on Image**

6. Sketch the Creepage Outline as shown in Figure 15. For better results, use fine lines—size 1. Use Polygon Selections.
7. Measure the area of the polygon (ANALYZE>MEASURE).
8. Label the area (ANALYZE>LABEL).
9. Write the value of the area, in mm<sup>2</sup>, with TEXT TOOL, and then click EDIT>DRAW.
10. Save the new file.

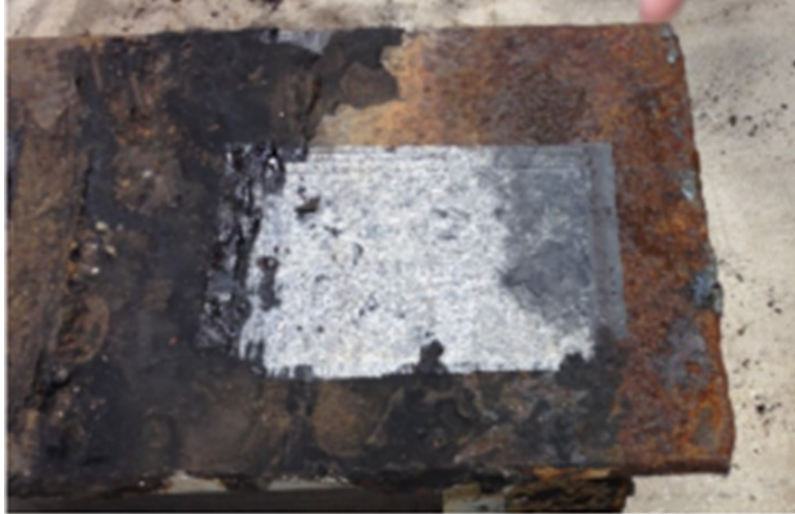
**Figure 16. Laser-Cleaned Surface Area and Surrounding I-Beam Surface Area Prior to Cleaning**

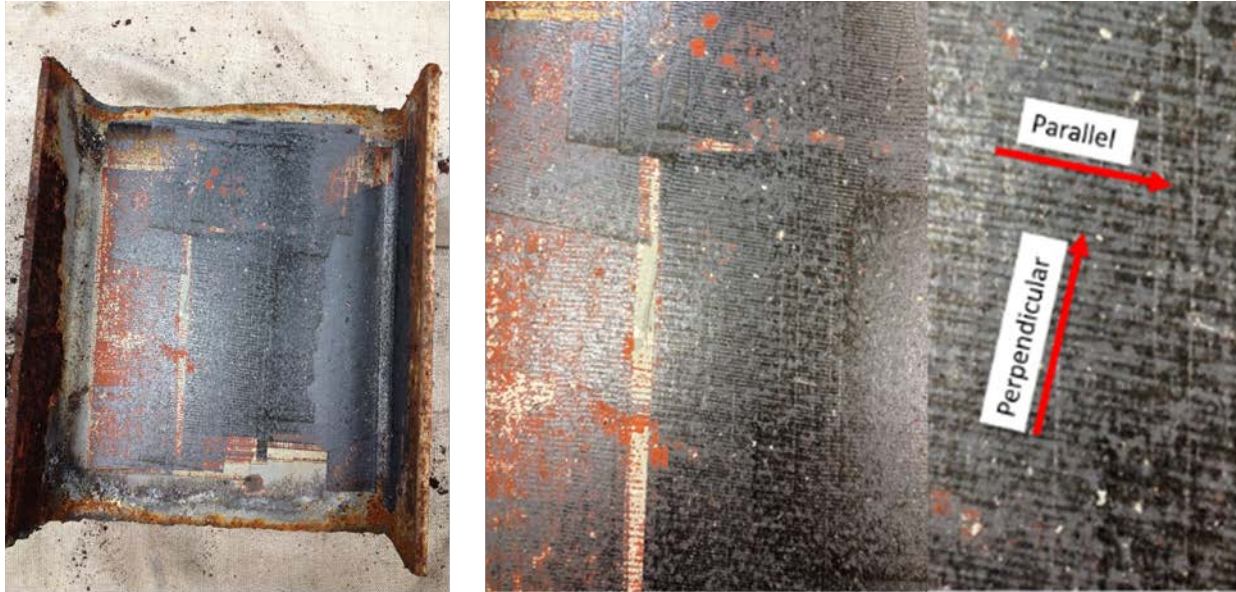
**Figure 17. Photographs of Laser-Cleaned Area: (left) laser “tracks” left behind on surface after laser ablation; (right) higher magnification of region between tracks of random surface pattern of darker- and lighter-colored regions. Surface roughness was characterized parallel and perpendicular to the laser tracks.**

These were parallel to the scanning laser beam and appeared darker than the surrounding substrate, as shown in Figure 17. The appearance of the tracks varied with the laser parameters used, including scan speed, pulse frequency, and the actual motion of the laser by the operator. In addition to the “darker” and “lighter” colors of these laser tracks, there appeared to be splotchy areas consisting of the darker-colored and lighter-colored areas surrounding these spots.

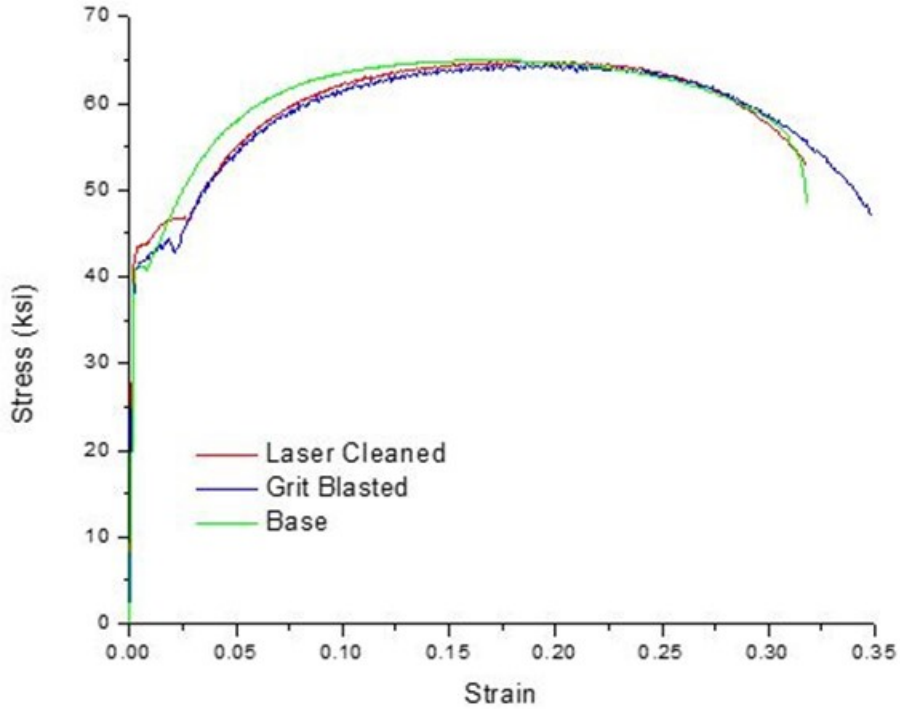
Figure 32. Stress Strain Curves for Base, Grit-Blasted, and Laser-Cleaned Metal

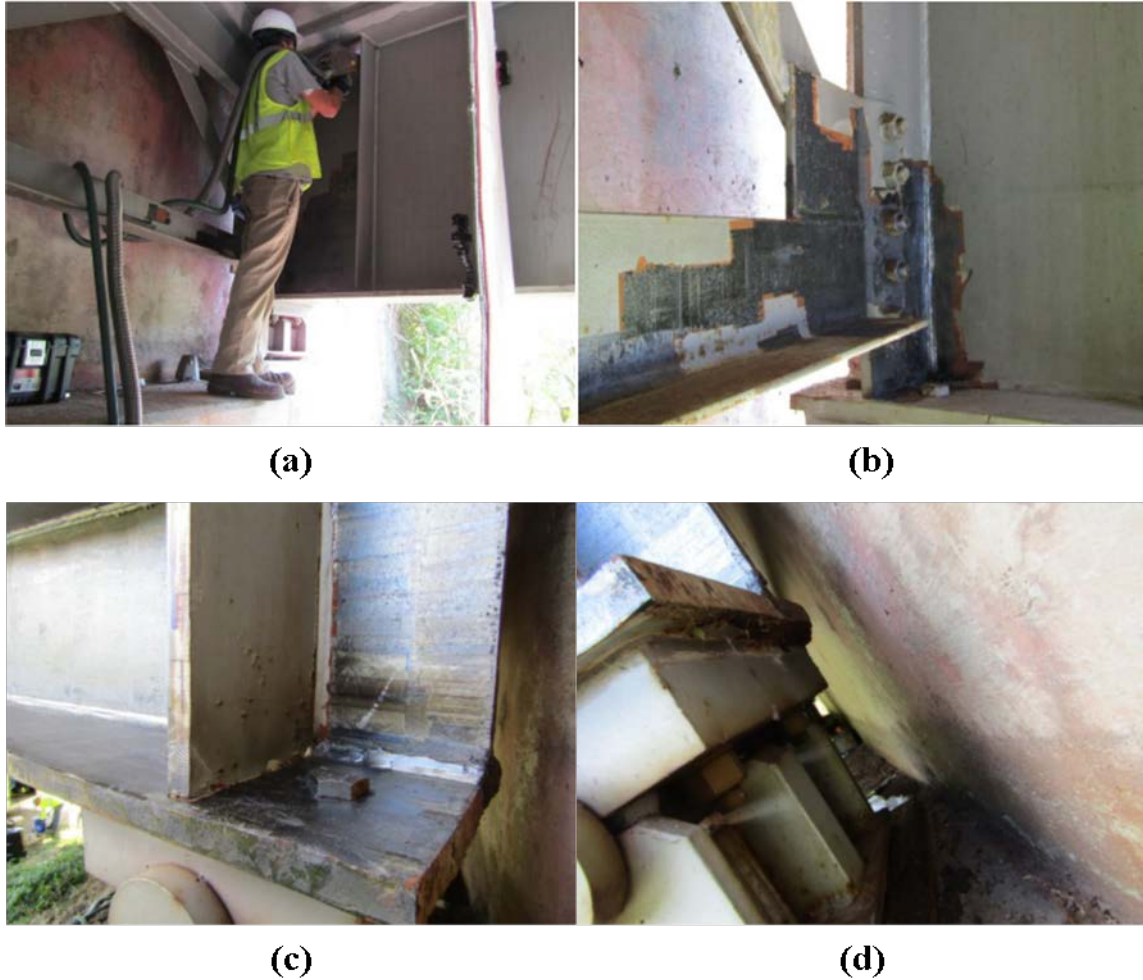
**Figure 35. Laser Ablation: (a) LACR system in use to clean a component of the beam end; (b) exposed surface after laser ablation; (b, c, and d) representative images of beam ends that could not be reached with the laser for cleaning. LACR = laser ablation coating removal.**

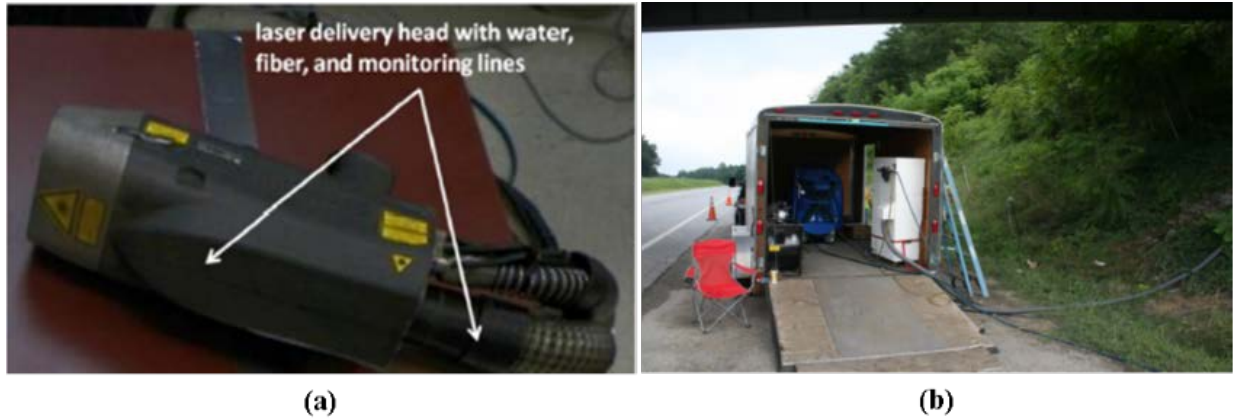
**Figure 36. LACR System During Cleaning: (a) cables exiting back of laser optic; (b) portable generator and on-site cables. LACR = laser ablation coating removal.**

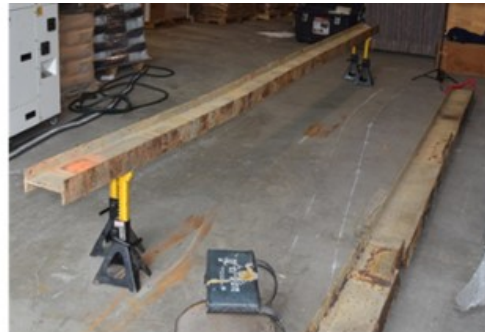
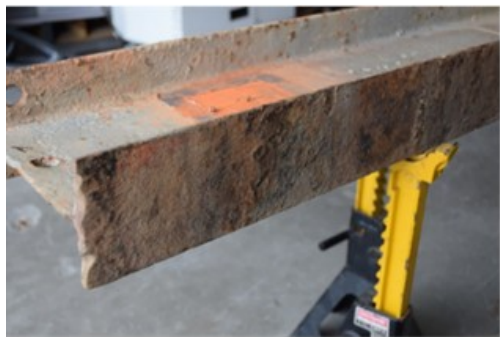
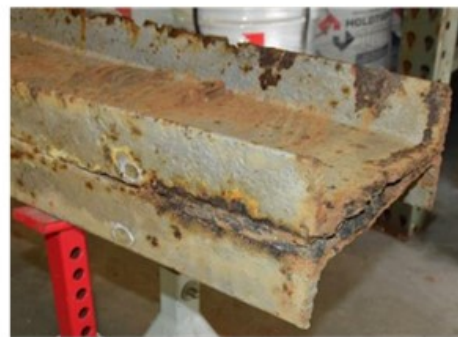
VDOT conducted an IH survey on July 30 and August 1, 2018, to investigate using LACR to abate hazardous coatings prior to hot work. Two beams were removed from a decommissioned bridge and transported to the facility of the LACR representative to have LACR performed. These beams are shown in Figure 38, which shows different stages of the cleaning operation. While this work was performed, it was observed that maintaining contact between the roller and the steel during LACR resulted in the best air quality and greatest efficiency during coating removal. After the coating was removed from several sections, the beams were moved to a VDOT yard to have hot work performed.

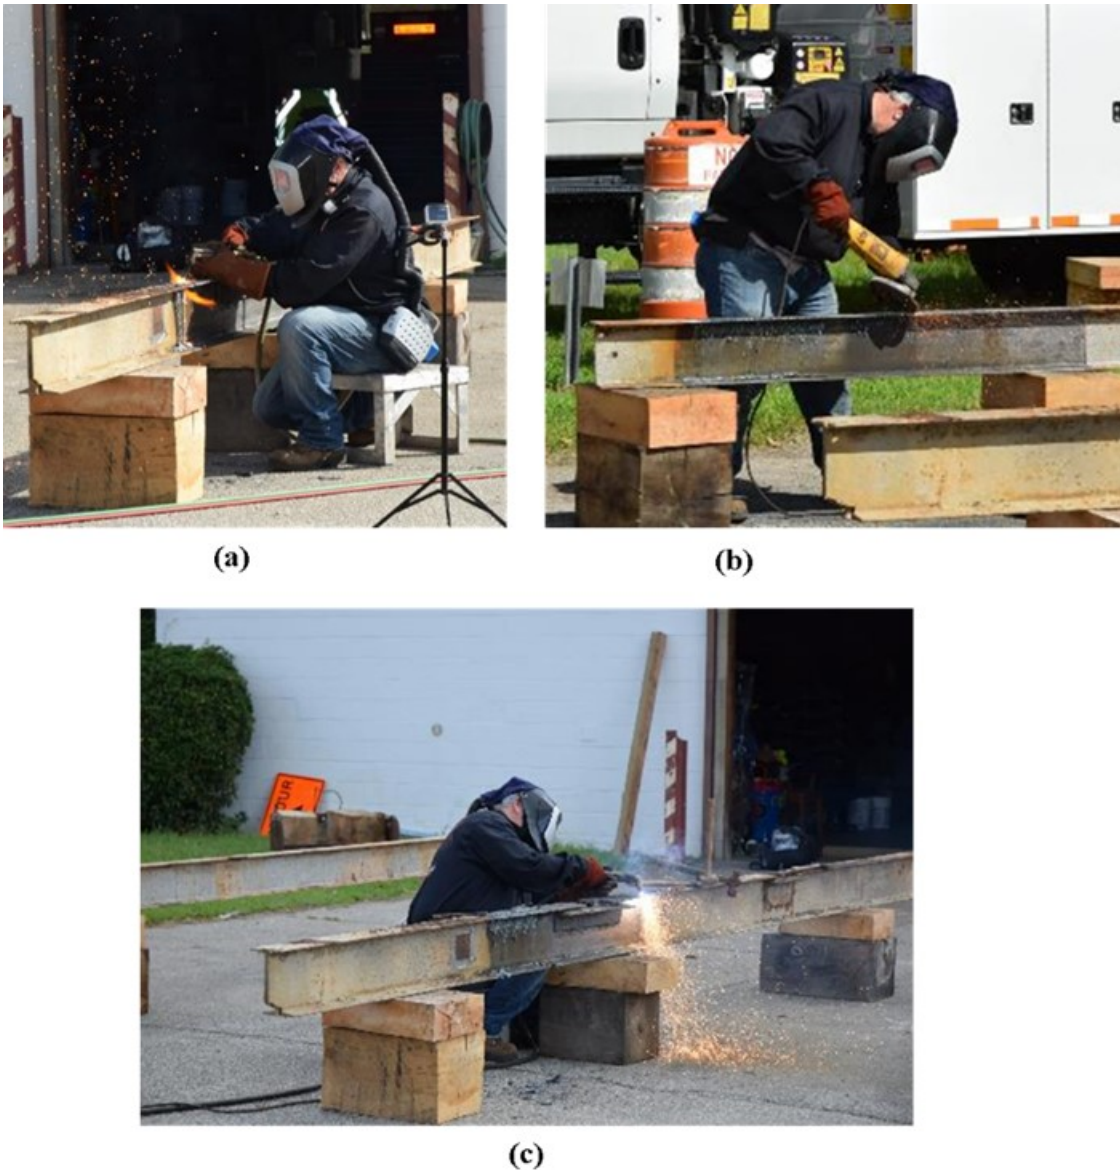
**Figure 39. Various Hot Work Processes Being Performed on Beams After LACR: (a) Beam A being cut with an oxyacetylene torch in an area cleaned using LACR; (b) grinding after coating has been removed using LACR on Beam A; (c) plasma torch cutting in same cleaned area. LACR = laser ablation coating removal.**

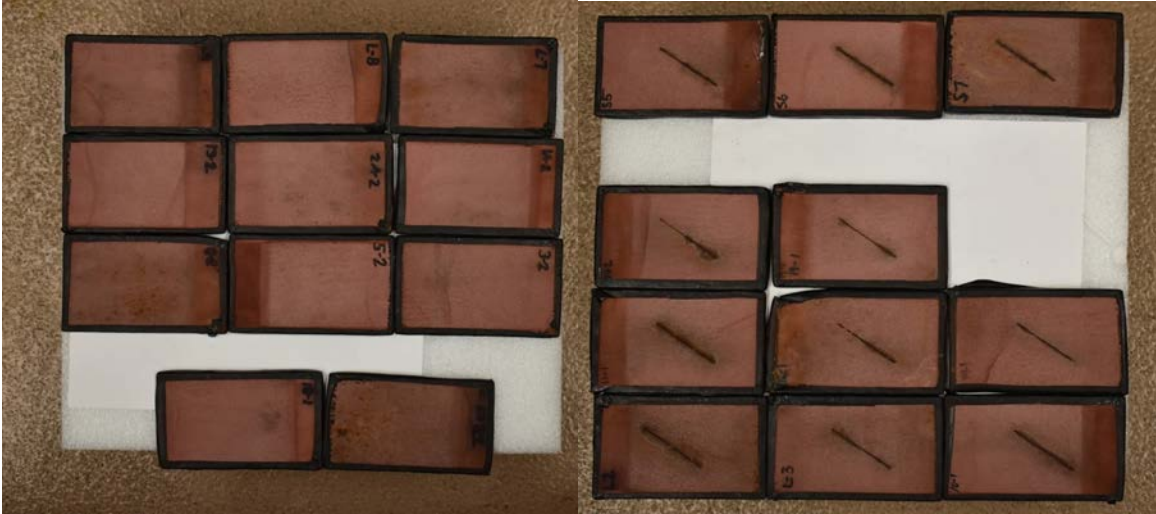
Figure 45. Panels Coated With Steel Spec Epoxy Primer. Grit-blasted panels are in upper row, and laser-ablated panels are in lower group.

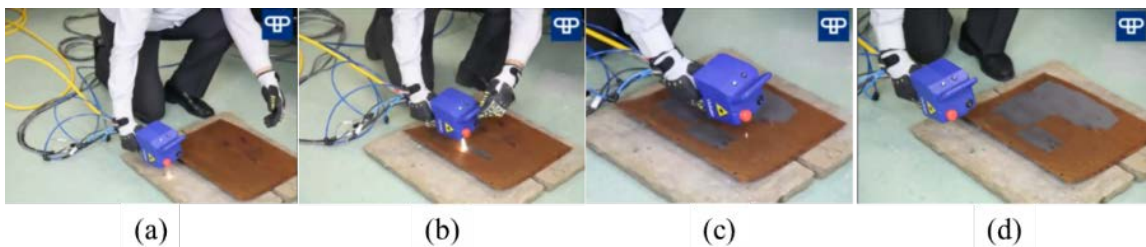
**Figure 52. Demonstration of Powerlase 1.6 kW Vulcan Laser Head in Operation. Note compact and lightweight design.**
