Performance of Bridge Deck Overlays in Virginia: Phase II: Service Life Performance

Final Report VTRC 20-R6

**PERFORMANCE OF BRIDGE DECK OVERLAYS IN VIRGINIA:
PHASE II: SERVICE LIFE PERFORMANCE**

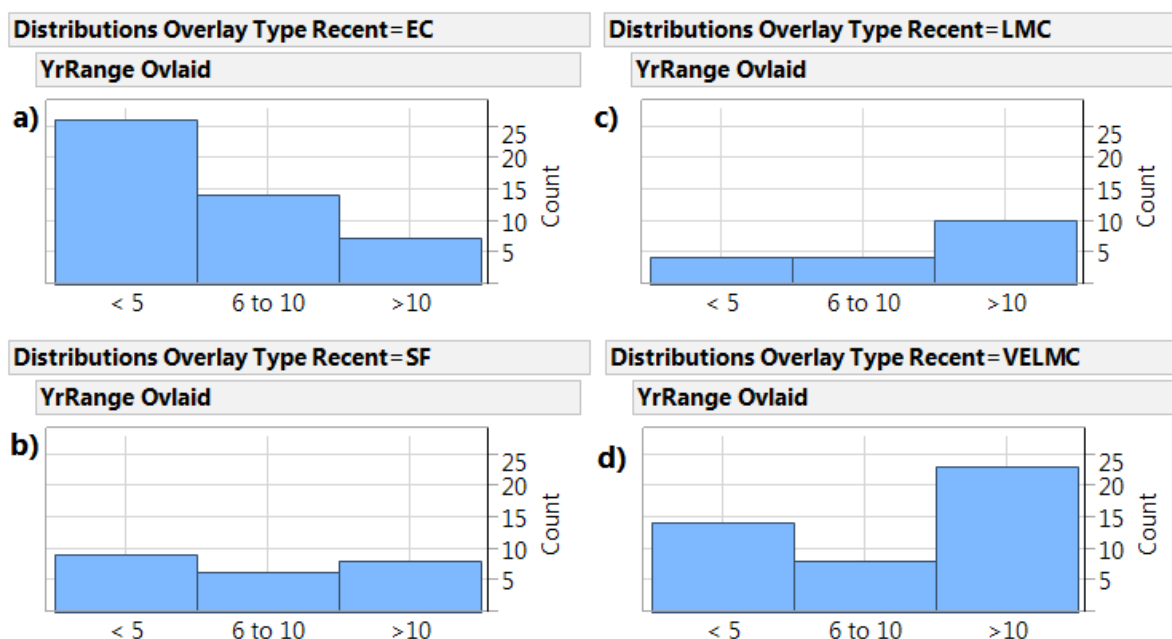
Figure 11. Ranges of Overlay Construction Years for Phase II Bridges: (a) EC overlays; (b) SF overlays; (c) LMC overlays; (d) VELMC overlays. EC = epoxy concrete; SF = silica fume; LMC = latex-modified concrete; VELMC = very-early-strength latex-modified concrete.

For robust statistical analysis, it is essential to have reasonable variation in the data points. This avoids the issue of unintended bias in the results. Figure 11 shows the frequency of overlays by construction year ranges and overlay type.

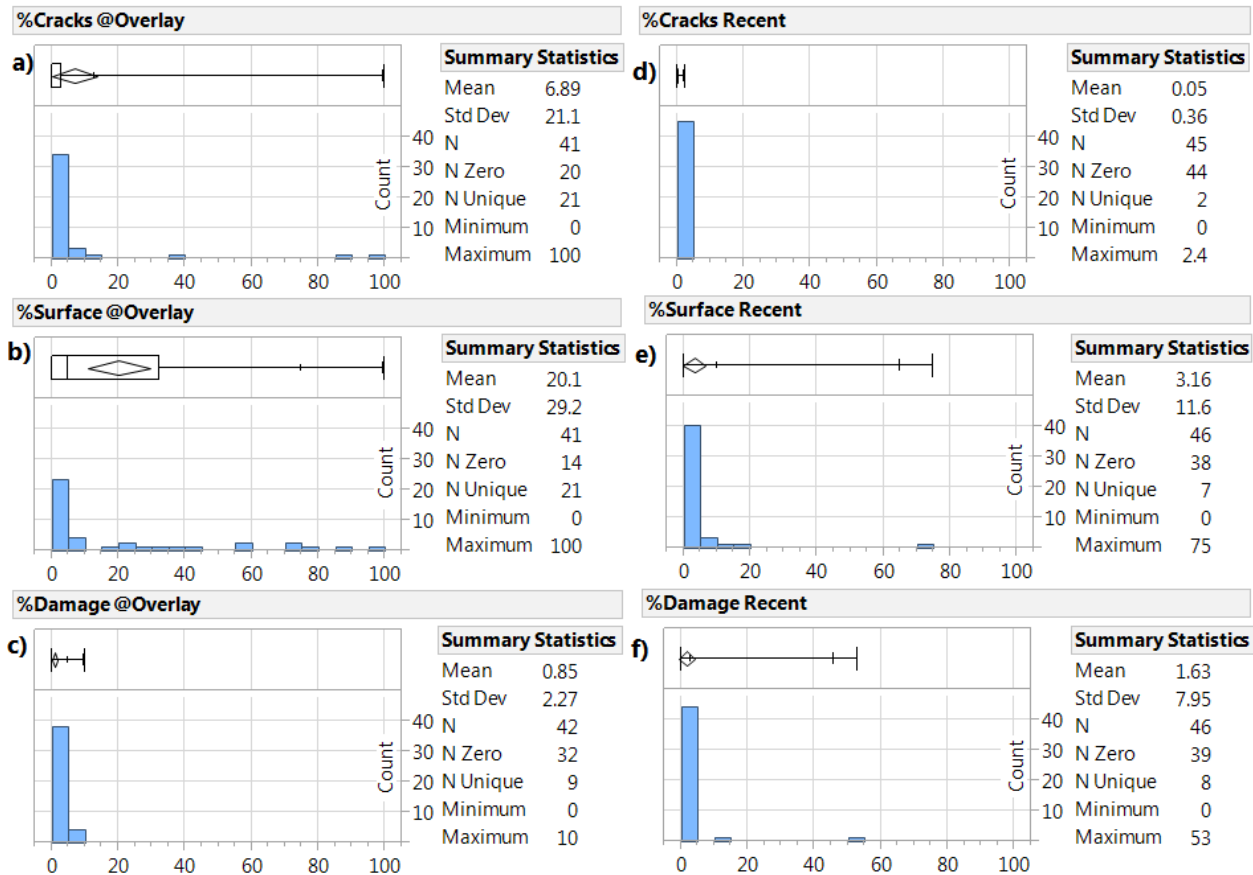
Figure 12. Histograms for Epoxy Concrete Overlays: (a) %Cracks at Overlay; (b) %Surface at Overlay; (c) %Damage at Overlay; (d) %Cracks Recent; (e) %Surface Recent; (f) %Damage Recent

Figure 12 shows the histograms of the three categories of deck deterioration immediately before the time of EC overlay construction and in the most recent inspection. The summary statistics to the right of the histograms display the basic statistics of the distributions.

Regarding deterioration prior to EC overlay, the ratios of N Zero to N were 0.49, 0.34, and 0.76 for cracks, surface wear, and damages, respectively. The lower the ratio, the higher the occurrence of that type of deterioration prior to overlay. This is important because this identifies the factors that influenced the bridge engineers to choose this type of overlay to address that type of deterioration or combination of deterioration types. This shows that the occurrence of cracks and surface wear such as aggregate polishing and loss of skid resistance were influential for districts in deciding to choose EC overlays. Ten of 42 decks had visible damages; however, the damages comprised an average of 0.85 percent by surface area. The ideal time to apply an EC

Regarding the deterioration reported in the most recent inspection, the proportions of zero values were 0.98, 0.83, and 0.85, respectively, for cracks, surface wear, and damages. Considering the spread of the service life of the EC overlays under study, this shows that EC overlays are more likely to have surface wear and damages than to have cracks.

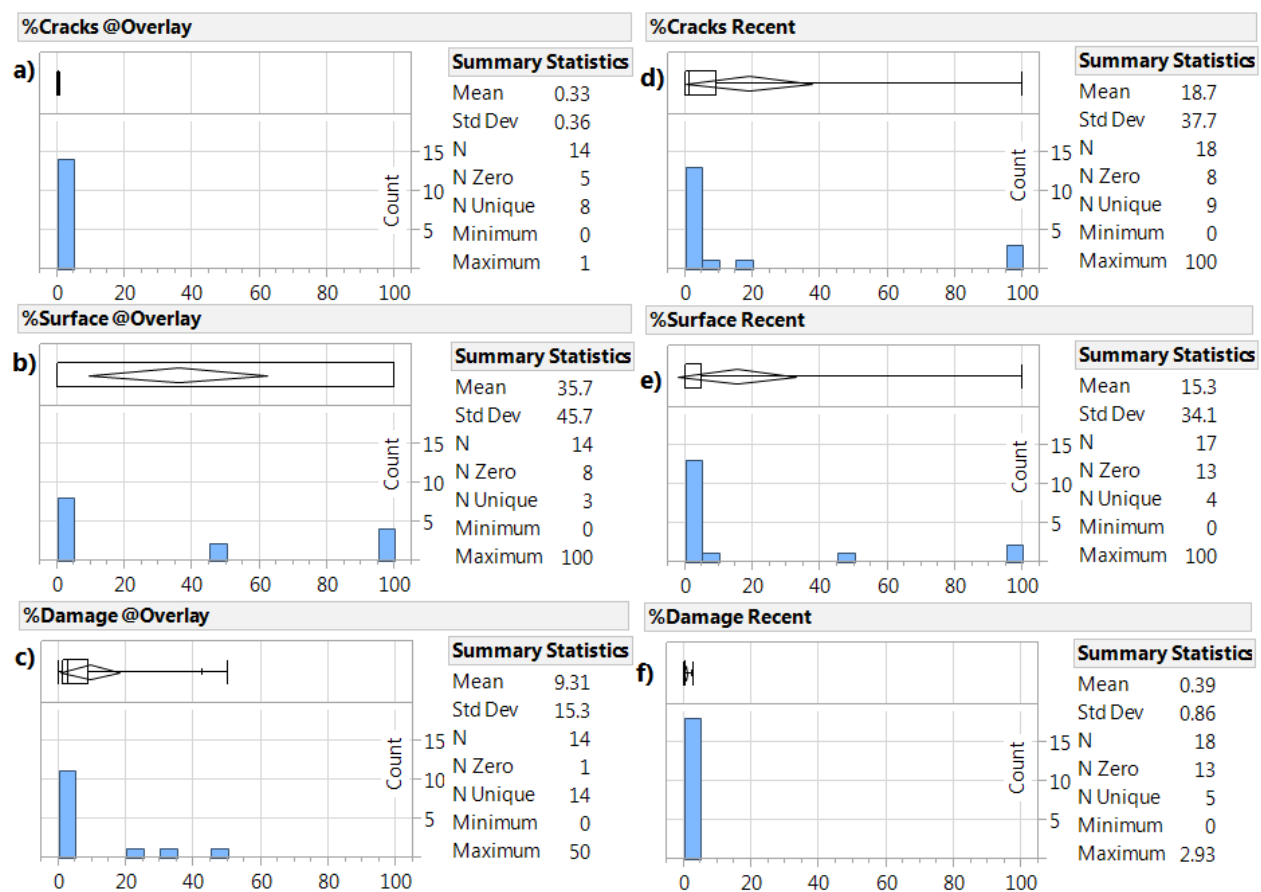
Figure 13. Histograms for Latex-Modified Concrete Overlays: (a) %Cracks at Overlay; (b) %Surface at Overlay; (c) %Damage at Overlay; (d) %Cracks Recent; (e) %Surface Recent; (f) %Damage Recent

Figure 13 shows the histograms of the three categories of deck deterioration immediately before the time of LMC overlay construction and in the most recent inspection.

Regarding deterioration prior to LMC overlay, the proportions between N Zero and N were 0.36, 0.57, and 0.07 for cracks, surface wear, and damages, respectively. Only 1 deck had no visible damages prior to LMC overlay. This shows that for most cases, the high occurrence of spalling damages and patches dictated the selection of an LMC overlay. In addition, the presence of cracks and surface wear may be irrelevant for this overlay.

Regarding the deterioration reported in the most recent inspection, the proportions of zero values were 0.44, 0.76, and 0.72, respectively, for cracks, surface wear, and damages. Considering the spread of the age of LMC overlays under study, the overlays are slightly biased to crack more than to have surface wear or damages.

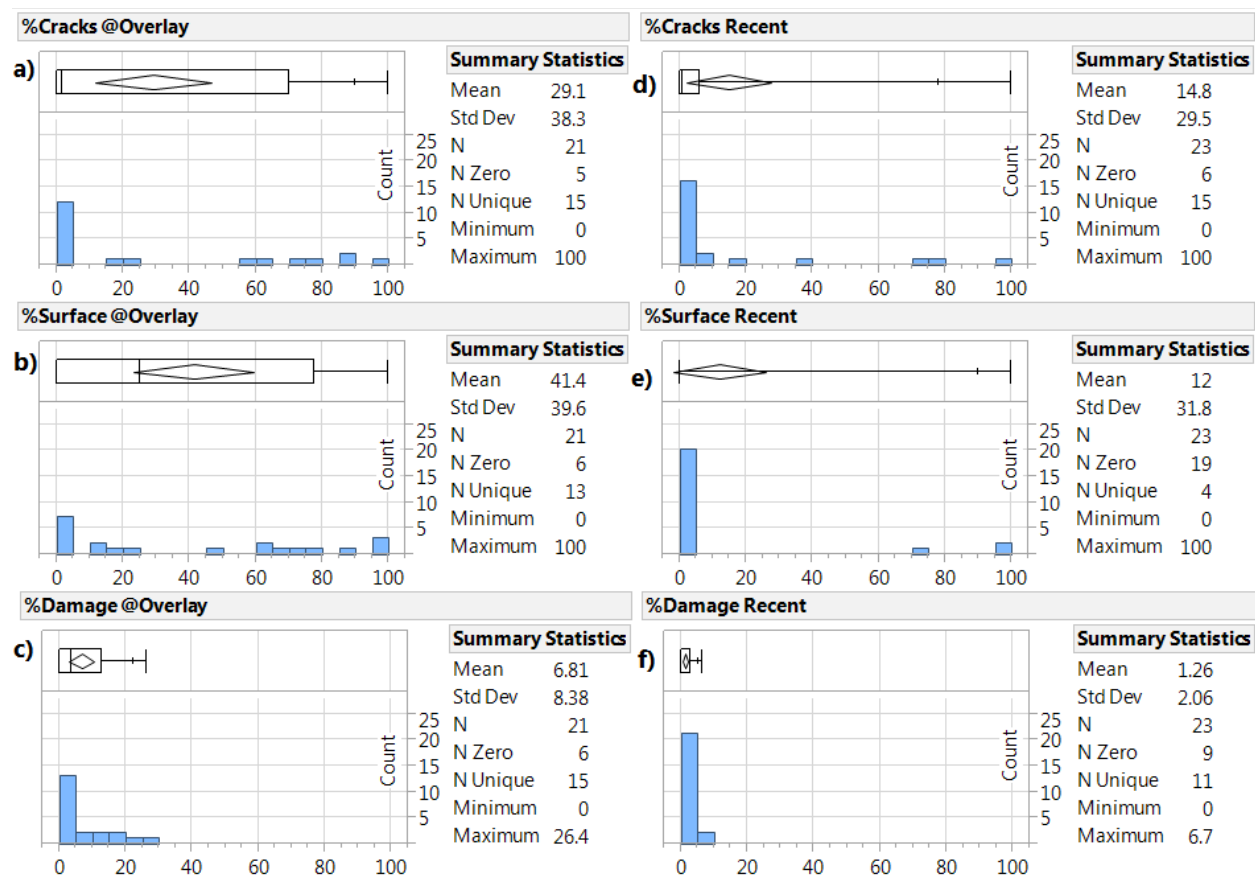
Figure 14. Histograms for Silica Fume Overlays: (a) %Cracks at Overlay; (b) %Surface Wear at Overlay; (c) %Damage at Overlay; (d) %Cracks Recent; (e) %Surface Wear Recent; (f) %Damage Recent

Regarding the deterioration reported in the most recent inspection, the proportions of zero values were 0.26, 0.83, and 0.39, respectively, for cracks, surface wear, and damages. Considering the spread of the age of the SF overlays under study, the overlays are heavily biased to crack and spall more than to have surface wear.

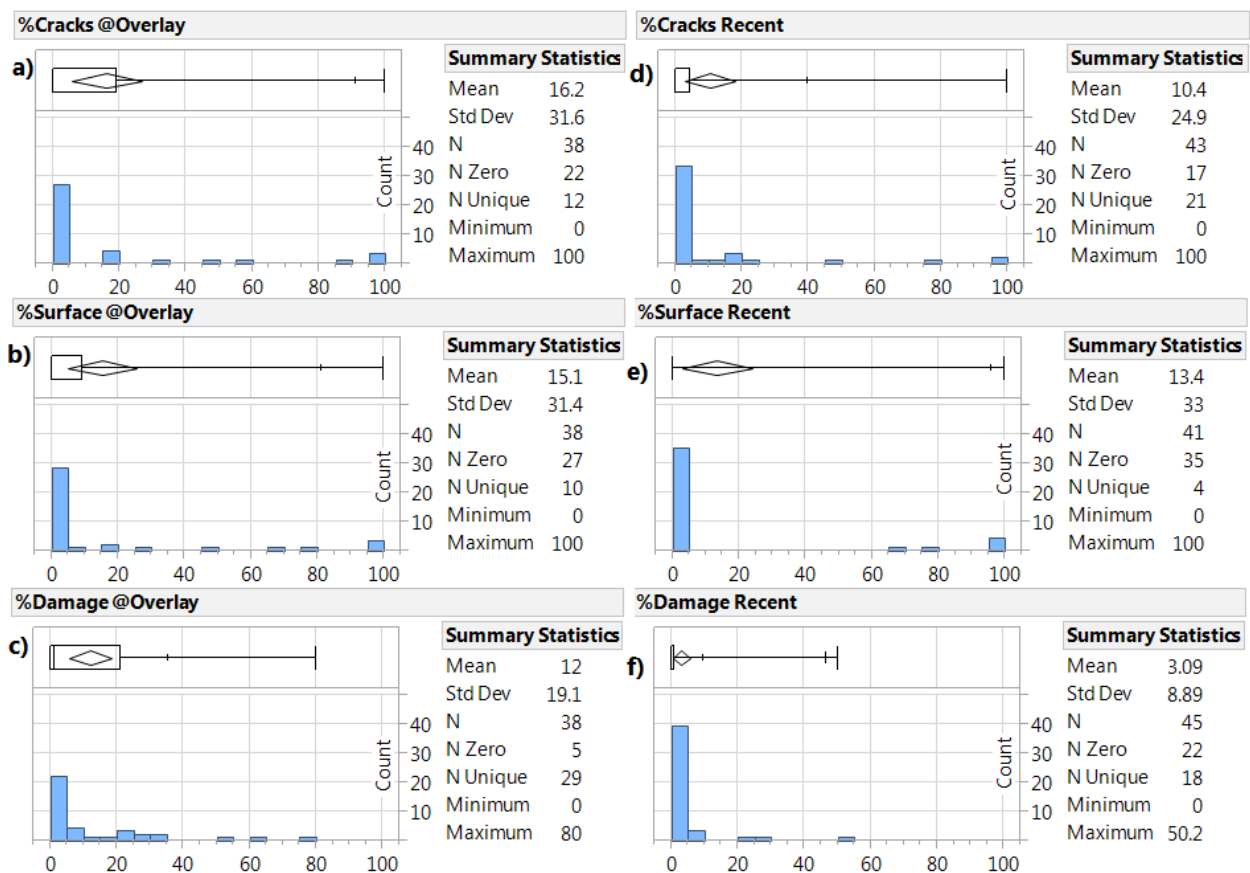
Figure 15. Histograms for Very-Early-Strength Latex-Modified Concrete Overlays: (a) %Cracks at Overlay; (b) %Surface Wear at Overlay; (c) %Damage at Overlay; (d) %Cracks Recent; (e) %Surface Wear Recent; (f) %Damage Recent

Regarding the deterioration reported in the most recent inspection, the proportions of zero values were 0.39, 0.85, and 0.49, respectively, for cracks, surface wear, and damages. Considering the spread of the age of VELMC overlays under study, the overlays are biased to crack and spall more than to have surface wear.

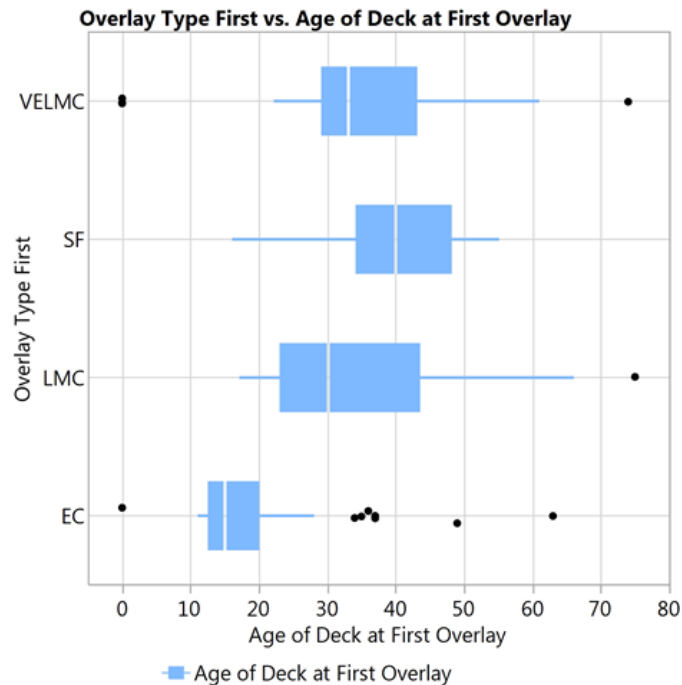
Figure 18. Age of Bridge Decks at First Overlay and Corresponding Overlay Type. VELMC = very-early-strength latex-modified concrete; SF = silica fume; LMC = latex-modified concrete; EC = epoxy concrete.

Surprisingly, four VELMC overlays were installed immediately after the construction of the bridge decks. These VELMC decks were on interstate bridges passing over interstate roads. These rigid overlays at construction were anomalies in their time; they were used to save construction time and to ensure durable decks, since it is difficult to perform repairs or rehabilitations on high-traffic interstate highways.

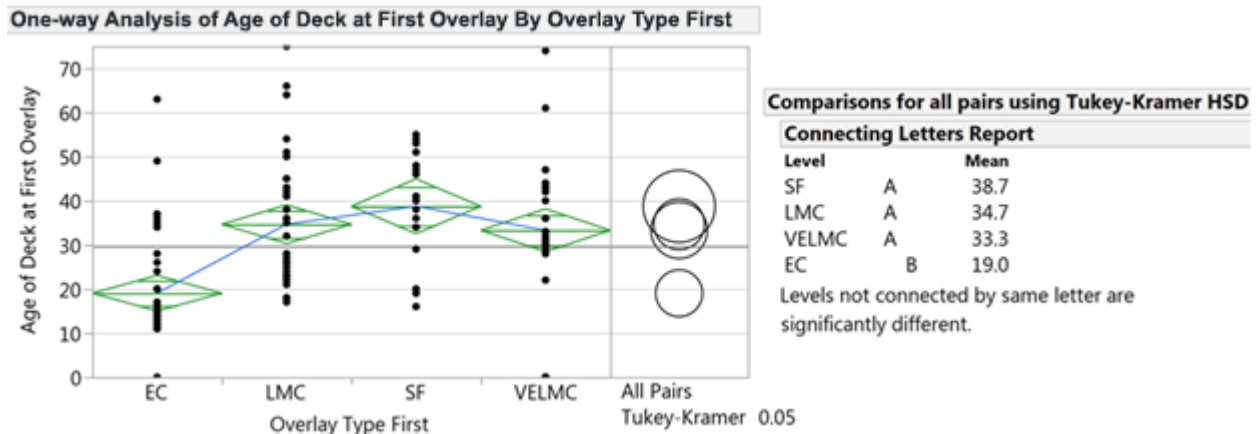
Figure 19. One-way Analysis of Age of Bridge Decks at First Overlay and Overlay Type. EC = epoxy concrete; SF = silica fume; LMC = latex-modified concrete; VELMC = very-early-strength latex-modified concrete.

The connecting letters report in Figure 20 is similar to the one in Figure 19, with an increase in the mean value for VELMC decks from Figure 19, since four anomalous decks were removed from this analysis.

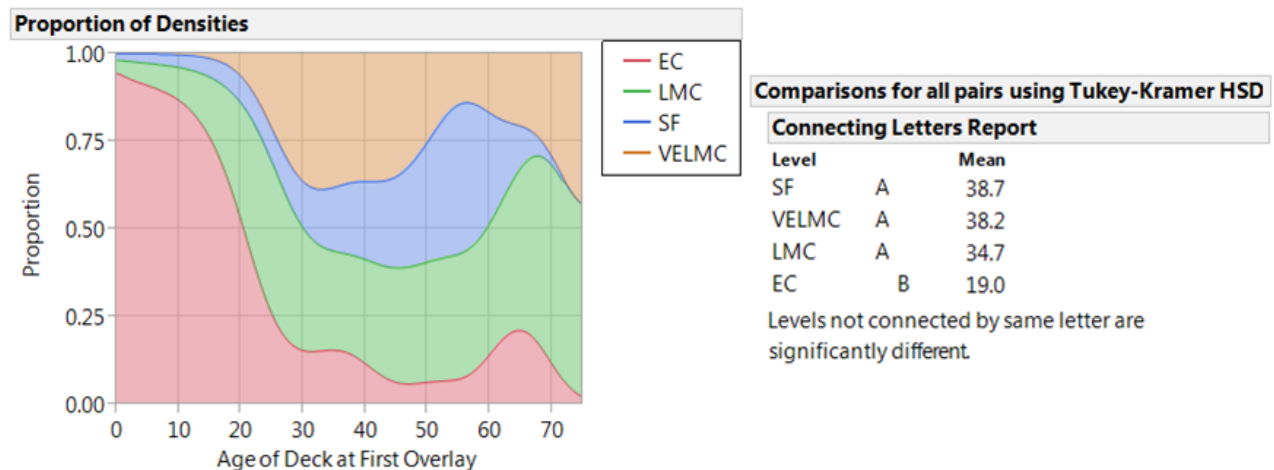
Figure 20. Age of Bridge Decks at First Overlay Excluding Anomalies. EC = epoxy concrete; SF = silica fume; LMC = latex-modified concrete; VELMC = very-early-strength latex-modified concrete.

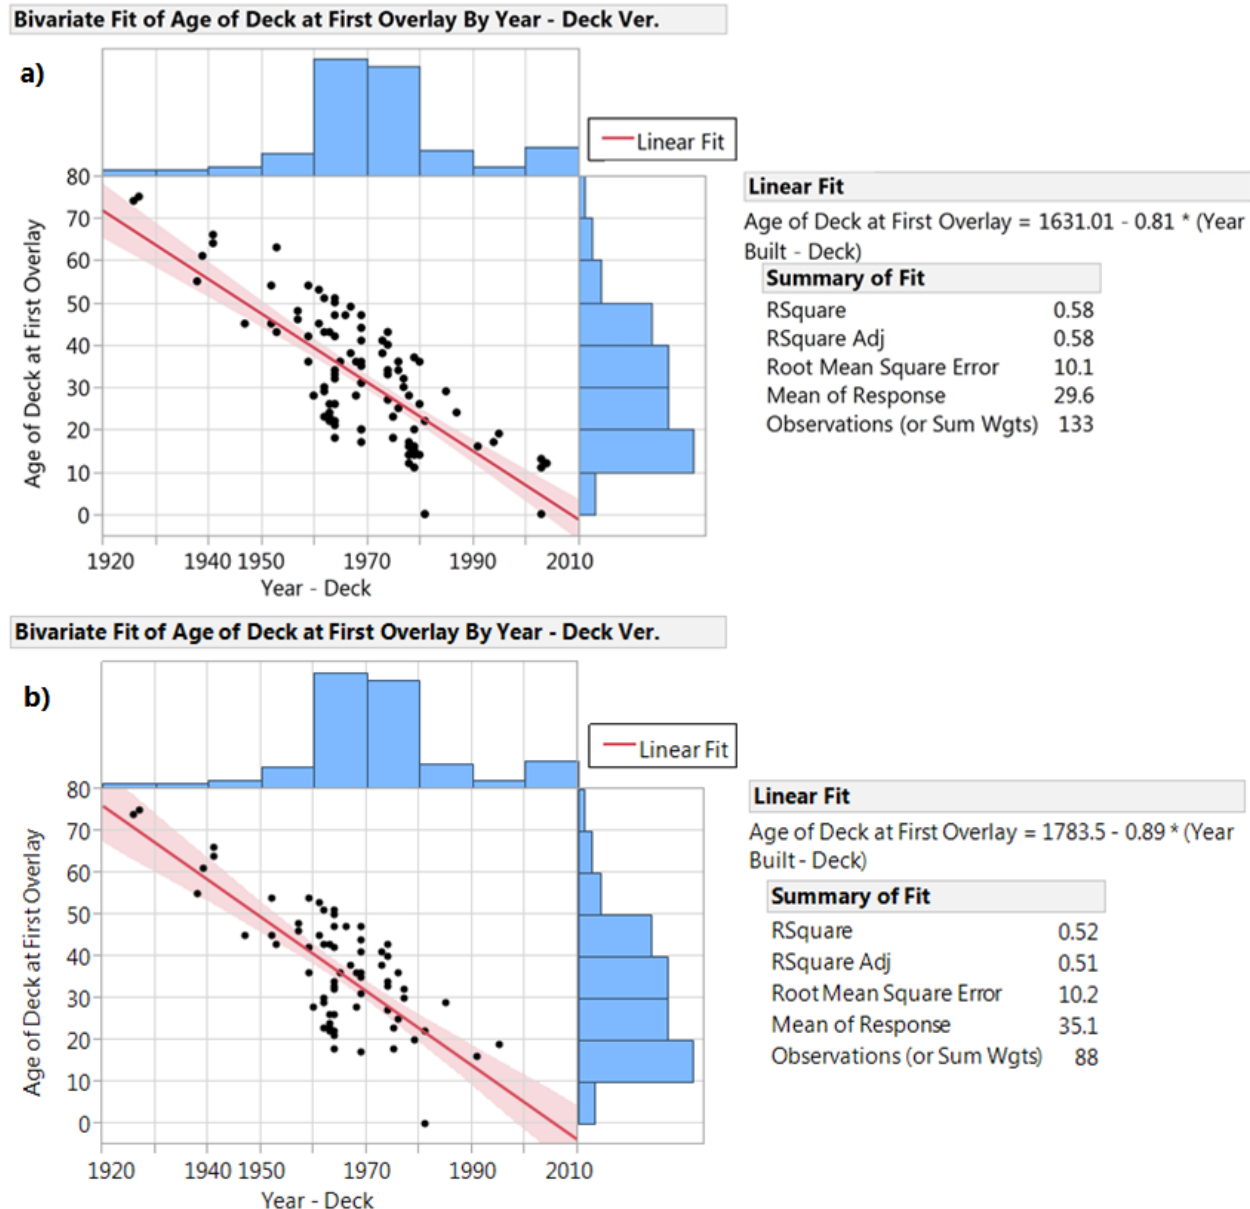
Figure 21. Relationship Between Age of Bridge Deck at First Overlay and Year of Deck Construction: (a) all decks under study; (b) excluding epoxy concrete overlays

A simple, but surprising, inverse correlation exists between age of deck at first overlay and year of deck construction (Figure 21). This might reveal the naturally growing reliance on overlays for deck rehabilitation in recent decades; however, it may also hint at the increased deterioration rates of recently built bridge decks. The quality of construction materials and methods has improved significantly in the more recent decades, which were not included in this study, including the use of low-permeability high performance concrete, corrosion-resistant reinforcement, and a deeper concrete cover over reinforcing steel. However, proportionally, the need to keep the roadways bare of snow and ice has called for increased use of increasingly corrosive pre-treatment methods.

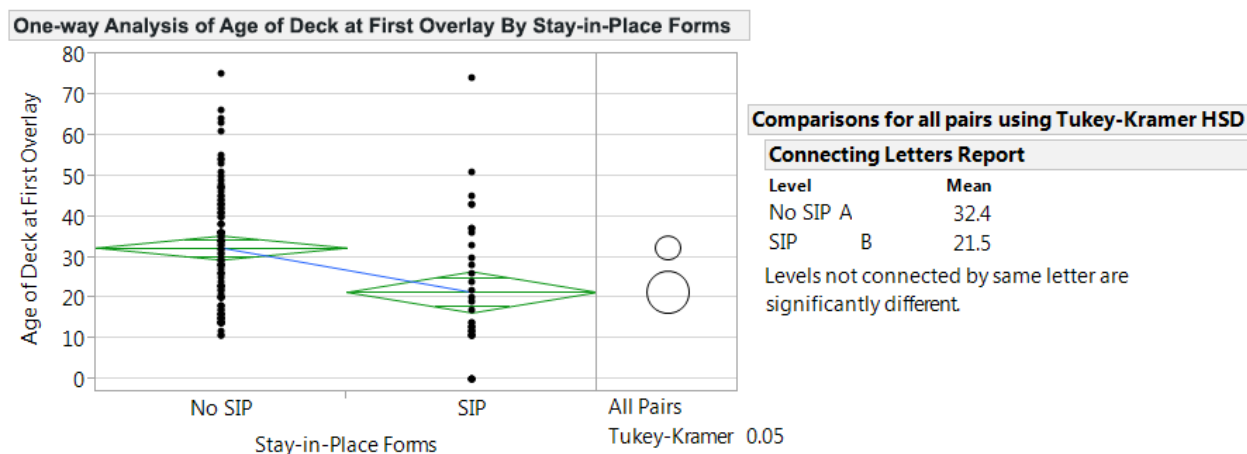
Figure 22. One-way Analysis of Age of Bridge Deck at First Overlay by Presence of Stay-in-Place Forms. SIP = decks with stay-in-place forms; No SIP = decks without stay-in-place forms.

Figure 22 shows the one-way analysis of age of bridge deck at first overlay by presence of SIP forms. Of interest, the Tukey-Kramer test showed through the connected letters report on the right that the decks built with SIP forms were overlaid significantly earlier than decks built without SIP forms. It should be noted that this finding is about the correlation between the two parameters only, i.e., age of deck at first overlay and use of SIP forms. There are other factors that could have influenced bridge deterioration.

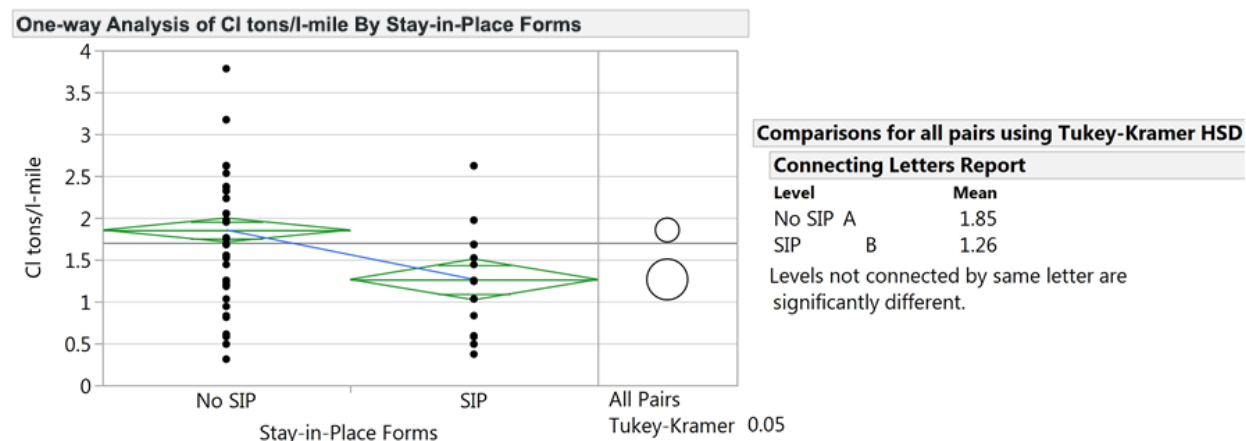
Figure 24. One-way Analysis of Rate of Chloride Application by Presence of Stay-in-Place Forms. SIP = decks with stay-in-place forms; No SIP = decks without stay-in-place forms.

Figure 24 shows the one-way analysis of salt usage by the presence of SIP forms. The results show that decks with SIP forms received significantly less chloride exposure. This might further indicate that the use of SIP forms does influence the rate of deterioration of bridge decks, as decks with SIP forms were overlaid sooner and received less salt application. However, the chloride exposure parameter is an average for the entire county and is not specific to a bridge deck. In addition, this parameter is a snapshot of the total exposure period from 2012-2017, which includes pretreatment methods, rather than the entire period, which would include varying deicing treatment methods. Thus, the influence of SIP forms on the service life of new decks remains debatable to date.

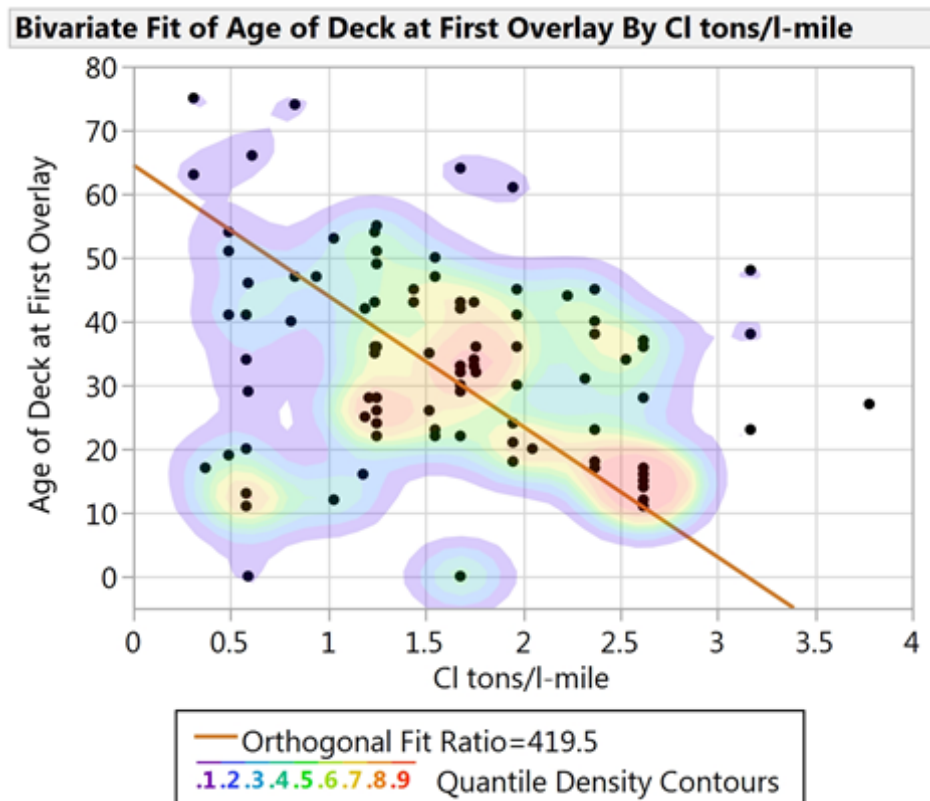
Figure 25. Relationship Between Age of Bridge Deck at First Overlay and Rate of Chloride Application

The reason for a weak fit is that there were multiple factors in play leading to differences in when a deck needed a first overlay construction. The aim of this exercise of correlating two factors at a time was to determine if there were consistent relationships between factors. Since it was proven otherwise, the best course of action was to compare multiple variables at once.

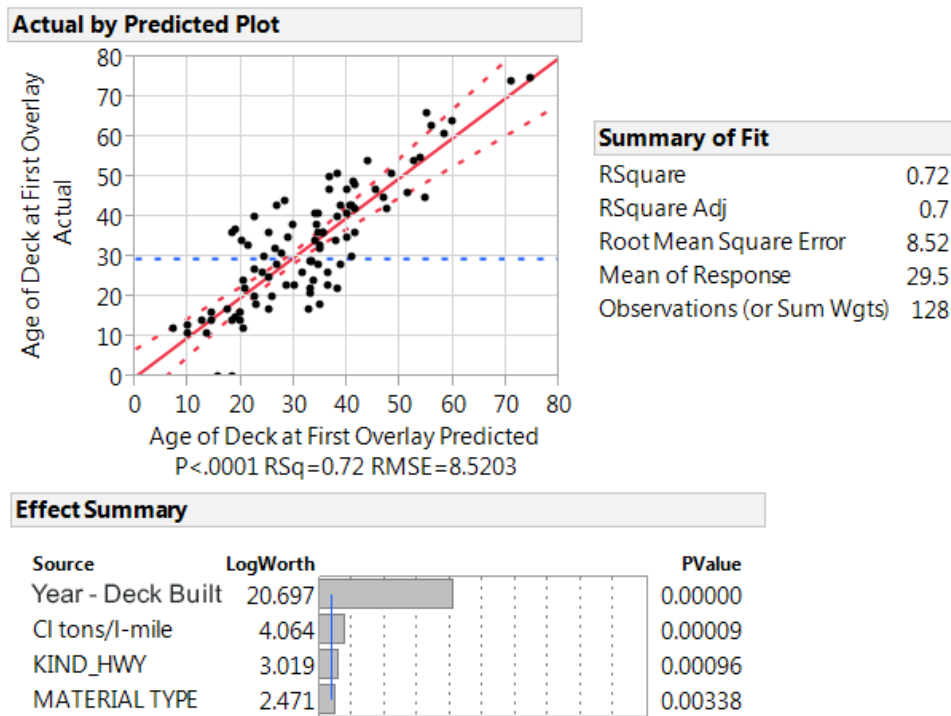
Figure 26. Multiple Regression Model: Age of Bridge Deck at First Overlay

Stepwise regression by the forward selection technique was used to screen for only the influential factors. The resulting regression model is shown in Figure 26. Four factors were narrowed down to be statistically significant. Equation 1 shows the multiple factor correlation for understanding the role of each of these factors in affecting the age of bridge decks at first overlay, with $R^2 = 0.72$, which indicates a healthy fit, especially considering the amount of inherent variability in the data.

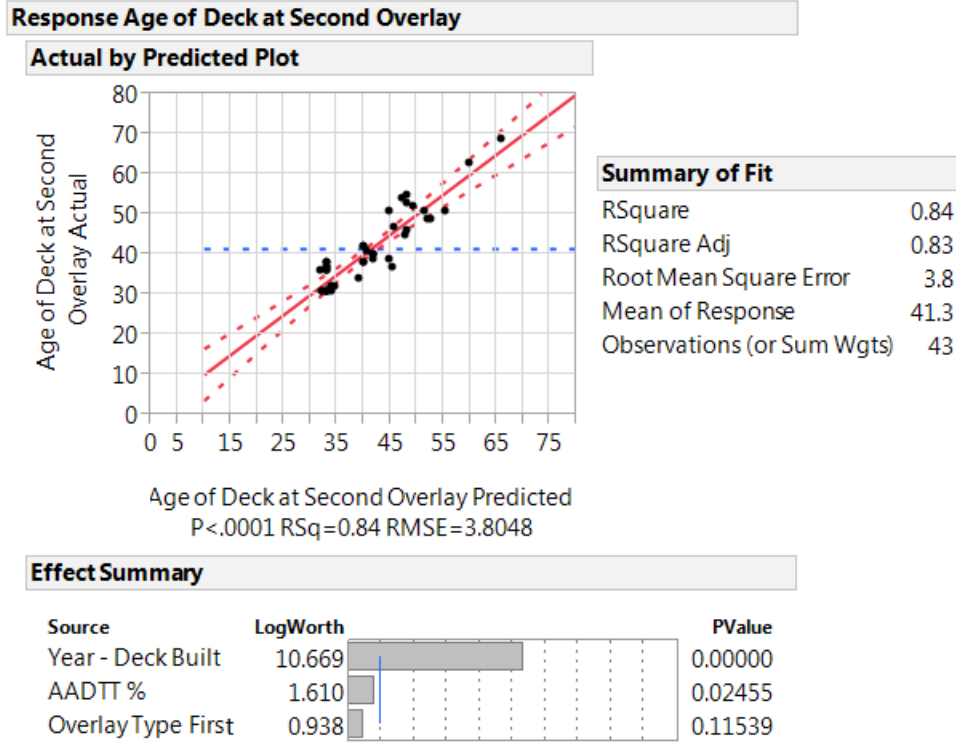
Figure 32. Multiple Regression Model: Age of Bridge Deck at First Overlay

Figure 32 shows the best model after uninfluential factors were eliminated through a stepwise forward selection process. This analysis identified AADTT% as a strong influential factor in the degradation of the first-generation overlays. The model presented in Equation 2 shows that LMC overlays are expected to last approximately 2.6 years longer than EC overlays.

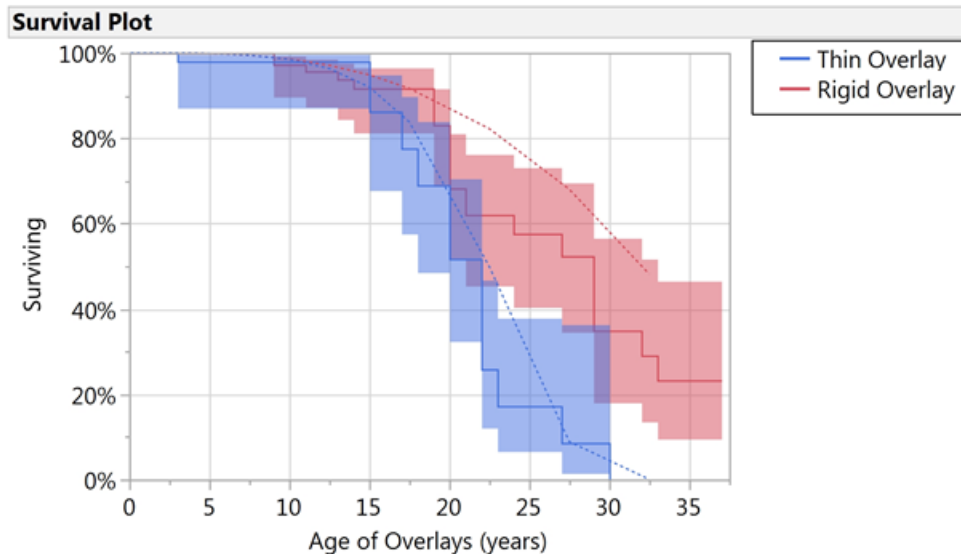
Figure 33. Kaplan-Meier Survival Plot for Age of Thin and Rigid Overlays

The projected mean service life, as shown in Table 9, for thin overlays was 20.9 years and for rigid overlays was 25.9 years. The standard error is the standard deviation of the sampling distribution; the lower the standard error, the higher the precision. To increase the precision of the estimation by twofold, the standard error should be halved, which in turn means that the sample size must be quadrupled.

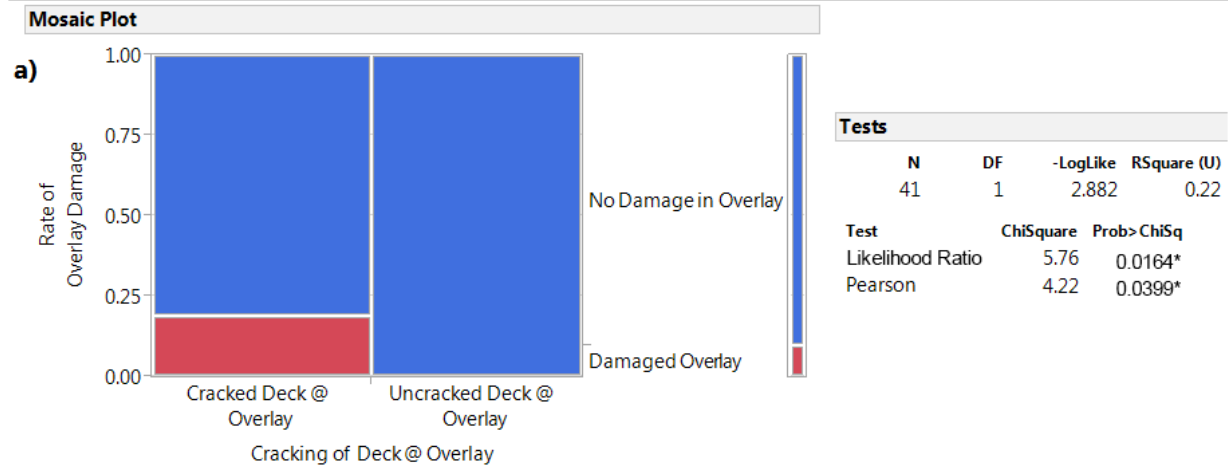
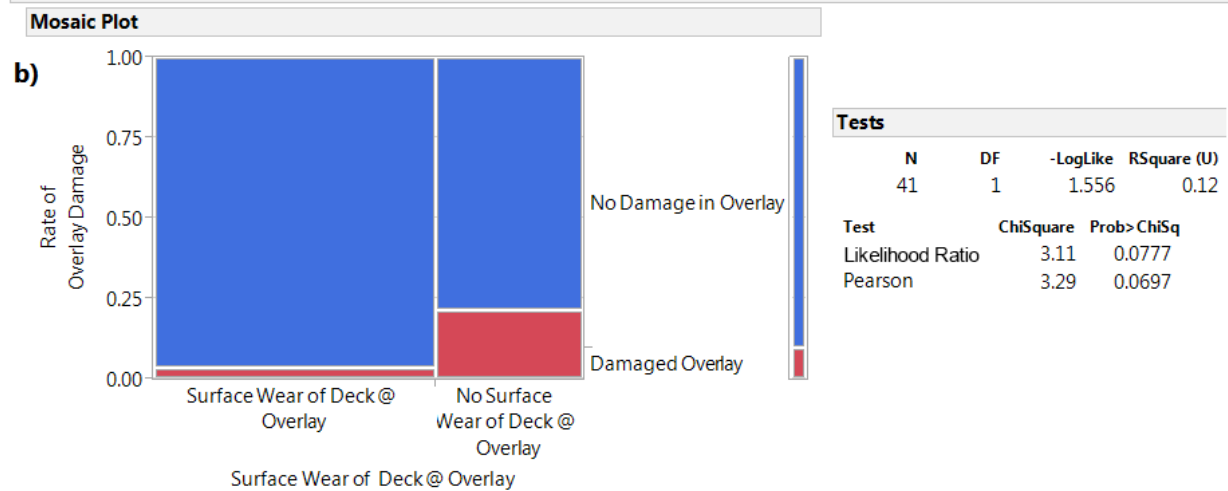
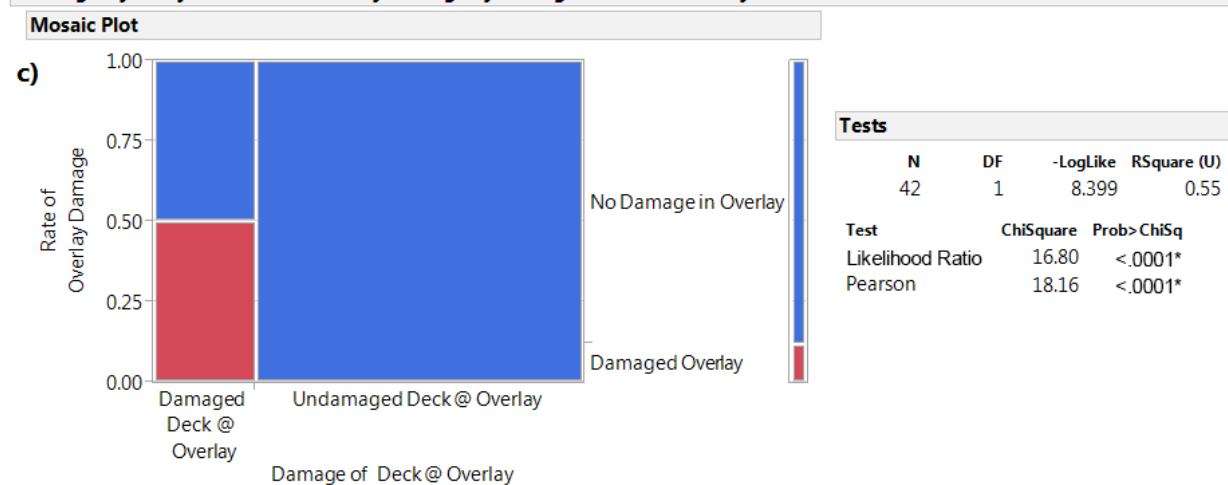
Contingency Analysis of Rate of Overlay Damage By Cracking of Deck @ Overlay

Contingency Analysis of Rate of Overlay Damage By Surface Wear of Deck @ Overlay

Contingency Analysis of Rate of Overlay Damage By Damage of Deck @ Overlay

Figure 35. Independence Test: Rate of Damage in Epoxy Concrete Overlays vs. (a) Cracks in Deck at Overlay, (b) Surface Wear of Deck at Overlay, and (c) Damages in Deck at Overlay

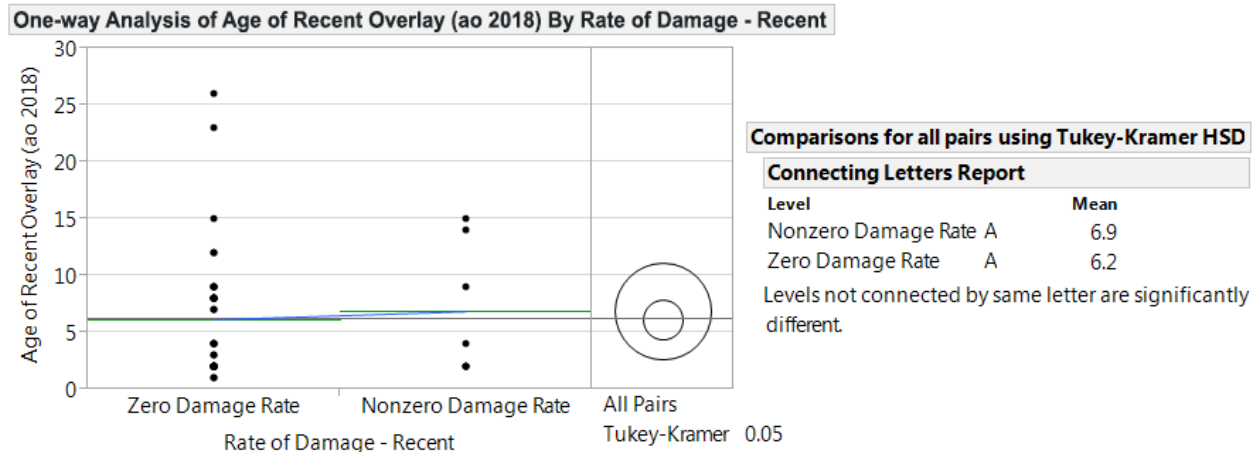
Figure 36. One-way Analysis of Age of Epoxy Concrete Overlays and Rate of Overlay Damage

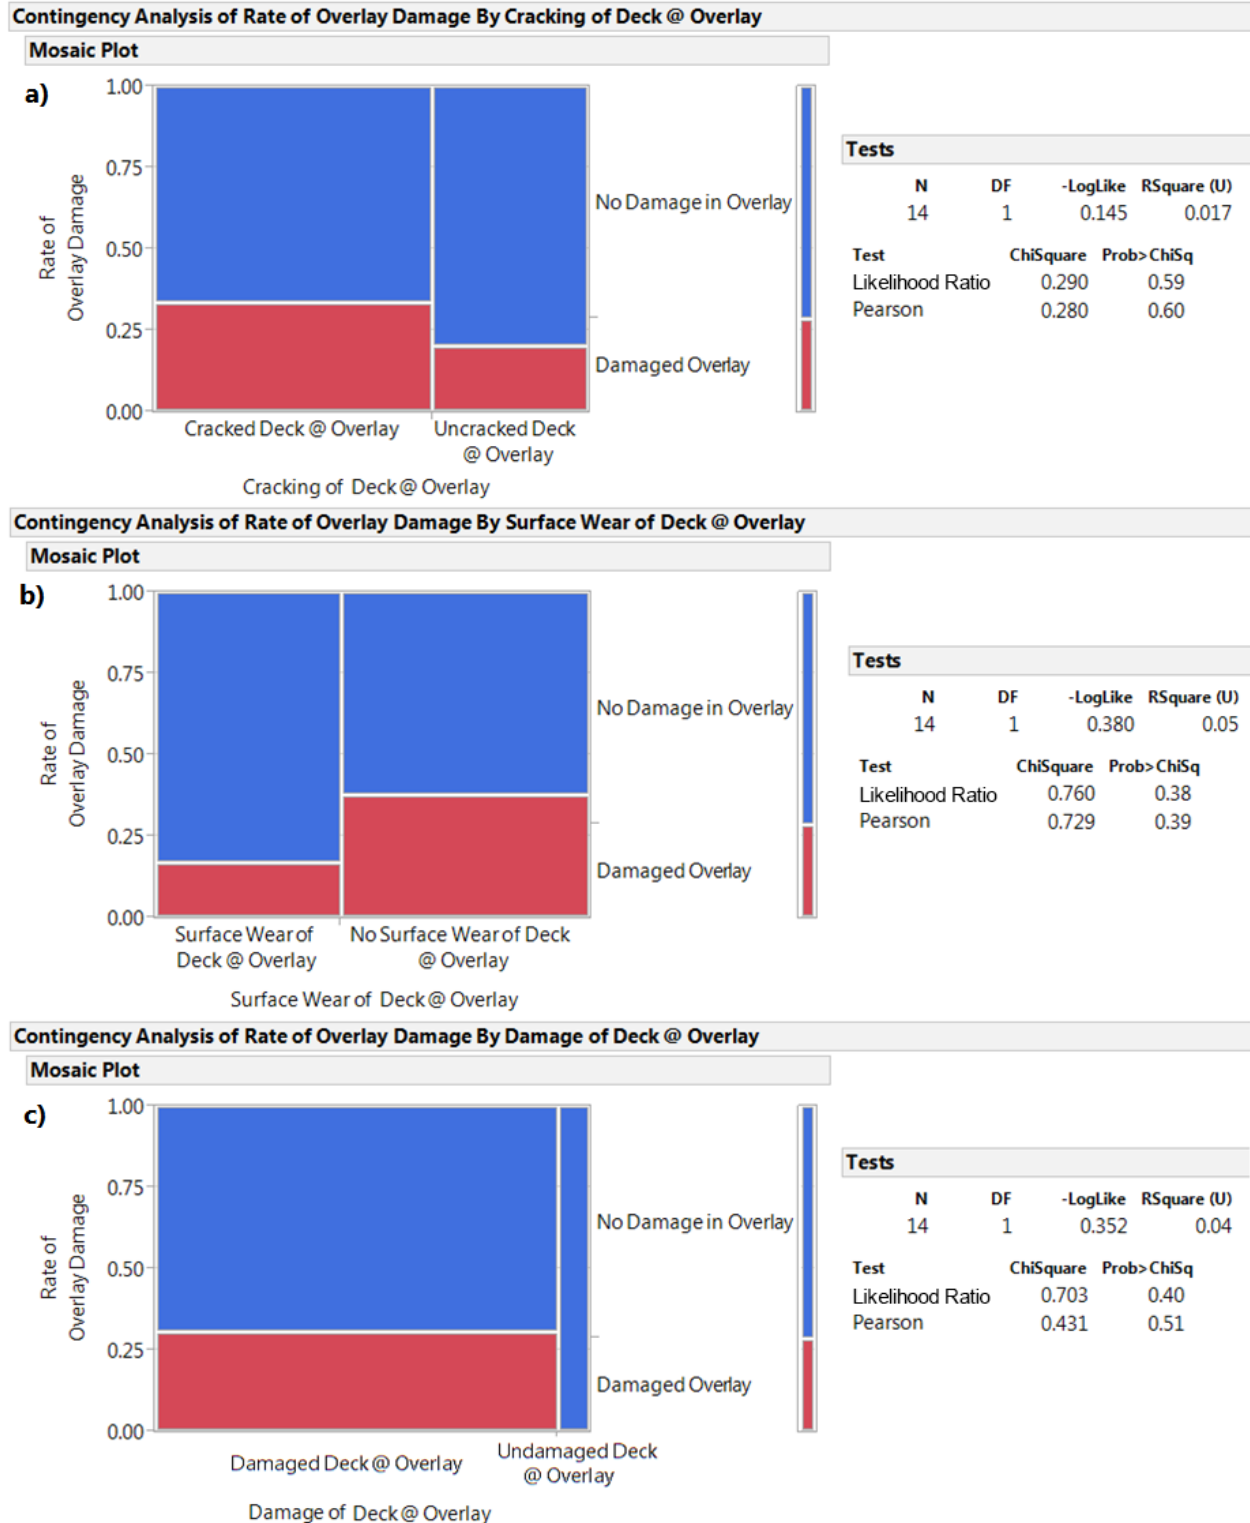
Figure 37. Independence Test: Rate of Damage in Latex-Concrete-Modified Overlays vs. (a) Cracks in Deck at Overlay, (b) Surface Wear of Deck at Overlay, and (c) Damages in Deck at Overlay

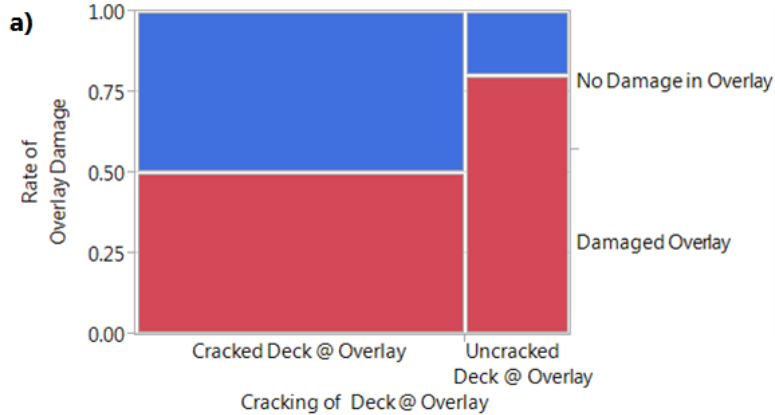
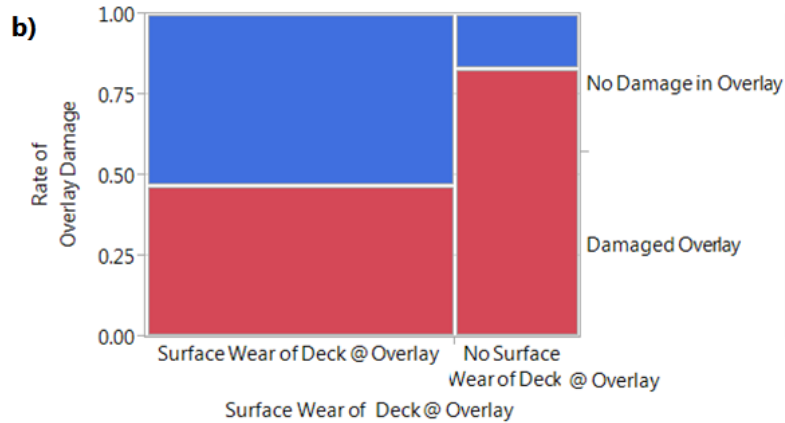
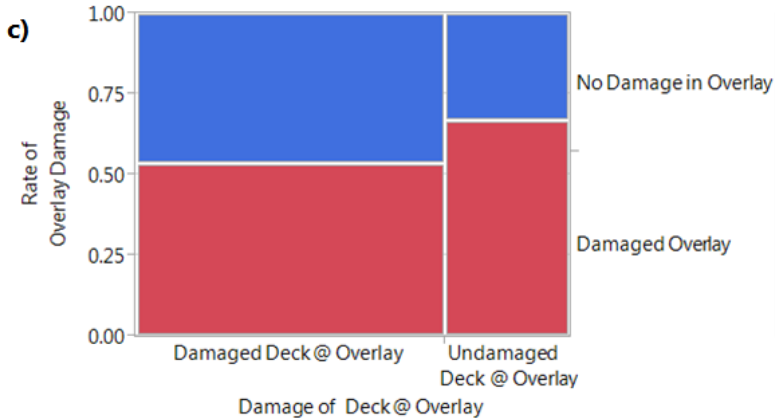
Figure 38 shows the mosaic plots for SF overlays. The rate of damage of overlays, calculated up to the most recent inspection, was compared with deck cracks prior to overlay (Figure 38a), deck surface wear prior to overlay (Figure 38b), and deck damages prior to overlay (Figure 38c). No significant dependence was found among the three pairs of parameters, since p-values were large (p-value > 0.05 = 95% significance level), even though mosaic plots for cracks and surface wear appeared to have some correlation. The high p-values indicated that the correlations were not significant. This might be because SF overlay construction involves removal of the chloride-contaminated top concrete surface, which would also remove the existing delaminations, patches, and cracks. This might act as a reset for the bridge decks in terms of damage accumulation.

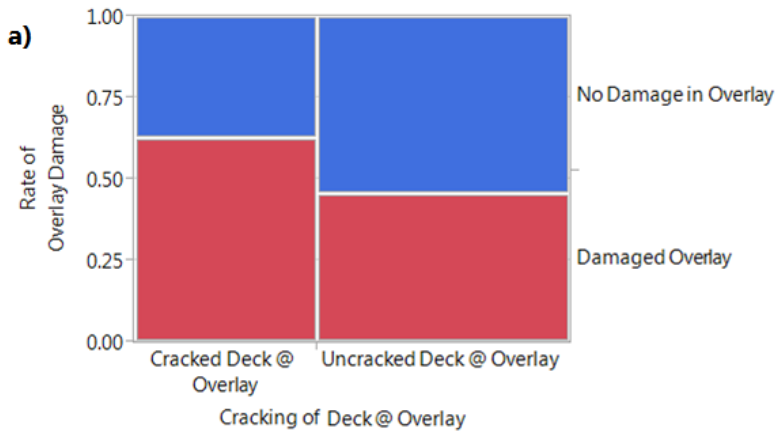
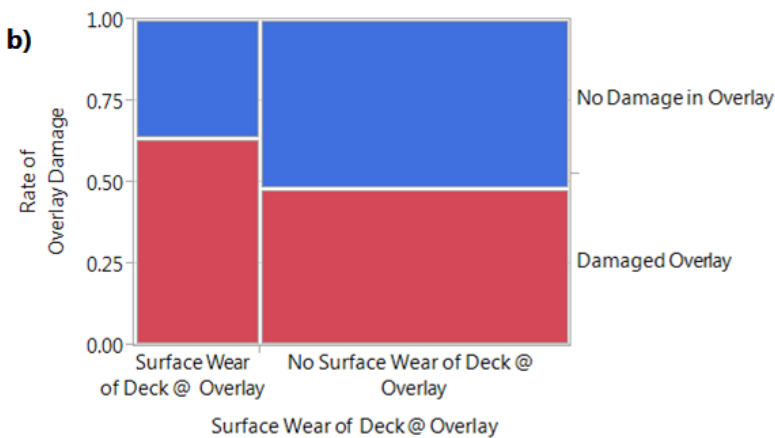
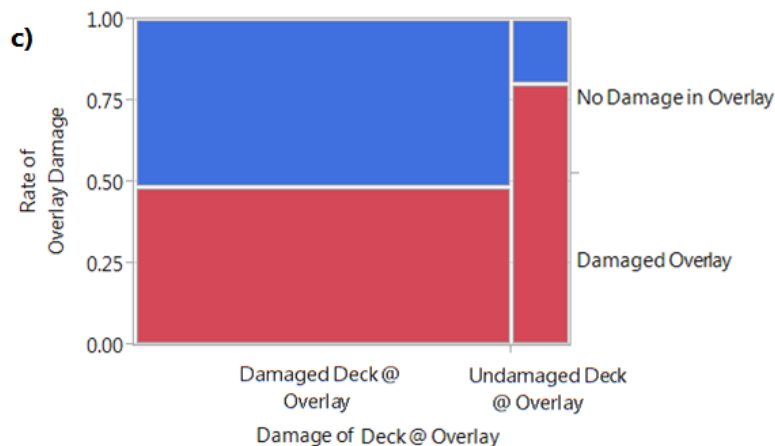
Figure 39. Independence Test: Rate of Damage in Very-Early-Strength Latex-Modified Concrete Overlays vs. (a) Cracks in Deck at Overlay, (b) Surface Wear of Deck at Overlay, and (c) Damages in Deck at Overlay

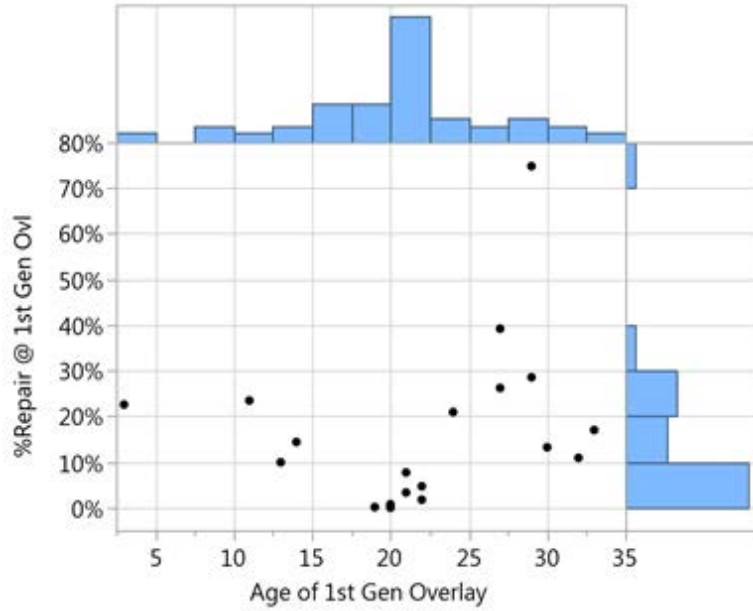
Figure 40. Surface Area Repaired at Time of First-Generation Overlay

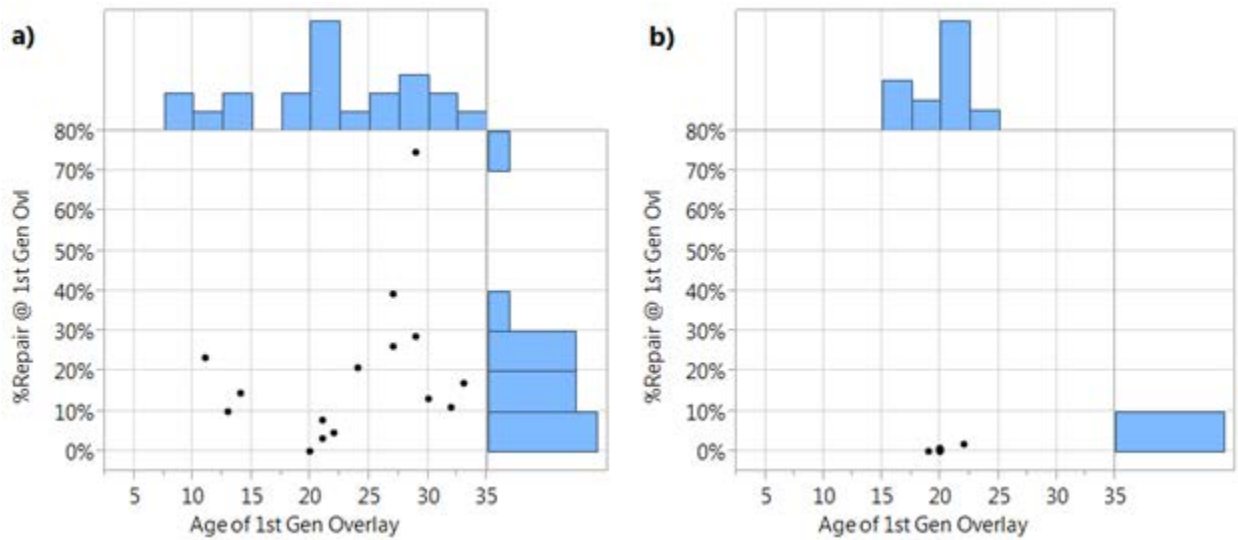
Figure 41. Surface Area Repaired at Time of First-Generation Overlay: (a) latex-modified concrete overlay only; b) epoxy concrete overlay
