Corrosion-Free Carbon Fiber Reinforced Polymer for Prestressed Piles

Final Report VTRC 19-R13

FINAL REPORT

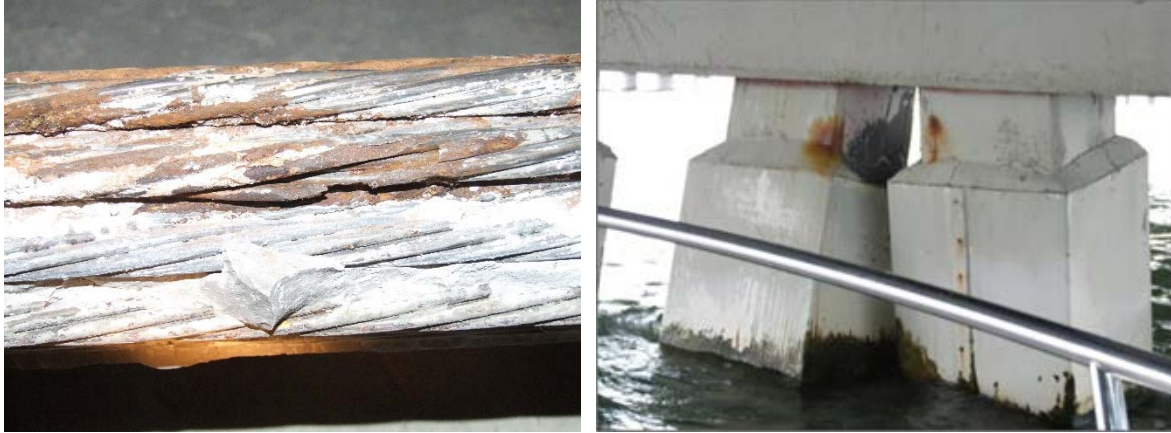
Figure 1. Corrosive Attack in Section of an External Steel Tendon After 17 Years (left); Corroding Piles, With Oldest Piles Being Driven in Late 1950s Requiring Repair by Early 1980s (right)³

Corrosion-related damage in prestressed elements occurs in both pretensioned and post-tensioned strands, as shown in Figure 1. In Figure 1, above the fiberglass jacket, rust stains are visible on the corner of the pile. Corrosion at this location in a bridge pile that is subjected to saltwater is not surprising since the chloride ions are diffusing into the concrete from two surfaces. The larger concern in this case, however, is that if corrosion is occurring above the fiberglass jacket, undetected corrosion could be occurring inside the jacket.

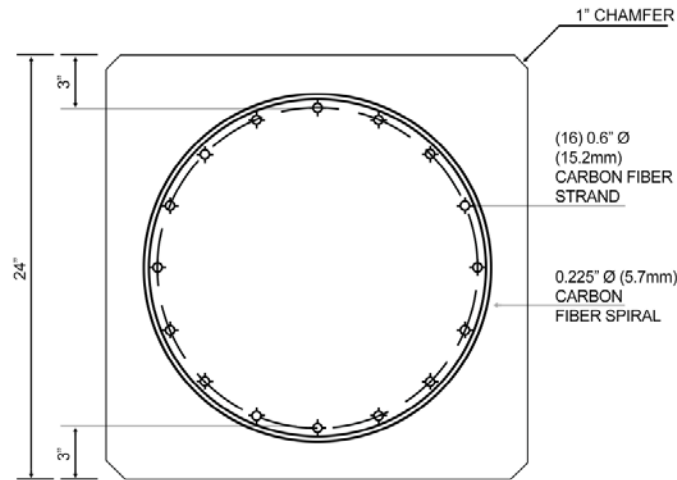
Figure 2. Cross Section of Pile

The project on the Nimmo Parkway over West Neck Creek in Virginia Beach has two bridges with 272 piles supporting the longer of the two bridges. In the longer bridge, 250 piles had conventional uncoated steel reinforcement, 18 had CFRP reinforcement, and 4 were reinforced with stainless steel strands and a spiral. The cross section of the 24-in-square CFRP pile with a circular spiral is shown in Figure 2. Design information for the conventional steel strand piles and the CFRP piles is summarized in Table 1.

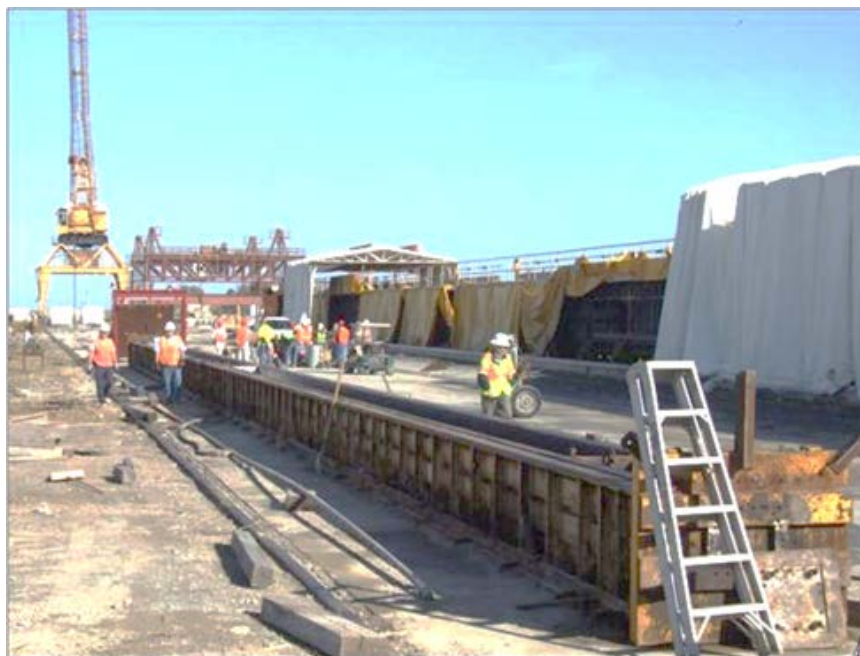
Figure 3. Pile With Carbon Fiber Reinforced Polymer at Casting Yard

The CFRP used in this project, carbon fiber composite cable, is a carbon fiber, derived from polyacrylonitrile, with an amine-cured epoxy matrix. It has low ductility and is anisotropic, resulting in high strength in the axial direction, but the strength decreases as the applied force rotates toward the transverse direction. CFRP can also burn, so CFRP can be cut using an angle grinder with an abrasive cutting blade rather than an oxy-fuel torch. Further, careful handling is required to avoid abrading or nicking the CFRP strand. These characteristics of CFRP still allowed all of the CFRP piles to be cast at a precaster's facility using the same prestressing equipment and concrete that is used to fabricate conventional steel reinforced piles (Figure 3).

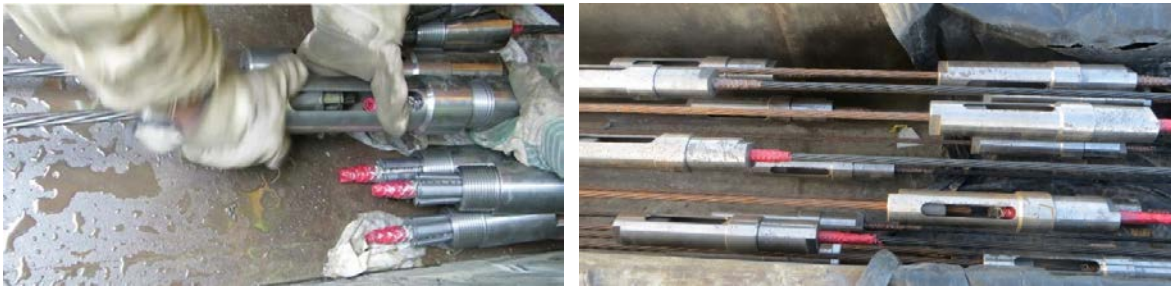
Figure 4. Carbon Fiber Composite Cable and Steel Couplers Joined (left); Couplers Staggered and Tensioned (right)

However, special handling requirements are necessary for the preparation of CFRP ends for stressing. Jacks do not directly grip and pull the end of the CFRP. Instead, steel strands are attached to CFRP strand by a coupler (Figure 4), and jacks then grip and pull the steel strands. To couple the steel and CFRP strand, the steel strand was placed in one-half of the coupler with a traditional chuck to secure it and the CFRP was prepared with special buffer materials and placed in the other end of the coupler. The CFRP end was prepared for the coupler by wrapping it with a mesh sheet made of layers of metal and plastic, followed by insertion of the wrapped end into a braided stainless steel grip, as shown in Figure 5. The prepared end was held by four-part wedges evenly inserted in a chuck barrel. Because of the time required for end preparation, daily cycles for the production of CFRP piles were not achieved, although conventional piles were prepared and detensioned in a 24-hour cycle.

After all couplers were assembled, they were staggered and a preload of 5 kips was applied with the prestressing jack. Although continuous loading is currently used, during this early fabrication, the jack was loaded in increments of 10 kips until the maximum tension of 34 kips was achieved. For conventional steel reinforcement, continuous and rapid loading is done by completing prestressing within 30 seconds. At each preload and then at maximum load, the extension of the CFRP was measured. There was no noticeable slippage of the strand, and the actual elongation matched the calculated figure. The reduced elongation of CFRP compared to the ASTM requirement of a minimum 3.5 percent did not compromise the prestressing operation.

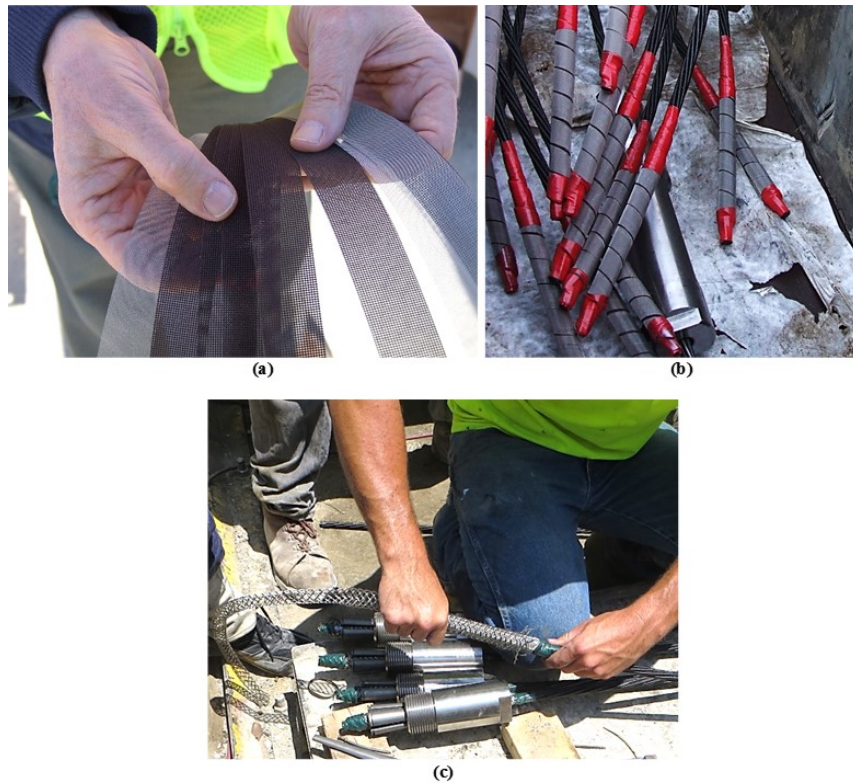
Figure 5. CFRP End Preparation for Tensioning Using Coupler. This requires (a) layered mesh sheets (b) to be wrapped around CFRP and taped (gray helical wrapping with red tape along the edge of the mesh sheet) and then (c) a braided grip to be slid over the mesh sheets and also taped. CFRP = carbon fiber reinforced polymer.

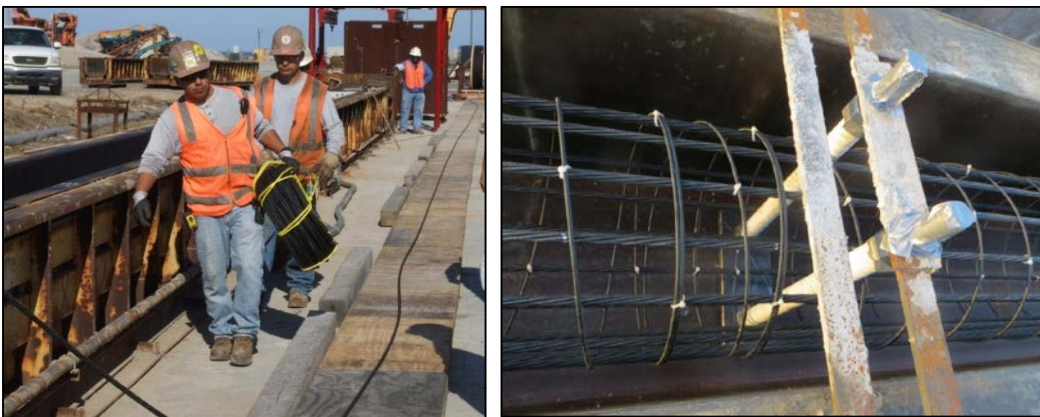
Figure 6. Spiral for Pile Carried by One Person (*left*); Lifting Device (*right*)

For safety reasons regarding the use of a new strand material at this facility, the CFRP was maintained prestressed overnight. On the following day, CFRP spirals that were already in the prestressing bed (placed before the strands) were tied to the CFRP strands with plastic ties. The CFRP spiral for each pile was light and could be carried easily by one person (Figure 6). There was no sagging in the CFRP strands after placement of the CFRP spiral; sagging would be normal with conventional steel reinforcement because of the weight of the steel. For each pile, two lifting devices were placed. The lifting device incorporated threaded rods that were placed in cardboard tubes to avoid contact of the steel with the CFRP and the spiral. Later, after the lifting devices were used to remove the pile from the bed, the lifting devices and the cardboard tubes were removed from the piles and the holes grouted (Figure 6). With no steel remaining in the finished pile, these piles are a corrosion-free option when long-term durability is important.

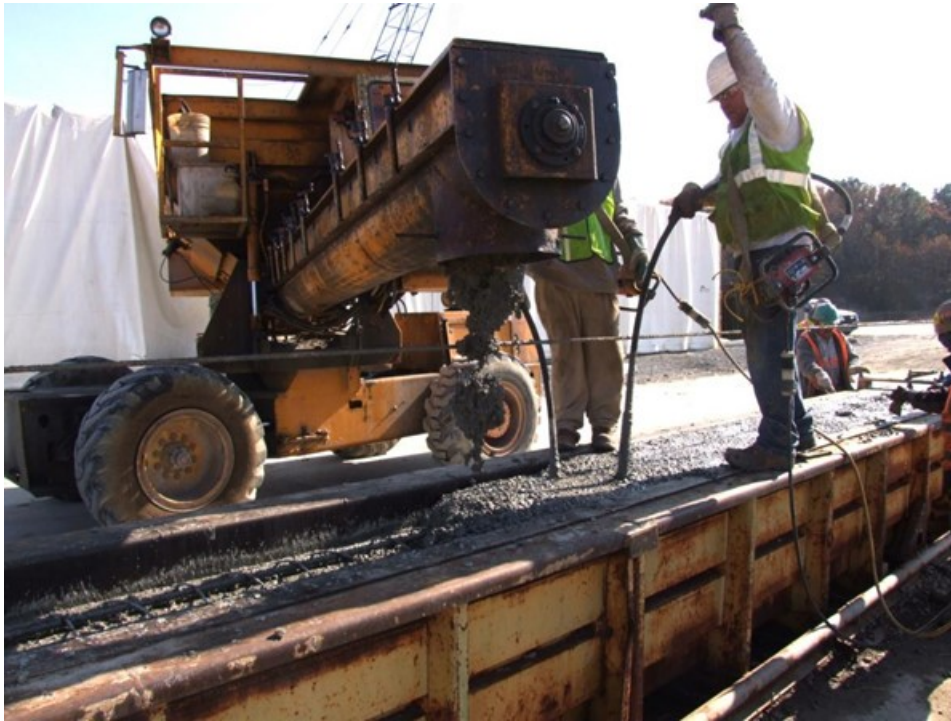
Figure 7. Concrete Consolidation Using Rubber Tipped Vibrators

Concrete was placed in the bed and consolidated using internal vibrators with rubber heads to prevent damage to the CFRP (Figure 7). Upon completion of concrete placement, the bed was covered and the test specimens were placed on a rack at one end of the bed. At this location, temperatures were lower than at the remainder of the bed to ensure that slippage of CFRP strand within the couplers did not occur.

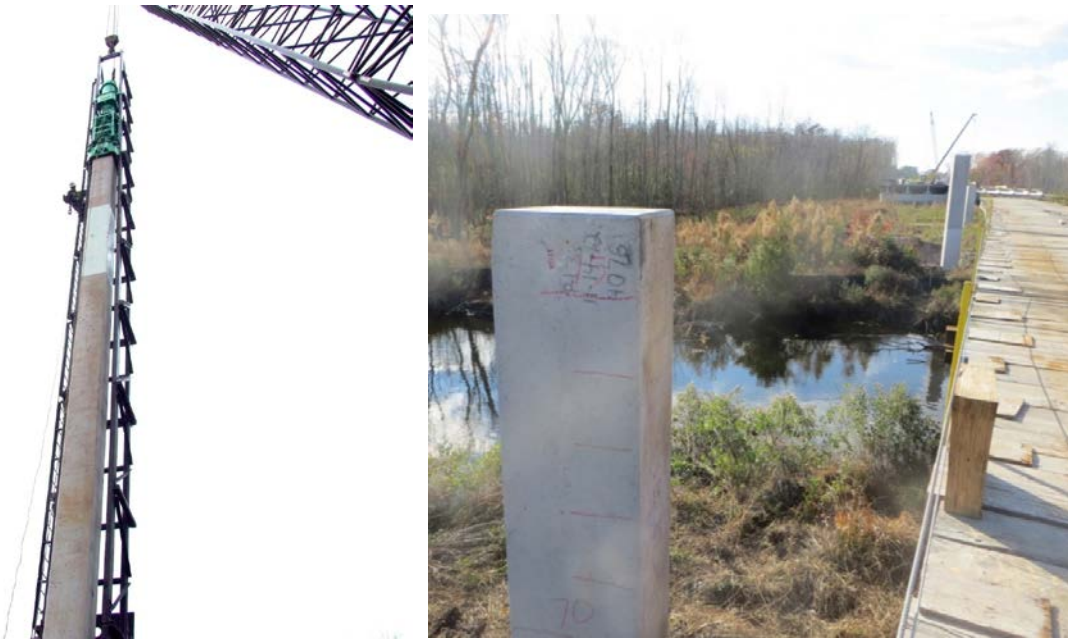
Figure 8. Preparing for Pile Driving (left); Pile in Place after Driving Showing No Signs of Damage to Upper Portion of Pile (right)

Two CFRP-reinforced piles were driven as test piles along with other traditional steel reinforced test piles during the construction of the Nimmo Parkway Bridge (Figure 8). During driving, the ram weight was 10,141 lb and the hammer stroke was 5.7 to 9.2 ft. The dynamic analysis indicated that there were no differences in the driving responses of piles with CFRP and conventional piles with steel strands. (Later, the 16 CFRP production piles were also driven with no problems.) The reduced elongation of CFRP compared to the ASTM requirement of a minimum of 3.5 percent elongation did not compromise the driving operation. The test piles demonstrated that although CFRP requires special end preparation (Figure 5) and some handling accommodations (Figures 6 and 7), a CFRP-reinforced pile can be driven in the same way as a pile with conventional steel strands.

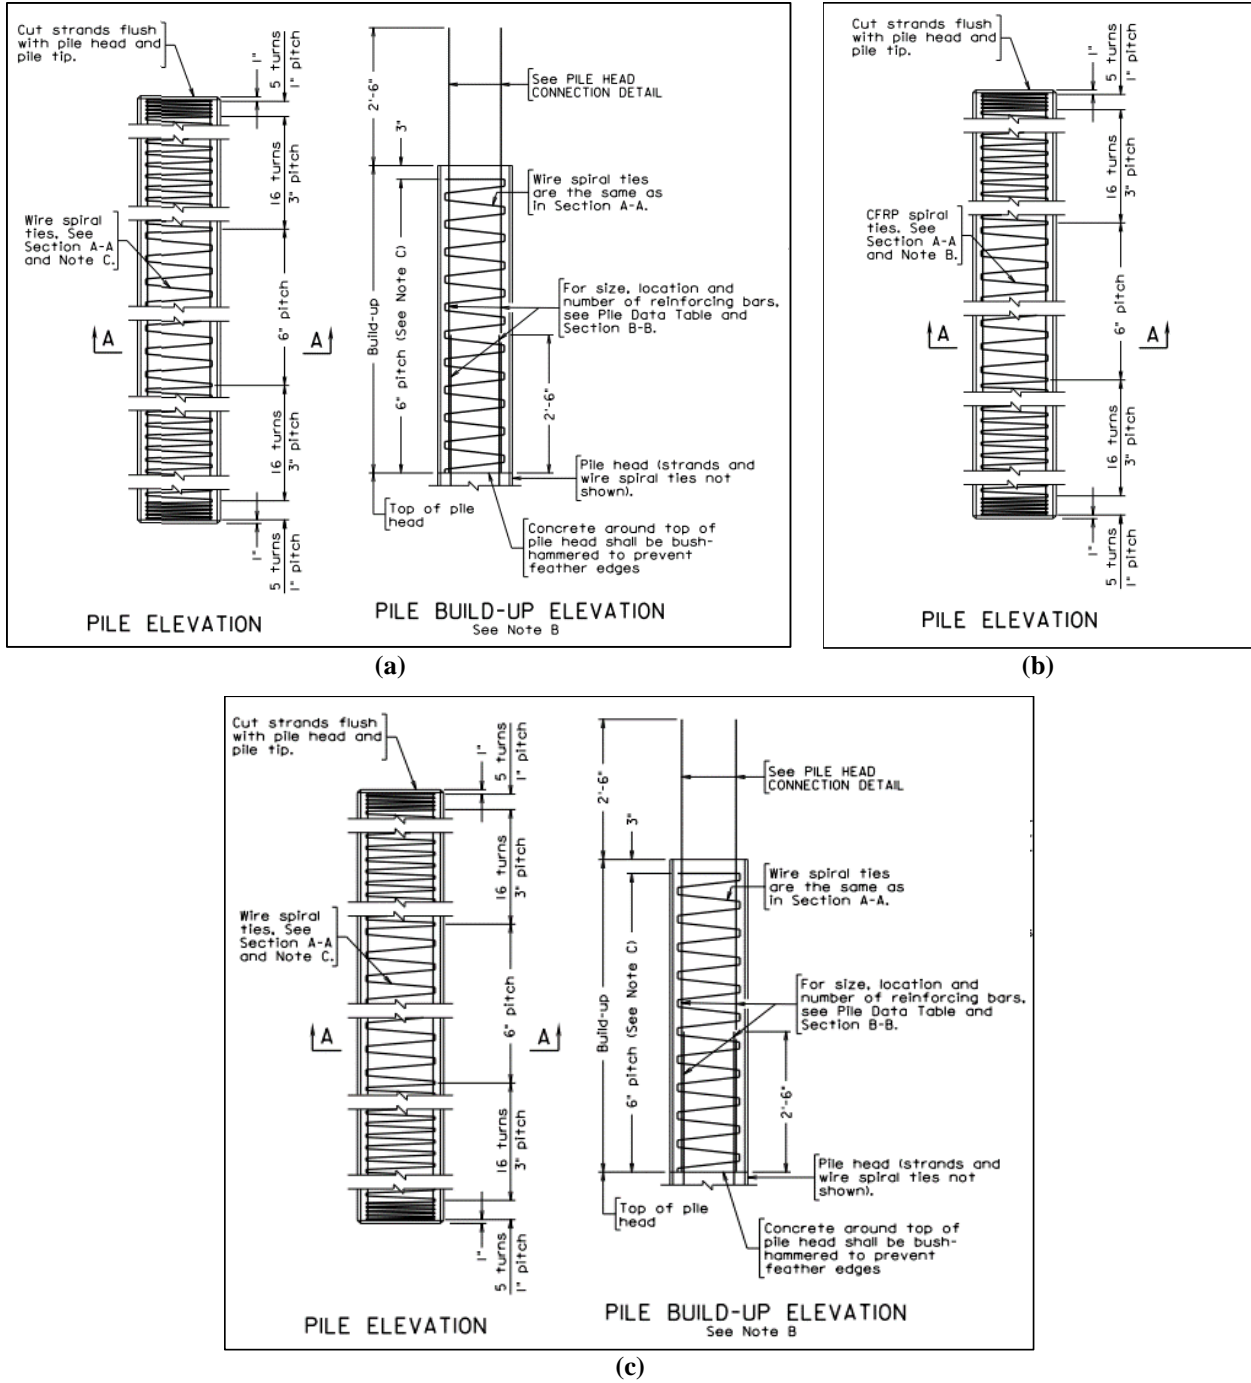
Figure 11. Design Schemas: (a) stainless steel strand; (b) CFRP; and (c) conventional steel strand reinforcement for concrete piles. CFRP = carbon fiber reinforced polymer.

Figure 12 shows reinforcing material costs per foot of pile calculated for 24-in concrete piles that are 65 ft in length based on three current standard concrete pile designs corresponding to the three reinforcement materials shown in Figure 11. It will be noted that both Figure 11 and the quantities in Figure 12 show that pile designs are substantially alike for the three materials.
