**Detection of Multiple Flaws in Concrete Bridge Decks Using
Ultrasonic Wave Propagation**

M066

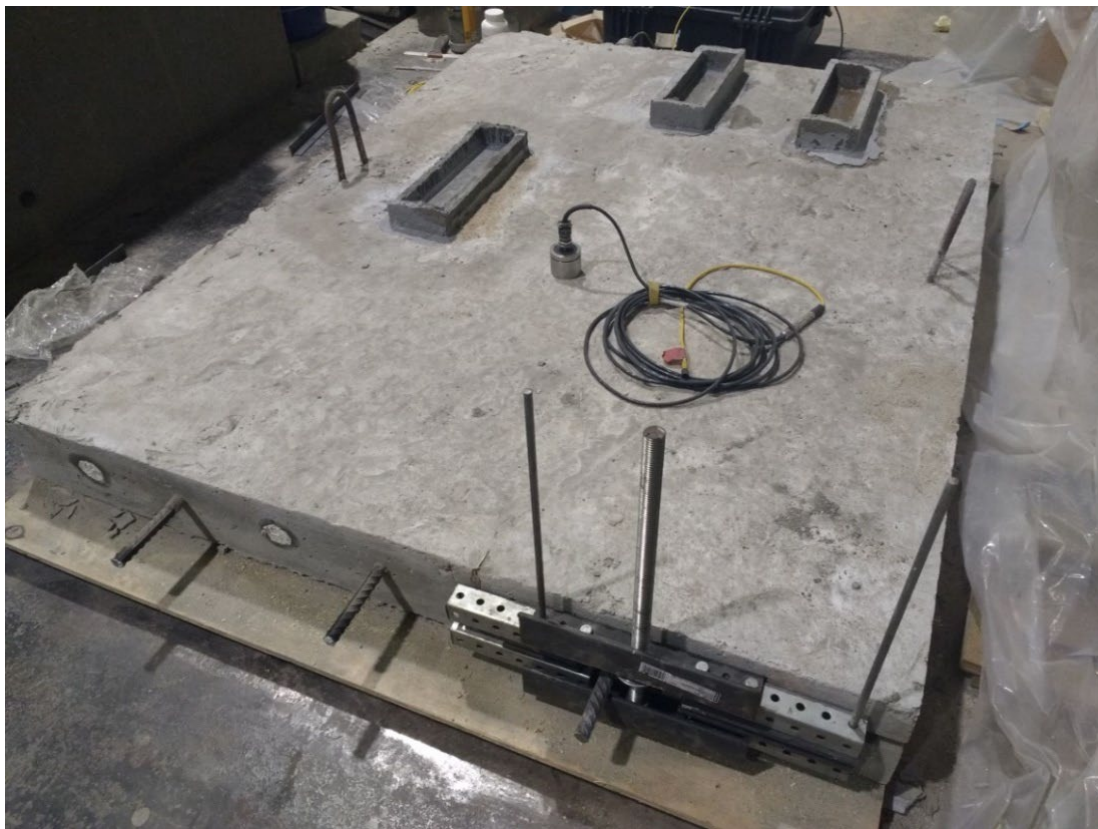
B. **Specimen Set 1B: One 60inch x 48 inch x 5 inch concrete slab** with three No.5 steel reinforcing bars spaced at 12inches (Figure 3): The purpose of this specimen was to: 1) investigate whether it is possible to detect the onset of corrosion in a larger and more complex specimen, 2) Whether it is possible to detect corrosion and delamination simultaneously. Certain regions of the slab were cast using 5% NaCl solution (salt water) rather than regular water to localize the corrosive environment. Further, to accelerate the corrosion in these regions, concrete basins of 12 inches x 3 inches x 2 inches were cast in those regions above the reinforcing bar (Figure 3). These were filled with 5% NaCl solution to accelerate the corrosion process. The solution inevitably gets absorbed and evaporates, so the basin was refilled with water every six days. The third steel reinforcing bar in this specimen was used to monitor simultaneous development of corrosion and delamination. This test is referred to as the “corrosion-delamination test”. The bar was exposed to corrosive conditions for 24 days, while simultaneously delaminated slowly over the same time period.

Figure 3- Specimen Set 1B (Corrosion-delamination Specimens)

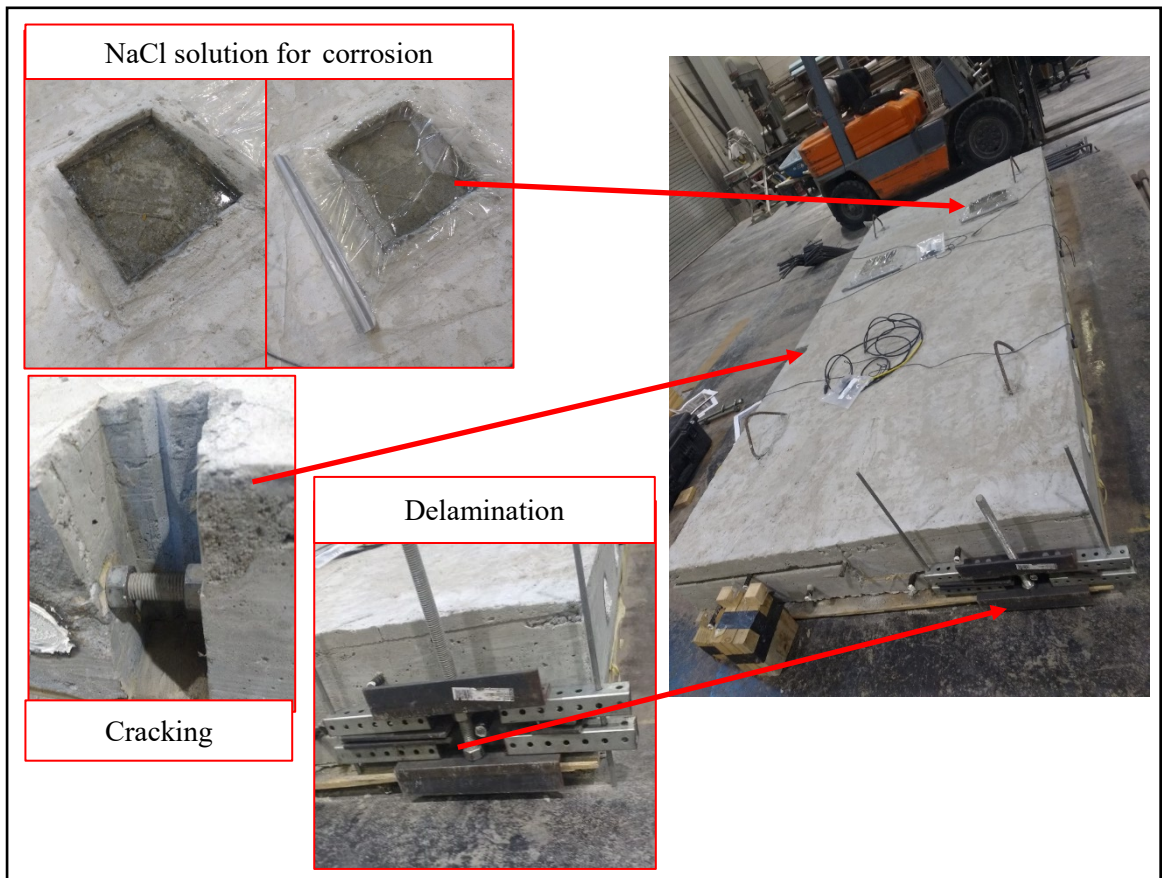
Figure 6- Specimen Set 3 and various areas of artificially introduced flaws

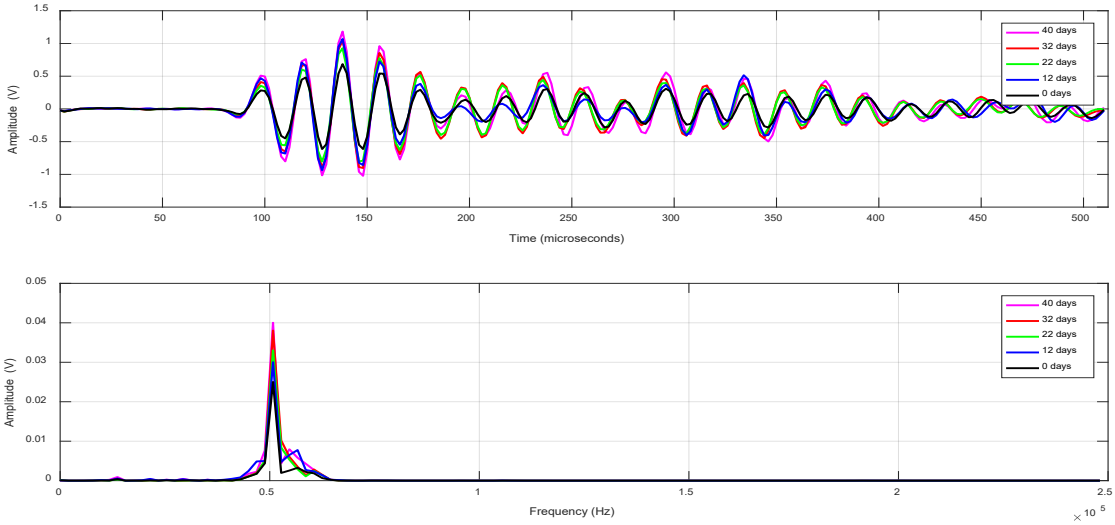
Figure 8- Velocity (top) and Amplitude (bottom) readings as the corrosion progressed up to 40 days

It can be concluded from this set of experiments that onset of corrosion, even as early as 5 days, is detectable with this method; and the percent difference increases as the corrosion builds up.

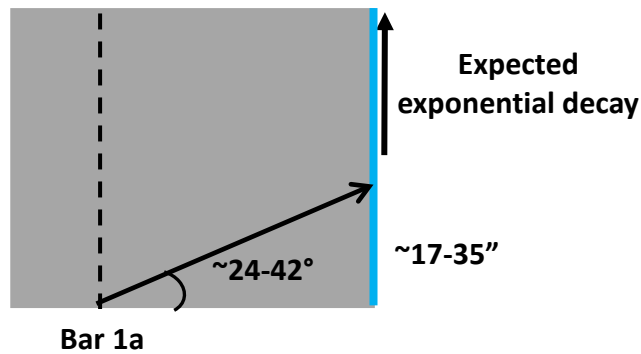
Figure 15- Schematic illustration of leakage angles with respect to the location of the sensor array shown with blue line (3 feet away from bar 1a)
