**Report SPR-P1(16)M041**

# **Automated Chain Drag Testing**

**Hongbin Sun, Jinying Zhu**

Department of Civil Engineering  
University of Nebraska-Lincoln

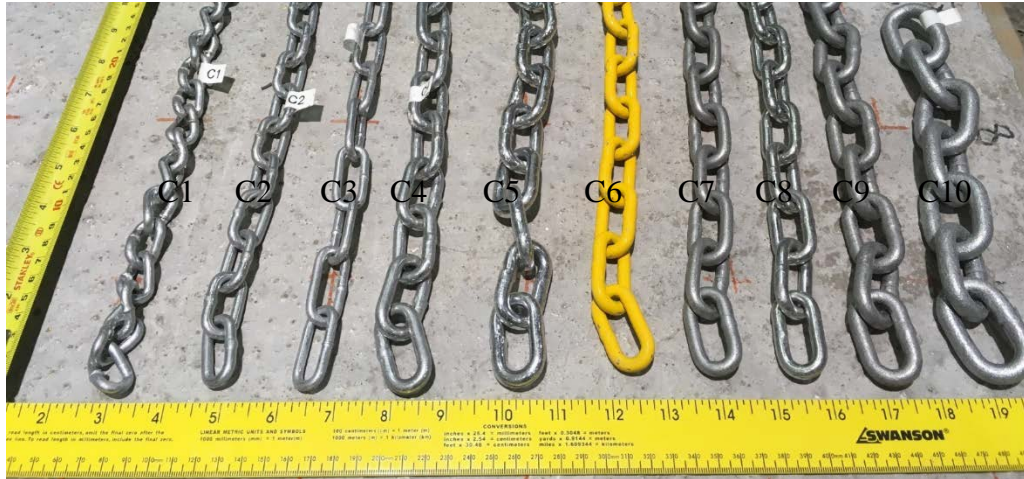
**Figure 3-3 Ten different types of steel link chains**

Many types of link chains are available, and they vary from material, coating, length per segment and weight. We tested ten different types of link chains (see **Figure 3-3**) and investigated noises caused by link clapping in air and surface friction when dragging on concrete surface. Test results indicate all links chains created high level noise in air, and many also have high level of noise when dragging on solid concrete surface. We chose link chains C5 (chain 1), C7 (chain 2) and the ball chain for detailed discussion. **Figure 3-4** shows two different types of steel link chains and the newly developed ball-chain.

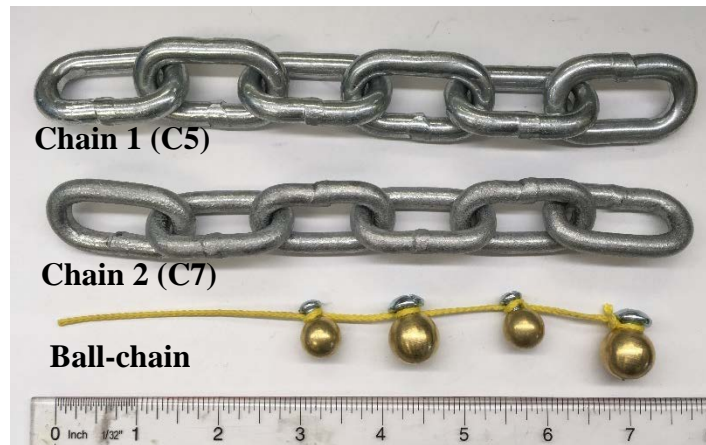
**Figure 3-4 Two steel chains and a ball-chain**

Both steel chains have the same 1/4-in diameter but with different surface finishing. Chain 1 has a shiny zinc-plated surface, while chain 2 has a galvanic surface finishing. The ball-chain consists of two 1/2-in and two 5/8-in brass balls connected by a flexible nylon string. The distance between the first and last ball is about 4 inches. Using different sizes of balls allows different impact contact times, which is useful to identify delaminations with different resonance frequencies. A smaller ball is more effective for delaminations with higher frequency and a larger ball is for delaminations with lower frequency.

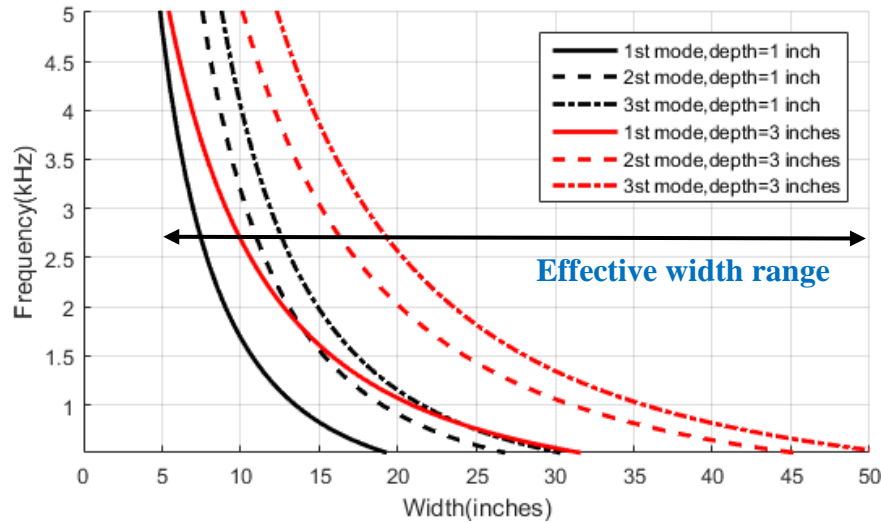
**Figure 3-7 Relationships between resonance frequency and delamination width**

in which  $C_p$  is the P-wave velocity of concrete,  $\nu$  is the Poisson's ratio of concrete,  $h$  is the depth of the delamination and  $c$  is the width of the delamination. In this experiment, the P-wave velocity is 4400 m/s and the Poisson's ratio is 0.22. Base on the two equations, relationships between frequency and delamination width are plotted in **Figure 3-7** for two depths: 1 inch and 3 inches. For depth of 1 inch, delaminations with width of 4.9 to 30 inches have the first three resonant frequencies in the range of 0.5 to 5 kHz. For depth of 3 inches, the width range is from 5 inches to 50 inches. It can be seen that the frequency range 0.5 to 5 kHz will cover major resonance modes for delaminations with lateral dimension in the range of 5-30 inches and at depth of 1-3 inches. In practice, most bridge deck delaminations occur at the top layer rebars, with a depth of 1-3 inches. Therefore, the major criterion for selecting proper sources is to ensure low noise level in 0.5 kHz to 5 kHz frequency range.

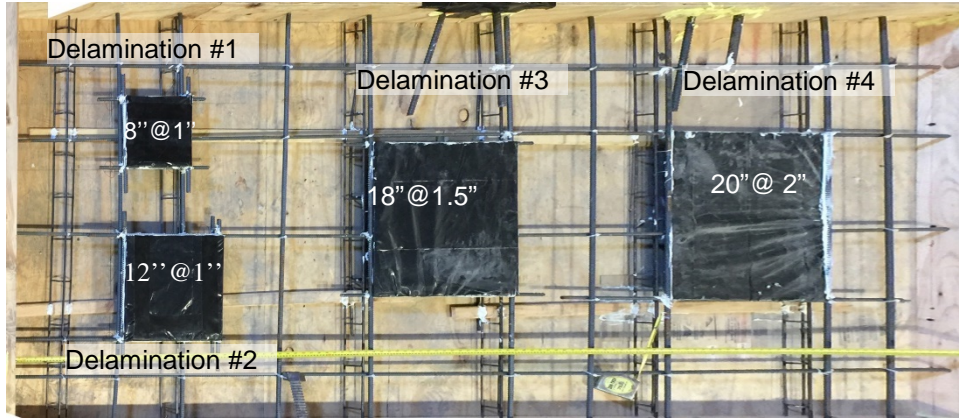
**Figure 4-1 Concrete specimen with four artificial delaminations**

A 10 feet by 4 feet reinforced concrete slab (4 inches thickness) was fabricated with four artificial delaminations of different sizes and depths (see **Figure 4-1**). A polymethyl methacrylate sheet covered with black plastic film was used to create an artificial delamination. The slab was cast with ready mixed self-consolidated concrete (SCC). Sizes and depth of four delaminations are marked in the figure below.

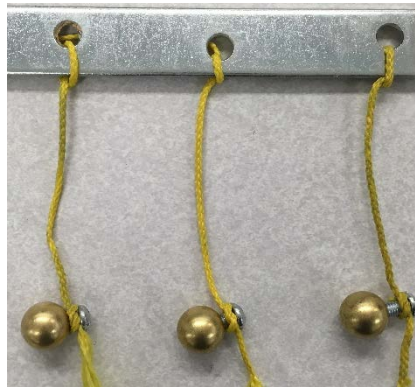
**Figure 4-10 Three parallel metal balls as excitation source**

In order to improve testing speed and signal amplitude without scarifying the spatial resolution, we connected multiple balls in parallel as the excitation source (**Figure 4-10**). Each ball will impact the concrete surface randomly and independently. This design increases the total number of impacts per unit length. The time domain signals of using different numbers of balls are shown in **Figure 4-11**. When increasing the number of balls, the time domain signals show more spikes which means more impacts and smaller spatial spacing. At a speed of 33 in/s (0.86m/s), the spatial resolutions are 1.7 in, 1.1 in, 0.9 in and 0.7 in when using 1, 2, 3 and 4 balls respectively. It is found that the spatial resolution does not increase linearly with the number of balls. Since the ball size affects frequency content of impact, we combined two small size balls and two large size balls (such as two ½ in balls and two 5/8 in balls) to cover delaminations with different fundamental frequencies.

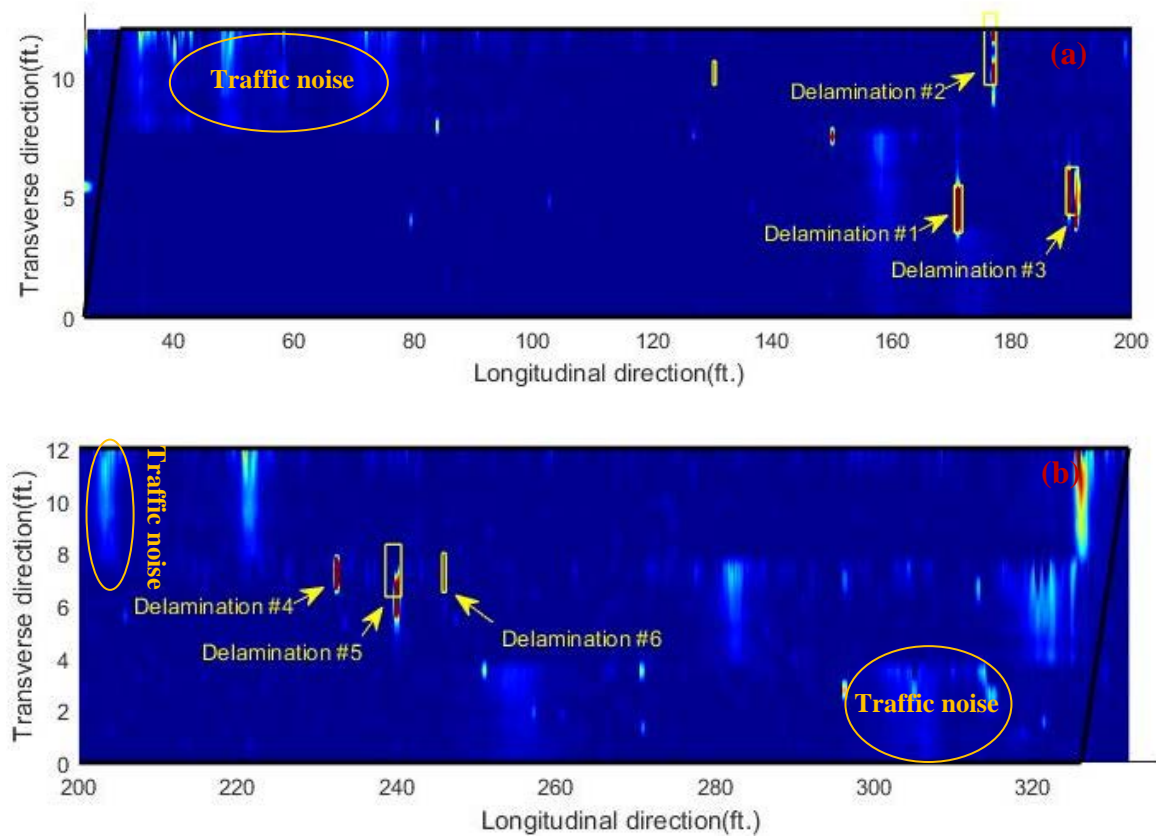
**Figure 5-11 Scanning images of Bridge 1 (right lane): (a) 25-200 ft, (b) 200-335 ft**

small delaminations. Using multiple ball-chains in each channel will improve longitudinal resolution by generating more impacts than using one ball-chain. Traffic noises (circled areas) can be observed in the images, which did not affect identification of the delaminations.

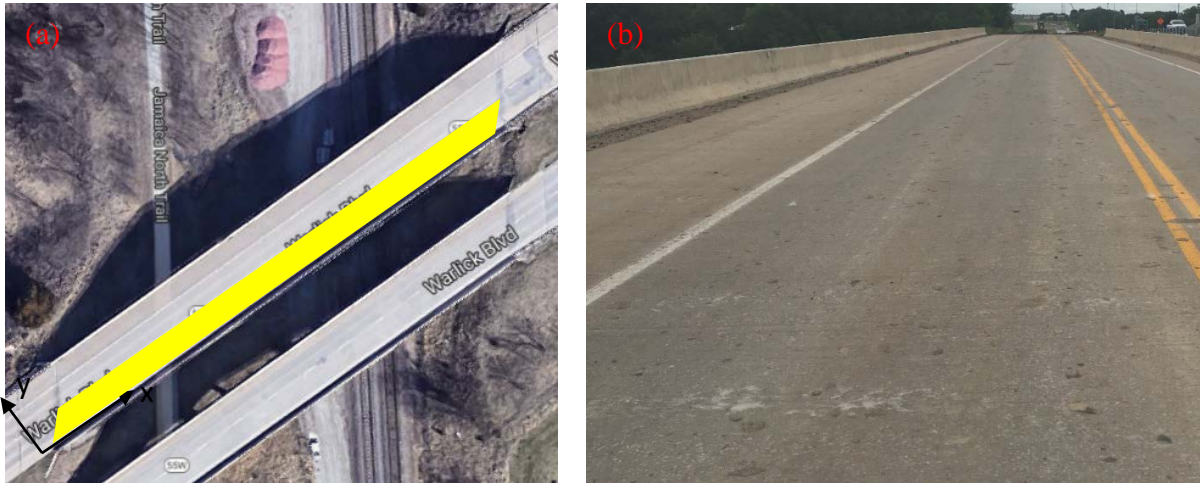
**Figure 5-13 Bridge 1 (left lane): (a) Google map and the scanned area in 2017, (b) Deck surface conditions**

The left lane of bridge 1 was tested in the 2017 as indicated by the yellow area in **Figure 5-13(a)**. A 6-ft wide frame with 12 channels was used for automated acoustic scanning. After the scanning, manual chain drag test was conducted to mark the positions of the delaminations. The manual chain drag results will be used as the verification of the acoustic scanning results.

The results of the two lanes are combined in **Figure 5-15** using the same coordinate system in **Figure 5-13**. The left lane shows more delaminations than the right lane. This is probably because the left lane experience higher traffic volume than the right lane.

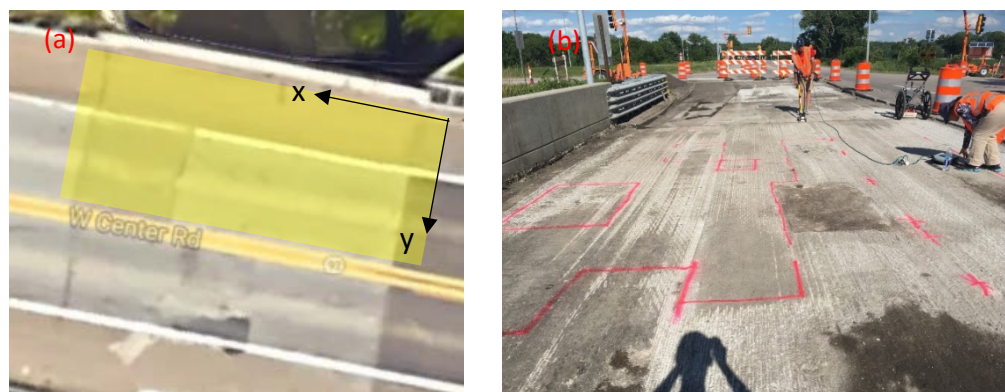
**Figure 5-16 Bridge 2: (a) Google map and the scanned area, (b) Concrete deck after asphalt removal**

Bridge 2 is located at Hwy. 92 & 240th Street, West Omaha. It has a concrete deck with an asphalt overlay. The overlay was removed before the deck repair in July 2017. The concrete deck had a very rough surface after the old asphalt layer was removed. The automated acoustic scanning system was then used to scan the bare concrete deck after asphalt removal. Manual chain drag test was performed by an NDOT engineer. Only the westbound lane and the shoulder (yellow area in **Figure 5-16** (a)) were tested, while the east bound lane was still open to traffic. A coordinate system is as shown in the figure below. The  $x$ -axis is along the longitudinal direction (traffic direction) and the  $y$ -axis along the transverse direction. **Figure 5-16** (b) shows the deck surface conditions after asphalt removal.

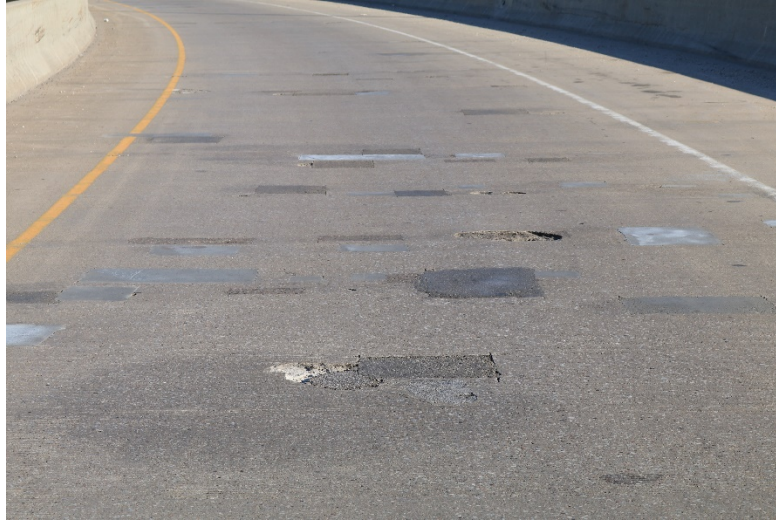
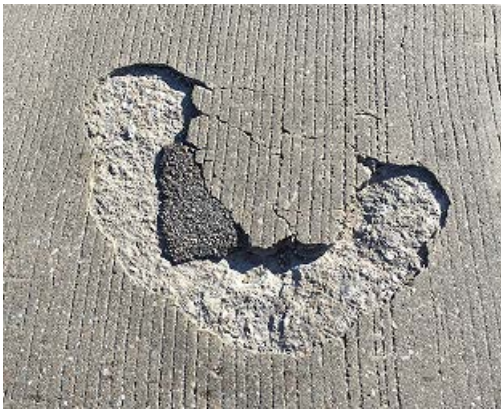
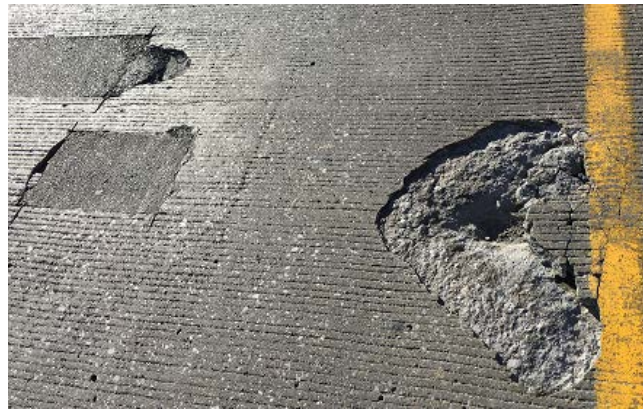
**Figure 5-19 Surface conditions of Bridge 3**

The highway intersection bridge is about 1600 feet long. We scanned three segments using the automated acoustic system, as highlighted in **Figure 5-18**. Each segment is about 300 feet long. Visual inspection indicated deteriorating surface conditions (see **Figure 5-19**) for the three segments. A quick screening scan of this area did not show any delaminations in the area between segment 1 and segment 2. Therefore, we decided to only test the three segments showing clear surface deteriorations.
