**ACCELERATED CORROSION TESTING OF GROUTS FOR PT STEEL STRAND**

FINAL REPORT

**Project BDV29-977-44  
(80002803)**

April 2021

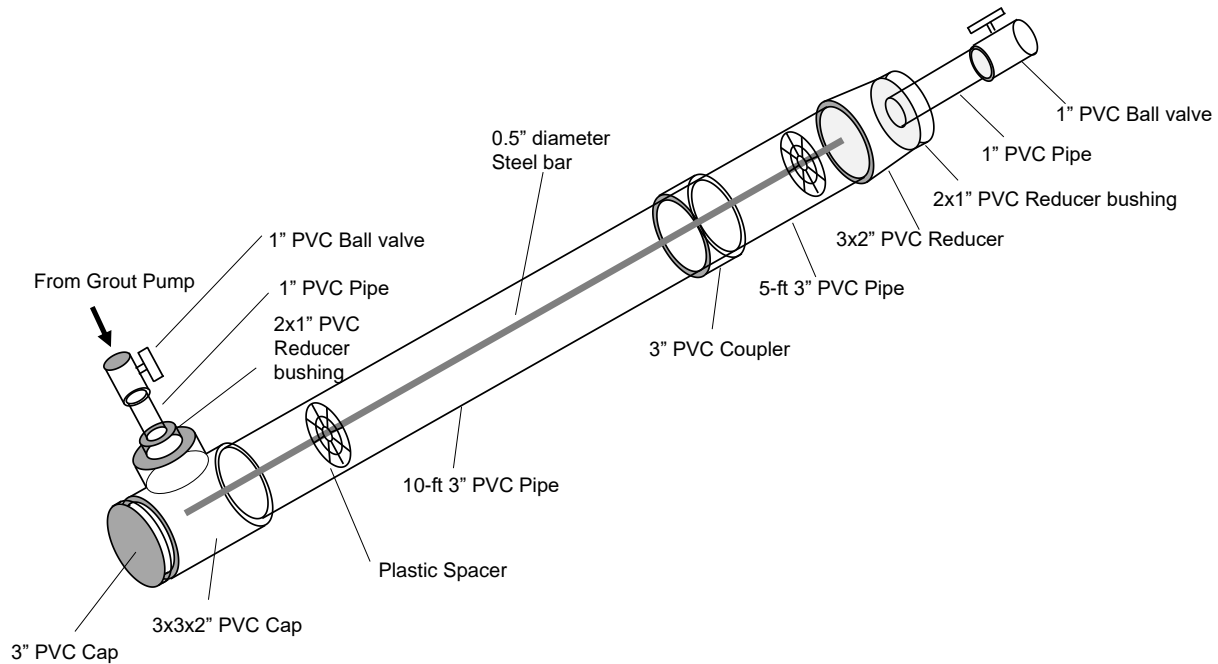
Figure 2.17. MIT test assembly

The MIT had been shown to promote some level of grout segregation. As such, the setup was used to produce grout samples for further chemical analysis and assessment of sampling procedures. The MIT test generally consists of pumping grout in a 3-inch diameter pipe, along a 15-foot length at a 30 degree incline. A schematic of the specimen assembly used in this research is shown in Figure 2.17. The relatively high grout volume and the vertical deviation could promote transport of moisture if the grout material is susceptible to bleed or segregate. The MIT test also included excess mix water to promote the moisture transport.

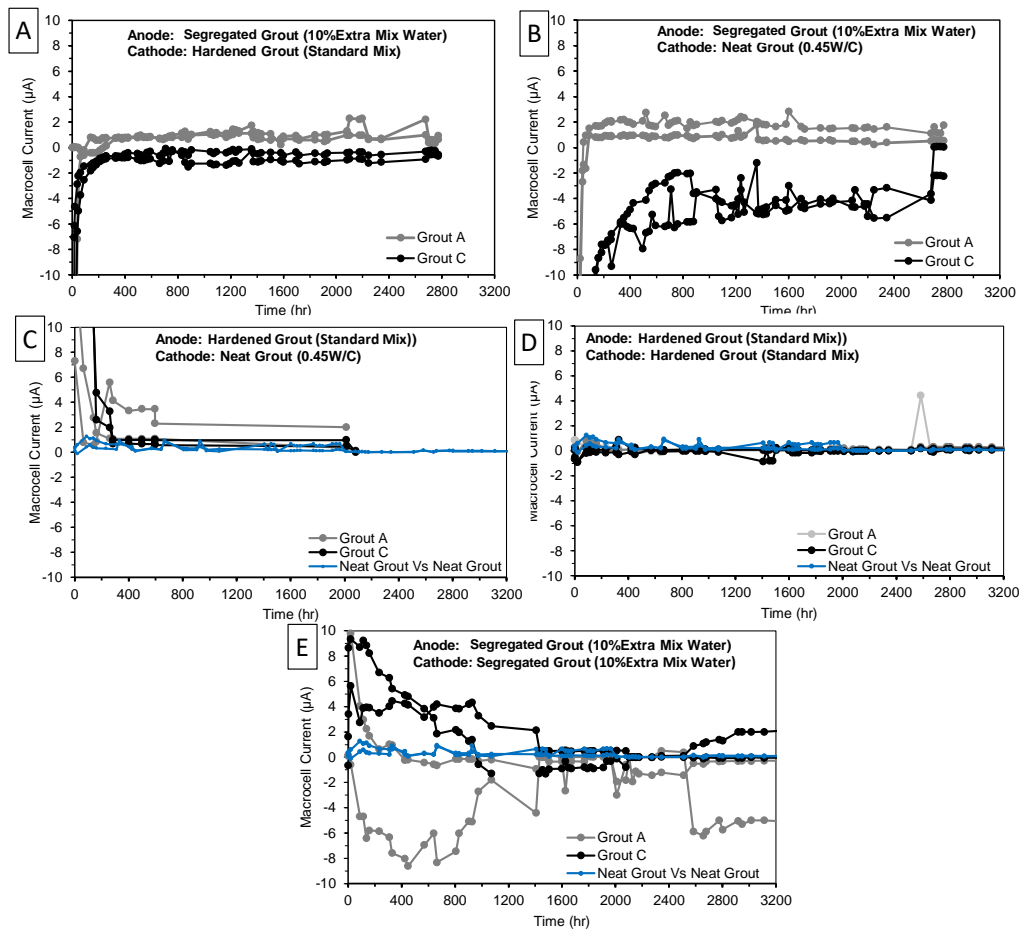
Figure 5.1: Macrocell currents in modified rapid-macrocell test. Negative values represent electrode 1 is net anodic and electrode 2 is net cathodic.

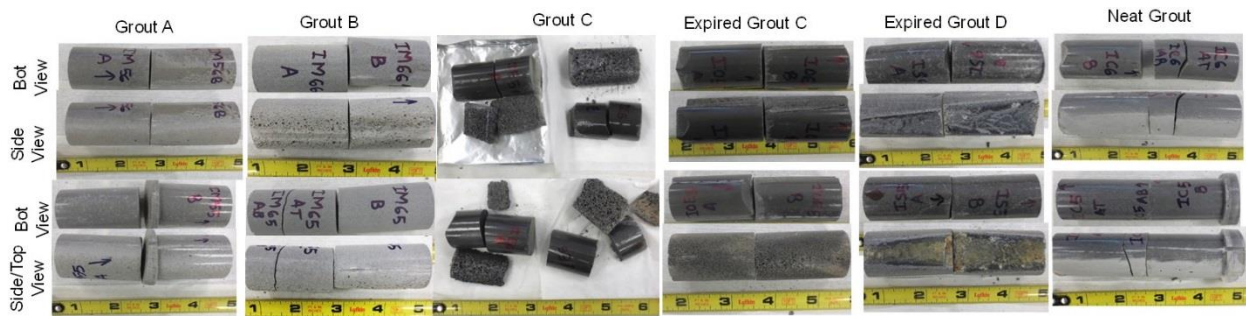
Figure A8. INT Tee-body test specimen after opening, cast with extra 10% mix water
