# MAGNETIC FLUX LEAKAGE (MFL) METHOD FOR DAMAGE DETECTION IN INTERNAL POST-TENSIONING TENDONS

FINAL REPORT  
FDOT Contract No. BDV29-977-45

Submitted By:  
Atorod Azizinamini, Ph.D., P.E.  
Florida International University  
10555 W. Flagler Street,  
Miami, FL 33174

June 2021

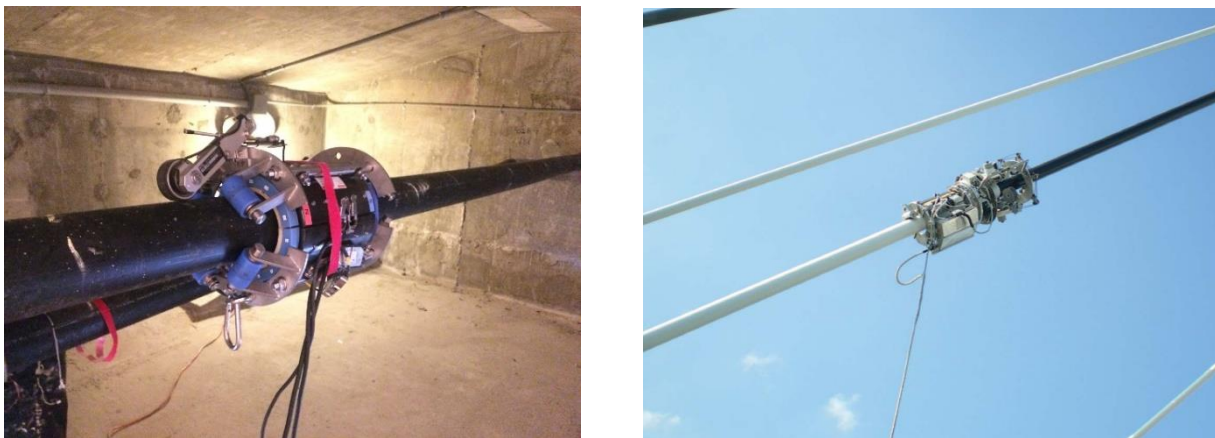
**Figure 1-3: MFL of an external PT tendon (Lau and Azizinamini, 2018) and cable stays (Alpin Technik Leipzig accessed online 2020).**

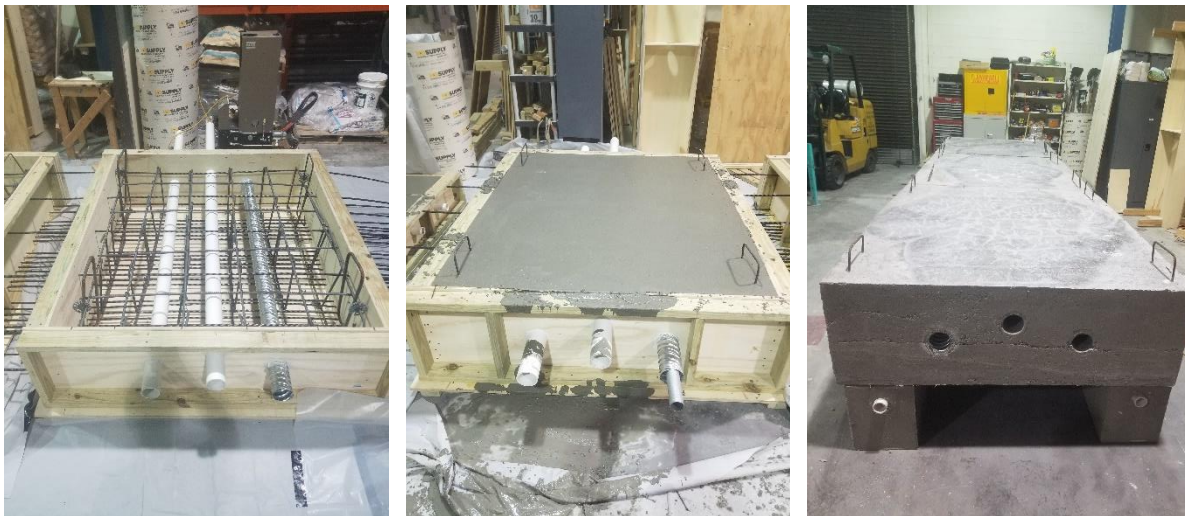
**Figure 4-28: Construction of specimen.**

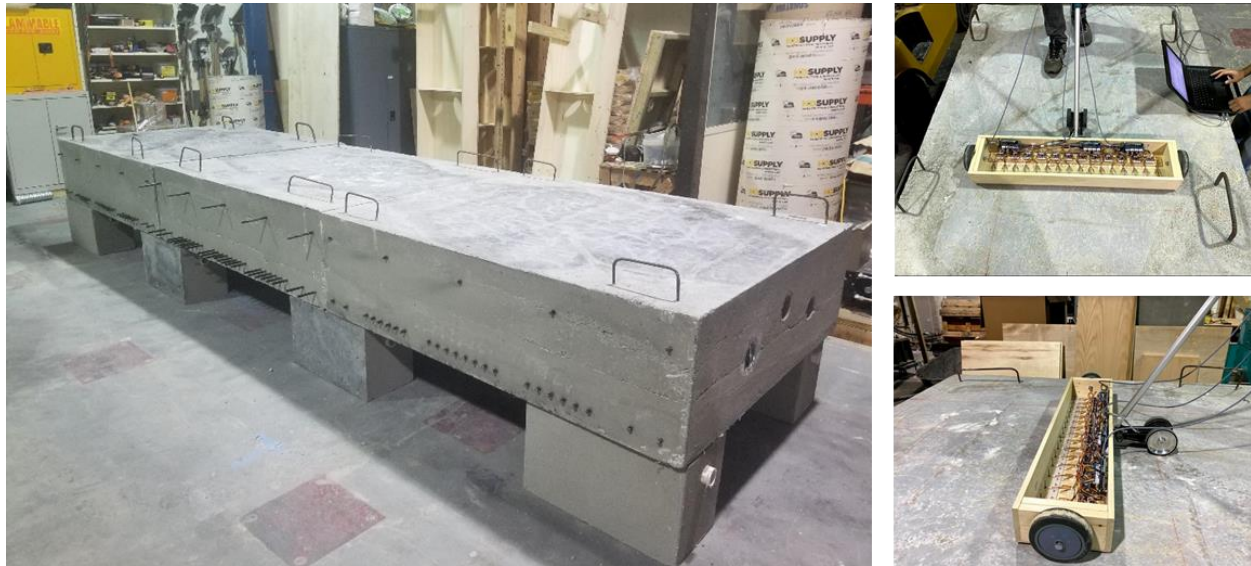
**Figure 4-30: Testing on concrete blocks.**

The three concrete blocks were placed in a series to obtain a working platform with a total length of 18-ft. The blocks were constructed with a matching interface at the top to allow smooth traversing with the prototype unit. The PT rod or strands were placed in one the ducts and the magnet assembly was used for magnetizing the rod from the bottom. Using the prototype unit-2, readings were taken from the top surface. The test platform and photographs during testing are shown in Figure 4-30.

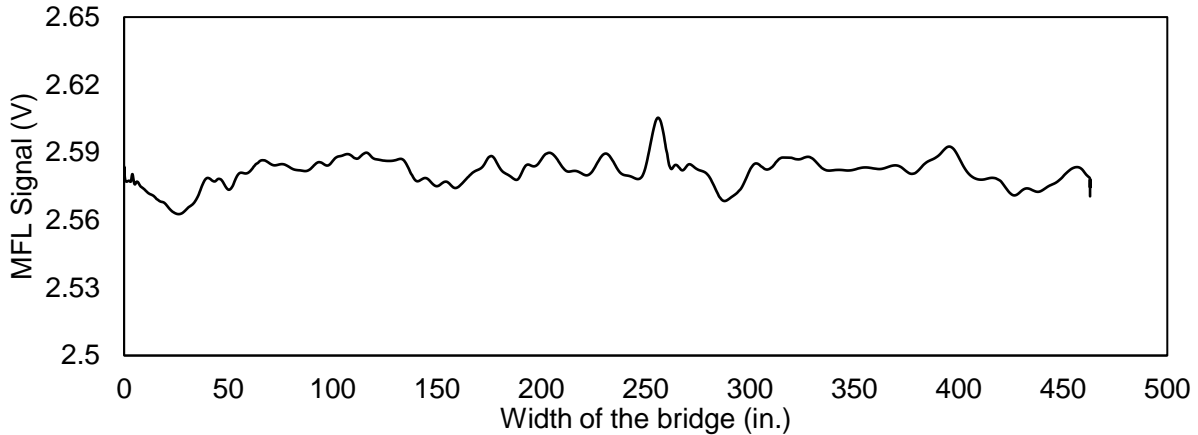
**Figure 5-5: MFL signal taken between PT rods without magnetization (test S-1-0) (sensors with flux concentrators).**

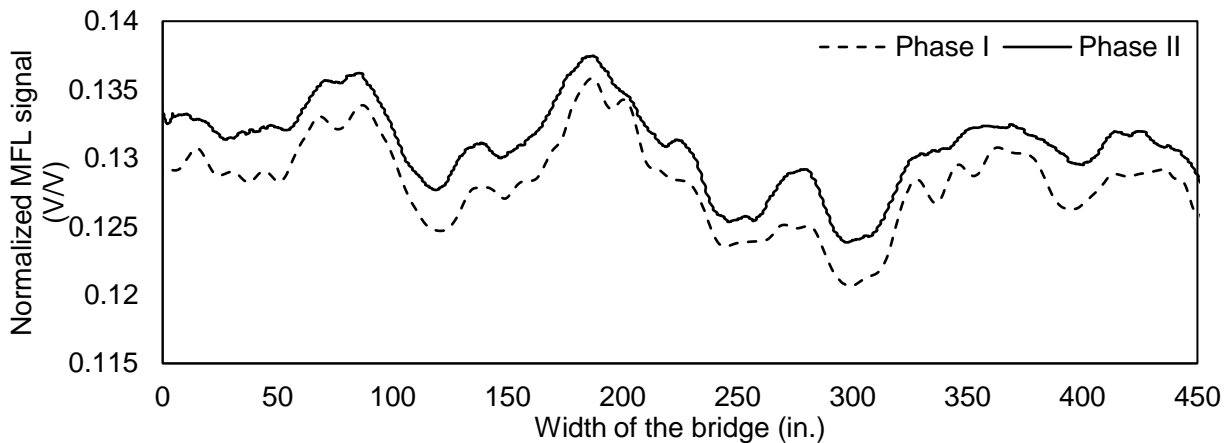
**Figure 5-8: Comparison of MFL signal from phase I and phase II on span 1 tendon 2.**

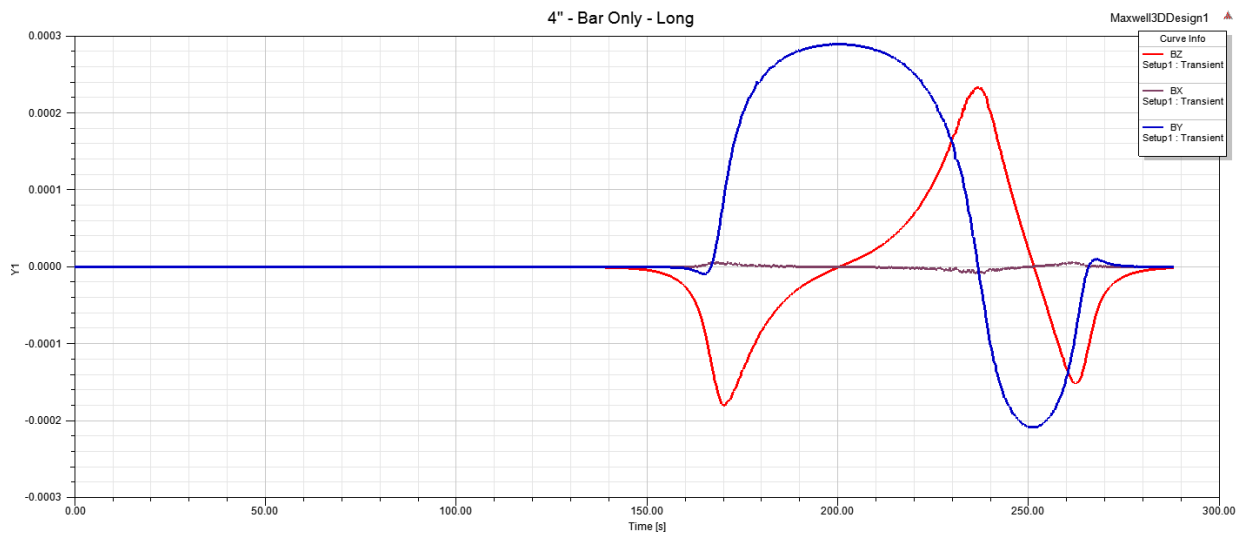
**Figure C-39: Results from 4-in. depth, no damage, bar only.**

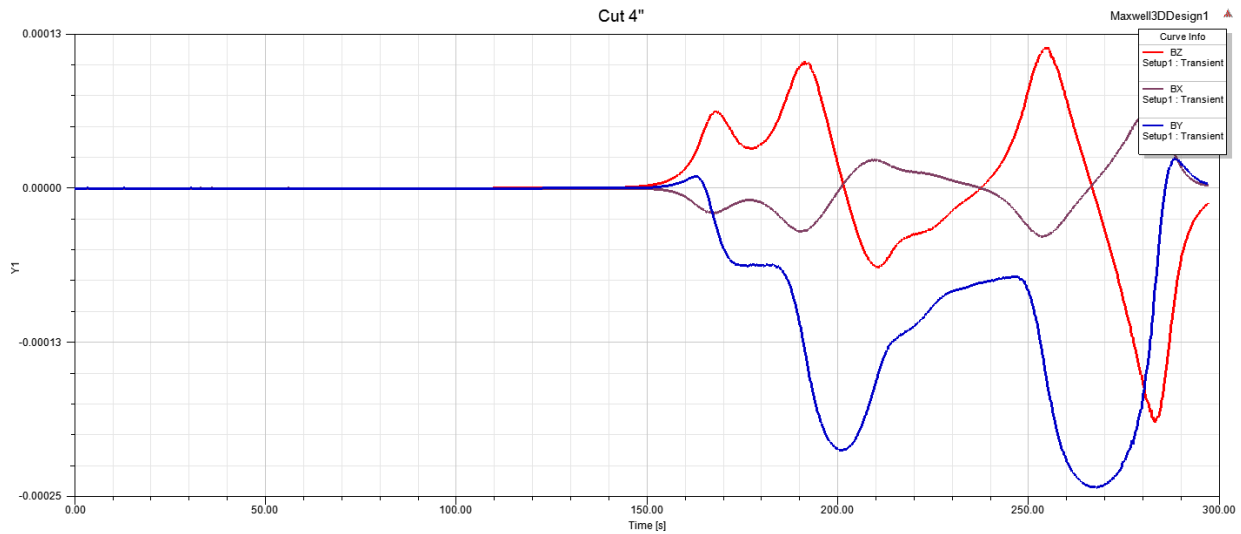
**Figure C-42: Results from 4-in. depth, damaged, bar only.**
