# MOUNTAIN-PLAINS CONSORTIUM

MPC 19-399.1 | D.S. Shinstine, K. Ksaibati, and D. Trusty

Regional Implementation of  
Tribal Transportation Safety  
Program:  
Standing Rock Sioux  
Tribe Roadway Safety  
Improvement Program

October 2019

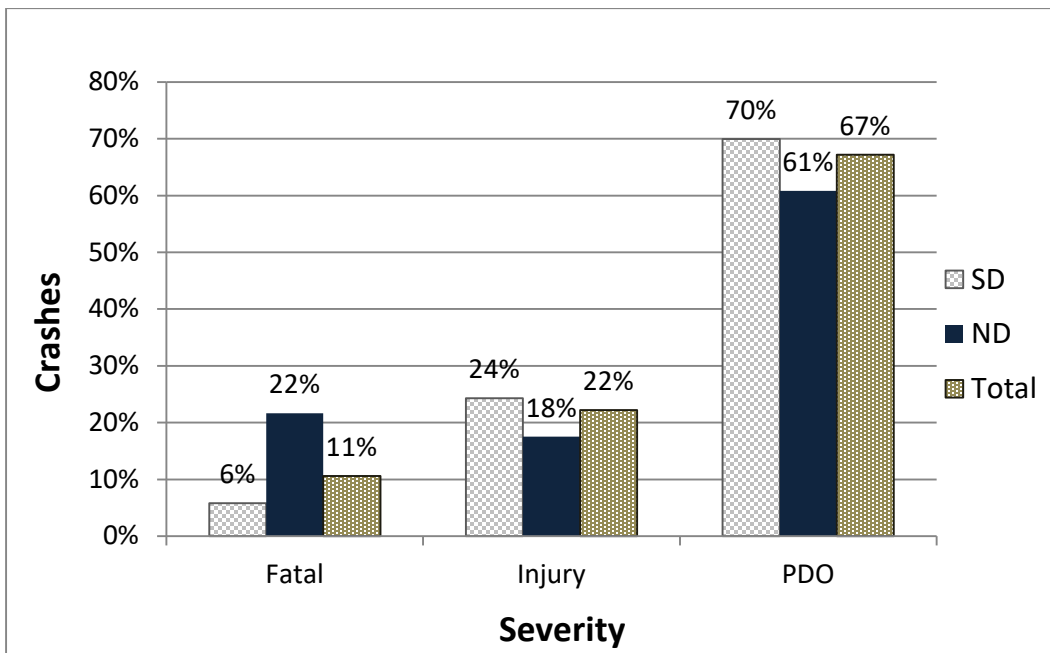
**Figure 4.2** SRST Crash Severity 2005-2013

Crash severity was divided into fatal, injury, and property damage only (PDO). As seen in Figure 4.2, 11% of all crashes on SRST were fatal, although 22% of crashes in Sioux County were fatal and only 6% in Corson County were fatal. This could be due to how much non-fatal crashes are reported in North Dakota compared with South Dakota.

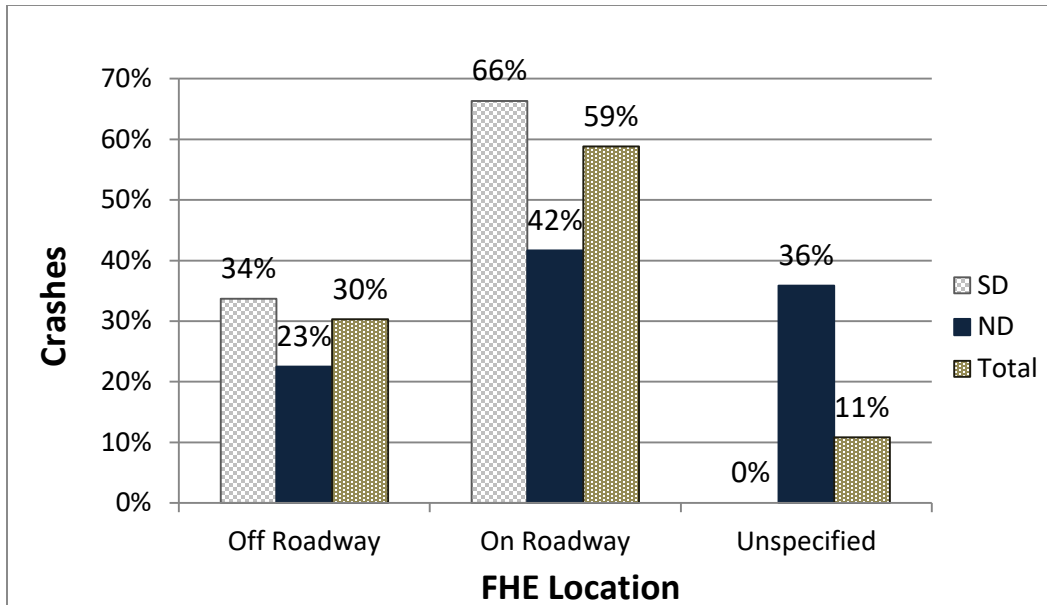
**Figure 4.4** SRST First Harmful Event Location 2005-2013

Of crashes reported, 59% occurred on the roadway. However, only 1% of crashes were reported as occurring off the roadway in North Dakota. But North Dakota also reported that 22% of crashes occurred on the shoulder and 36% were unspecified. This is compared with South Dakota, where 32% were off the roadway, only 1% on the shoulder, and none were unspecified. This could also be due to different reporting procedures between the states. See Figure 4.4.

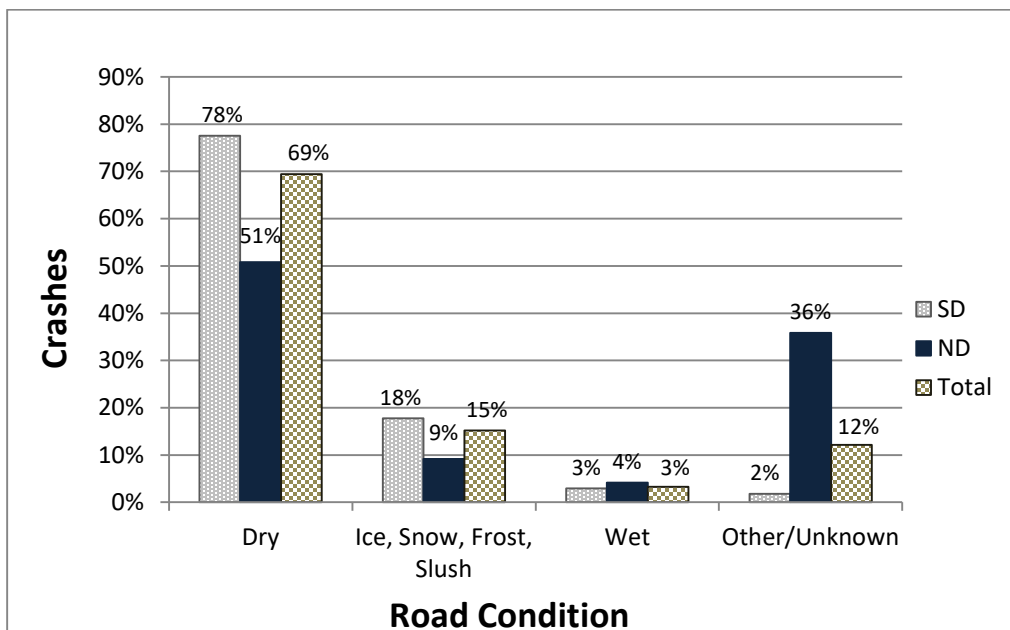
**Figure 4.5** SRST Road Conditions 2005-2013

Road conditions were reported as dry for 69% of the crashes, and as ice, snow, frost, or slush for 15% (Figure 4.5). When comparing the two counties, 78% of all crashes in Corson County and 51% in Sioux County were reported as dry conditions. In Sioux County, 36% of crashes had unspecified road conditions compared with Corson County, which had only 2% unspecified. This could be due to a difference in reporting procedures. Lighting conditions for the most part showed that crashes were evenly distributed between daylight and dark at 43% and 48%, respectively (Figure 4.6).

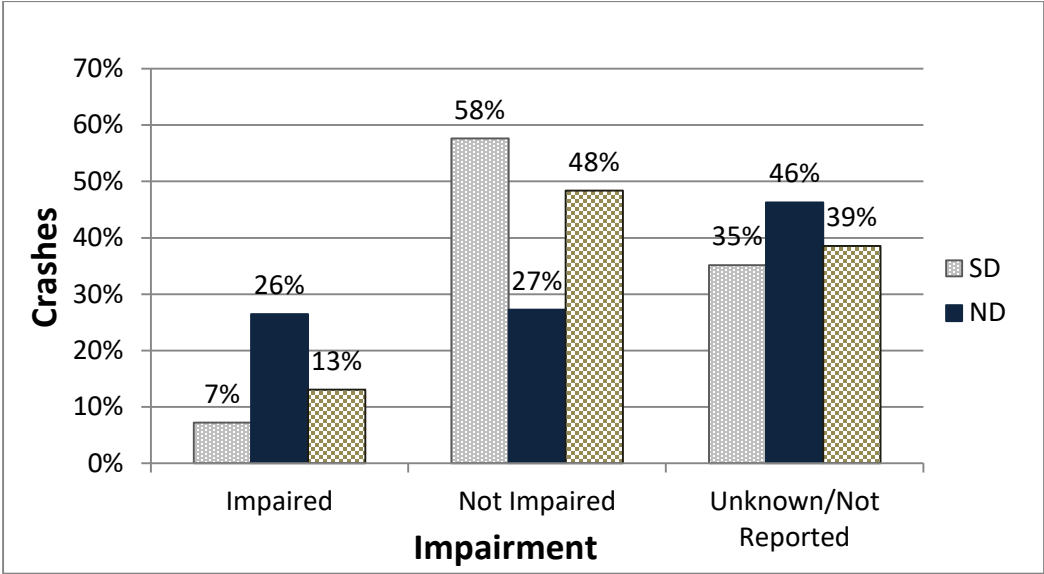
**Figure 4.7** SRST Crashes Involving Alcohol 2005-2013

There is a large disparity between North Dakota and South Dakota regarding crashes involving alcohol. North Dakota has a much higher percentage of alcohol being involved in crashes at 26%, compared with 7% for South Dakota. It should be noted that both have a high percentage of unknown or unreported alcohol involvement. See Figure 4.7.

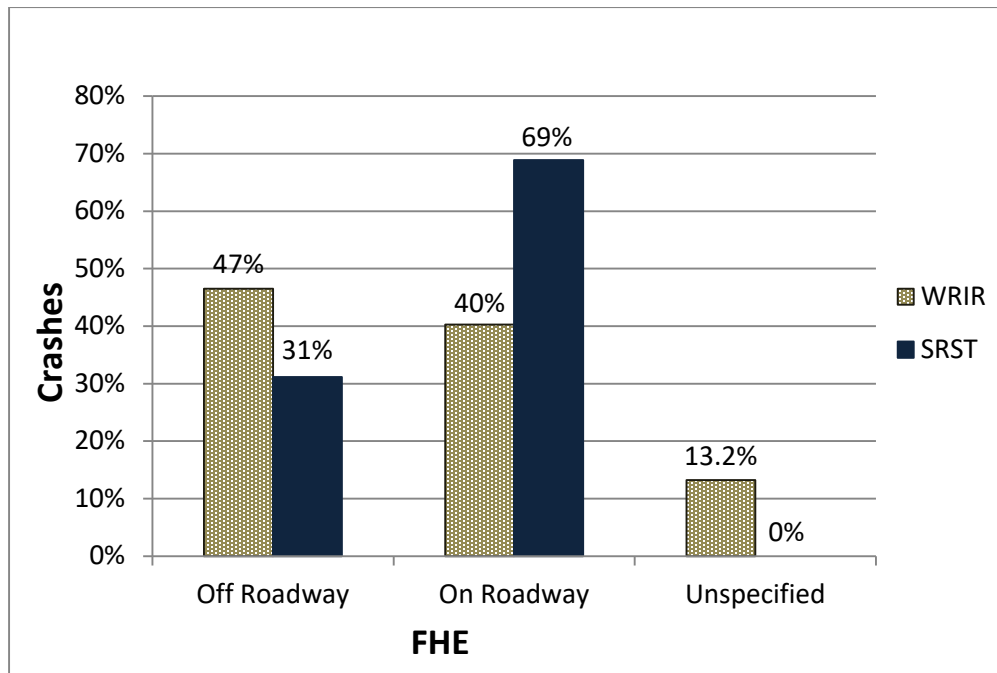
**Figure 4.15** FHE Location SRST and WRIR, 10-Year Analysis

Finally, more crashes occurred off the roadway on the WRIR at 47%; whereas 69% of crashes on the SRST occurred on the roadway (Figure 4.15).

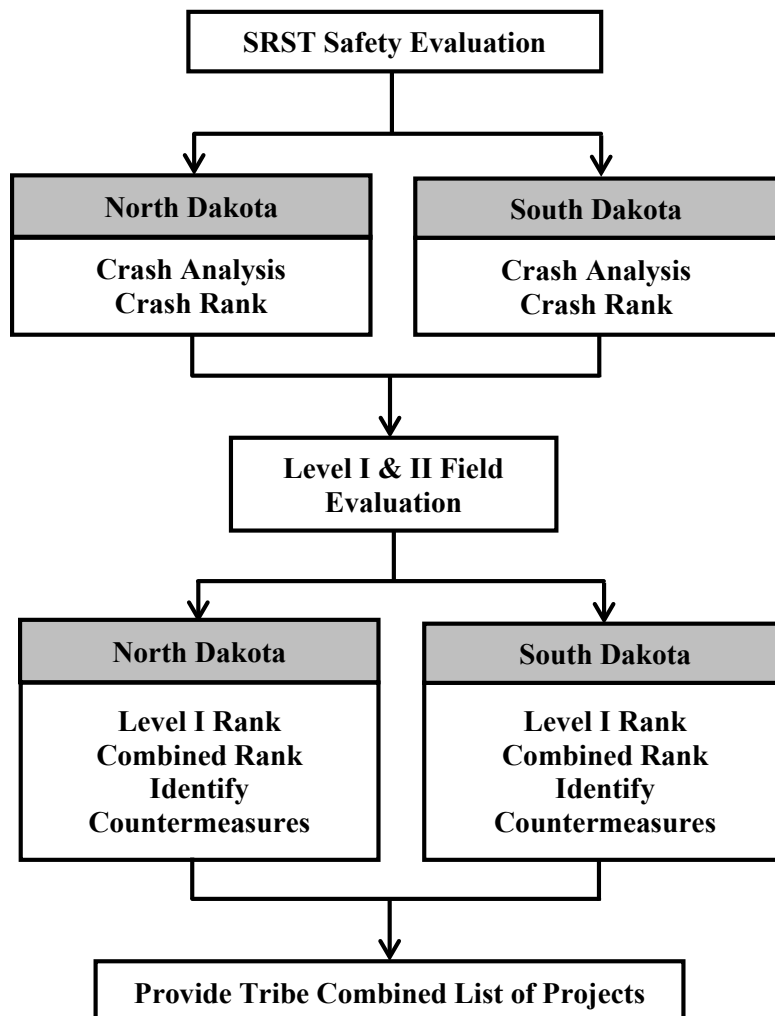
Figure 5.1 Applied Methodology

Because Standing Rock Reservation lies within two states, the methodology was altered to rank the crashes and the Level I field evaluation separately for each state. A combined ranking and countermeasures were determined separately as well. In order to maximize resources, the Level I and Level II evaluations were performed simultaneously. See Figure 5.1.

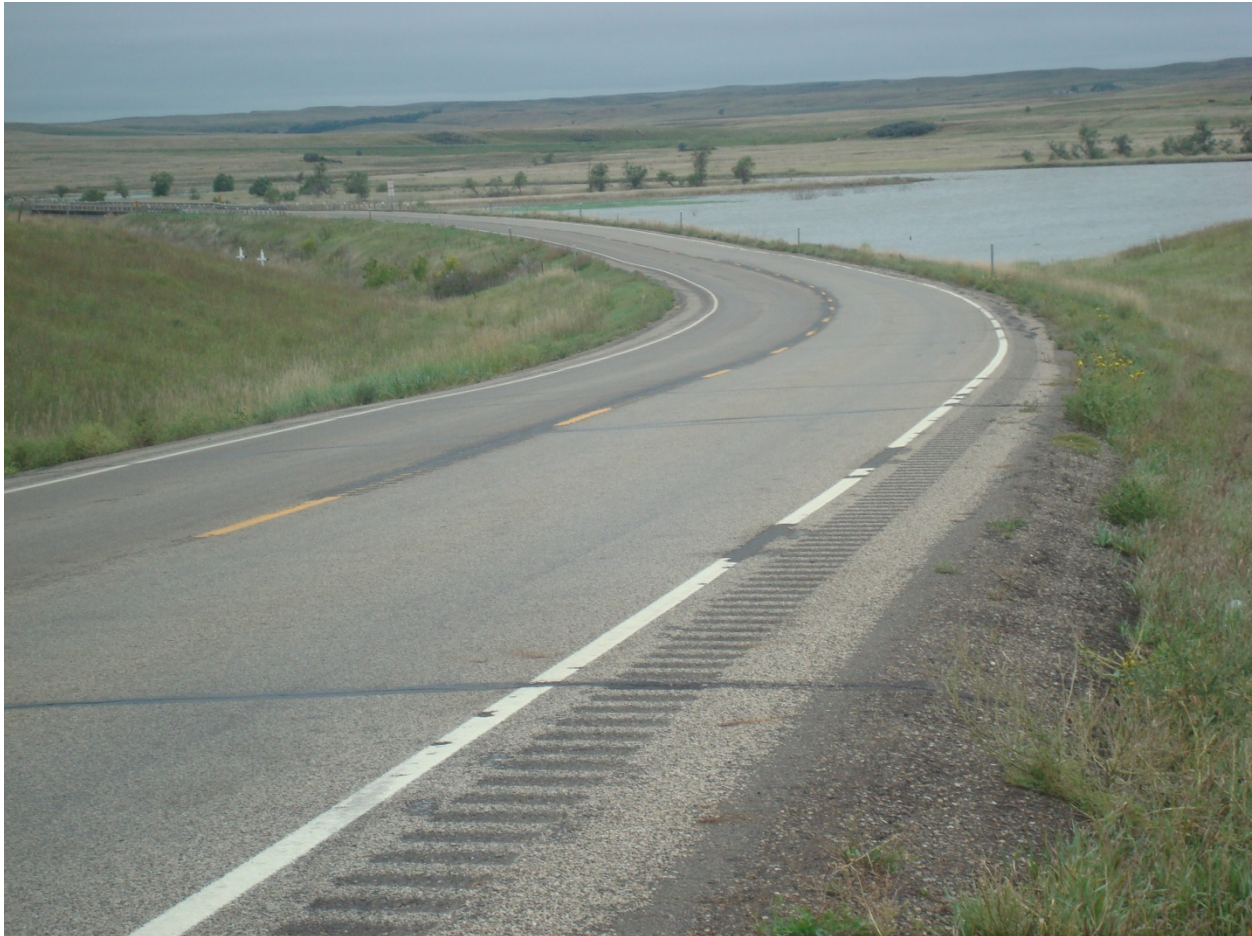
**Figure 5.3** ND Highway 24 Curve at Bridge (MP 14 to MP 15)

There were two locations along ND 24 where fatalities occurred along a horizontal curve. One location in particular is also located near a bridge (MP 14 to MP 15). These locations contain curve warning signs with no advisory speeds. One of the curve locations (MP 34 to MP 35) appears to have good sight distance along a wide radius. This location could have some speeding issues, and a speed and safety study by NDDOT would be recommended. Near the bridge location, a guard rail is recommended (see Figure 5.3).

In Sioux County, the emphasis was on state highways based on feedback from the tribe. They have safety concerns for ND Highway 24 and ND Highway 1806. Based on the crash analysis and field evaluations, three roads were reviewed for safety improvements, ND 24, ND 1806, and Big Lake Road. Several fatalities are reported along ND 24. Signage will provide low-cost safety improvement. Just north of a bridge along a horizontal curve (MP 16), fatalities were reported along with known run-off-the-road crashes. Guardrails are recommended for this location.

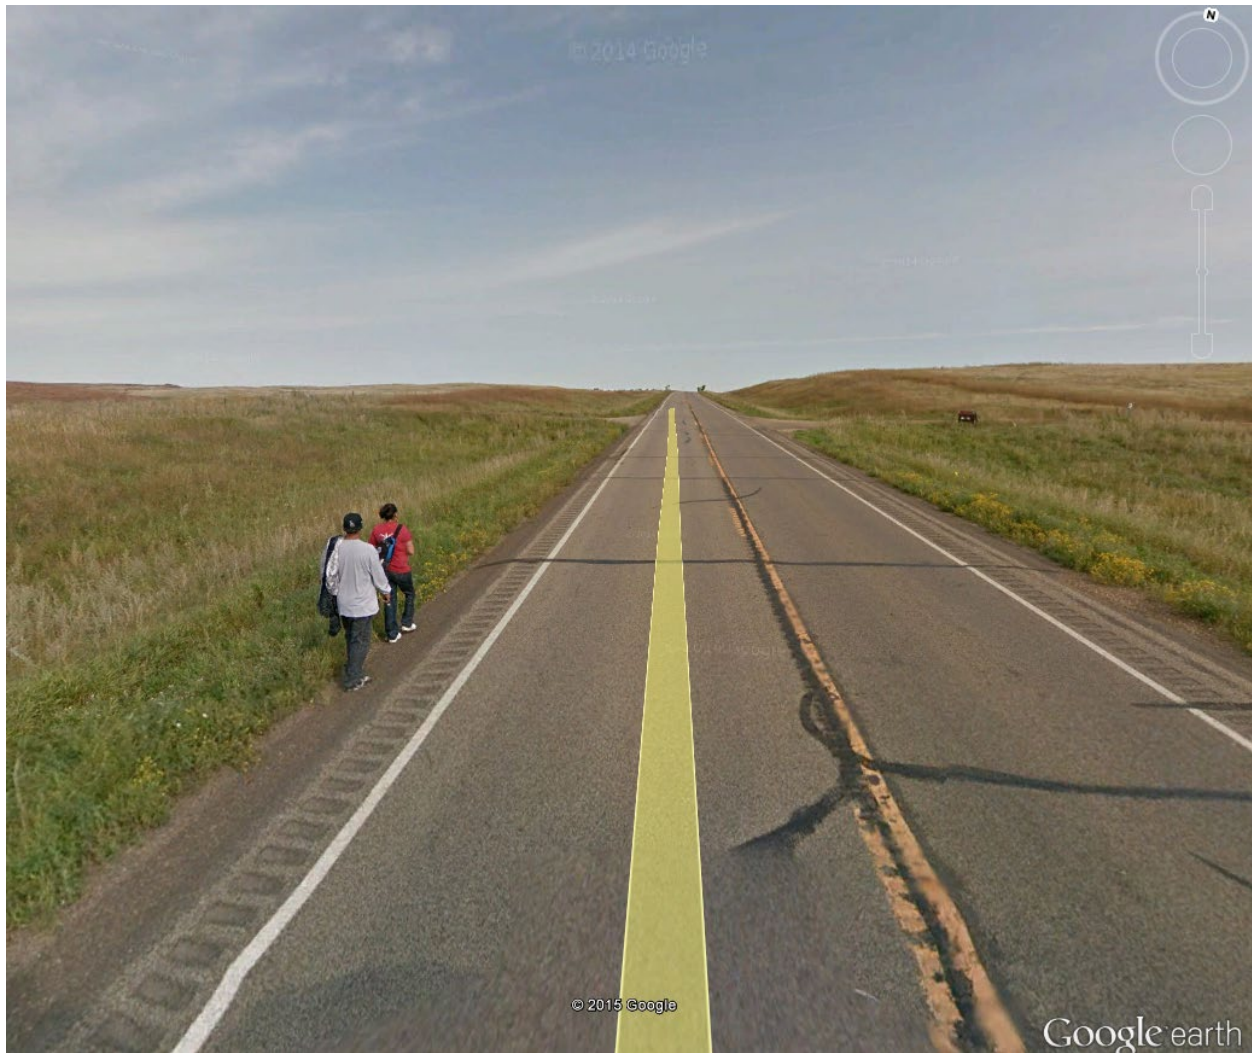
**Figure 5.4** ND Highway 24 North of Prairie Knights Casino (MP 24)

Pedestrian safety is a concern on SRST. Pedestrian crashes resulting in fatalities were identified along ND 24. People will walk to work and to other services on the reservation. Some pathways have been constructed around Ft. Yates, but pedestrian travel extends across the reservation. Without adequate pedestrian facilities, individuals are forced to walk along the rural highways, which have narrow shoulders and high-speed traffic. Figure 5.4 shows how ND 24 is used by pedestrian.

Safe pedestrian access is a concern for the tribe. Fatal pedestrian crashes have been reported along ND 24. High-speed traffic and narrow shoulders are extremely hazardous conditions for pedestrians. However, tribal members walk across the reservation to get to work and other services. A long-range pedestrian access plan should be developed for the tribe to identify the high pedestrian traffic locations and needed improvement areas, which should then be included in the strategic plan.

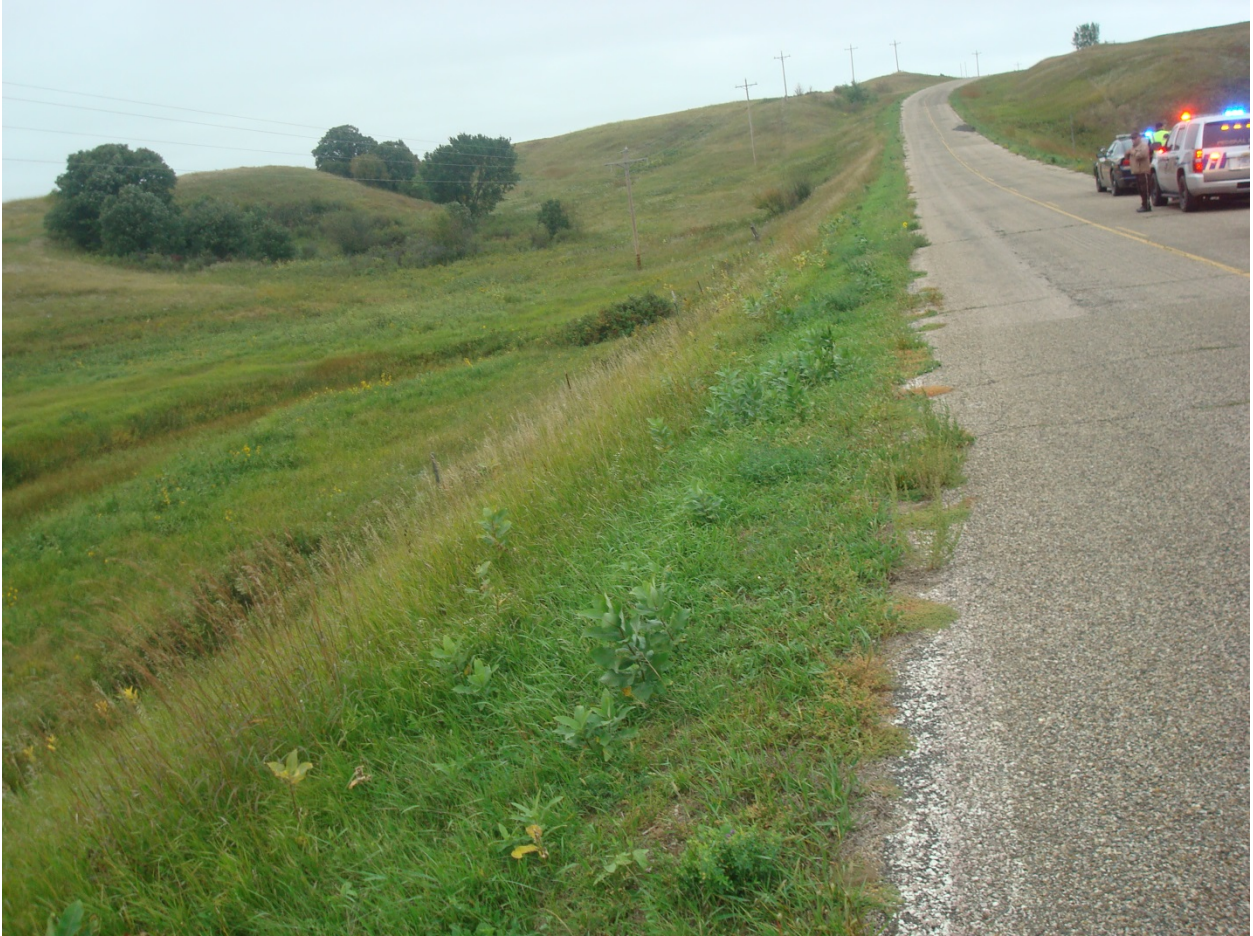
**Figure 5.5** Big Lake Road

Big Lake Road was the only tribal road reviewed for safety improvements. This road is very narrow with no shoulders or recovery slopes. There are no pavement markings or lighting along this roadway. The slightest distraction or any reduction in visibility could lead to a serious incident. Three fatal crashes were recorded along this road. It is unknown how many other crashes of less severity have occurred there. The best solution for this roadway would be to widen it along the section that traverses a stream with a high drop-off (see Figure 5.5).

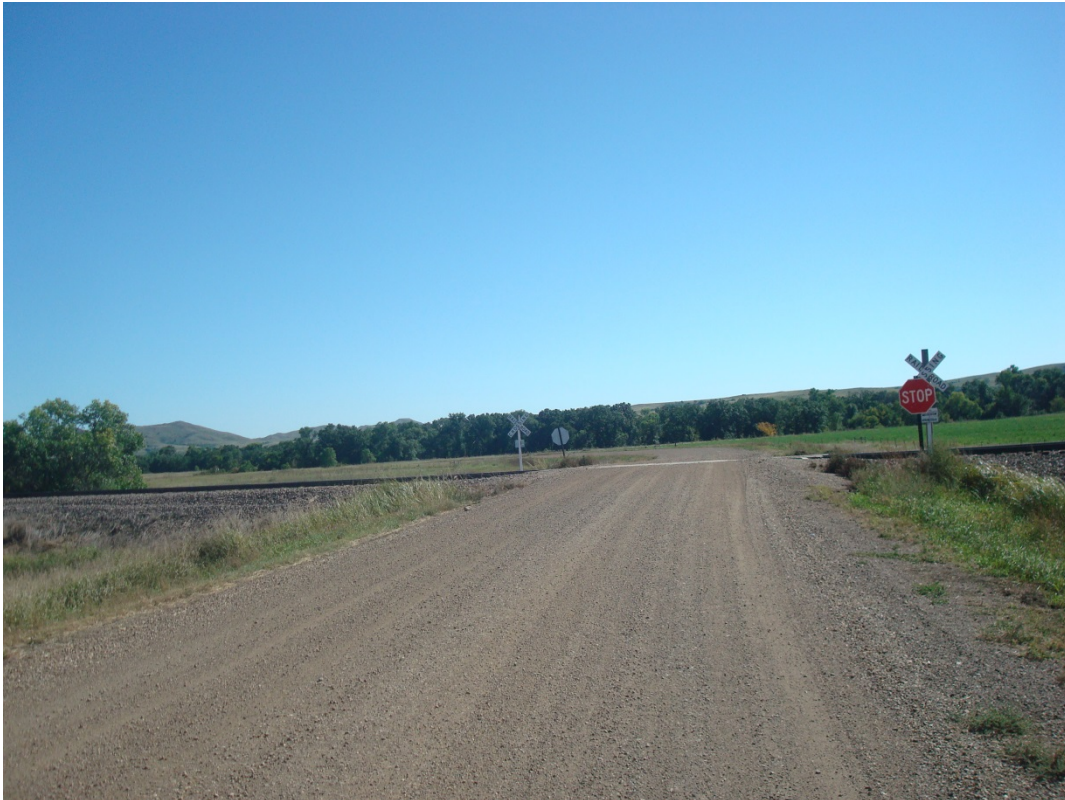
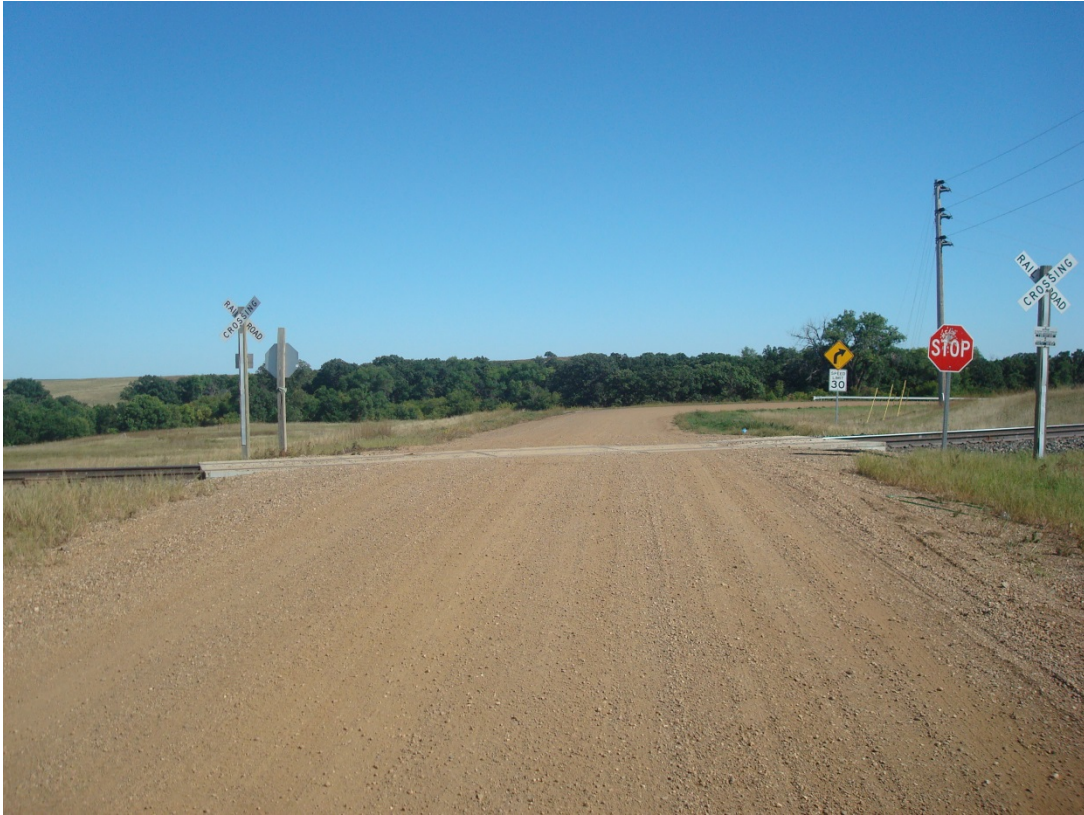
BIA 44 is a gravel road with varying conditions throughout. The evaluation started at 272<sup>nd</sup> Avenue and proceeded to Wakpala (MP 0 to 11). Areas along the segment have vegetation within the clear zone that could easily be removed. Several curves exist with curve warning signs in place. In two locations the road curved immediately after a railroad crossing, and neither location was signed properly for the curves (See Figure 5.6 and Figure 5.7). Advance warning signs for stop ahead and/or railroad crossing ahead should be added. An advanced curve warning sign should be added for the curve at MP 2.5. The curve warning signs should include the proper advisory speed plate.

**Figure 5.6** BIA 44 at Railroad Crossing (MP 2.5)

**Figure 5.7** BIA 44 at Railroad Crossing (MP 9.4)

BIA 44 is a gravel road in average condition. Some areas had vegetation in the clear zone and are recommended to be removed. Two railroad crossings exist along this roadway, with curves immediately after the crossings. Stop signs exist at the crossings, and one curve warning sign exists at the second crossing but with a regulatory speed limit sign. It is recommended that curve warning signs with advisory speed plates be posted for both curves. In addition, either stop ahead signs or railroad crossing ahead signs (or both) should be installed.

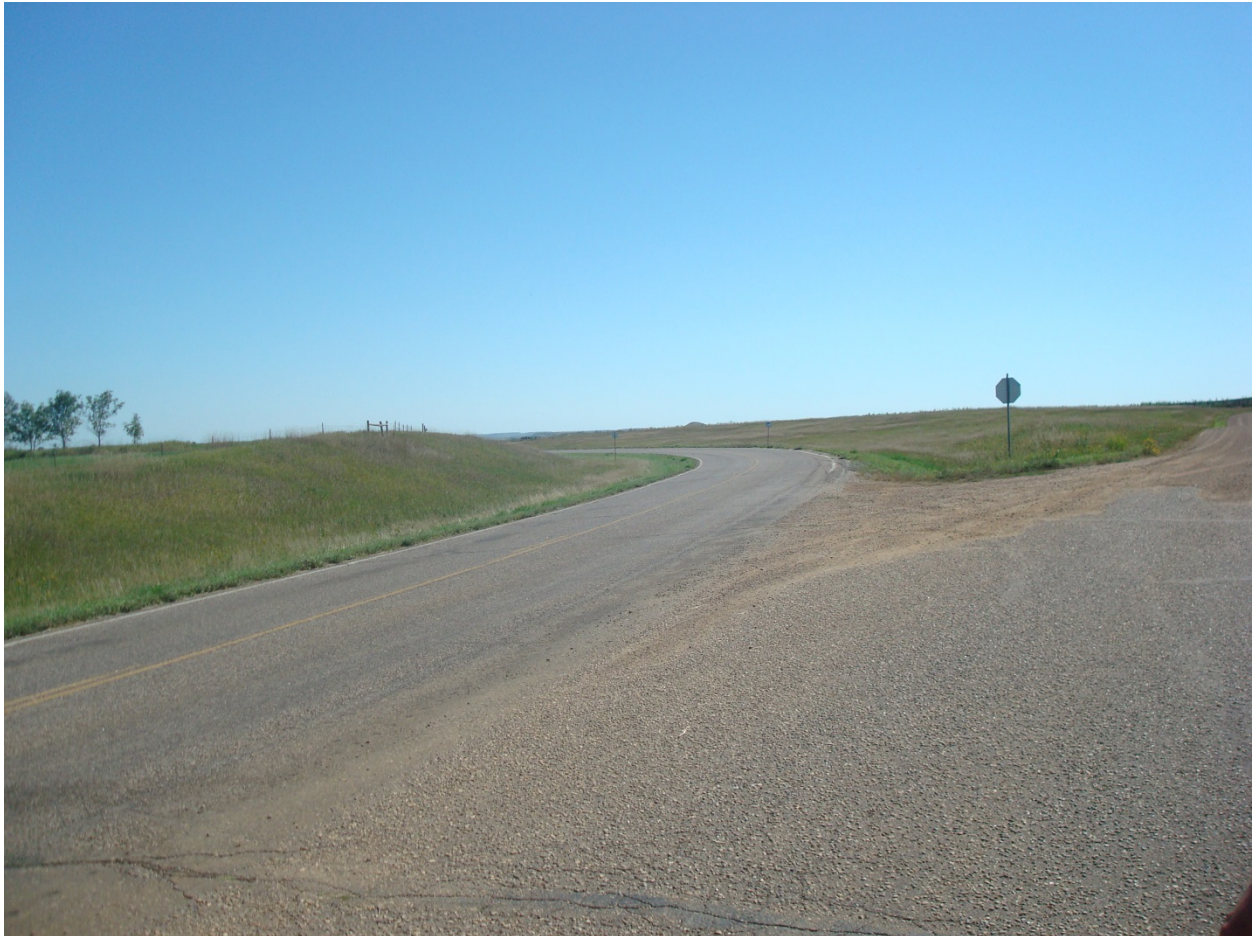
**Figure 5.8** BIA 3 at State Line (MP 8)

No curve warning signs exist at the 90-degree curve at the state line (MP 8). At the curve, the pavement continues to extend to 100<sup>th</sup> Street. This allows drivers to continue at a high speed off the main roadway. Drivers entering as they head north are entering at a skew (see Figure 5.8). Advanced curve warning signs and possibly chevrons should be installed. The tribe should consider realigning the intersection at the curve to a 90 degree intersection, as illustrated in Figure 5.9. With the new construction starting at MP 12.4, it should be verified that curve warning signs were added.

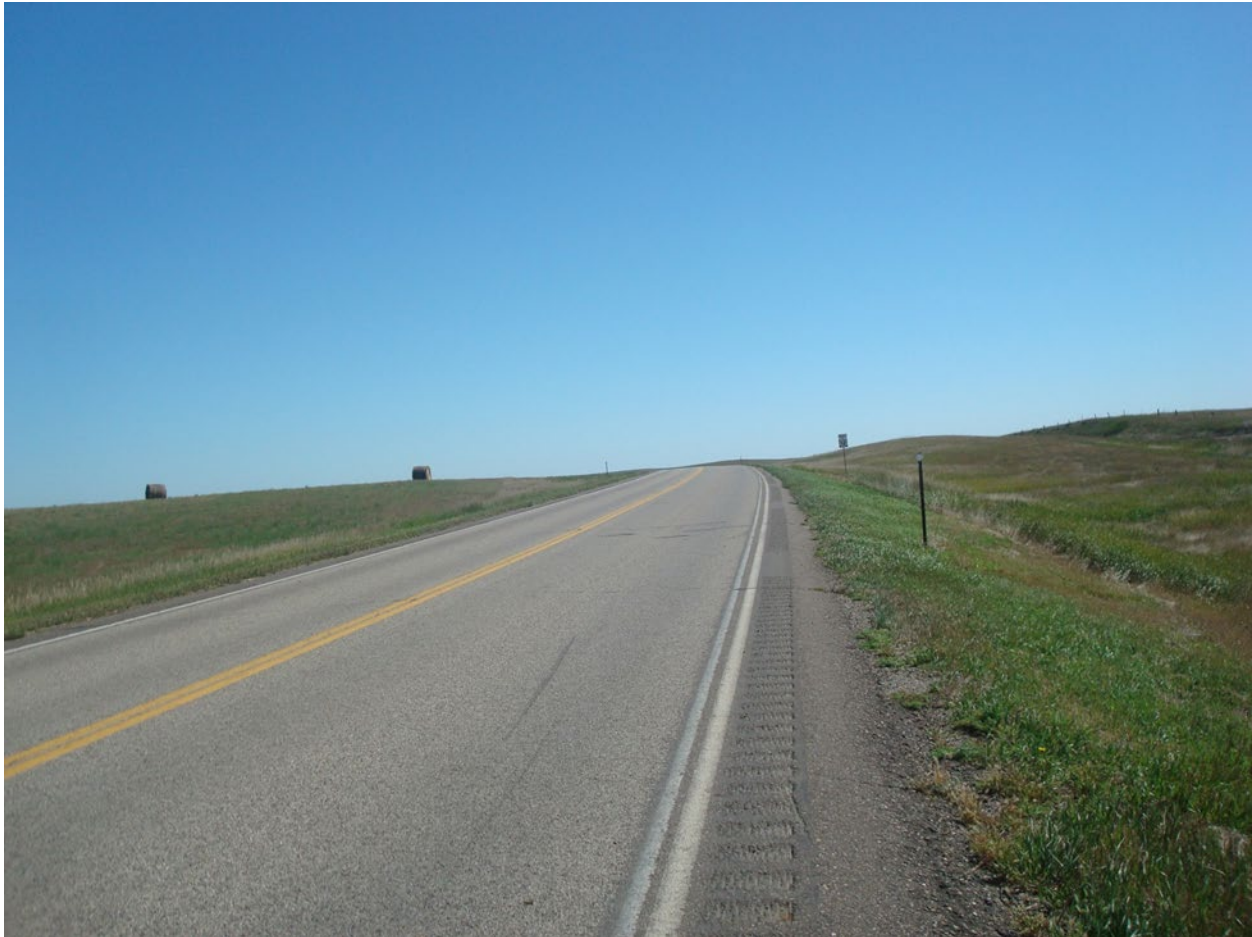
**Figure 5.10** Reverse Superelevation at Curve on US 12 (MP 116.3)

Over a 10-year period, 22 crashes occurred along this segment (2004-2013). Most were either animal-related or rollover crashes. Curves exist with proper advanced warning signs in place along with no-passing zones. Although the shoulders are narrow, rumble strips are located the length of the segment. Speeding could be a concern, and a safety speed study by the DOT is recommended. Particular attention should be given to the curve located at MP 116.3. It appears that a reverse superelevation exists along this curve (see Figure 5.10). A study to determine a safe speed to maneuver this curve should be performed and advisory speed posted with the advanced curve warning sign.

US 12 between Morrystown and Wantaga (MP 114 to 122) had 22 crashes over a 10-year period (2004-2013). Most were either animal or rollover crashes. A speed study is recommended for this location and, if it is an issue, it should be included in the tribe's strategic highway safety plan. One curve located at MP 116.3 appears to have a reverse superelevation. Advisory speed should be determined by the DOT and posted with the curve warning sign. Chevrons should also be added along this curve.
