MPC 19-399.2 | D.S. Shinstine, K. Ksaibati, and D. Trusty

Regional Implementation of  
Tribal Transportation Safety  
Program:  
Sisseton Wahpeton  
Oyate Roadway Safety  
Improvement Program

October 2019

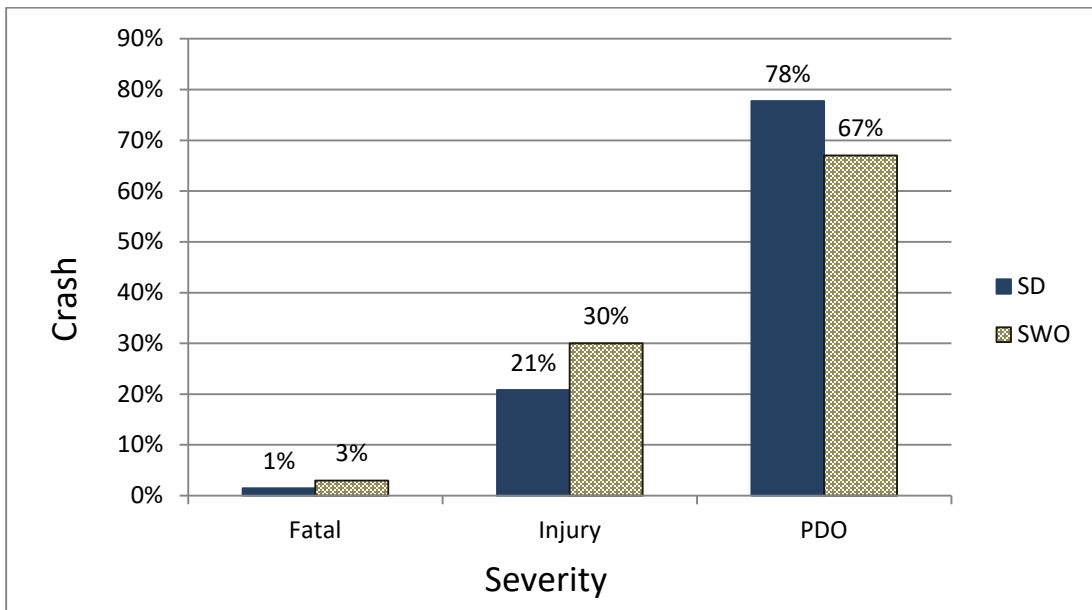
Crash severity was divided into fatal, injury, and property damage only (PDO). As seen in Figure 4.2, 3% of all crashes on SWO were fatal, compared with 1% for all crashes in South Dakota.

**Figure 4.2** Crash Severity in SD and SWO 2004-2013

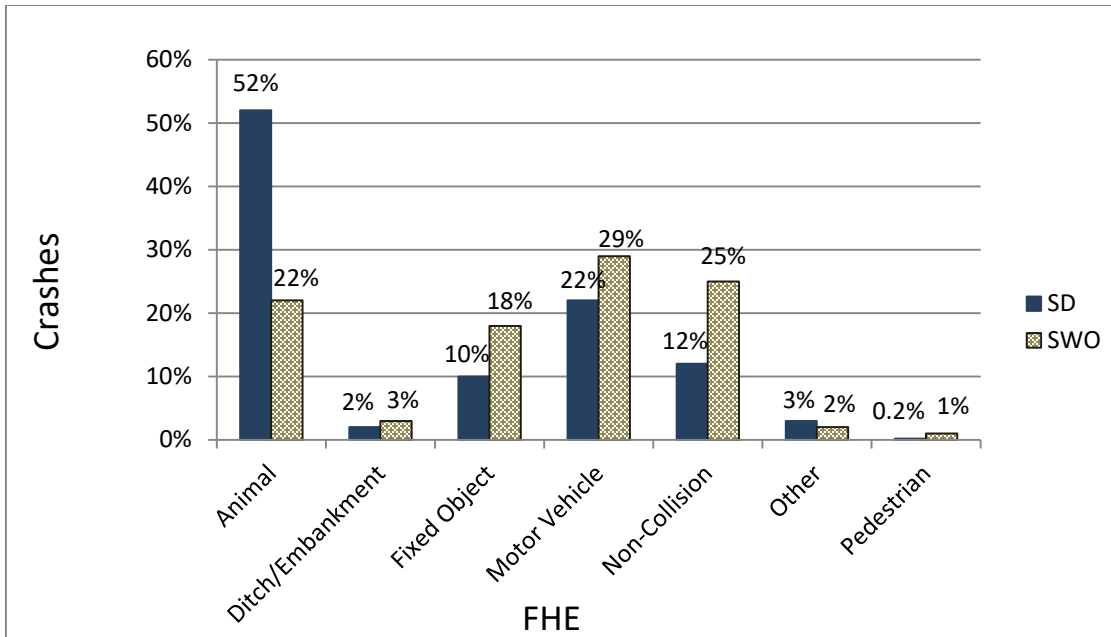
The FHE revealed that SWO animal crashes were much lower than the state at 22%, compared with 52% of SD crashes. Non-collisions were much higher at 25% compared with 12% for the state. Non-collision crashes included rollover crashes. Motor vehicle and fixed object were also higher. Of all crashes, 1% involved pedestrians. Most of the reservation is rural with long distances between communities. No extensive pedestrian pathways exist to connect these communities, and pedestrians tend to use the rural highways for travel. The FHE results are in Figure 4.3.

**Figure 4.3** First Harmful Event for Crashes in SD and SWO 2004-2013

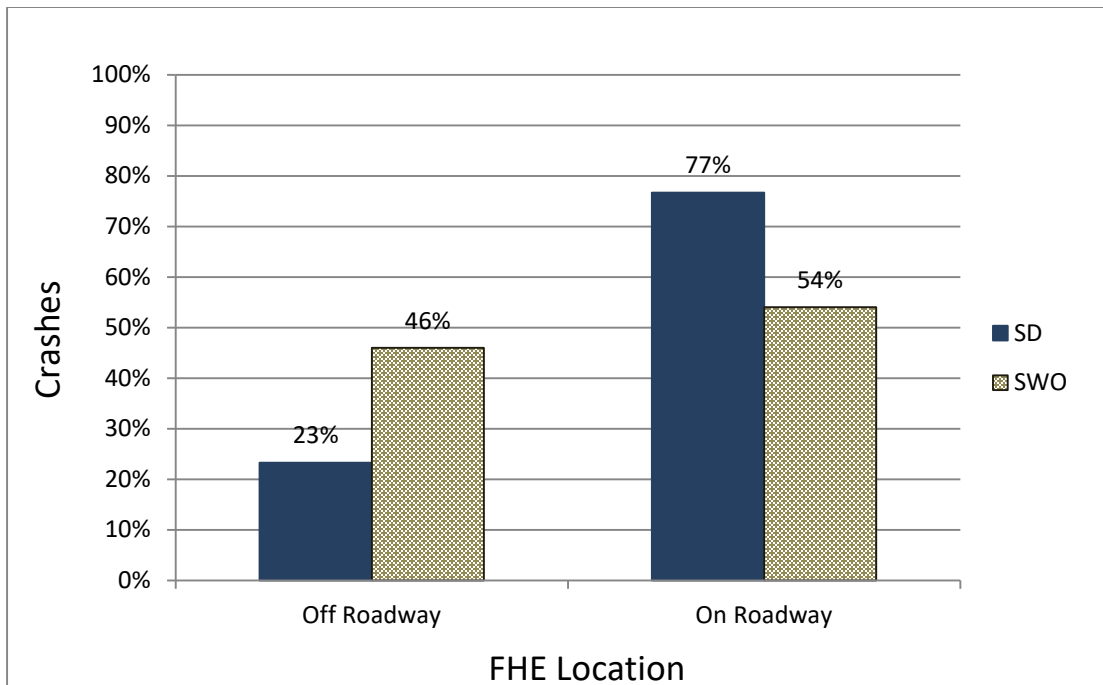
More off-roadway crashes were reported on SWO than the state at 46% compared with 23%, respectively. With 54% occurring on the roadway, on-road and off-road crashes are of equal concern. See Figure 4.4.

**Figure 4.4** FHE Location for SD and SWO 2004-2013

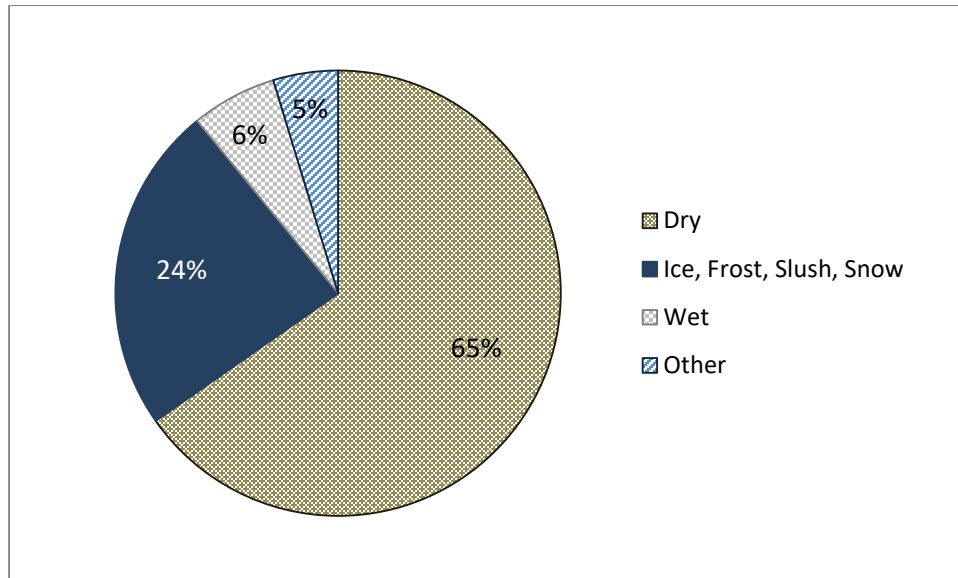
Road conditions were reported as dry for 69% of the crashes, and as ice, snow, frost, or slush for 24%. Wet roads only accounted for 6% of all crashes. See Figure 4.5.

**Figure 4.5** SWO Road Conditions 2004-2013

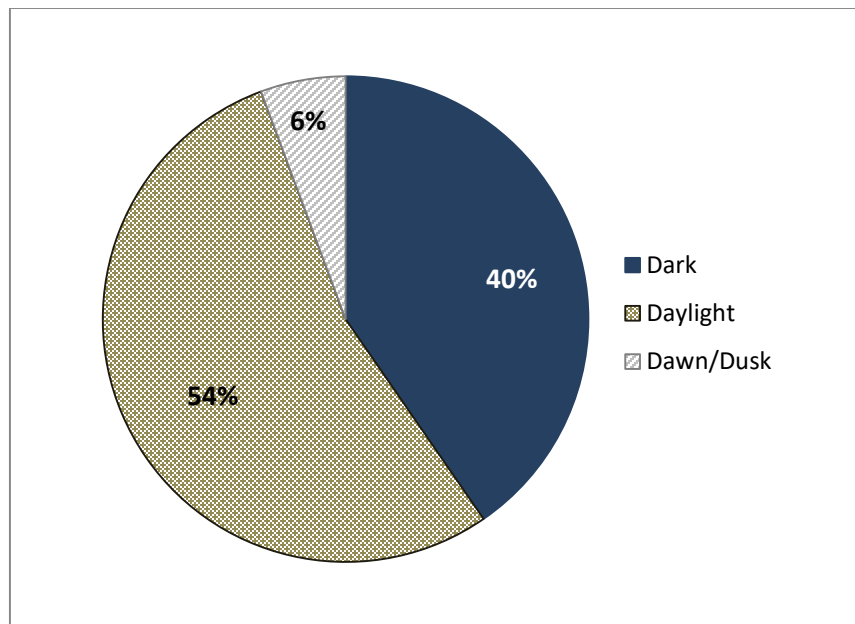
Lighting conditions for the most part showed that crashes were evenly distributed between daylight and dark at 54% and 40%, respectively (Figure 4.6).

**Figure 4.6** SWO Lighting Conditions 2004-2013

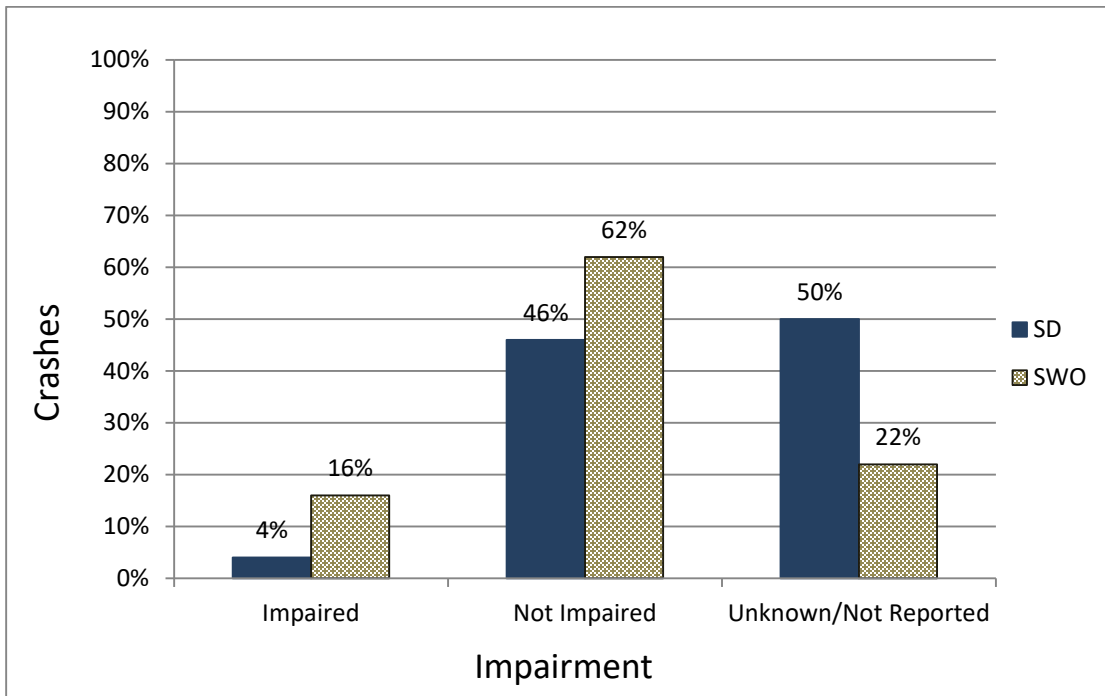
Alcohol was involved in 16% all SWO crashes reported; statewide showed only 4% impaired. However, it should be noted that the statewide also shows 50% as unknown or not reported impairment, as compared with SWO at 22% unreported. See Figure 4.8.

**Figure 4.8** Crashes Involving Alcohol in SD and SWO 2004-2013

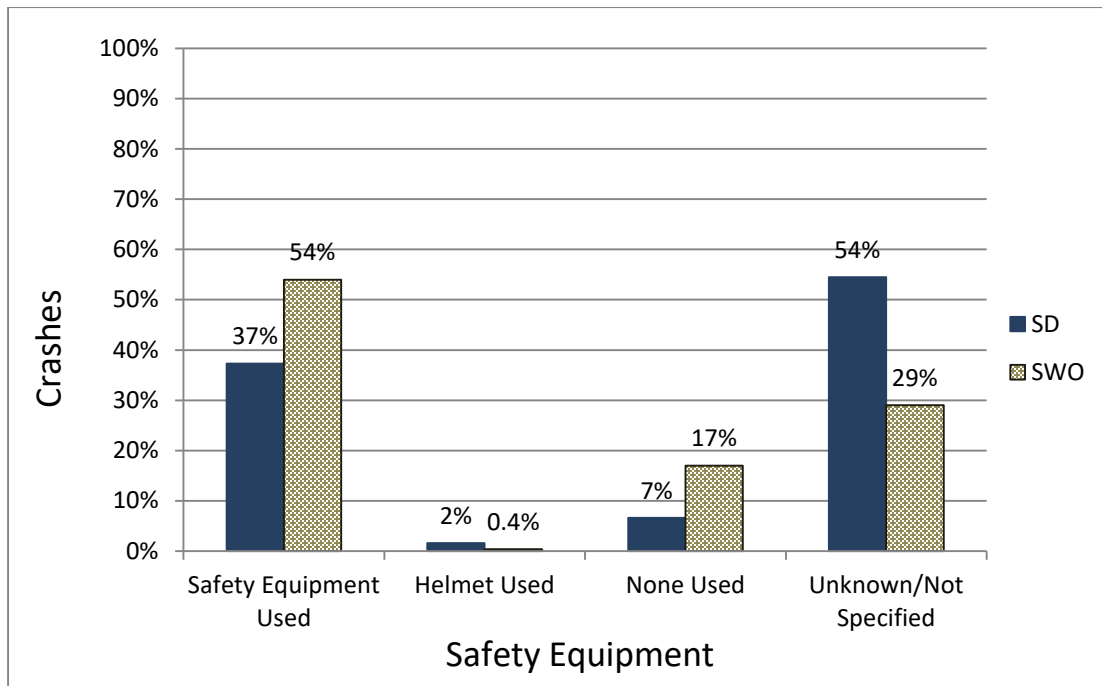
Safety equipment use is reported as higher on the reservation at 54%, compared with 37% across the state (Figure 4.9). This could account for fewer fatal rollover crashes.

**Figure 4.9** Safety Equipment Use in SD and SWO 2004-2013

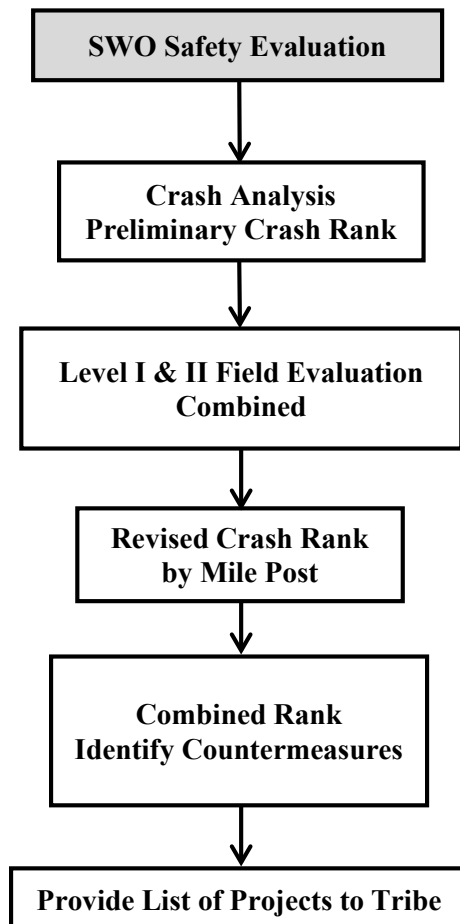
The methodology was slightly modified to fit the needs of SWO. A preliminary crash ranking was first performed based on mapped locations. A revised crash ranking was performed once mile post locations were established during the field evaluations. In order to maximize resources, the Level I and Level II evaluations were performed simultaneously. See Figure 5.1.

**Figure 5.1** Applied Methodology

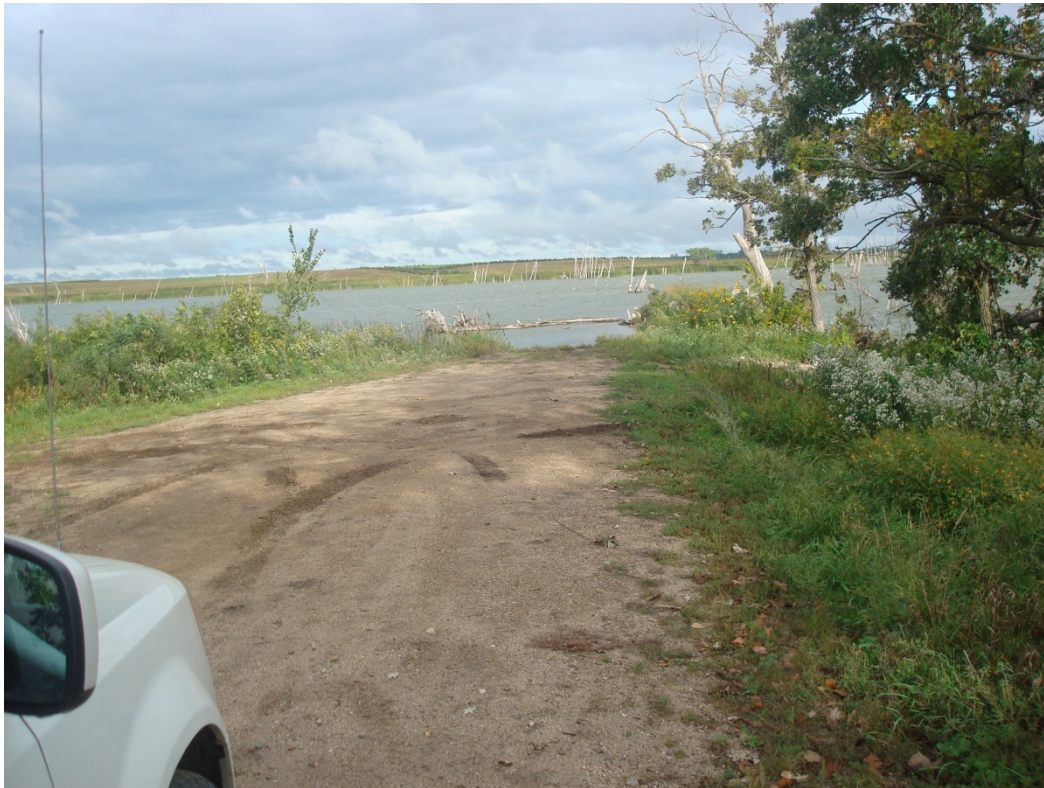
When the team was traveling from 123<sup>rd</sup> Street to evaluate another road, 124<sup>th</sup> Street was traveled. This was not on the list of roads to evaluate. However, some discrepancies were noted. This road is very low volume, and vegetation is present within the driving lanes. A road closed sign was lying in the brush on the side of the road. The road ended at water's edge about a mile later (See Figure 5.2). This is potentially dangerous if a driver is unfamiliar with the road or is traveling at night. It is recommended that the road closed sign be re-installed and the proper barricade (MUTCD Type III) be installed at the end of the roadway.

**Figure 5.2** 124<sup>th</sup> Street End of Roadway at Water's Edge

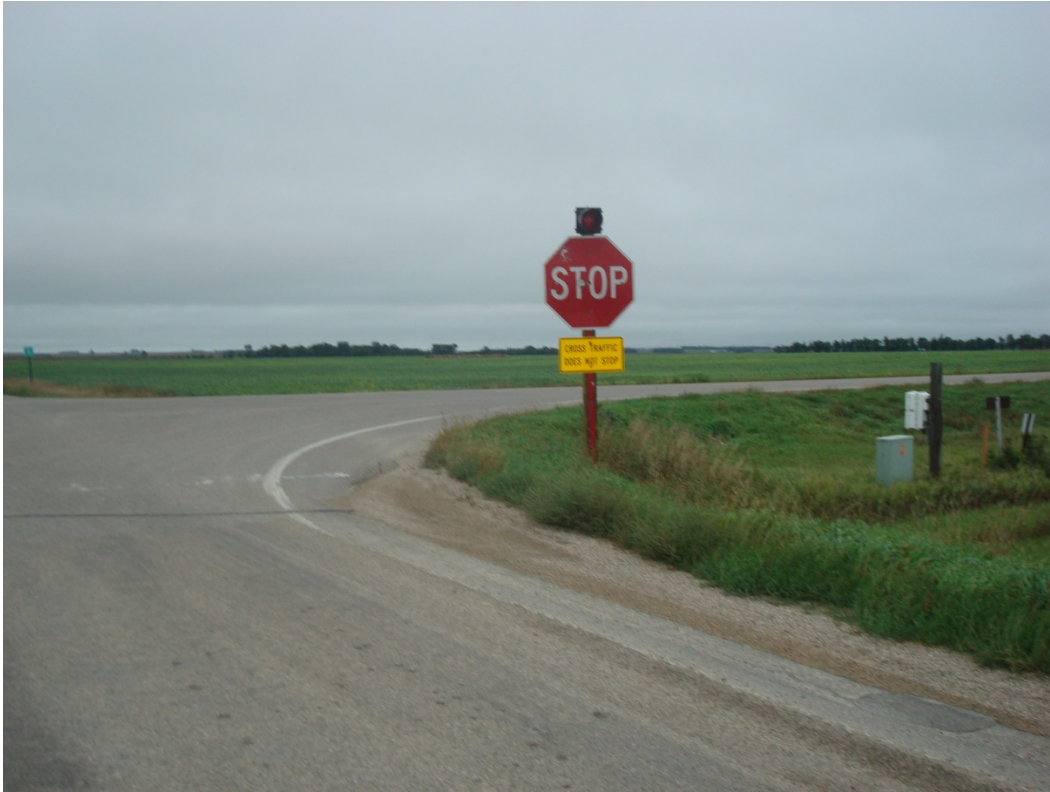
The intersection of 164<sup>th</sup> Street and 455<sup>th</sup> Avenue has experienced several fatalities. A flashing red light is mounted on the large stop sign, and stop-ahead signs are in place for 164<sup>th</sup> Street approaches (Figure 5.5). It appears from the crash data that collisions are still occurring at this intersection. Transverse rumble strips at the 164<sup>th</sup> Street approaches to 455<sup>th</sup> Avenue is recommended. It is also recommended that a four-way stop/signal warrant study be performed for this intersection.

**Figure 5.5** 164<sup>th</sup> Street Approach to 455<sup>th</sup> Avenue
