Reducing Wildlife Mortality on Roads in
Vermont:
Determining Relationships Between Structure
Attributes and Wildlife Movement Frequency
Through Bridges and Culverts to Improve
Related Conservation Investments

Research Project
Reporting on SPR-A 332 (2017-2019)

Final Report 2019-15

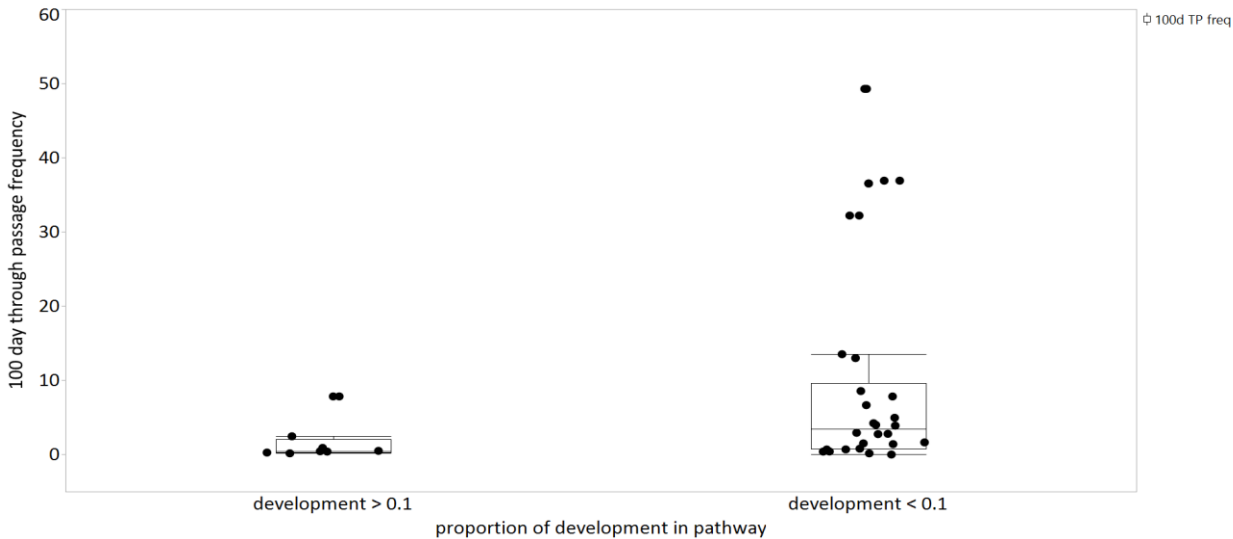
Figure 11. Comparison of 100day through-passage frequencies of sites where the development index <0.1 vs >0.1 . Comparison includes sites from project phases 1 and 2, with new Post-Irene structures (6), structures with poor movement surface availability (1), sites with fragmented structural connectivity (4) excluded. Difference between the mean of both groups is statistically significant (Wilcoxon rank-sum test, $p=0.031$).

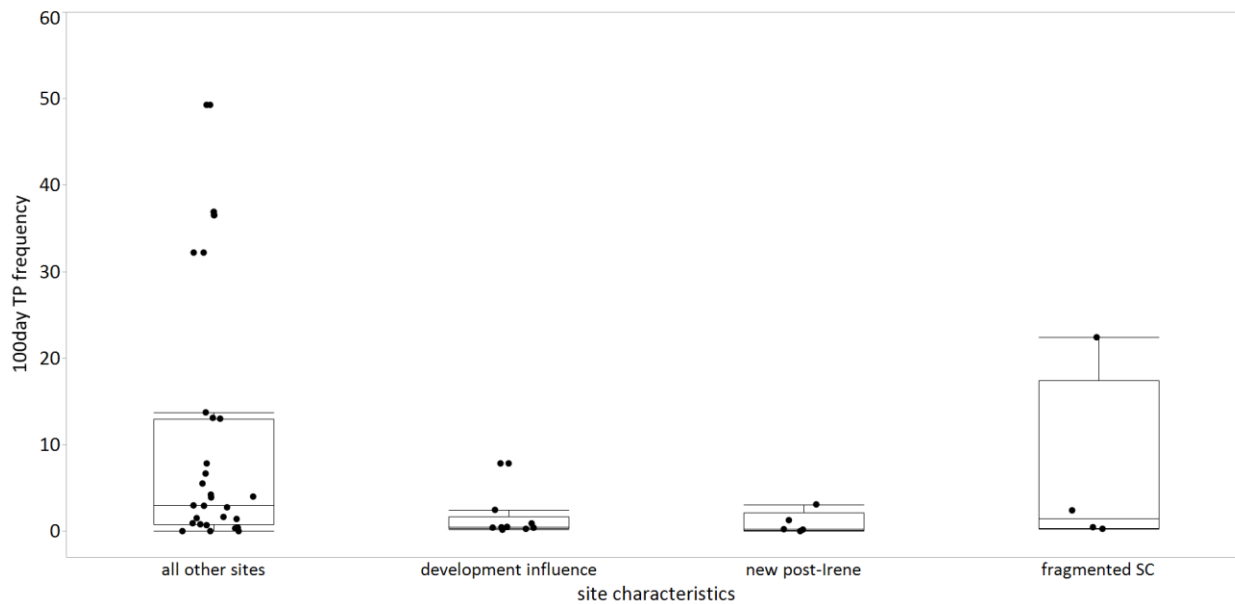
Figure 12. Through-passage frequency data for all Phase 2 and Phase 1 (Marangelo and Farrell 2016) sites by site characteristic category, with overlaid box-plots. Category specific results were used to justify excluding sites in the “development influence”, “new post-Irene” and “fragmented SC (Structural Connectivity)” categories from the analysis on the effects of structure design on through-passage frequency.

The relationship between stream bankfull width and structure width intuitively would seem to influence over the amount of dry movement surface availability in a structure: the wider a structure is with respect to the size of the stream, the greater the availability consistently dry movement surfaces for wildlife. To investigate this relationship, we calculated stream bankfull width from hydraulic geometry equations for Vermont (using estimates of upstream watershed area using USGS streamstats (<https://streamstats.usgs.gov/ss/>)) and plotted bankfull width estimates against through-passage frequencies, excluding all sites in low wildlife use categories from Figure 12.

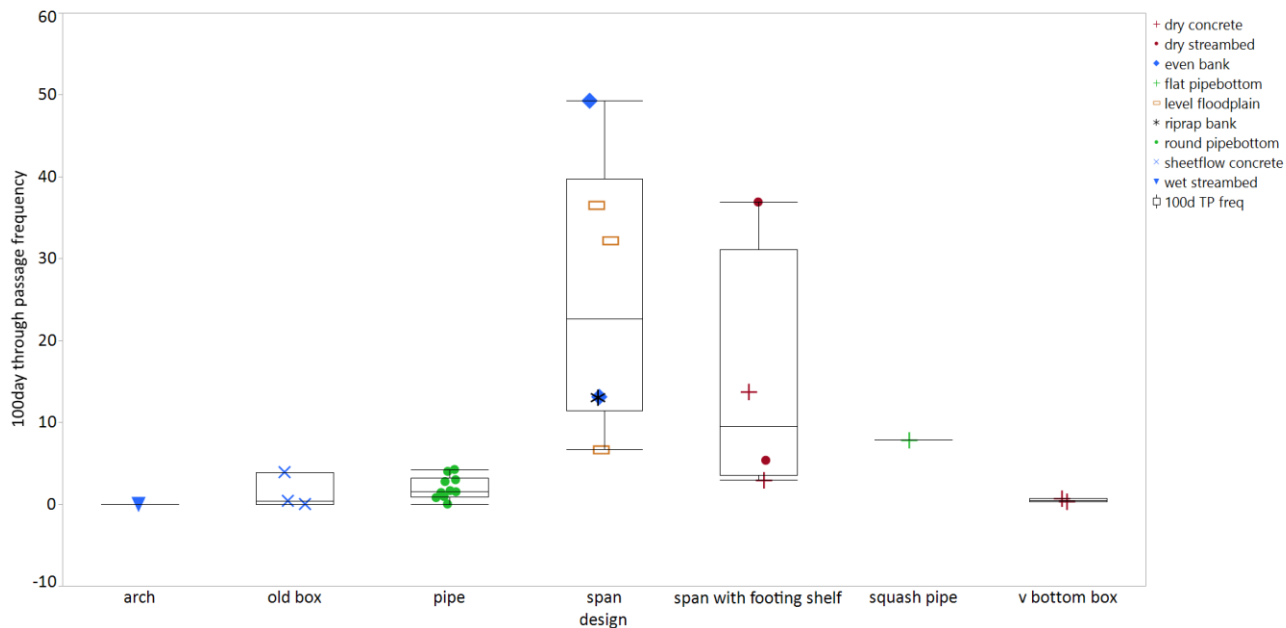
Figure 13. Through-passage frequency data points and box plots categorized by structure design type. Data point markers correspond to specific movement surfaces. ANOVA means test (excluding categories with <3 data points)

indicated significant differences between the means ($p=0.004$), with differences between spans and old box culverts and spans and pipe culverts significant (Tukey's $p=0.037$ and $p=0.0043$, respectively).

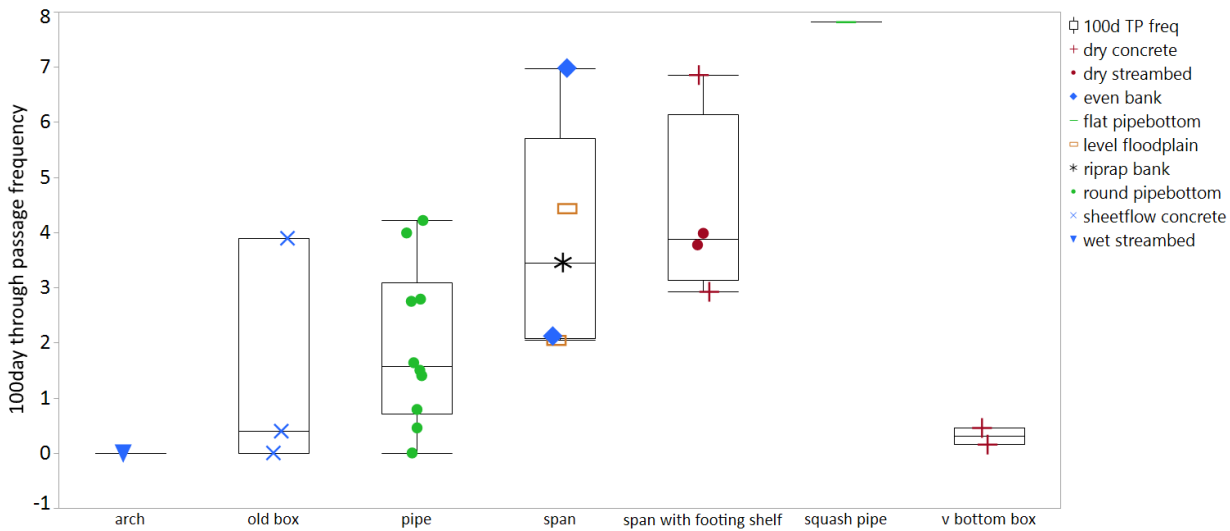
Figure 14. Through-passage frequency data with deer excluded and box plots categorized by structure design type. Data point markers correspond to specific movement surfaces. ANOVA means test (excluding categories with <3 data points) indicated that differences in category means were nearly significant ($p=0.0504$).

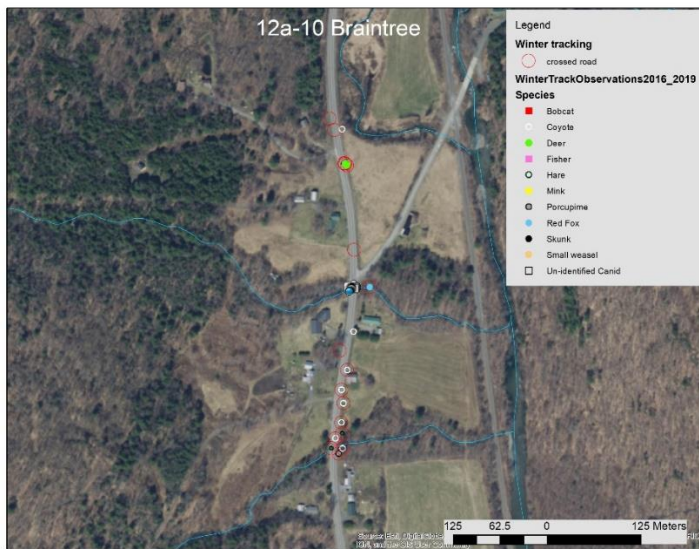
Figure 22. Map of focal species road crossings at Site 12-10, (Braintree). This site had only 1 deer through-passage during the project and had a relatively high development index. Road crossings denoted by red circles. Red circles without a species identifier represent crossings of non-focal species.

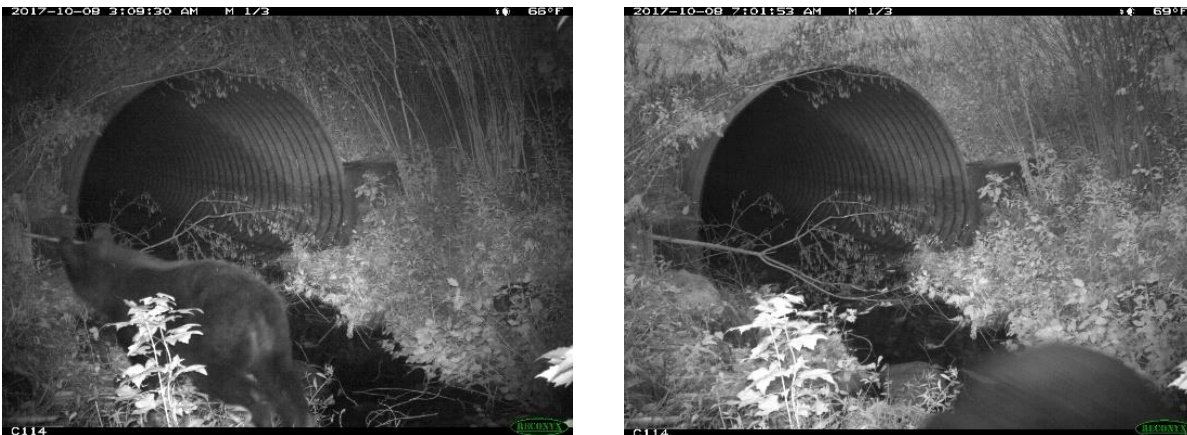
Figure 24. Bear bypassing a culvert while apparently moving towards crossing US 7 in Sunderland, with photo from return trip (Site 7-19-5, *squash pipe*). This culvert was regularly used by bobcat for through-passage.

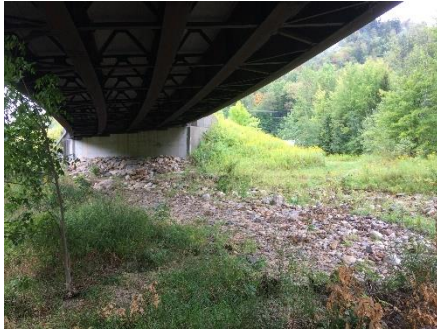
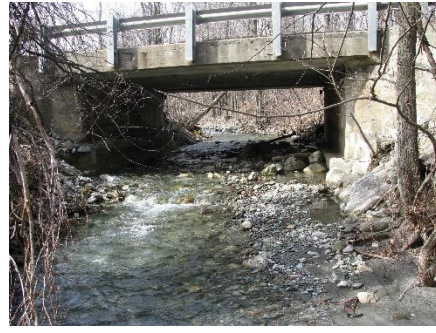
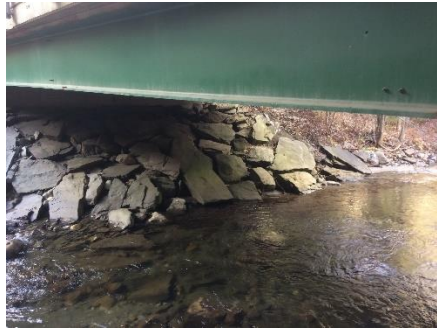
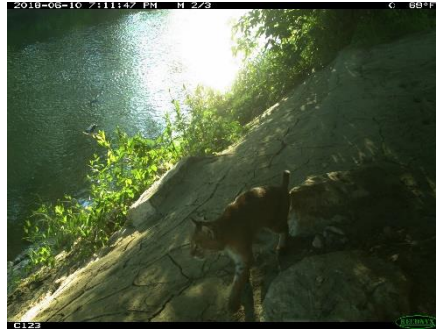
Figure 25. Examples of the variety of movement surface types that *spans* can provide. Upper left: “even floodplain” under valley-spanning bridge (9-25b, Searsburg). Upper right: “dry streambed” in a *span with footing shelf* where nearly all through-passages occurred on the streambed, which was typically entirely dry during summer months. Lower left: “riprap” streambank movement surface commonly found under many *spans* (not a project site). Lower right: “even streambank” of fine sediments under a *span* that does not cross an entire river valley (Union Street, Brandon, VT).

These designs appear best suited for maximizing wildlife through-passage. Their large size is amenable to the broadest set of wildlife species for through-passage (Figure 25), and they sometimes host more than one movement surface type. Standard practices such as rip-rapping streambanks² hinder wildlife usability however, unless the hydrological conditions under a bridge allow for the deposition of finer sediments that fill up lower elevation riprap crevices, or entirely preclude the need for extensive bank armoring under the span. Some *spans* serve valley-spanning roadway alignment needs. Such *spans* are the largest of all, have very large structure width/bankfull width ratios (all >2.5 in this study), do not constrict floodplains with abutments, and thus can offer the width of an entire floodplain for under-road wildlife movement. Moreover, it is possible that our through-passage frequency data under-represents wildlife use of the larger bridges in particular, as cameras need to detect animals over longer movement detection fields than at smaller structures, making them less sensitive to detecting smaller species.

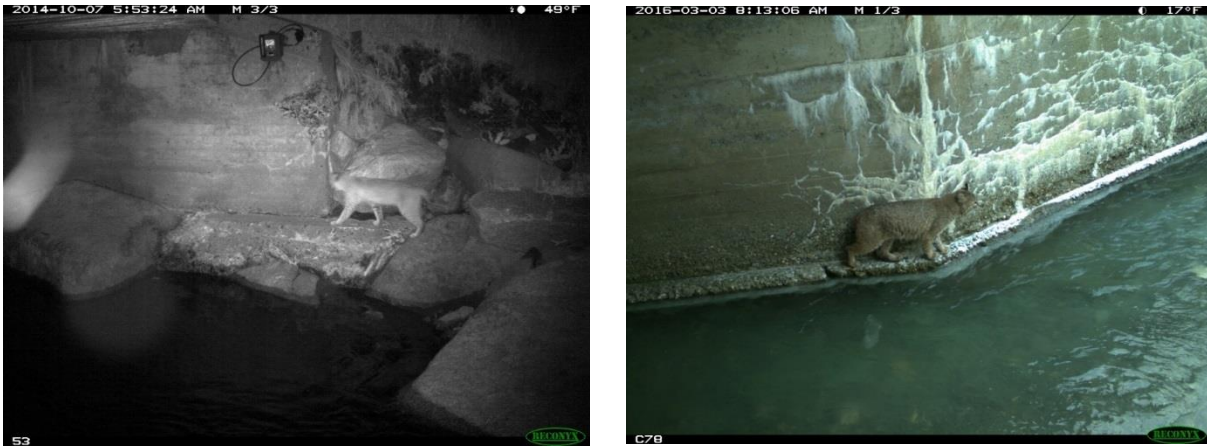
Figure 26. Bobcat through passages at span with footing shelves structure design types (Site 114-20 (left) and 4a-13 (right)).

Two of the four spans with footing shelves (Sites 133-13 and 30-84) conveyed intermittent streams. At these sites, “Dry streambeds” were the movement surfaces used by wildlife in these structures instead of “dry concrete”.

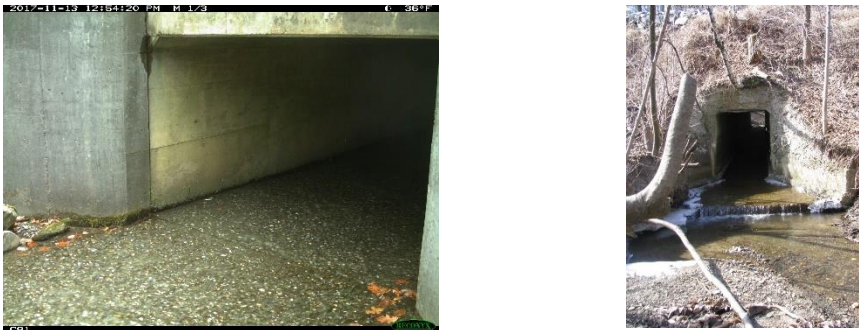
Figure 27. Examples of old box culverts with “sheetflow concrete” movement surface. Site 30-22 (West Townshend) and 15-76 (Cambridge, Marangelo and Farrelll 2016).

These structures typically receive use by only species that tolerate wet movement surfaces. Their bottoms are flat and unless they host an intermittent stream, feature a movement surface characterized by the sheetflow of water over flat concrete under nearly all flow conditions “sheetflow concrete” (Figure 27). These structures are especially abundant throughout Vermont.

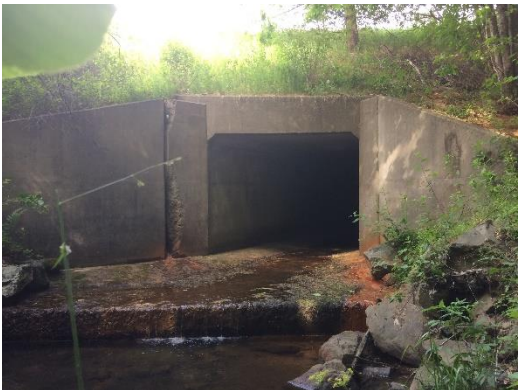
Figure 29. Example of a *V bottom box culvert*, with “dry concrete” movement surfaces along culvert walls. Site I91-17-2, Putney.

These structures are very rare – we found only 2 suitable for game cameras. By channeling water into the center of the culvert, they offer superior dry movement surface availability compared to the wet flat bottoms of typical of *old box culverts* (Figure 29). Project data probably does not reflect the potential of this design type for encouraging wildlife through-passage, as both structures studied were much longer than most wildlife prefer (both were over 235 feet long). Since newly constructed box culverts are likely to feature embedded designs, and are thus more likely to have more favorable movement surfaces than dry concrete (Figure 11), the relevance of “V bottomed box culverts” to the management of road corridors for increased permeability for wildlife appears questionable.
