Regional Implementation of
Tribal Transportation Safety
Program:
Yankton Sioux Tribe
Roadway Safety
Improvement Program

**Regional Implementation of Tribal Transportation Safety Program:
Yankton Sioux Tribe Roadway Safety Improvement Program**

October 2019

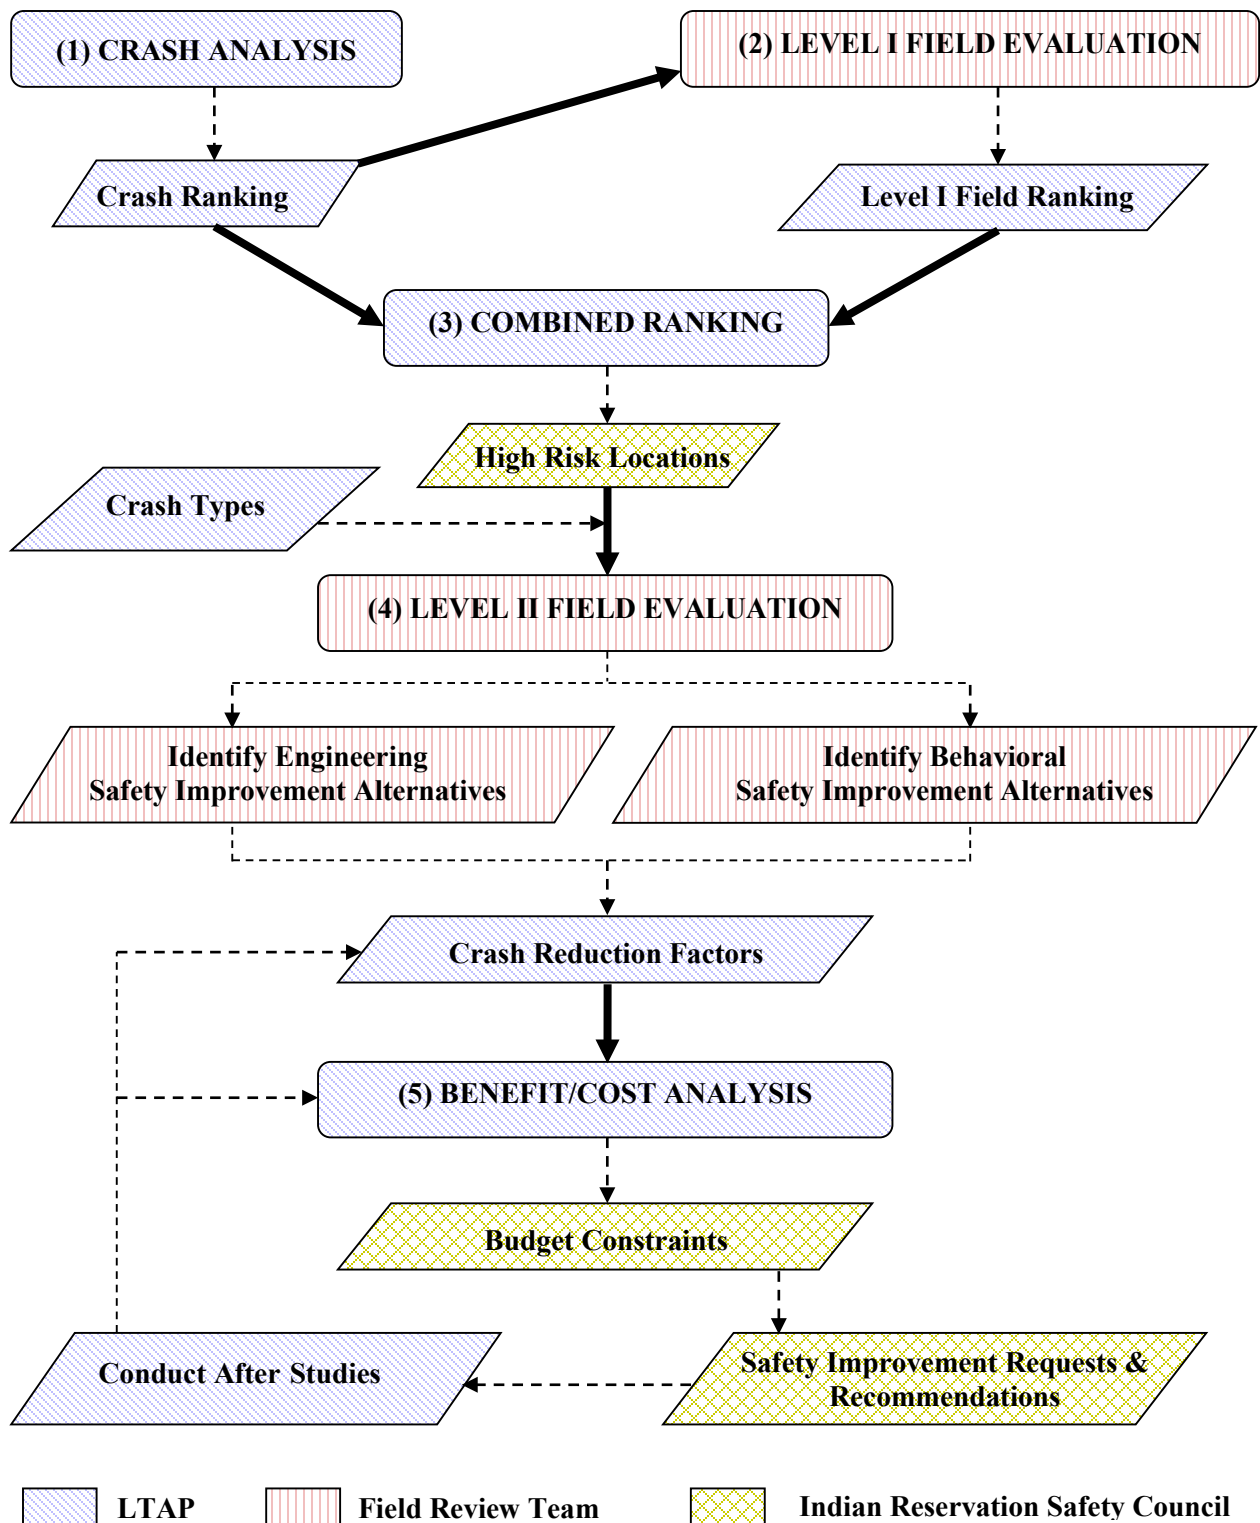
Figure 3.1 Five-Step Process for Indian Reservation Safety Improvement Program

This procedure is shown graphically in Figure 3.1. Crash data are analyzed and a ranking is established based on the high-crash locations. From this ranking, a list of roadways is proposed for field evaluation. From the field evaluation, a ranking of the conditions of the roadway is developed. The two rankings are combined to provide a list of proposed roadways considered for safety improvements. Another field evaluation is performed to identify safety improvements. Cost estimates are developed and a benefit-cost analysis is performed. The combination of historical crash data and field evaluations provides a substantive basis for identifying high-risk locations. The benefit-cost analysis gives the tribe a measure to prioritize the projects.

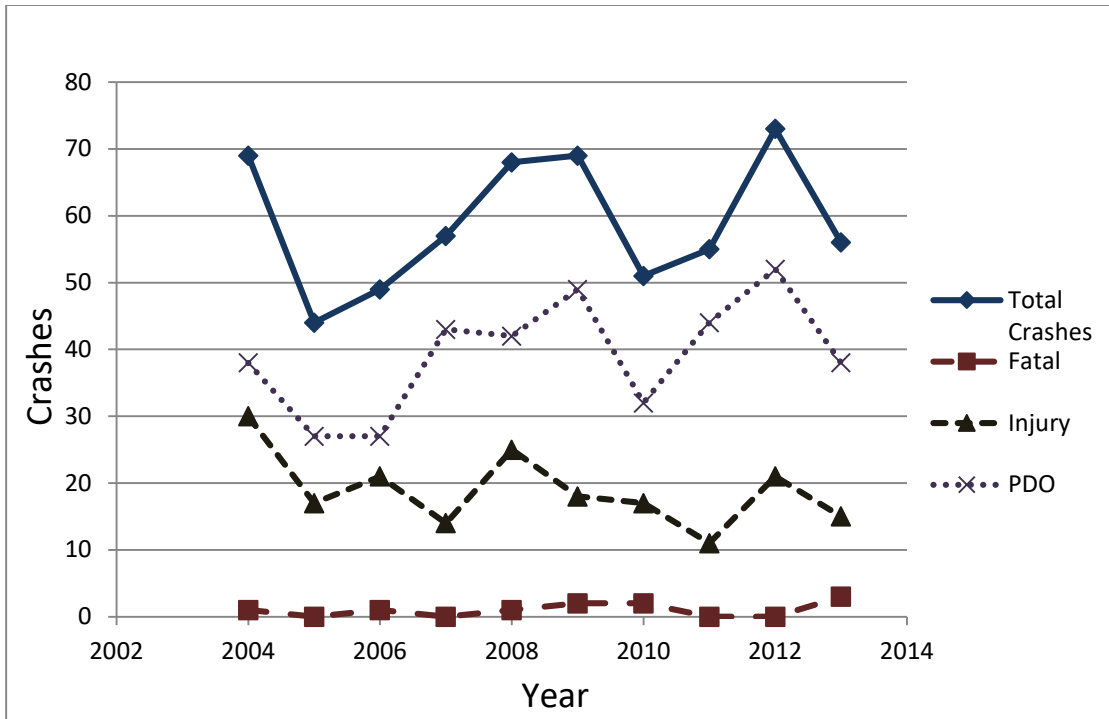
Figure 4.1 YST Crashes 2004-2013

There were 591 crashes recorded for YST from 2004 through 2013. Overall, the trend shows that crashes have increased over the 10-year period. At closer observation, property damage only (PDO) crashes have increased, injury crashes have decreased, and fatal crashes have remained relatively constant. The crash trends can be observed in Figure 4.1. Further study should be done to determine if the increase in PDO crashes is due to better reporting or if they are in fact increasing.

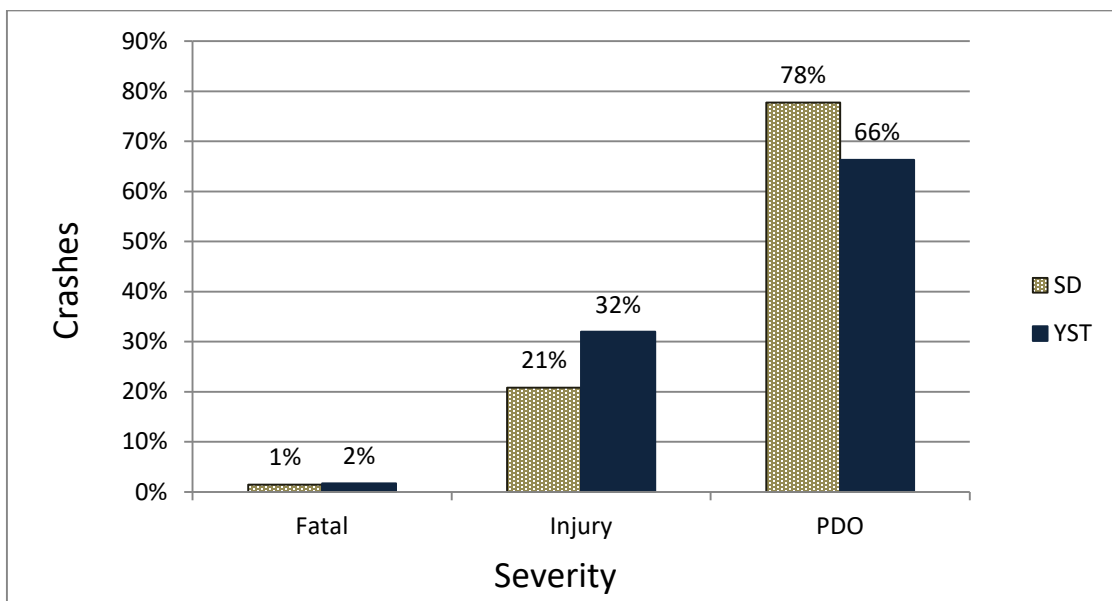
Figure 4.2 Crash Severity in SD and YST 2004-2013

Crash severity was divided into fatal, injury, and PDO. As seen in Figure 4.2, fatal crashes were slightly higher on YST at 2%, compared with South Dakota at 1%. Injury crashes on the reservation were more than 10% higher than statewide at 32% and 21%, respectively.

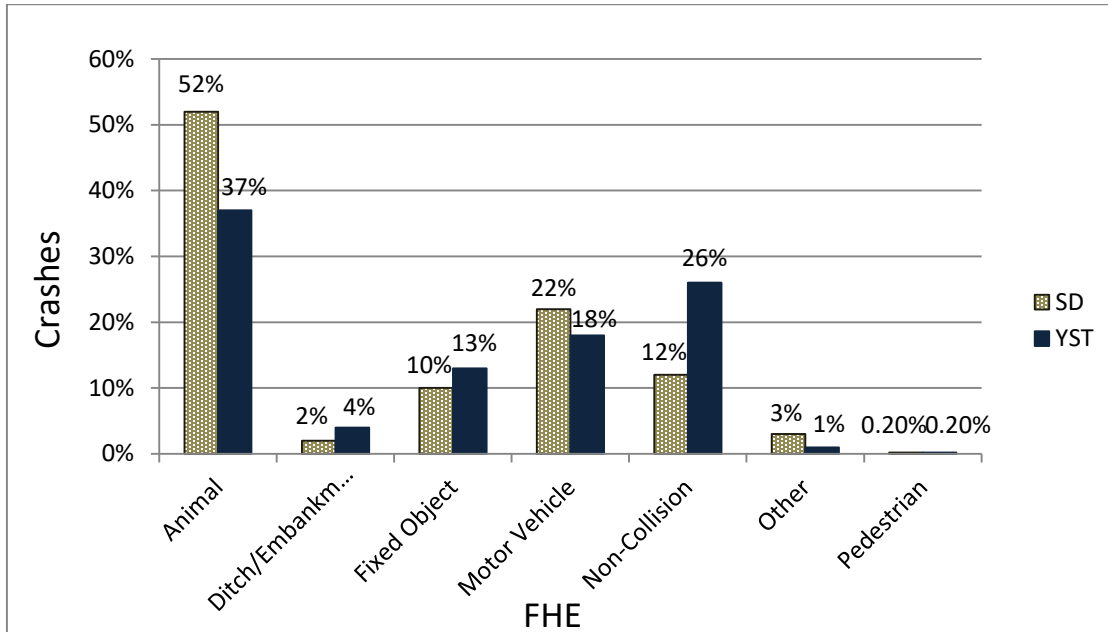
Figure 4.3 First Harmful Event for Crashes in SD and YST 2004-2013

The FHE revealed that animal crashes were lower than those across the state at 37%, compared with 52%. Non-collisions were much higher at 26% compared with 12% for the state. Non-collision crashes include rollover crashes. Motor vehicle crashes (crashes involving more than one vehicle) were lower, and fixed object crashes were higher. Crashes involving pedestrians were the same for YST and the state at 0.2% percent. The FHE results are located in Figure 4.3.

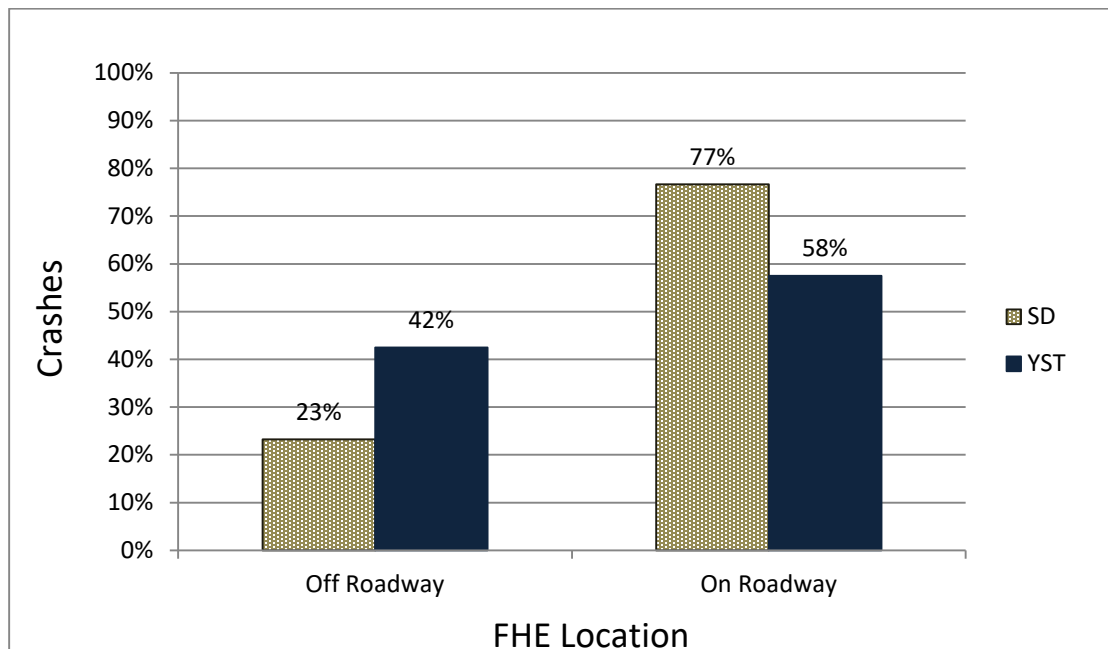
Figure 4.4 FHE Location for SD and YST 2004-2013

Almost two times as many crashes occurred off the roadway on YST as compared with the state at 42% and 23%, respectively. With 58% occurring on the roadway, on-road and off-road crashes are of equal concern. See Figure 4.4.

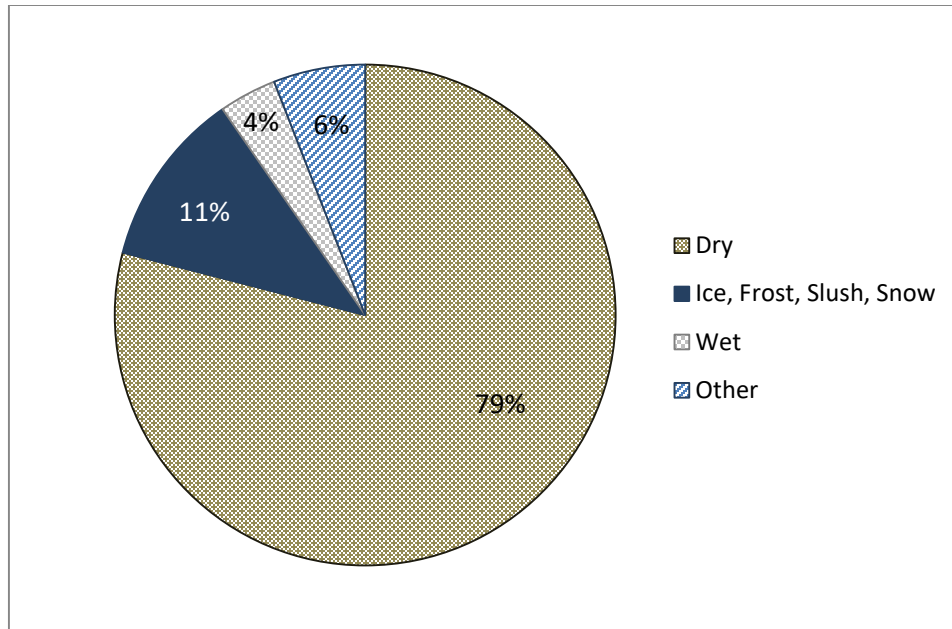
Figure 4.5 YST Road Conditions 2004-2013

Road conditions were reported as dry for 79% of the crashes, and as ice, snow, frost, or slush for 11%. Wet roads accounted for only 4% of all crashes. Other road conditions, such as sand, mud, dirt and gravel, accounted for 6% of all crashes. See Figure 4.5.

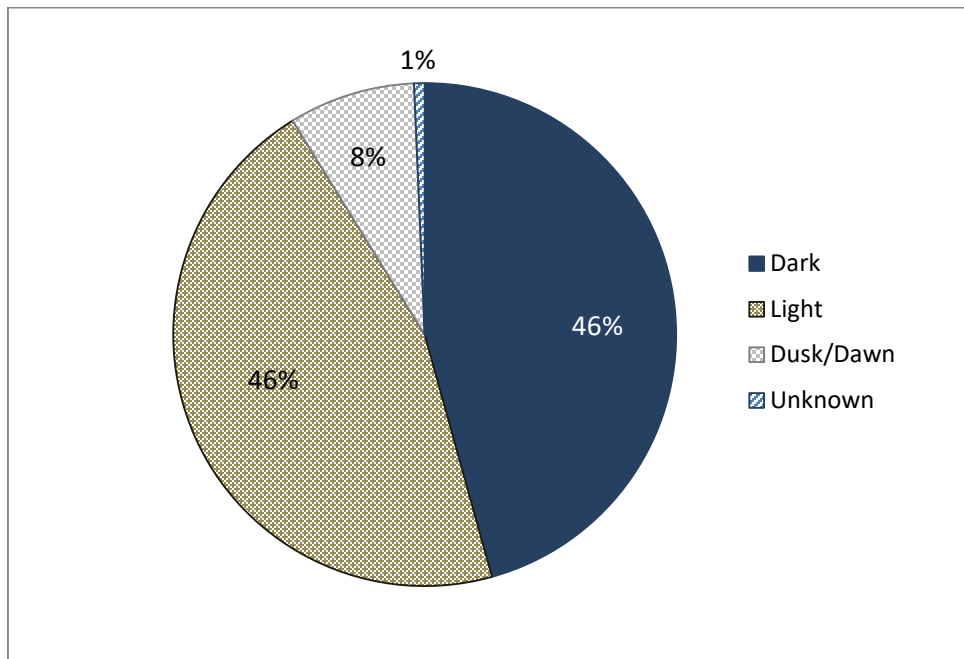
Figure 4.6 YST Lighting Conditions 2004-2013

Lighting conditions showed that crashes were evenly distributed between daylight and dark at 46% for both (Figure 4.6).

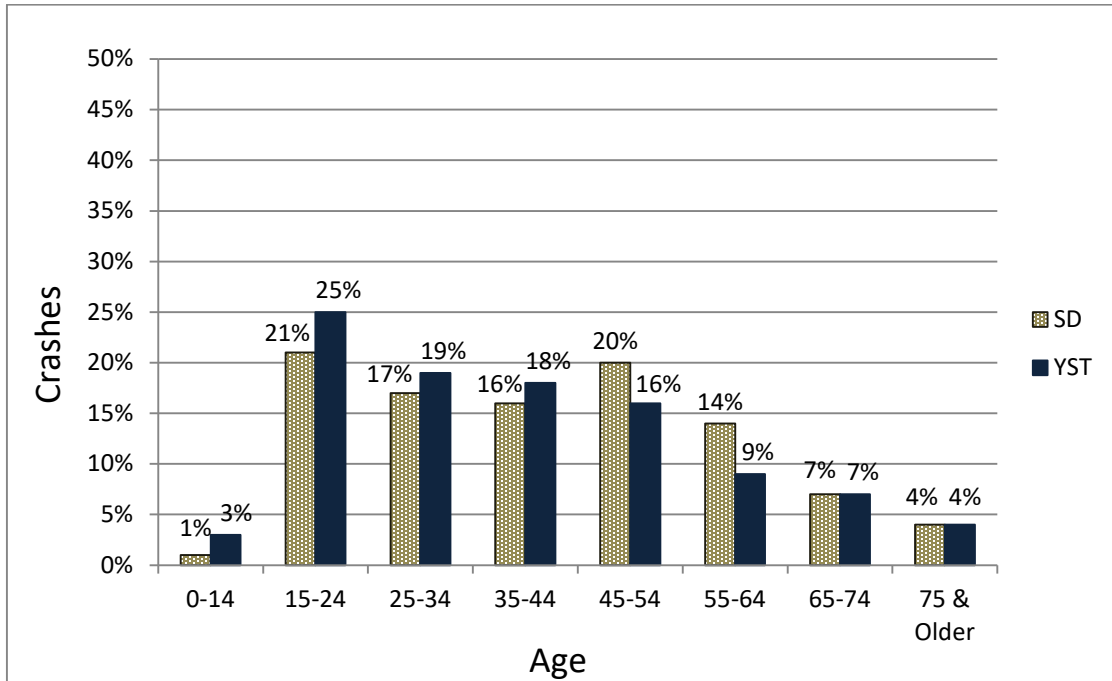
Figure 4.7 Driver Age for SD and YST 2004-2013

There was a slightly higher percentage of young drivers involved in crashes on YST compared with statewide. The analysis showed 25% were between the ages of 15 and 24, and 19% were between 25 and 34. For statewide, these values were 21% and 17%, respectively. For the 45 to 54 and 55 to 64 age groups, the statewide percentage of drivers was higher than YST. See Figure 4.7.

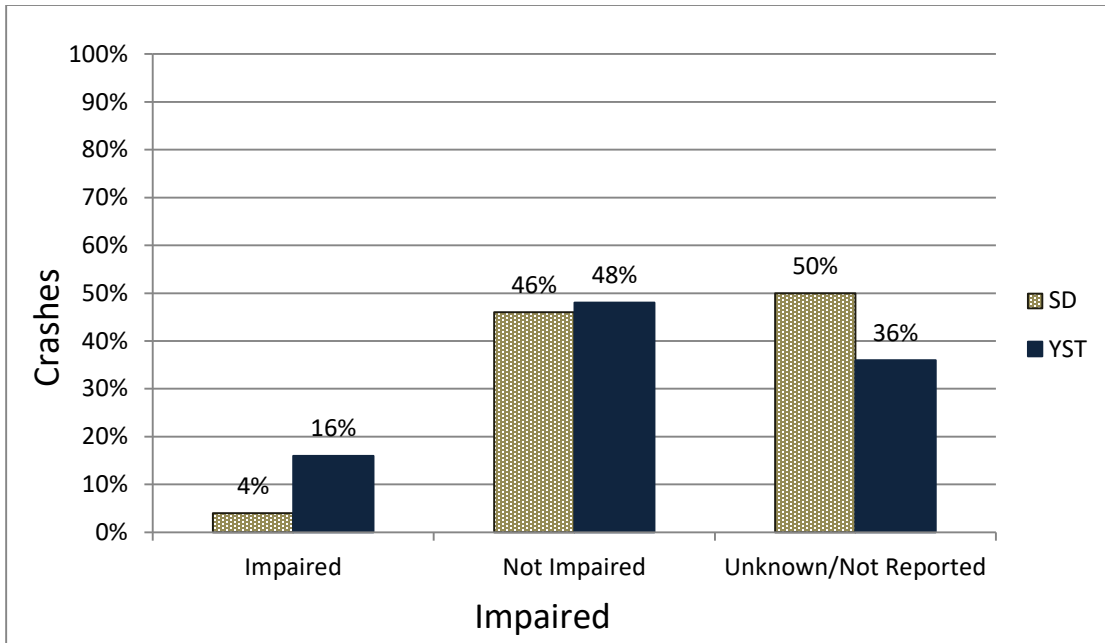
Figure 4.8 Crashes Involving Alcohol in SD and YST 2004-2013

Of all crashes reported, alcohol was involved with 16% statewide, showing only 4% impaired. However, it should be noted that the statewide also shows 50% as unknown or not reported impairment, as compared with YST at 36% unreported. See Figure 4.8.

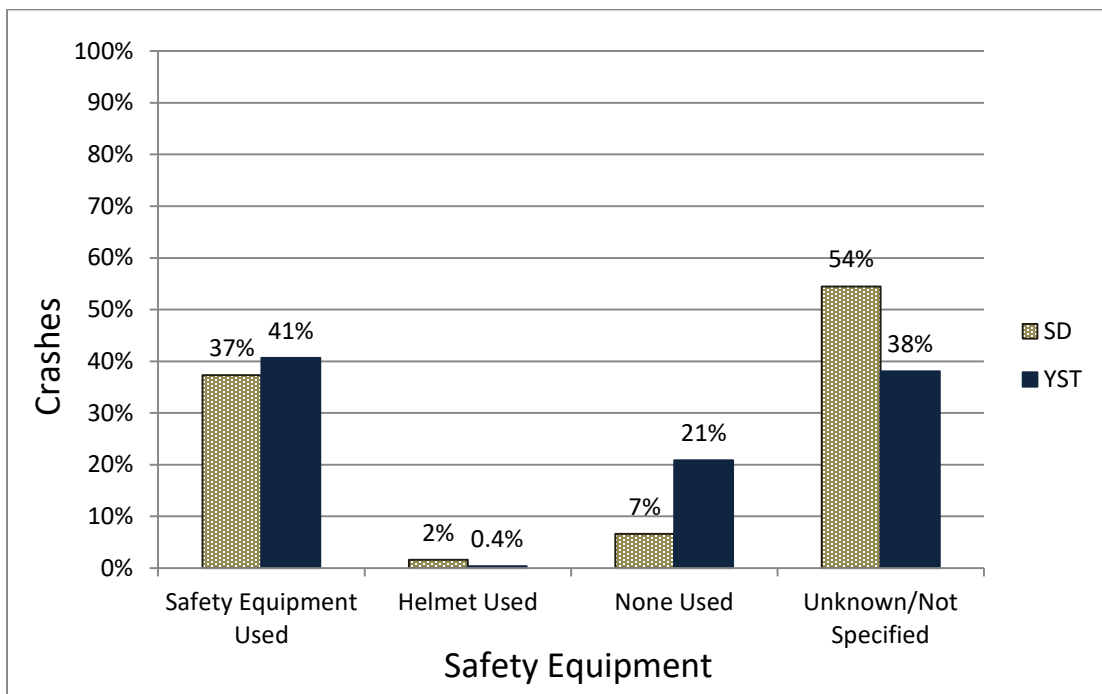
Figure 4.9 Safety Equipment Use in SD and YST 2004-2013

Safety equipment use is reported as slightly higher on the reservation at 41%, compared with 37% across the state. However, non-use of safety equipment was three times higher for YST compared with the state (Figure 4.9).

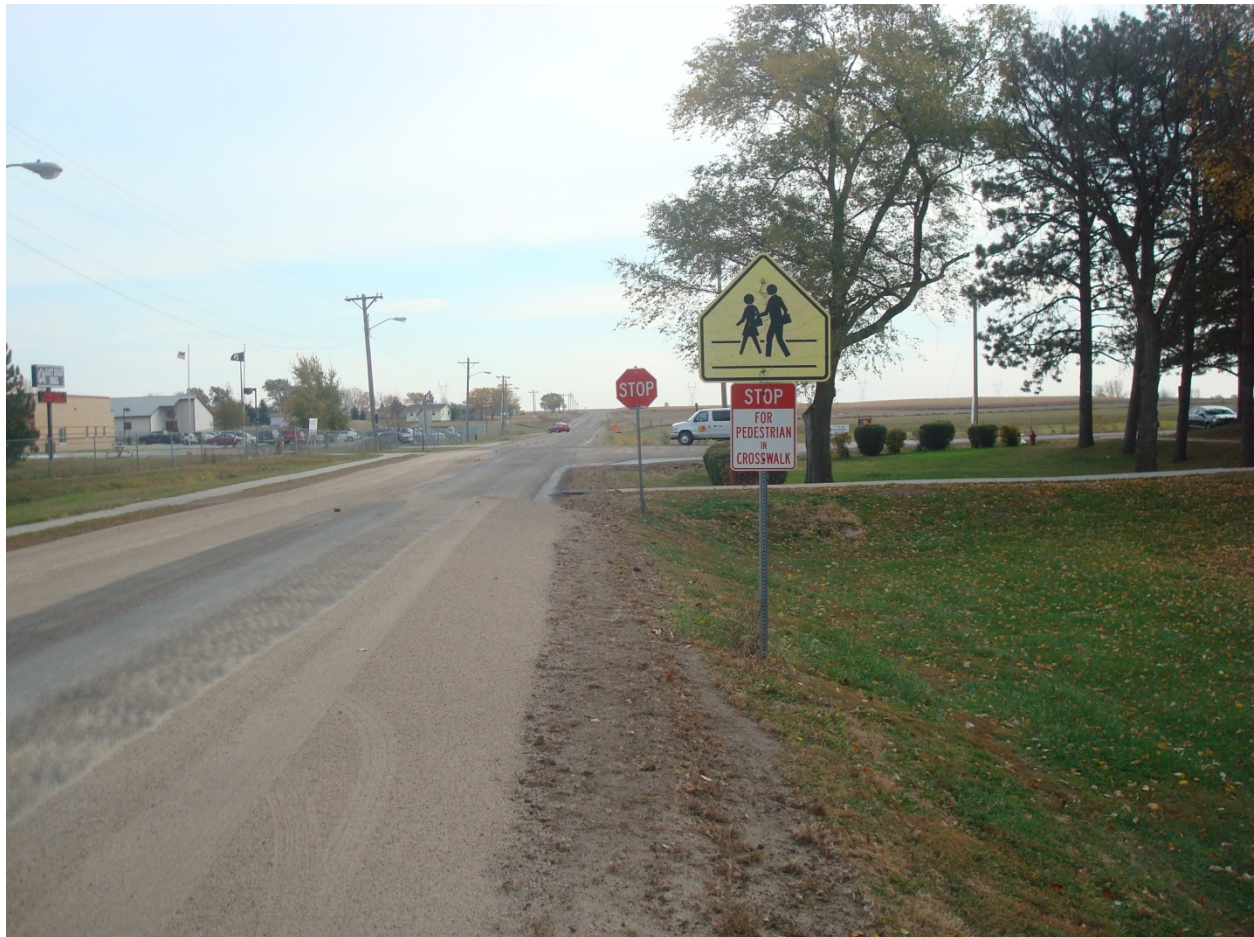
Figure 5.3 303rd Street in Marty near 388th Avenue Intersection

The intersection of 388th Avenue is within the school zone in Marty. The existing signage is not in compliance with the MUTCD and is confusing to the driver. A stop sign is located at the crosswalk, which is about 50 feet from the T intersection of 388th Avenue (see Figure 5.3)

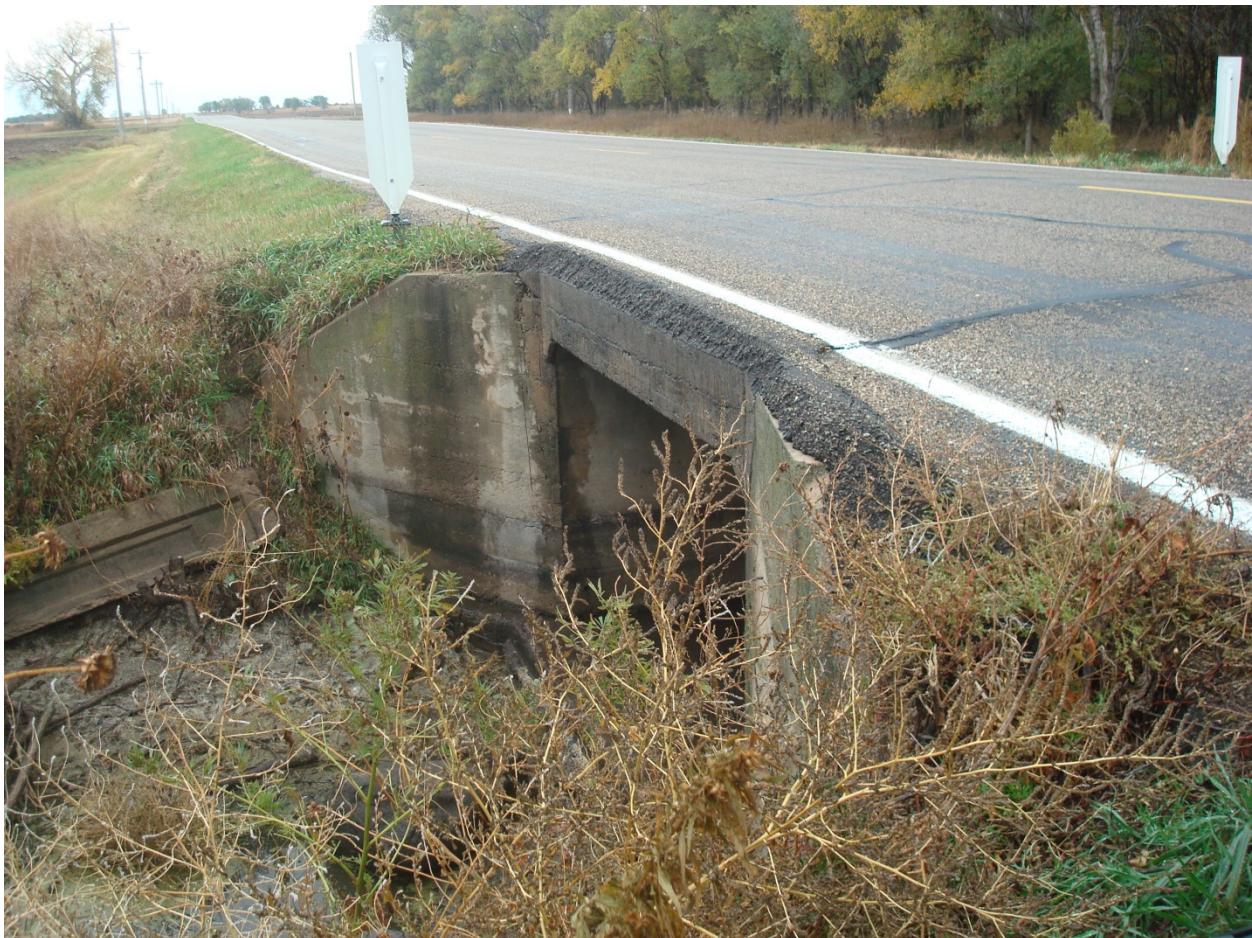
Figure 5.5 Culvert on 395th Avenue three Miles North of SD Hwy 46

About three miles north of South Dakota Highway 46 on 395th Avenue, a narrow culvert crossing exists with no shoulder or guardrail. It does have object markers, but the road drops off within inches of the edgeline (see Figure 5.5). This culvert should be widened and railings added to provide recovery for any vehicles crossing the edgeline.
