Field Implementation of the Vertical In situ Permeameter (VIP)

Final Report

FDOT Contract No. BDV31-977-88

University of Florida
Engineering School of Sustainable Infrastructure & Environment

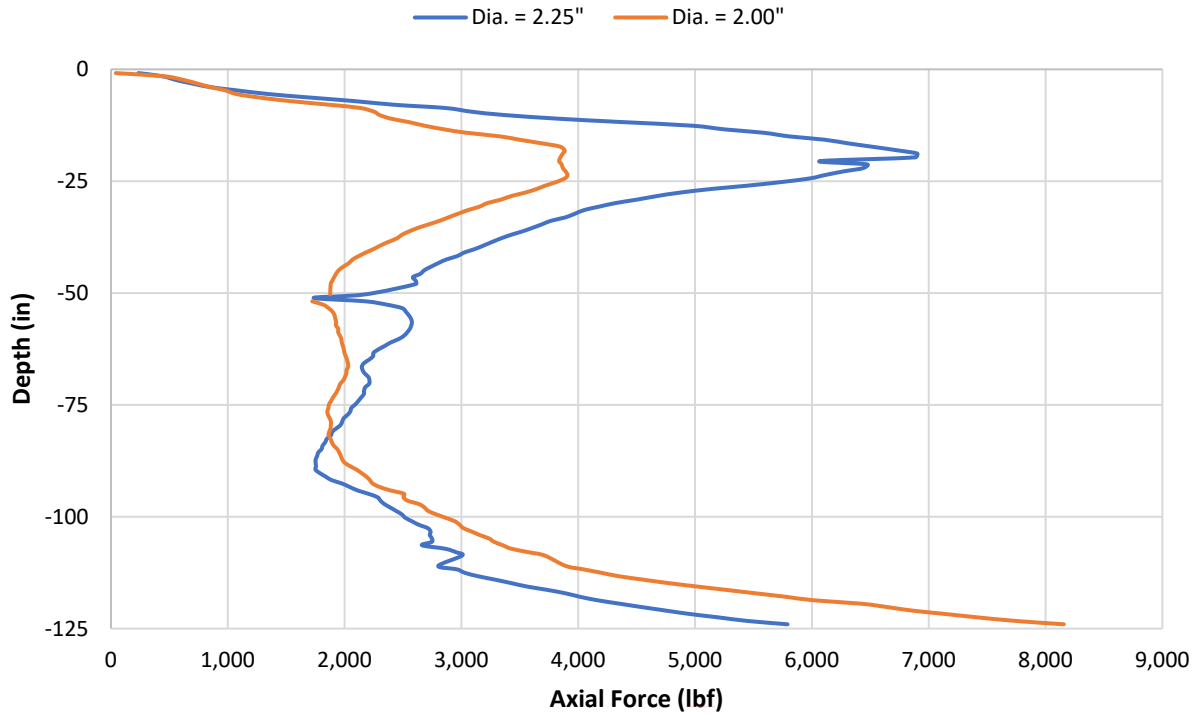
Figure 2-3. Push tests conducted in location 2 at the SMO.

In Figures 2-2 through 2-4, the same general soil profile can be observed. In Figure 2-5, at Kanapaha, the two soil profiles show less similarities. This is due to the highly variable nature of the Kanapaha site and encountering soft limestone at two different depths. Encountering the soft limestone was confirmed by observing rock collected on the probe after it was extracted, Figure 2-6.

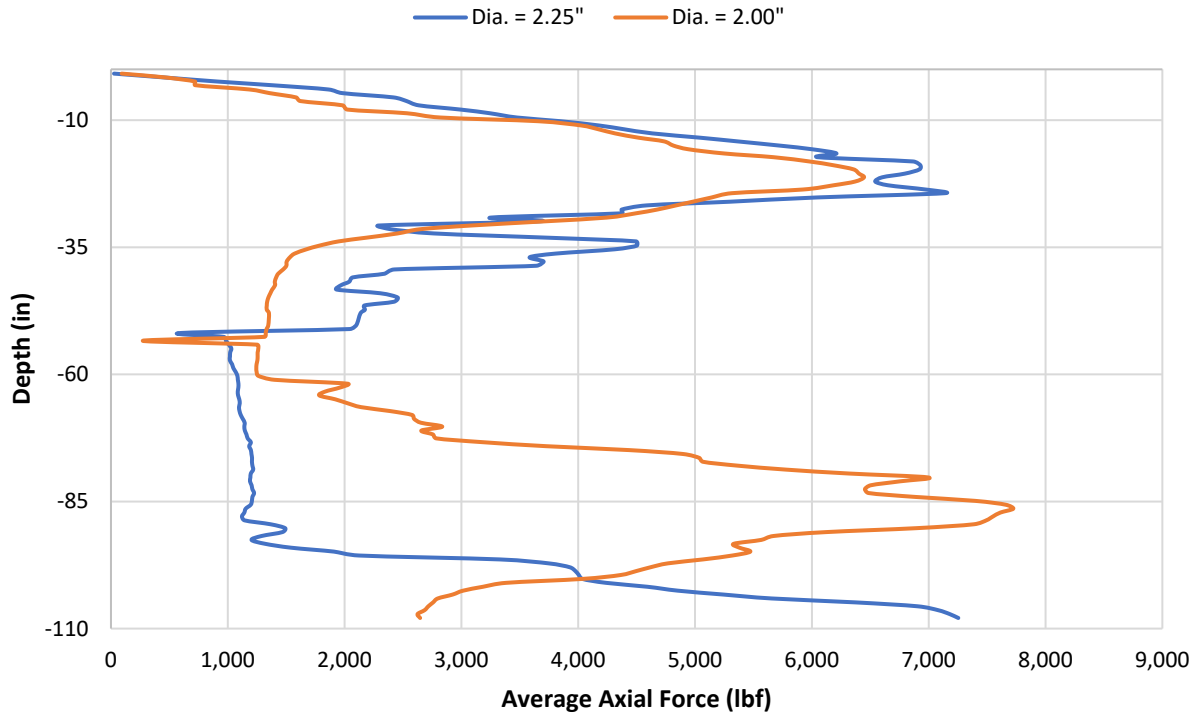
Figure 2-5. Push tests conducted at the FDOT’s Kanapaha site in Gainesville, Florida.

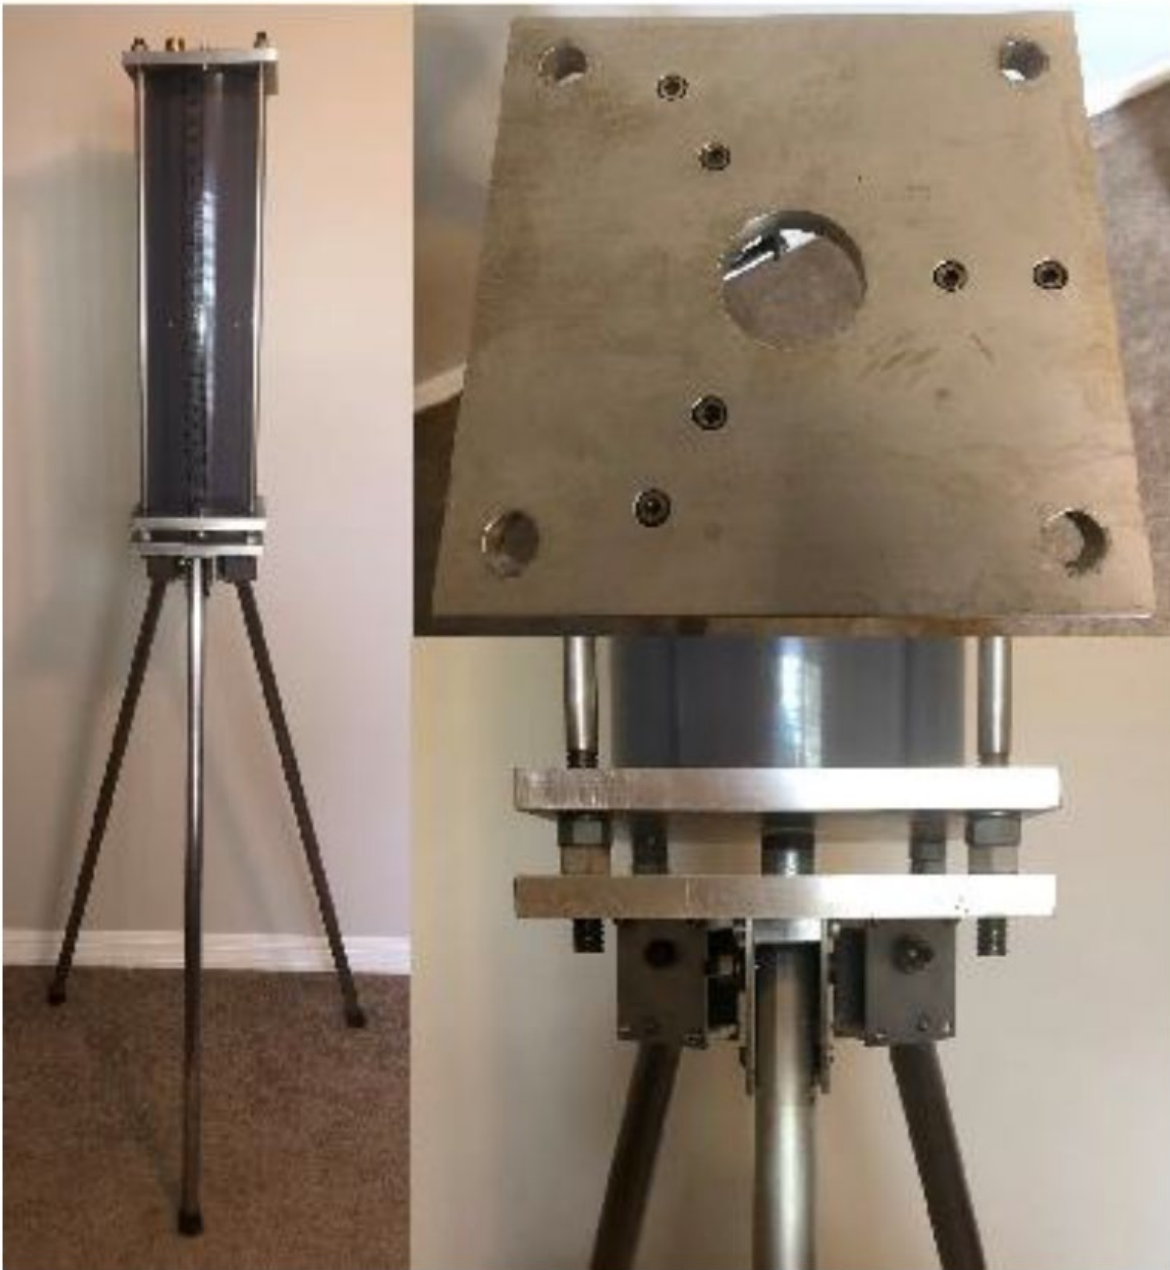
Figure 2-11. New falling head vessel design, displaying removable pieces.

- Aluminum plates used instead of steel (original) to reduce the weight for onsite transport,
- Greater wall thickness in falling head vessel to provide a more robust design,
- More robust tripod stand,
- All pieces are individual and removable which allows the vessel components to be more easily replaced if damaged.

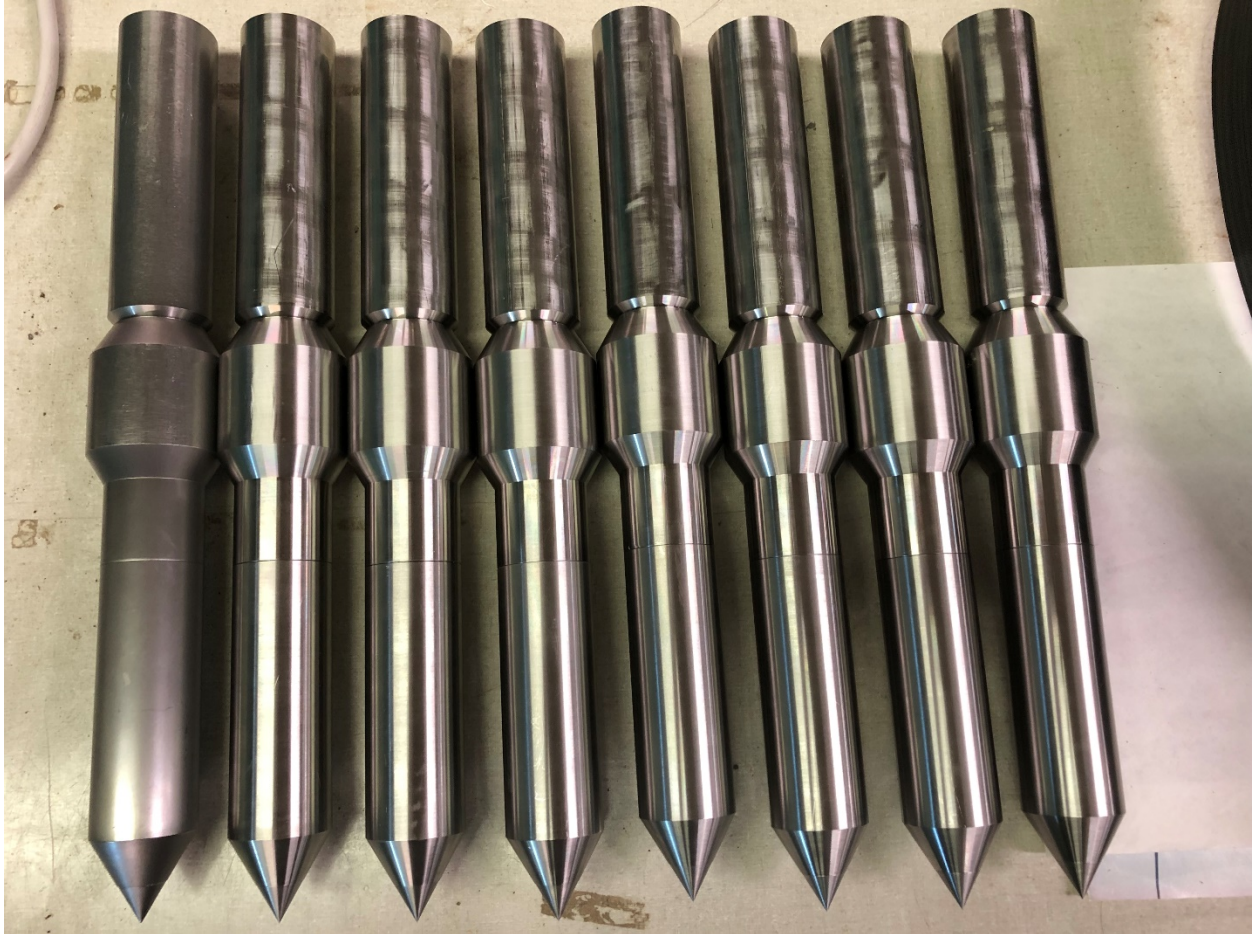
Figure 2-12. Eight new VIP probes.

In total, eight VIP probes and falling head vessels were fabricated during the research effort. Figures 2-12 and 2-13 provide images of the probes and falling head vessels, respectively.

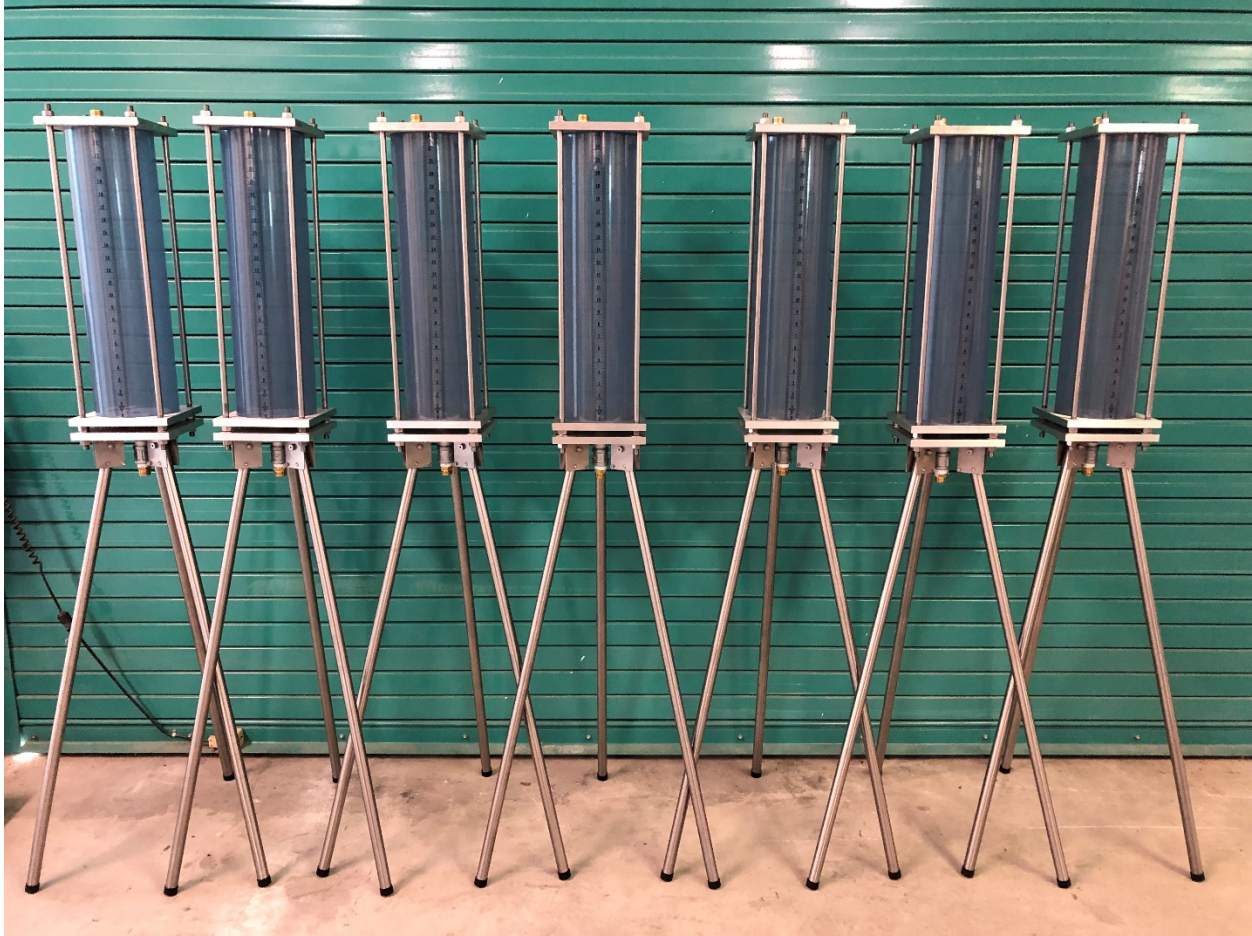
Figure 2-13. Seven new falling head vessels (prototype not depicted).

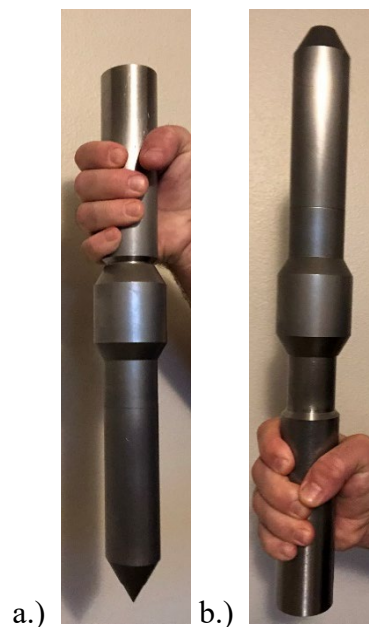
Figure 3-2. O-ring compression hand calibration procedure displaying a.) the probe remaining closed supporting its own weight and b.) the probe remaining open supporting its own weight.

1. Grip the probe by the AWJ connection and hold the probe with tip facing down, Figure 3-2a. When the internal components are dry, the probe will remain closed off. When the internal components are wet, the probe will slowly open under its own weight.
2. Open the probe (two inch lift) to initiate the upper inner rod O-ring seal within the friction reducer. Grip the AWJ connection with the probe tip facing upwards, Figure 3-2b. When the internal components are dry, the probe will remain open. When the internal components are wet, the probe will slowly close under its own weight.

Note: When the internal components are dry, the probe can be opened and closed by hand with some resistance. When the internal components are wet, the probe can be opened and closed under its own weight or by hand with minimal resistance.

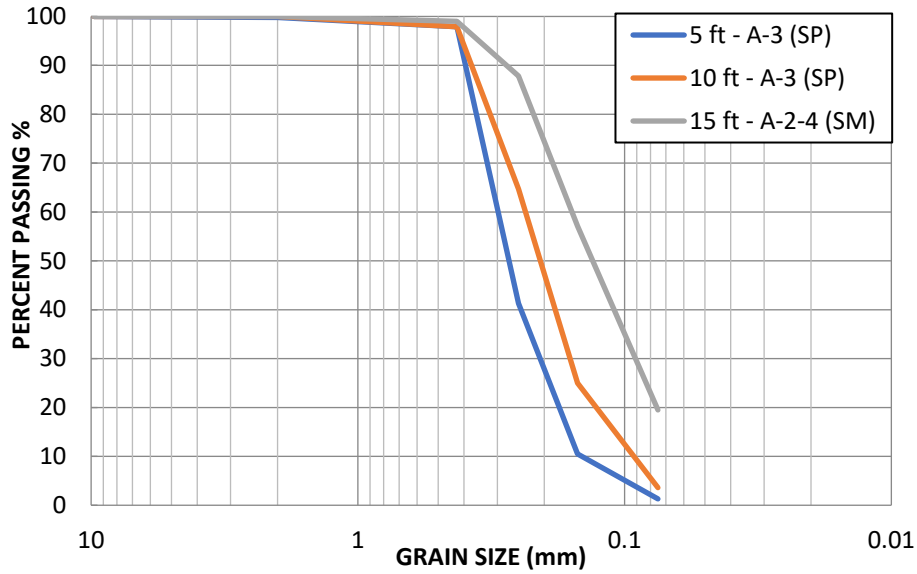
Figure 3-5. Sieve analyses from Location 1 in Trenton.

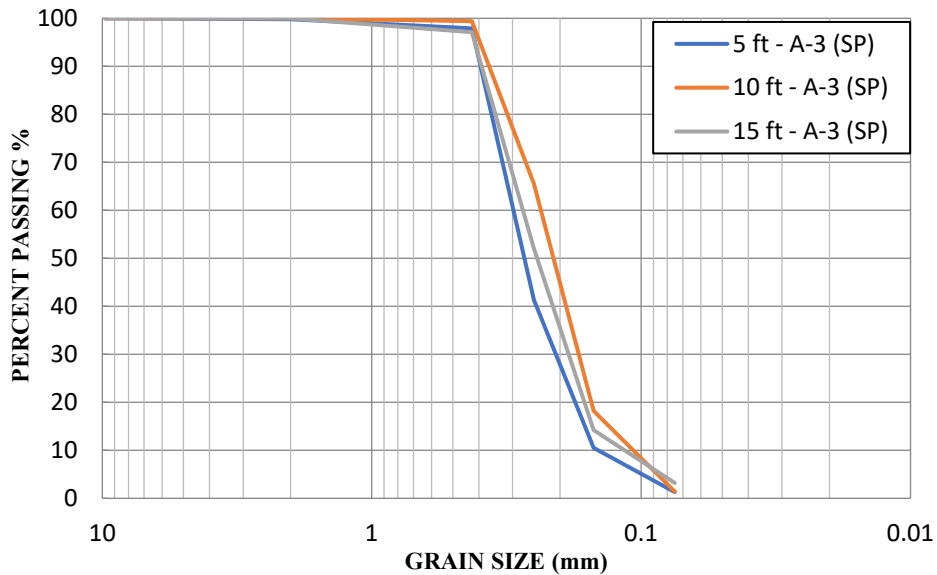
Figure 5-7. Trenton Location 2 sieve analyses.

At Location 2, the soil type was the same at each test depth. However, SPT blow counts and VIP probe push tests (Figure 3-8) both indicated increasing soil density at the depth which the VIP and CCH results both indicated a decrease in permeability.

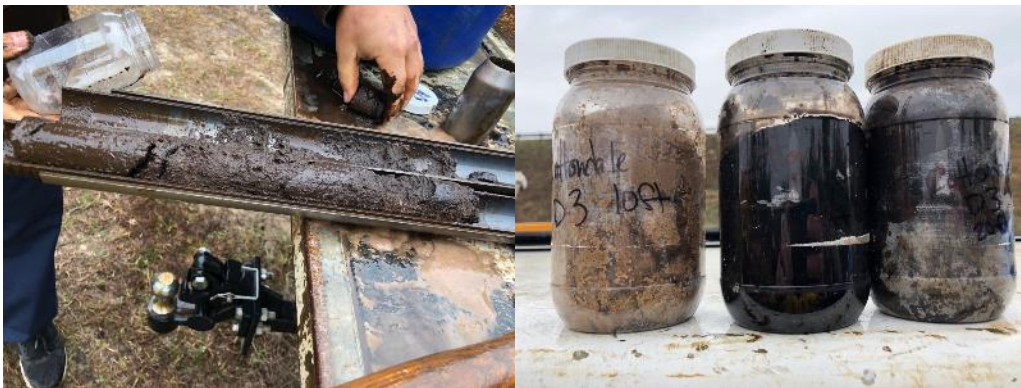
Figure 5-17. Soil samples collected at the Cottondale site.

At the Cottondale site, three locations were tested each at three different depths (10, 15, and 20 feet). The permeability measured was variable at each location and depth. However, the average permeability measured at each depth was nearly identical across the site (5.28×10^{-4} cm/s @ 10-ft, 3.50×10^{-4} cm/s @ 15-ft, 3.64×10^{-4} cm/s @ 20-ft). Location C-3 had the lowest average permeability. Images of the soil samples collected are provided in Figure 5-17, sieve analyses are provided in Figure 5-18, and the VIP results are provided in Figure 5-19.

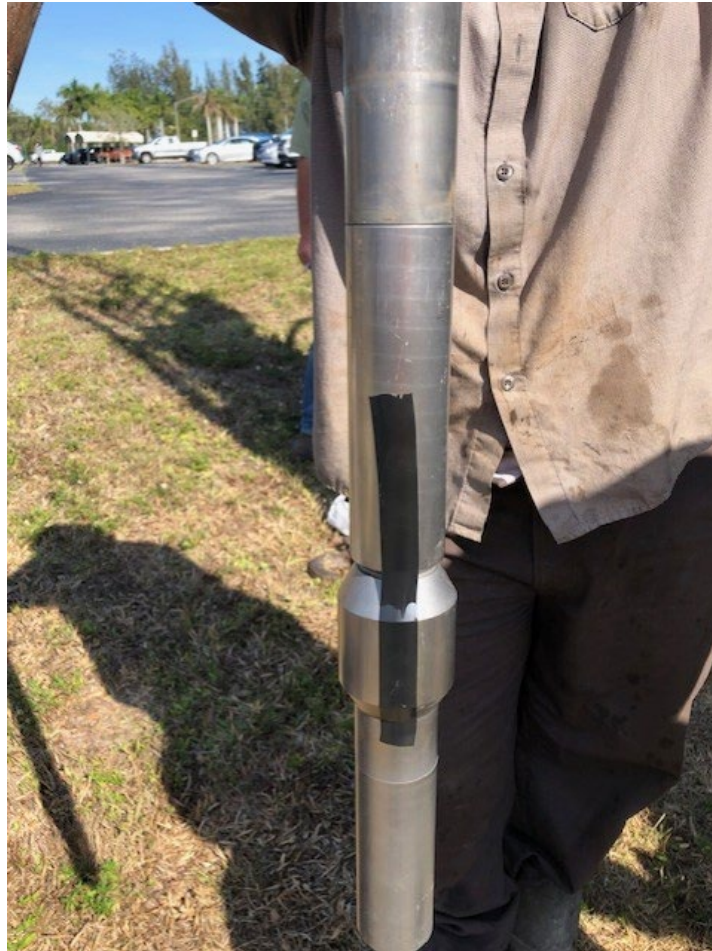
Figure 5-23. VIP probe with electric tape to ensure closed position for open-hole advancement.

subsequent test locations at the District 4 site and is recommended for future open-hole advancements. For example, if pre-drilling is required to advance the probe, predrill the hole to a minimum of one foot above the test depth, place electric tape on the VIP probe as indicated in Figure 5-23, advance the probe down the open hole, direct push the final one foot or more to the test depth, and then initiate the VIP test. Location 2 sieve analyses are provided in Figure 5-24, and the VIP results are provided in Figure 5-25.

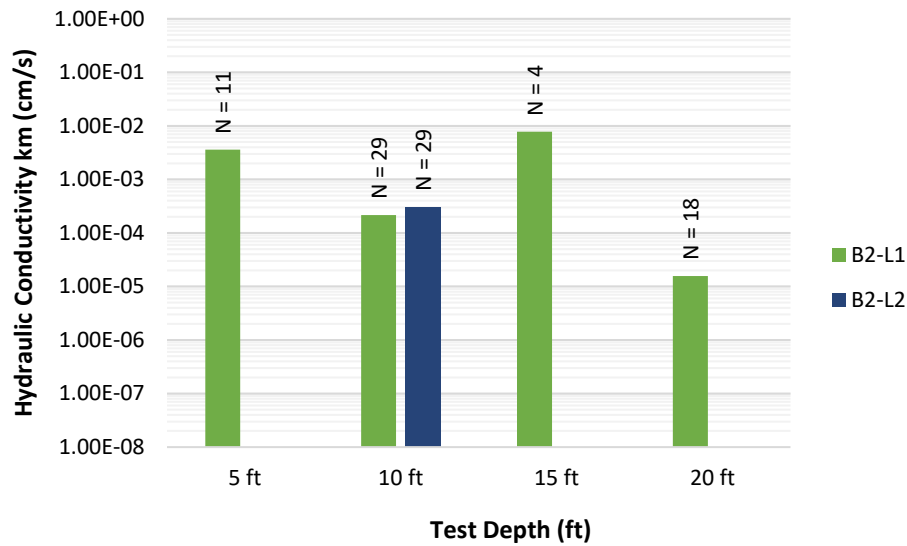
Figure 5-25. District 4 Location 2 VIP results.

Observed in Figure 5-25, the VIP result at a depth of 20 feet appeared low for the soil type and SPT blow counts measured at this depth based on the other VIP and SPT measurements recorded at the location. It was discovered that this was a false reading, and a result of too much copper grease being applied at the AWJ rod threaded connections which was transmitted through the drill string and out of the probe tip (Figure 5-26). Researchers suspect the grease permeated into the soil and caused the false reading. This VIP measurement was removed from further consideration.

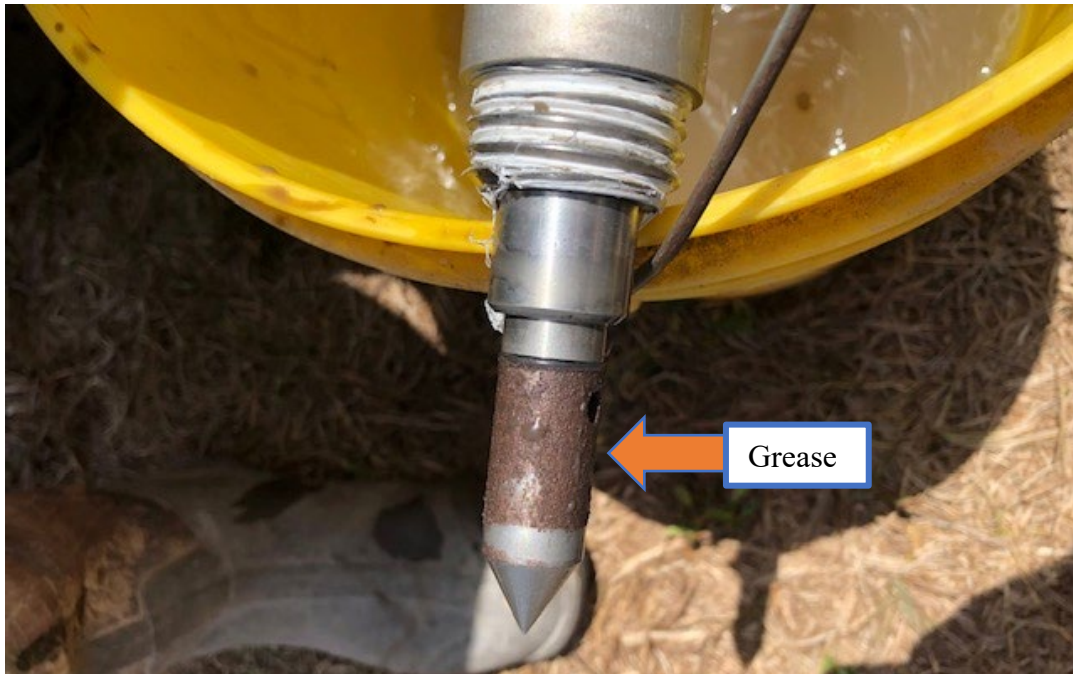
Figure 5-26. Grease transmitted through the drill string and out of the probe.

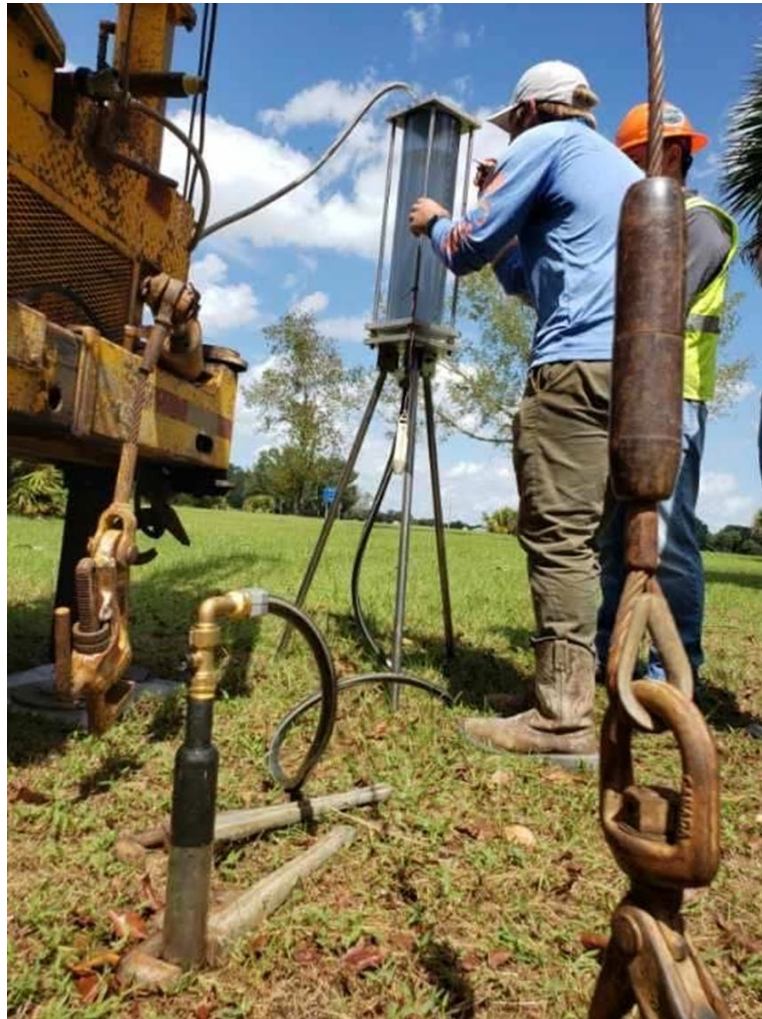
Figure 5-29. VIP being used for an infiltrometer tests.

At Location PBS 4, 10 VIP were completed from two different locations with depths ranging from one to twenty feet. The VIP test at one foot was conducted to see how VIP would perform as a potential replacement to time consuming double ring infiltrometer tests (Figure 5-29). The procedure included pushing the probe approximately 10 inches into the ground to allow the friction reducer to fully penetrate the surface. The falling head vessel is then attached and the AWJ connection is lifted two inches and held in place by a large wrench as depicted in in Figure 5-29. The VIP test procedure is then completed without saturation. The test results were calculated as unsaturated permeability. Sieve analyses are provided in Figure 5-30, and the VIP and CCH results are provided in Figure 5-31. The VIP measurements were consistent with changes in soil type and SPT blow counts at each location and depth. The VIP infiltrometer test compared well with the saturated permeability at a depth of five feet. No conventional infiltrometer tests were completed for direct comparison, however, the VIP approach required minutes to setup and perform the unsaturated test whereas double ring infiltrometer tests (conventional approach) requires six hours to complete the test per ASTM D3385-18 specifications. UF researchers recommend VIP approach should be investigated more thoroughly and compared to conventional methods before any conclusions are drawn on its viability. The

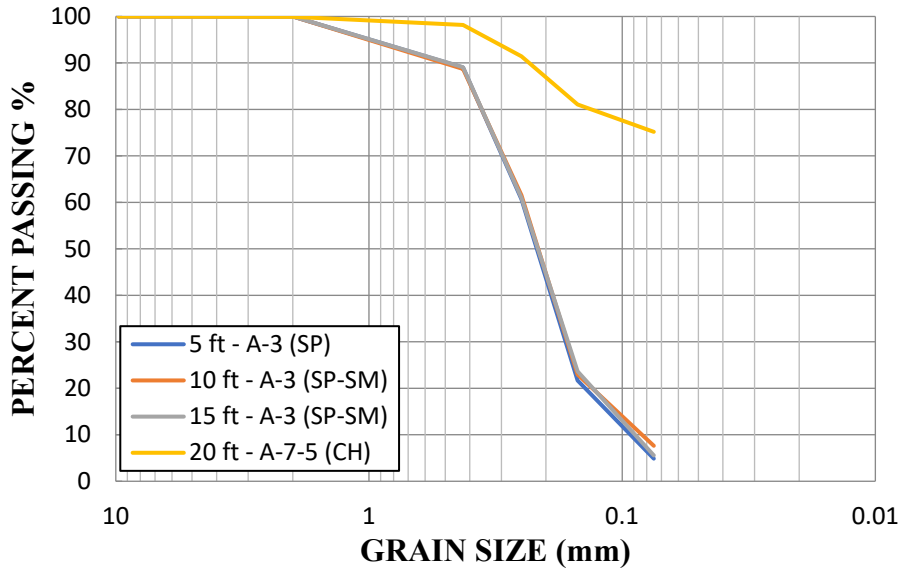
Figure 5-34. Location PBS 15 sieve analyses.

At location PBS 15, two different soil types were encountered A-3 at depths 5, 10, and 15 feet, and A-7-5 at a depth of 20 feet. Sieve analyses are provided in Figure 5-34, and the VIP and CCH results are provided in Figure 5-35. The VIP and CCH tests were in agreement at depths 5, 10, and 20 feet and were consistent with the soil type and density encountered. At a depth of 15 feet, the results were more variable, and the first VIP test appears low for the soil type and SPT blow counts. The trends of the data indicate the permeability increased moving away from the first VIP location at PBS 15, which is in agreement with the soil type and SPT data.

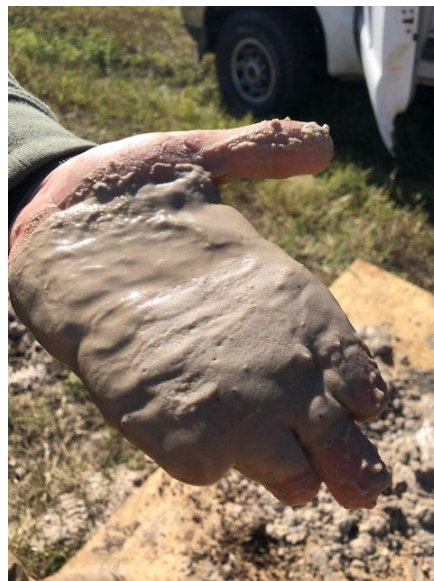
Figure 5-43. Fine grained soil recovered by a hand auger at the Veterans Expressway site.

At Veterans Expressway, the water table was 2.6 feet below ground surface which reduced the speed of the VIP tests. This is due to the low available head to push the water efficiently through the soil. Consequently, only six tests were completed with depths ranging from one to 15 feet. Historical data indicated a permeability range of $k_m = 7.37 \times 10^{-3}$ cm/s to 2.43×10^{-4} cm/s. The VIP results were consistent with the historical data and reflected the fine grain soil collected by a hand auger, shown in Figure 5-43. VIP results are provided in Figure 5-44.

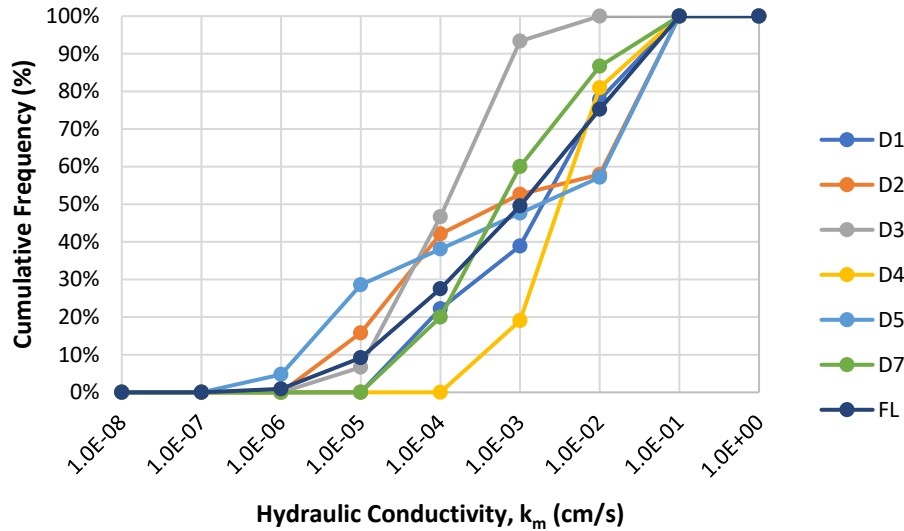
Figure 5-46. VIP cumulative frequency distributions for each FDOT district and Florida.

the results of the VIP probe statewide and to analyze the results based on geological environments and the soils commonly encountered within each region of the state. In Figure 5-46, cumulative frequency distributions are provided for each FDOT district and the state of Florida as a whole. Figures 5-47 through 5-52 provide the cumulative frequency for individual districts compared to the Florida distribution.

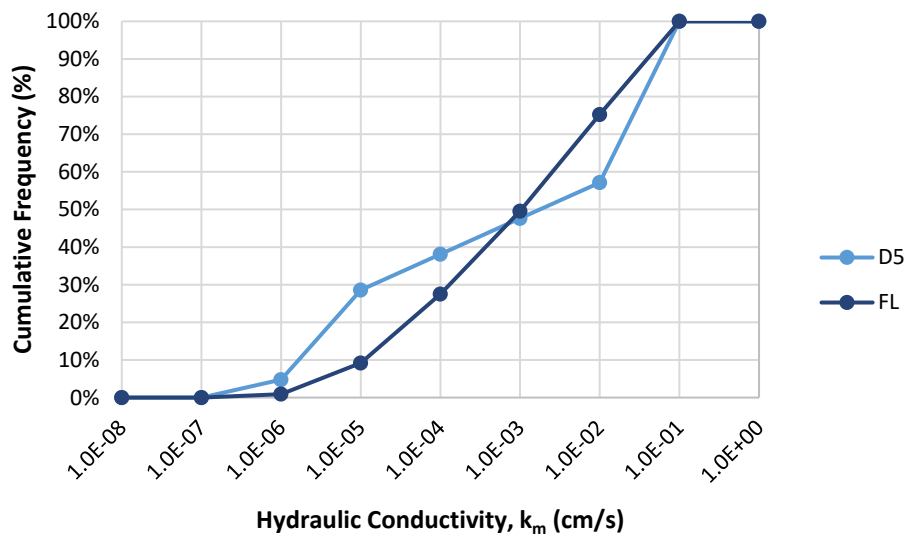
Figure 5-49. VIP cumulative frequency distributions for FDOT District 5 and Florida.

Similar trends observed in District 2, were also observed in District 5 which is located just south of District 2. District 5 is also located in Northern Central Florida and the frequency distribution indicates the widest range of permeabilities and closely resembles the distribution from District 2. The lowest permeability measured statewide was located in District 5.

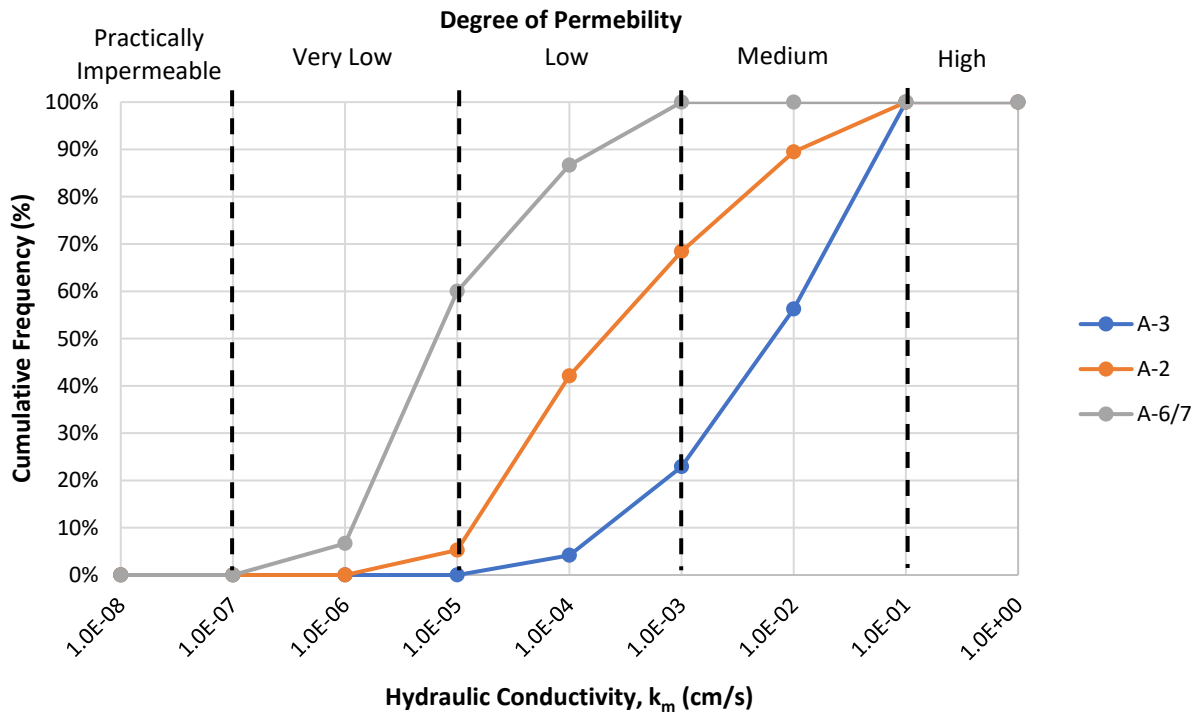
Figure 5-53. VIP cumulative frequency distributions for Florida based on AASHTO soil type.

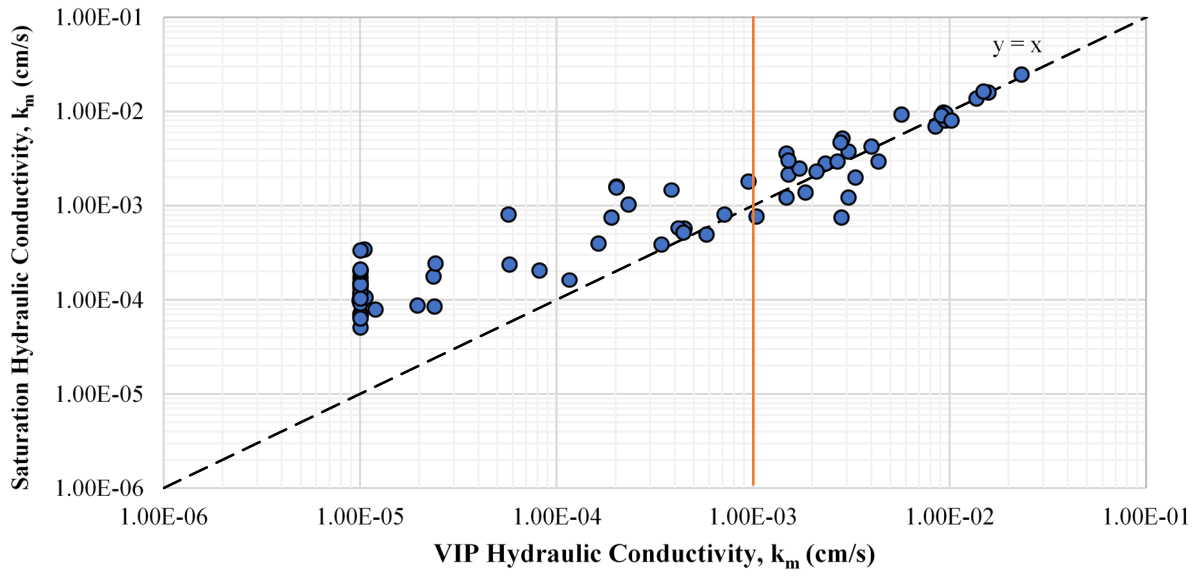
Figure 5-54. Saturation hydraulic conductivity vs. VIP test hydraulic conductivity.
