# Improving Amphibian Roadway Mitigation to Decrease Mortality and Increase Connectivity by Experimenting with Ecopassage Design

*Prepared for:*  
The Ohio Department of Transportation,  
Office of Statewide Planning & Research

State Job Number 135504

*Final Report*

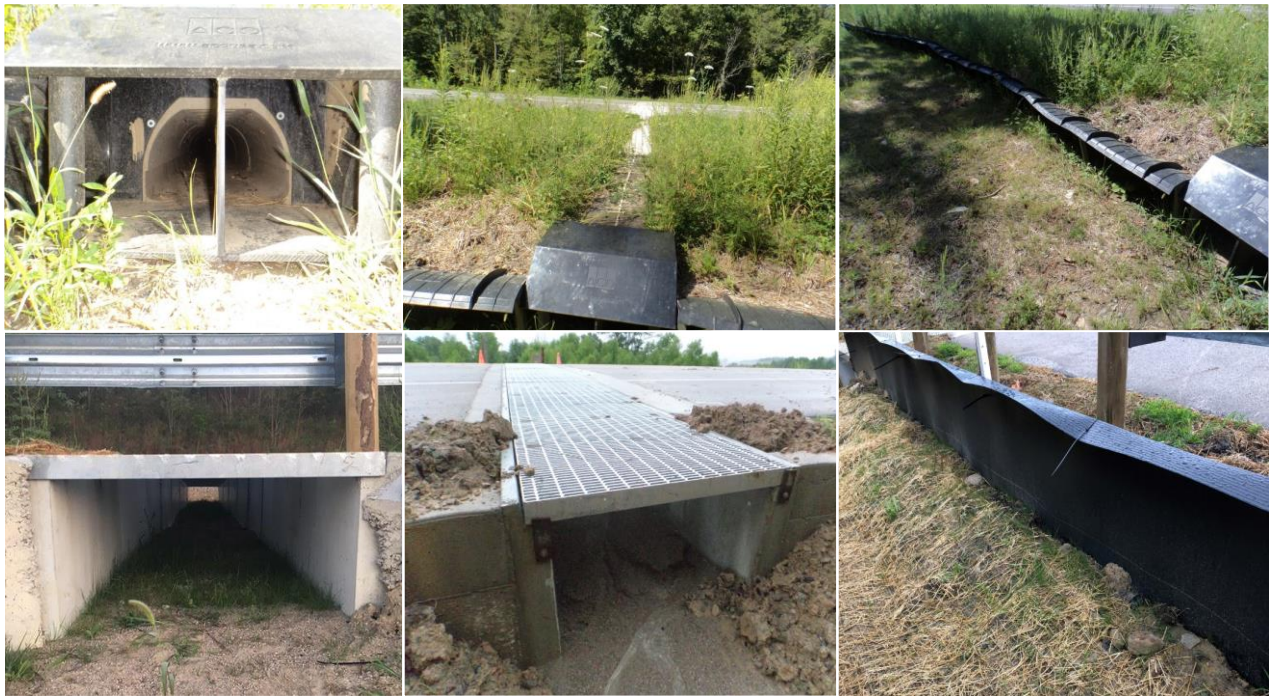
Figure 3. Images of the 2013 and 2018 barrier-ecopassage systems in place along State Route 78 near Nelsonville in Athens County, Ohio. Entrance view of a 2013 barrier-ecopassage system ecopassage (top left); 2013 ecopassage crossing the road (top center); 2013 barrier fence (top right). Entrance view of a 2018 barrier-ecopassage system ecopassage (bottom left); ecopassage crossing the road (bottom center); 2018 barrier fence (bottom right).

We hypothesized that the effectiveness of the 2013 barrier-ecopassage system could be greatly improved on by designing passages that provided greater connectivity and by implementing a new mitigation system where we detected the most amphibian movement in 2015-2016 (Figure 5). In 2017 and 2018, we tested alternative ecopassages of varying entrance size, sky exposure, and line-of-sight (i.e., visibility through the ecopassage) to determine amphibian ecopassage preferences. In July 2017, we recommended that a new barrier-ecopassage structure with wider passages, more sky exposure, full line-of-sight, and soil substrate be implemented along SR 78 based on our findings. A new barrier-ecopassage mitigation system following those recommendations was installed in 2018 (Figure 3, Figure 4) along the road section where 62% of carcasses were detected in 2015-2016 (Figure 5). The 2018 barrier-ecopassage system had ecopassages with 48 in. wide by 28-32 in. tall entrances, grated tops, a maintained line-of-sight across the ecopassages, and a natural soil bottom (Figure 3). The 2018 passages also had taller fencing with a folded top lip to

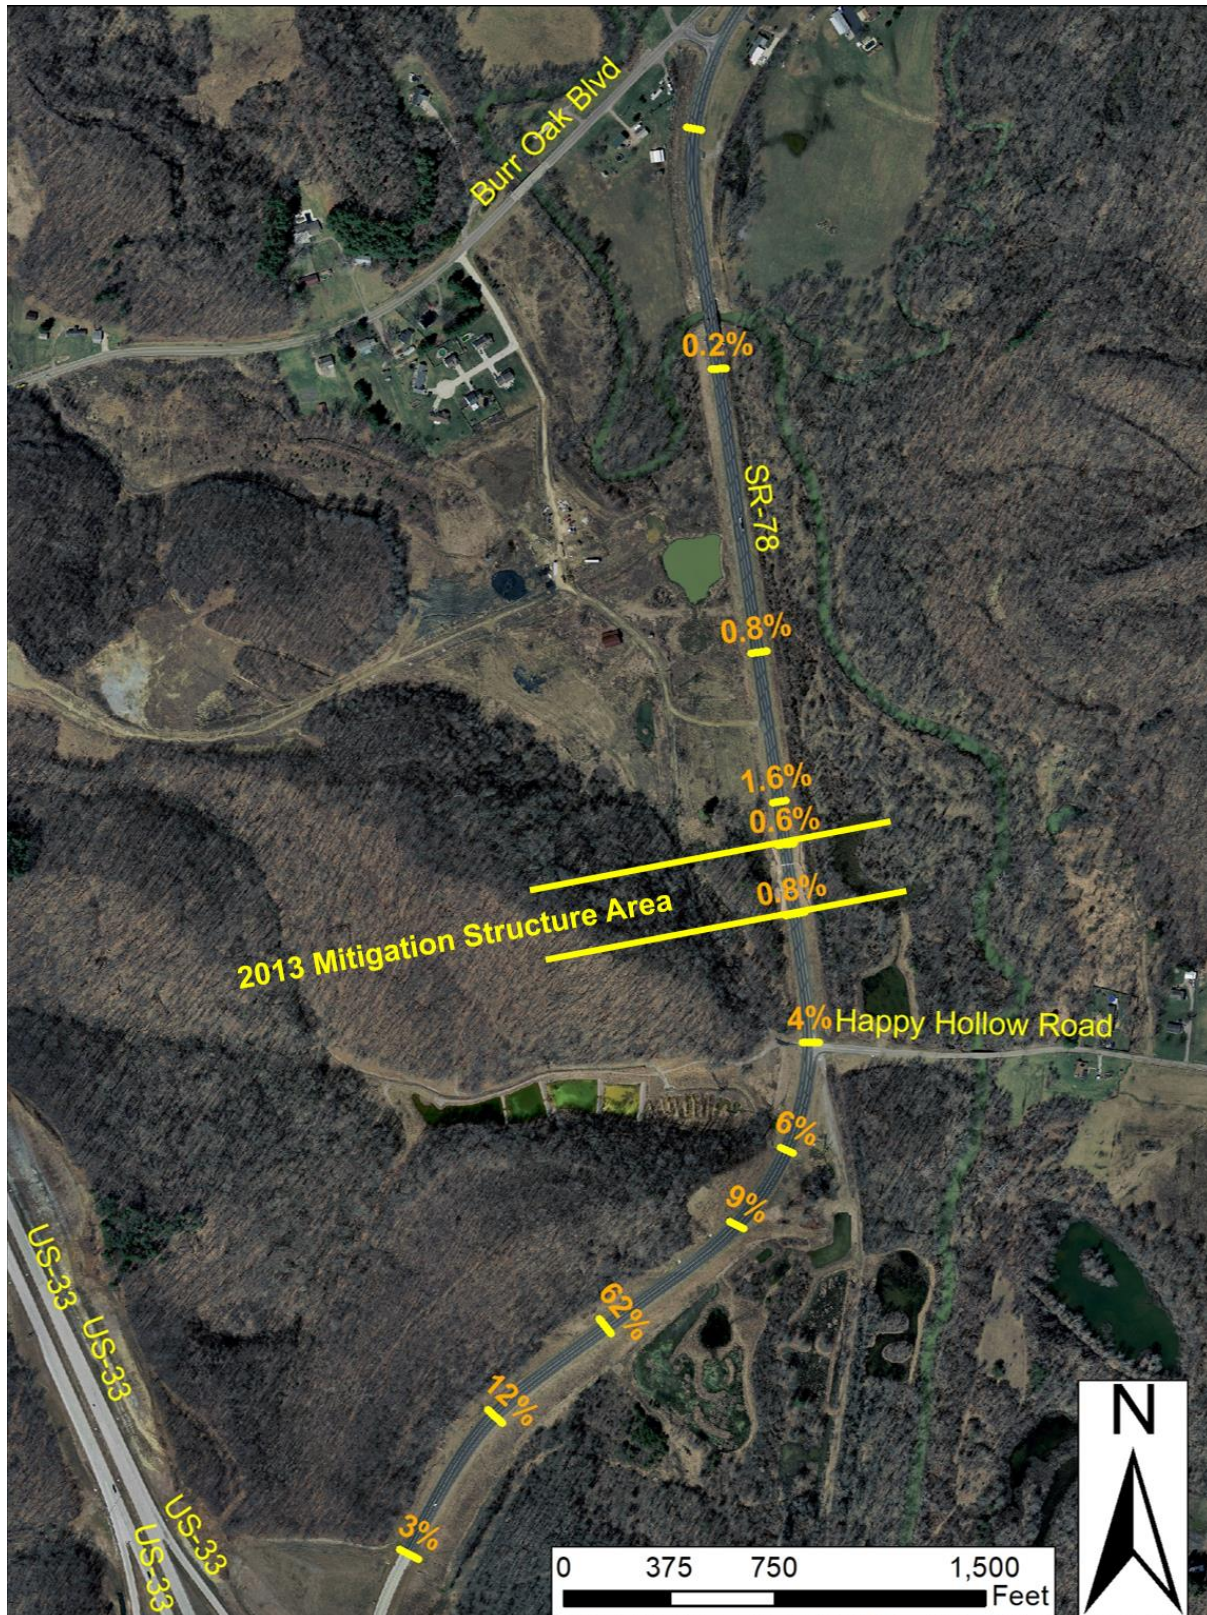
Figure 5. Percentages of mortality found in each roadway section along State Route 78 near Nelsonville in Athens County, Ohio, 2015-2016. 62% of roadway mortality was found in section S4, the fourth section south of the 2013 barrier-ecopassage mitigation structure.

Before the pseudoecopassage experiment, 62% of the mortality was found in road section S4 (Figure 5). While the pseudoecopassage experiment was in place, we still found 34-20% of mortality in S4, but once the 2018 barrier-ecopassage system was in place we saw mortality shift to road sections S3 and S5. The 2018 mitigation structure reduced mortality from 62% of total mortality down to 4% in the area it was located, though we saw evidence of concentrated mortality at the barrier fence ends, (i.e., fence-end effect), with mortality shifted to the road sections on either side of the barrier fence.

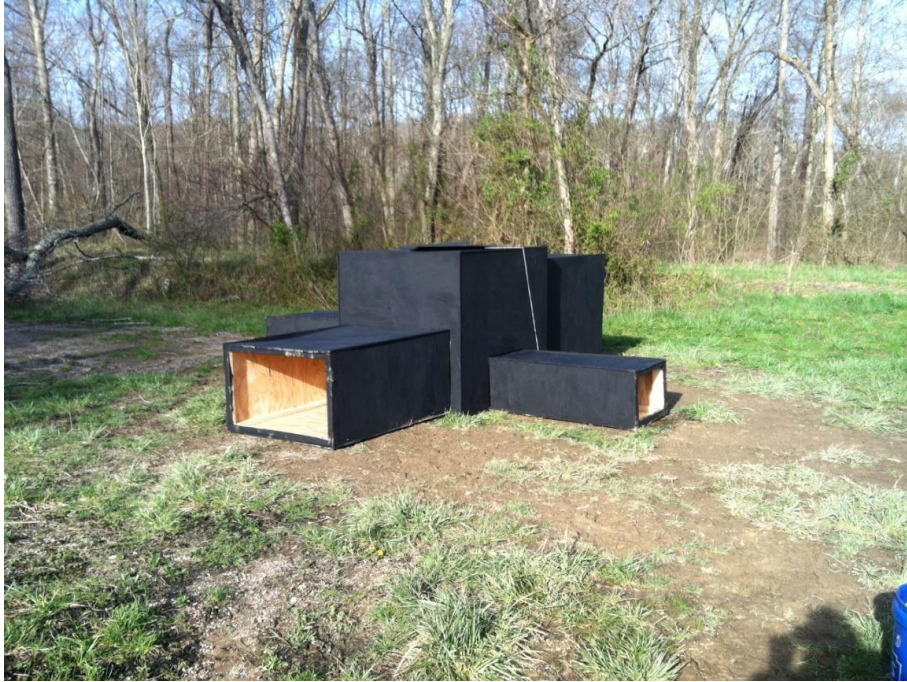
Figure A2-2. Entrance size choice experiment, with four exits differing in size.

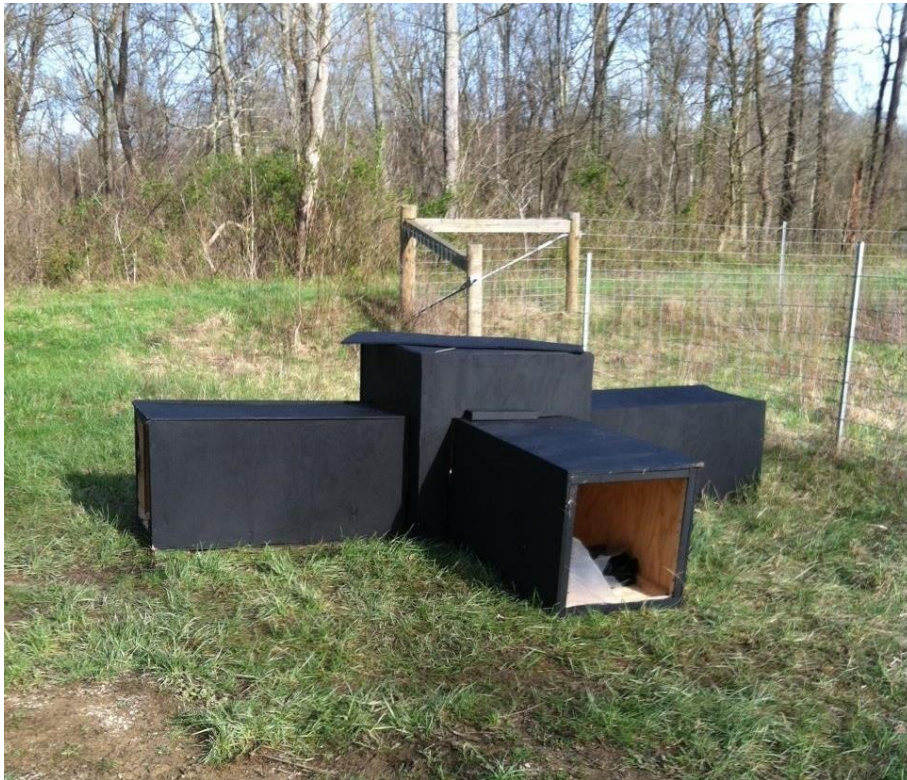
Figure A2-3. Setup for sky exposure and line-of-sight choice experiments, with three exit passages that are all the same size.

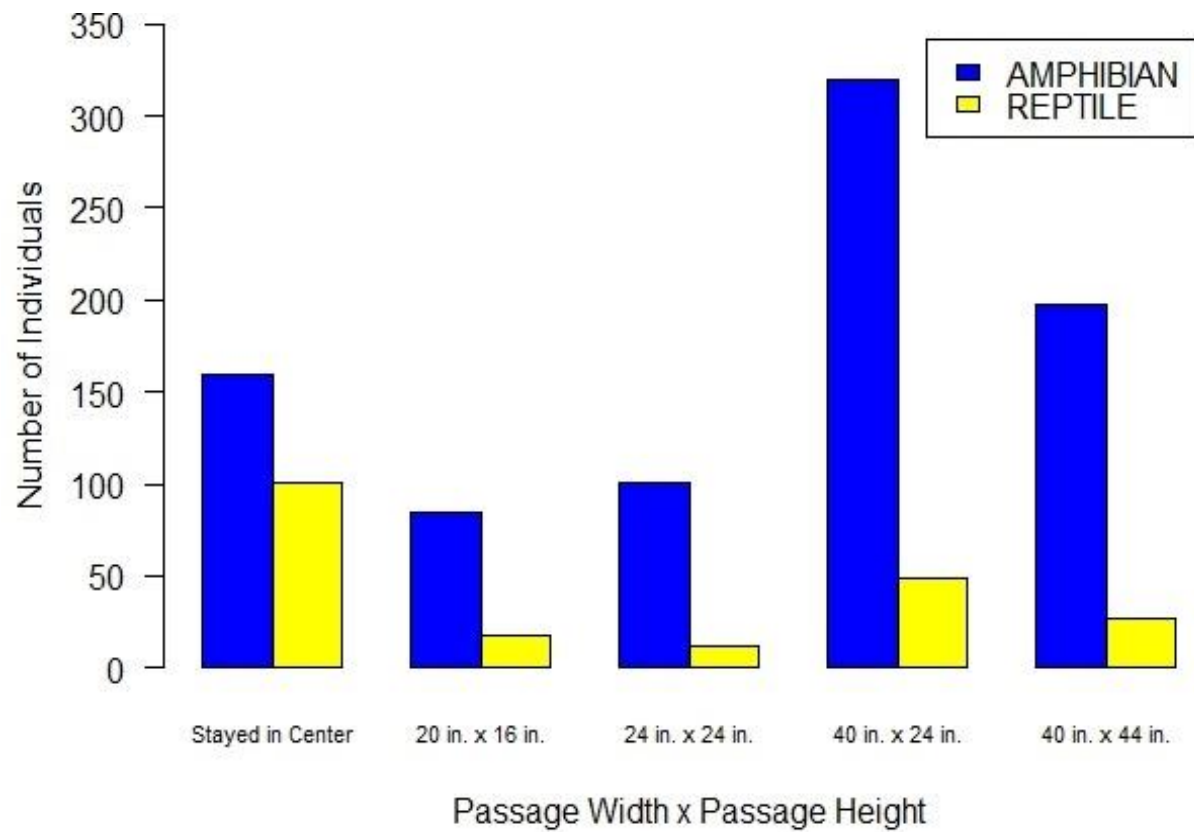
Figure A2-5. The number of individual amphibians and reptiles that chose each exit passage in the entrance size choice experiment. Individuals could choose passages with entrance sizes of 20 in. x 16 in., 24 in. x 24 in., 40 in. x 24 in., 40 in. x 44 in., or to stay in the center chamber.

We used 20 species of herpetofauna in our choice experiments (Table 1, Table 2, Figure A2-4). In our choice experiments, we found that herpetofauna preferred wider ecopassages (Table A2-1, Figure A2-5), ecopassages with full sky exposure (Table A2-2, Figure A2-6), and ecopassages with a full line-of-sight (Table A2-3, Figure A2-7). This was mirrored by the results of the pseudoecopassage experiment, where the majority of herpetofauna chose passages with a fully maintained line-of-sight and full sky exposure (Table A3-2, Figure A3-7). These two experiment types are consistent in that animals made the same choice despite experiment type (Table A4-1, Figure A4-2, Table A4-2, Figure A4-3).

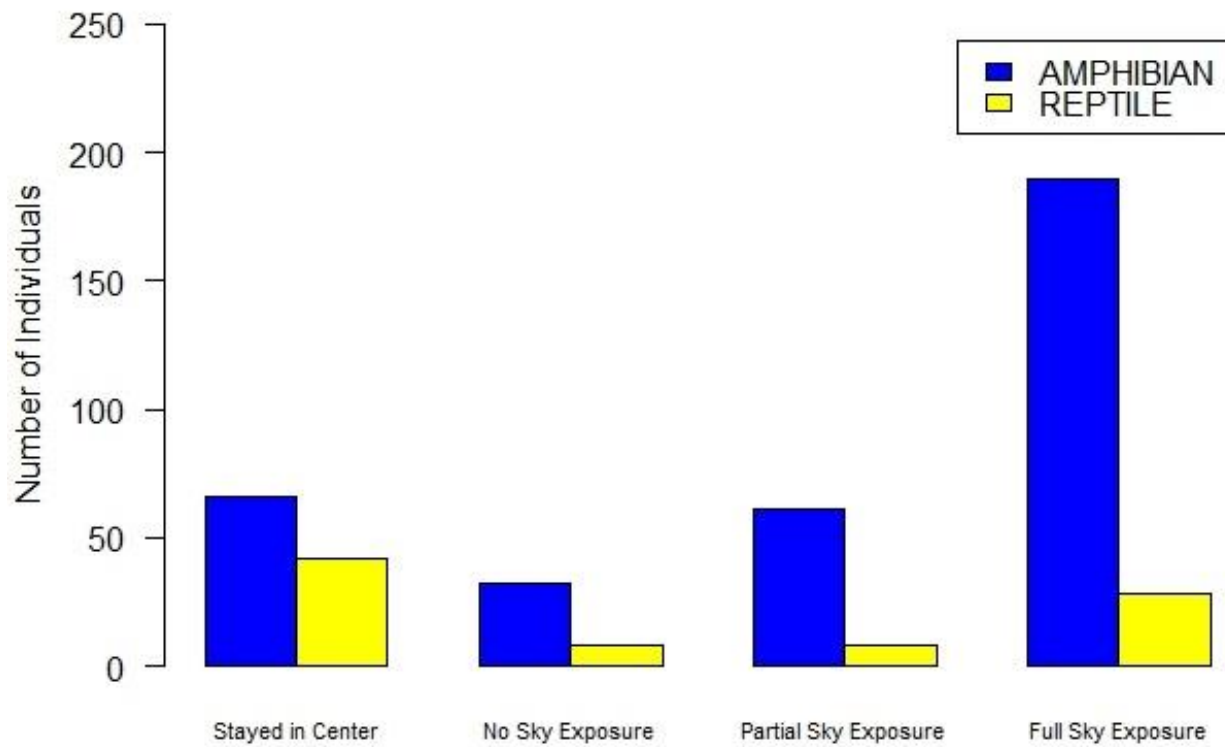
Figure A2-6. The number of individual amphibians and reptiles that chose each exit passage in the sky exposure choice experiment. Individuals could choose passages with no sky exposure, partial sky exposure, full sky exposure, or to stay in the center chamber.

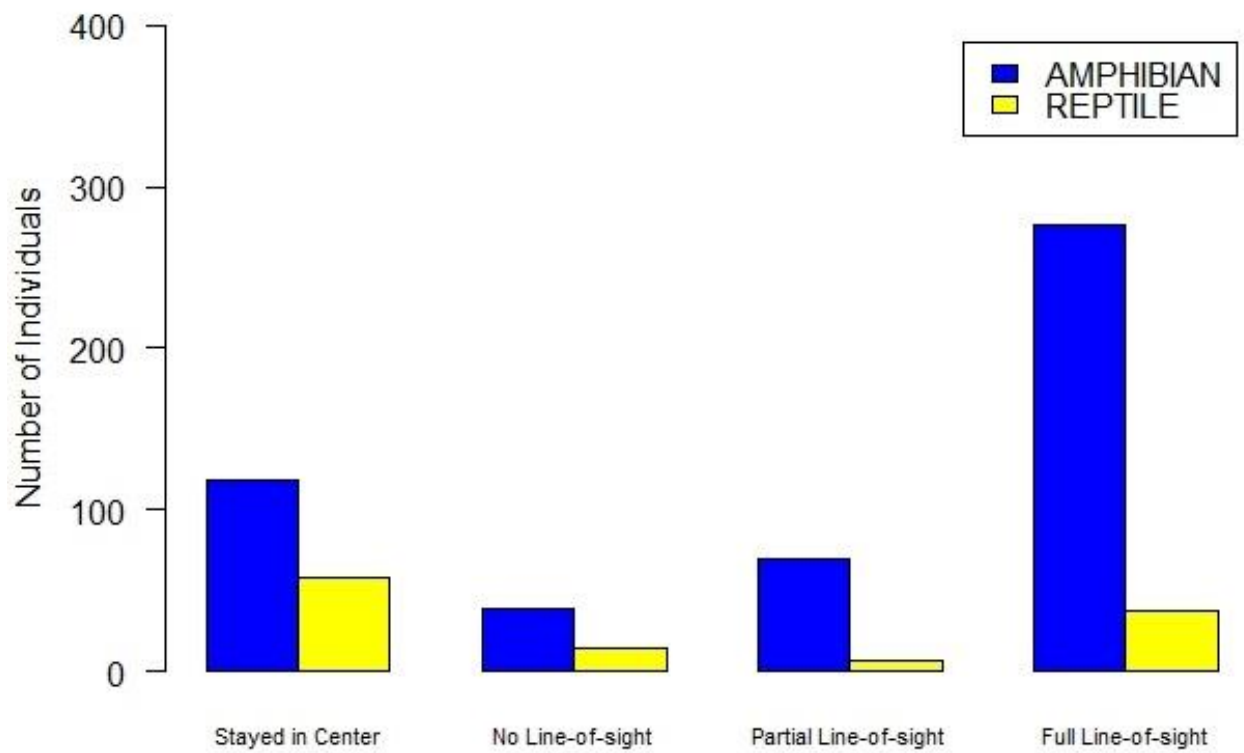
Figure A2-7. The number of individual amphibians and reptiles that chose each exit passage in the line-of-sight choice experiment. Individuals could choose passages with no line-of-sight, partial line-of-sight, full line-of-sight, or to stay in the center chamber.

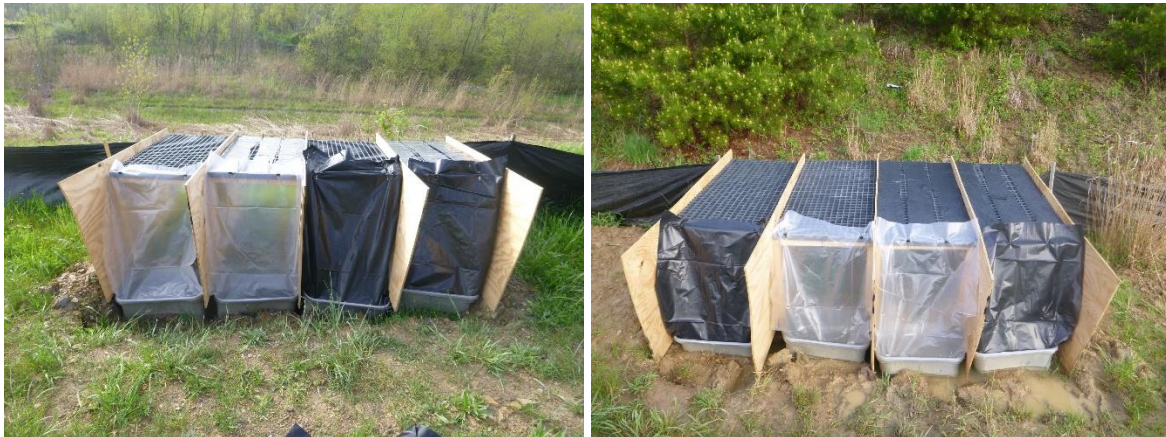
Figure A3-1. Pseudoecopassage replicates along State Route 78 near Nelsonville in Athens County, Ohio. The order of the design treatments was randomized for each pseudoecopassage replicate. There were eight pseudoecopassage replicates in 2017 and 14 pseudoecopassage replicates in 2018.

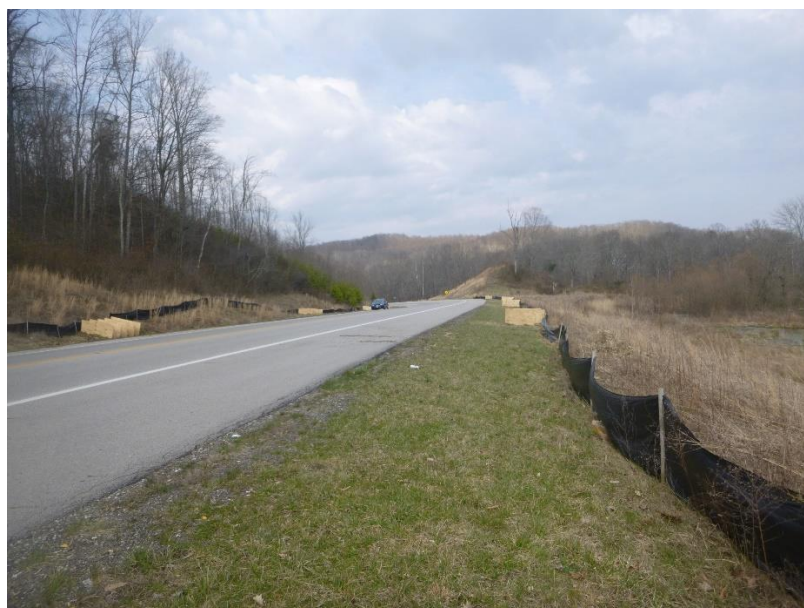
Figure A3-3. Pseudoeocopassage experiment in place along State Route 78 near Nelsonville in Athens County, Ohio.

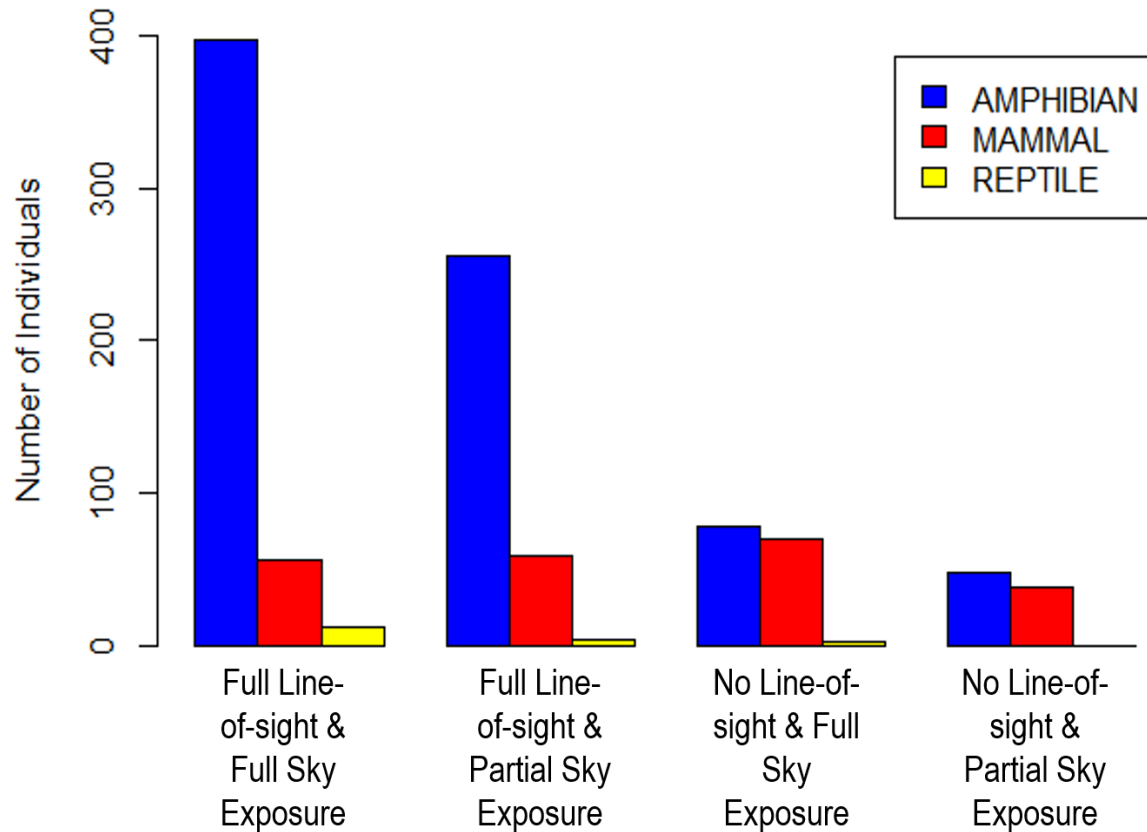
Figure A3-7. The number of individual amphibians, mammals, and reptiles that chose each exit passage in the pseudoecopassage experiment in place along State Route 78 near Nelsonville in Athens County, Ohio, 2017-2018. Individuals could choose pseudoecopassages with full line-of-sight & full sky exposure, full line-of-sight & partial sky exposure, no line-of-sight & full sky exposure, or no line-of-sight & partial sky exposure.

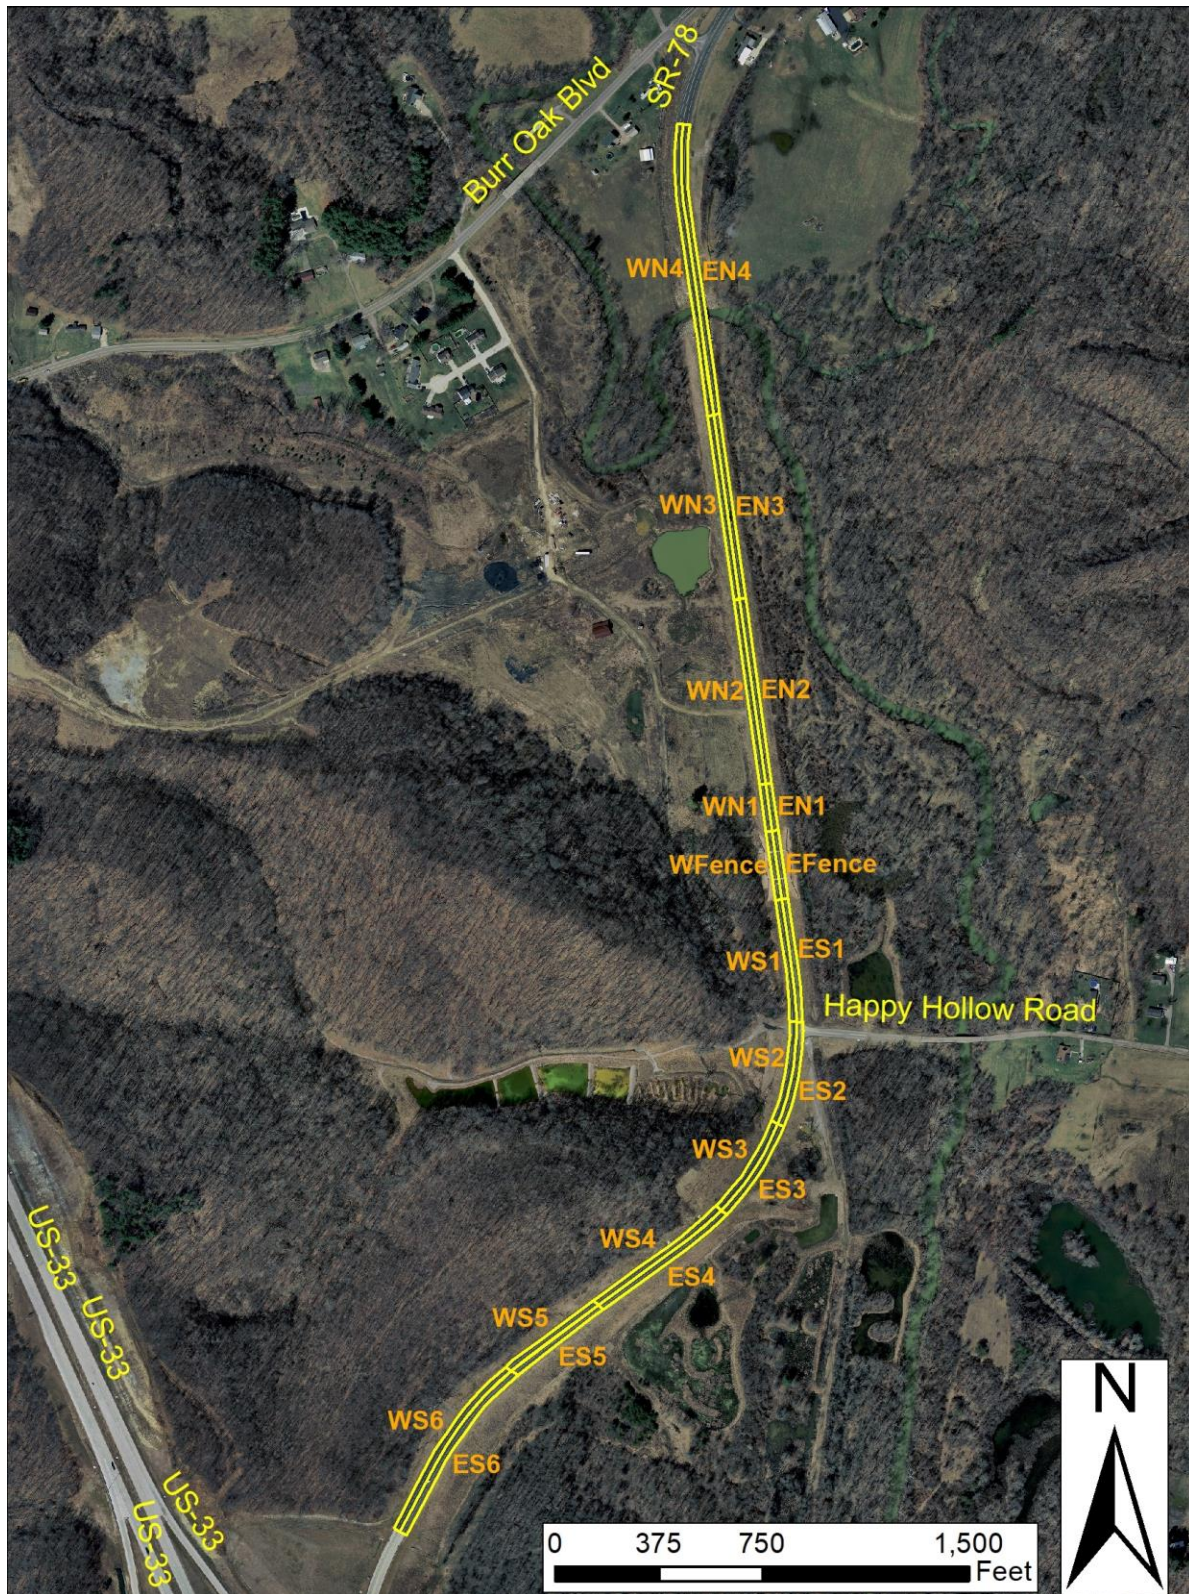
Figure A5-1. Roadway sections surveyed for vertebrate carcasses along a 1.2 mile stretch of State Route 78 near Nelsonville in Athens County, Ohio. The US Highway 33 exit is at the southwestern edge of the figure and the Burr Oak Blvd intersection is at the north edge of the figure. For analyses we combined the number of carcasses found on each side of the road for each section (ex. WS5 + ES5 = S5).

Beckmann & Shine 2015). In addition, the roadway section the animal was found in was recorded; roadway sections were determined by habitat changes along SR 78 (Figure 5; labeled in Figure A5-1). Roadkill survey data was tabulated and summarized in graphical format for descriptive analysis. We also evaluated road section mortality data from six time frames: (1) before the pseudoecopassage experiment, (2) during the 2017 pseudoecopassage experiment, (3) during the 2018 pseudoecopassage experiment, (4) during the 2018 barrier-ecopassage system implementation, (5) after 2018 barrier-ecopassage system implementation occurred while repairs to the system were taking place, and (6) after the 2018 barrier-ecopassage system was fully completed. To assess whether the number of vertebrate carcasses detected in each roadway section for a given time frame varied we used chi-square tests, with the null hypotheses that all roadway sections would have equal amounts of carcasses in each time frame. To assess whether the six time frames had different roadway section mortality rates from each other we used chi-square tests for goodness-of-fit. Thus, our null hypotheses were that any given time frame would not have significantly different road section mortality frequencies as compared with the road section mortality frequencies of any other time frame. See Appendix 5: Roadway Mortality for additional detail.

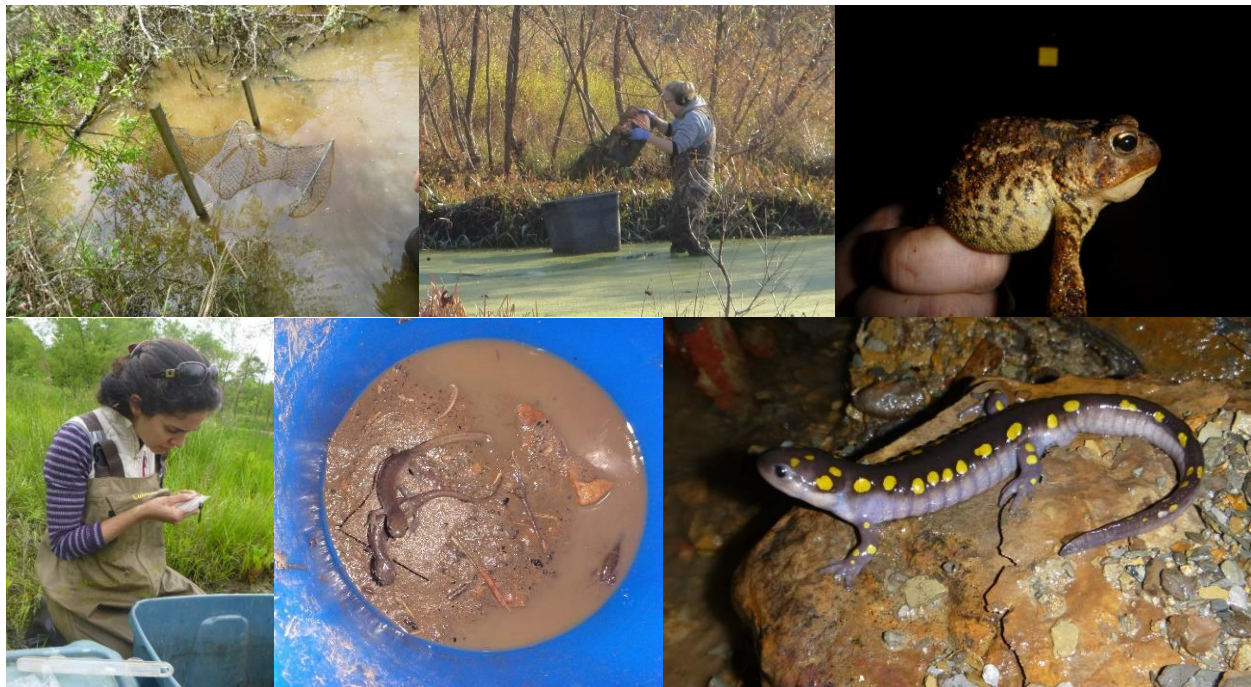
Figure A6-2. Images of a 36 in. hoop net trap (top left), C. B. Hopkins checking a minnow trap (top center), an American Toad found during a spotlight survey (top right), K. E. Harman measuring a Green Frog (bottom left), two Jefferson Salamanders in a pitfall trap (bottom center), and a Spotted Salamander released after measurements were taken (bottom right).

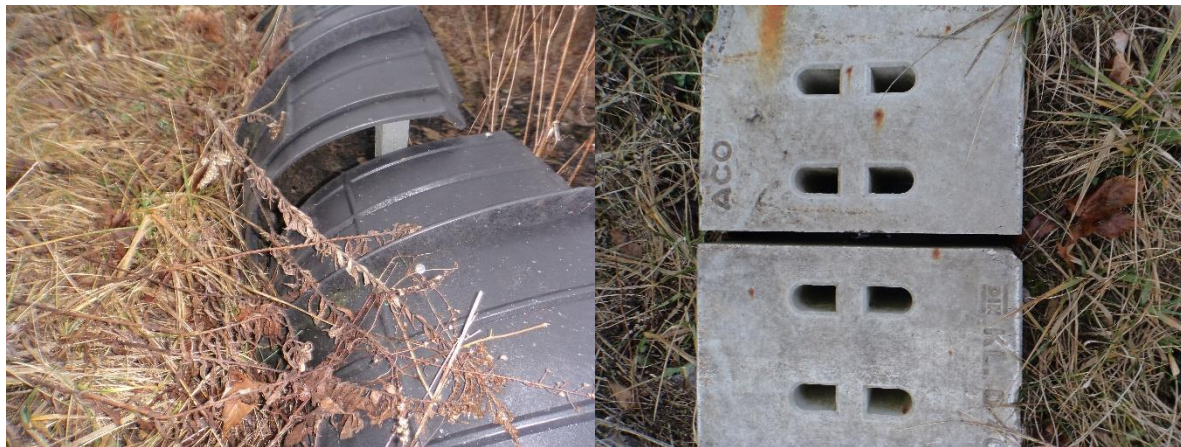
Figure A7-5. Maintenance concerns of the 2013 barrier-ecopassage system in place along State Route 78 near Nelsonville in Athens County, Ohio. Gaps and cracks in the plastic barrier fencing (left) and separation of concrete blocks that make up the ecopassages (right).

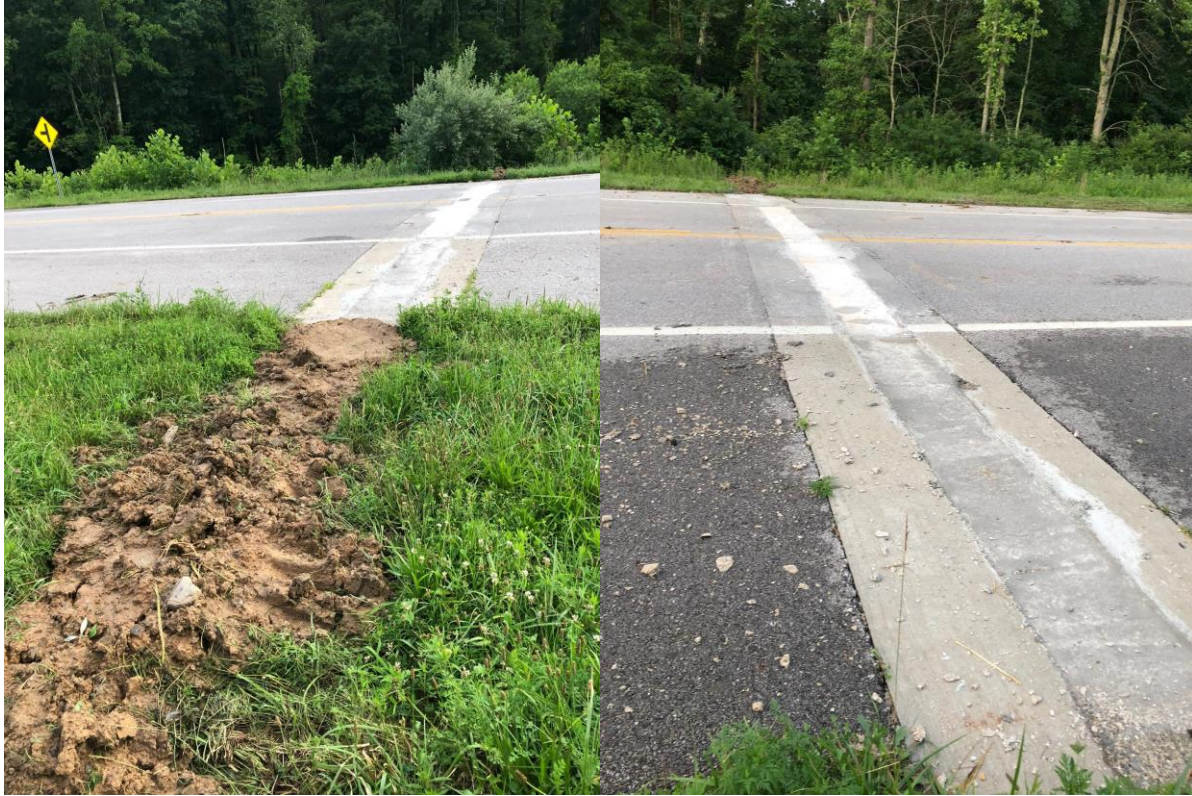
Figure A7-6. The 2013 ecopassages in place along State Route 78 near Nelsonville in Athens County, Ohio after they were filled in with concrete on June 27, 2019.

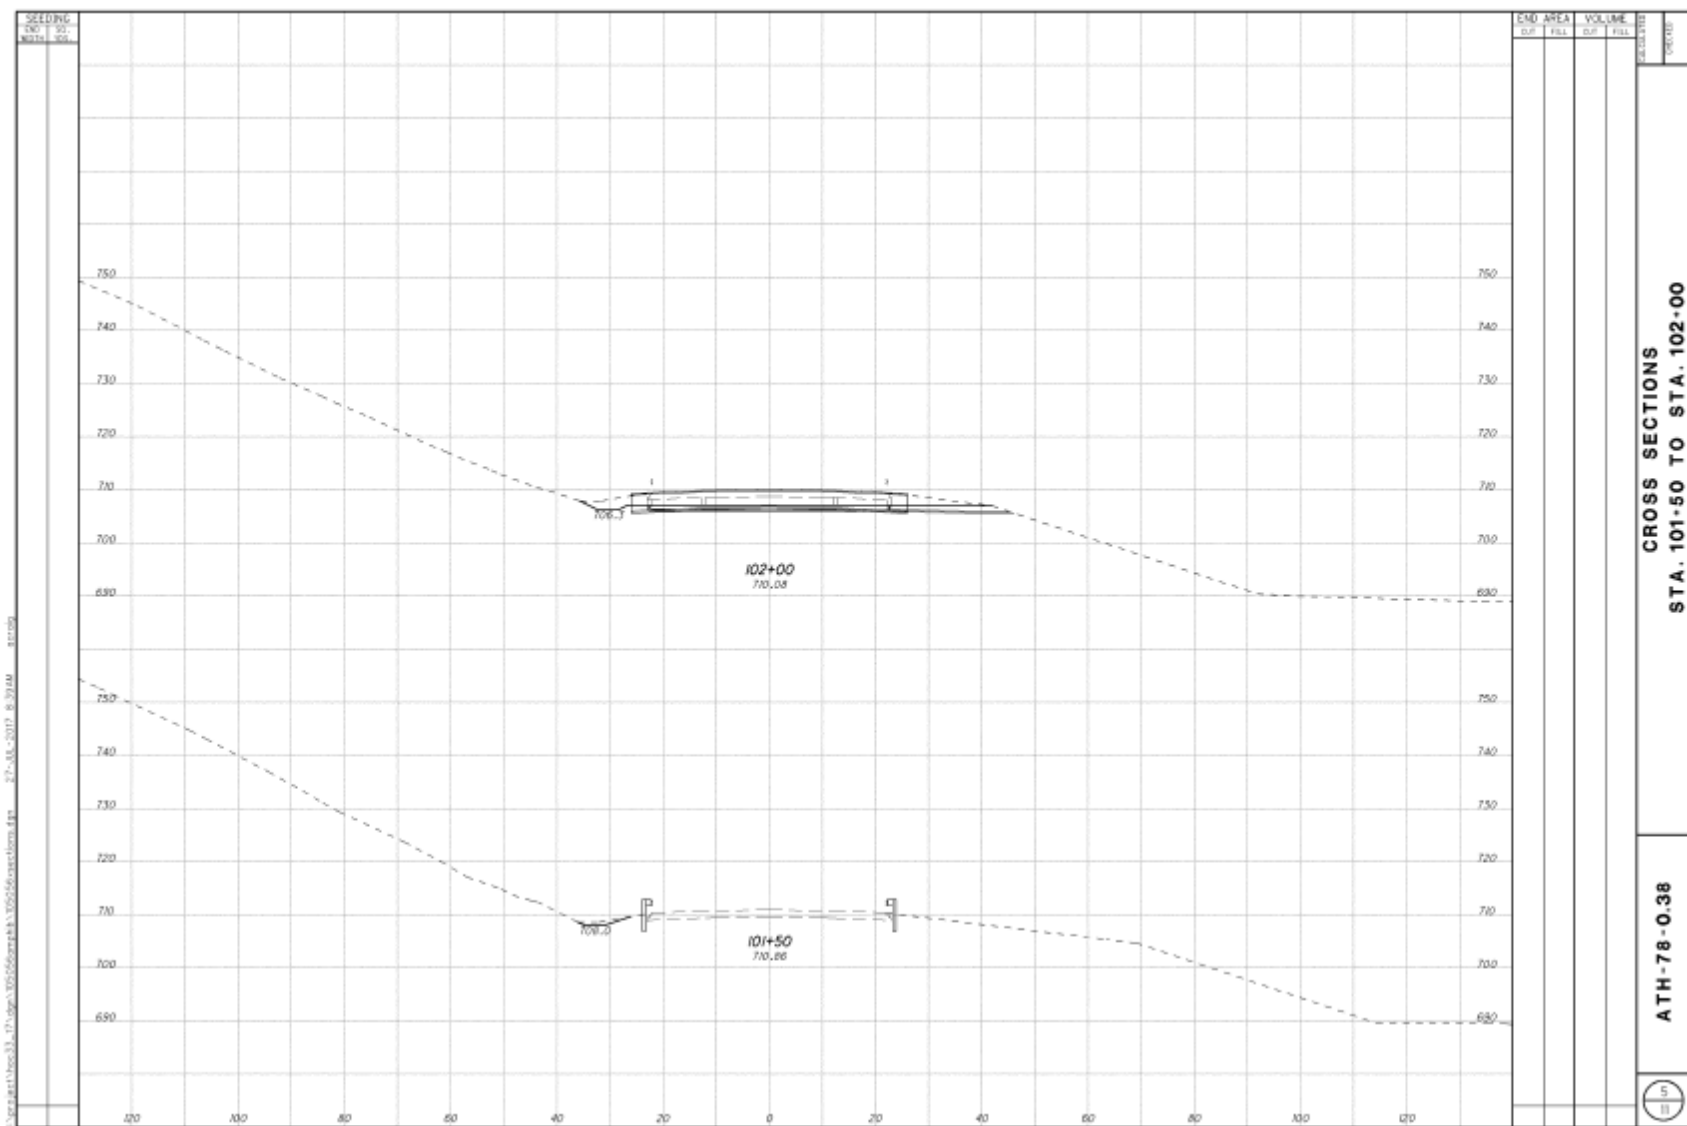
Figure A9-4. Design plan cross section for ecopassage 2 of the 2018 barrier-ecopassage system implemented along State Route 78 near Nelsonville in Athens County, Ohio (ecopassages are labeled in Figure A9-2). Created by Alan Craig, District 10 Planning Engineer, Ohio Department of Transportation District 10.

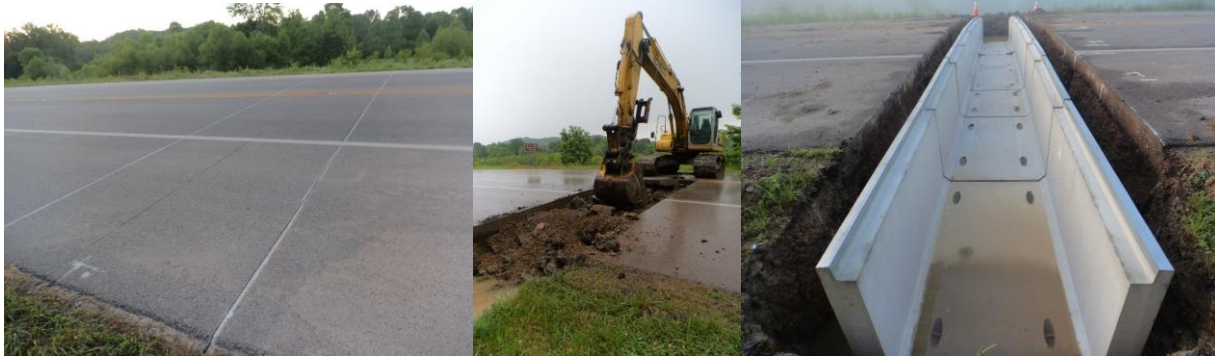
Figure A9-9. Roadway that has been painted and sawed through (left), excavated road cut (center), and concrete ecopassage placed into an excavated road cut (right).

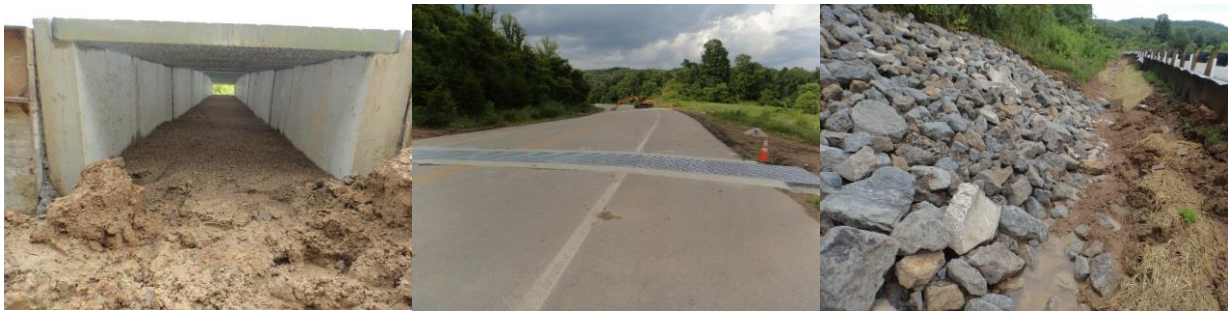
Figure A9-10. Ecopassage with layer of soil on the bottom (left), ecopassage with grated top in place (center), and rock bank and hay on biodegradable mesh used to prevent erosion (right).

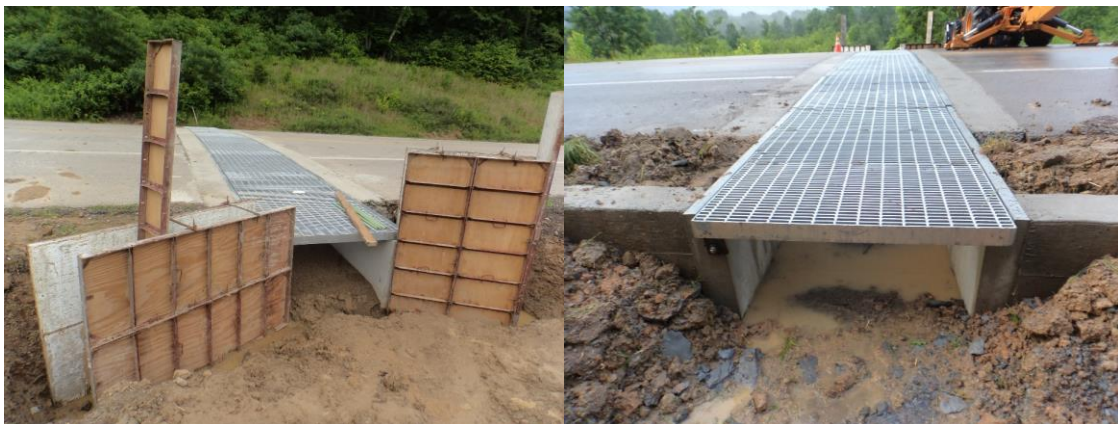
Figure A9-11. Ecopassage headwalls being created at an angle on the east side of the road (left) and completed headwalls that are straight on the west side of the road (right).

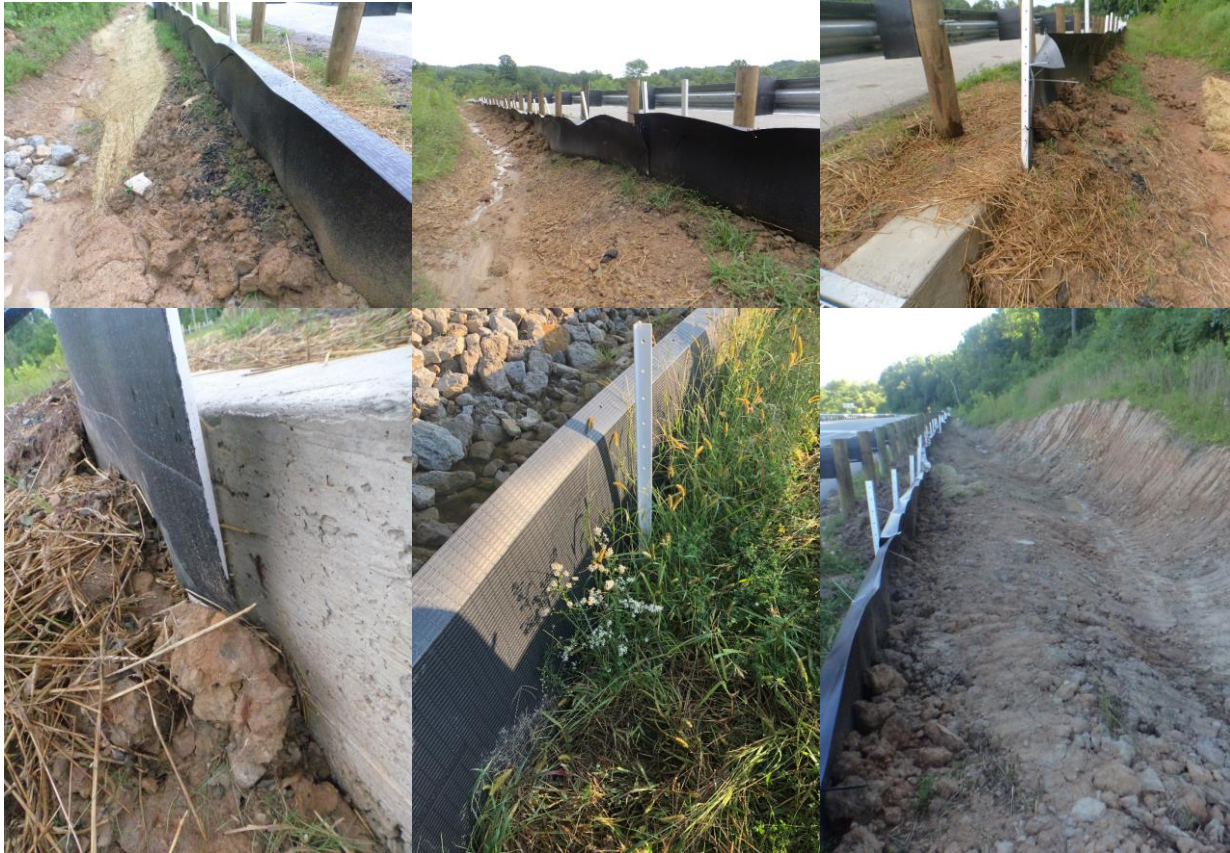
Figure A9-12. Ecopassage barrier fencing not buried in the ground (top left), barrier fencing top lip not folded properly (top center), barrier fencing not properly interfacing with the ecopassage headwall to prevent animal trespass (top right), bare headwall being climbed by a Red-spotted Newt (bottom left), barrier fencing not properly attached to fence post (bottom center), and steep ditch with no erosion control measures (bottom right).

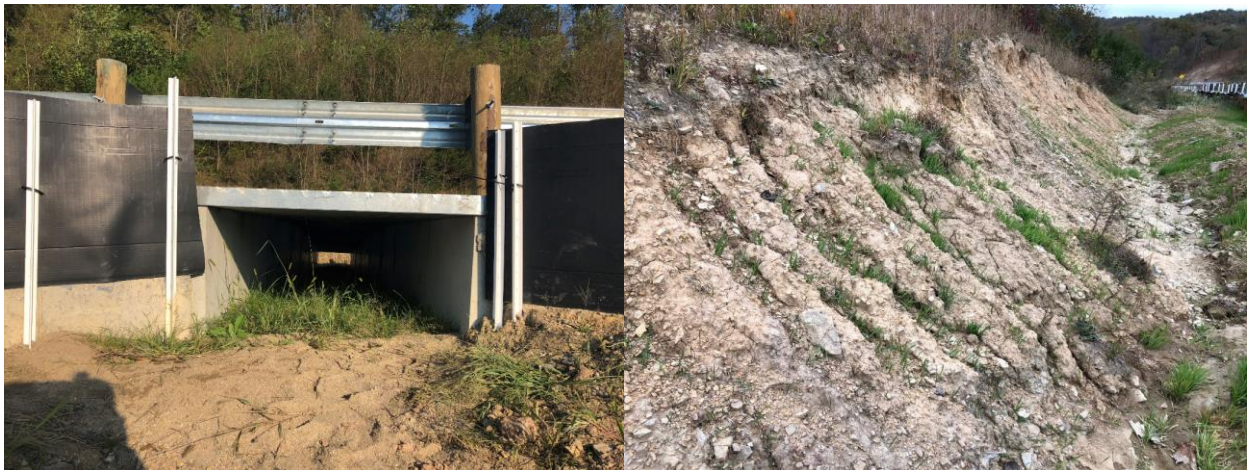
Figure A9-13. Barrier fencing attached to ecopassage headwalls (left) and grasses growing after the seeding of bare soils to reduce erosion (right).

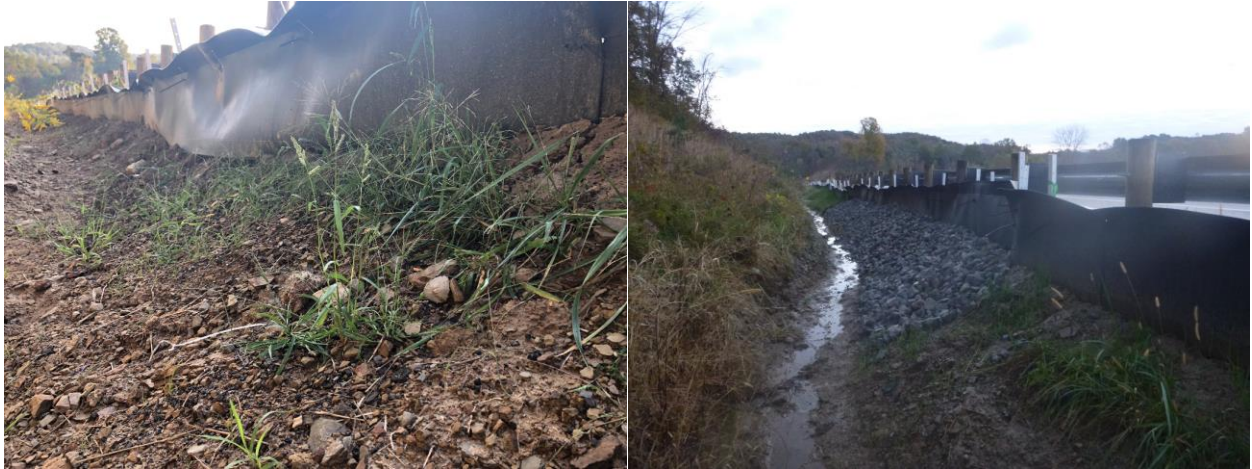
Figure A9-14. Area of erosion along fence before (left) and after (right) a rock bank was installed to reduce erosion.

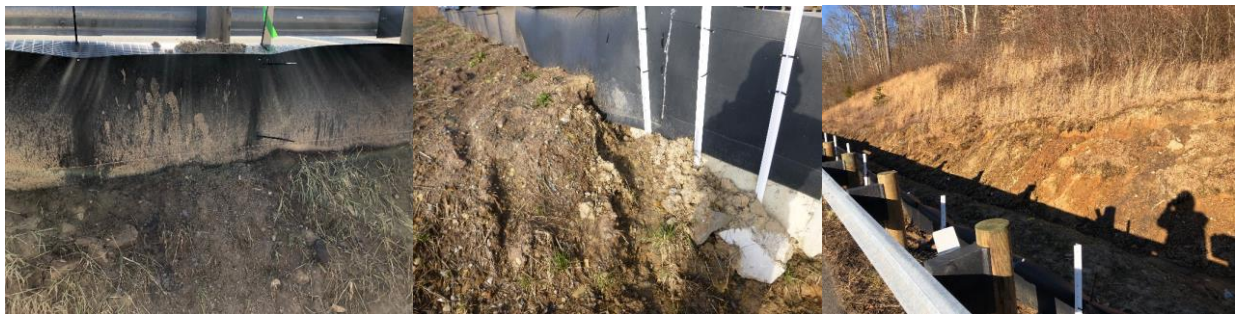
Figure A9-15. Area of erosion along barrier fence (left), area of erosion near an ecopassage headwall (center), and erosion on hillside (right) all after rains in spring 2019.

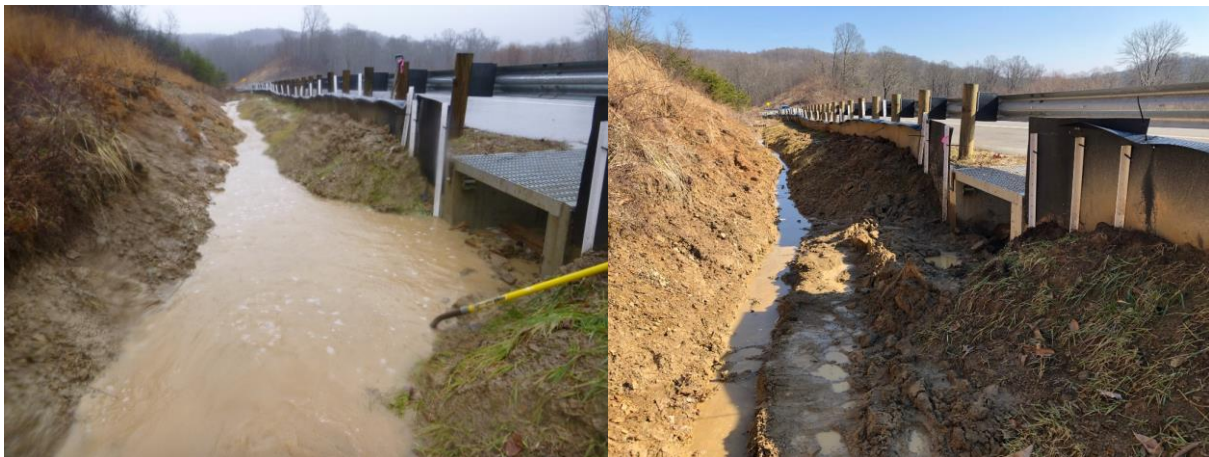
Figure A9-16. Flooding of ecopassage 3 in spring 2019 (left) and ecopassage 3 after an earthen dam was constructed to prevent further flooding (right) (ecopassages are labeled in Figure A9-2).

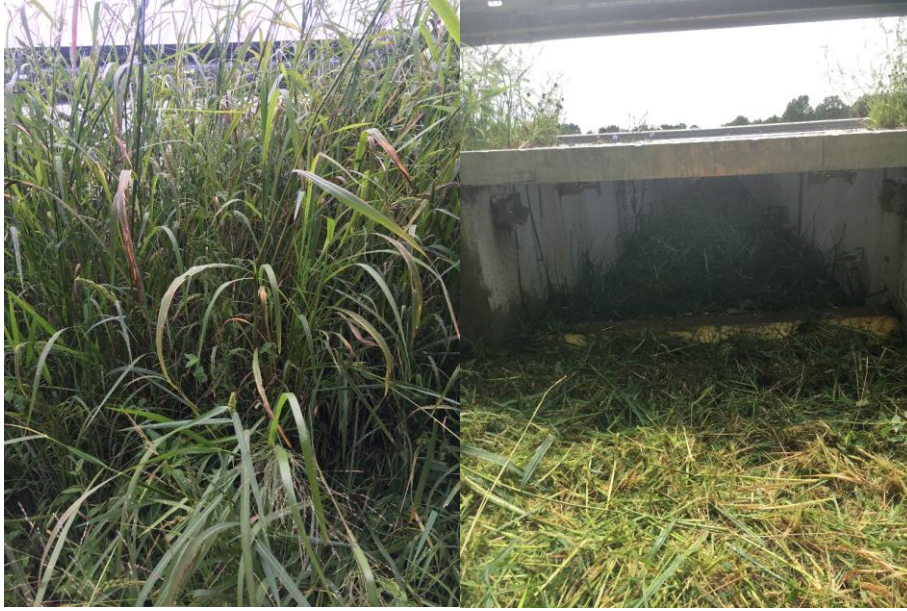
Figure A9-17. Before (left) and after (right) vegetation removal in front of one of the ecopassage entrances on August 23, 2019.
