# Improving Amphibian Roadway Mitigation to Decrease Mortality and Increase Connectivity by Experimenting with Ecopassage Design

*Prepared for:*  
The Ohio Department of Transportation,  
Office of Statewide Planning & Research

State Job Number 135504

*Final Report*

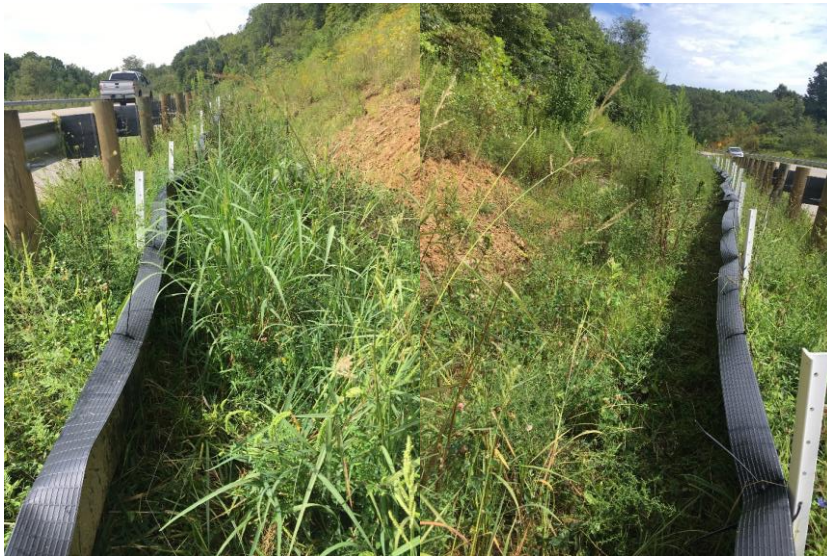
Figure A9-18. Before (left) and after (right) vegetation removal along the barrier fence on August 23, 2019.

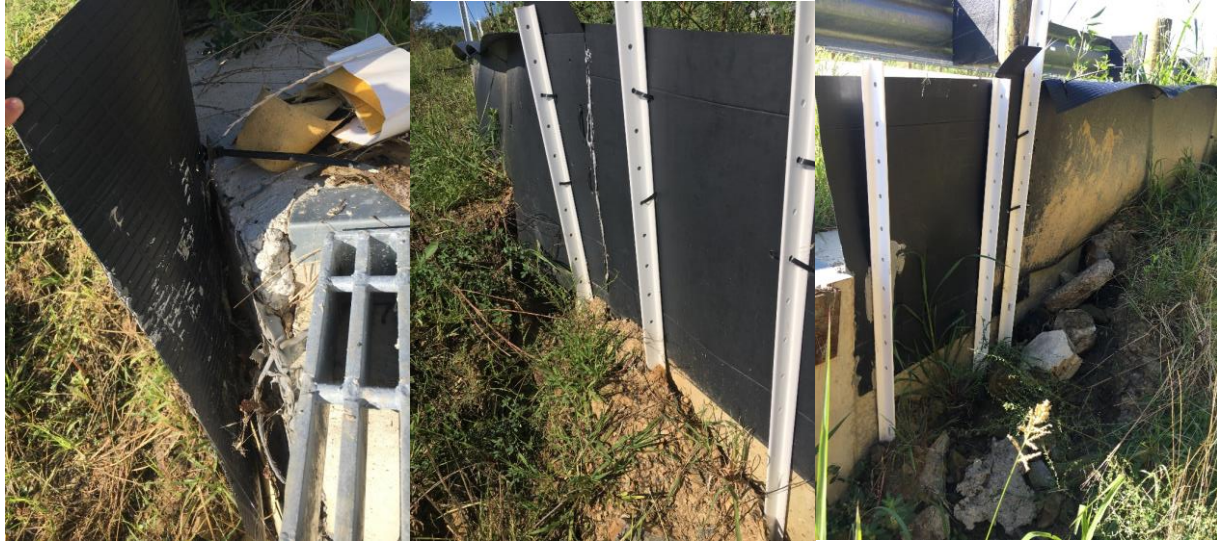
Figure A9-19. Area where fencing had separated from the headwall (left), area along a headwall where two pieces of fence had separated (center), and a persistent eroded area along the southwest headwall of ecopassage 5 (right) (ecopassages are labeled in Figure A9-2).

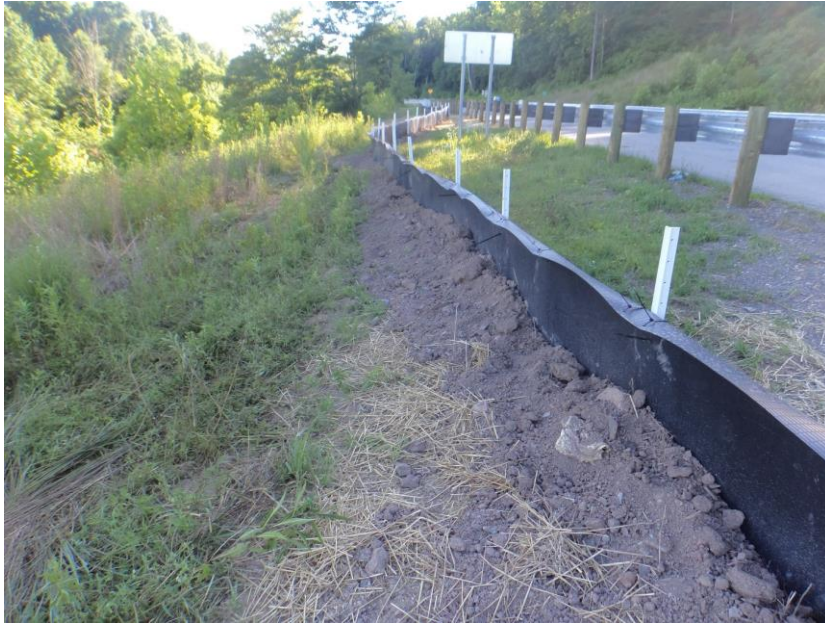
Figure A10-1. The 2018 barrier fencing angled toward ecopassages from the center on the east side of State Route 78 near Nelsonville in Athens County, Ohio.

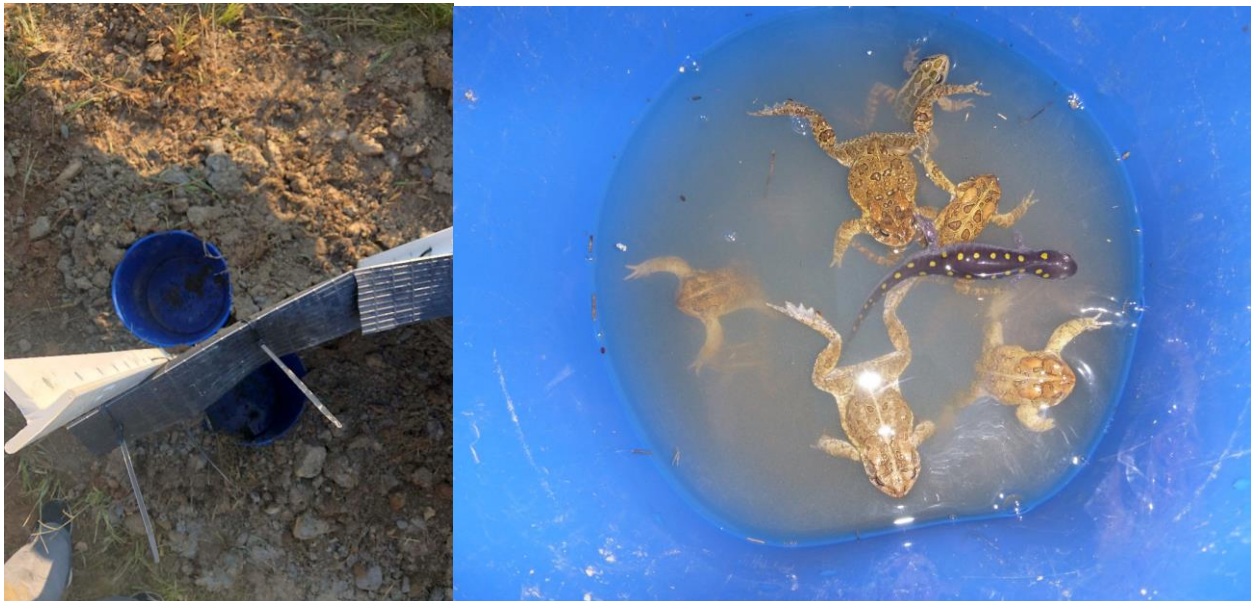
Figure A10-2. Pitfall traps on either side of the end of the 2018 barrier fencing along State Route 78 near Nelsonville in Athens County, Ohio (left) and several American Toads, a Pickerel Frog, and a Spotted Salamander trapped in a pitfall trap (right).

We captured 11 species of frogs and salamanders in the pitfall traps at the ends of the 2018 barrier fence; the only species not captured in the pitfall traps that was detected in the ecopassages was Gray Treefrog (Figure A10-7 through A10-9), which is able to climb out of pitfall traps. A total of 1,284 individual amphibians were trapped in the fence end pitfall traps (Figure A10-7 through A10-9).

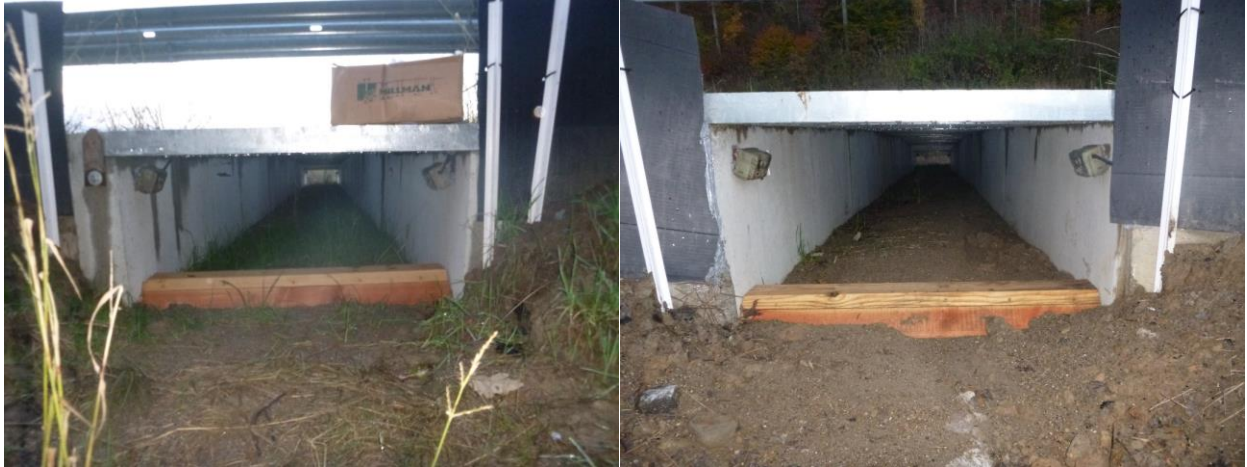
Figure A10-3. Spypoint Tiny-W3 cameras and viewing ramps set up to take photographs of the ecopassage entrances. Right photo shows some erosion from under the ramp after a rain, which was repaired later that day.

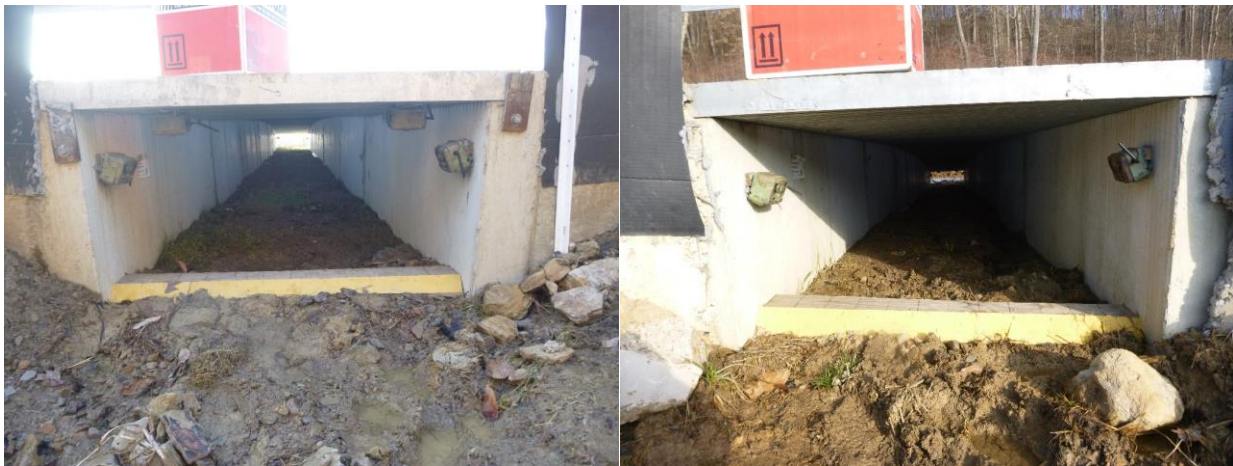
Figure A10-4. Spypoint Tiny-W3 cameras and viewing ramps set up on a west passage entrance (left) and an east passage entrance (right) in the spring of 2019.

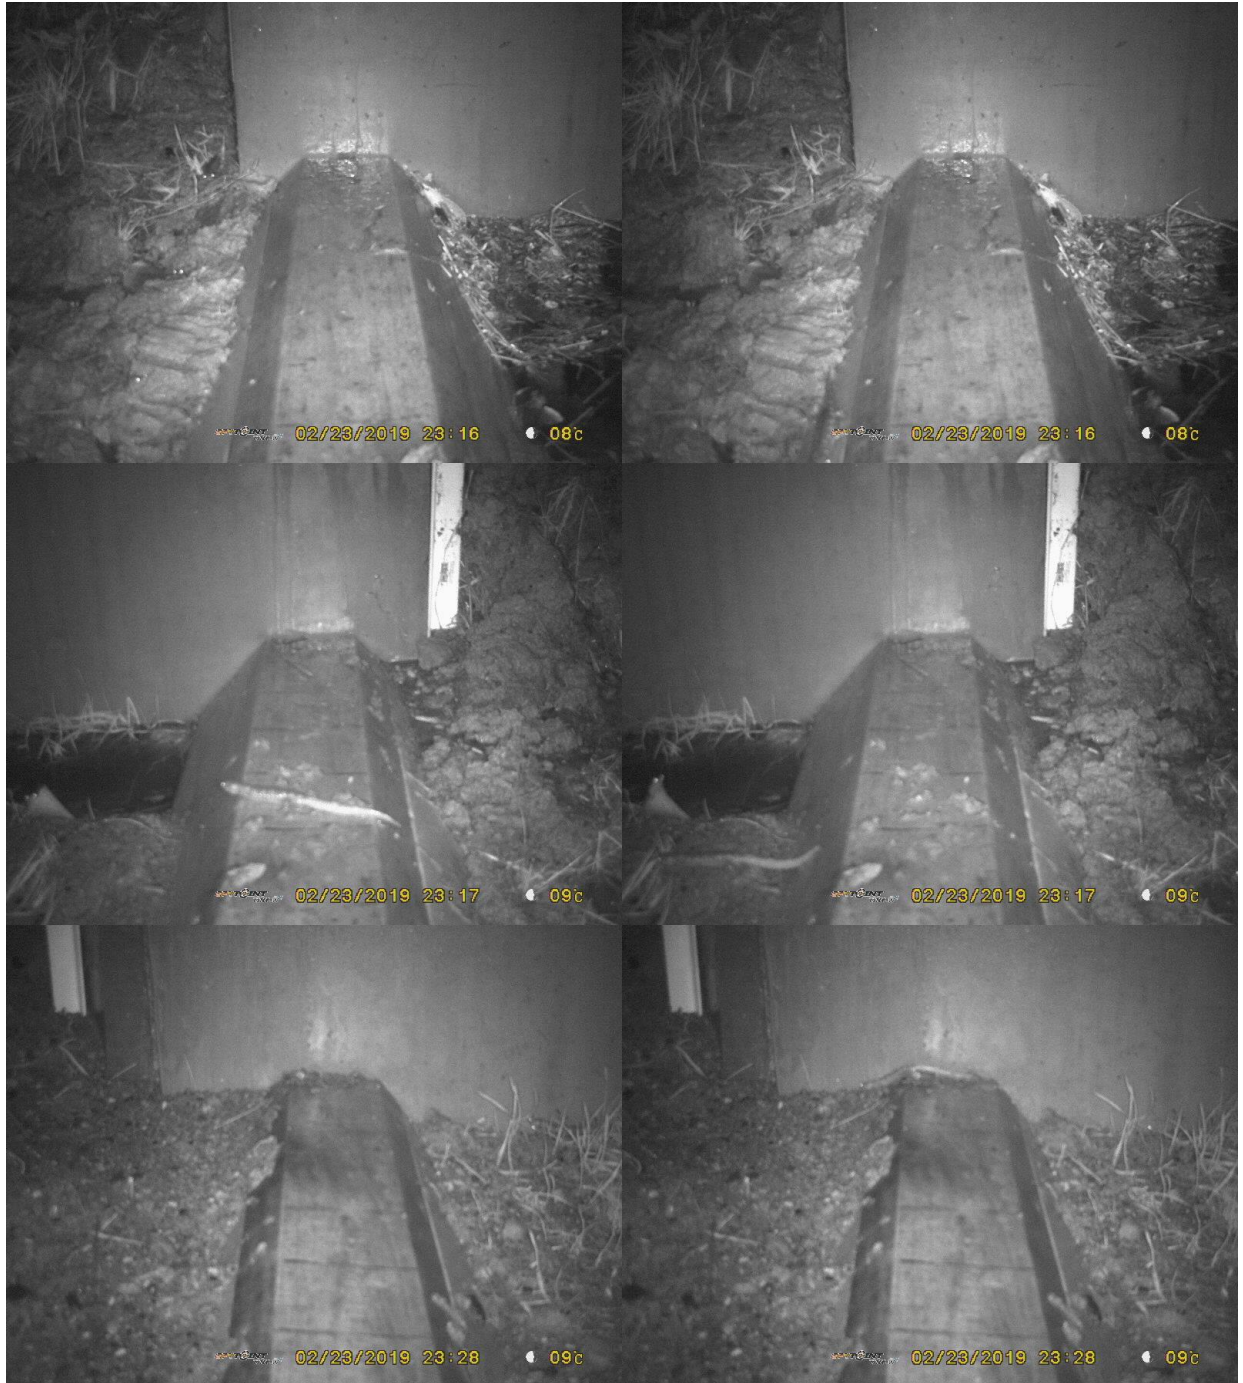
Figure A10-5. A Spotted Salamander detected by a north facing ecopassage entrance camera on the west side of the road (top left and right), then detected by the south facing camera on the west side of the road (center left and right), and then detected by the south facing camera on the east side of the road (bottom left and right).

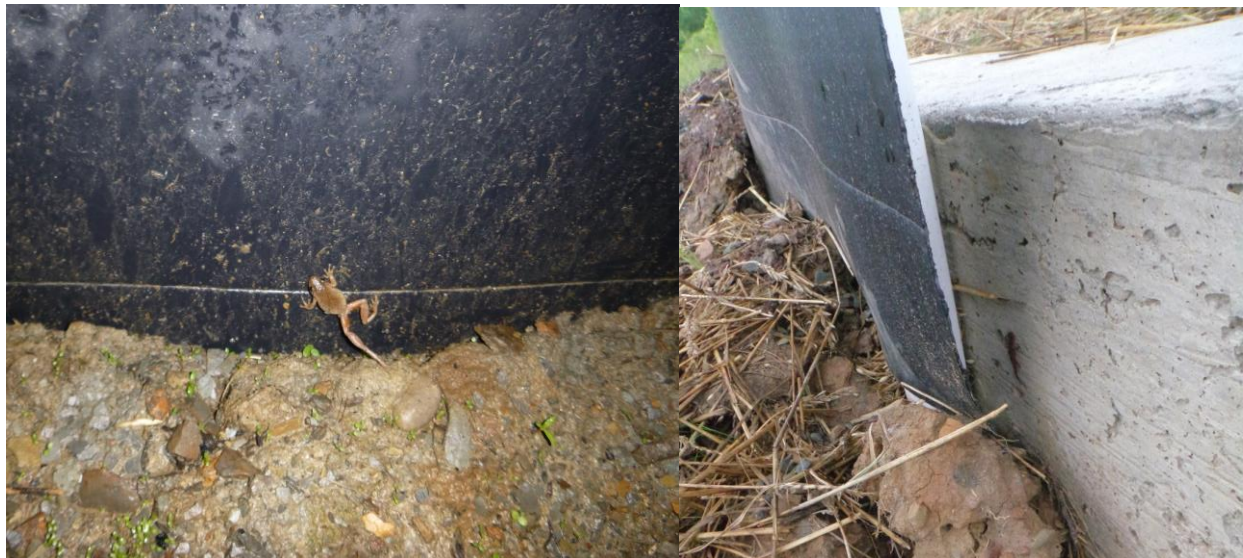
Figure A12-3. A Spring Peeper climbing the 2018 barrier fence (left) and a Red-spotted Newt climbing a concrete ecopassage entrance headwall (right).

**RESULTS** – We observed six amphibians as they approached the barrier fence and all of them followed the curve of the fence toward the nearest ecopassage. Four amphibians (two Spring Peepers and two Gray Treefrog) climbed up the barrier fencing (Figure A12-3), but were unable to get over the fence due to the lip at the top. We also witnessed several Red-spotted Newts and one Jefferson Salamander trying to climb the fencing, but none succeeded in making it off the ground. We observed nine amphibians (six Red-spotted Newts and three Spring Peepers) climb the concrete headwalls before we attached the plastic fencing on September 20, 2018 (Figure A12-3, see Appendix 9: Implementation of 2018 Barrier-ecopassage System). We observed six Green Frogs and one American Toad abandon walking along the fence and move in a direction away from the fence. The farthest we saw a Green Frog travel along the fence was 360 ft. (1 hr. and 4 min.). The farthest we watched a Pickerel Frog travel was 80 ft. (12 min.), and we saw one juvenile American Toad walk 60 ft. (30 min.). The farthest we witnessed Spring Peepers, Gray Treefrogs, and Marbled Salamanders travelling along the fence

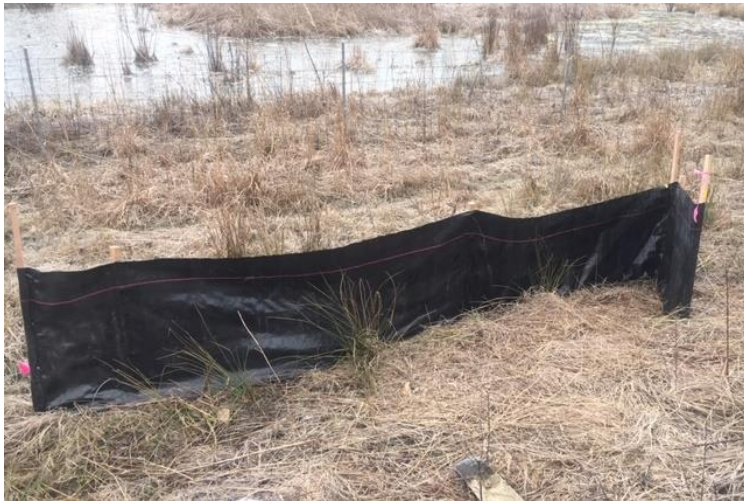
Figure A13-1. An experimental pseudofence set up with the 45-degree angle fence-end treatment on the right side of the fence.

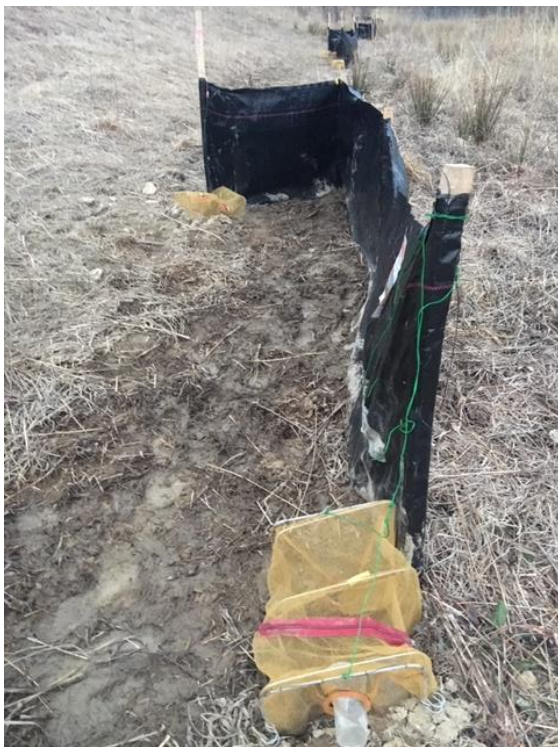
Figure A13-2. A side view of an experimental pseudofence array with funnel traps at each end. The treatment trap is located on fence-end treatment (top) and the control trap adjacent to the linear fence (bottom).

**RESULTS** – We captured 56 individual amphibians across five species (Spring Peepers, American Toad, Green Frog, Pickerel Frog, and Red-spotted Newt) in the pseudofence funnel traps. During this experiment, 77% (n=43) of the total captures were in the control traps compared to 23% (n=13) in the treatment traps. Spring Peepers comprised the majority of the amphibians captured (n=36). All amphibian species were more often captured in the control traps compared to the treatment traps (Figure A13-3), and a significantly higher number of individuals were captured in the control traps overall (paired t-test, t value=3.5, df=12, P-value <0.05).

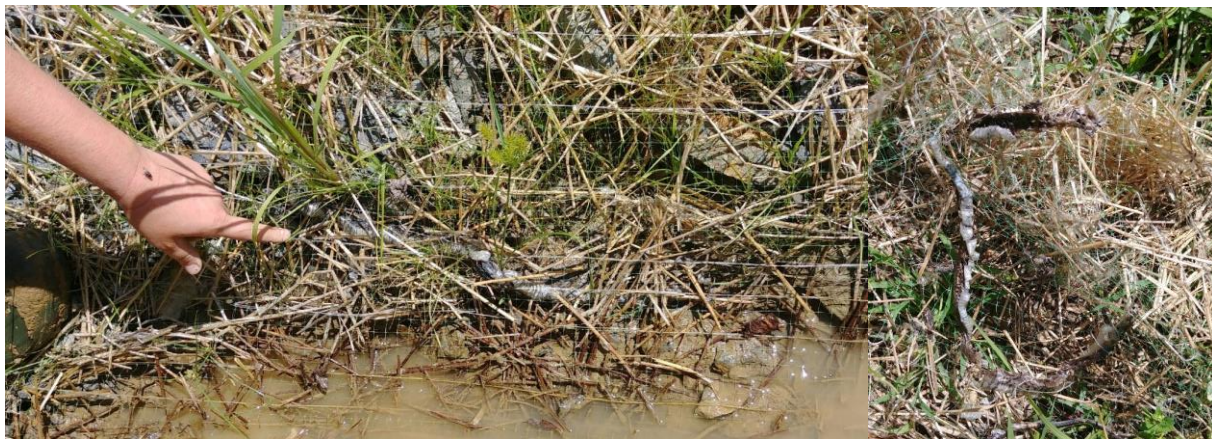
Figure A14-1. Images of a Black Racer (left) and a Northern Watersnake (right) that were entangled and killed in the biodegradable mesh used along the 2018 barrier fencing.
