# Grouting Effects on Performance of Sliplined Steel Pipes

<b>1 Report No.</b> K-TRAN: KU-17-3	<b>2 Government Accession No.</b>	<b>3 Recipient Catalog No.</b>	
<b>4 Title and Subtitle</b> Grouting Effects on Performance of Sliplined Steel Pipes		<b>5 Report Date</b> November 2019	<b>6 Performing Organization Code</b>
		<b>8 Performing Organization Report No.</b>	
<b>7 Author(s)</b> Jie Han, Ph.D., P.E., F.ASCE, Seyed Mustapha Rahmaninezhad, Ph.D., Mahdi Al-Naddaf, Robert L. Parsons, Ph.D., P.E., Saif Jawad, Hao Liu		<b>10 Work Unit No. (TRAIS)</b>	
<b>9 Performing Organization Name and Address</b> The University of Kansas Department of Civil, Environmental & Architectural Engineering 1530 West 15th St Lawrence, Kansas 66045-7609		<b>11 Contract or Grant No.</b> C2095	
		<b>13 Type of Report and Period Covered</b> Final Report September 2016–April 2019	
<b>12 Sponsoring Agency Name and Address</b> Kansas Department of Transportation Bureau of Research 2300 SW Van Buren Topeka, Kansas 66611-1195		<b>14 Sponsoring Agency Code</b> RE-0716-01

Final Report

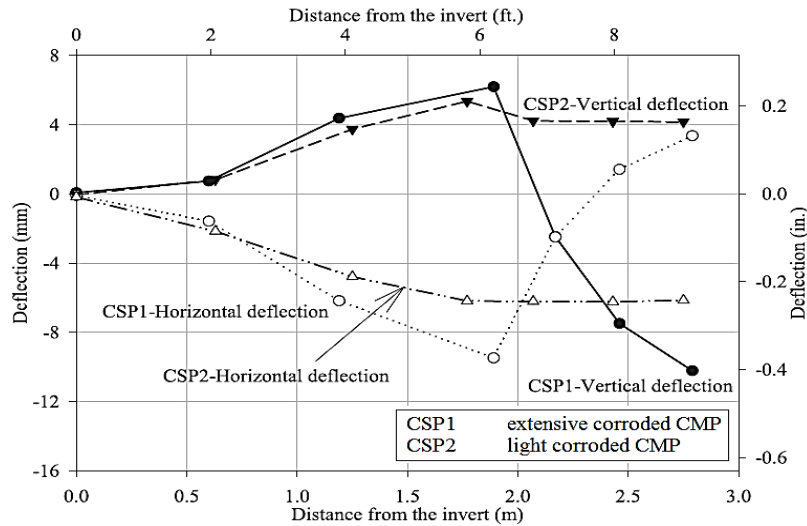
**Figure 2.1: Diameter changes of the CMPs during backfilling**  
After Mai et al. (2013)

Mai et al. (2013) compared the performance of two corroded corrugated metal (steel) pipes (CMP) during backfilling and under surface loading. The diameter and the intact wall thickness of CMPs were 1.8 m and 4.5 mm, respectively. The average degrees of corrosion along both sides of the invert of the extensively corroded CMP were 30% and 52%, and those for the lightly corroded CMP were 17% and 10%. The fill material was a well-graded sandy gravel, which is classified as A-1 by AASHTO (2009). The CMPs were backfilled with 0.6 and 0.9 m thick cover and loaded by a steel pad. Figure 2.1 shows the vertical and horizontal diameter changes of the corroded CMPs

during backfilling. During backfilling from the invert to the crown, the diameter changes of both CMPs were similar. However, these CMPs performed differently under the overburden pressure. The difference in the performance of the CMPs was due to their different stiffness values.

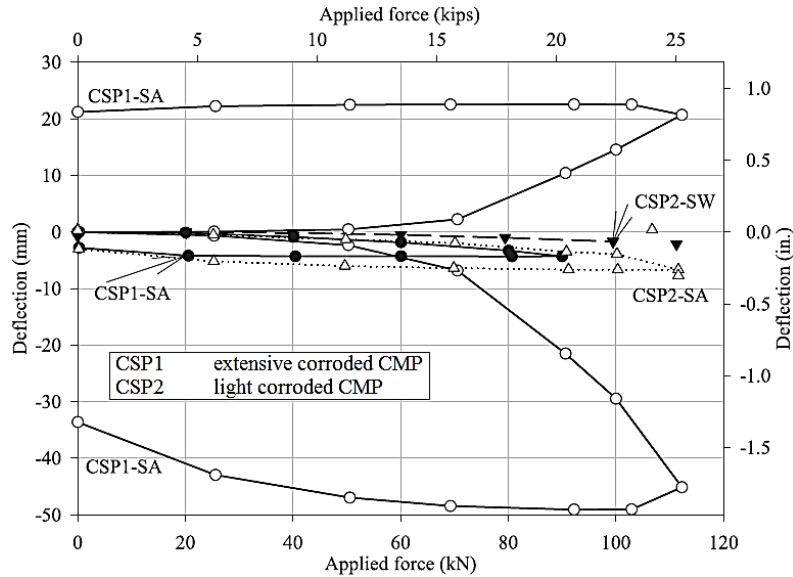
**Figure 2.2: Diameter changes of the CMPs under surface loading**  
After Mai et al. (2013)

Figure 2.2 shows the vertical and horizontal diameter changes of the CMPs covered by 0.6 m thick backfill, which are nonlinear. The deflections of the CMP with extensive corrosion were considerably larger than those of the CMP with light corrosion. Both CMPs had initially stiffer behavior until the applied force reached 40 kN. After 40 kN, the rate of diameter changes dramatically increased for both CMPs.

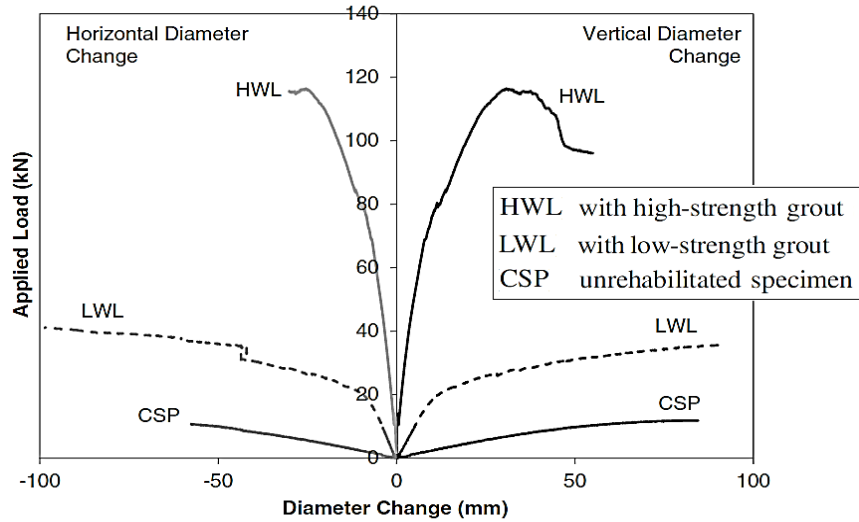
**Figure 2.3: Applied load versus diameter changes for the intact and sliplined steel pipes**  
After Smith et al. (2015)

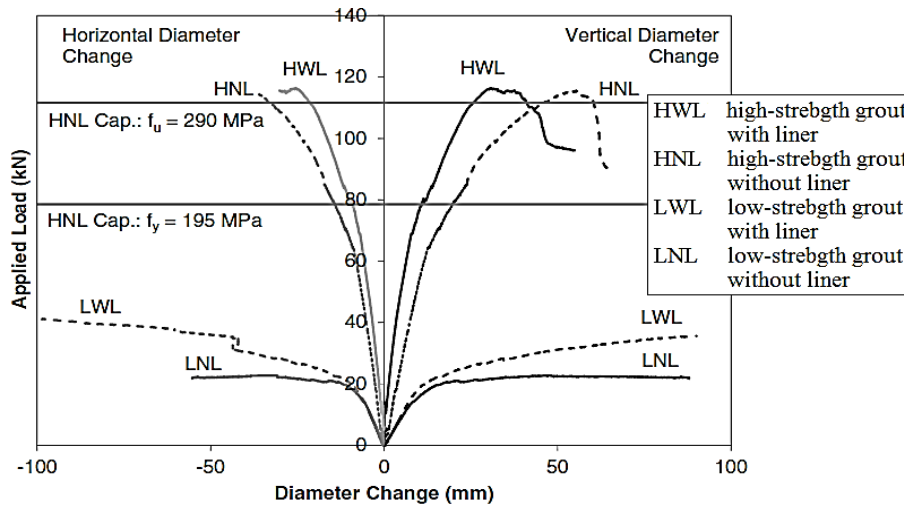
**Figure 2.4: Applied load versus diameter changes of rehabilitated steel pipes with and without a liner**  
After Smith et al. (2015)

capacity of the rehabilitated steel pipe with the high-strength grout. However, the liner increased the load-carrying capacity of the rehabilitated steel pipe with the low-strength grout by approximately 60%.

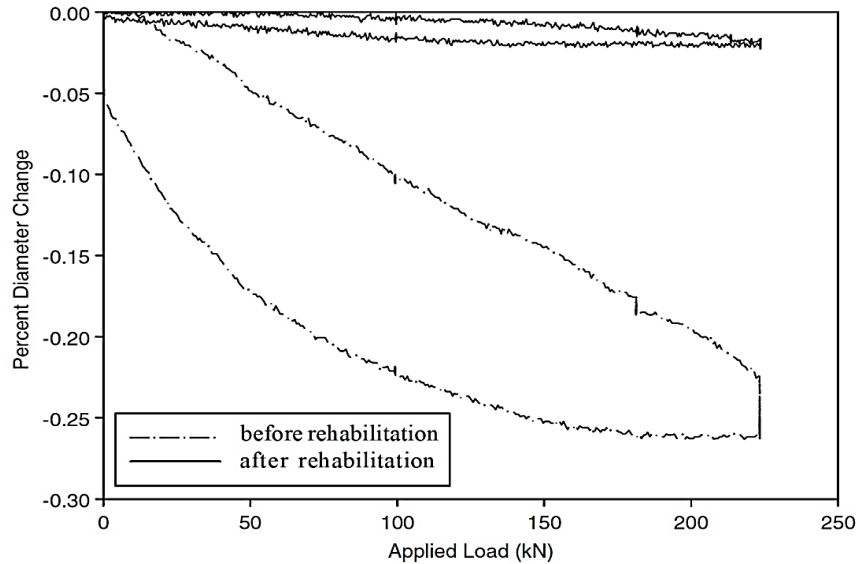
**Figure 2.5: Vertical diameter change versus applied load before and after sliplining**  
After Simpson et al. (2015)

Simpson et al. (2015) found that the critical response areas for the corrugated steel pipes before and after sliplining occurred in the upper shoulder and crown region. In addition, the increased stiffness of the sliplined steel pipe resulted in less load being spread to the surrounding soil.

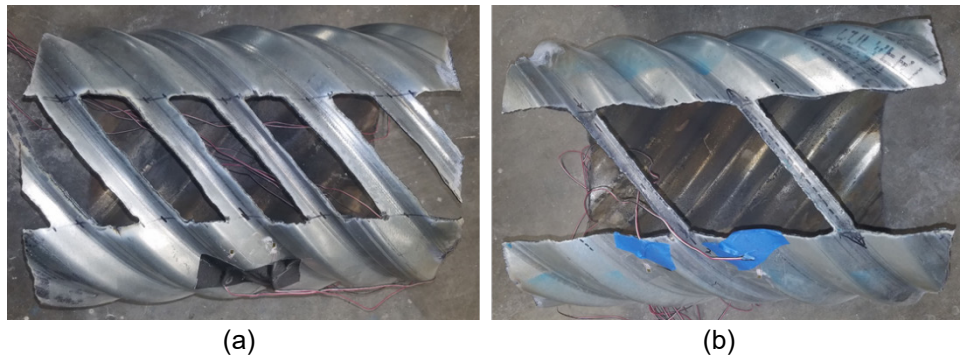
**Figure 3.3: Corrugated Steel Pipes with Simulated Corrosion: (a) 50% Cutout and (b) 90% Cutout**

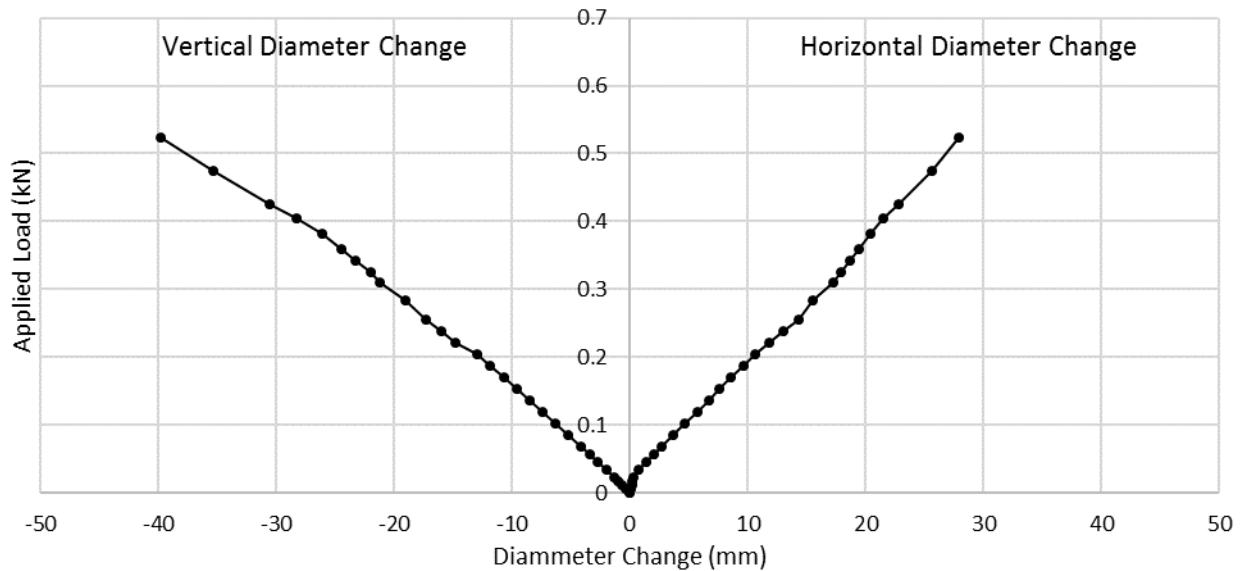
**Figure 3.4: Applied load versus vertical and horizontal diameter changes of the liner**

pipes after the removal of the segments. PVC pipes with an inside diameter of 254 mm, a wall thickness of 3 mm, and a length of 455 mm were used as liners. These pipe liners were flexible. Figure 3.4 presents the applied load versus diameter change for the PVC liner, indicating a linear load-diameter change relationship. Moreover, at the same applied load, the vertical diameter change was larger than the horizontal one with a ratio of 1.33. The load-carrying capacity of the liner at 5% vertical diameter change (approximately 12.8 mm, typically used as a serviceability criterion in the practice for flexible pipes), was approximately 0.2 kN.

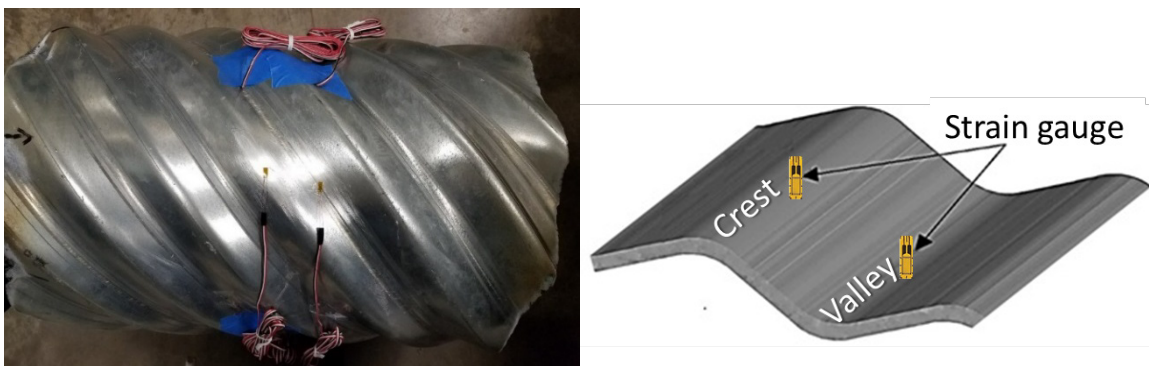
**Figure 3.5: Strain gauges at both the crest and valley of a corrugation in the transversal direction of the pipe**

The applied load was measured using an S-shape load cell with a capacity of 40 kN. The vertical and horizontal diameter changes of the steel pipes and the liners were measured using two types of displacement transducers (DTs) with displacement limits of 100 mm and 50 mm, respectively. The intact and cut steel pipes were instrumented with 10 and eight foil electrical resistance strain gauges, respectively. The strain gauges were attached at both the crest and valley of the outside surface of a corrugation of the steel pipe so that the average strain and curvature of the pipe could be calculated as shown in Figure 3.5. The strain gauges had a gauge length of 5 mm and an electrical resistance of  $120 \Omega$ .

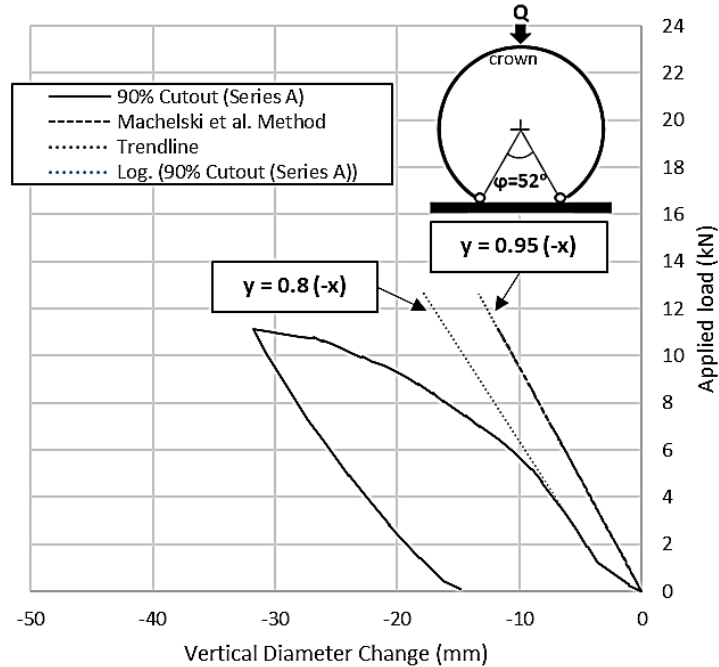
**Figure 3.8: Applied load versus vertical diameter change on the unlined steel pipe with 90% cutout and the corrugated steel arch culvert**

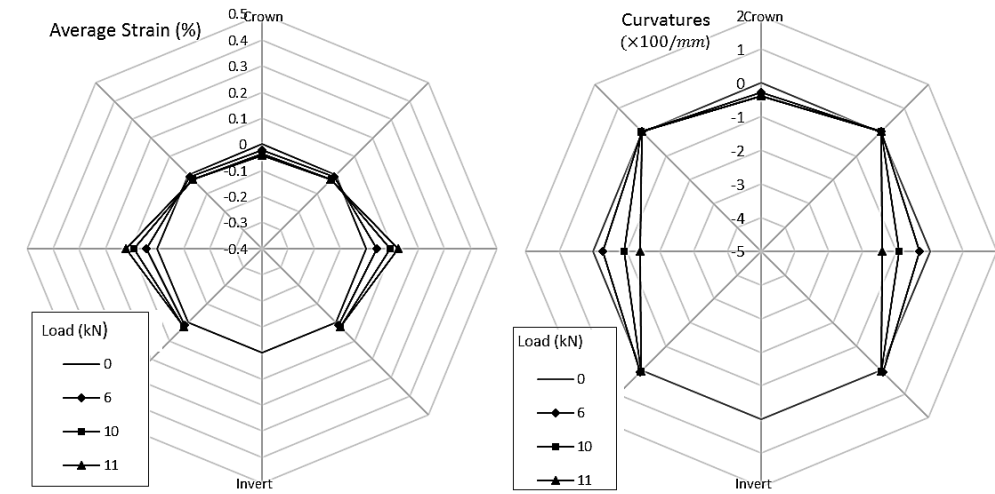
**Figure 3.11: Average strains and curvatures around the sliplined steel pipes with: (a) 0% cutout in Series B, (b) 50% cutout in Series B, (c) 90% cutout in Series B, and (d) 0% cutout in Series C (Continued on next page)**

Figure 3.11 shows the calculated average strains and curvatures around the circumference of the sliplined steel pipes in test Series B and C, under different applied loads. Similar to the unlined steel pipes during loading, the negative strains were observed at the crown and invert of the steel pipes. However, the positive strains were localized at the springlines of these pipes. For example, under the applied load of 11 kN, the maximum average positive strains in the steel pipes with 0%, 50%, and 90% cutout were approximately 0.11%, 0.13%, and 0.17%, respectively. These results show that after sliplining, the maximum average positive strains in the steel pipes with 0%, 50%, and 90% cutout were reduced by 45%, 69%, and 26%, respectively. At the same applied load, the maximum average negative strains at the crown of these pipes were -0.04%, -0.05%, and -0.13%, respectively. Moreover, after sliplining, the maximum average negative strains in the steel pipes with 0%, 50%, and 90% cutout were reduced by 50%, 84%, and 7%, respectively.

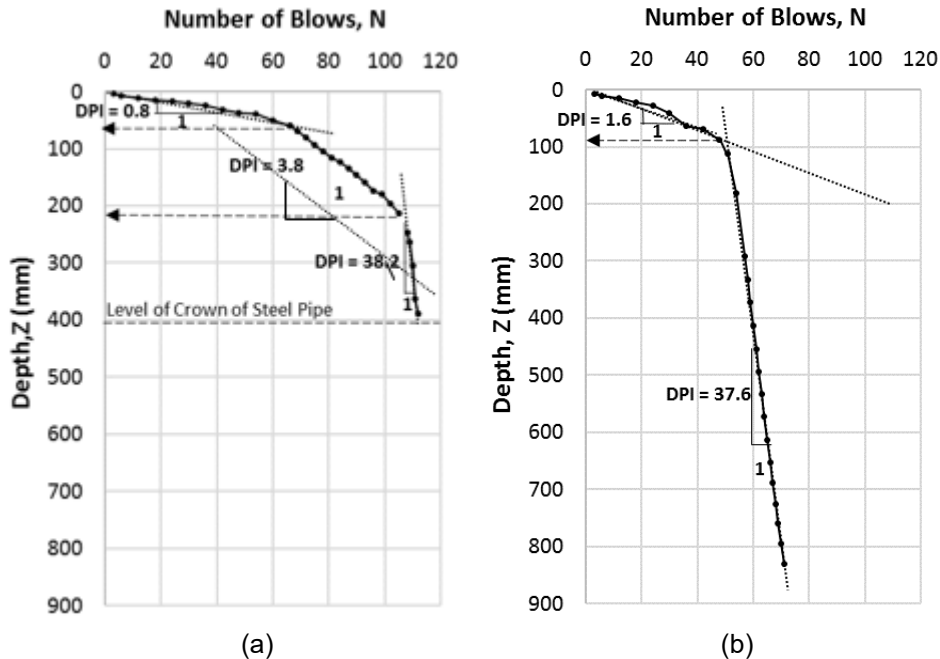
Figure 4.1. DCP test results: (a) above the pipe and (b) 2 m at the east-side of the pipe

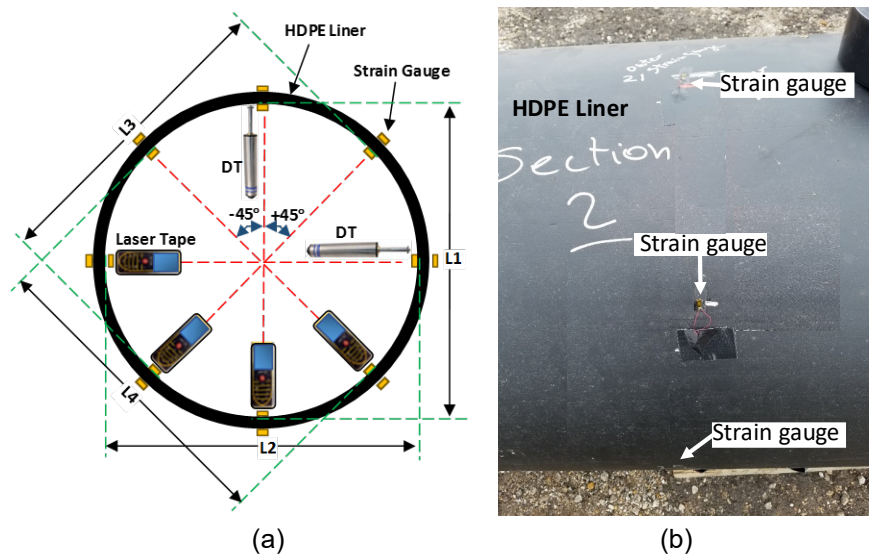
**Figure 4.5: Instrumentation: (a) positions of strain gauges, DTs, and laser tape (not to scale) and (b) an attached strain gauge on outer face of the liner**

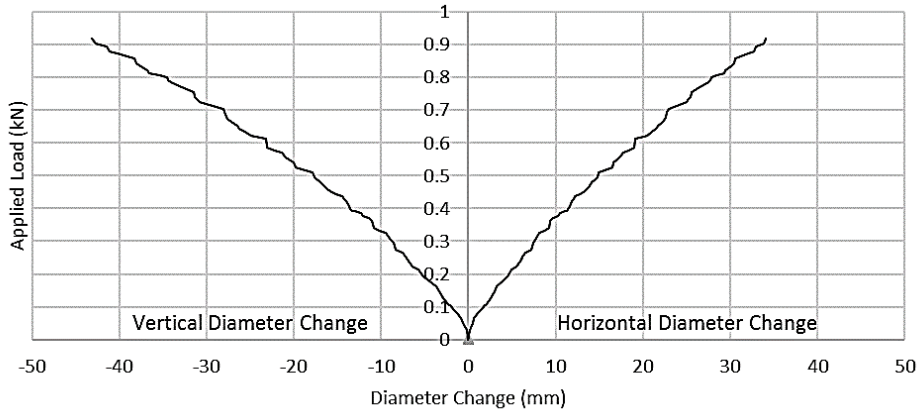
**Figure 4.7: Applied load versus vertical and horizontal diameter changes of the liner**

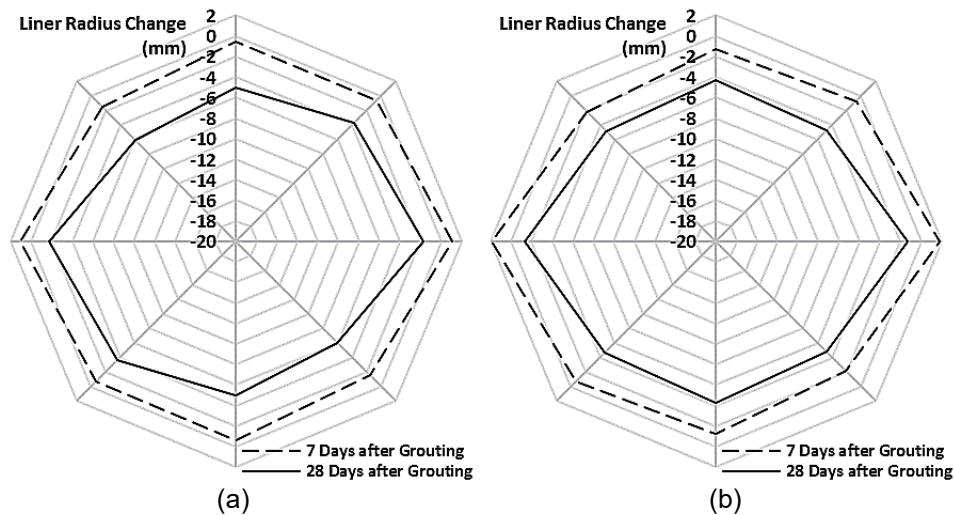
**Figure 4.8: Radius changes for the liner: (a) Section 1 and (b) Section 2**

distance between the springlines (L2) increased. Moreover, the diameters of the liner at  $+45^\circ$  (L3) and  $-45^\circ$  (L4) from the vertical decreased. In Section 1, the changes at L1, L2, L3, and L4 were -1.2, 2.1, -1.3, and -3.1 mm, respectively. In Section 2, the changes at L1, L2, L3, and L4 were -2.6, 3.7, -1.4, and -4.3 mm, respectively. The average diameter changes in Section 1 and Section 2 were -0.9 and -1.1 mm, respectively. However, at 28 days after grouting, the liner contracted. Since the average temperature during the measurement was  $-2^\circ\text{C}$  as shown in Figure 4.3, the radius changes of the liner might be influenced by freezing. The radius reduction of the liner might result from the water expansion within the grout after freezing. The average diameter changes in Section 1 and Section 2 were -8.2 and -7.6 mm, respectively, at 28 days after grouting.

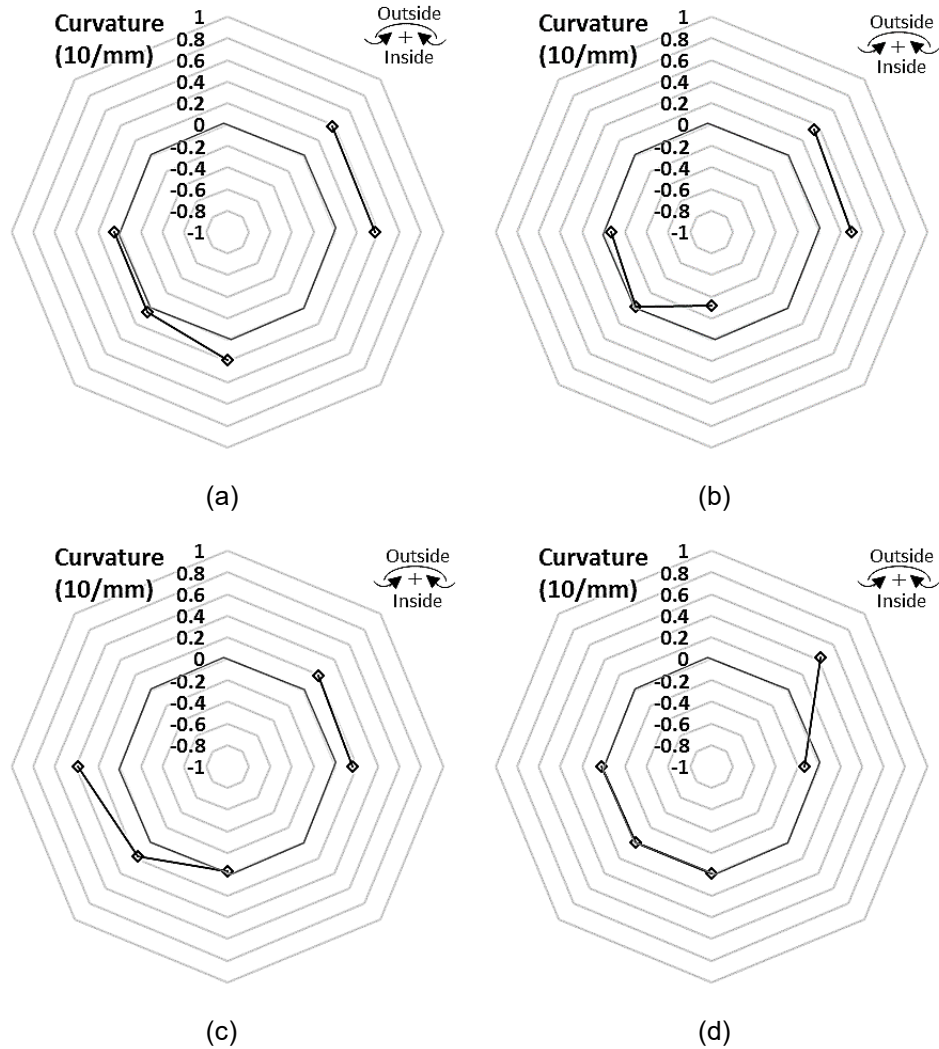
**Figure 4.10: Curvature around the liner at the locations of Section 1: (a) after installing the liner; (b) after grouting; (c) at 7 days after grouting; and (d) at 28 days after grouting**

shoulder of the liner. However, no significant curvature occurred at the left springline and the left haunch. During the grouting process, the pressure induced by the grout generated a negative curvature at the invert of the liner as shown in Figure 4.10(b). At 7 days after grouting, the grout hardening caused a positive bending at the left springline and the left haunch as shown in Figure 4.10(c). Except for positive bending at the right shoulder induced during liner installation, no meaningful curvature was perceived at 28 days after grouting as shown in Figure 4.10(d).

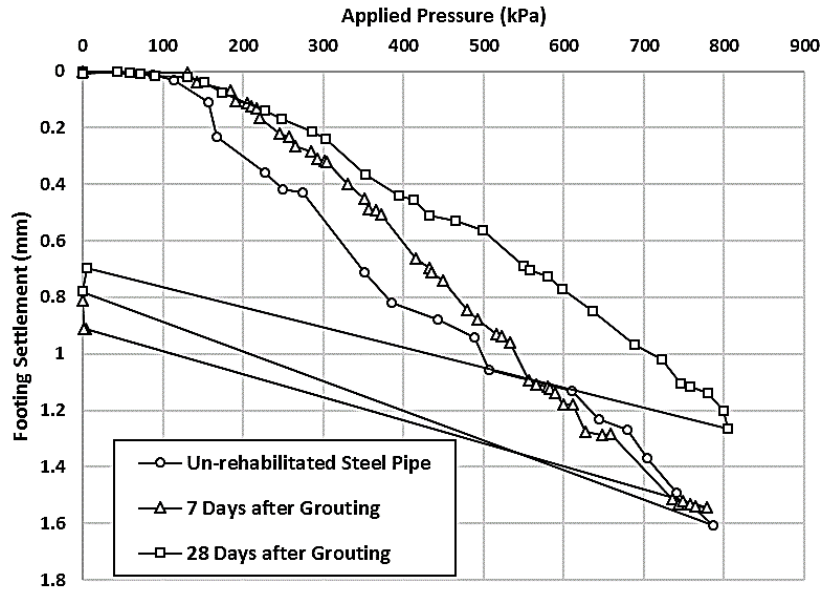
**Figure 4.17: Pressure-settlement curves of the plate**

The average measured displacement from two DTs represented the settlement of the plate. Figure 4.17 shows the pressure-settlement curves of the plate. When the applied pressure was lower than 110 kPa, the pressure-settlement curves, before and after sliplining, were similar. However, after 110 kPa, the pavement before sliplining had larger settlement than the pavement at 7 and 28 days after grouting. Then, after 550 kPa, the pavement at 7 days after grouting behaved similarly to that without sliplining again. Under the applied pressure of 780 kPa, the settlement values of the plate on the pavement before sliplining, at 7 days, and 28 days after grouting were approximately 1.6, 1.5, and 1.1 mm, respectively. In other words, sliplining and grouting reduced the settlement of the pavement at 7 and 28 days after grouting by 6% and 31%, respectively, as compared with that before sliplining. In all tests, the permanent settlement of the pavement after unloading was approximately 0.8 mm.

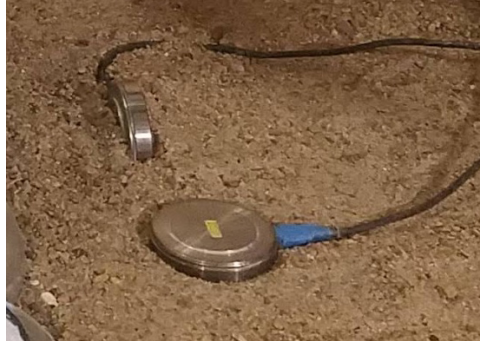
**Figure 5.2: Earth pressure cells**

The applied load was measured using an S-shape load cell with a load capacity of 22.3 kN mounted above the footing. A pressure gauge was used to control the hydraulic pressure applied to the footing. The settlement of the footing, and the vertical and horizontal diameter changes of the liner were measured using two types of DTs with displacement limits of 100 mm and 50 mm, respectively. Pressure cells were used to measure vertical and lateral earth pressures as shown in Figure 5.2.

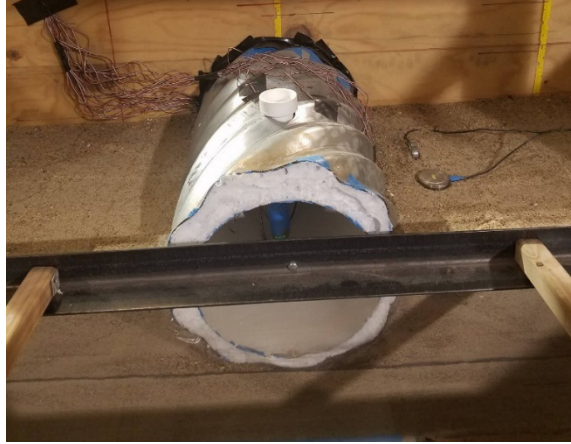
**Figure 5.4: Placed steel pipe and liner**

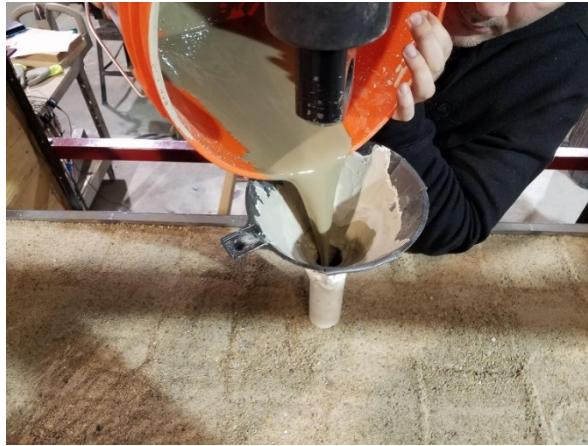
**Figure 5.5: Pouring grout into the annulus through a drop tube**

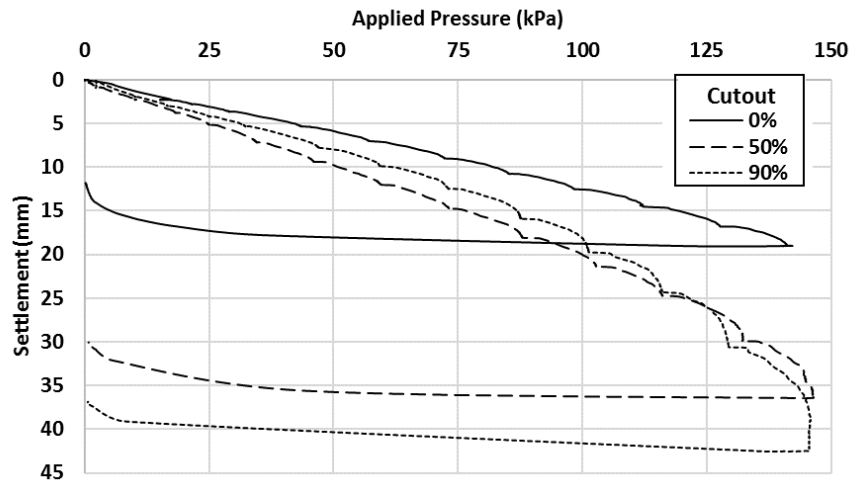
**Figure 5.8: Pressure-settlement curves of the footings for the models with the unlined steel pipes in test Series A**

pressure was lower than 115 kPa, the steel pipe with 90% cutout had less vertical diameter change than the pipe with 50% cutout. However, above 115 kPa, the pipe with 50% cutout had smaller vertical diameter changes than the pipe with 90% cutout while the steel pipe with 90% cutout had smaller horizontal diameter changes than the pipe with 50% cutout. As discussed in Chapter 3, this phenomenon resulted from the fact that the pipe with 90% cutout behaved like an arch with a flat base.

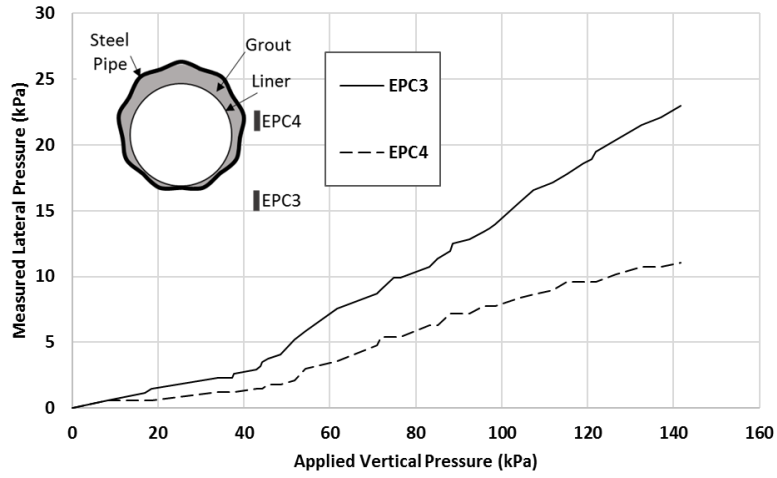
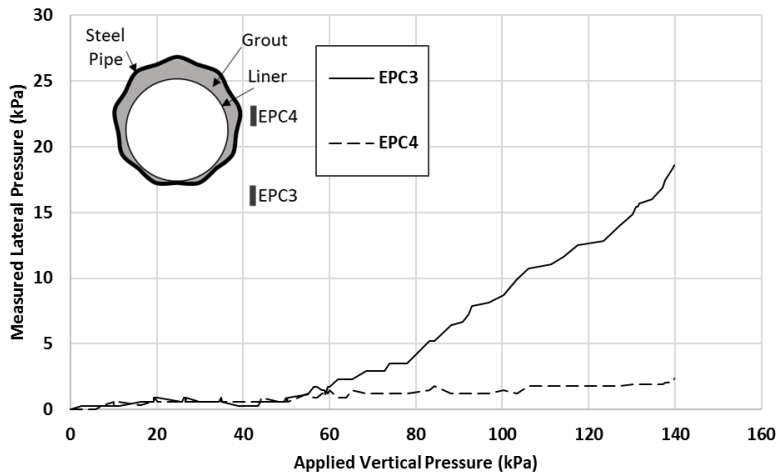
Figure 5.15 shows the lateral earth pressures induced by footing loading around the sliplined steel pipes for test Series B. The results show that regardless of the percentage of the cutout, the measured lateral pressures from EPC3 were higher than those from EPC4. The measured lateral pressures from EPC3 in the models with the sliplined pipes having 0% and 90% cutout and under the same applied pressure were approximately equal, as shown in Figures 5.15(a) and (b). However, the measured pressures from EPC4 in the model with the sliplined pipe having 0% cutout were higher than those having 50% cutout. In the model with the unlined steel pipe having 90% cutout, when the applied pressure was lower than 56 kPa, the measured pressures from EPC3 and EPC4 were approximately equal, as shown in Figure 5.15(c). However, when the applied pressure was higher than 56 kPa, EPC3 measured higher pressures than EPC4. Moreover, in the model with the sliplined steel pipe having 90% cutout, the measured pressures from EPC4 were lower than those in the model with the sliplined steel pipe having 50% cutout.
