# Implementing Rubblization and Drainage Improvement Techniques on Severely Distressed Concrete Pavements: Technical Report

Implementation Report Report 5-4687-03-R1

TEXAS A&M TRANSPORTATION INSTITUTE  
COLLEGE STATION, TEXAS

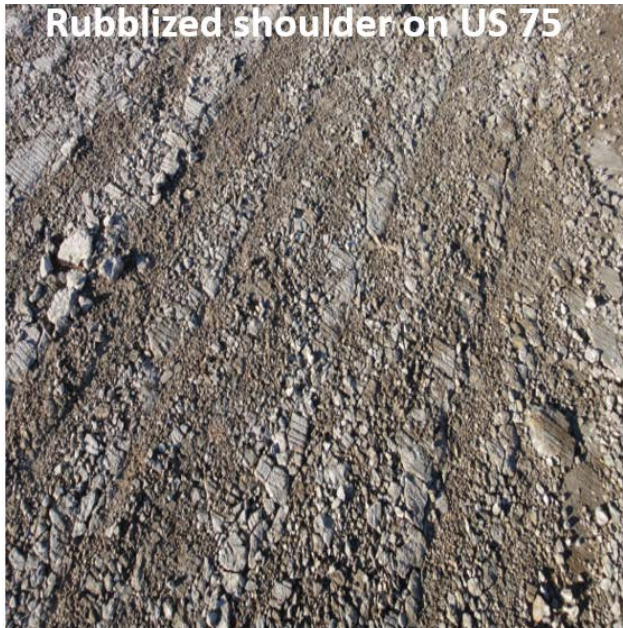
**Figure 5. Example of a Rubblized Surface Plus Cost Estimates.**

Figure 5 demonstrates the economics of the cost effectiveness of rubblization.

- **Cost of Rubblizing \$ 2 to \$3 Sq. Yard**
- **Cost of Removal \$4 to \$5 per Sq. Yard**
- **Add new base \$15 to 20 per sq. yard (10 inches thick)**

- **Most jobs in Texas are for removal**
- **Very few rubblized layers left in place as new base**
- **Rubblized Concrete much better than a flexible base**

The cost of simple rubblization is relatively inexpensive at around \$2.50 per sq. yard. Once it is rubblized, it will cost another \$4 to \$5 to pick up, haul off, and dispose of the broken concrete. If the work includes building a new pavement on the site, then the cost of importing new base material will be around \$15 per sq. yard.

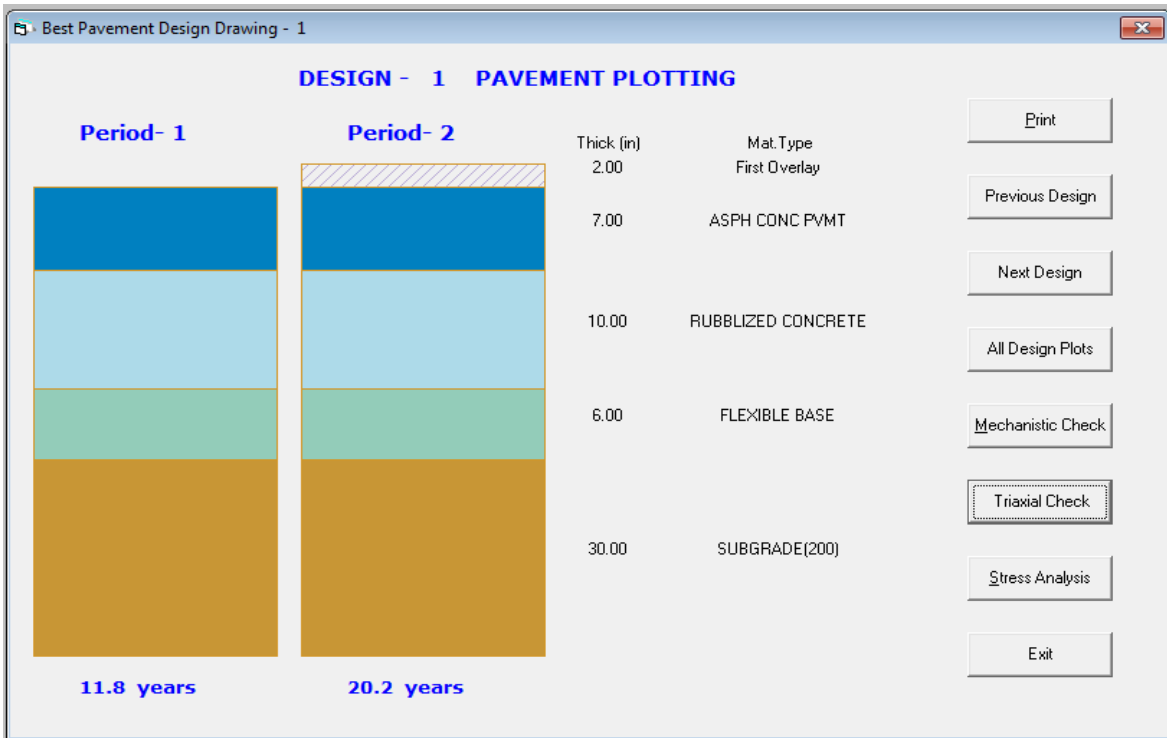
**Figure 11. Proposed Pavement Design for US 75.**

Figure 11 shows the proposed design and the overlay required (2 inches) in year 12 to achieve the 20-year design life.

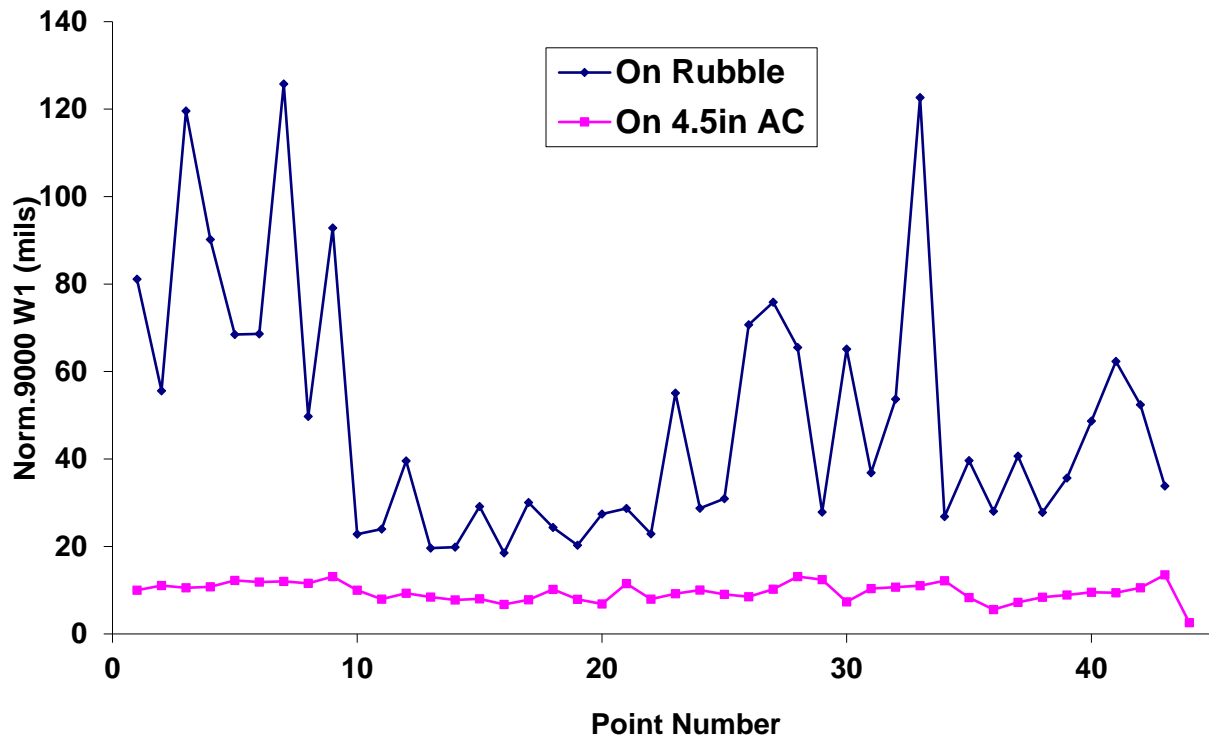
Figure 23 and Figure 24 show FWD testing on top of rubblized concrete (rubble) and conditions on one of the worst joints during rubblization in July 2010. Figure 25 illustrates the comparisons of FWD maximum deflections (normalized to 9000 lb) between those from on top of rubblized concrete (rubble) and immediately after a 4.5-inch HMA overlay. Significant deflection reductions were observed. Figure 26 shows the backcalculated modulus values from 2010

Figure 25. Comparisons of the FWD Deflections between 1) on Top of Rubblized (Rubble) Concrete and 2) on Top of 4.5-Inch HMA Overlay.

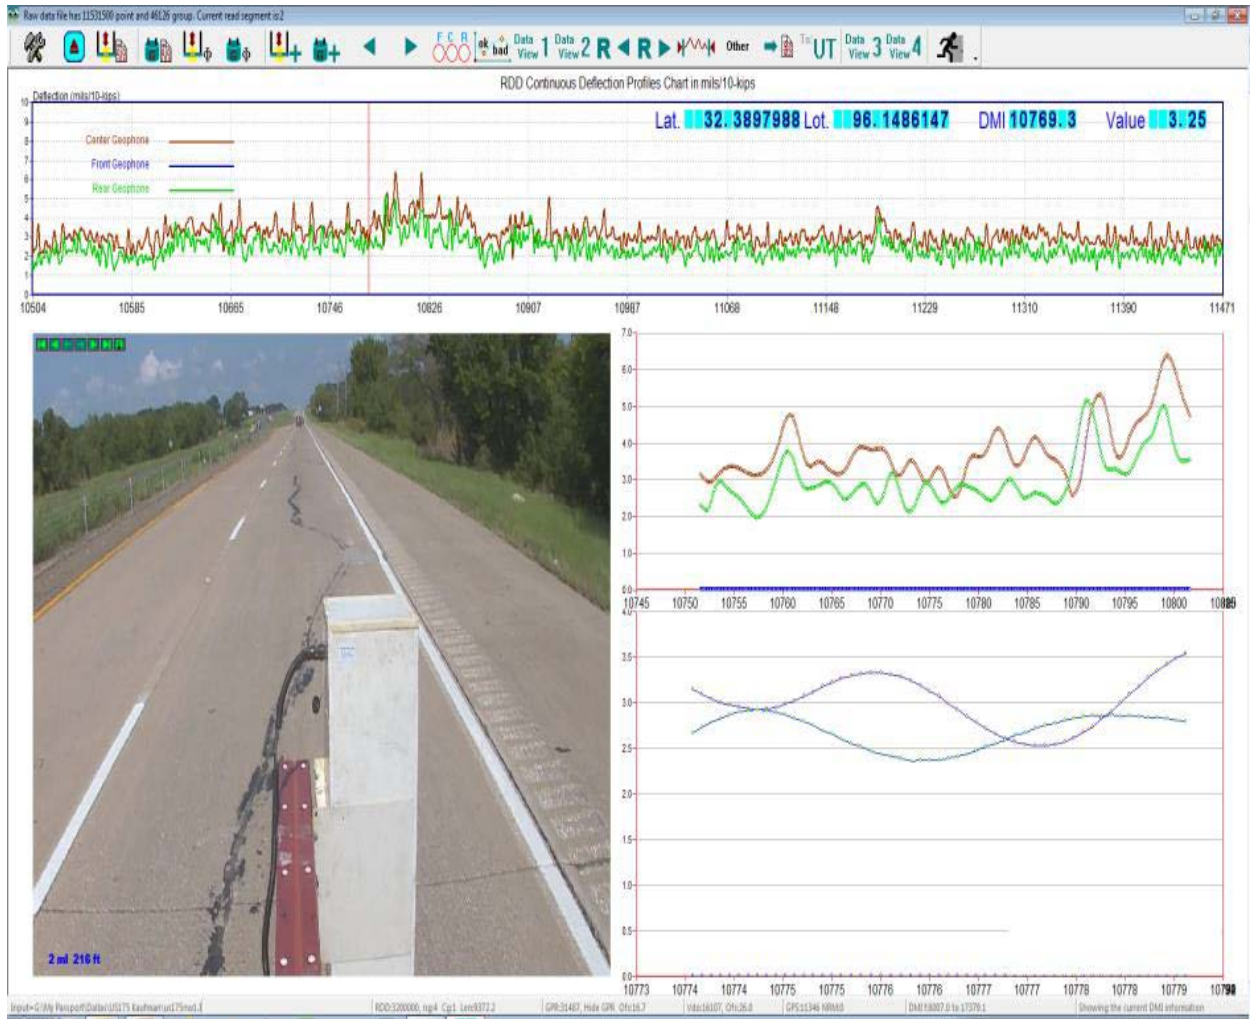
**Figure 30. Rolling Deflectometer from Section 2, Very Low Deflections.**

Figure 30 shows rolling deflection data over the proposed Section 2. The deflections in the upper plot are relatively low indicating that the slabs have a reasonable foundation layer and no excessively weak support that would be problematic for rubblization.

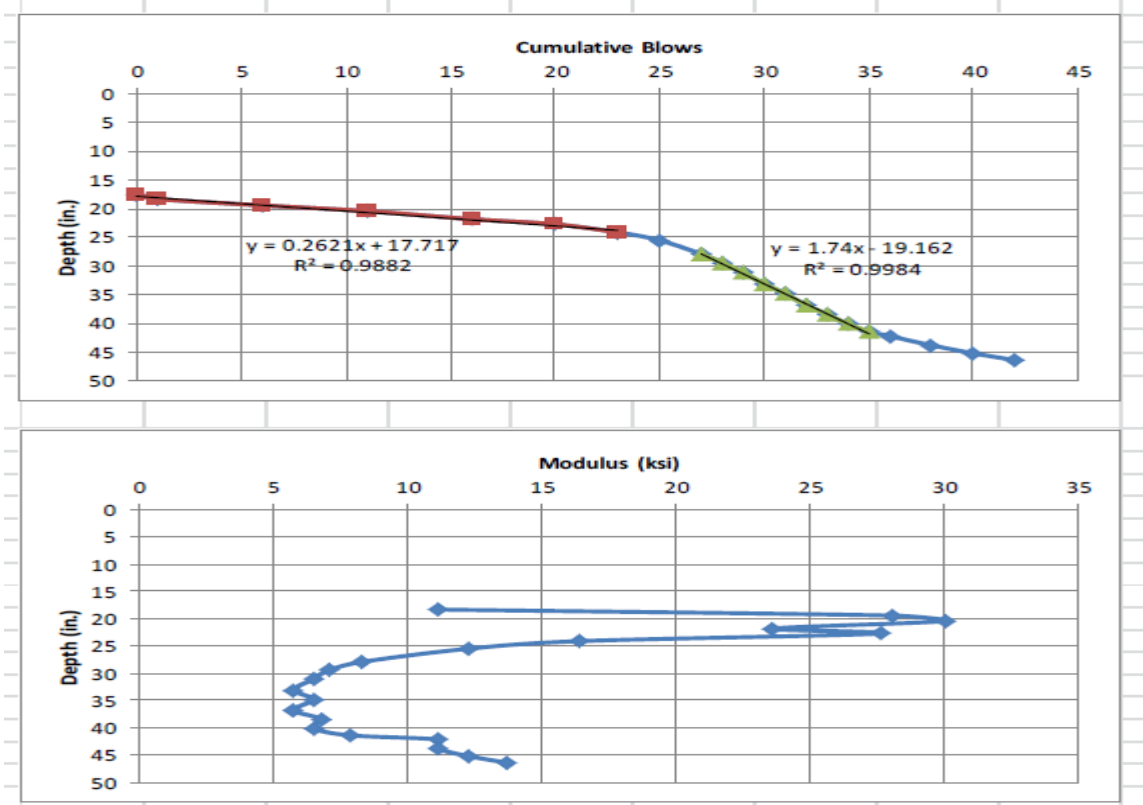
Figure 31 shows the DCP for Section 2. The DCP in Section 1 was better. In Section 2, the computed layer modulus was found to be fairly low, 25 inches below the surface at 6 ksi. This value was used in the pavement design.

Figure 31. DCP Data from Section 2, Weak Subgrade at a Depth of 25 Inches below the Surface.

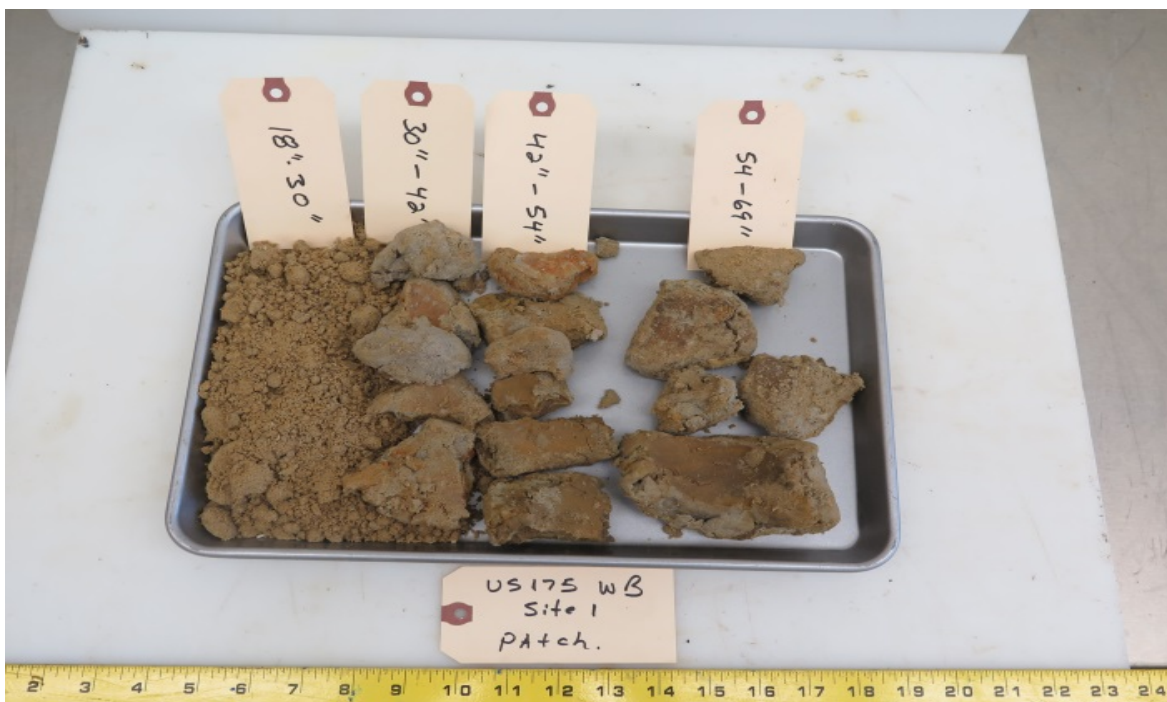
Figure 32. The Subgrade on Each Site Was Found to be a Tan Sandy Clay.

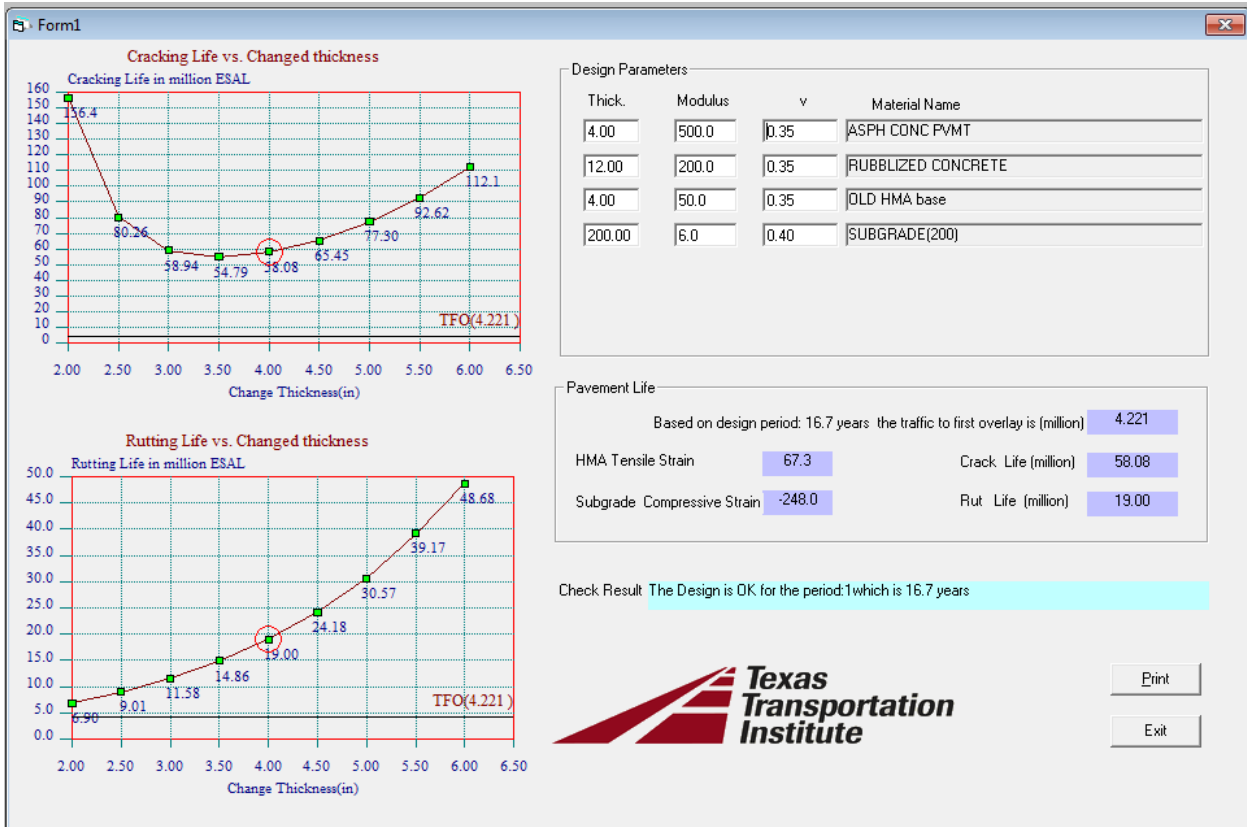
Figure 38. Mechanistic Check for US 175, No Problems.

Figure 38 and Figure 39 show both the mechanistic check and the Texas Triaxial check for the as-designed pavement structure; the proposed design had no problem passing both of the design checks.
