# JOINT TRANSPORTATION RESEARCH PROGRAM

## Real Life Experiences with Major Pavement Types

Shah, A., Olek, J., & McDaniel, R. S. (2022). *Real-life experiences with major pavement types* (Joint Transportation Research Program Publication No. FHWA/IN/JTRP-2022/05). West Lafayette, IN: Purdue University. <https://doi.org/10.5703/1288284317371>

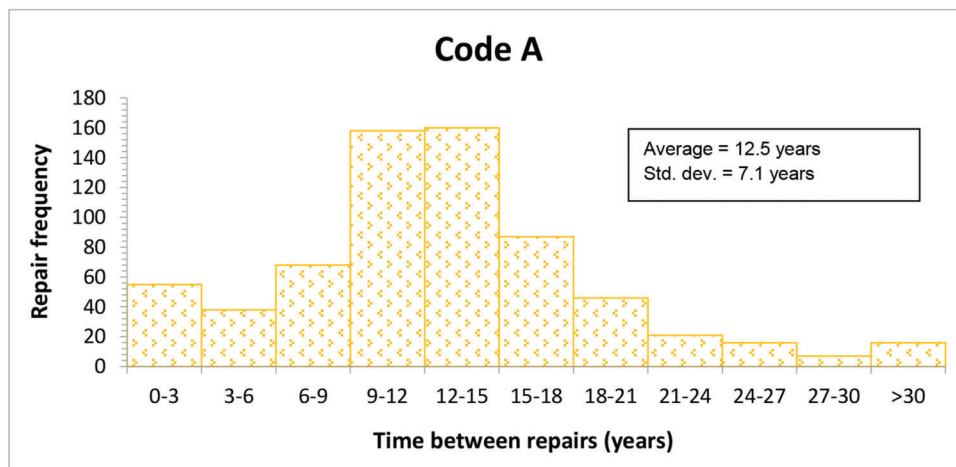
**Figure 2.8** Asphalt surface (plus unknowns).

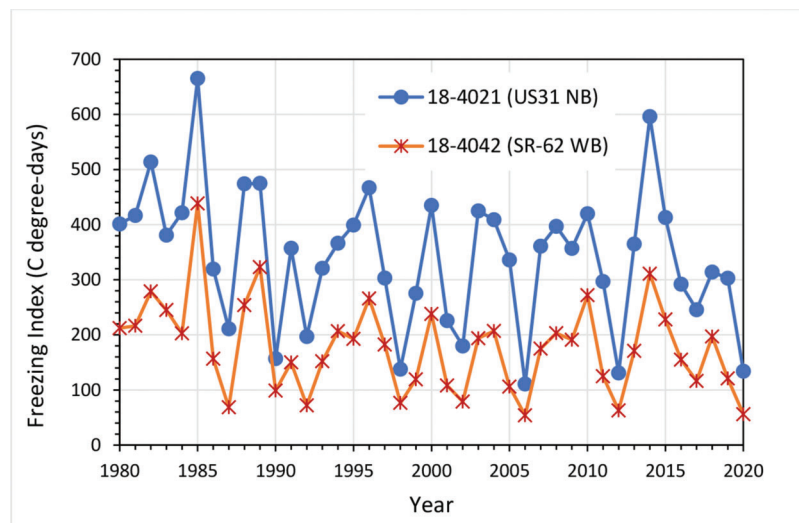
**Figure 3.3** Annual average freezing index at the JPCP GPS-4 sites.

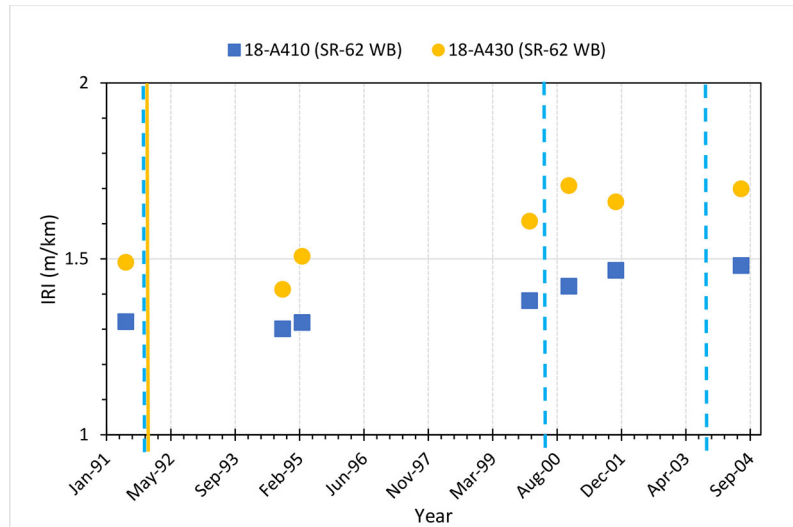
**Figure 3.11** IRI and M&R events at the JPCP SPS-4 sites.

due to technician inexperience or undocumented M&R events. In addition, the overall IRI in both sections remained low (see Figure 3.11), and was comparable to that of a new pavement all through the study period.

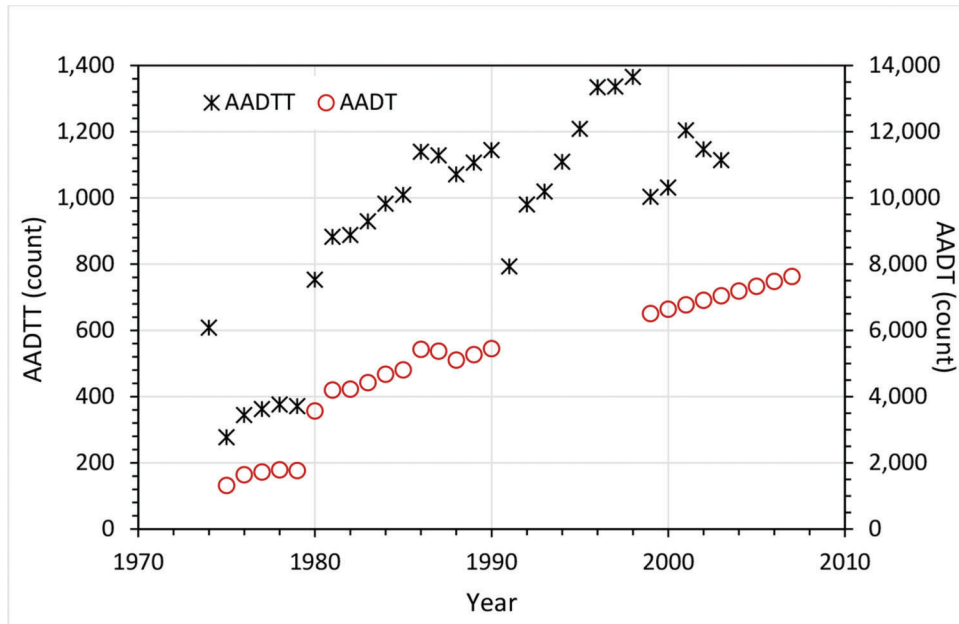
**Figure 3.14** Traffic volume at the JPCP SPS-6 sites.

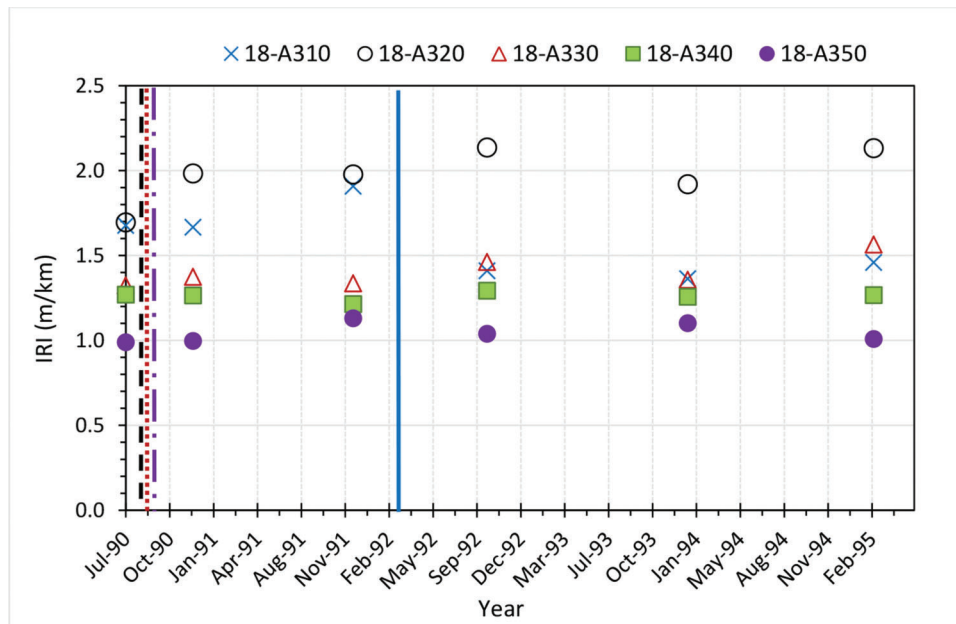
Figure 3.23 IRI and M&R events on the ACP SPS-3 sections.
