DOT HS 813 282

June 2022

# **Firewall Design in Buses To Mitigate the Propagation of Engine Fires**

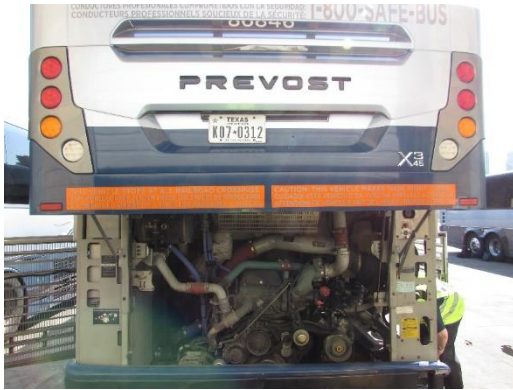
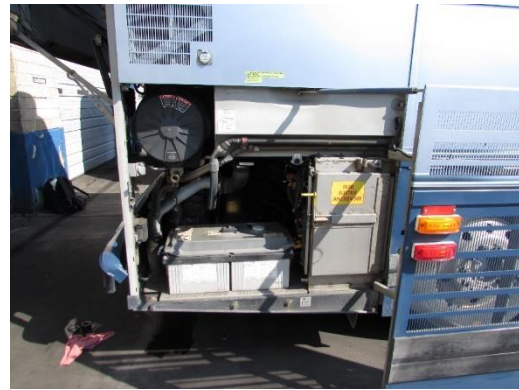
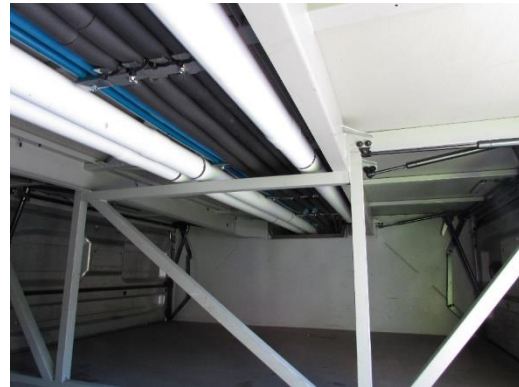
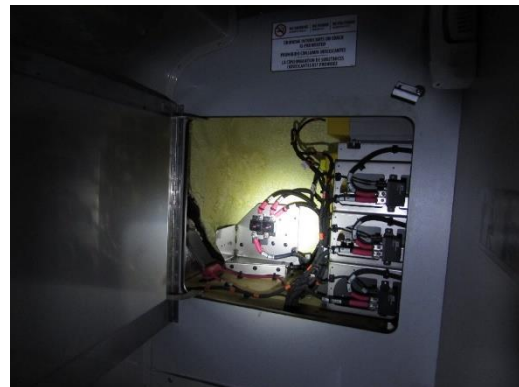
*Figure 3. Photograph array of surveyed motorcoach (X3-45 Prevost)*

Rear view of engine compartment

Side view showing toilet tank

View toward rear of cable routing

View toward front of cable routing

Engine access panel

Cavity behind the lavatory mirror

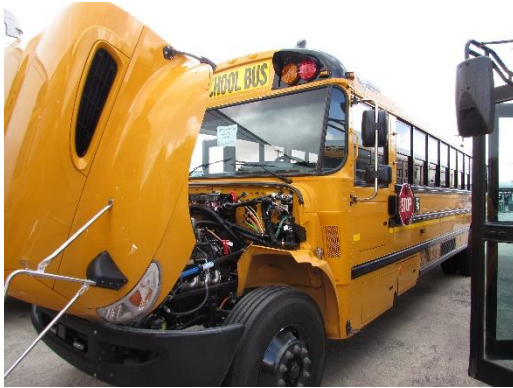
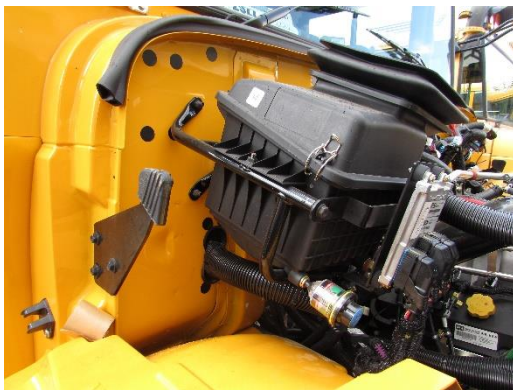
*Figure 5. Photograph array of surveyed school bus*

Figure 5 shows selected photographs from one of the surveyed school buses (2021 IC School Bus – Full-Length) and Table 7 shows a summary of the observed penetrations areas.

Overall view of school bus

Driver (right) side of firewall

Passenger (left) side of firewall

Center of firewall

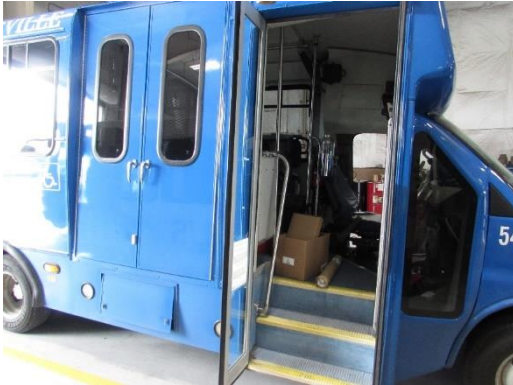
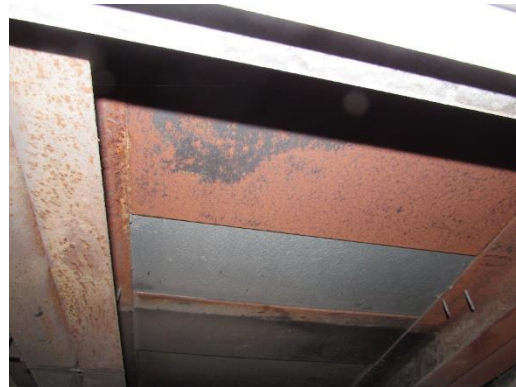
*Figure 8. Photograph array of Champion/GM Cutaway bus (supplemental batteries)*

The last newly observed propagation pathway for this type of bus was the supplemental battery compartment, which was located just rear of the main doorway. Figure 8 shows a photograph array of this area. Per the site visit host, this additional battery compartment is quite common in newer medium-size buses and in the event of an electrical short of the main battery in the engine compartment, it is possible to also short out these supplemental batteries and provide a more direct path for fire and smoke into the passenger compartment.

Overall view with battery compartment under wheelchair access door

Additional view of battery cable routing

View of bus floor directly above batteries

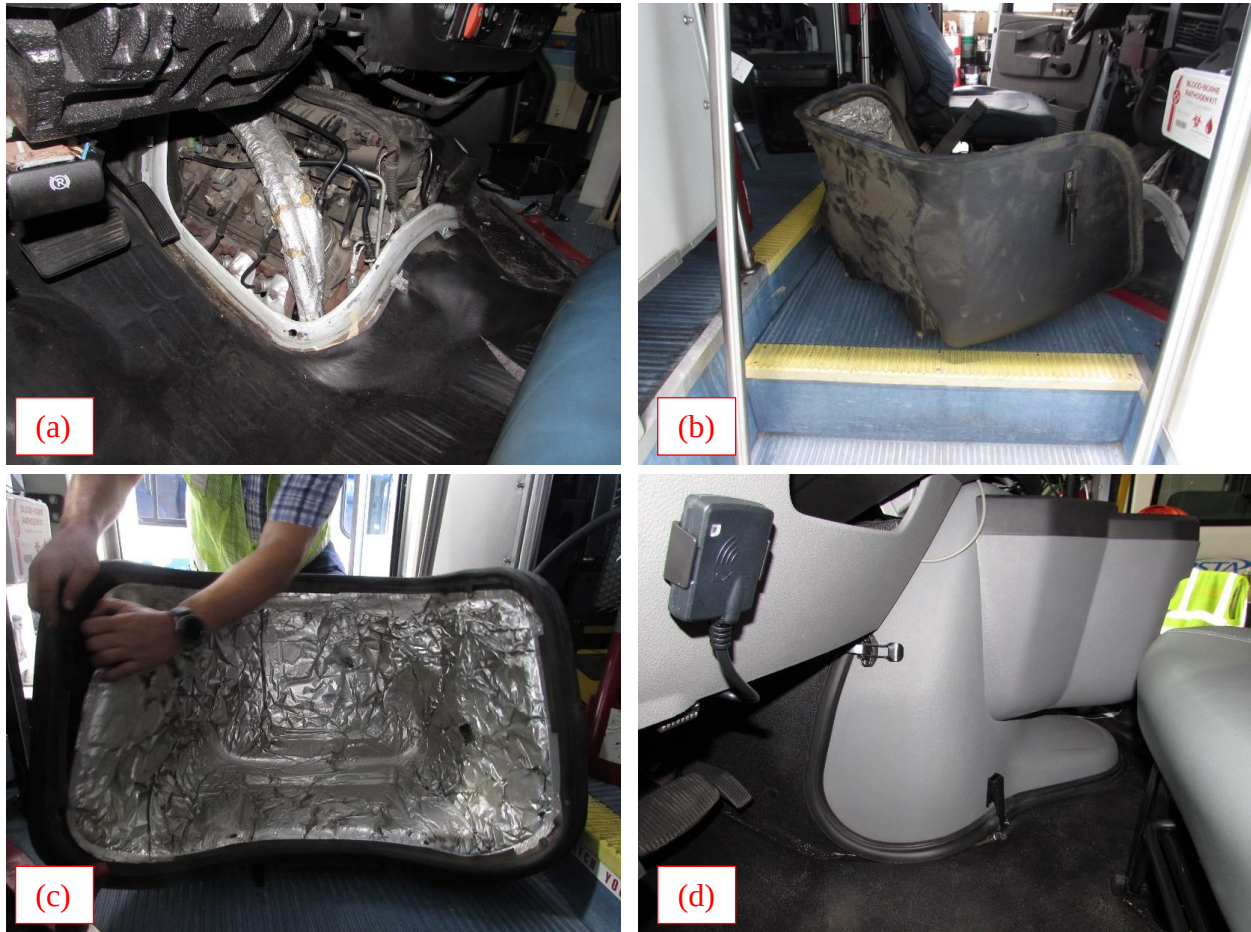
Figure 16. Pictures of engine extension and cowling in MB1 (a-c) and MB5 (d)

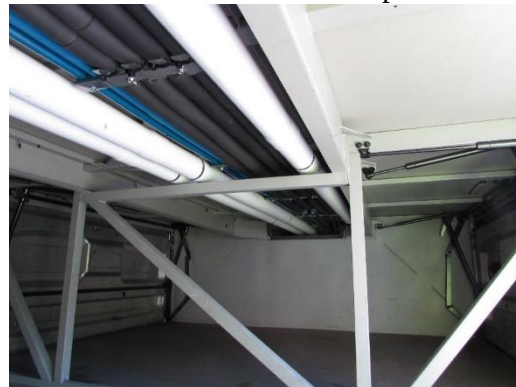
*Figure E-1. Photograph array for Prevost motorcoach surveyed at Greyhound facility*

Figure E-1 shows a photograph array of the Prevost motorcoach engine compartment surveyed at the Greyhound facility. Table E-1 provides a summary of the observed firewall penetration findings. The only visible penetrations are related to the lavatory connections. However, there are also two hatches that make some type of connection between compartments and the estimated penetration listed in Table 4 assumes a ¼-in gap forming around the perimeter of this hatch area in the event of a fire. This is likely a conservative assumption for a flame spread path. If these leakage perimeter areas are taken away, then the penetration area is reduced from 1.5 percent to 0.69 percent of the area of the firewall.

Overall view

Left rear side with fan compartment

Right rear side with electrical box

Cable routing through luggage area

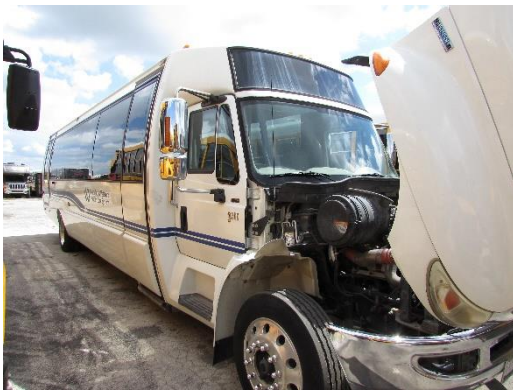
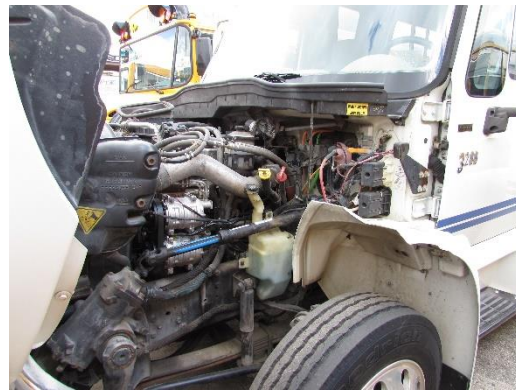
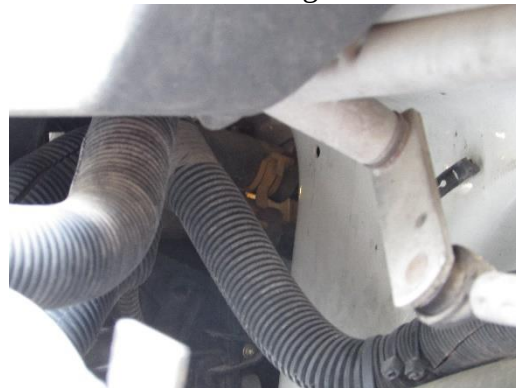
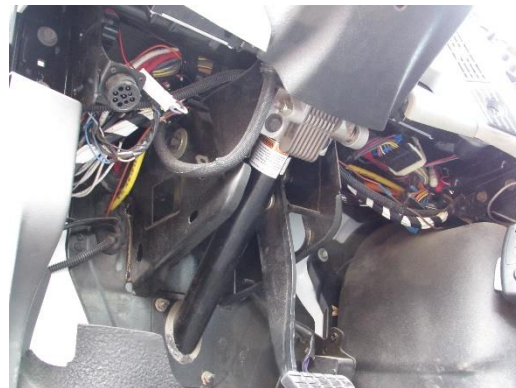
*Figure F-1. Photograph array for IC commercial bus surveyed at Navistar/IC Bus*

Figure F-1 shows a photograph array of the IC commercial bus engine compartment surveyed at Navistar/IC Bus. Table F-1 provides a summary of the observed firewall penetration findings. Figure F-2 shows a schematic of the observed penetrations.

Overall view

Firewall on right side

Firewall on right side (close-up view)

Penetrations on left side

Driver's location – Interior

Interior – View from below steering wheel

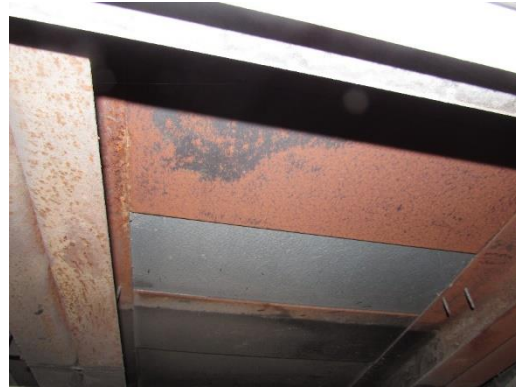
Figure G-3. Photograph array for Champion/GM Cutaway bus (supplemental batteries)

The last newly observed propagation pathway for this type of bus was the supplemental battery compartment, which was located just rear of the main doorway. Figure G-3 shows a photograph array of this area. Per the site visit host, this additional battery compartment is quite common in newer medium-size buses and in the event of an electrical short of the main battery in the engine compartment, it is possible to also short out these supplemental batteries and provide a more direct path for fire and smoke into the passenger compartment.

Overall view with battery compartment under wheelchair access Door

Close-up view of supplemental batteries and associated Cabling

Additional view of battery cable routing

View of bus floor directly above batteries

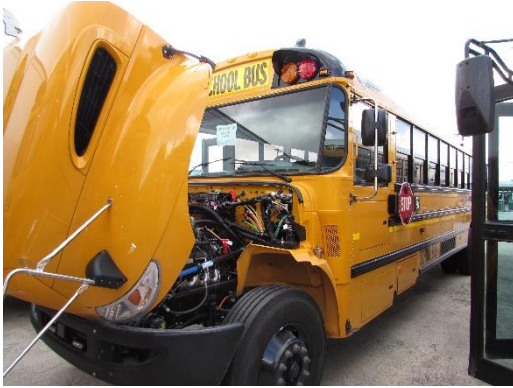
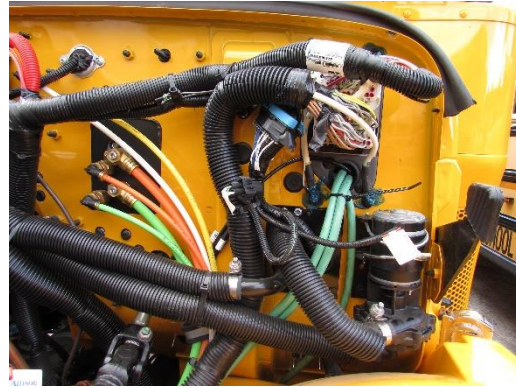
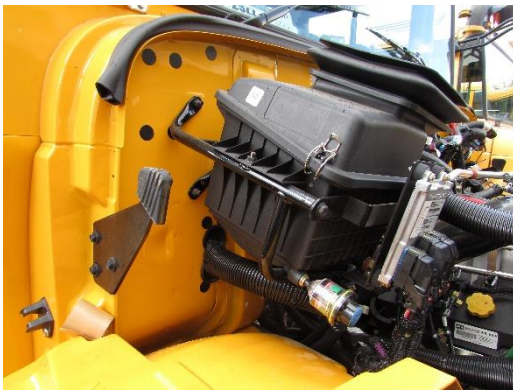
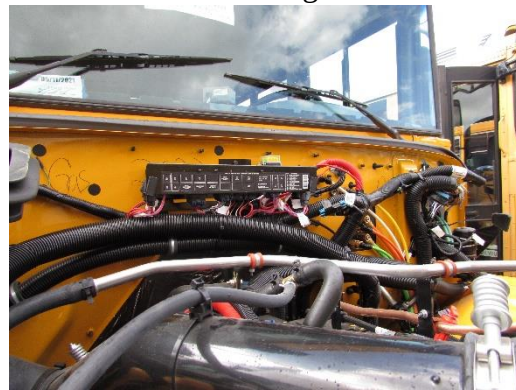
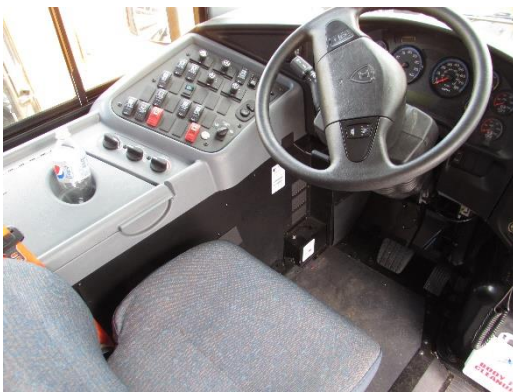
*Figure L-1. Photograph array for IC school bus at Navistar/IC Bus*

Figure L-1 shows a photograph array of the IC school bus engine compartment. Table L-1 provides a summary of the observed firewall penetration findings. The school bus surveyed looked very similar to the one surveyed at VRTC. Figure L-2 shows a schematic of the penetrations observed during the site visit.

Overall view

Firewall on right side

Firewall on left side

Firewall in center section

Driver's location – Interior

Interior – View from below steering wheel

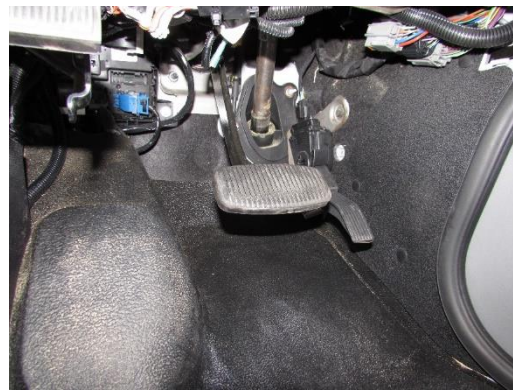
*Figure O-1. Photograph array for Ford/Starcraft Cutaway Paratransit bus*

Right side firewall view

Interior view on driver's side
