ARIZONA DEPARTMENT OF TRANSPORTATION

REPORT NUMBER: FHWA-AZ88-202-II

SMALL SIGN SUPPORT ANALYSIS

**Phase II
Static, Pendulum and Full-Scale Crash Test Programs
Volume I (Report)**

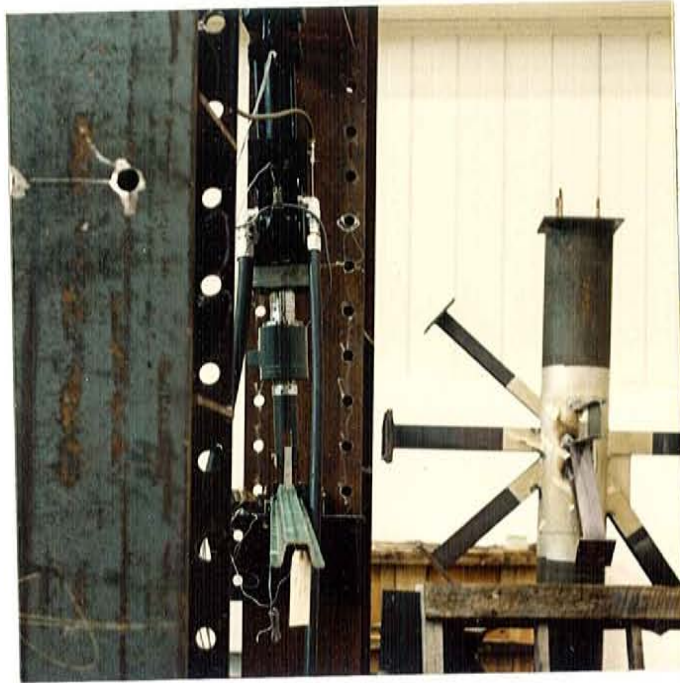
FIGURE 5.11. PHOTOGRAPH OF 18 INCH LATERAL TIP DEFLECTION MEASURED DURING A FACE TO FACE TEST IN THE NON-CRITICAL CONFIGURATION.

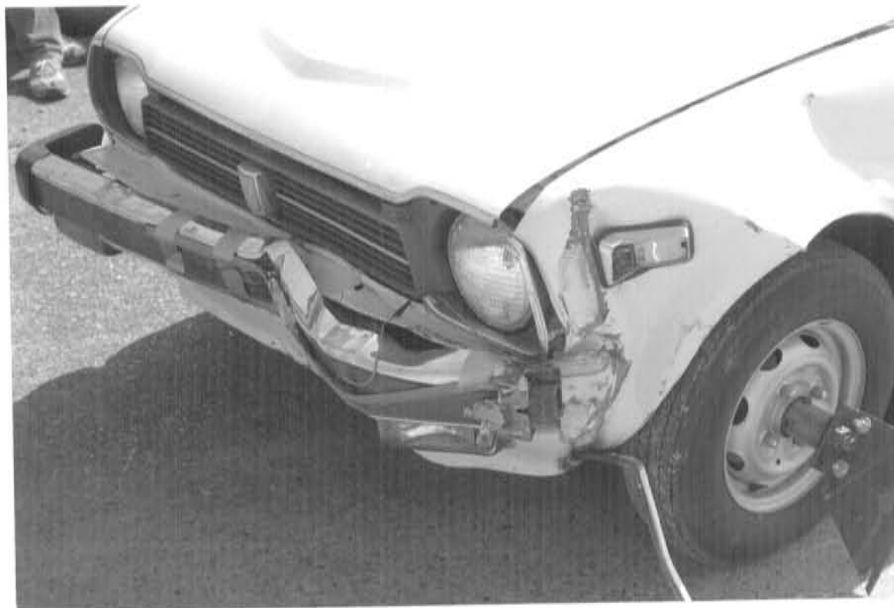
FIGURE 7.5. VEHICLE DAMAGE FOLLOWING TEST 7024-24.

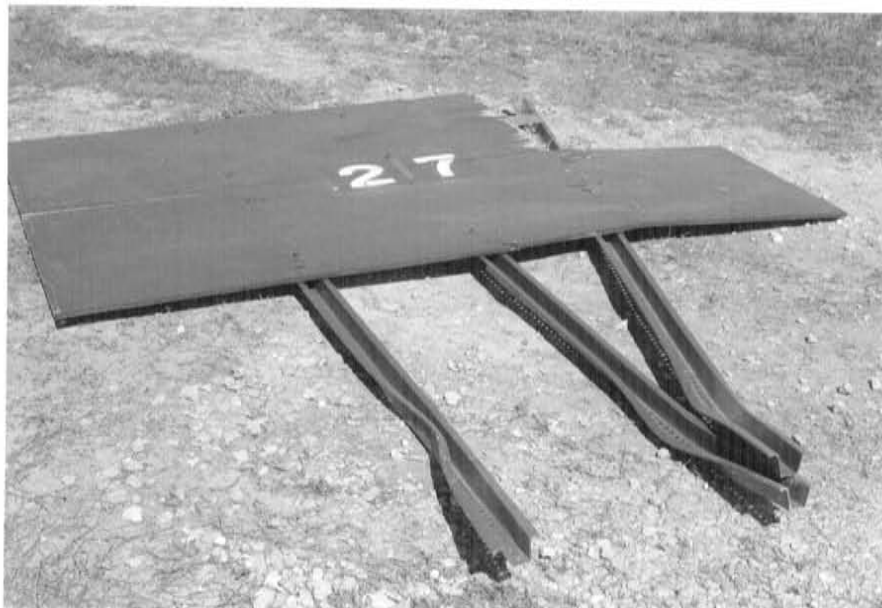
FIGURE 7.20. SIGN INSTALLATION FOLLOWING TEST 7024-27.

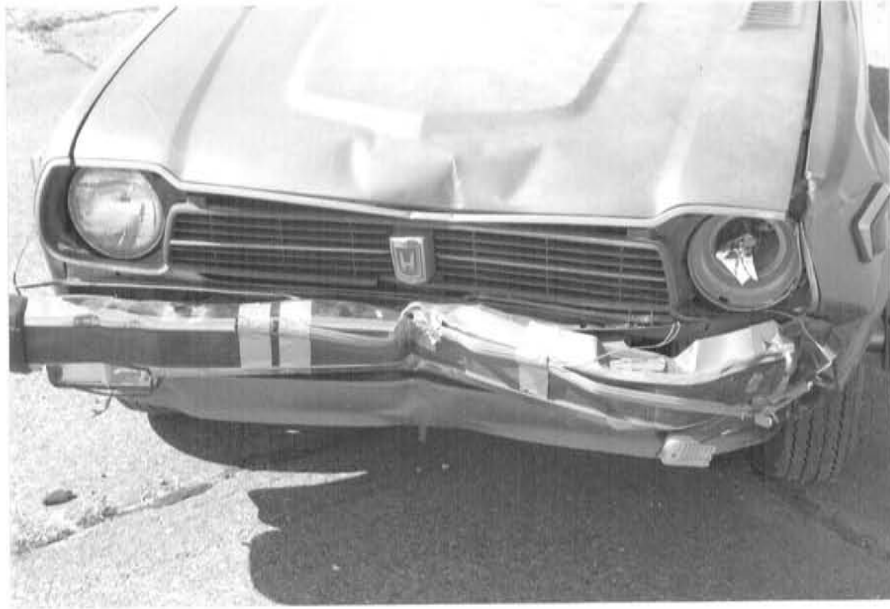
FIGURE 7.21. VEHICLE DAMAGE FOLLOWING TEST 7024-27.

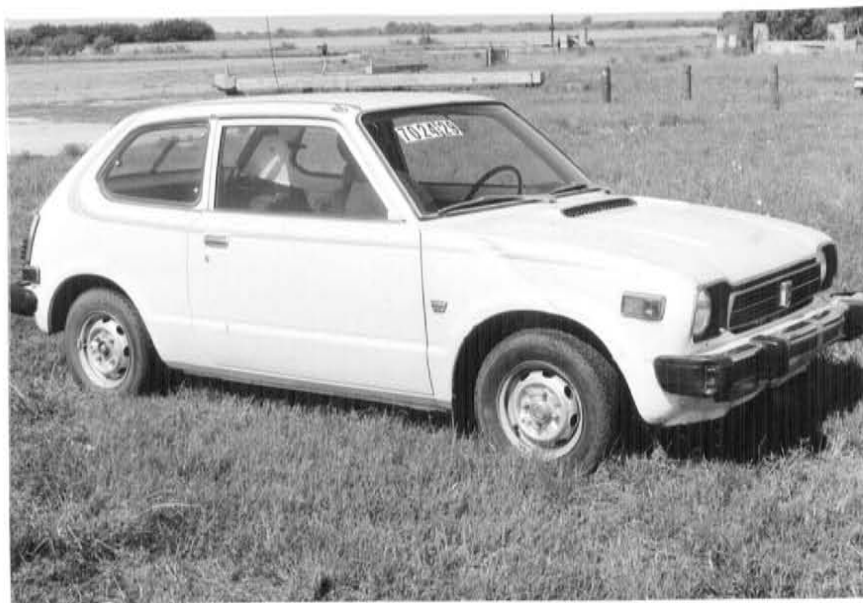
FIGURE 7.28. VEHICLE DAMAGE FOLLOWING TEST 7024-29.
