Transportation Consortium of South-Central States

UHPC Shear Keys in Concrete Bridge Superstructures

Project No. 18CNMS01

Final Report
August 2019

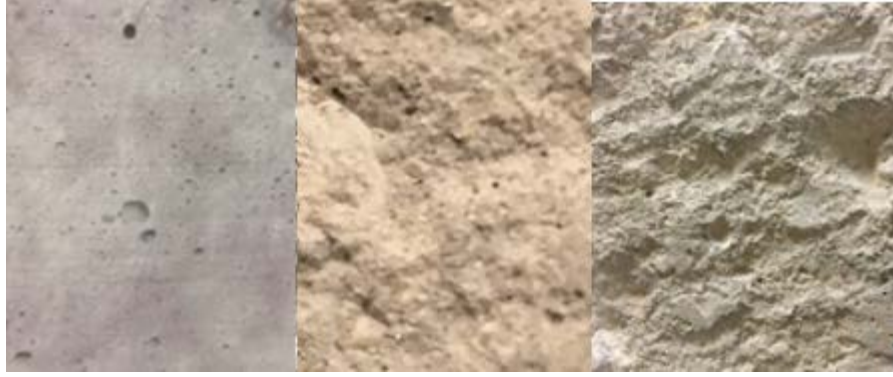
Surface Preparation: Texture depth was determined in accordance with ASTM E965 (6). Surface preparation varied from formed to medium roughness. The formed surface was prepared by using a stiff wire brush to dust off loose material and the chipped surfaces were prepared by using an air hammer to chip off the formed surface. Figure 3 illustrates three of the substrate textures.

Figure 3. Substrate textures: formed, 0.06 in. (1.52 mm), and 0.10 in. (2.54 mm).

Surface Preparation: The normal strength concrete substrate was textured in the same manner as the slant-shear specimens to achieve the same texture depths (Figure 3).

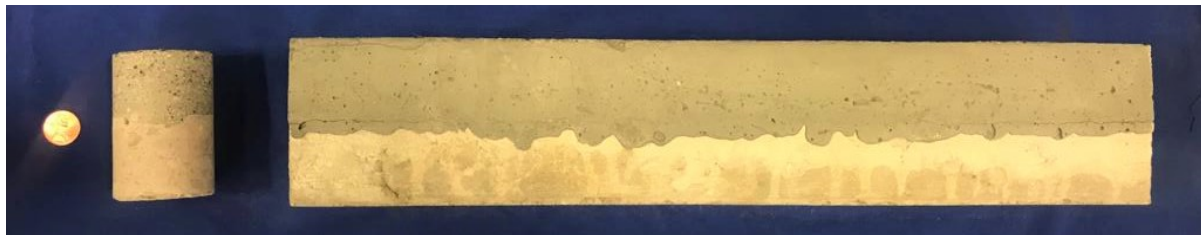
Figure 6. Direct tension specimen preparation.

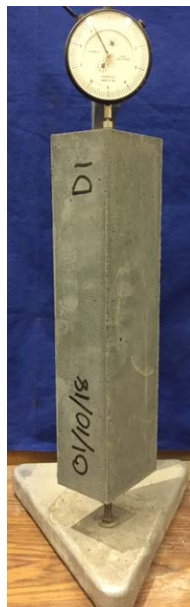
Longer-Term Shrinkage Test: Shrinkage monitoring began immediately after the beams were removed from the molds. Changes in length were measured using a comparator as shown in Figure 8. Measurements were recorded for 28 days that included the seven days of moist curing (73°F [23°C] and 98% relative humidity) and the remaining time at ambient conditions (68°F [20°C] and 30% relative humidity). Specimens cured at ambient lab conditions had measurements recorded for 28 days after demolding. Shrinkage strains for the longer-term shrinkage tests were computed using the changes in length from the comparator readings and Equation 3.

Figure 8. Longer-term shrinkage test setup.

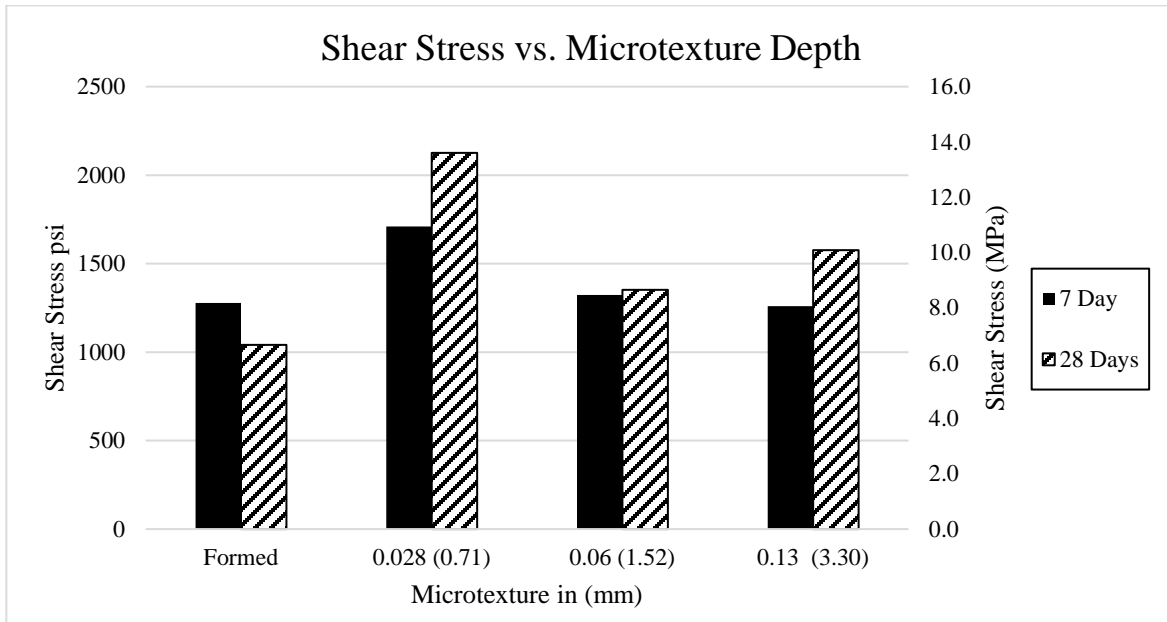
Figure 15. Slant-shear bond strengths.

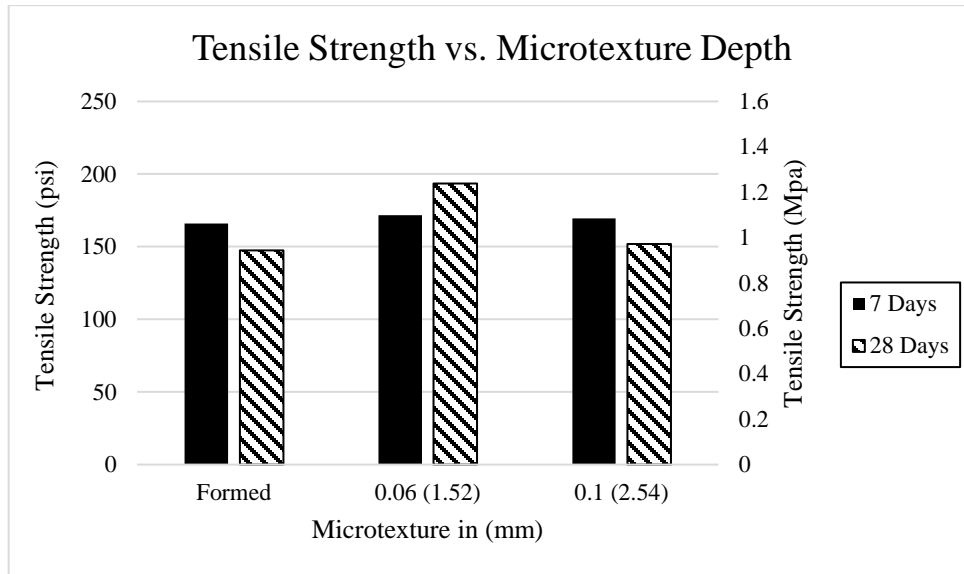
Figure 16. Direct tension strengths.

For the textured surfaces, all of the fractures occurred in the substrate. This is an indication that the bond was excellent, but tensile strength was limited the strength of the substrate. As with the textured slant-shear specimens, substrate strength could also have been reduced by cracks caused by chipping during surface preparation.

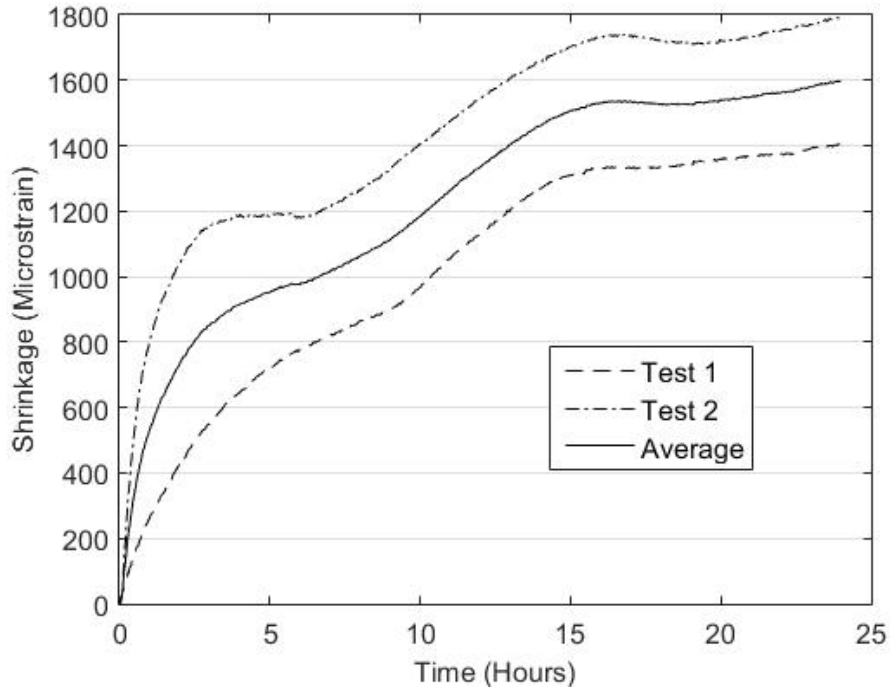
Figure 21. First 24 hours of early-age shrinkage data.
