**Nevada Department of Transportation  
Research Report No. 023-20-803  
Repair and Testing of Out-of-Plane Seismic  
Response of Pocket Connections  
January 2022**

Repair and Shake Table Testing of Out-of-Plane Seismic Response of Simplified  
Cast-in-Place Joints using ABC Pocket Connection

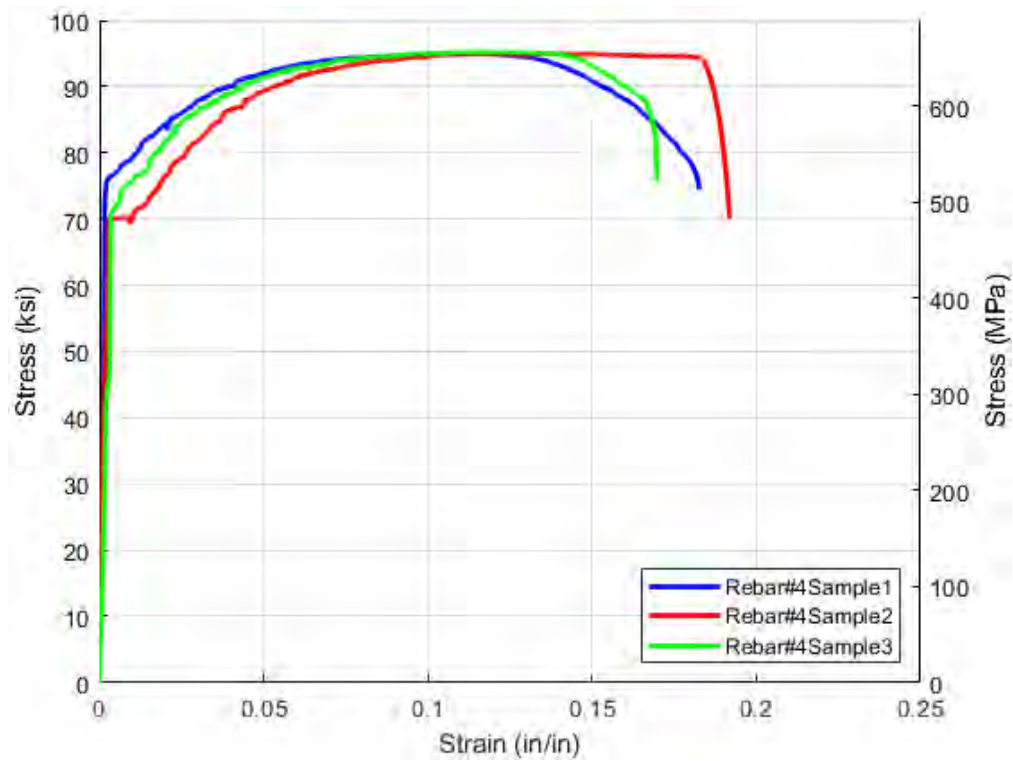
Figure 2.18 Measured stress-strain relationships for #4 bars

The properties of the reinforcement steel were also tested based on the ASTM A370 Standard. Three coupons of #3 and #4 reinforcement bars were used for tensile tests. Figures 2.17 and 2.18 show the stress-strain diagram of the #3 and #4 reinforcement bars, respectively. The occasional jagged result in the stress-strain diagrams was caused because of some instantaneous test setup glitches or slippage of the reinforcement bars. The yield stress, ultimate stress, yield strain, and the ultimate strain were determined based on the stress-strain relationship. Table 2.2 summarizes the key stress and strain values determined from the material tensile tests.

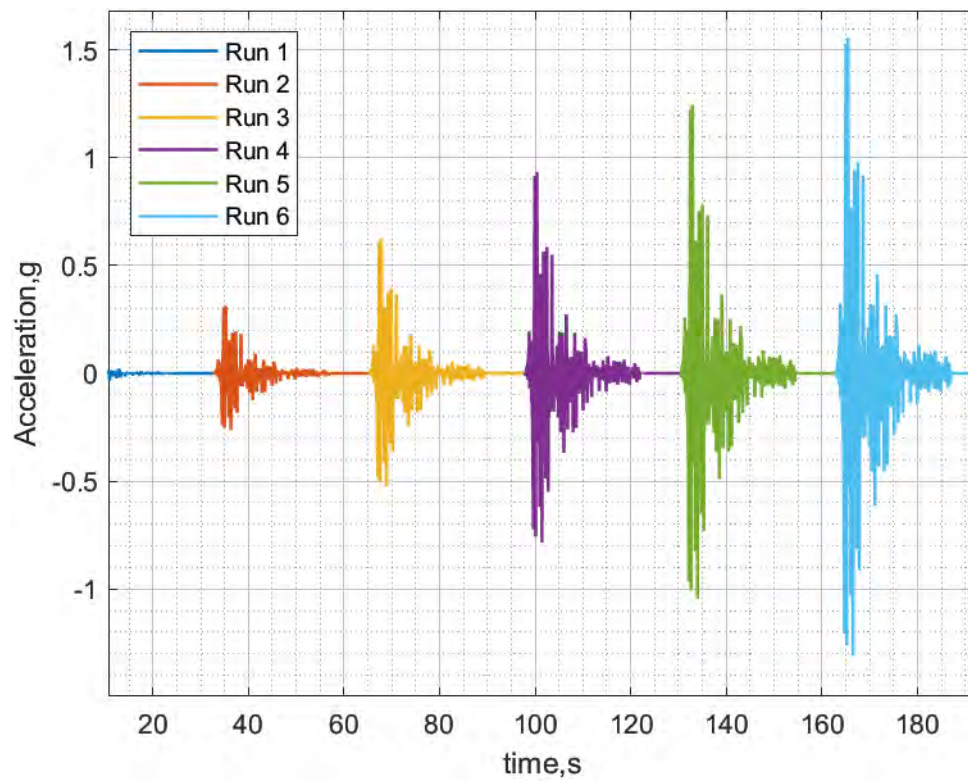
Figure 2.28 Acceleration history for runs 1-6

that in the occurrence of the 12<sup>th</sup> run, the displacement demands increased significantly and the laboratory staff decided to stop the test in the middle to avoid any damage to the test setup or the shake table. Figures 2.28 and 2.29 show the spliced acceleration history for all the runs. The intensity was increased in the original test and again in the repaired test until the specimen failed in order to develop the full hysteresis envelope. The loading protocol is summarized in Table 2.4 .

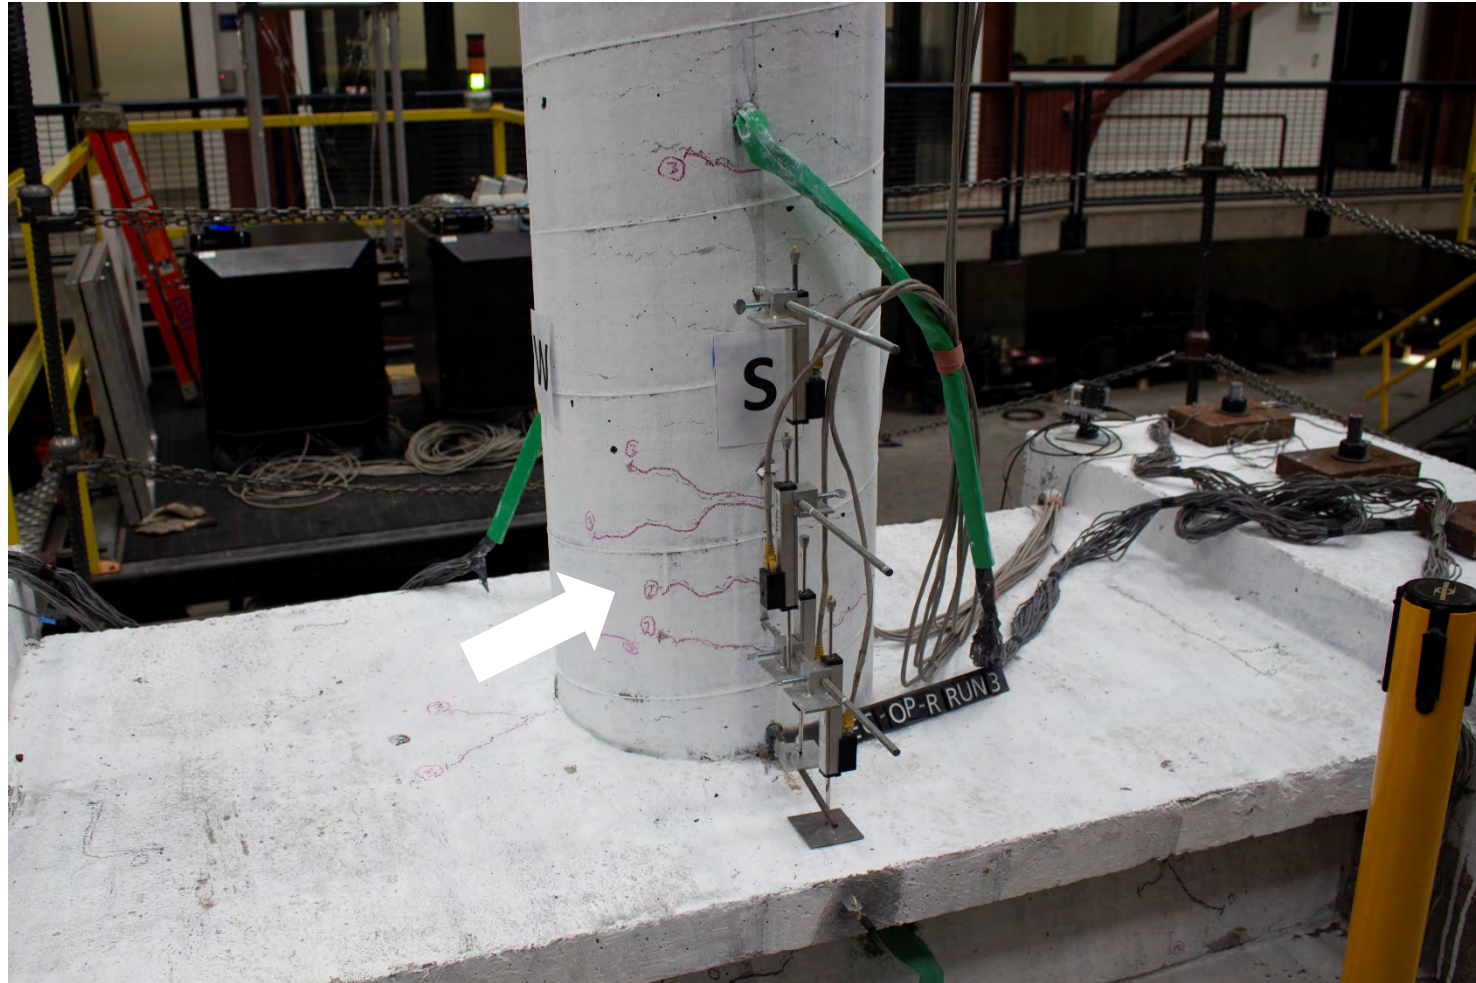
Figure 3.2 Additional flexural cracks (run #3)

were low and did not cause visual damage in the column. More flexural cracks were observed after run #3 in the south side of the plastic hinge zone in the column as shown in Fig. 3.2, and new flexural cracks appeared on the upper part of the column as depicted in Fig. 3.3. Shear cracks were also noticed around the cap beam interface (Fig. 3.4). The maximum drift ratio in run #3 was 1.98%.

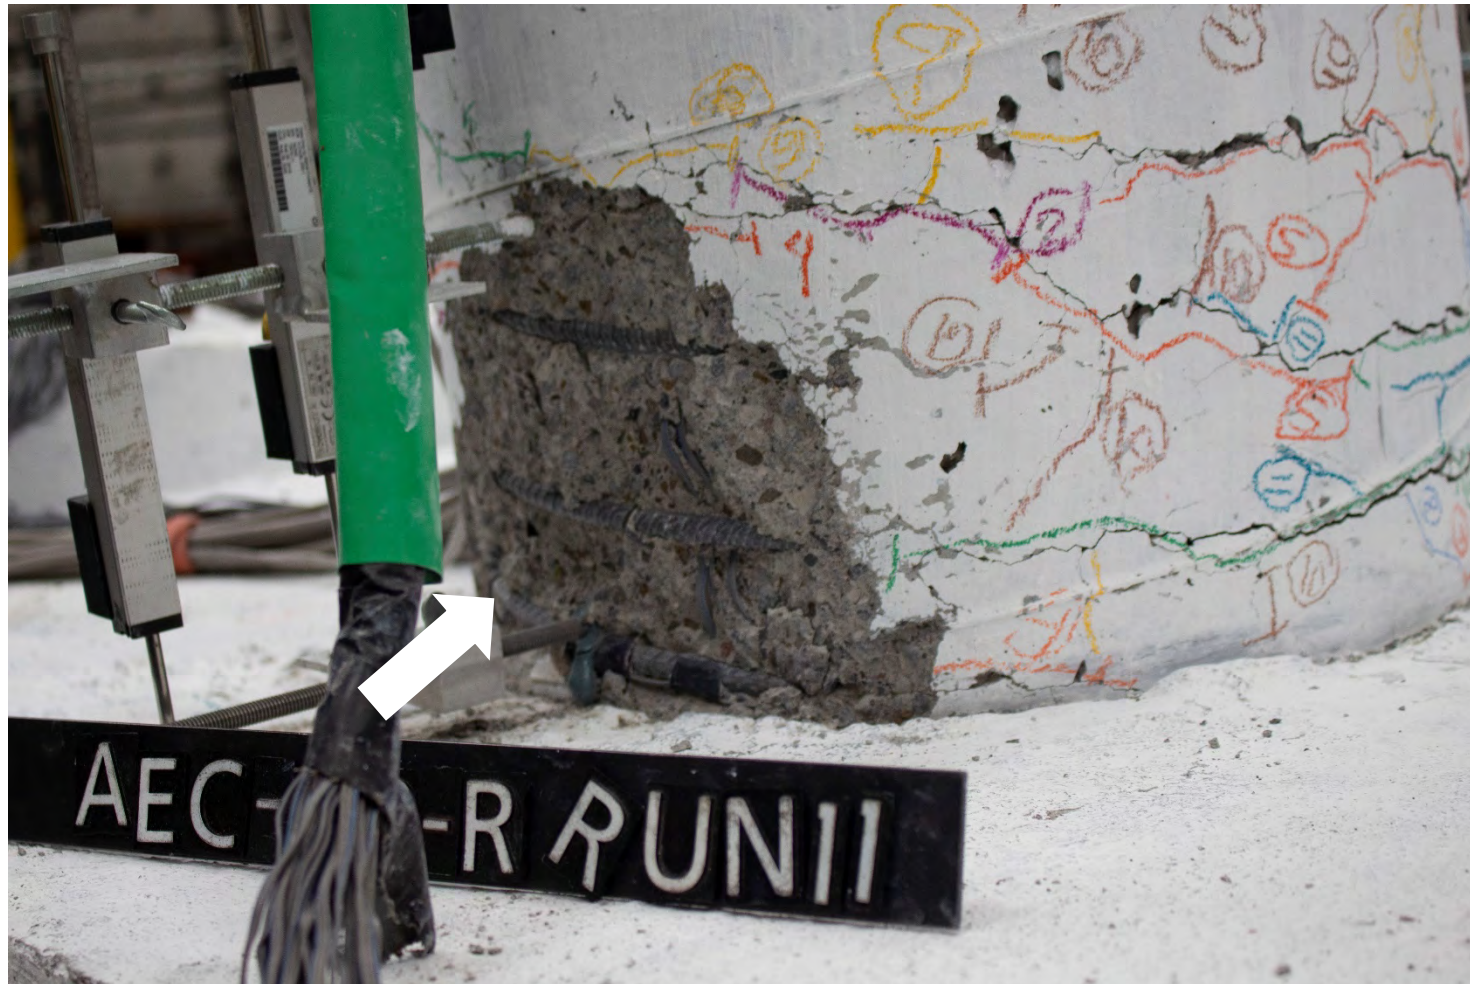
Figure 3.14 Concrete spalling in the north direction (run #11)

In run #10, the specimen started to have significant damage concentrating in the plastic hinge zone. The column recorded a maximum drift ratio of 6.95% towards the north direction. The motion caused more flexure cracks to expand (Fig. 3.12) with additional spalling on the north side (Fig. 3.13). For run #11 with a drift ratio of 10.27%, the spalling in the north side grew larger with multiple spiral reinforcements exposed (Fig. 3.14). Additional flexure cracks and shear cracks also

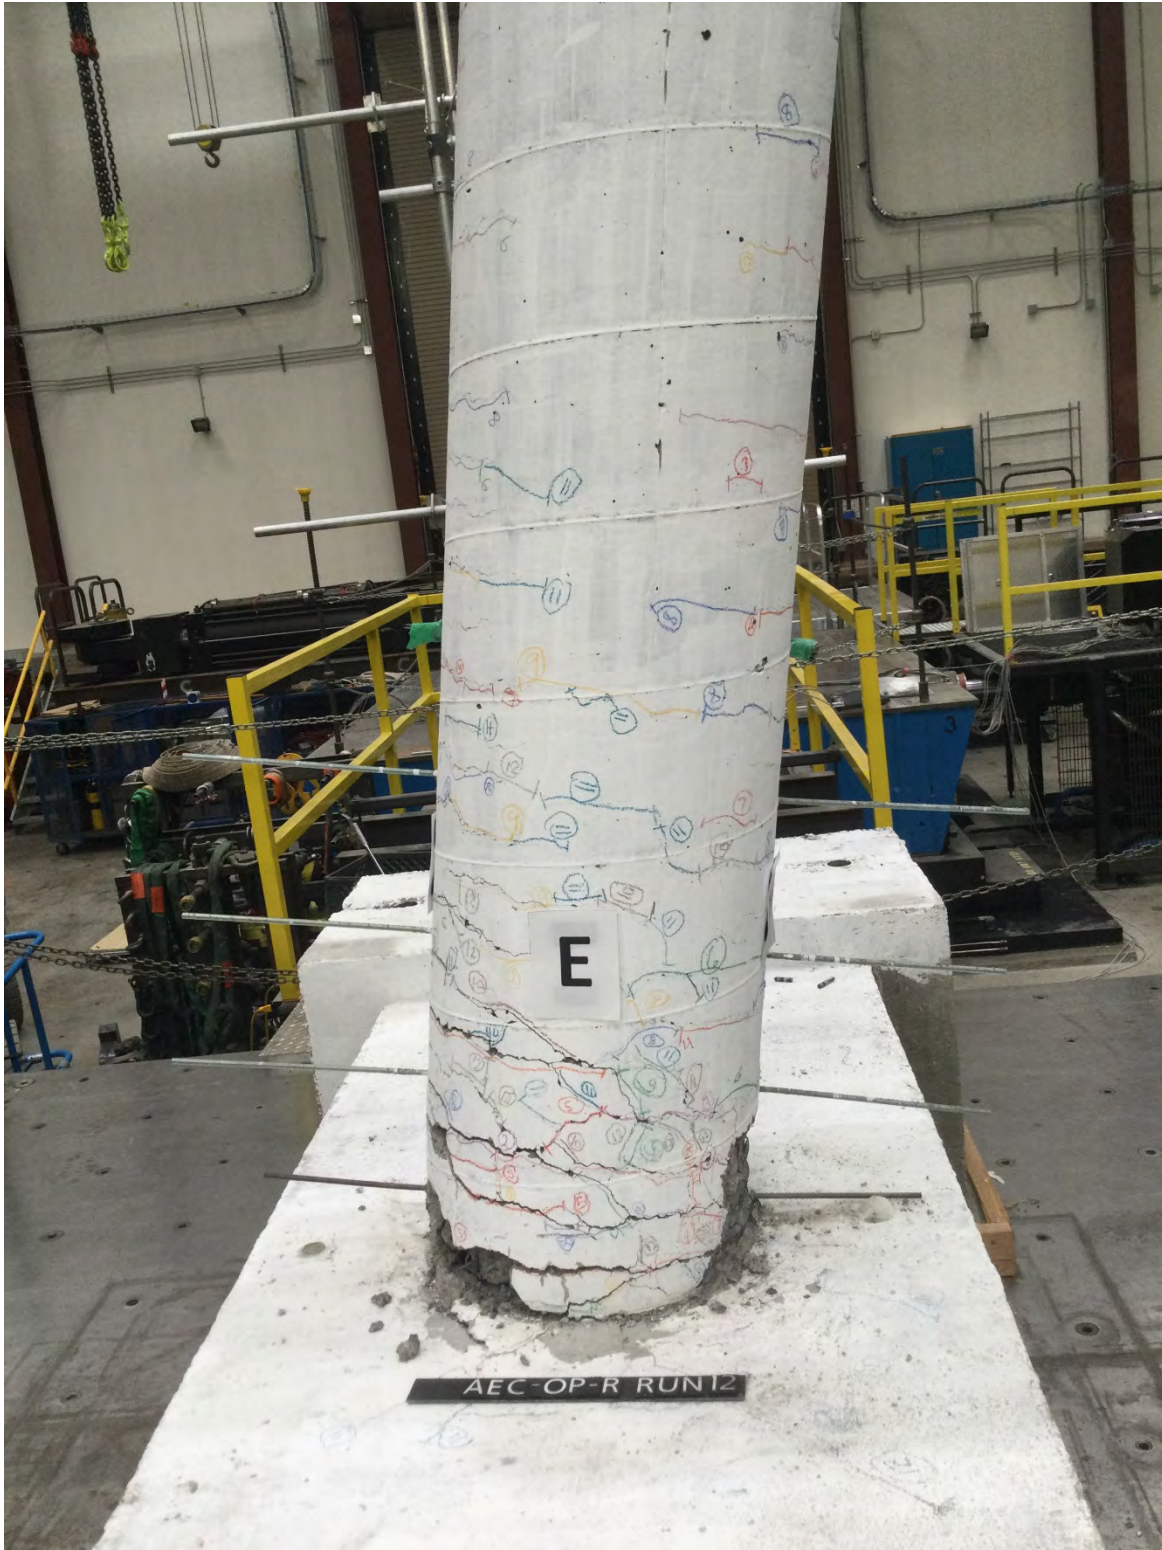
Figure 3.18 Column position after run #12

appeared on the east side (Fig. 3.15). The flexural cracks also expanded in the south portion of the plastic hinge zone. After run #11, one more additional run, i.e. run #12, using the same scaled motion that was applied in run #11. During run #12 while the earthquake motion was being applied, loud popping sounds indicating rupture of the column longitudinal rebars was heard. Thus, the laboratory staff decided to stop the test instantaneously before the full intended motion was completed to avoid any damage to the test setup or shake table. In this last run, significant damage was evident in both the north and south sides of the plastic hinge zone. The spalling of both sides of the plastic hinge zone can be seen in Figs. 3.16 and 3.17. The final column orientation and permanent drifts is shown in Fig. 3.18 where the column is seen to have permanently drifted towards the north side.

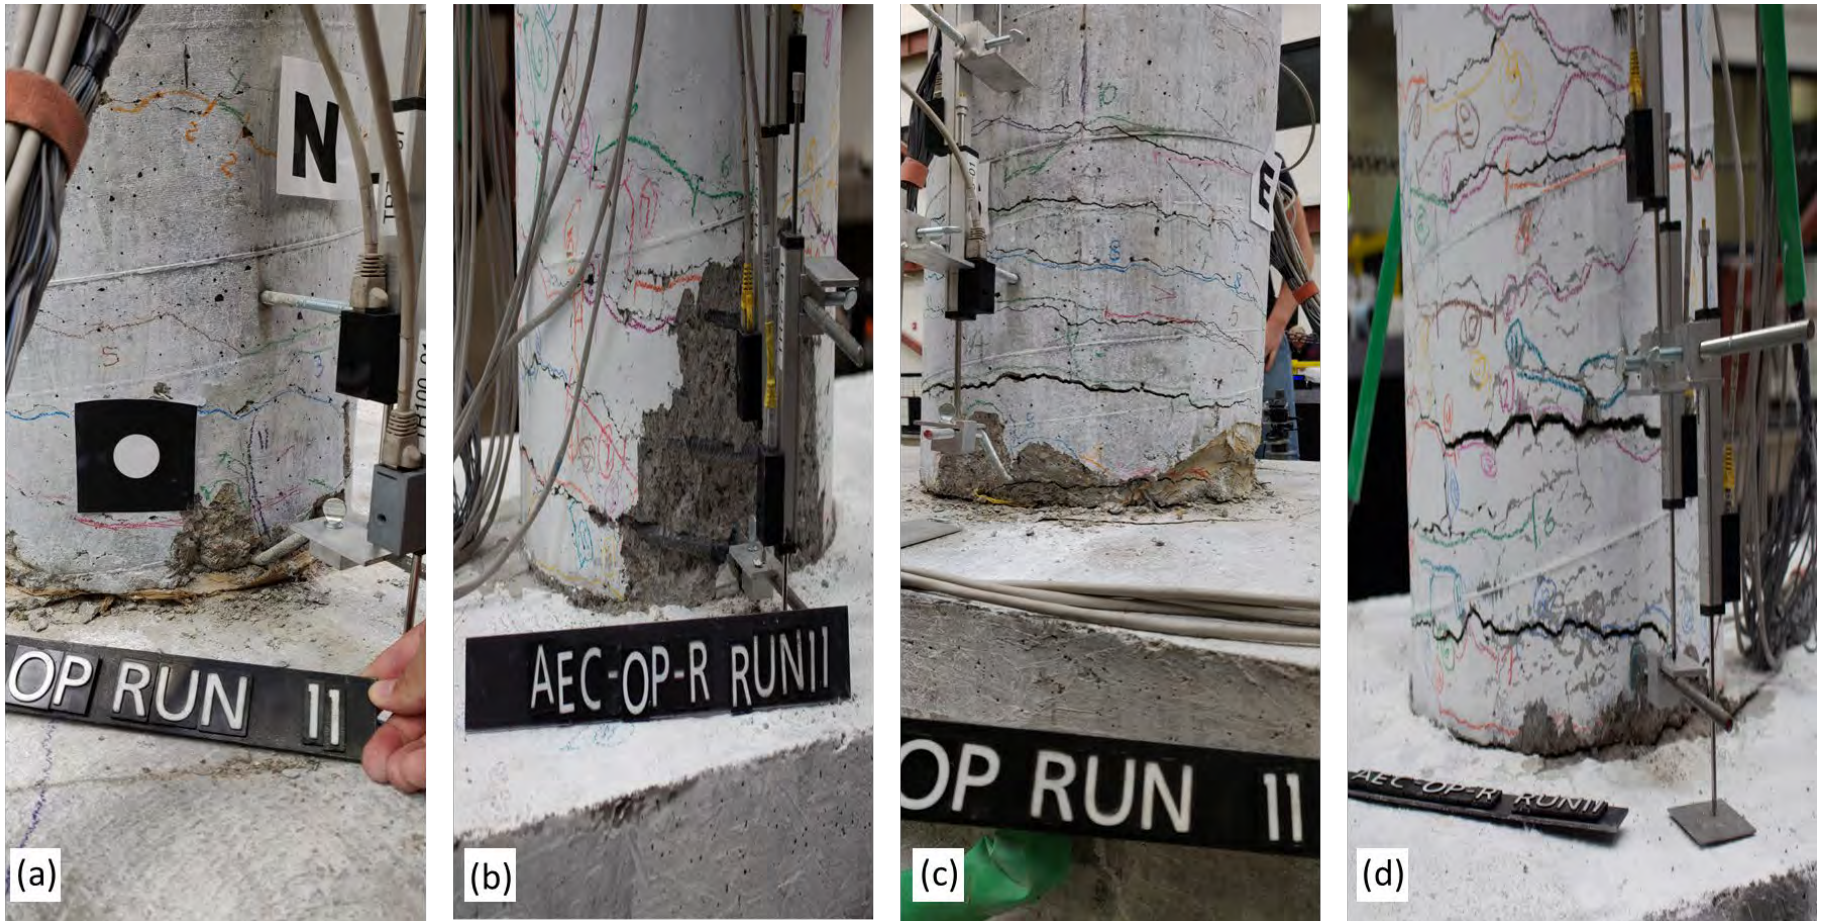
Figure 4.3 Comparison of concrete spalling as observed from the specimens tests located at: (a) north section of the original specimen, (b) north section of the repaired specimen, (c) south section of the original specimen, and (d) south section of the repaired specimen
