Final report

November 2021

## MASH Validation Testing of Low Profile Barrier

## **MASH TL-2 EVALUATION OF PORTABLE CONCRETE CONSTRUCTION ZONE BARRIER**

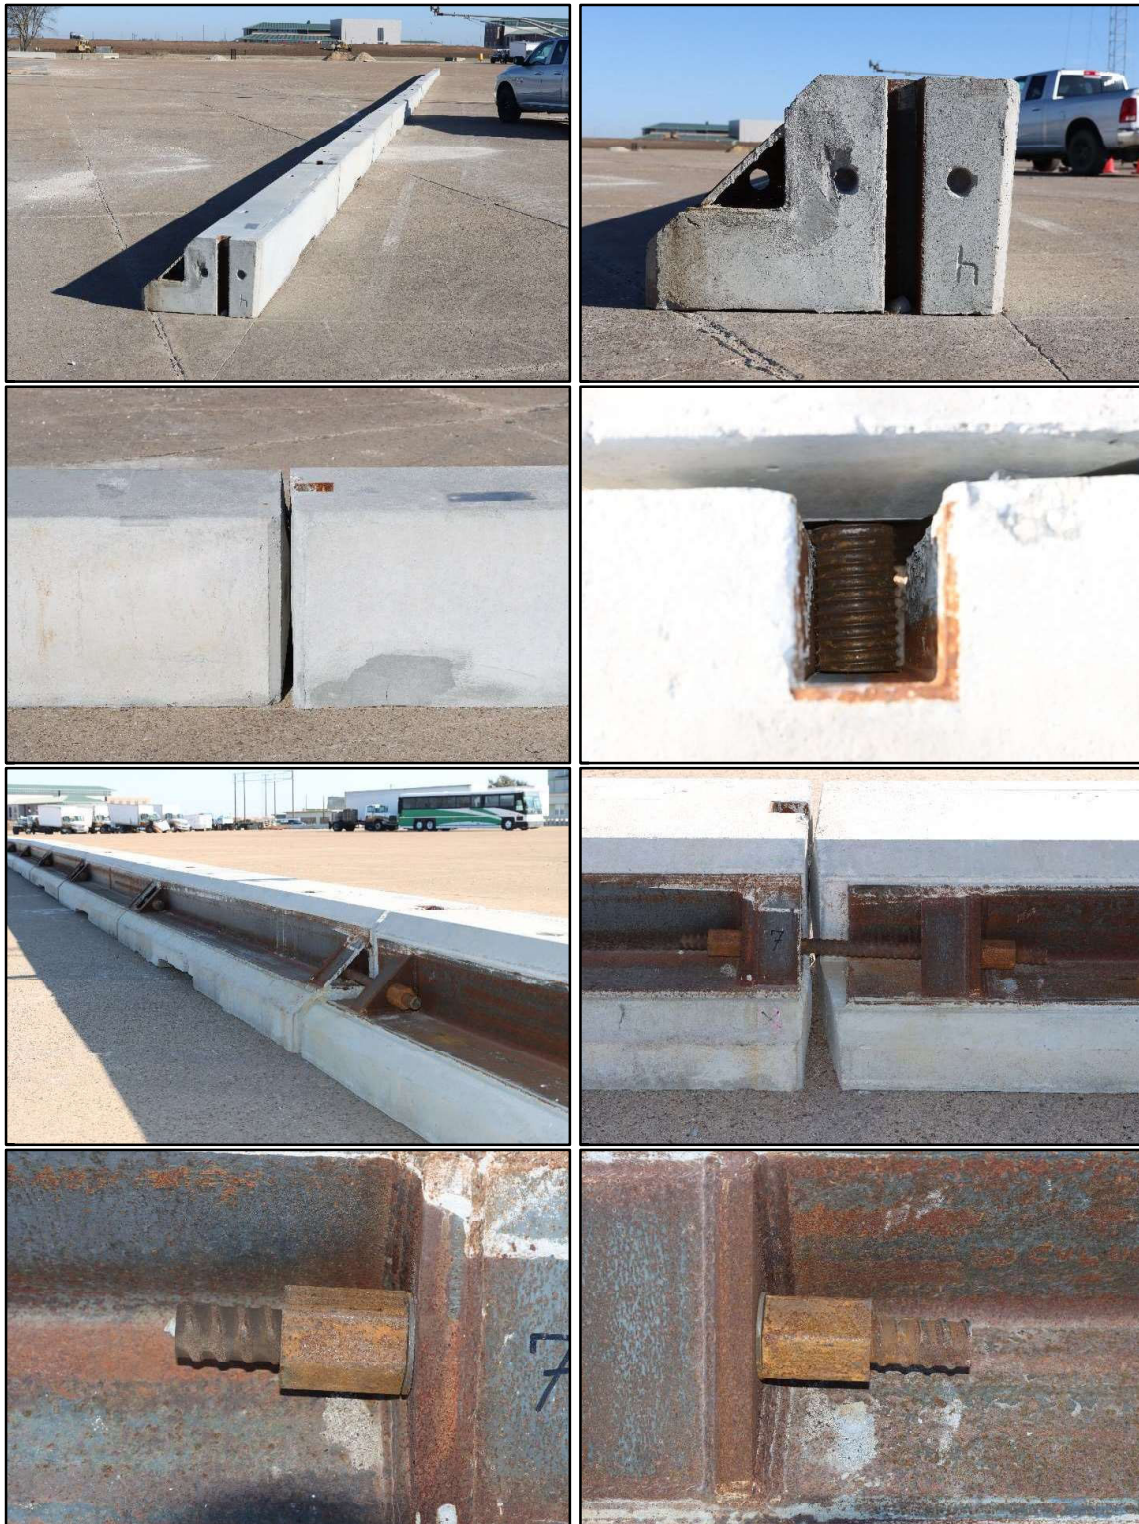
**Figure 2.2. Portable Concrete Construction Zone Barrier prior to Testing.**

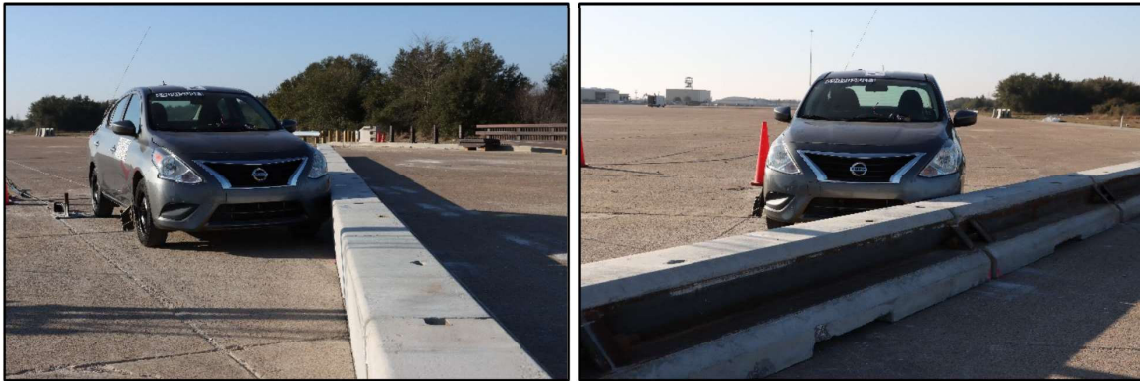
**Figure 5.1. Barrier/Test Vehicle Geometrics for Test No. 690905-UOF1.**

*MASH* Test 2-10 involves a 1100C vehicle weighing  $2420 \text{ lb} \pm 55 \text{ lb}$  impacting the CIP of the longitudinal barrier at an impact speed of  $44 \text{ mi/h} \pm 2.5 \text{ mi/h}$  and an angle of  $25 \text{ degrees} \pm 1.5 \text{ degrees}$ . The CIP for *MASH* Test 2-10 on the portable concrete construction zone barrier was  $3.3 \text{ ft} \pm 1 \text{ ft}$  upstream of the center of the joint between barriers 6 and 7. Figure 3.1 and Figure 5.1 depict the target impact setup.

The 1100C vehicle weighed 2402 lb, and the actual impact speed and angle were 44.4 mi/h and 25.6 degrees. The actual impact point was 3.6 ft upstream of the center of the joint between barriers 6 and 7. Minimum target impact severity (IS) was 25 kip-ft, and actual IS was 30 kip-ft.

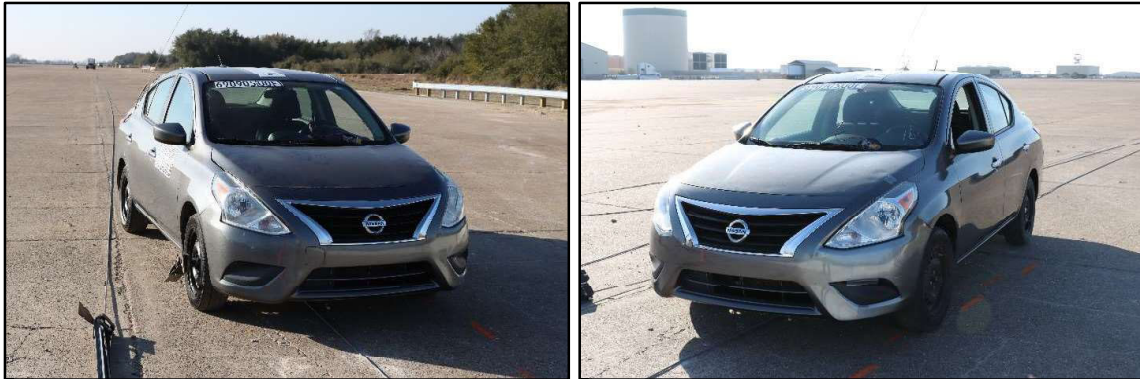
**Figure 5.2. Test Vehicle before Test No. 690905-UOF1.**

Figure 5.2 shows the 2016 Nissan Versa used for the crash test. The vehicle's test inertia weight was 2402 lb, and its gross static weight was 2567 lb. The height to the lower edge of the vehicle bumper was 7.0 inches, and the height to the upper edge of the bumper was 22.25 inches. Table C.1 in Appendix C.1 gives additional dimensions and information on the vehicle. The vehicle was directed into the installation using a cable reverse tow and guidance system, and was released to be freewheeling and unrestrained just prior to impact.

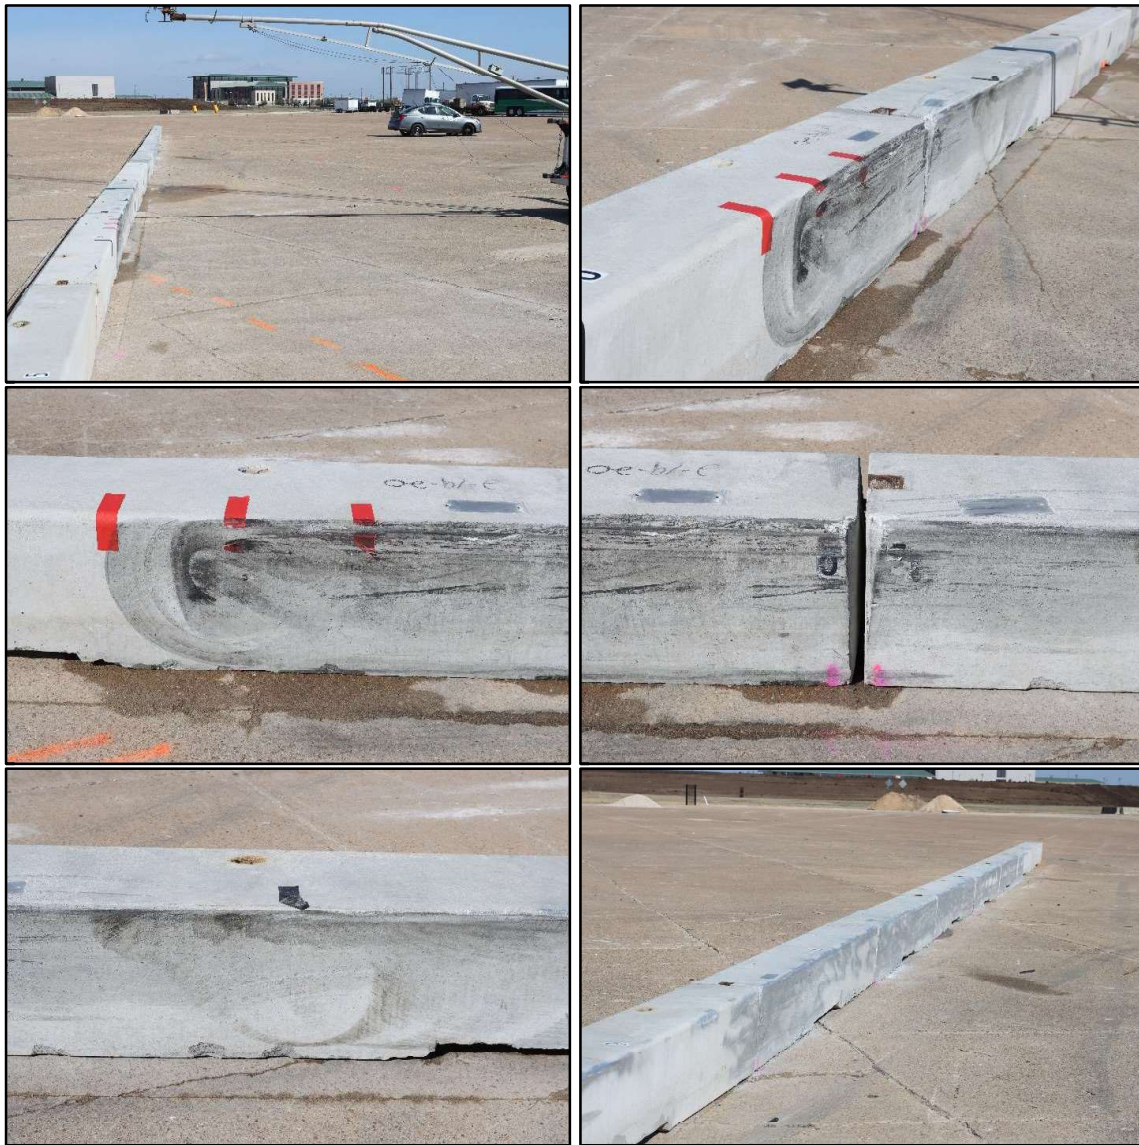
**Figure 5.3. Portable Concrete Construction Zone Barrier after Test No. 690905-UOF1.**

There was some scuffing at impact and at the secondary impact location 69 inches downstream from the upstream end of barrier 8. Barrier 5 at its upstream slot location had a 17 $\frac{3}{4}$ -inch long crack extending 3 $\frac{1}{4}$  inches from the top traffic side edge of the slot downstream. Barrier 6 had an existing crack which widened to  $\frac{1}{4}$ -inch and extended further downstream ending at 34 $\frac{1}{4}$  inches downstream from the upstream end of the barrier. Barrier 10 had some spalling at its downstream field-side toe.

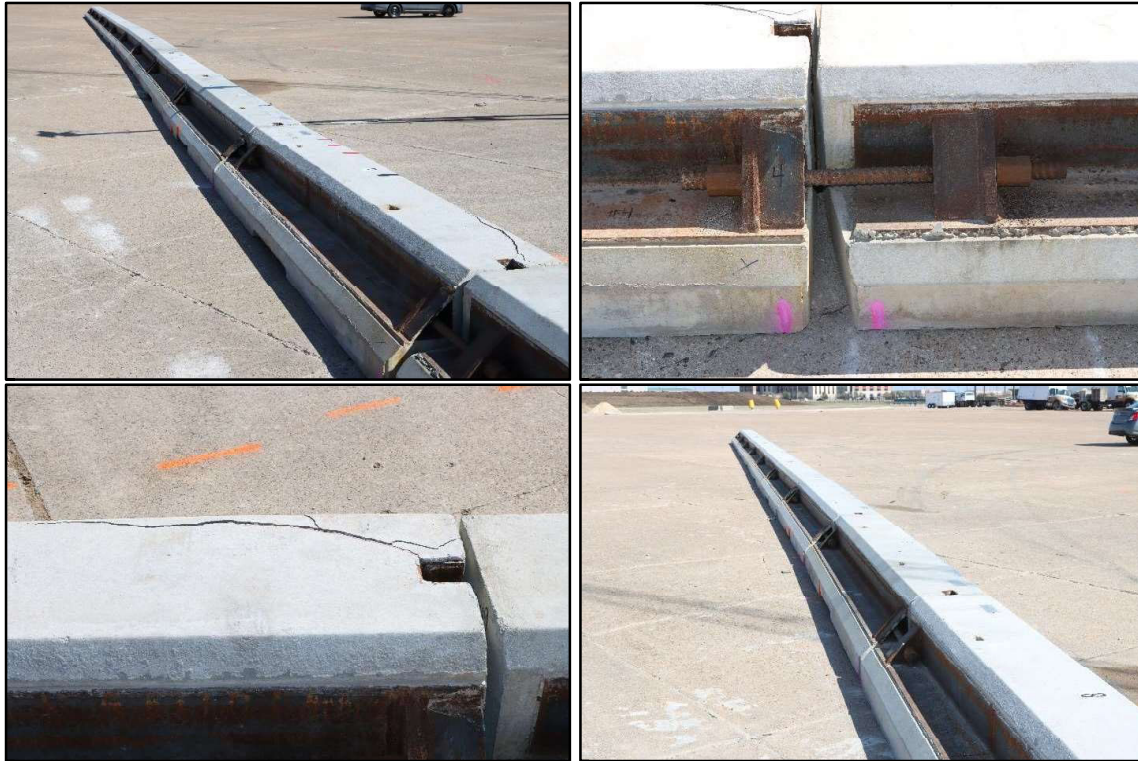
**Figure 5.4. Damage to Field Side of Barrier after Test No. 690905-UOF1.**

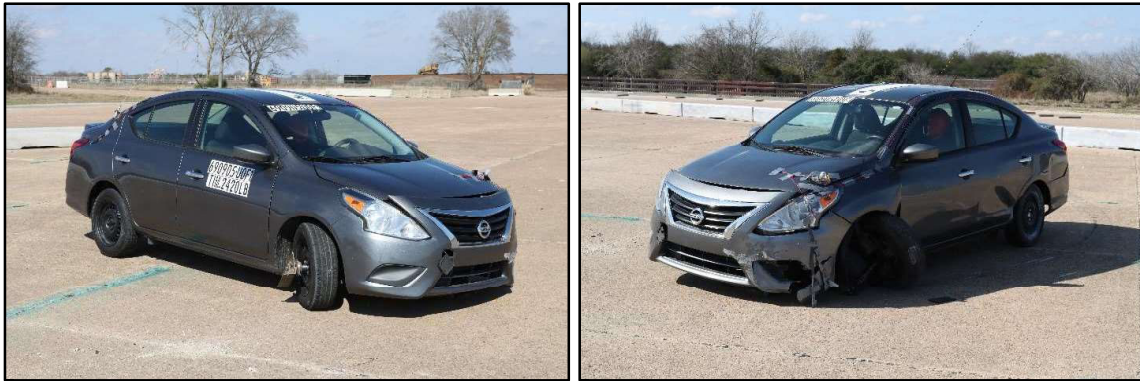
**Figure 5.5. Test Vehicle after Test No. 690905-UOF1.**

Figure 5.5 shows the damage sustained by the vehicle. The front bumper, left front wheel rim, left front fender, left front and rear doors, left rear wheel rim, and rear bumper were damaged. No fuel tank damage was observed. Maximum exterior crush to the vehicle was 3.0 inches in the front and side planes at the left front corner at bumper height. No occupant compartment deformation or intrusion was observed. Figure 5.6 shows the interior of the vehicle. Tables C.2 and C.3 in Appendix C.1 provide exterior crush and occupant compartment measurements.

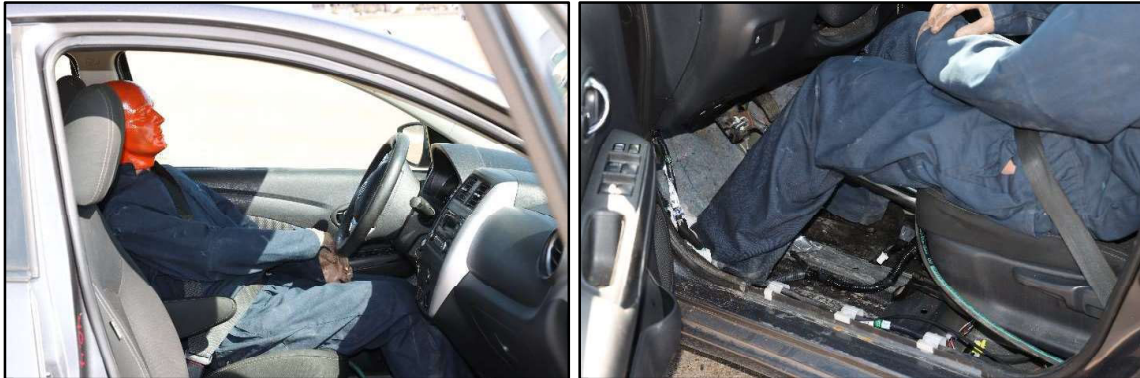
**Figure 5.6. Interior of Test Vehicle after Test No. 690905-UOF1.**

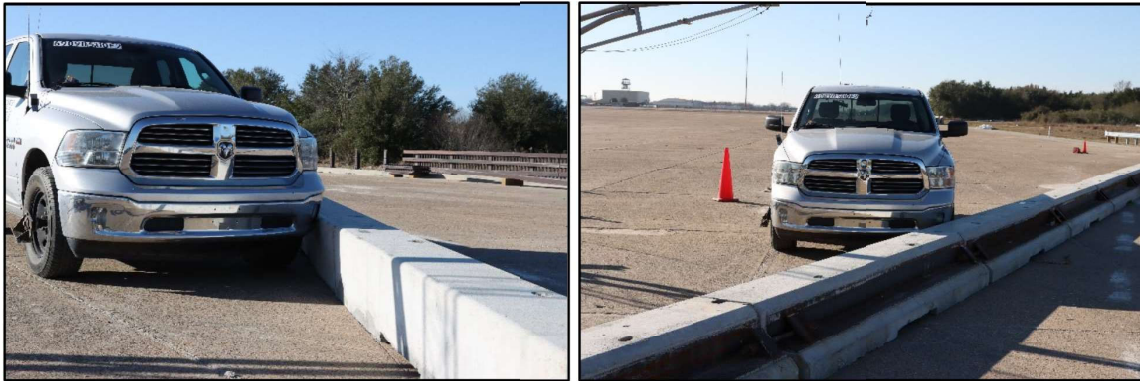
**Figure 6.1. Barrier/Test Vehicle Geometrics for Test No. 690905-UOF2.**

*MASH* Test 2-11 involves a 2270P vehicle weighing  $5000 \text{ lb} \pm 110 \text{ lb}$  impacting the CIP of the longitudinal barrier at an impact speed of  $44 \text{ mi/h} \pm 2.5 \text{ mi/h}$  and an angle of  $25 \text{ degrees} \pm 1.5 \text{ degrees}$ . The CIP for *MASH* Test 2-11 on the portable concrete construction zone barrier was  $2.6 \text{ ft} \pm 1 \text{ ft}$  upstream of the center of the joint between barriers 6 and 7. Figure 3.2 and Figure 6.1 depict the target impact setup.

The 2270P vehicle weighed 5016 lb, and the actual impact speed and angle were  $42.5 \text{ mi/h}$  and  $26.4 \text{ degrees}$ . The actual impact point was  $3.6 \text{ ft}$  upstream of the center of the joint between barriers 6 and 7. Minimum target IS was 52 kip-ft, and actual IS was 60 kip-ft.

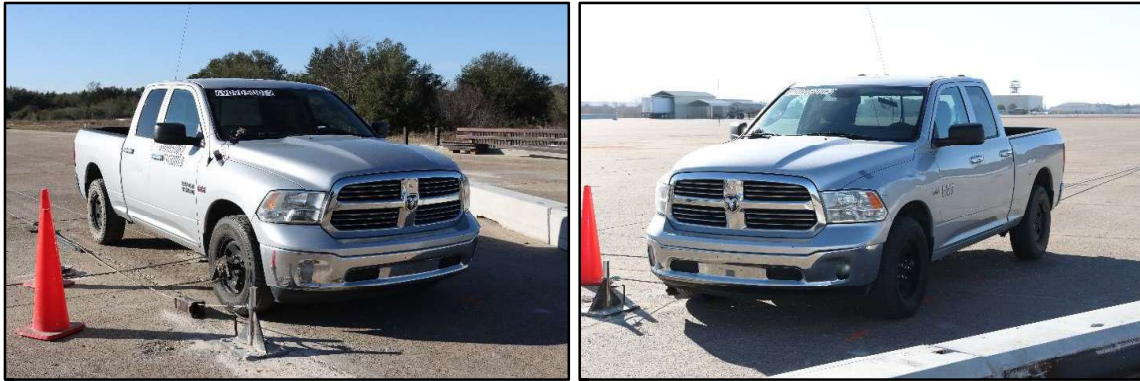
**Figure 6.2. Test Vehicle before Test No. 690905-UOF2.**

Figure 6.2 shows the 2016 RAM 1500 pickup truck used for the crash test. The vehicle's test inertia weight was 5016 lb, and its gross static weight was 5016 lb. The height to the lower edge of the vehicle bumper was 11.75 inches, and height to the upper edge of the bumper was 27.0 inches. The height to the vehicle's center of gravity was 28.37 inches. Tables D.1 and D.2 in Appendix D.1 give additional dimensions and information on the vehicle. The vehicle was directed into the installation using a cable reverse tow and guidance system, and was released to be freewheeling and unrestrained just prior to impact.

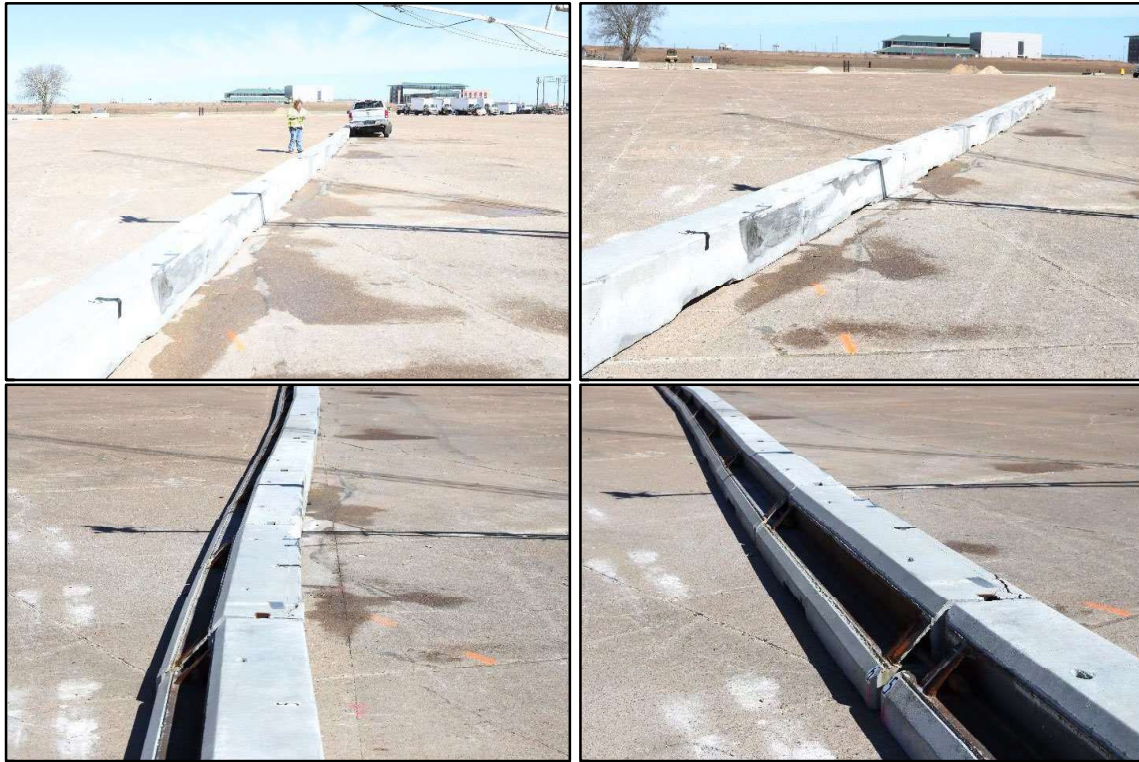
**Figure 6.3. Barrier after Test No. 690905-UOF2.**

Table 5.2 shows barrier displacements after the test. Working width\* was 40.5 inches, and height of working width was 5.0 inches. Maximum dynamic deflection during the test was 13.2 inches, and maximum permanent deformation was 12.5 inches.

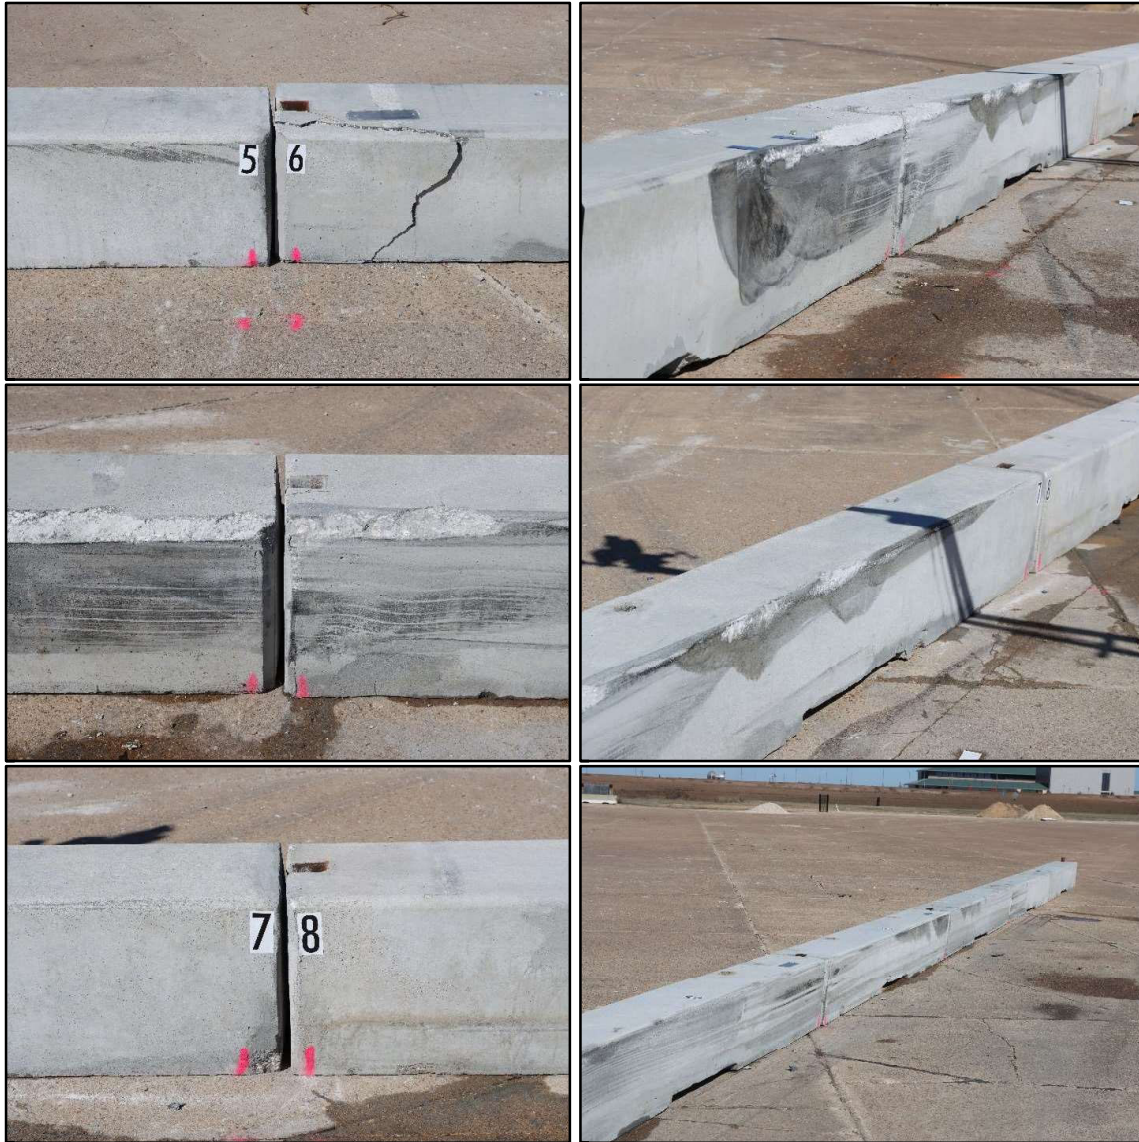
**Figure 6.4. Damage to Traffic Side after Test No. 690905-UOF2.**

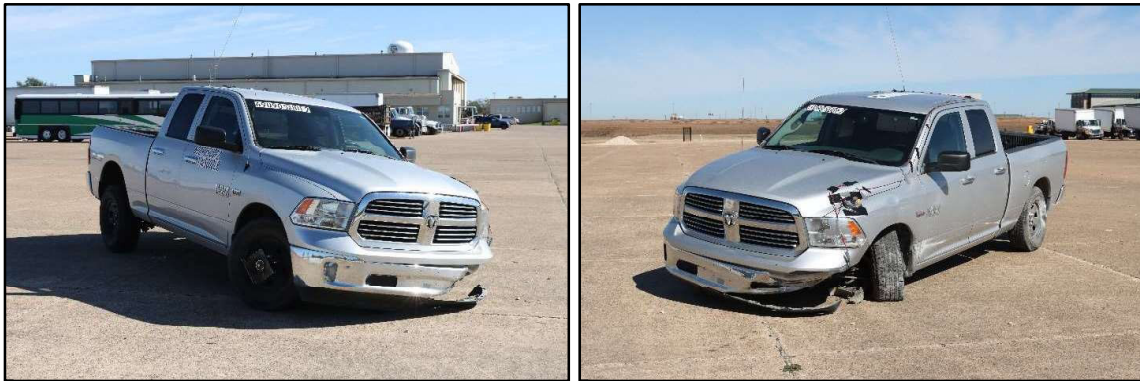
Figure 6.6. Test Vehicle after Test No. 690905-UOF2.

Figure 6.4 shows the damage sustained by the vehicle. The front bumper, left front fender, left tire and rim, left lower control arm, left front and rear doors, left rear cab corner, left rear rim, and left exterior bed were damaged. No fuel tank damage was observed. Maximum exterior crush to the vehicle was 10.0 inches in the front and side planes at the right front corner at bumper height. No occupant compartment deformation or intrusion was observed. Figure 6.5 shows the interior of the vehicle. Tables D.3 and D.4 in Appendix D.1 provide exterior crush and occupant compartment measurements.

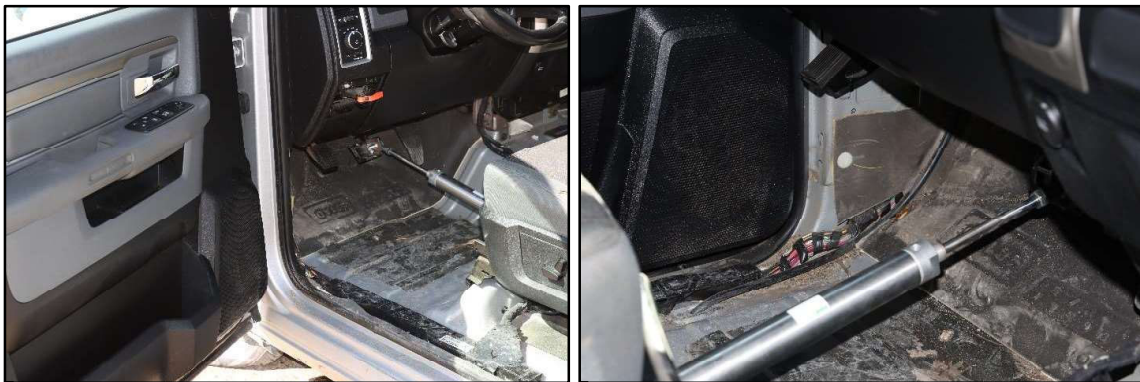
Figure 6.7. Interior of Test Vehicle after Test No. 690905-UOF2.
