# Textured Epoxy Coated and Galvanized Reinforcement to Reduce Cracking in Concrete Bridge Decks and Components

WisDOT ID no. 0092-19-01

August 2021

WISCONSIN HIGHWAY RESEARCH PROGRAM

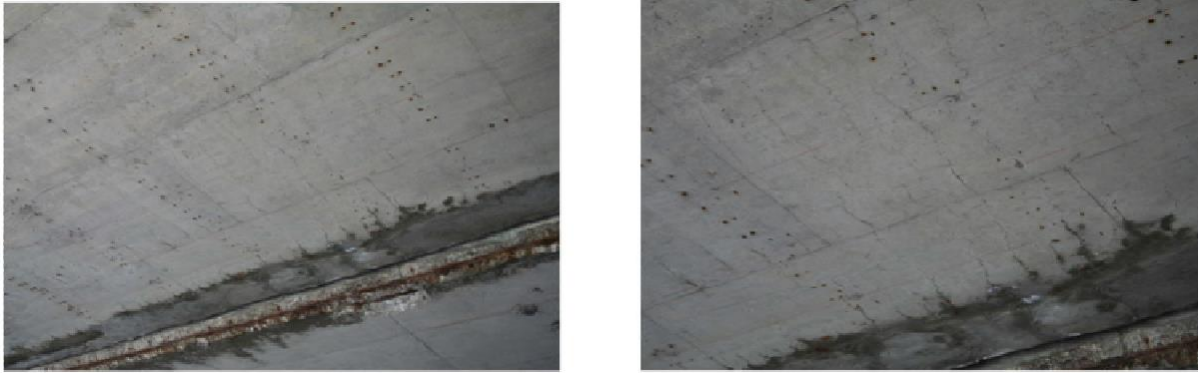
**Figure 2 - Examples of under deck bridge cracking. Photos are from a previous WHRP report [5].**

While cracks occur in all bridge structures, they are particularly problematic in bridge decks (Figure 2). Decks are exposed to precipitation, are directly loaded by traffic, and are in contact with deicing chemicals. Cracks in bridge decks provide access points for corrosion agents, including those in deicing chemicals, to initiate and exacerbate corrosion of steel reinforcement [1]. Indeed, corrosion of steel reinforcement can be a primary limitation on the service life of concrete bridge decks [3], and controlling cracks can be an effective strategy in mitigating the effects of corrosion [4].

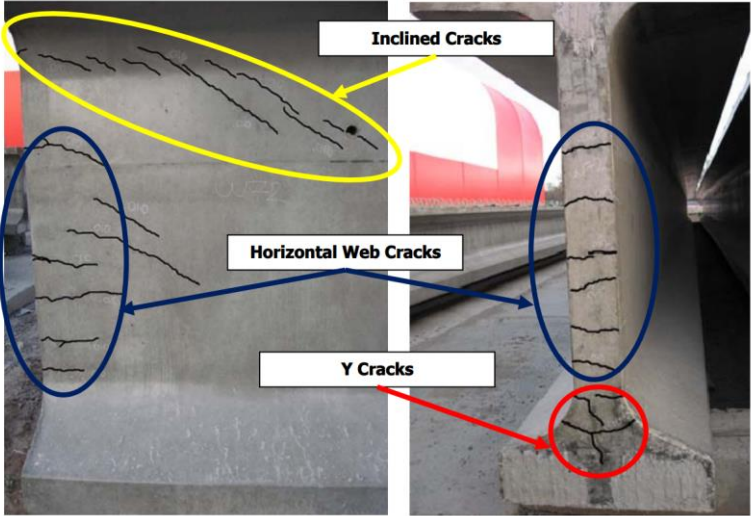
Figure 3 - Type of end region cracks [19].

End region cracking of precast-pretensioned concrete girders is a common challenge in Wisconsin (Figure 3) and in general. The primary cause of end region cracks is tensile stresses that occur from concentrated prestressing forces and are distributed from their point of application in the bottom flange to other parts of the girder cross-section (Figure 4).

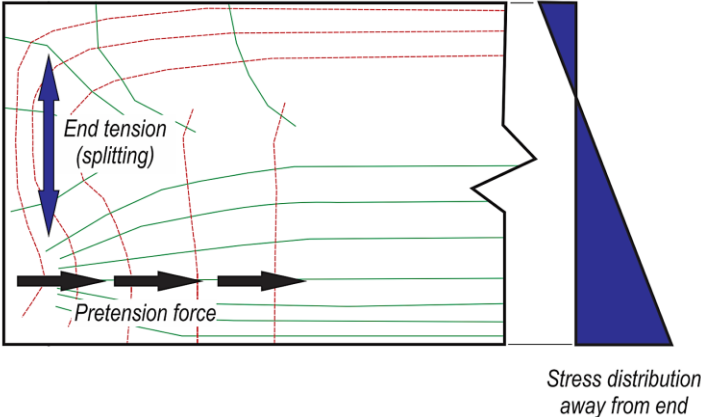
Figure 4 - End region cracks form due to tensile stresses (green trajectory lines), which form as the pretension force is distributed from the bottom flange to the rest of the cross-section. Figure based on Willis [23].

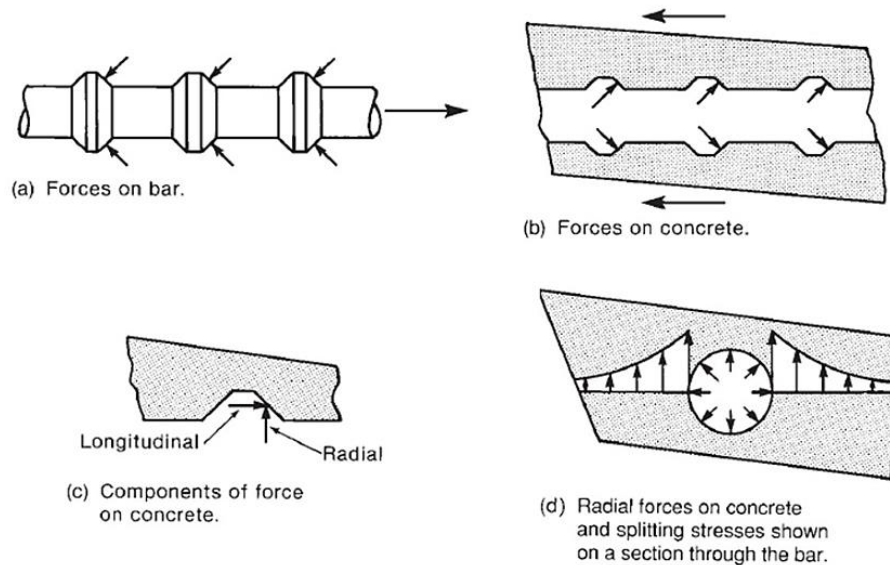
**Figure 5- Bond transfer mechanism (Figure from [38]).**

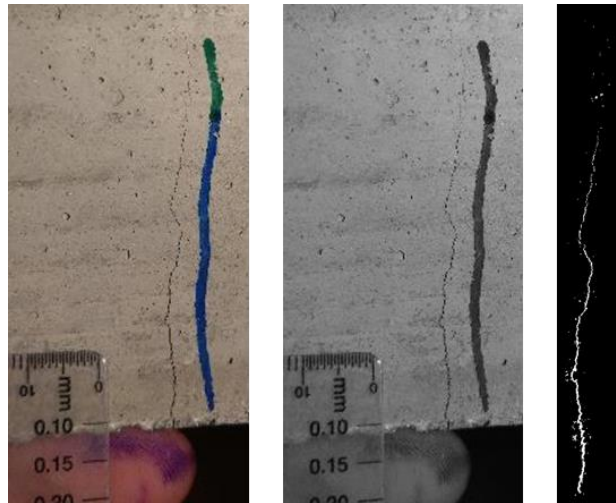
**Figure 6 - Original photo (left), conversion to 8-bit (center), crack highlight (right).**

Crack sizes were measured using ImageJ software [46]. This software analyzes digital images to determine widths, lengths, and areas. The process is shown from left to right in Figure 6. An item of known length was captured within a digital image and is used to establish a scale of pixels/mm within the software. After the scale was established, the format of the image was converted to 8-bit. The threshold tool in ImageJ was then used to tune and highlight the portion of the image containing the crack. Any “noise” around the crack was edited in MS Paint to eliminate the small spots which would add to the highlighted portion of the crack. The highlighted cracked portion was identified as a set of discrete particles close to each other in ImageJ and was converted to an area measurement using the scale. The average width was then determined outside the program by dividing the area by the manually measured crack length.

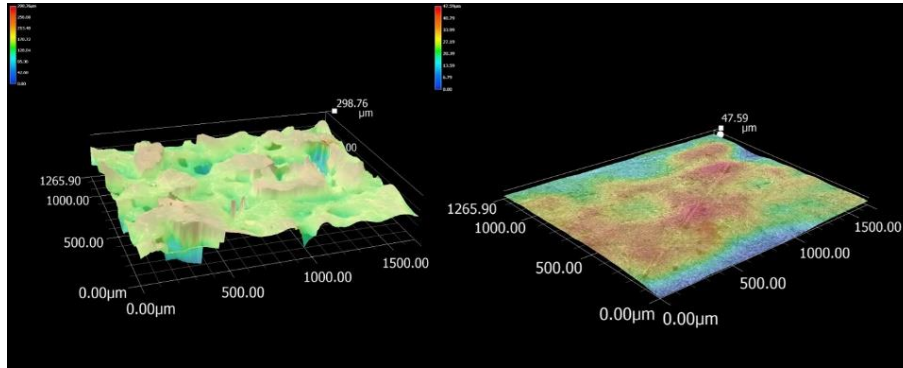
**Figure 7 - Microscope images for textured-epoxy surface (left) and smooth-epoxy surface (right). Colors in the image denote the surface topography.**

A VHX-7000 Keyence optical microscope was used to measure the surface roughness from samples of each coating type. The VHX-7000 has a depth of field that is 20 times greater than conventional optical microscopes. It can deliver 2D and 3D measurements, roughness, contamination, grain size, and other analyses with one tool. Additionally, observation can be carried out automatically at magnifications from 20× to 6000× without changing the lens. Example microscope images for textured-epoxy and smooth epoxy-coated bars are shown in Figure 7. The roughness measurement was particularly relevant for documenting the textured-epoxy bars because they are a new product and do not have a standardized level of roughness. The measured values are shown in Figure 8. Values in the figure for a given coating type are the average of two measurements taken on three bar samples. The figures' values were corrected to account for the round surface of the bars, which impacted the microscope roughness measurements. The correction was automated in the software used to run the microscope.

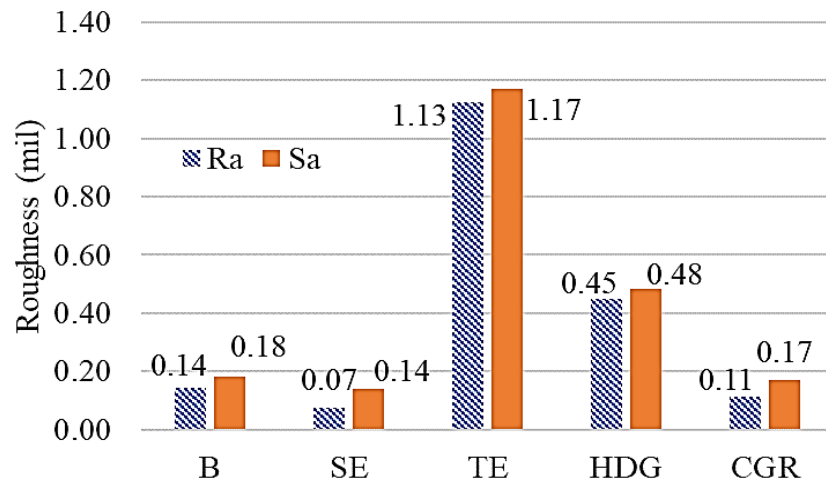
**Figure 8 - Roughness measurements for samples of each bar coating type.**

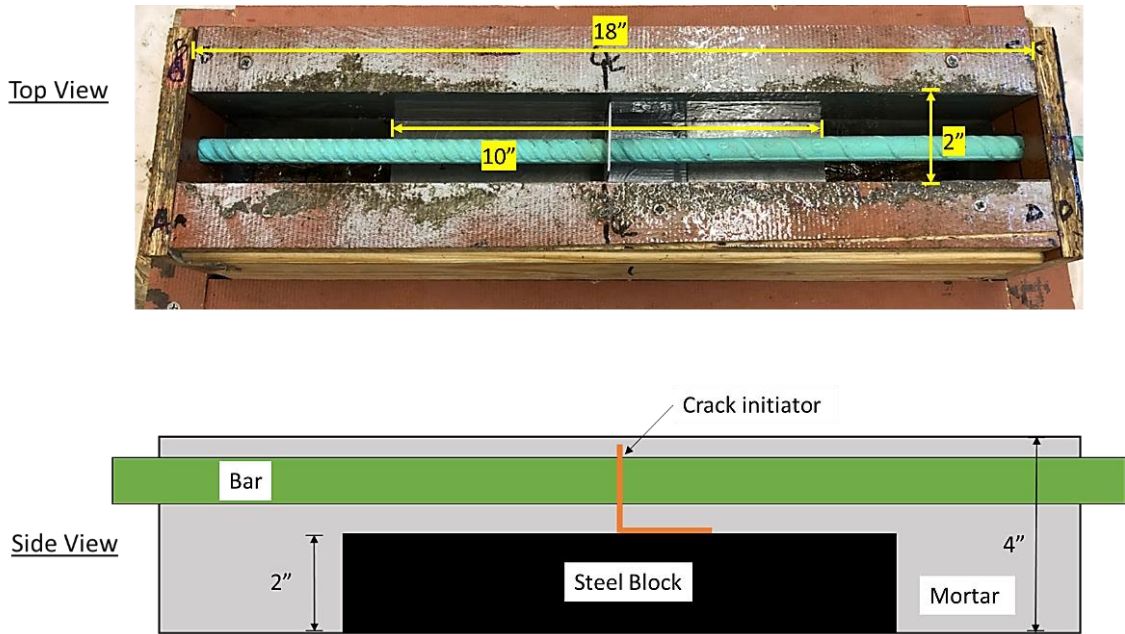
**Figure 9 - Shrinkage cracking test set-up.**

The mortar was prepared using a pan mixer and was placed in the formwork in two layers. After each layer, the specimen was placed on a vibrating table to conciliate the mortar. The formwork was removed approximately 3-hours after casting. A table fan was placed in front of the specimens after the formwork removal to accelerate evaporation and enhance shrinkage cracking. Mortar mixture proportions, flow table results, and compressive strengths are reported in the Appendix.

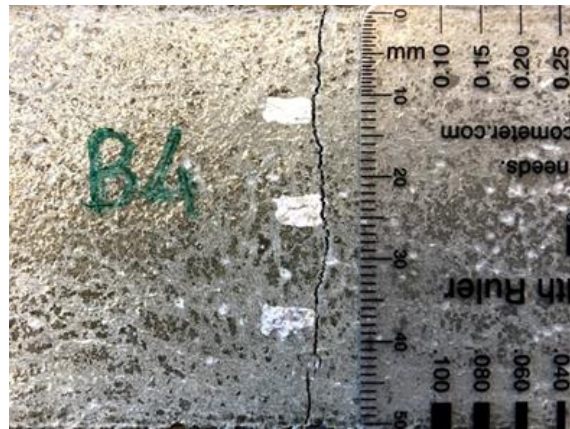
**Figure 10 - Shrinkage cracking in an example test specimen.**

Cracks were observed in all specimens, and crack data were collected 24 hours after casting the mortar. Digital images of the cracks were collected, and crack width was also measured at three locations using a handheld microscope. An example crack is shown in Figure 10. Eight series of shrinkage tests were conducted, and one specimen of each coating type was included in each series.

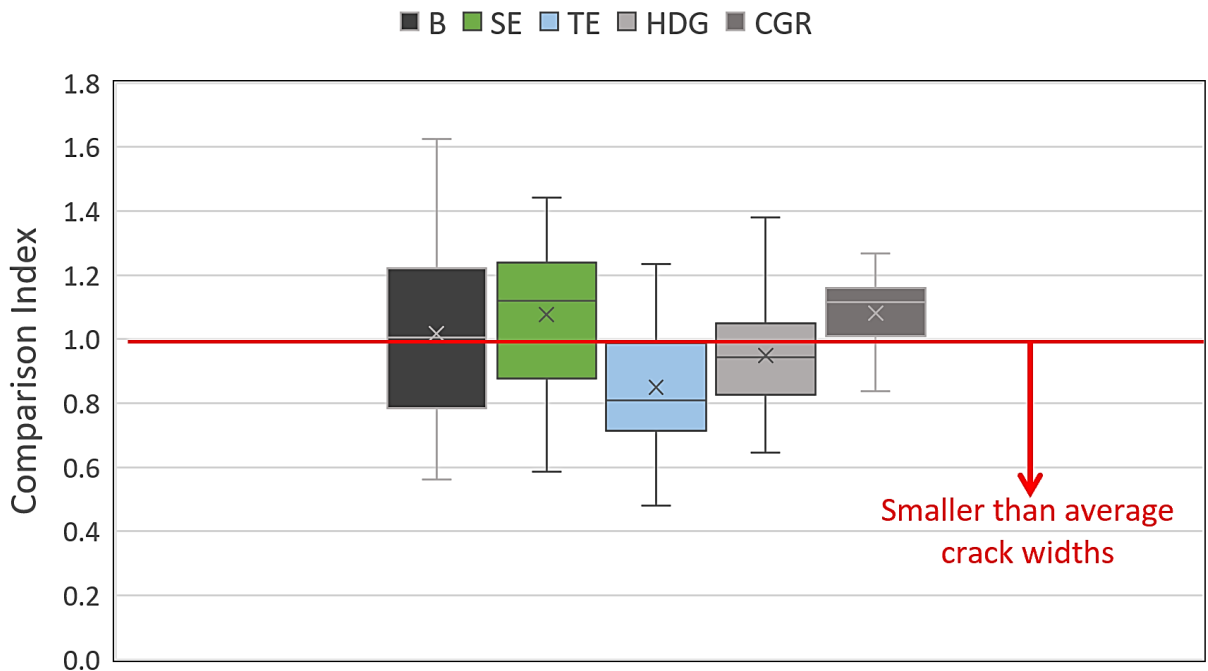
**Figure 11 - Comparison index of the average crack width, prepared using the data from image analysis.**

Comparison Index results are shown in Figure 11 to provide a graphical means of evaluating and interpreting the shrinkage crack data. The “box” portion of the data indicates the upper and lower quartiles of the data. The “whisker” portion shows the range of the data points, excluding any outliers. Data in the figure come from ImageJ and microscope measurements, and only three outliers were recorded in the dataset out of 128 comparison index values. The “x” in the figure indicates the mean value, and the horizontal line in the box indicates the median value.

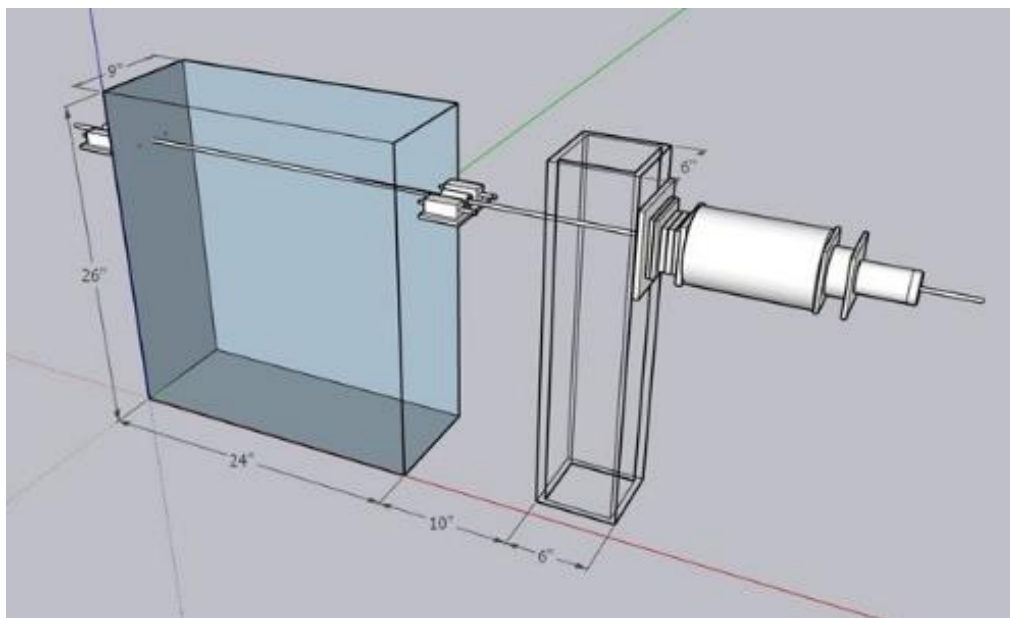
**Figure 12 - Bond test schematic set-up.**

Load data were collected using a load cell placed between the hydraulic jack and the strand chuck and was checked by a pressure gauge placed in the hydraulic line supplying the jack. Two linear potentiometers were placed at the back of the specimen to measure slip, and two were placed at the front to measure displacement (Figure 13). The average measurement of each potentiometer pair was used to analyze the tests. The linear potentiometers, load cell, and pressure gauge were calibrated immediately prior to testing. Data were continuously monitored and recorded using a computer data acquisition system.

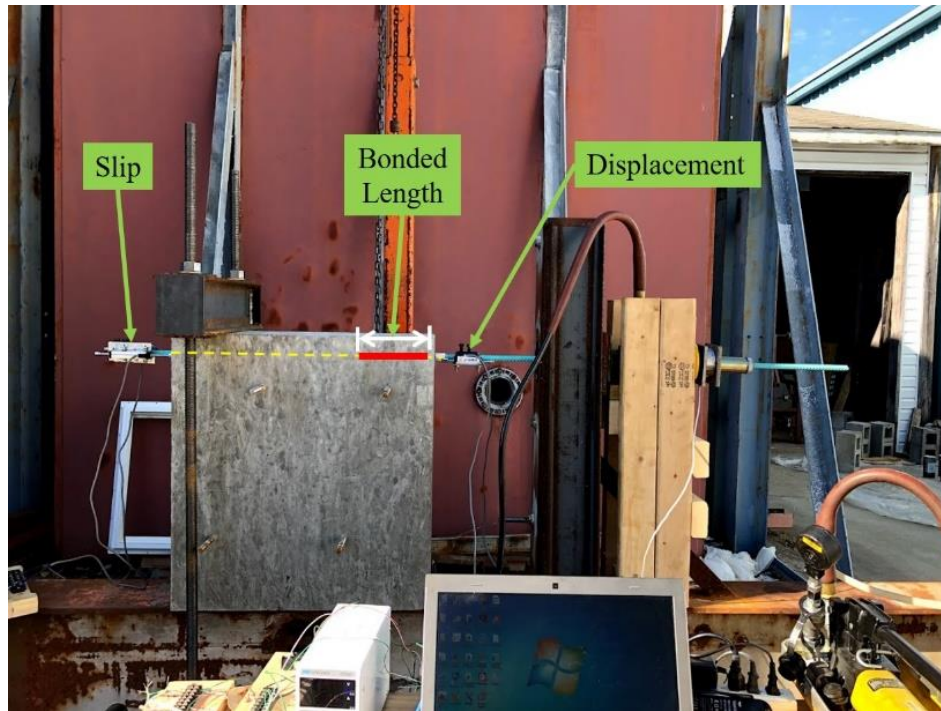
**Figure 13 - Bond test set-up.**

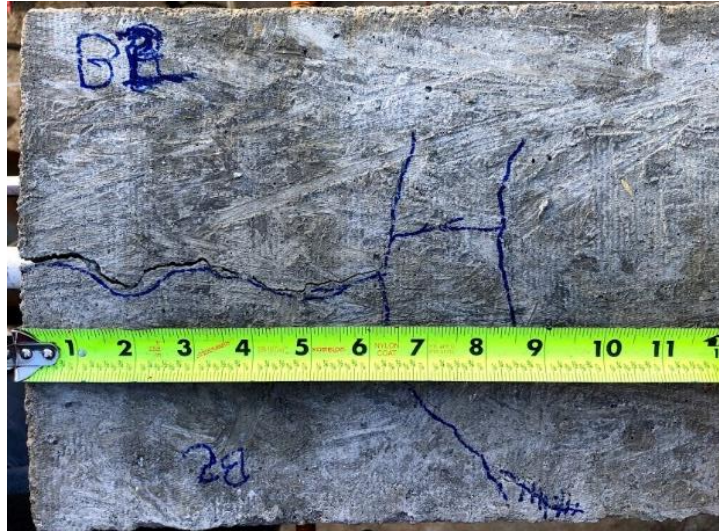
**Figure 14 - Splitting failure in the black bar specimen from series 2, which had a bonded length of 6 in.**

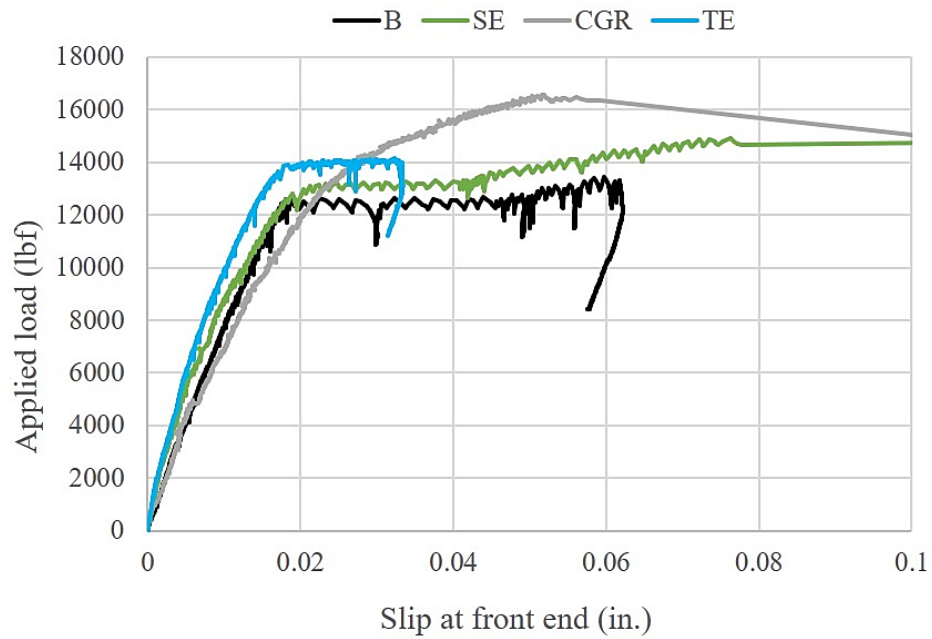
**Figure 15 - Load vs. displacement for bond series 1.**

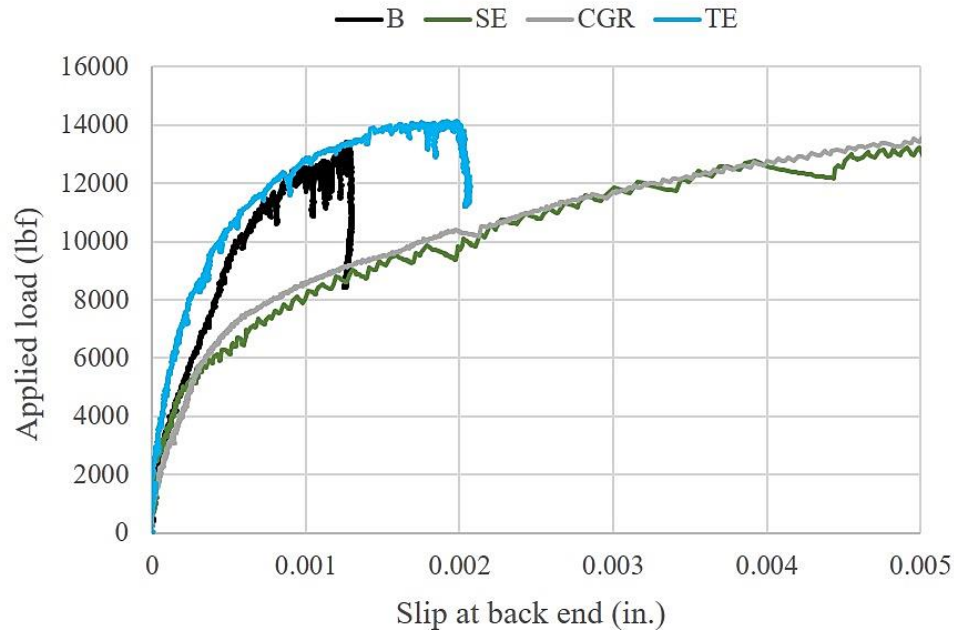
**Figure 16 - Load vs. slip for bond series 1.**

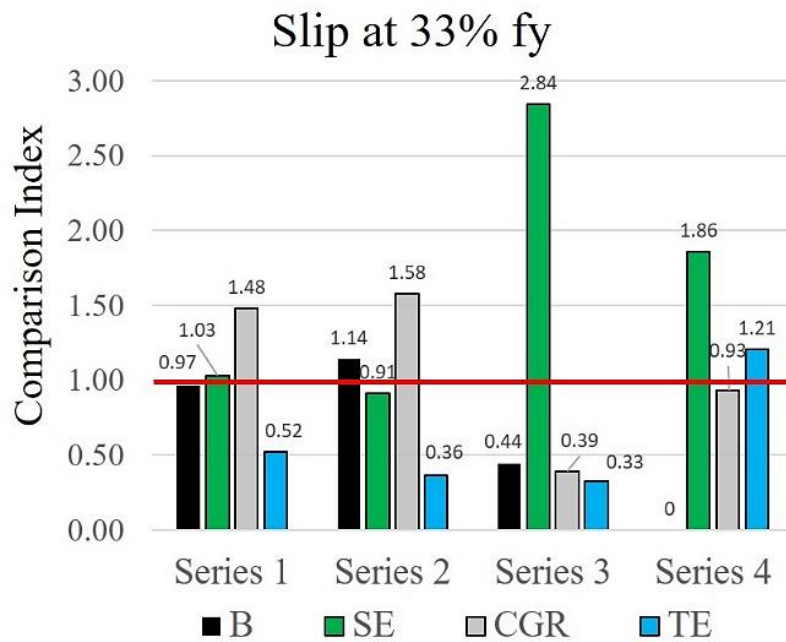
**Figure 17 - Comparison index of bar slip at 33% of yield stress**

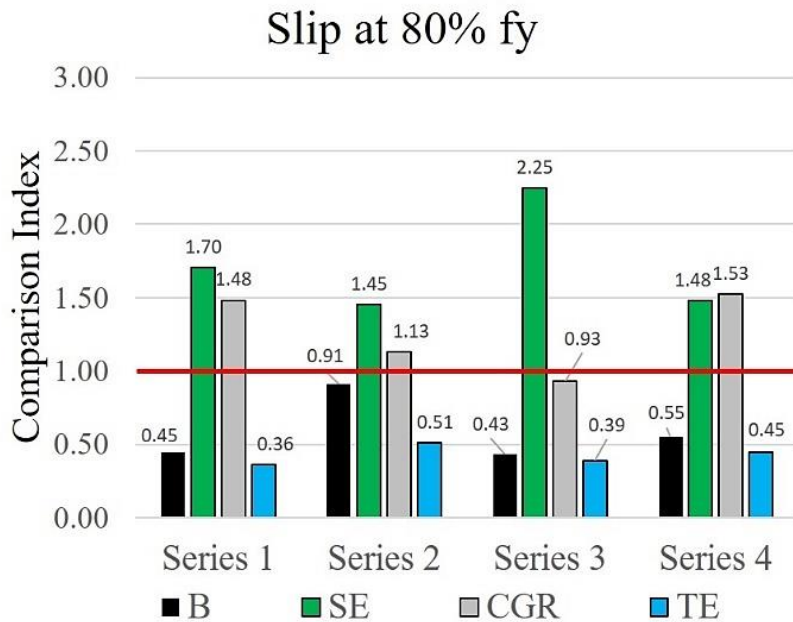
**Figure 18 - Comparison index of bar slip at 80% of yield stress**

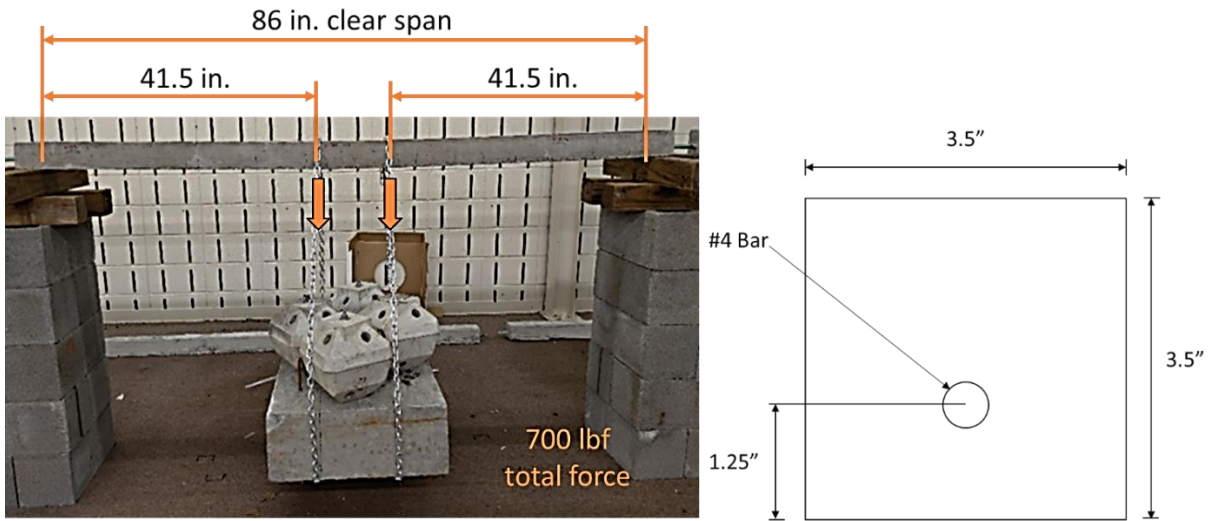
**Figure 19 - Static-load test set-up (left) and specimen cross-section (right).**

The static load test setup was based on the Peterman Beam Test [49]. The basic concept of the test is a simple-span beam with a load suspended at two points (Figure 19). The specimen cross-section, span length, and load were designed so that the beam would crack extensively but would not reach flexural failure. This setup allowed investigation and documentation of the cracks. Three series of specimens were tested, with each series having one specimen with black, textured-epoxy, smooth-epoxy, and continuously galvanized coated bars. Concrete and steel material properties are reported in the Appendix.

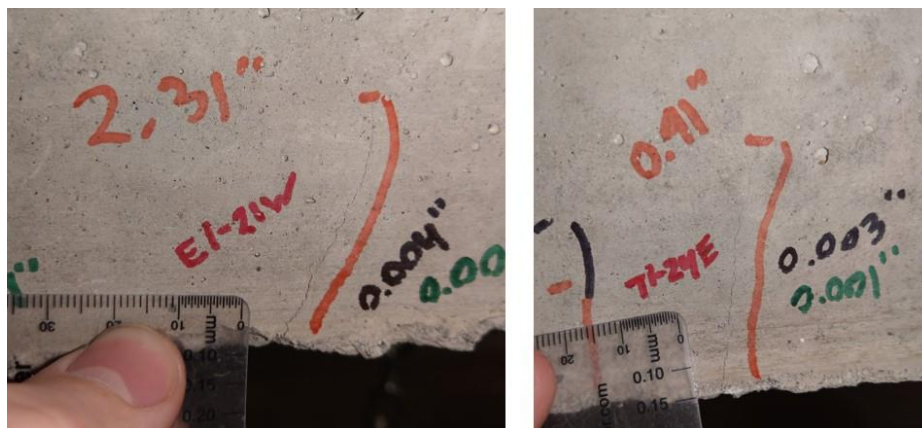
**Figure 20 - Sample images of cracks from a smooth epoxy-coated specimen in the first series.**

Data collection included measuring beam deflection and documentation of cracks. Digital images of cracks were collected (Figure 20), and the crack quantities, locations, spacings, and lengths were measured. The digital images were analyzed using ImageJ to determine crack length, width, and area. A handheld microscope was used to check a few of the crack width results from ImageJ and were found to be in good agreement. Data were collected immediately, 24-hours, and 7-days after load was applied.

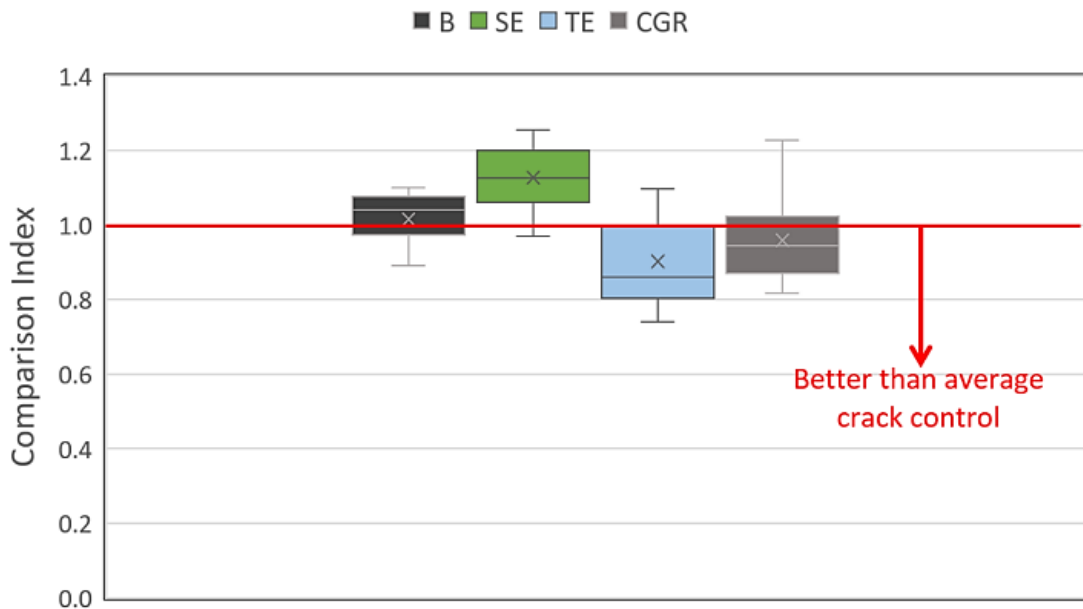
**Figure 21 - Comparison index values for static-load cracking tests.**

The textured epoxy-coated specimens had the greatest number of cracks in each series. In contrast, the smooth epoxy-coated bars had the fewest cracks in two of the three series. This result is attributed to superior bond for textured-epoxy bars and relatively poor bond for smooth-epoxy bars. The crack spacing is related to the number of cracks in a beam. If there are fewer cracks, then the spacing between the cracks is larger. The specimens with textured-epoxy bars had the lowest, or near lowest, crack spacing in all series.

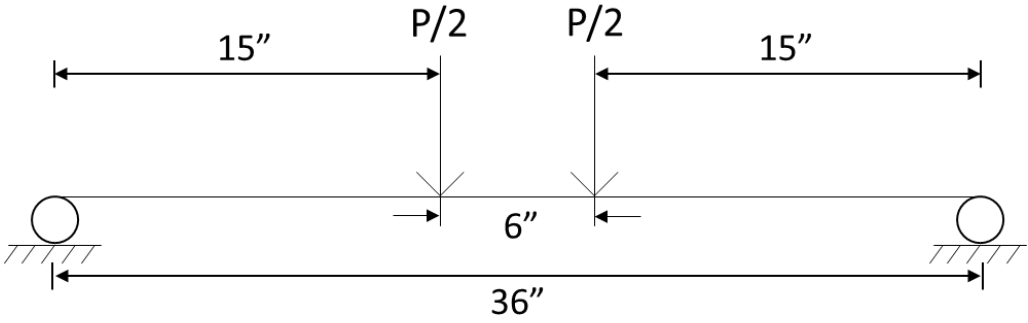
**Figure 23 - Free Body Diagram of the test set-up.**

Figure 23 shows the free-body diagram of the test setup. Linear potentiometers (LP) were used at the center of the beam to measure crack displacement. The woodblocks used to mount the LP had consistent dimensions for each test specimen. This ensured comparable crack opening data across tests. The overall setup for the test is shown in Figure 24. The setup of the linear potentiometers is shown in Figure 25.

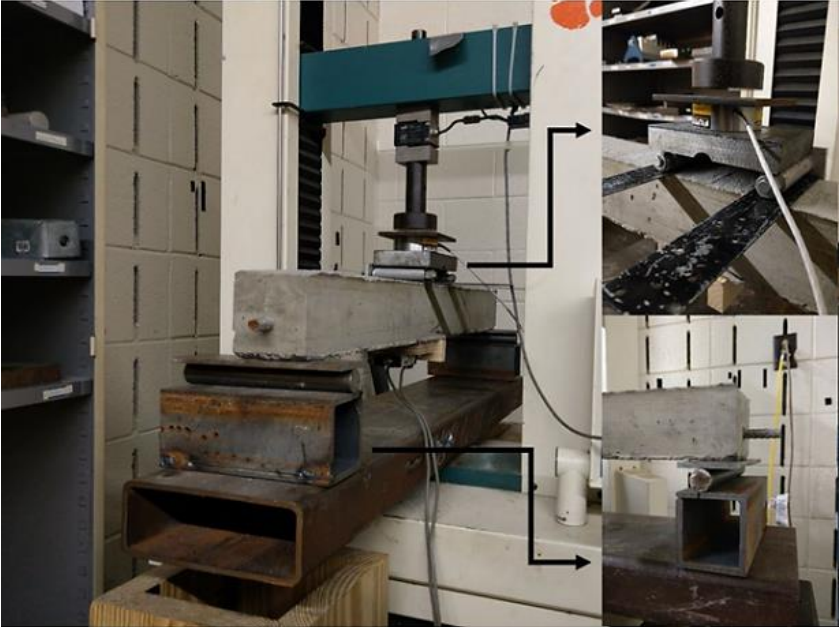
**Figure 24 - Short beam test set-up.**

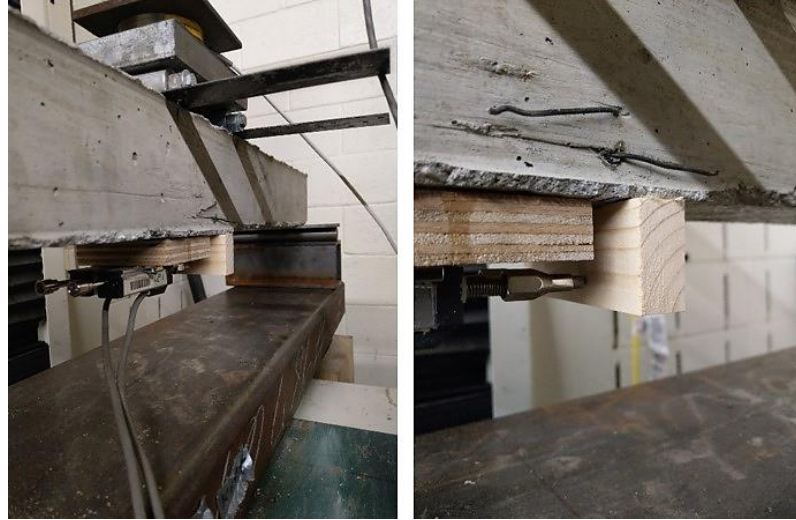
**Figure 25 - Linear potentiometer set-up using woodblocks.**

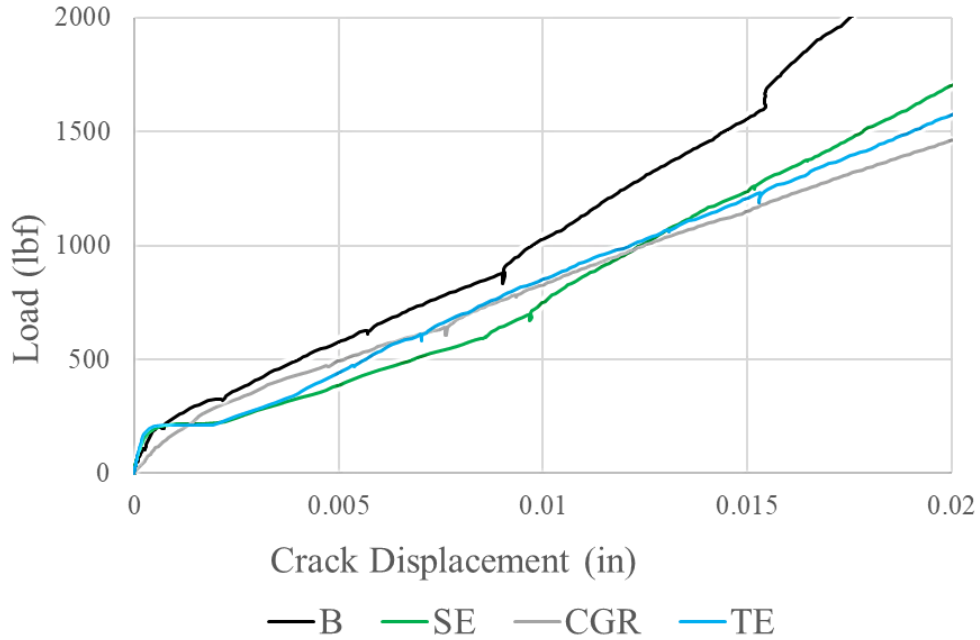
Figure 26 - Load vs displacement from series 2.

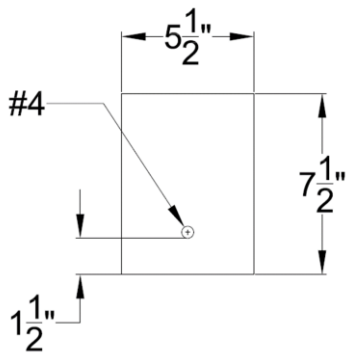
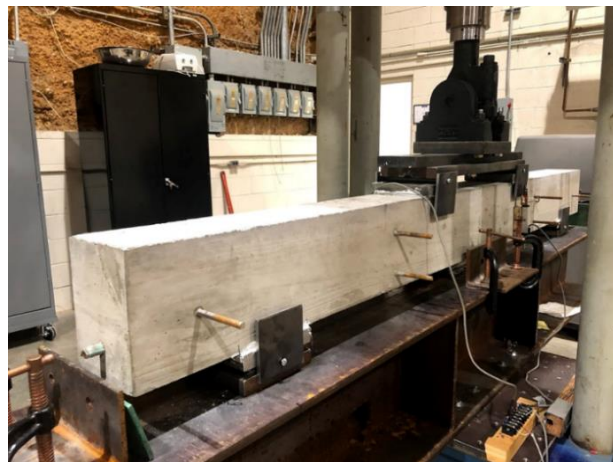
Figure 27 - Cyclic load test specimen cross-section (left) test setup (right).

Three specimens were loaded to 1,000,000 cycles to evaluate the response of beams with alternative rebar coatings to cyclic loading. The specimens had either smooth-epoxy, textured-epoxy, or hot-dipped galvanized coatings. The specimen cross-section (Figure 27) and loading scheme were intended to approximate a segment of the concrete bridge deck. All specimens were cast from the same concrete batch, which had a 28-day average concrete strength is 5140 psi. The mix design was the same as that used in the other test programs. Specimen geometry and boundary conditions are shown in Figure 27.

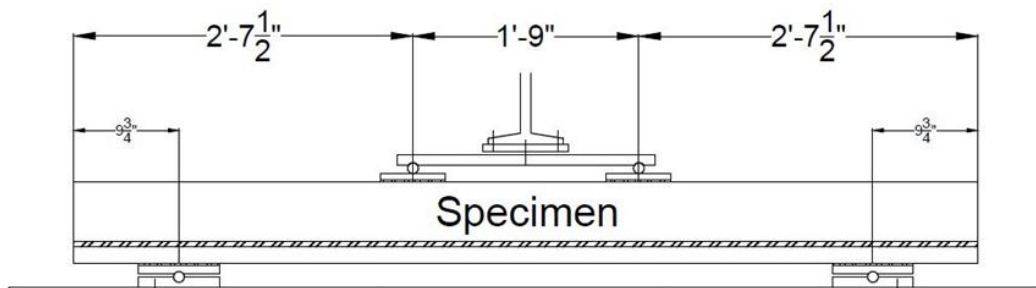
Figure 28 - Cyclic load test geometry.

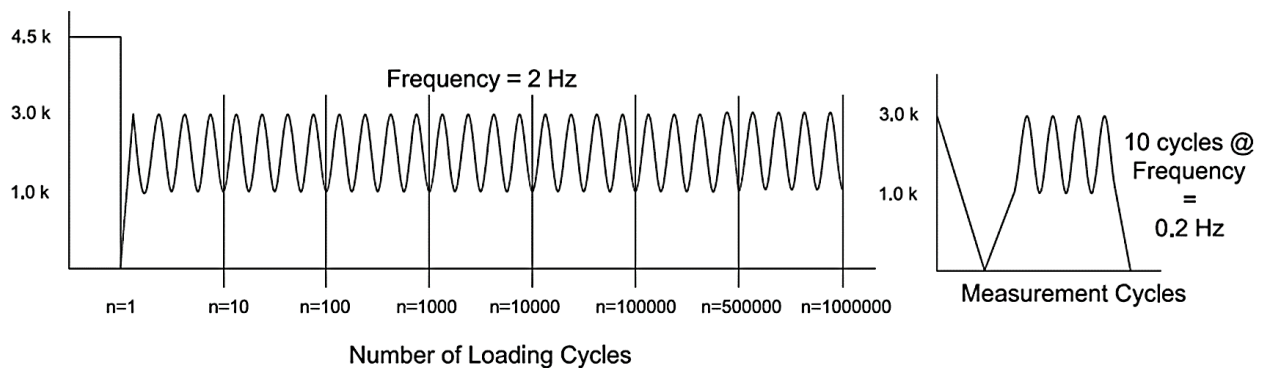
**Figure 29 - Cyclic-loading protocol (left) and measure cycle protocol (right).**

Load and displacement data were collected during “measurement cycles” after each order of magnitude (1, 10, 100, ...) of load cycles. Data were also collected after 500,000 cycles. The measurement cycles consisted of ten cycles from 1 kip to 3.0 kips at a frequency of 0.2 Hz. The unloaded displacement was measured and recorded at the end of each measurement cycle.

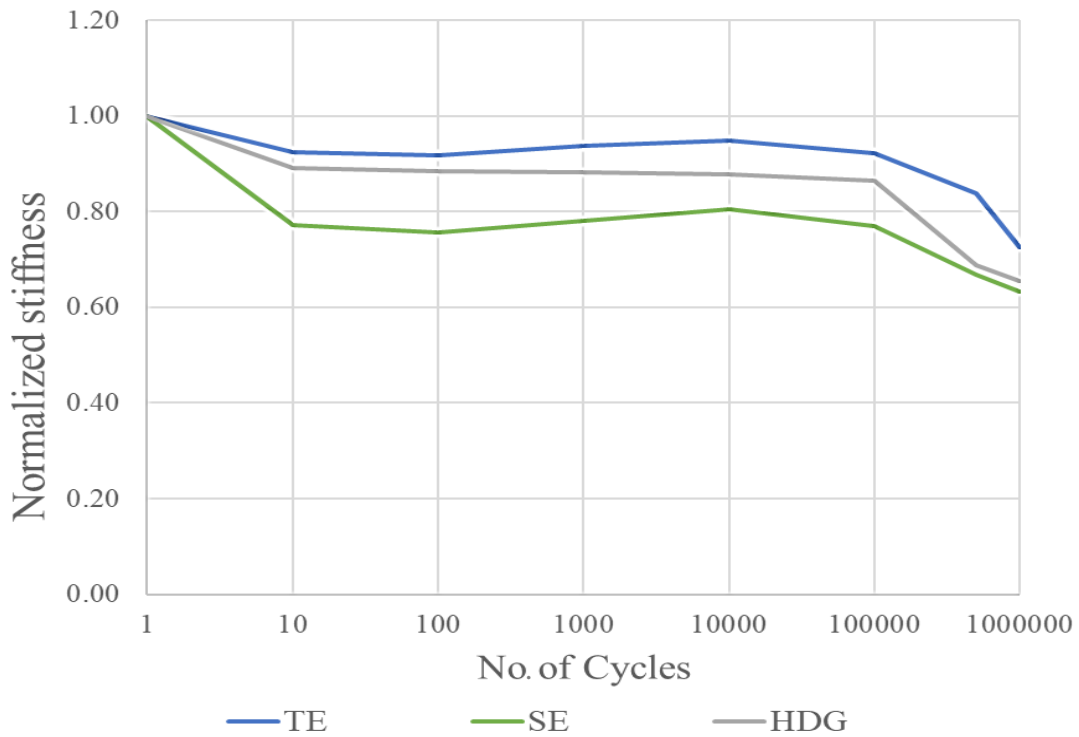
**Figure 30 - Stiffness variation as a function of load cycles.**

Stiffness of all specimens decreased between 10,000 and 1,000,000 cycles. The textured-epoxy specimen maintained a stiffness closest to its pre-cracked condition, while the smooth-epoxy specimen indicated stiffness loss.

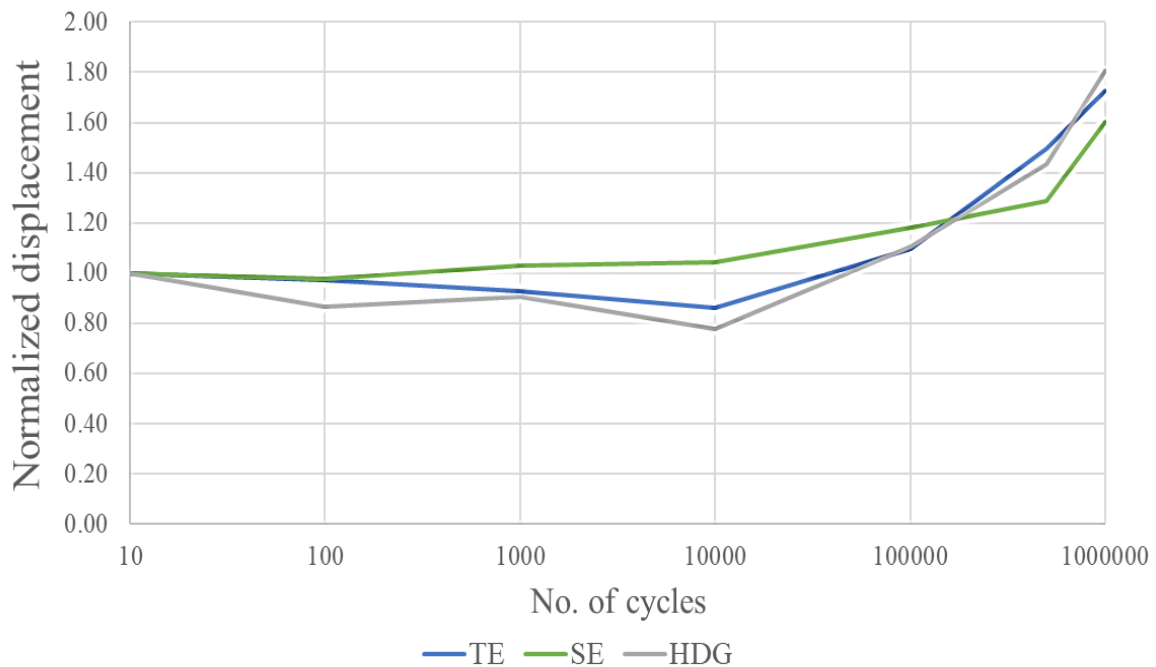
**Figure 31 - Initial displacement values (normalized) at the data collection stages.**

The unloaded displacement grew 60% to 80% over the cycles indicating damage due to the loading. Similar to the trends observed in stiffness, the changes in displacement were also most notable after 10,000 cycles. At the end of all cycles, the absolute unloaded displacement was 0.021 in. for textured-epoxy, 0.046 in. for smooth-epoxy, and 0.022 in. for hot-dipped galvanized. The beams with textured-epoxy and hot-dipped galvanized coated bars had higher percent change but lower total displacement than the beam with the smooth epoxy-coated bar.

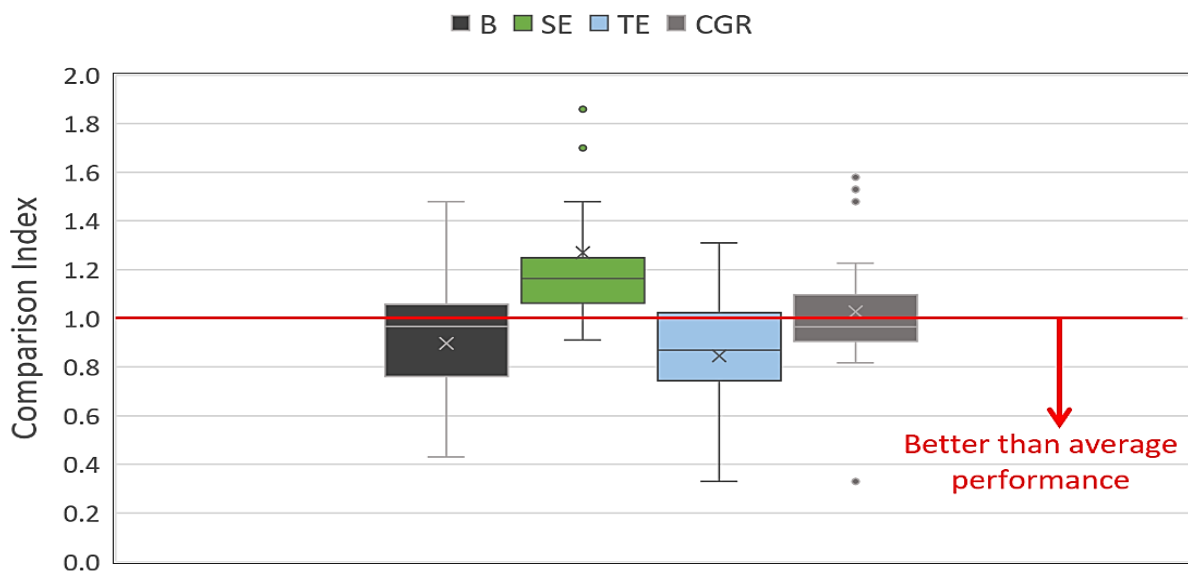
Figure 32 - Synthesis of results for bond, static load, and small beam test programs.

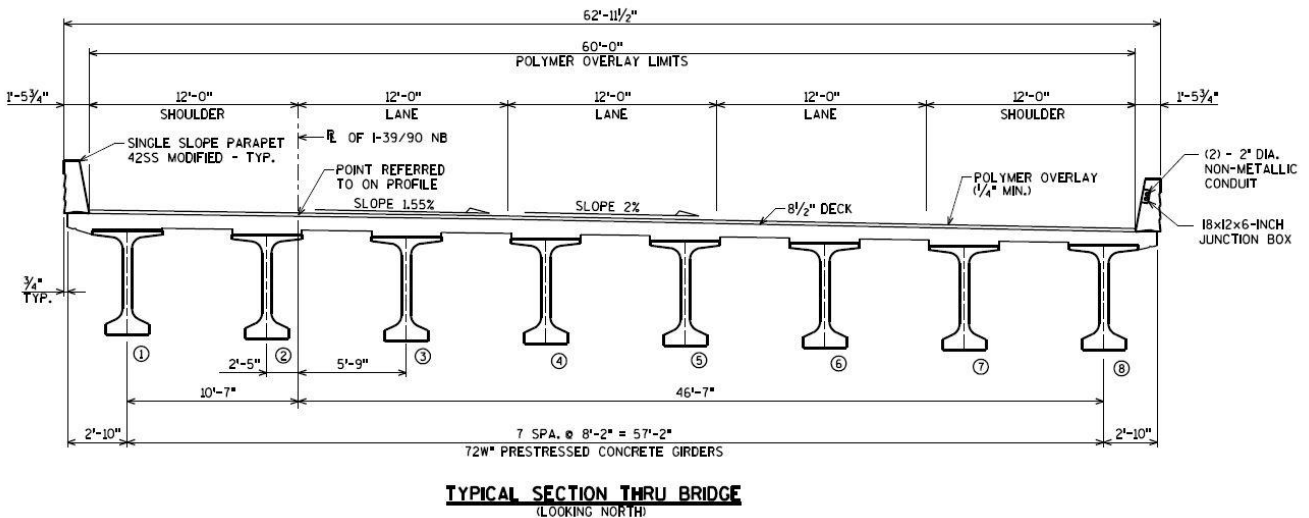
Figure 33 - Cross-section of the bridge showing the girders and deck.

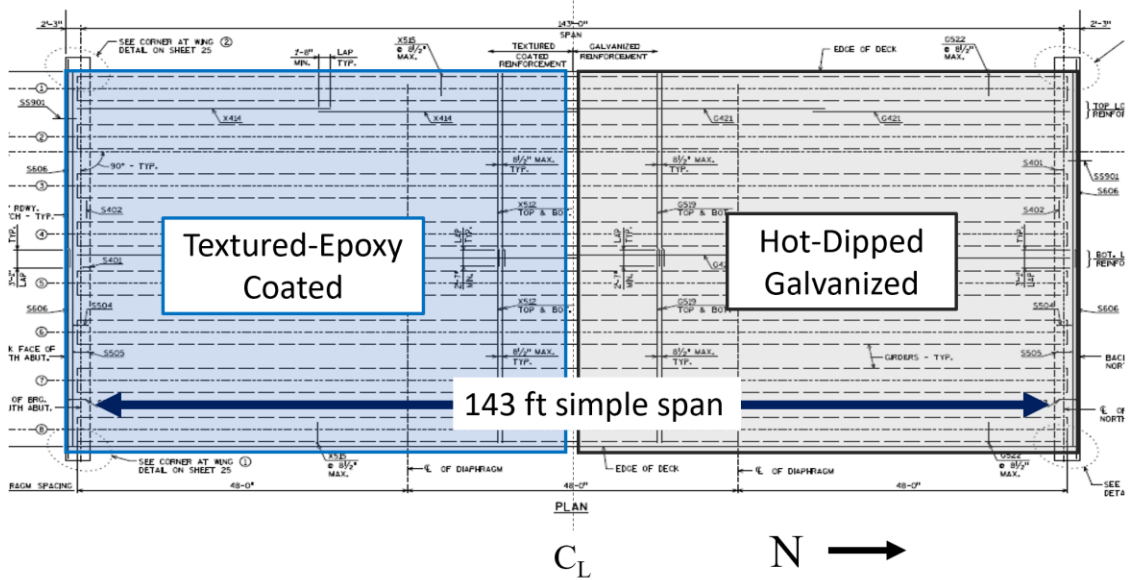
**Figure 34 - Placement of textured epoxy-coated and hot-dipped galvanized bars in the deck.**

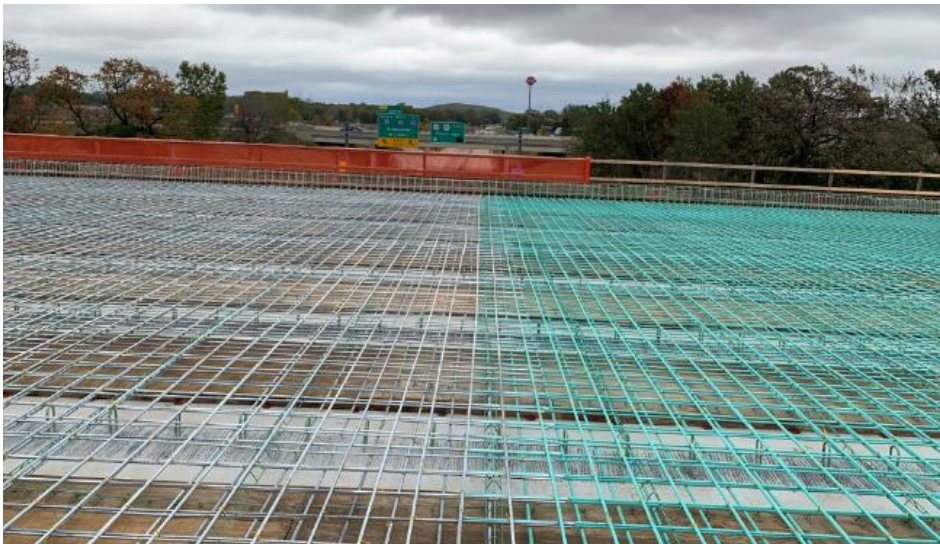
**Figure 35 - Photo of the deck before casting concrete (looking east).**

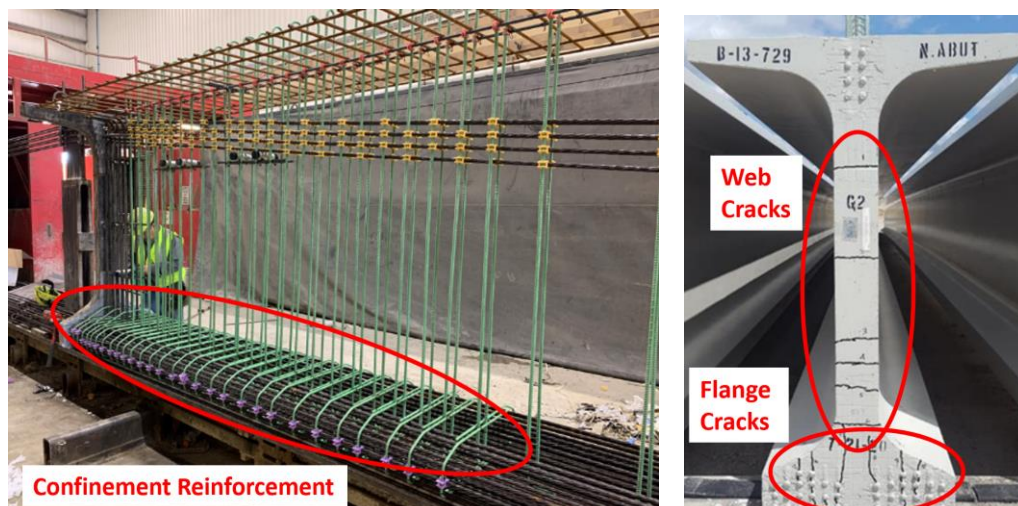
**Figure 36 - Girder reinforcement prior to casting concrete (left) and representative end cracking (right).**

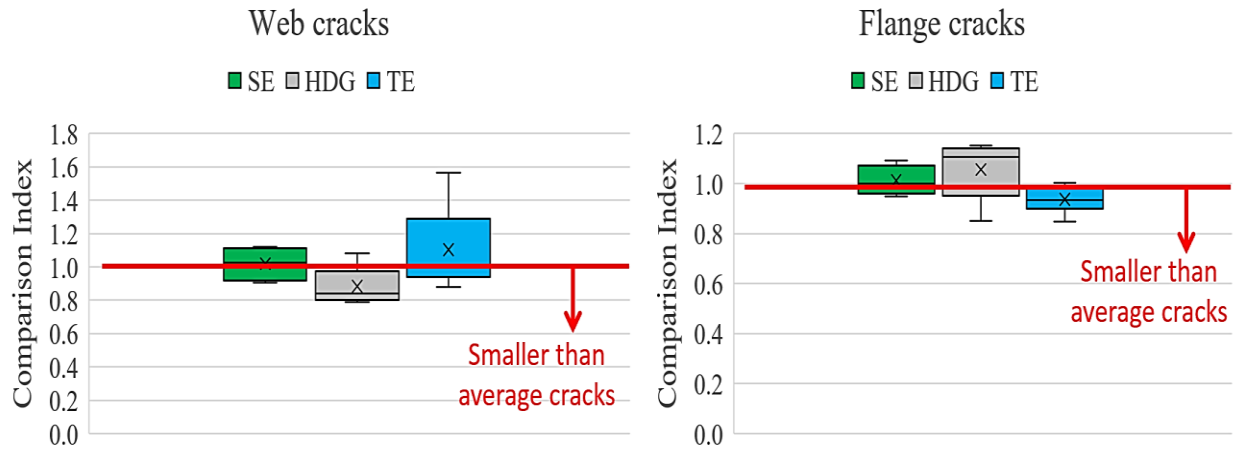
**Figure 38 - Crack widths at girder ends with different confinement bar coatings.**

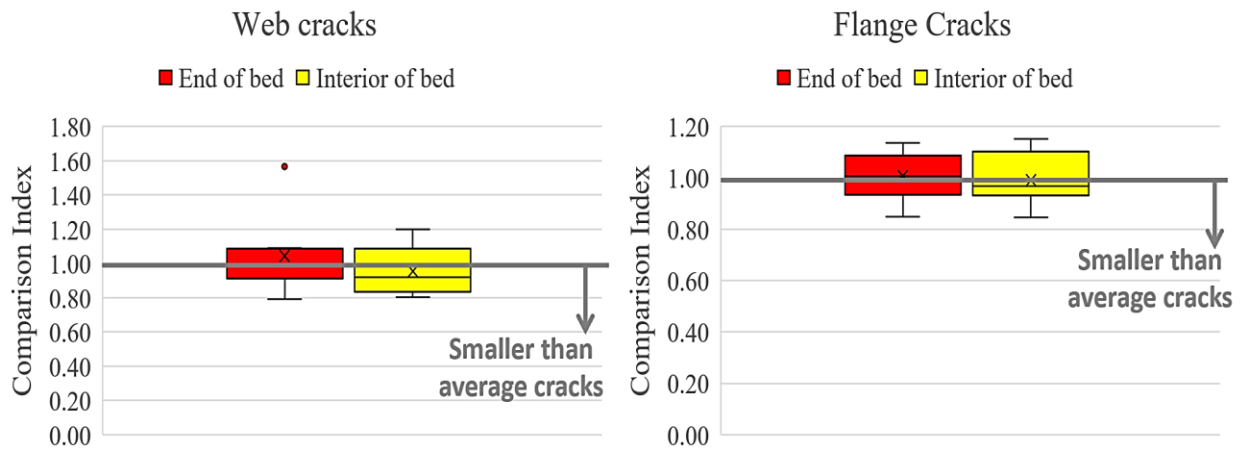
**Figure 39 - Crack widths at girder ends based on stressing bed position.**

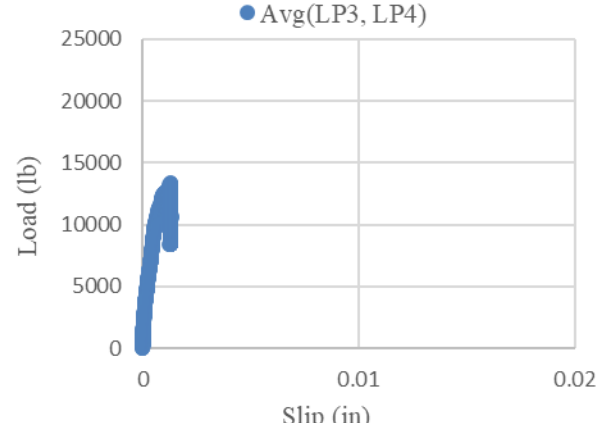
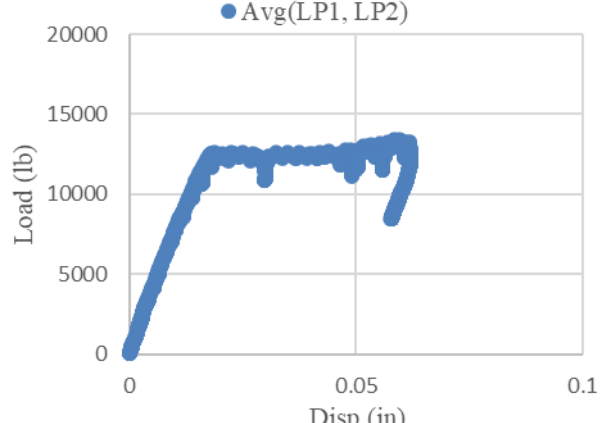
Slip at 4 kip = 0.0001225 in		Max Load = 13416 lb      Max Stress = 68328 psi
Slip at 10 kip = 0.0005375		Apparent Yield Stress ~ 65 ksi
Description of the test		Picture after test
The rebar was not loaded upto its bond failure. Instead, test had to be stopped as the jack reached the maximum stroke length. From the load –disp plot the bar has yielded.		The specimen did not crack. Hence, no photos were taken.
