# Textured Epoxy Coated and Galvanized Reinforcement to Reduce Cracking in Concrete Bridge Decks and Components

WisDOT ID no. 0092-19-01

August 2021

WISCONSIN HIGHWAY RESEARCH PROGRAM

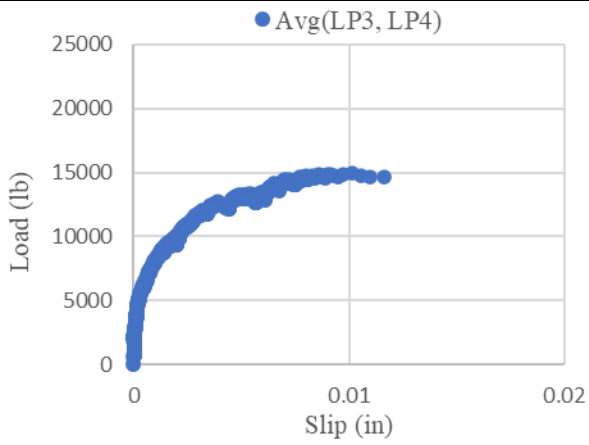
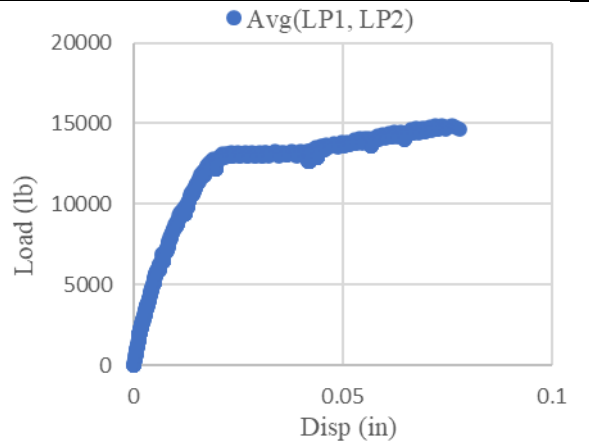
Slip at 4 kip = 0.000131 in		Max Load = 14902 lb
Slip at 10 kip = 0.0020445 in		Max Stress = 75896 psi
Description of the test		Apparent yield strength = 68 ksi
The rebar was loaded beyond its yielding point and there was a bond failure with splitting of concrete.		Picture after test

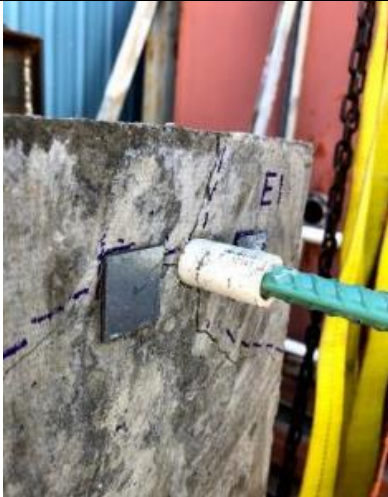
Bond Test Summary of specimen G1		
Bar Size: #4 Bar Type: Continuously Galvanized Bonded Length: 6 in		Cast Date: 10-07-2019 Test Date: 11-06-2019
Concrete Strength		
Test Age(days)	No. of Cylinders	Avg. compressive strength (psi)
2	1	2510
9	2	3900
14	1	4080
21	2	4620
28 (B1)	3	5070
30 (E1 & G1)	1	5150
35 (T1)	1	5360
Load – Slip (back of specimen)		Load – Disp (front of specimen)
Slip at 4 kip = 0.0001875		Max Load = 16528 lb
Slip at 10 kip = 0.001778		Max Stress = 84177 psi
Description of the test		Picture after test
Rebar was loaded beyond its yield point and the specimen failed with splitting of concrete.

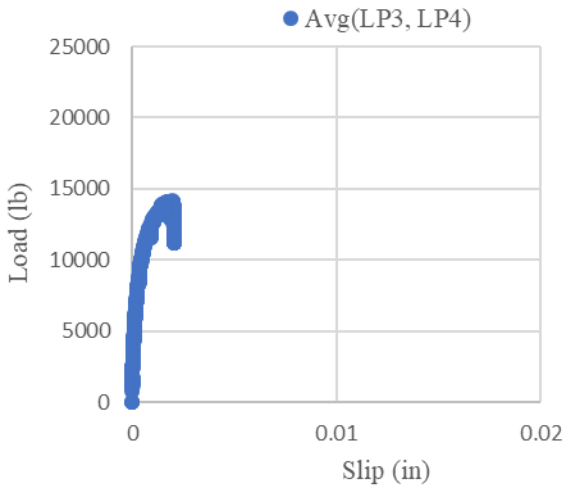
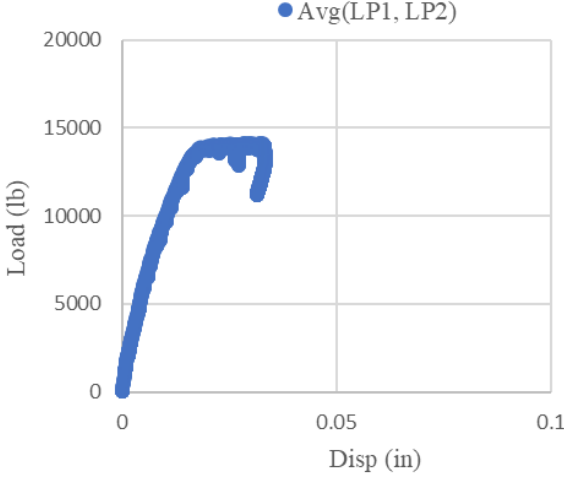
Slip at 4 kip = 6.6E-05		Max Load = 14130 lb
Slip at 10 kip = 0.0004365		Max Stress = 71963 psi
Description of the test		Apparent Yield Stress ~ 70 ksi
Picture after test		
The rebar was loaded well beyond its yield point. No bond failure happened. The test was stopped as the jack reached its maximum stroke length.

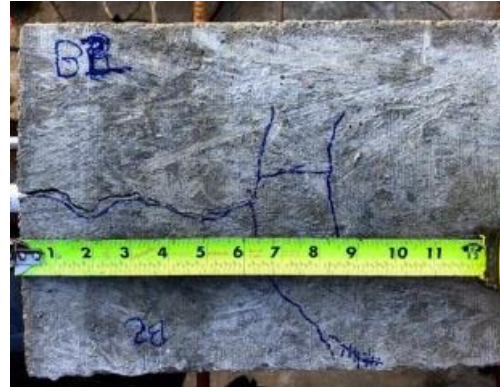
The rebar was loaded beyond its yield point. Bond failure happened with splitting of concrete.

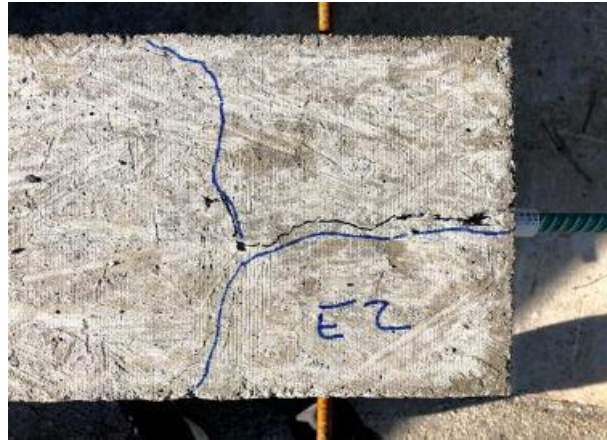
Bond Test Summary of specimen G2		
Bar Size: #4 Bar Type: Continuously Galvanized Bonded Length: 6 in		Cast Date: 10-28-2019 Test Date: 12-12-2019
Concrete Strength		
Test Age(days)	No. of Cylinders	Avg. compressive strength (psi)
7	2	4960
8	1	4940
14	1	5590
21	1	5690
28	3	5940
45 (E2 & G2)	1	6960
51 (B2 & T2)	2	6860
Load – Slip (back of specimen)		Load – Disp (front of specimen)

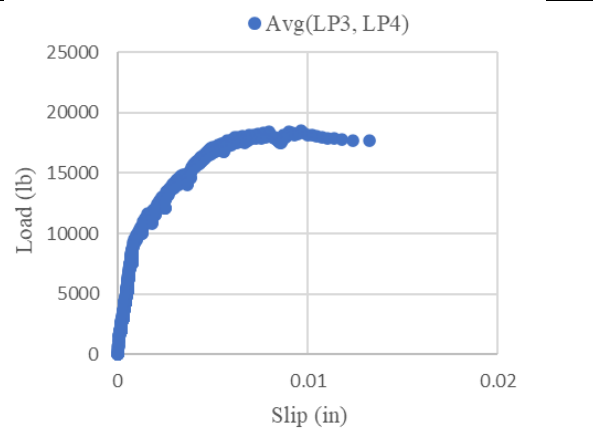
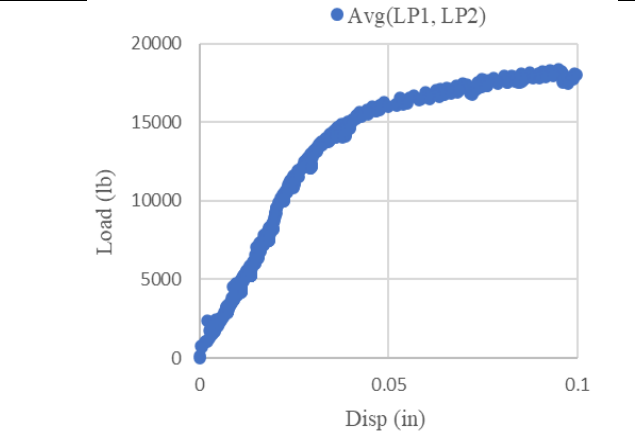
Slip at 4 kip = 0.000335		Max Load = 18490 lb
Slip at 10 kip = 0.0010775		Max Stress = 94167 psi
Description of the test		Apparent Yield Stress ~ 67 ksi
The rebar was loaded beyond its yield point. Bond failure happened with splitting of concrete.		Picture after test

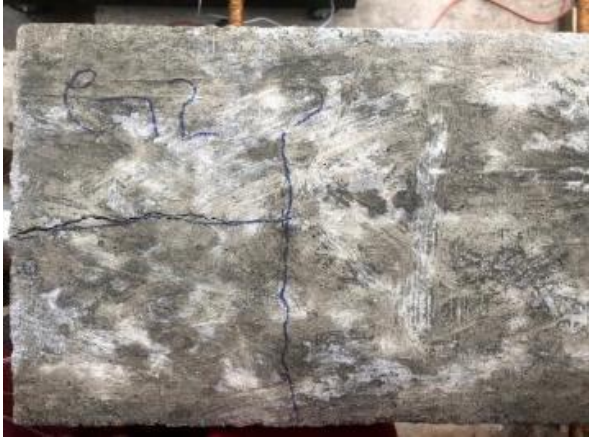
Bond Test Summary of specimen T2		
Bar Size: #4 Bar Type: Textured Epoxy Bonded Length: 6 in		Cast Date: 10-28-2019 Test Date: 12-18-2019
Concrete Strength		
Test Age(days)	No. of Cylinders	Avg. compressive strength (psi)
7	2	4960
8	1	4940
14	1	5590
21	1	5690
28	3	5940
45 (E2 & G2)	1	6960
51 (B2 & T2)	2	6860
Load – Slip (back of specimen)		Load – Disp (front of specimen)

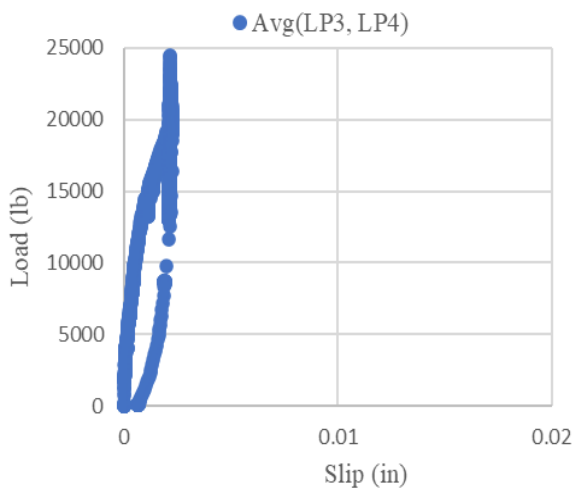
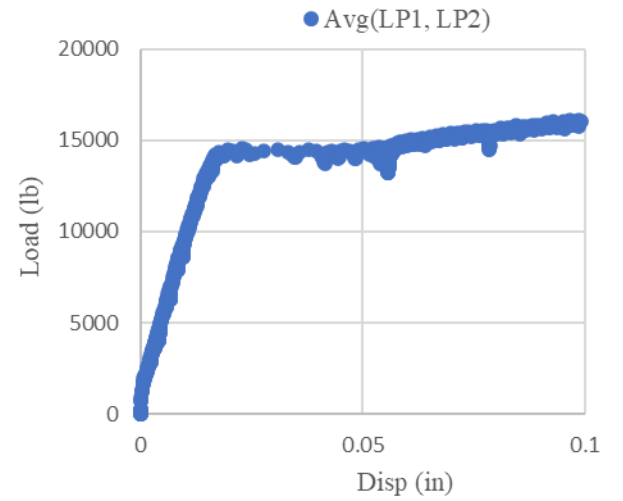
Slip at 4 kip = 7.7E-05		Max Load = 24445 lb
Slip at 10 kip = 0.000486		Max Stress = 124496 psi
Description of the test		Picture after test
The rebar was loaded well beyond its yield point. No bond failure happened. The test was stopped as the jack reached its maximum stroke length.

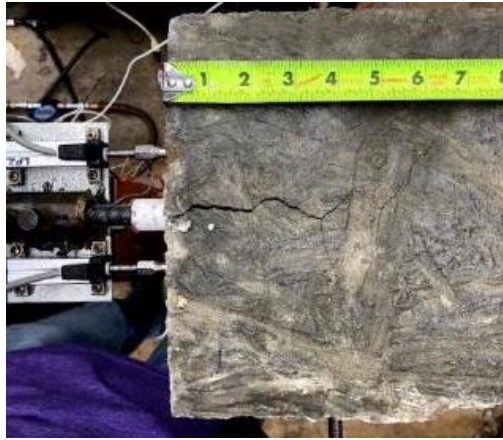
Bond Test Summary of specimen B4		
Bar Size: #4 Bar Type: Black in	Bonded Length: 4 in	Cast Date: 01-29-2019 Test Date: 02-18-2020
Concrete Compressive Strength		
Test Age(days)	No. of Cylinders	Avg. compressive strength (psi)
7	2	3710
14	2	4367
20 (B4)	1	5122
21 (G4)	2	4291
23 (T4)	2	4567
24 (E4)	2	4457
Load – Slip (back of specimen)		Load – Disp (front of specimen)
Slip at 4 kip = 1E-05 in	Max Load = 11223 lb	Max Stress = 57160 psi
Slip at 10 kip = 0.002489 in	Apparent Yield Stress ~ 56 ksi	
Description of the test	Picture after test
