Bridge Inspecting with Unmanned Aerial Vehicles R&D

Project No. 17STLSU11

Lead University: University of Louisiana at Lafayette

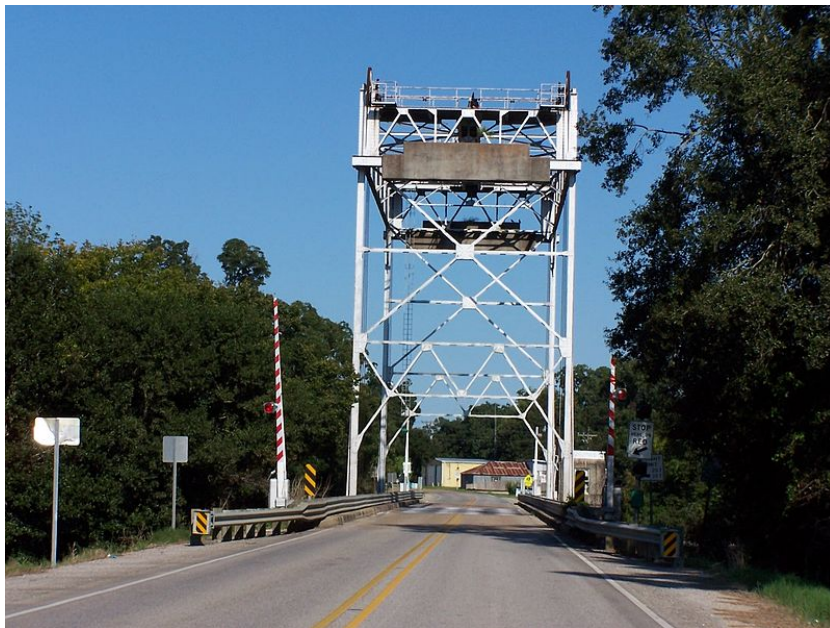
Figure 2. Vermilion River Bridge, Milton, LA – Example of a draw or lift bridge.

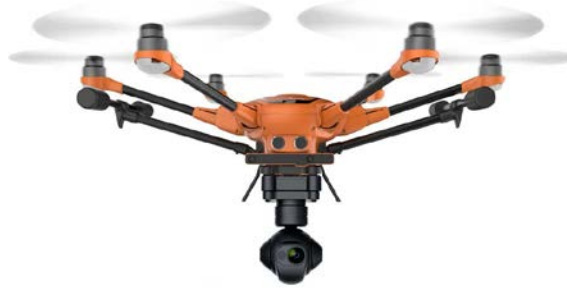
Figure 4. Yuneec H520 UAV.

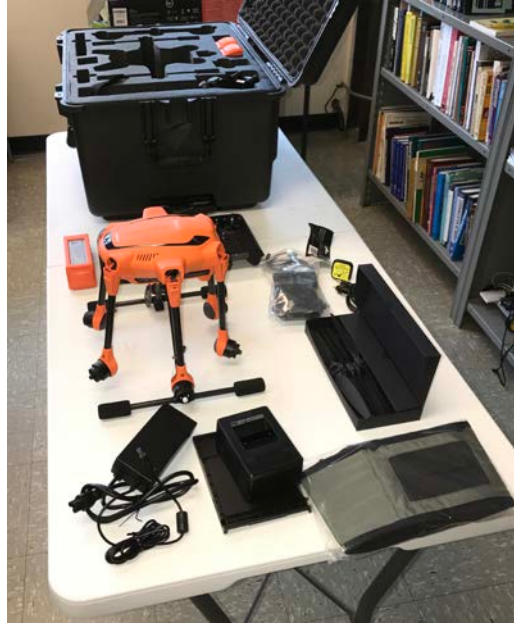
Figure 5. The Yuneec H520 UAV, shown next to its integral components in the Lab alongside its black protective Pelican case

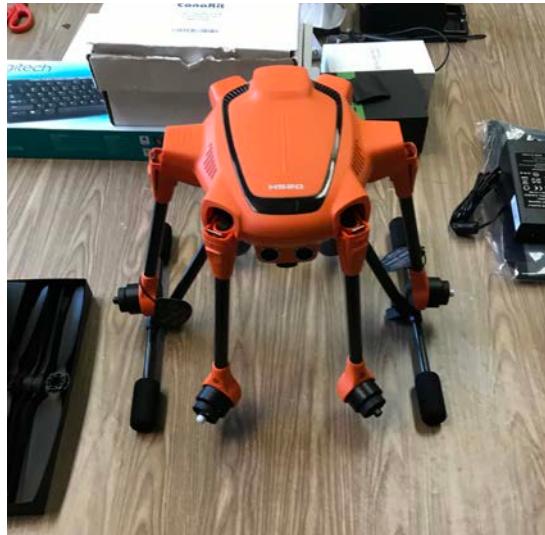
Figure 6. The Yuneec 520 UAV showing six (6) flight arms in the down position, for installation in the Pelican Case.

From Figure 6, the Yuneec H520 UAV aircraft main section came out of its protective Pelican Case with arms folded down. Each of the six arms are easily extended in place for flight, manually. Once fully extended, one hears a distinct click as arms come in to place for flight.

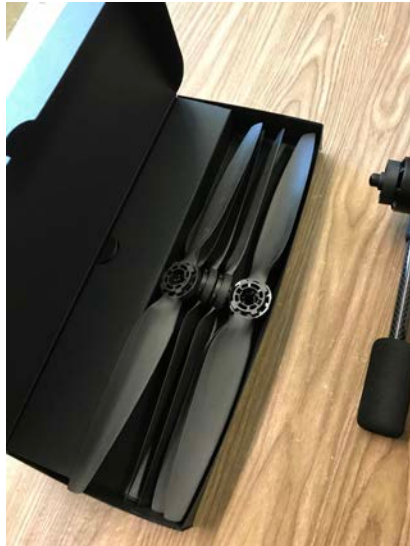
Figure 7. Six propellers were included for six motors.

From Figure 7, six propellers come with the Yuneec H520 UAV aircraft for quick click-on installation onto the shafts of each motor. The craft has two sets of motors, i.e. Set A and B, with Set A motors rotating directionally opposite from Set B motors. Both propellers and motors are labeled as to which set they belong, and it is a simple matter to click-install each Set A propeller onto a Set A motor shaft and each Set B Propeller onto a Set B Motor shaft.

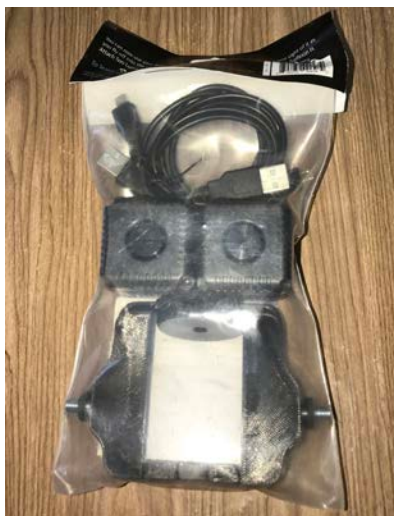
Figure 8. Showing two illumination cubes and potential mounting brackets – for illumination beneath bridge deck.

From Figure 8 above, two (2) illumination cubes (i.e. spot lights) and a potential mounting bracket were purchased with the UAV aircraft, so as to allow illumination for beneath bridge-deck flight inspection, if same was considered feasible.

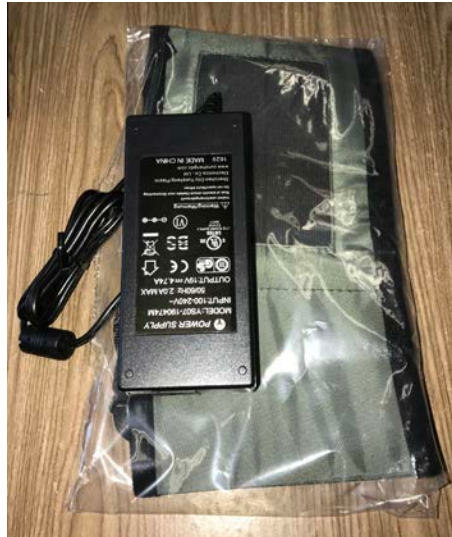
Figure 9. Showing main power unit for charging both the UAV flight power battery and/or the aircraft's ST16S remote controller.

From Figure 9, the main power unit can, with its adapter slot and micro USB cable, be use to charge the UAV's flight battery, and /or its ST16S remote flight controller.

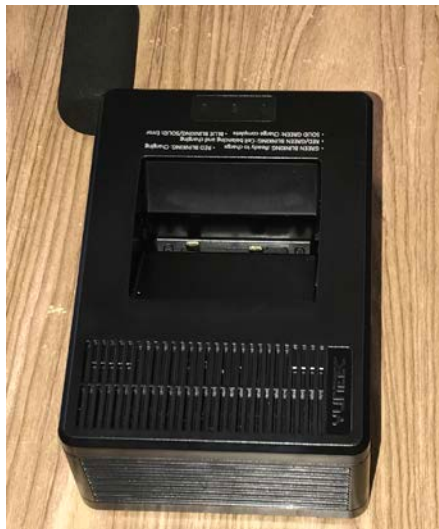
Figure 10. Showing the battery charge slot plugged into the main power unit for charging both the UAV flight power battery and/or the aircraft's ST16S remote controller.

From Figure 10, the battery charge slot is plugged into by a power cable coming from the main power unit, shown which in turn is plugged into a standard wall outlet. The UAV's orange flight battery is then inserted into the charge slot shown for charging which may require up to 3 hours for charging each battery fully.

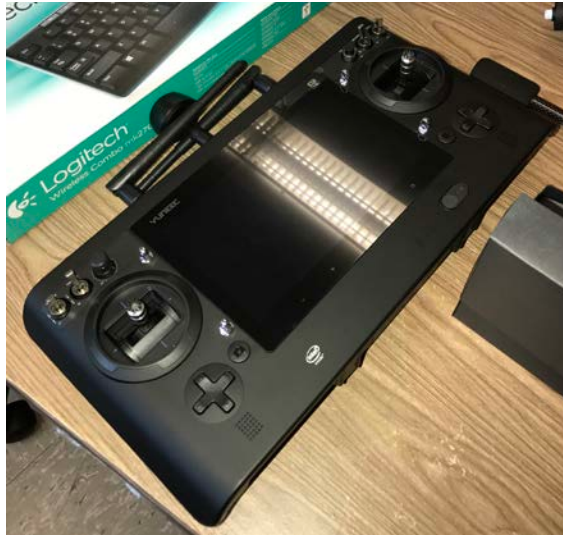
Figure 11. Showing the UAV's ST16S remote flight controller.

Figure 11 shows the UAV's ST16S remote flight controller. It includes an integral Android tablet, which displays the UAV's flight telemetry, including flight battery remaining charge level, altitude, compass heading for the aircraft, angle orientation of the E90 camera with respect to the aircraft, as well as FPV from the perspective of the aircraft's E90 camera. The ST16S unit can capture screenshots of its own screen showing both the FPV image at the time along with telemetry from the aircraft.

The joystick on the right of the ST16S controller, controls the aircraft translation, i.e. forward motion with respect to the nose of the aircraft, or backward motion, or movement to the right or left. Hence, moving the joystick up causes the aircraft to move forward, while moving the joystick down causes backward movement in the aircraft. Moving the joystick to the right causes the aircraft to move right and moving it to the left, causes the aircraft to move left. The degree to which the joystick is moved linearly controls the degree to which the aircraft responds.

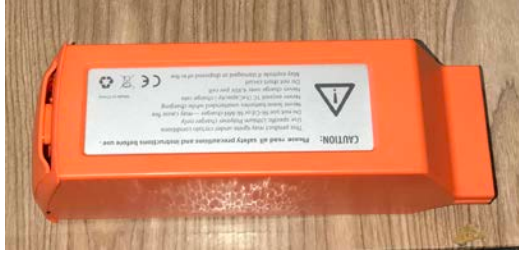
Figure 12. Showing the UAV's plug-in flight battery.

Note: While the UAV's literature claims that the UAV flight time with these batteries is approx. 28-30 minutes. Actual measured flight time, in the field was approx. 20 minutes if battery is operated according to recommendations, i.e. allowing a battery discharge to no lower than 30 percent remaining capacity.

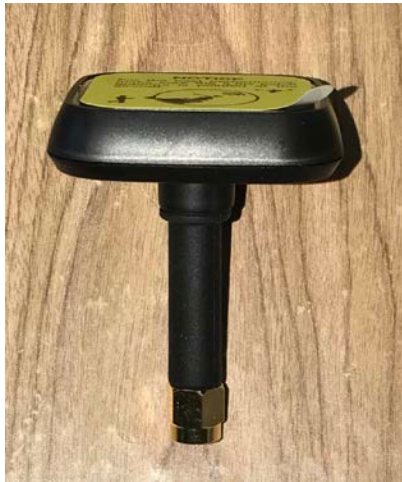
Figure 13. Close up photo of the ST16S controller's long-range WiFi antenna, used for communicating control to and receiving telemetry from the Yuneec H520 UAV aircraft.

The antenna has a flexible stem allowing it to be tilted in the direction of the aircraft for better connectivity between the aircraft and the ST16S remote controller, from Figure 11.

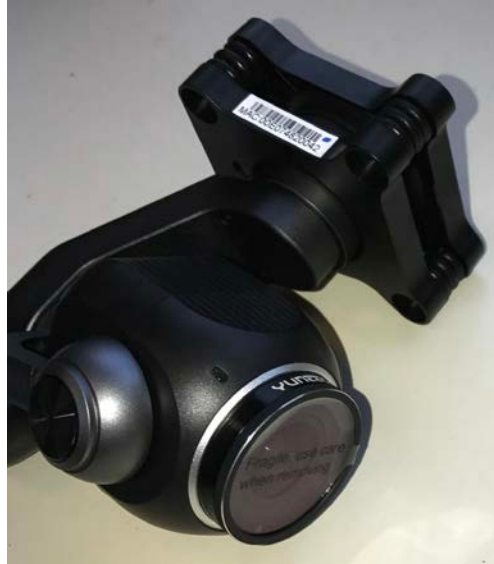
Figure 14. Close up photo of the E90, 4K UHD video, 20MP still shot photo camera and attached gimbal and gyro stabilizing mechanism.

The UAV's E90 camera is much more than just a camera, as it is integral with both the video/image stability mechanism and the UAV's stability mechanism. Underneath the camera is a slot for a micro SD card, where images from photo shots and videos taken during flight are stored, and where the firmware that controls the aircraft flight is put for firmware updates. The aircraft appears to depend upon the stabilization and gyro sensing in the camera stability mechanism for stable flight operation, as it also depends upon the GPS signal. It is not possible to communicate between the ST16S controller and the aircraft without the camera installed on the aircraft.

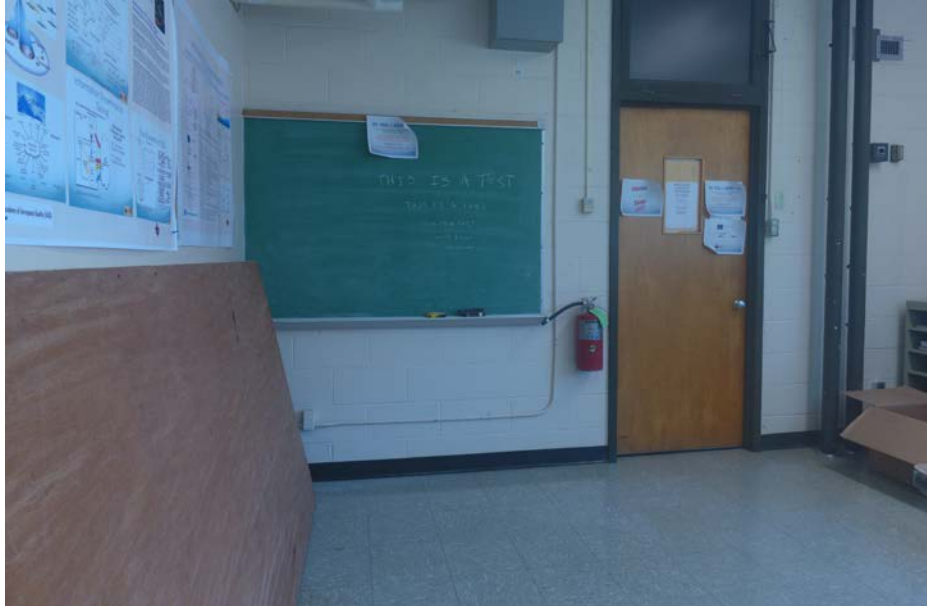
Figure 18. Test of snapshot with E90 camera looking toward a blackboard in the lab from a distance of about 20 feet. The blackboard contains letters as small as $\frac{1}{2}$ in size, and a sign on an $8\frac{1}{2}$ by 11 inch paper sheet, for comparison, at the board top-center.

In Figures 19 and 20, we see Figure 18 digitally zoomed to yield close ups. Note that the camera has zoomed in on the $8\frac{1}{2}$ by 11 inch paper sheet taped to the top center of the blackboard. Note by examining the image contained in Figures 19, and 20, that lettering in the print, and on the blackboard, little more than $\frac{1}{4}$ inch in size can be viewed and recognized from more than 20 feet away, using the E90 camera, again allowing enough resolution to capture bridge rivets, and deck board nails, as well as small cracks and evident section loss, provided sufficient illumination is present, as evidence by the thumbtack at the top center of the $8\frac{1}{2}$ by 11 inch sheet.

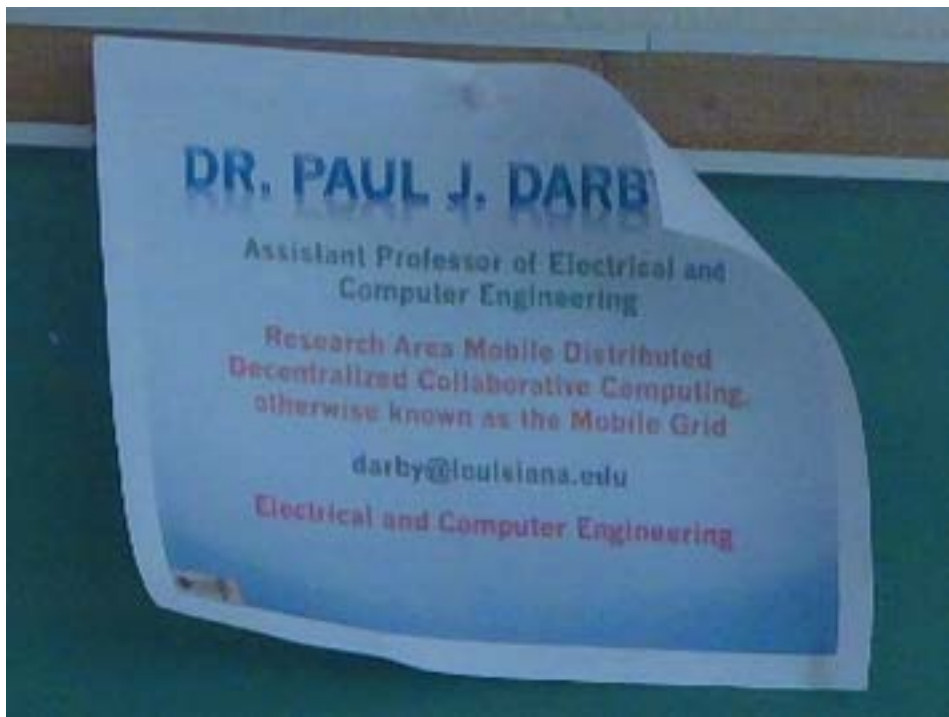
Figure 19. Digital zoom or enlargement of the photo image from Figure 18.

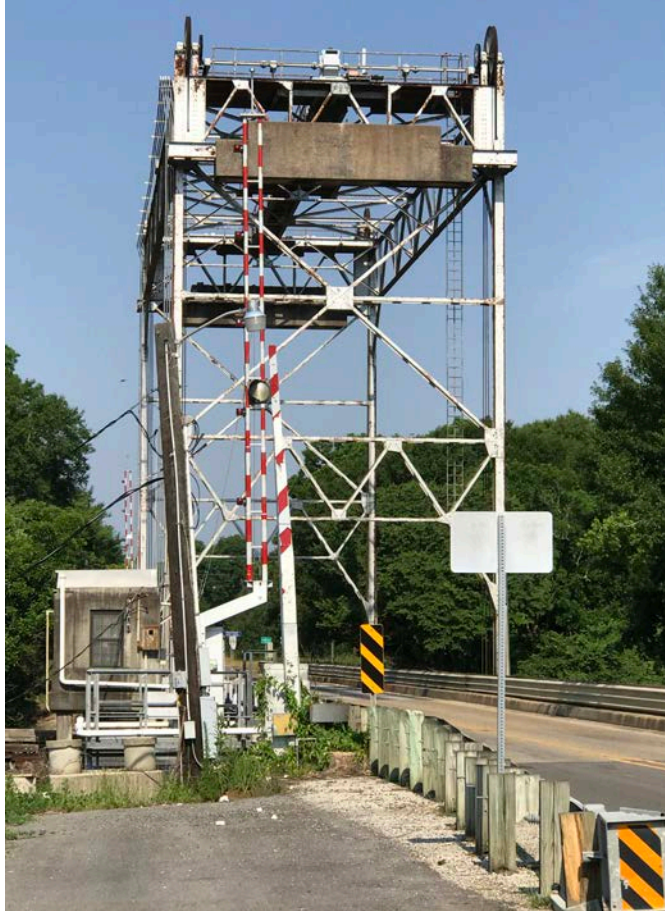
Figure 21. Shows an overview of the Vermilion River Bridge in Milton, LA, i.e. the sample bridge.

Observations from Figures 21 and 22:

- The drawbridge mechanisms, superstructure, and winches appear to be of significant hazard to a UAV during flight, as to capture video or photos of the top sections may present the UAV with having to travel in tight spots, especially in the case of windy conditions.
- Should the UAV crash while flying over the bridge superstructure, there is a potential for it to get tangled or wrapped up in the bridge winch mechanism, potentially causing damage to the bridge.

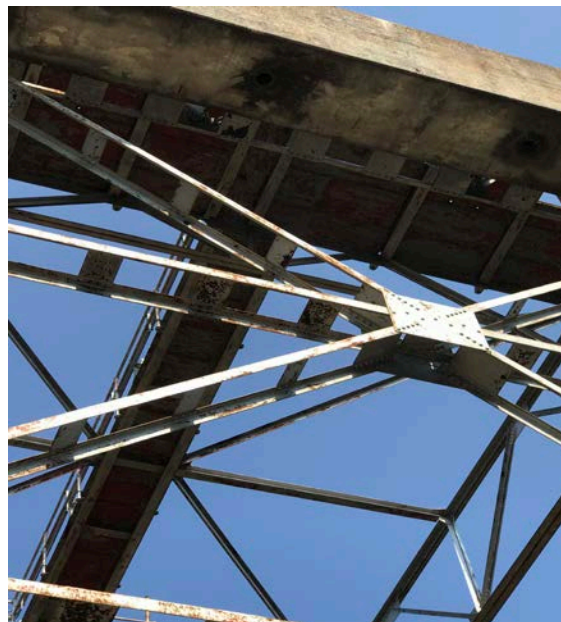
Figure 22. Shows a close up of the bridge superstructure top section showing tight spaces between structural members.

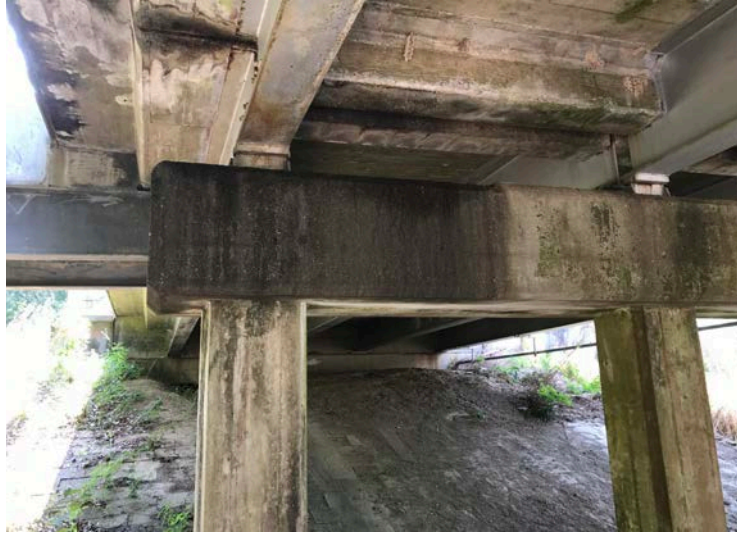
Figure 23. Shows tight space confinement beneath the deck of the sample bridge.

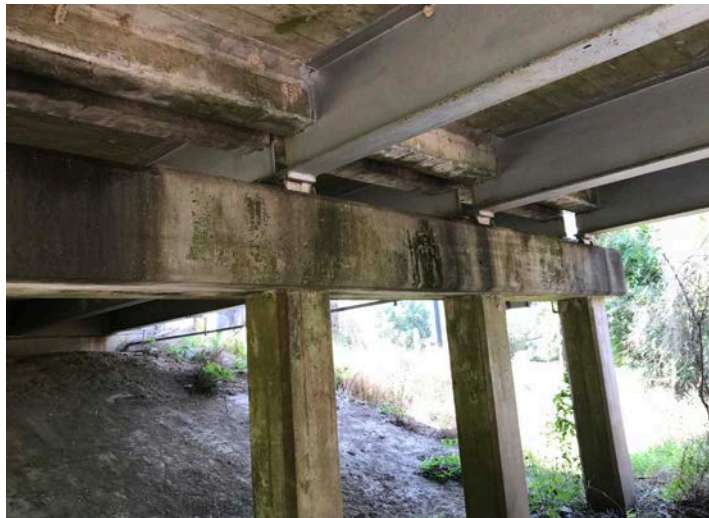
Figure 24. Again shows tight space confinement beneath the deck of the sample bridge.

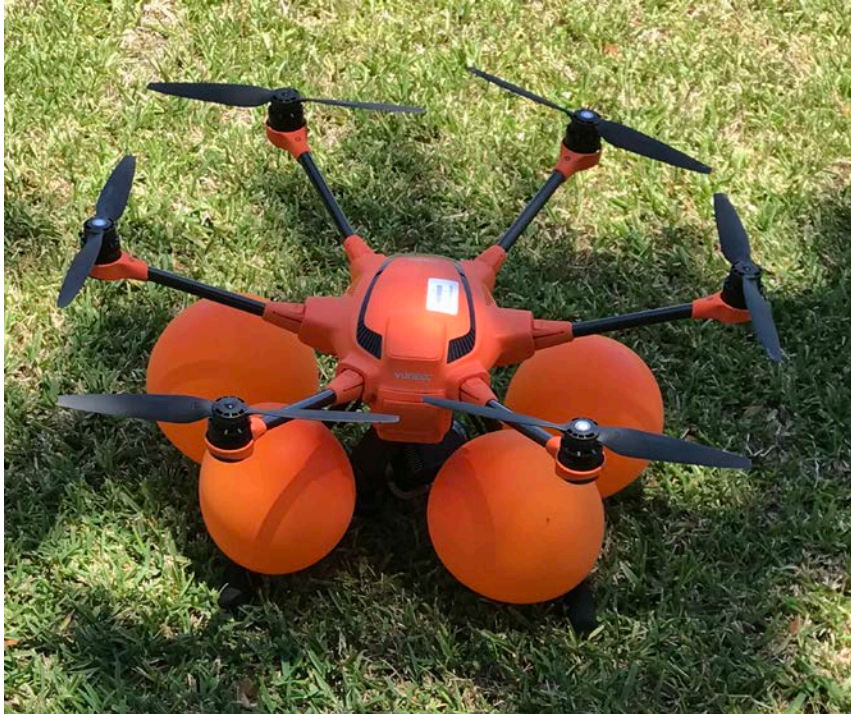
Figure 25. Aircraft shown, modified to include four (4) balloon floatation devices, 5 inches in diameter.

For the purposes of the experiment, four balloons were attached symmetrically to the aircraft's landing gear as shown in Figure 25, in a worse-case size of approx. 5 inches in diameter.

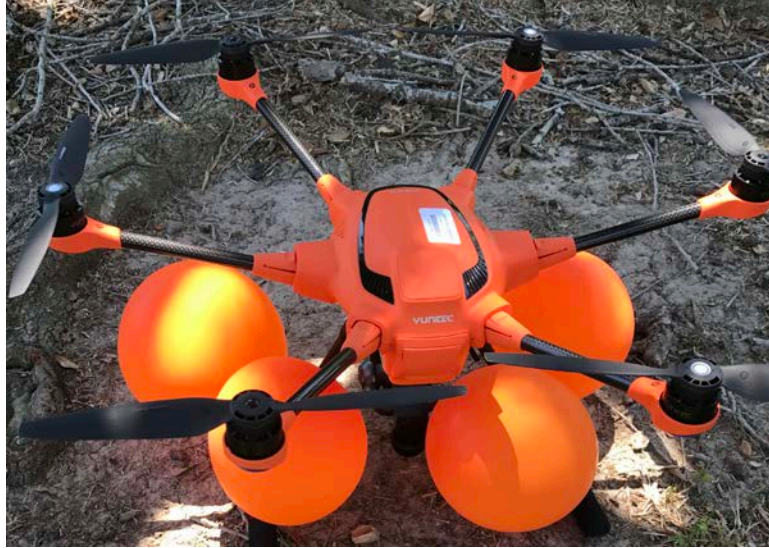
Figure 28. Yuneec H520 aircraft with attached balloon floatation devices, and E90 camera, taken at the LSU Bridge.

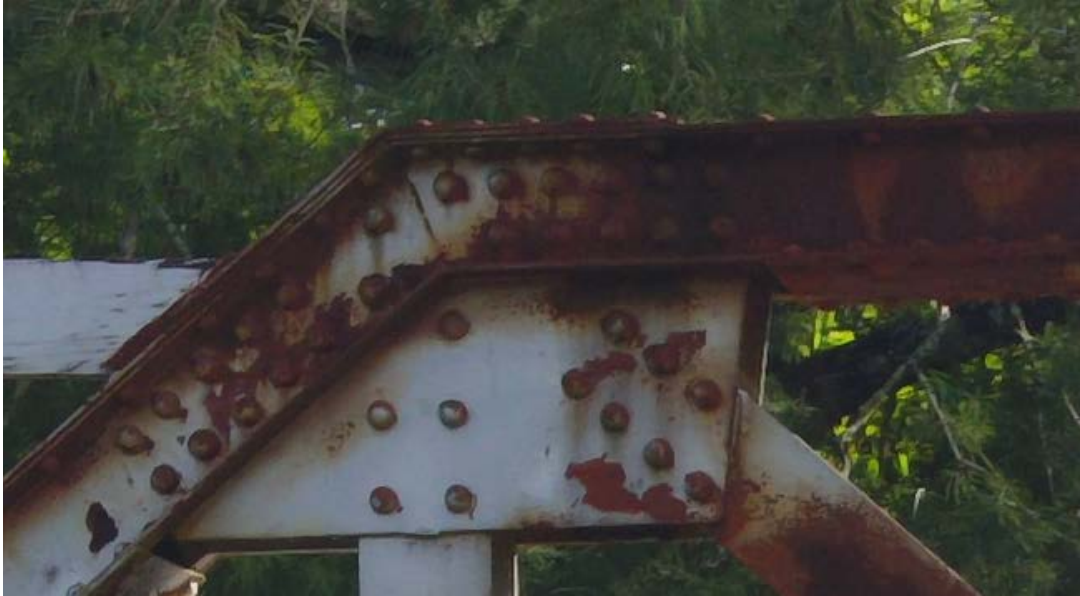
Figure 33. Photo enlargement showing the condition of bridge superstructure joint and outside rivets.

Note: That while some exterior rust is apparent in parts of the bridge superstructure members, the exposed side of the rivets in view appear to be in relatively good condition with no section loss.

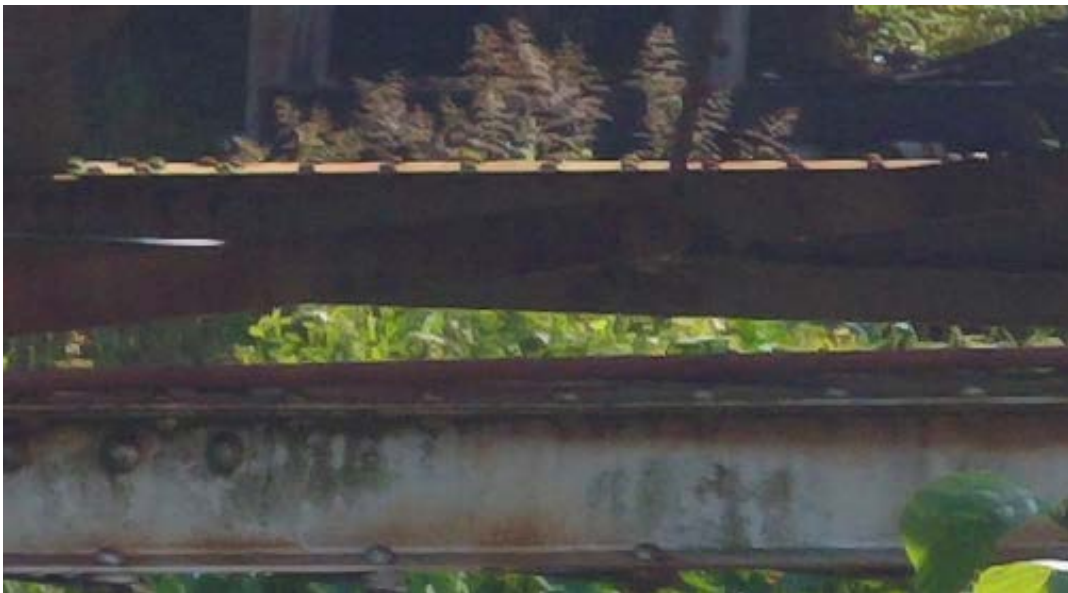
Figure 34. Photo enlargement showing the condition of the near and far rivets in the lower members of the superstructure truss.

Note: Rivets appear to be in good condition.

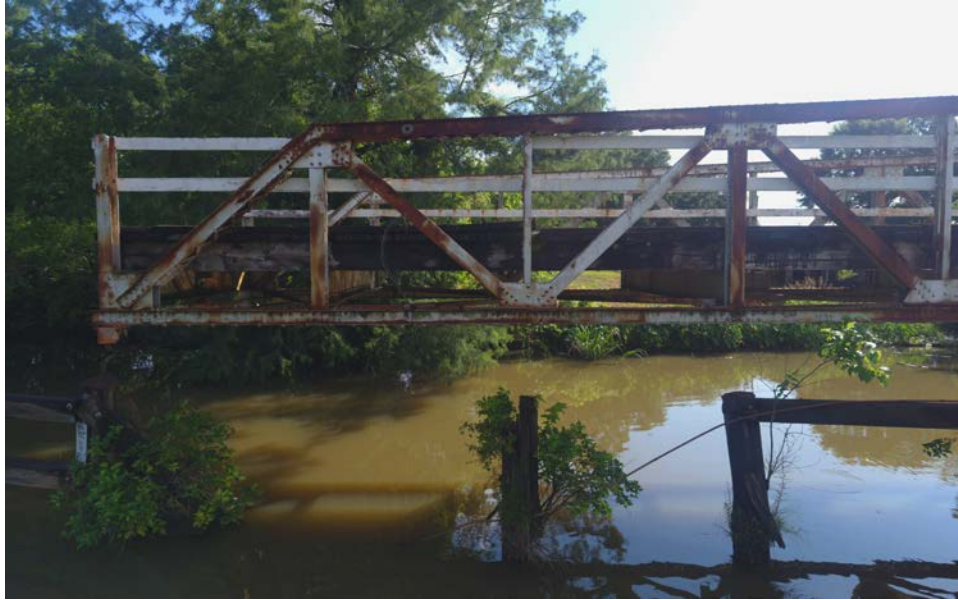
Figure 35. Photo showing the original image from which the photo enlargements shown in Figures 33 and 34 were developed.

Note: Image is taken from distance exceeding 30 feet, yet digital enlargements still contain sufficient information to allow individual rivet conditions to be viewed for section loss.

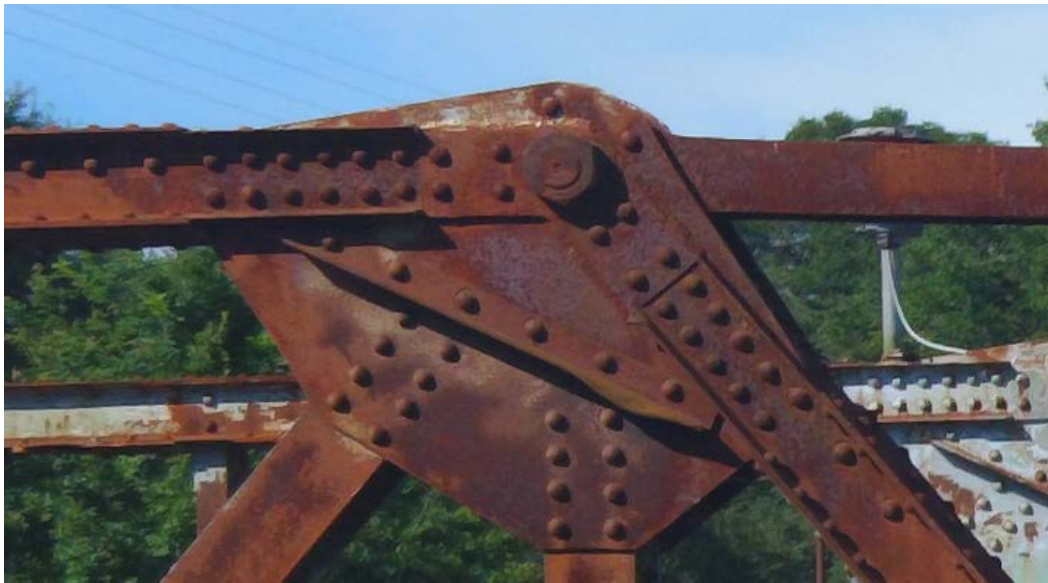
Figure 36. Photo enlargement showing the condition of joint and rivets in the northeast side of the bridge superstructure truss.

Note: Rivets appear to be in good condition, some rust on members, but no section loss on rivets or members or any part of the joint is apparent.

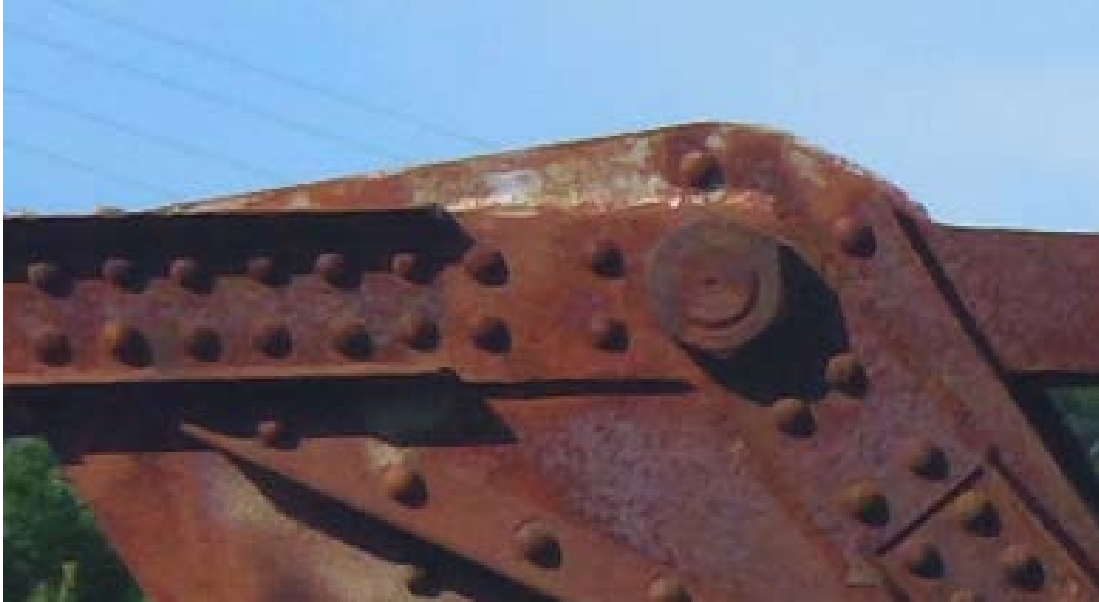
Figure 37. Photo – greater enlargement of same joint shown in Figure 36, again showing closer snapshot the condition of joint and rivets in the northeast side of the bridge superstructure truss.

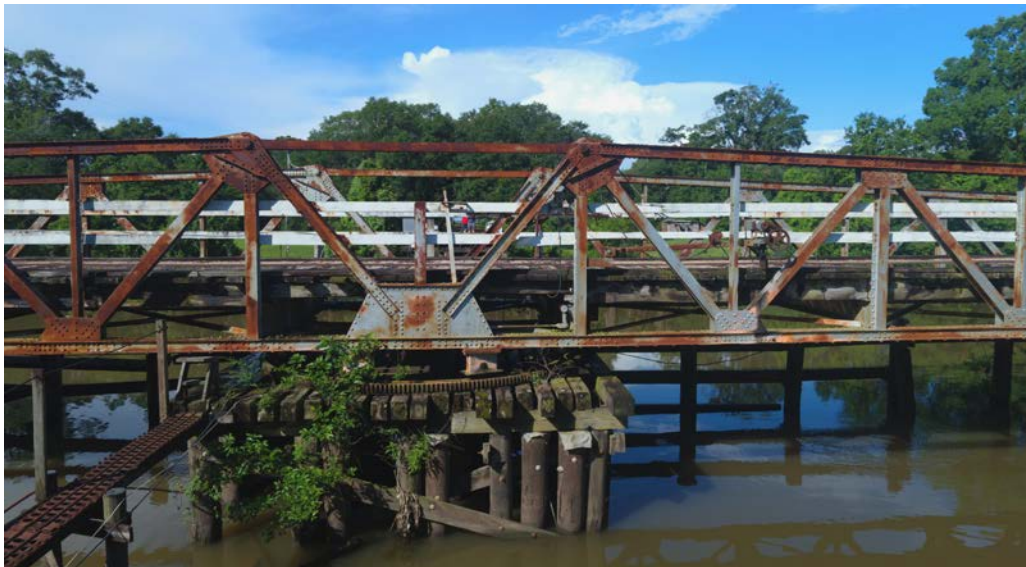
Figure 38. Photo showing the original image from which the photo enlargements shown in Figures 36 and 37 were developed.

Note: Image is taken from distance exceeding 30 feet, yet digital enlargements still contain sufficient information to allow individual rivet conditions to be viewed.

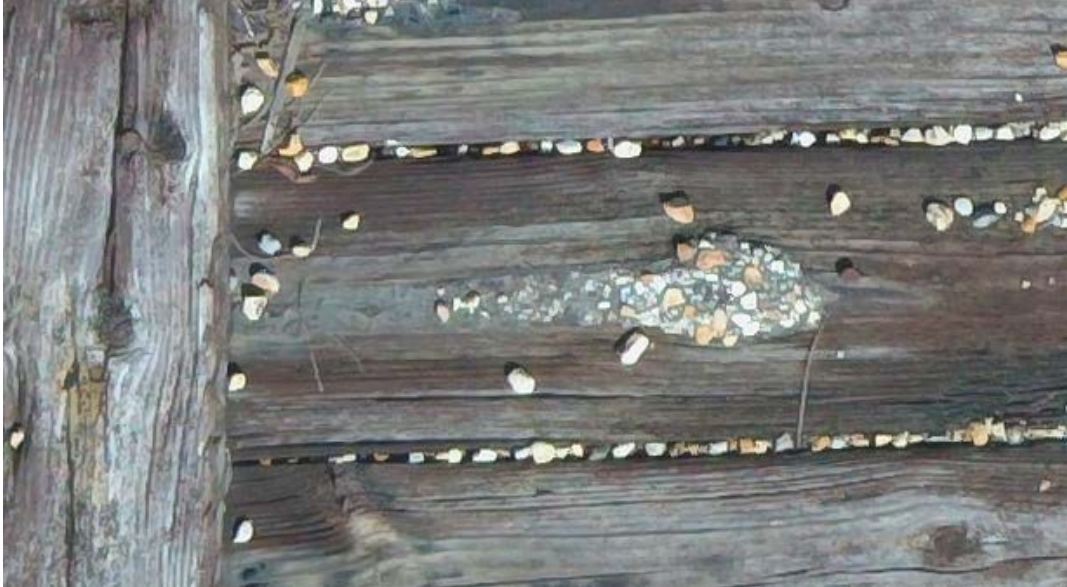
Figure 39. Photo enlargement showing the condition bridge deck boards shown from top, where cracks in the exterior of deck beam are visible as are nail heads slightly protruding from the deck board.

Note: Board exterior cracks and protruding nails clearly visible.

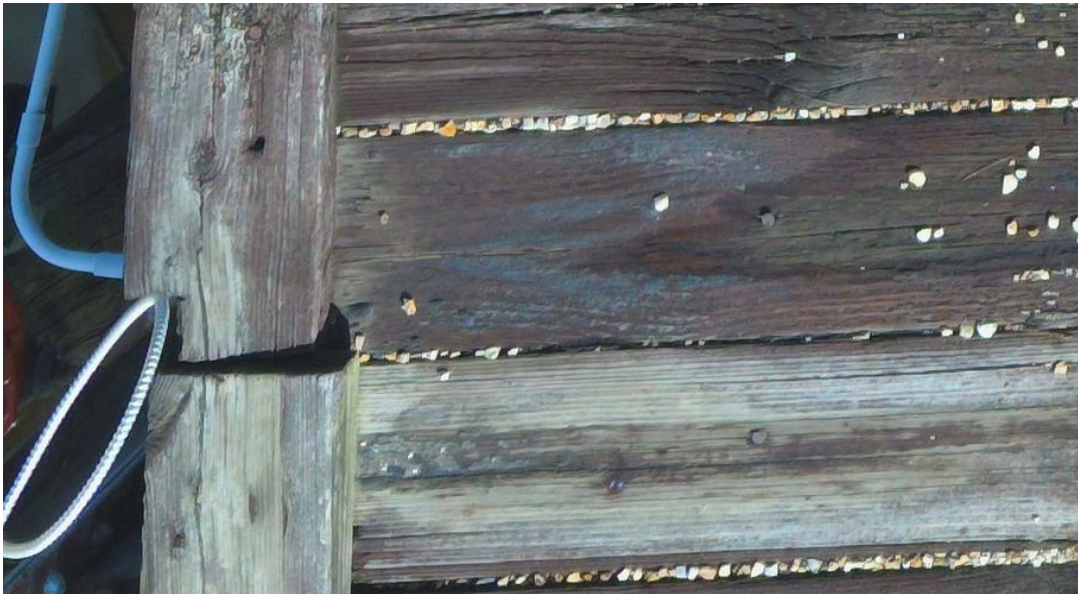
Figure 40. Photo enlargement of another section of the bridge deck, showing the condition bridge deck boards shown from top, where apparent board misalignment is seen as are the heads of protruding nails.

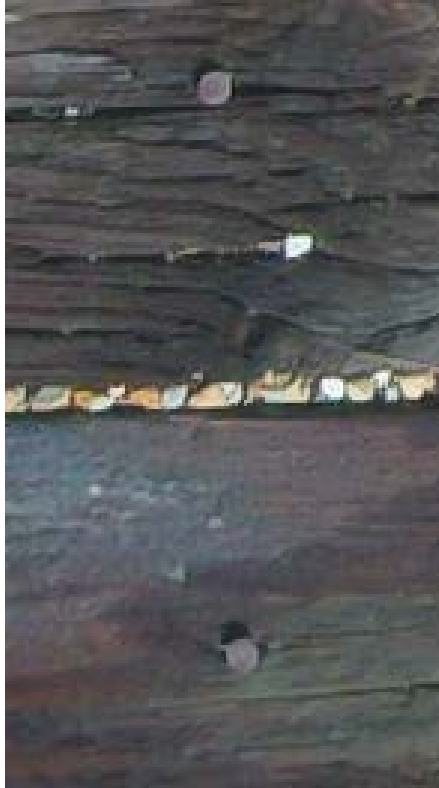
Figure 41. Photo enlargement even closer of another section of the bridge deck, showing board cracks and protruding nail heads.

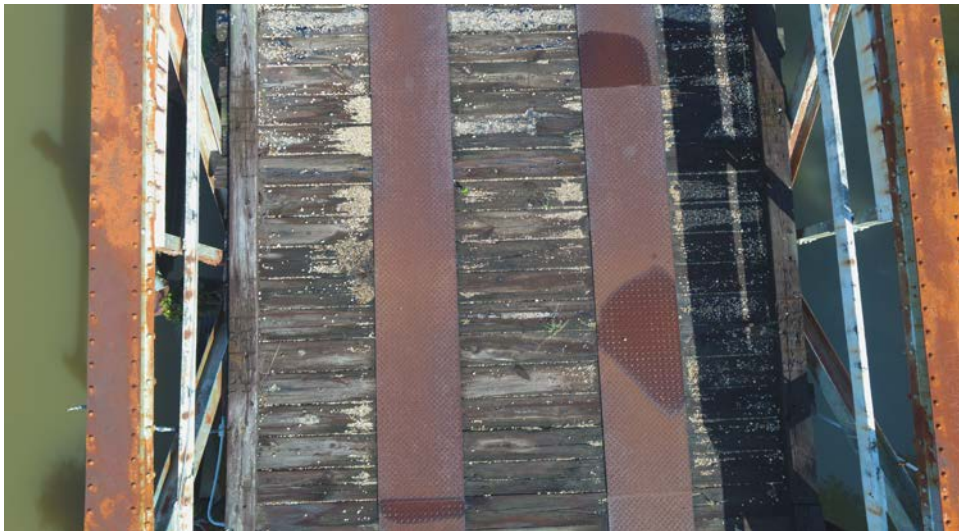
Figure 42. Photo showing the original image from which the Photo Enlargements shown in Figs. 39, 40, and 41 were developed.

Note: Image is taken from distance exceeding 20 feet above the deck, yet digital enlargements still contain sufficient information to allow individual nails and cracks to be viewed.

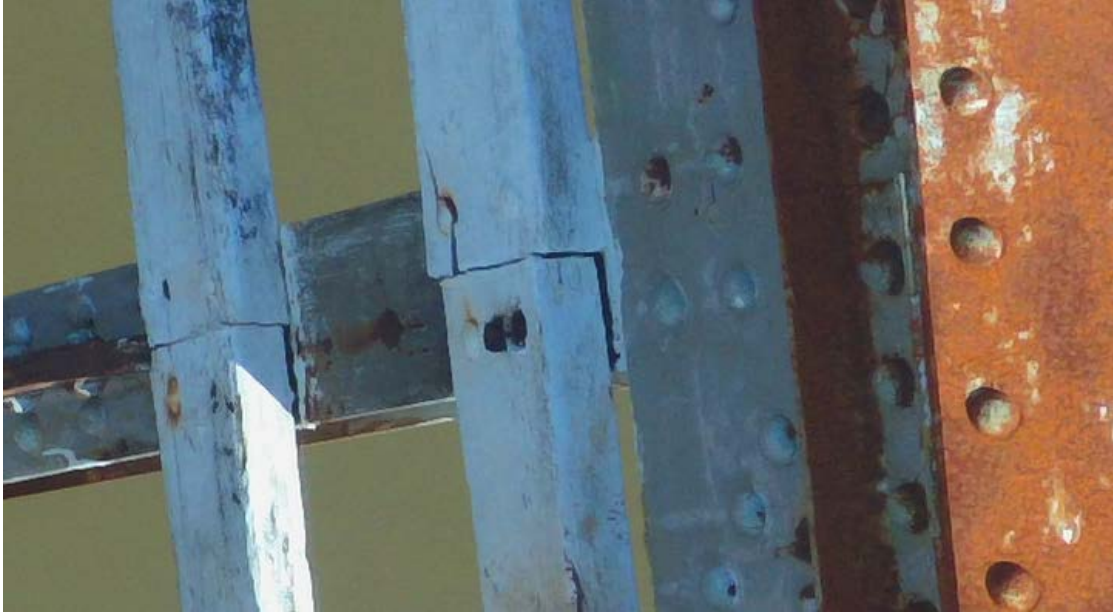
Figure 43. Photo enlargement of another section of the bridge superstructure shown from the inside deck, view, showing the condition rail with apparent crack near rivet.

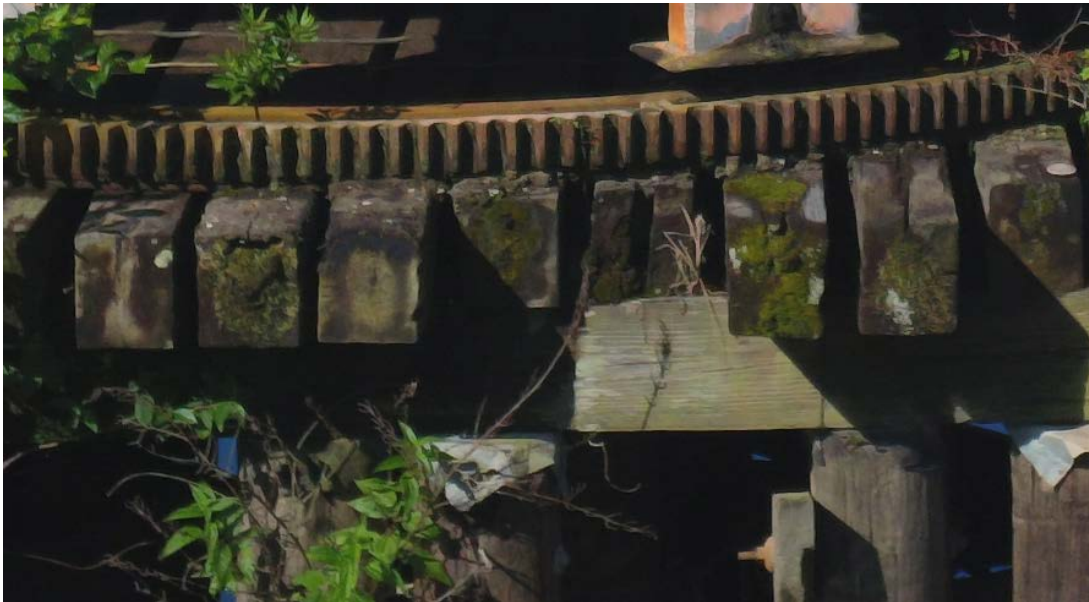
Figure 44. Photo enlargement of timbers supporting the entire bridge swing mechanism, showing apparent exterior wood decay.

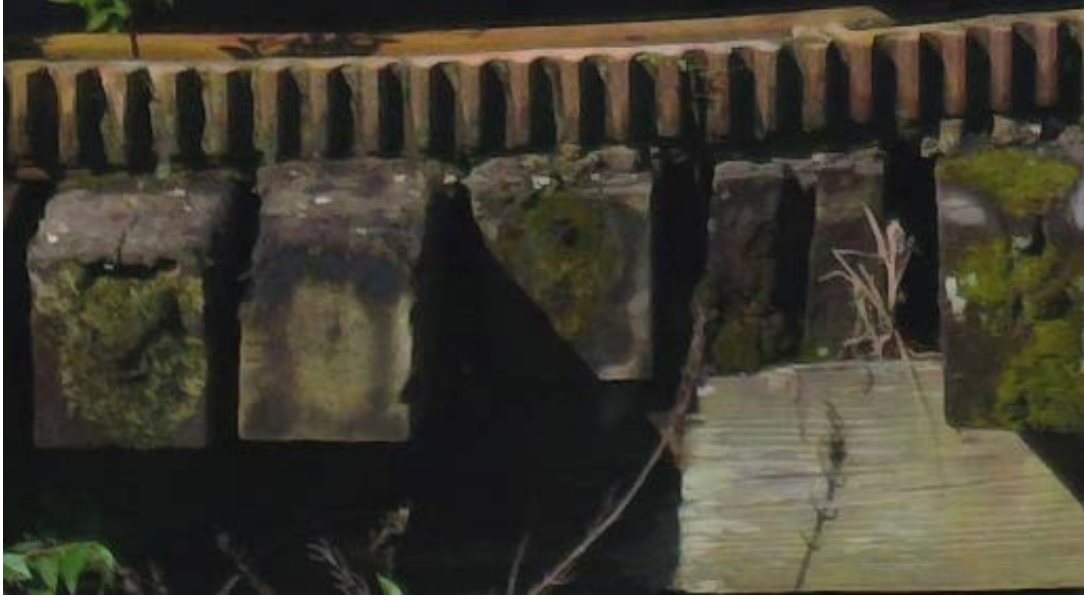
Figure 45. Further enlarged image from Figure 44, showing close view of the affected support timbers.
