# TechBrief

Office of Bridge Technology  
FHWA-HIF-20-042  
August 2021

## Development of Reference Criteria for Electrically Isolated Post- Tensioning Tendons in U.S. Bridge Applications

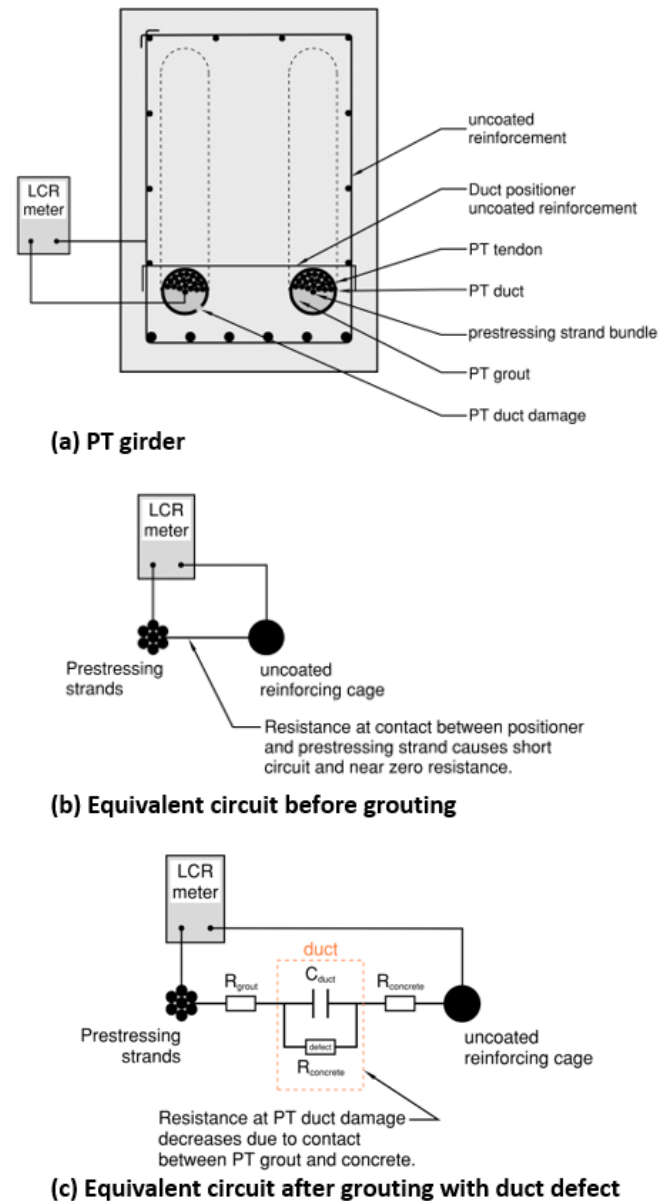
**Figure 3. Illustrations. Measurement of AC impedance in an EIT system. An LCR meter measures the inductance (L), capacitance (C), and resistance (R) of an electrical circuit.**  
Source: FHWA

EIT technology was introduced as a means of providing construction quality control of PT bridge girders and monitoring the integrity of the isolation system. EIT systems utilize AC (alternating current) impedance measurements between PT strands and the general reinforcement cage of the girder as a means of detecting and monitoring potential sources of corrosion attack of the tendon from sources outside of the PT duct. In the presence of duct damage, electrical current may pass through the defect, which has a much lower electrical impedance than the duct itself.

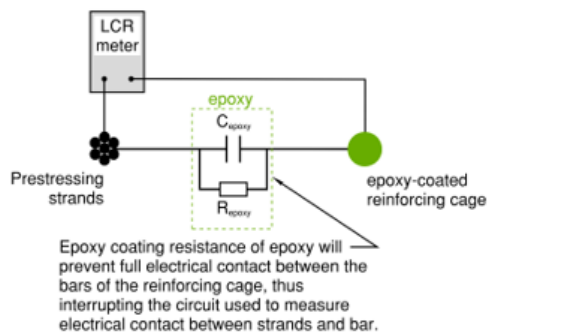
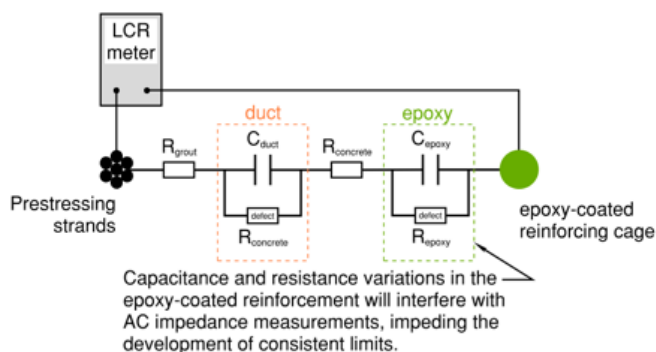
**Figure 4. Illustrations. Measurement of AC impedance in an EIT system surrounded by epoxy-coated mild reinforcement.**

There is a concern, however, that the epoxy coating prevents electrical continuity of the reinforcing cage, and thus is not a viable counter electrode for electrical measurements (Angst and Büchler, 2020). This is illustrated in Figure 4 for electrical measurements taken before and after grouting.

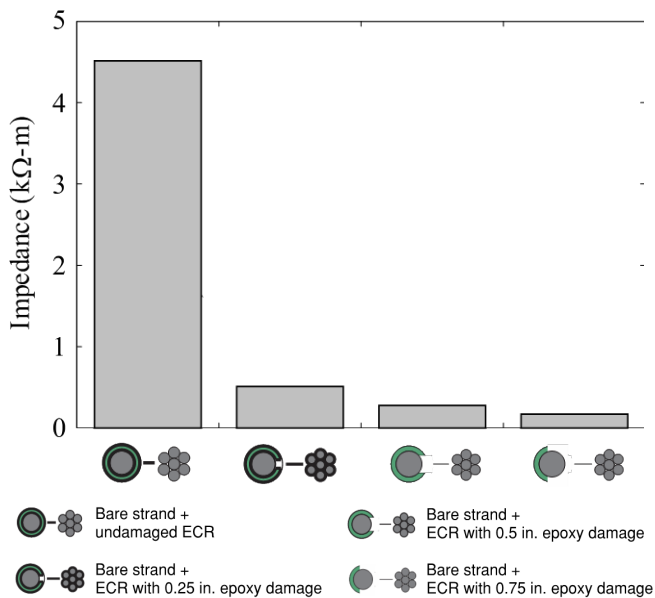
**Figure 6. Graph. Effect of epoxy coating damage on electrical readings.**

Figure 6 shows the results of cylinder tests that were conducted with two embedded electrodes. The bare prestressing strand was the working electrode, intended to simulate the strand bundle in a PT tendon. ECR was used as the counter electrode, intended to simulate the ECR cage surrounding the PT tendon in the concrete section. Damage was inflicted on several of ECR electrodes to simulate potential damage in the field; square areas of epoxy as indicated in the figure legend were removed. The variation in AC impedance readings was slight among the specimens with damaged epoxy coating; the decline in readings from undamaged to damaged, however, was nearly 90%.

To ensure the integrity and consistency of the EIT readings, if ECR were to be used as the counter electrode, the quality control would need to be such that no damage could be allowed to occur to the epoxy coating. In general, this is not a practical solution. Thus, if ECR is used to protect the reinforcement from corrosion, then an additional bare counter electrode should be used for electrical measurements.

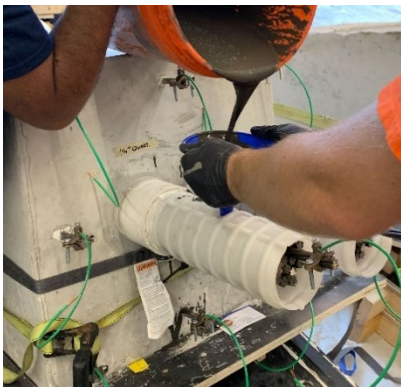
**Figure 10. Photo. Grout placement using funnel through opening in top of duct. Copper grounding clamps with #10 AWG copper wire are attached to counter electrodes and tendon strand for electrical measurements.**

The commercial prepackaged PT grout was mixed in a five-gallon bucket and poured through a funnel and into a 1-inch diameter hole in the duct extension at the top of the tendon. Grout was placed in a single lift until the grout line was visible in the duct extension.

Figure 9 shows positioning of the segment on a slope to simulate the slope that can occur due to the variation in tendon position. As shown in Figure 10, this also allowed grout to be poured into the duct from the upper end rather than by injection, which is the customary method of grout placement.

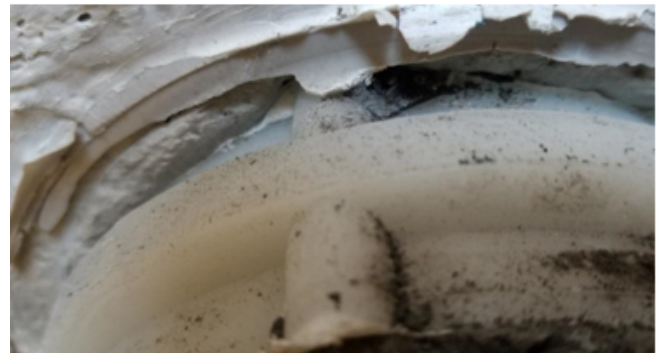
Figure 13. Effect of PT grout leakage at PVC cap.

(a) Illustration. Grout leakage through end cap.

(b) Photo. Traces of grout on outside of duct, which resulted in low AC impedance readings.

In the first few days following grouting, it was not clear why the undamaged ducts showed such distinct differences in readings. During grouting, it was noted that grout had leaked out of one of the end caps and was in contact with the concrete. Upon closer inspection, grout leaks out of the duct were noted on several of the ducts (Figure 13). Following the grout pour of the first duct, a small leak was discovered in the duct coupler at the front of the segment and at the PVC cap at the low end of the duct slope.

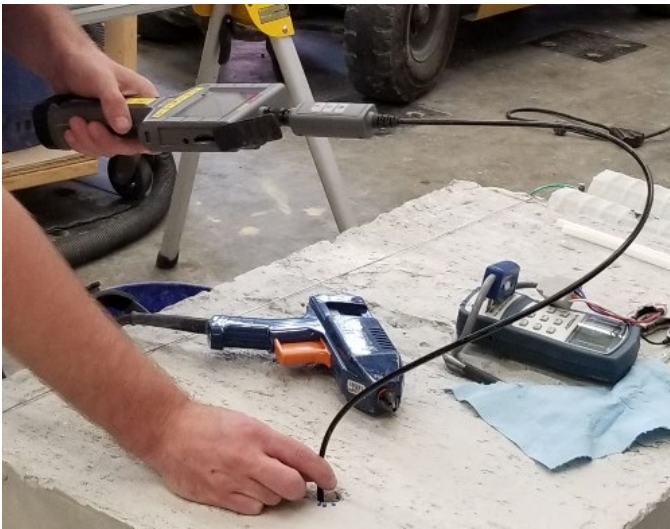
**Figure 17. Photo. Insertion of borescope to verify correct placement of duct bonding glue.**

The test procedure began with drilling a single 0.75-in. diameter hole through the concrete and into the duct to expose the grout (Figure 16); the holes were drilled at about six inches from the segment end. Once the holes had been drilled, the selected repair material was applied to the duct at the bottom of the hole and the hole was filled with the selected material; in the case of S2 damaged and S3 undamaged, the same material was used for both (Table 1). A borescope was used to guide the repair process (Figure 17).
