**National Highway
Traffic Safety
Administration**

DOT HS 813 319

Development of Test Procedures for Lower Interior Rear Seat Occupant Protection

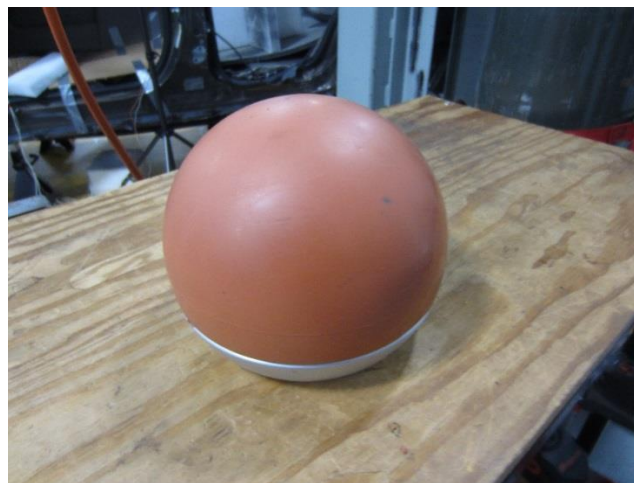
The APHF is shown in Figure 2. It weighs 9.92 lb (4.5 kg) and consists of an aluminum headform covered with a 0.55-inch (14-millimeter (mm)) thick synthetic skin, with the headform and skin having a total diameter of 6.5 inches (165 mm). The diameter is considered to represent the forehead portion of the 50th percentile adult male. This headform has a spherical contact surface with the accelerometer and center of gravity within 0.39 inch (10 mm) of the geometric center of the sphere.

Figure 2. Adult pedestrian headform

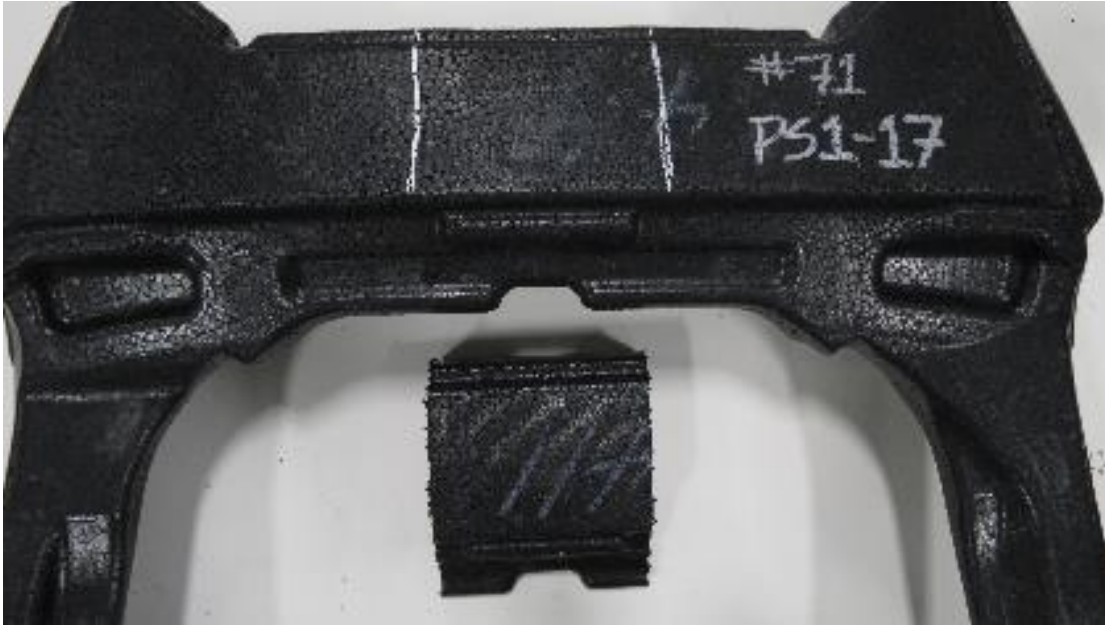
The Jeep Grand Cherokee tested in the initial series incorporated expanded polypropylene (EPP) foam bezels around the seat back frame shown in Figure 11. Research testing showed the foam to be a good energy absorber. Sections were cut from the top part of the bezel and thickness ranged from 1.4 inches (35 mm) to 1.5 inches (38 mm). Bezels were obtained for approximately \$65 each.

Figure 11. Jeep Grand Cherokee seat back foam bezel

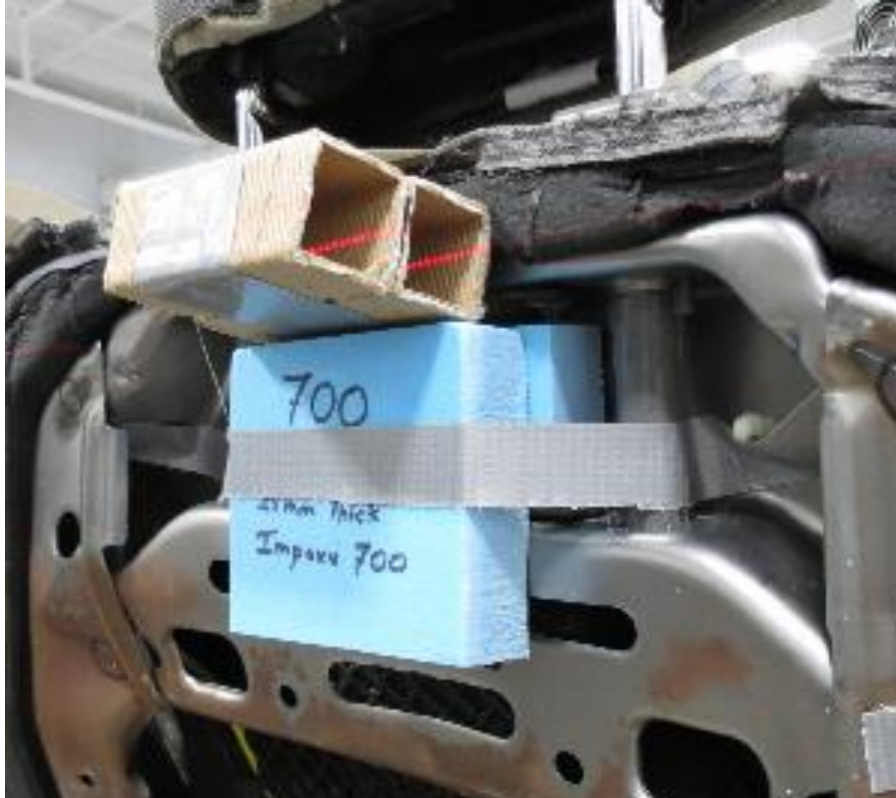
To place the countermeasure material, the seat back and head restraint were deconstructed to expose the underlying metal seat frame and head restraint post. The countermeasures were affixed to the seat back frame and head restraint posts with double-sided tape. Duct tape was used to stabilize the countermeasure. Several countermeasures were used in some tests to prevent chin and lip interaction between the 201HF and the metal frame, as shown in Figure 13.

Figure 13. Example of countermeasures use

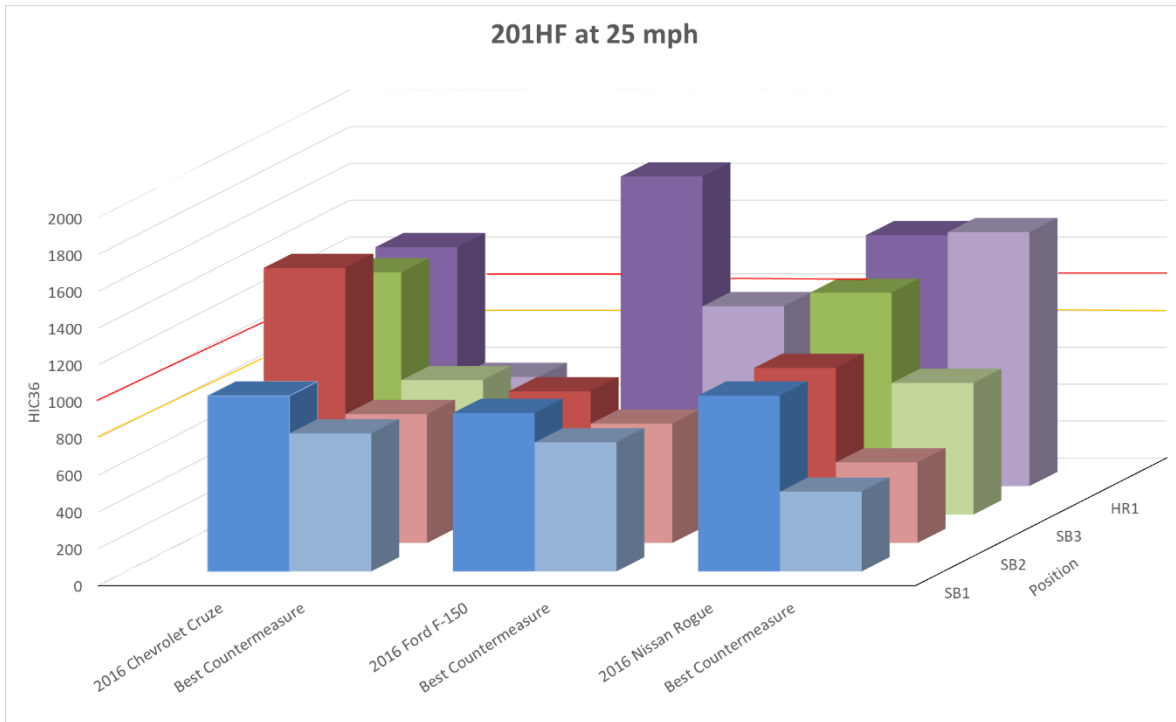
The results are shown graphically in Figures 14 and 15. The darker shade of color represents the baseline test and the lighter shade of color shows the lowest achieved HIC with countermeasures regardless of countermeasure used. Baseline HIC36 values were reduced to less than 800 for both the 201HF and APHF, and a reduction in HIC36 values below 800 was achieved in 27 of the 65 (42 percent) impacts performed; some level of HIC reduction was observed in 9 other tests.

Figure 14. Countermeasure results by impact location and vehicle – 201HF at 25 mph

At least one countermeasure solution was found that reduced HIC36 values below 800 for 9 of the 11 impact locations with the 201HF and for 6 of the 9 impact locations with the APHF. There is no apparent trend in the results to determine if one countermeasure performed superior to the other. The APHF typically required more countermeasure solutions to achieve the goal of lowering HIC36 values under 800.

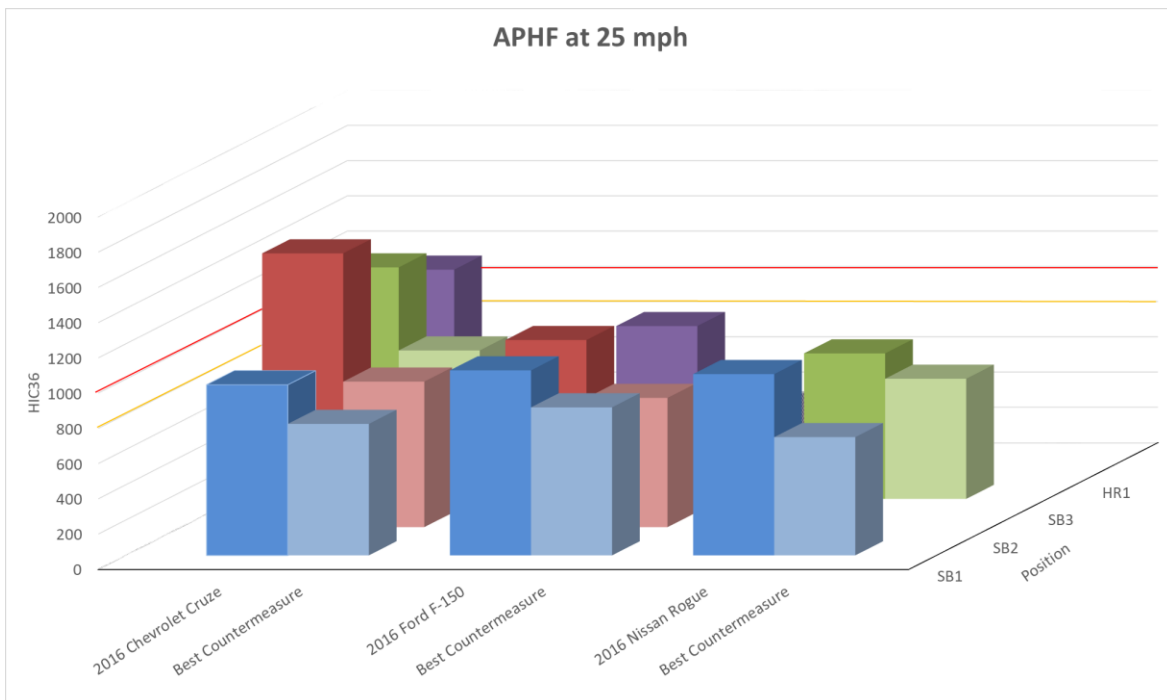
Figure 15. Countermeasure results by impact location and vehicle – APHF at 25 mph

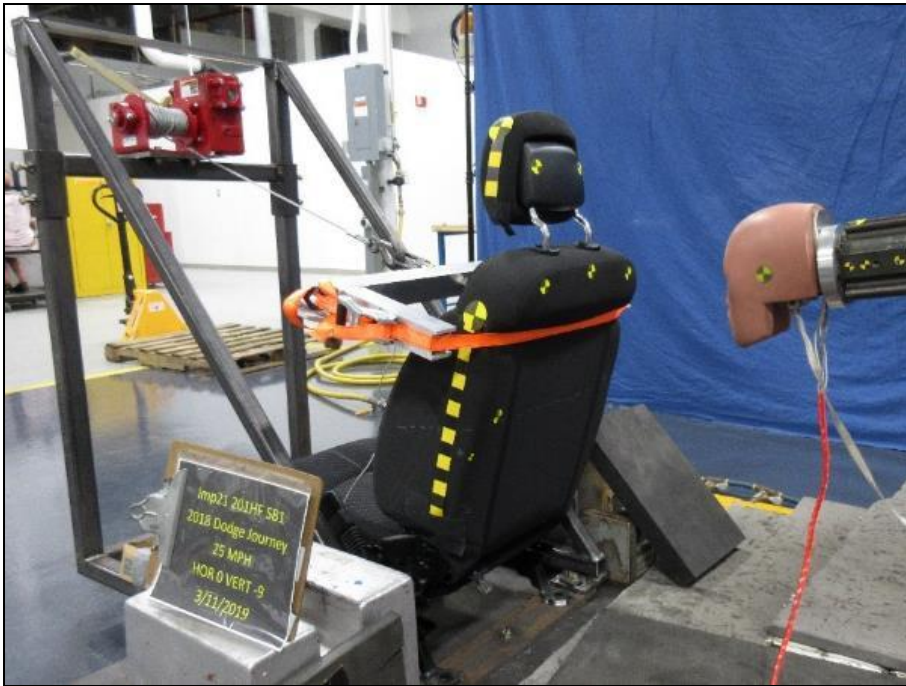
The seat load fixture was fabricated to apply a specified load to the seat back during an impact test. The modified seat load fixture (Figure 16) allowed a load to be exerted on the seat back, while reducing the pinching that was observed in the previous fixture design. The fixture loads the seat back without changing the horizontal angles for any of the target locations. The 1.5-inch (38-mm) strap used in the fixture was designed to load the seat without interfering with the impact locations or headform.

Figure 16. Setup of impacts with forward force exerted on seat backs

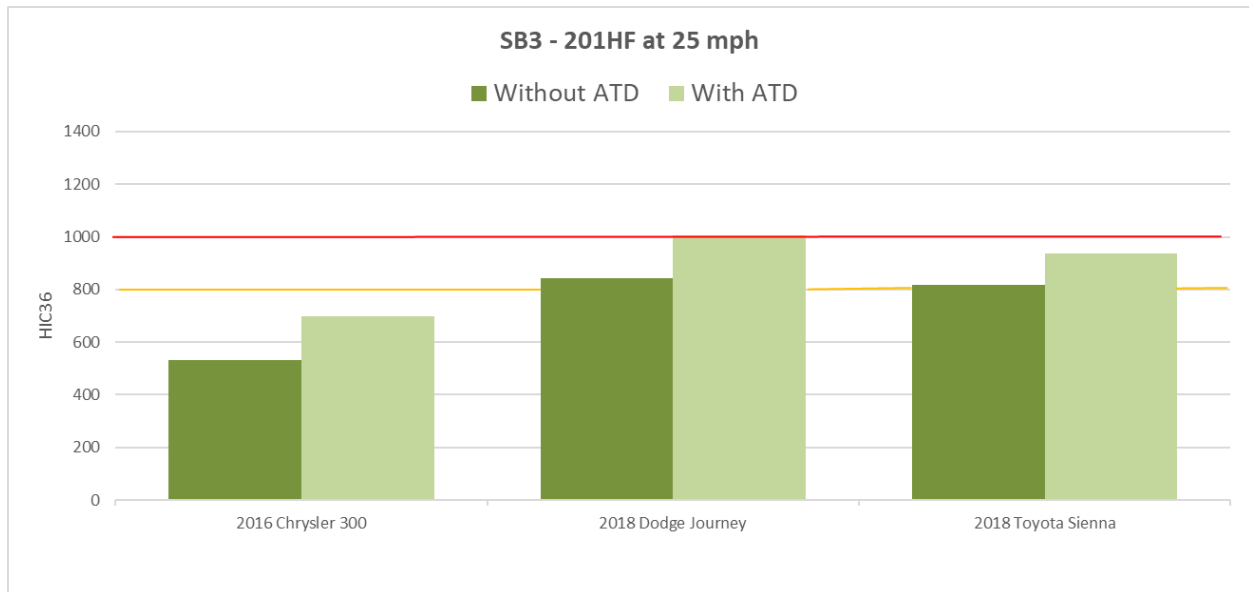
Impacts on the three different vehicle models showed higher HIC36 values with the HIII-50M ATD in the front seat, as opposed to tests with no ATD. Figures 17 to 20 illustrate the higher HIC36 values when the ATD was placed in the seat.

Figure 17. HIC results at SB1 without and with an ATD

Figure 18. HIC results at SB2 without and with an ATD

Figure 19. HIC results at SB3 without and with an ATD

Figure 20. HIC results at HR1 without and with an ATD

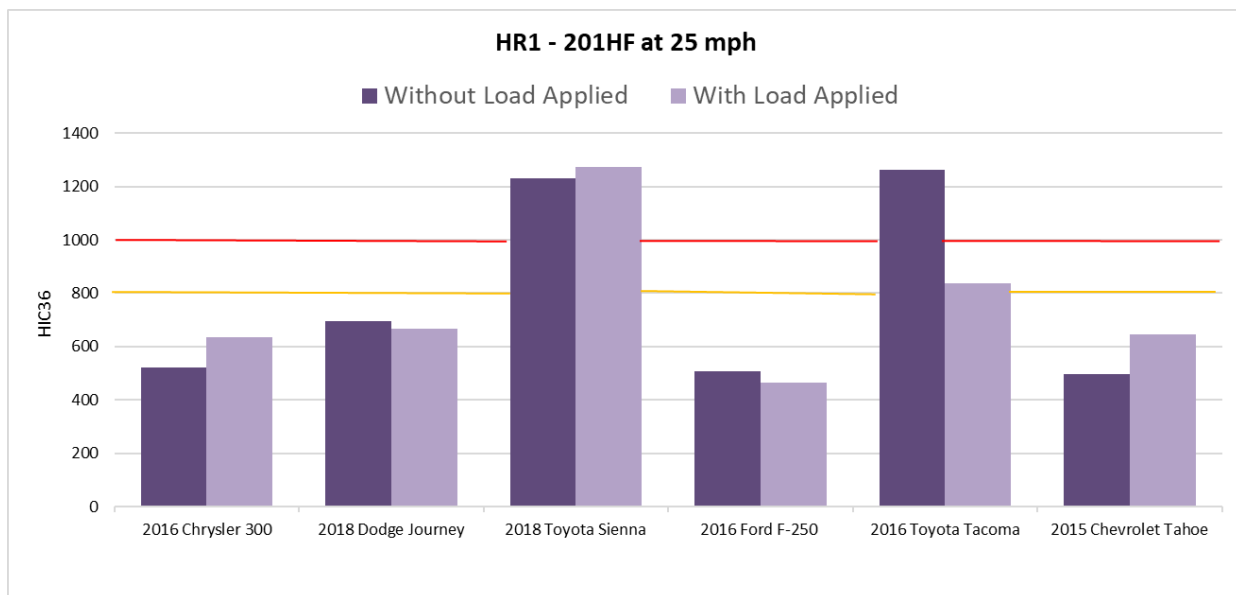
The bar charts shown in Figures 21 through 24 illustrate the HIC36 values for the seat back and head restraint impacts for the six vehicle platforms tested to compare the test conditions with and without applied load. The 2018 Toyota Sienna seat back produced higher HIC36 values overall compared to the other vehicles and exceeded the IARV in two of four tests, for both test conditions (seat without load applied and seat with load applied).

Figure 21. HIC results at SB1 without and with load applied

Figure 22. HIC results at SB2 without and with load applied

Figure 23. HIC results at SB3 without and with load applied

Figure 24. HIC results at HR1 without and with load applied

The HIC36 differences were not consistent when comparing the two conditions. Four of the six vehicles reported higher HIC36 average values for the loaded condition at SB1, compared to three of the six vehicles when struck at HR1.

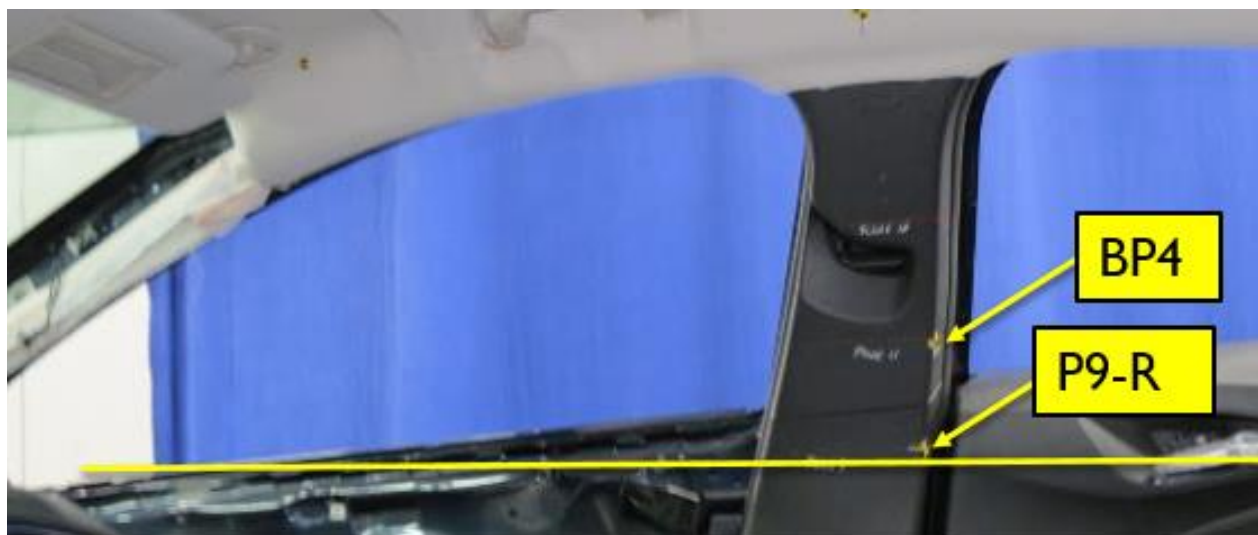
The upper interior test procedure of FMVSS No. 201 was followed for establishing the vertical and horizontal approach angles at the BP4 and P9-R target shown in Figure 29. The standard defines the vertical approach angle limits as -10 and 50 degrees for the B-pillar structure. The horizontal limits are defined based on the CG-R and CG-F occupant positions. The horizontal approach angle is the angle between the +X axis (towards the rear of the vehicle) and the impact velocity vector projected onto the X-Y plane and measured in the counter-clockwise direction. The horizontal approach angle for a right-side B-pillar is limited to between 15 and 165 degrees.

Figure 29. Lower B-pillar impact locations

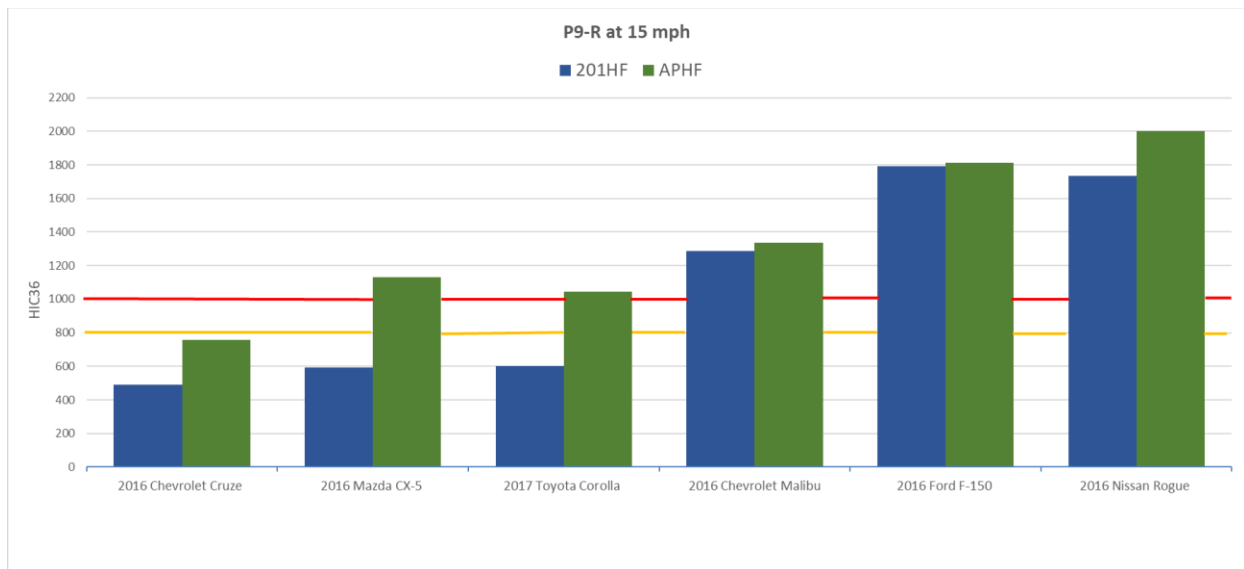
Appendix A, Table A2 lists all the test results. The APHF produced HIC36 values greater than 1000 at the P9-R location in five of six vehicles; the exception was the Chevrolet Cruze as illustrated in Figure 31. The APHF also produced HIC36 values less than 1000 at the BP4 location in five of six vehicles, with the exception being the Ford F-150 as illustrated in Figure 32. The 201HF produced HIC36 values greater than 1000 at the P9-R location in three vehicles and below the 80 percent threshold in the other three vehicles. It also produced HIC36 values at BP4 below the 80 percent threshold in five vehicles, while the HIC36 value at BP4 exceeded 1000 in the Ford F-150.

Figure 31. Lower B-pillar P9-R impact location fleet results

The results show higher HIC values for the APHF compared to the 201HF for both impact locations in the six vehicles. The APHF’s hemispherical geometry allows for an impact velocity vector perpendicular to the trim surface resulting in a more severe test condition.

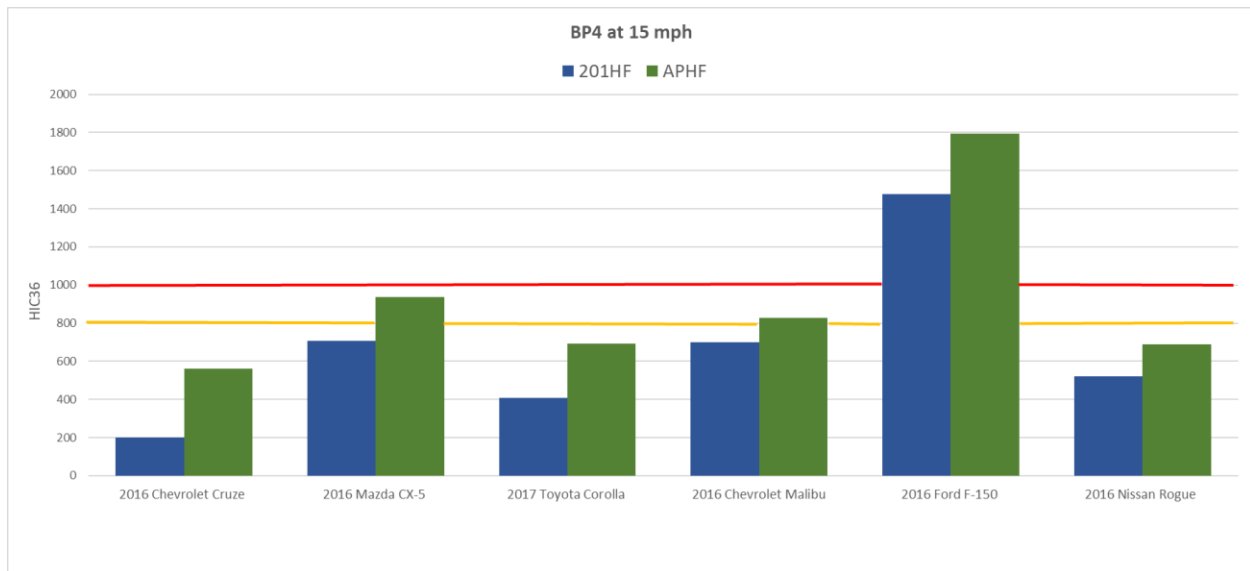
Figure 32. Lower B-pillar BP4 impact location fleet results

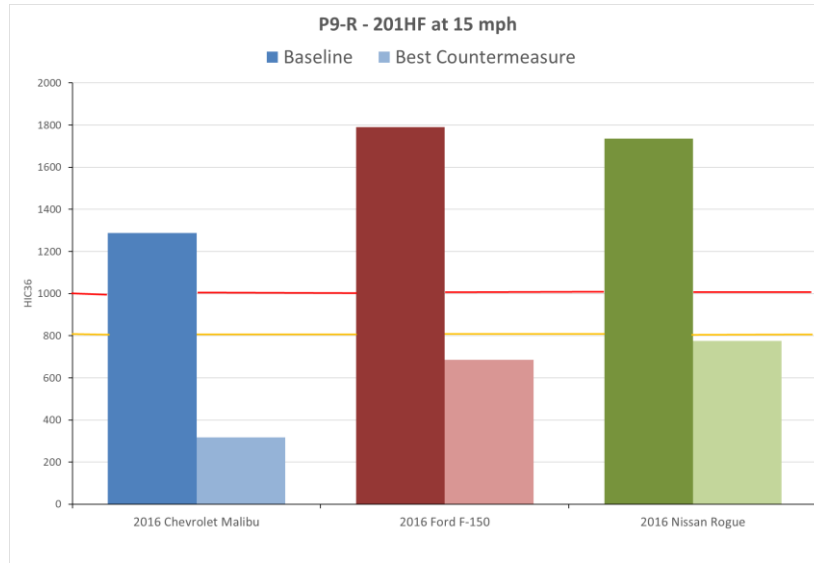
The results from impacts to P9-R with countermeasure materials implemented are shown in Appendix A and graphically in Figures 34 and 35. The darker shade of color represents the baseline test and the lighter shade of color shows the lowest achieved HIC with countermeasures regardless of countermeasure used. Due to unfamiliarity with the countermeasure response, a trial and error approach was taken with the Chevrolet Malibu, the first vehicle tested in the series. This resulted in a high number of tests on this vehicle. With the gained experience, the process was streamlined for the two other vehicles. Baseline HIC36 values were reduced to less than 800 for both the 201HF and APHF in all three vehicles, and a reduction in HIC36 values below 800 was achieved in 15 of the 26 (58 percent) impacts performed. Of the 11 other impacts, 8 had some reduction in HIC.

Figure 34. Countermeasure results at P9-R impact location with 201HF

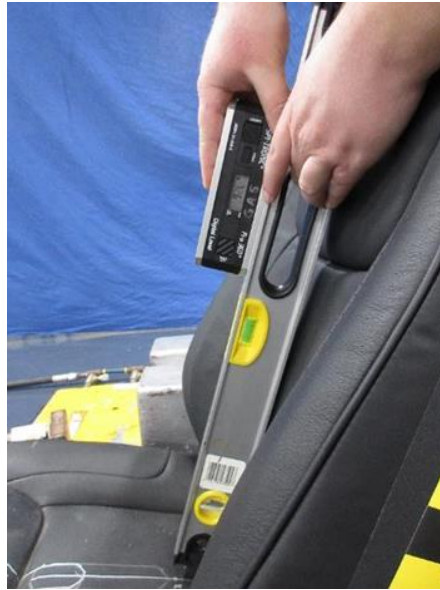
1. To determine the target locations, begin with the seat pan in the lowest position, mid-track, and mid-angle. The head restraint should be in lowest locking detent.
2. The seat back should be set to 25 degrees (or the closest angle allowed by the detents) using the SAE-J826 manikin. Remove the manikin and measure the seat back angle using an inclinometer and level. The level should be in contact with as much of the seat back cushion as possible without resting on the seat pan (Figure C1). Measure the head restraint post angles (left and right) using an inclinometer (Figure C2). Record the values.

Figure C1. Seat back angle measurement

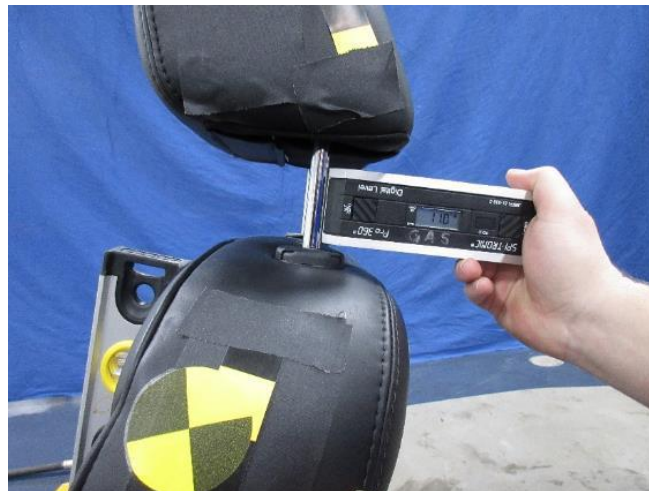
Figure C2. Head restraint post angle measurement

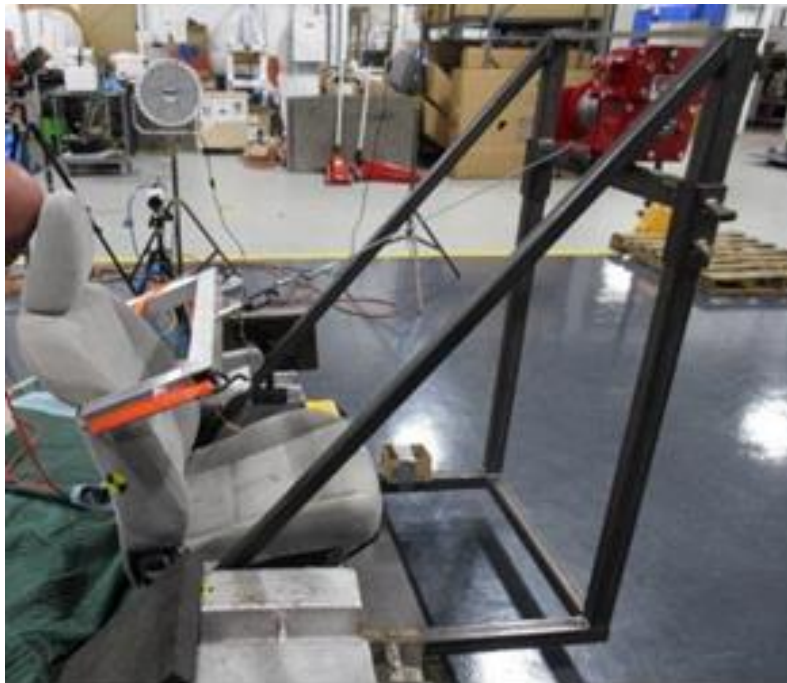
20. Unbolt the outer seat bolts from the steel mounting plate.
21. Clear the immediate vicinity of the seat to make room for the seat load fixture (Figure C4).

Figure C4. Seat load fixture

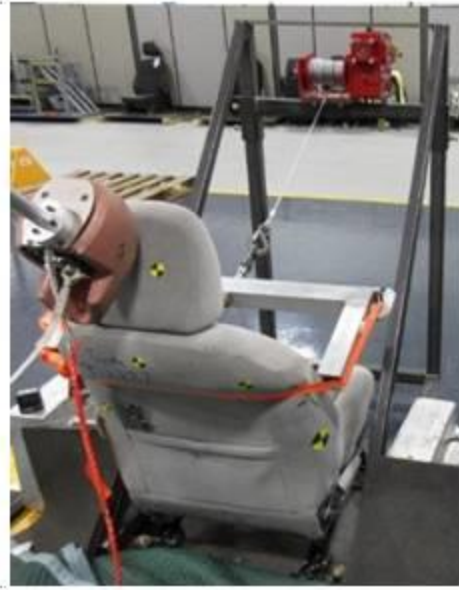
Figure C5. Forward tension attachment strap

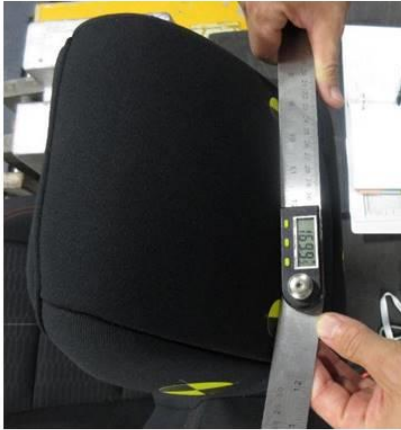
30. Line up the APHF to the back of the seat back per target to achieve the most perpendicular angle from the APHF forehead to the seat back target while monitoring the load and seat back angle with a 2-foot level. Repeat three times for consistency. Record the angle.
31. To determine the horizontal approach angle, use a digital protractor with one edge on the flat part of the seat back or head restraint and the other edge along the curved surface where the impact target is placed (Figure C6). The headform should impact the target in a perpendicular direction. Record the angle.

Figure C6. Measuring horizontal approach angle

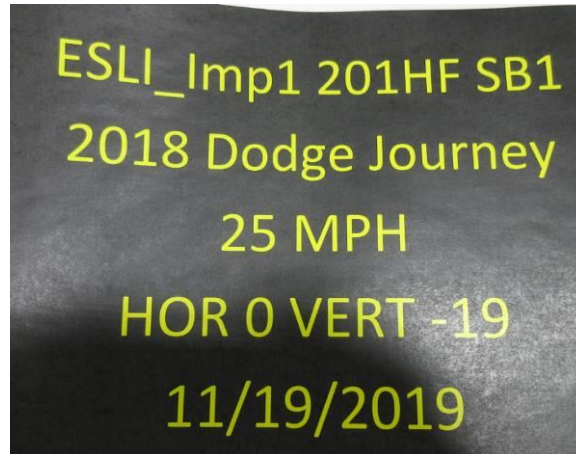
41. The seat and floating floor may need to be adjusted to the final impact position. With the headform and extender on the end of the impactor, position the floating floor such that the headform is aligned with the impact location, with a gap of no more than 0.5 inch (13 mm) between the headform and the target and within 0.5 degree of the determined approach angles.
42. Add a signboard (Figure C8) such that it is within the frame of the video view. The signboard should include test number, vehicle make and model, speed, horizontal and vertical approach angles, and date.

Figure C8. Example signboard

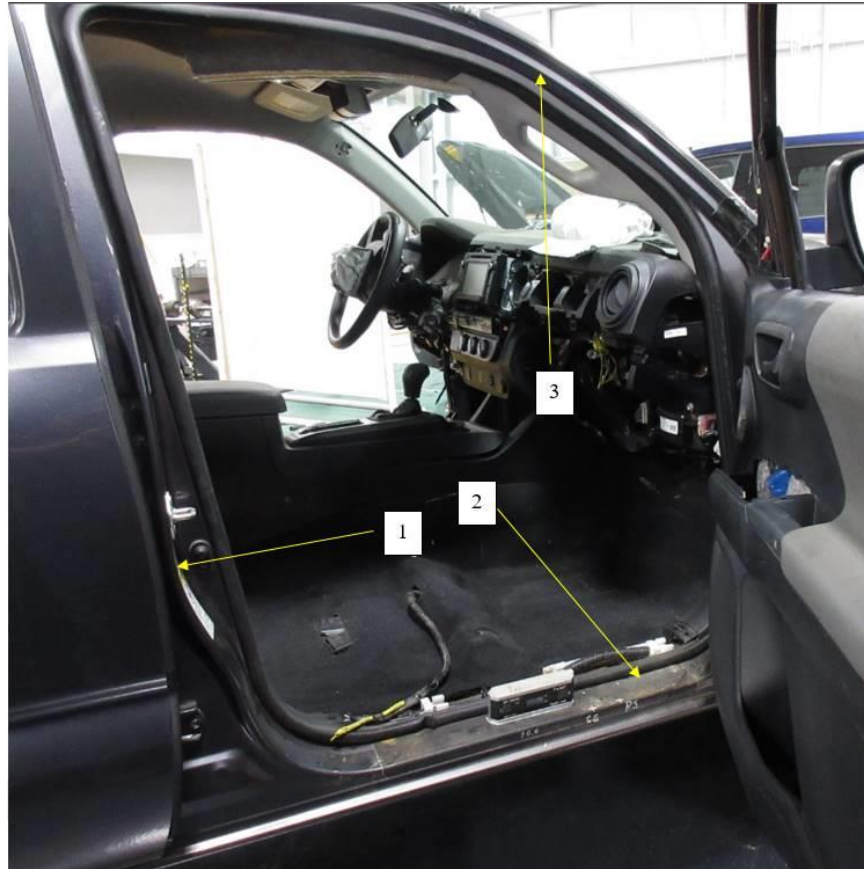
1. Remove front driver and passenger seats and any other parts that are not needed for B-pillar testing. Ensure the door trim, lower and upper B-pillar trim, and second row seat are installed.
2. Verify all tire pressures are at the manufacturer's specified pressure for the specific vehicle.
3. Place a minimum of three reference points on the vehicle in order to relocate the CMM during testing (Figure D1).

Figure D1. Example of reference point locations

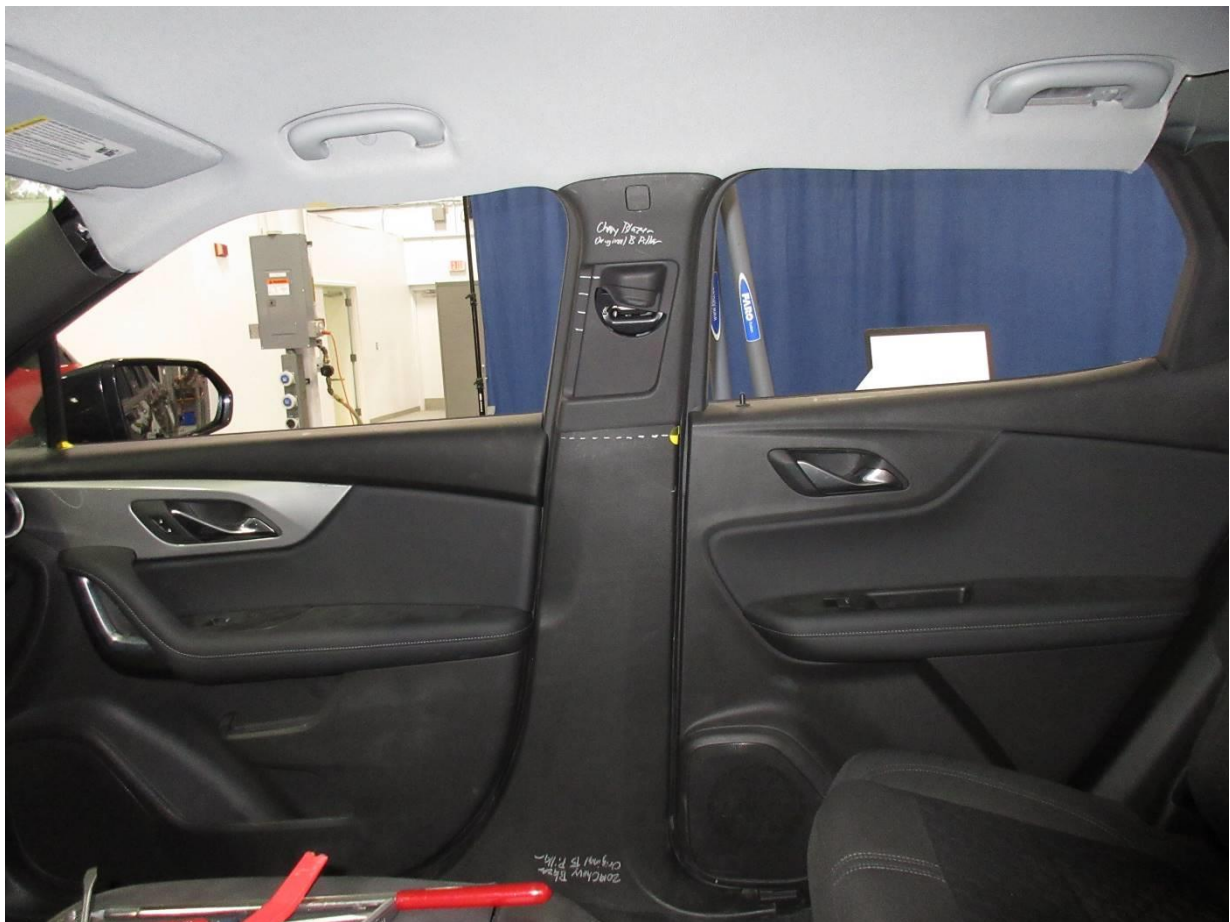
7. Determine the Plane 9 – Rear Edge (P9-R) impact location.
 - 7.1. Create a Plane 9 line that is at the Z-height of the lowest point of daylight opening forward of the B-pillar with the door closed (Figure D2).
 - 7.2. Mark the Plane 9 line on the B-pillar trim (Figure D2).
 - 7.3. Using the CMM, find the shortest distance from the CG-R point to the Plane 9 line on the B-pillar, and mark a crosshair at that location.
 - 7.4. Record the P9-R location from the crosshair. Place a target at the point and label it P9-R (Figure D3).

Figure D2. Determine P9-R impact location

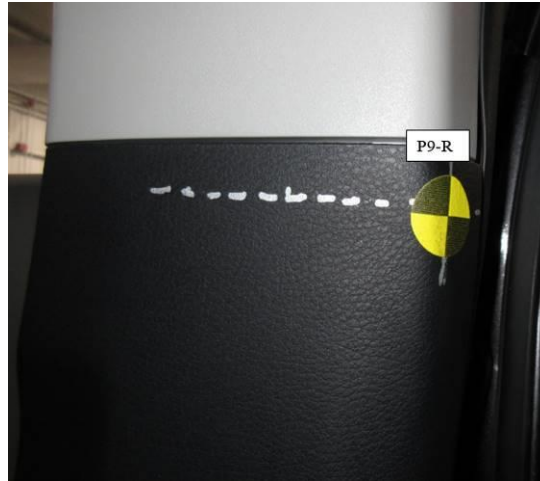
Figure D3. P9-R impact location on B-pillar trim

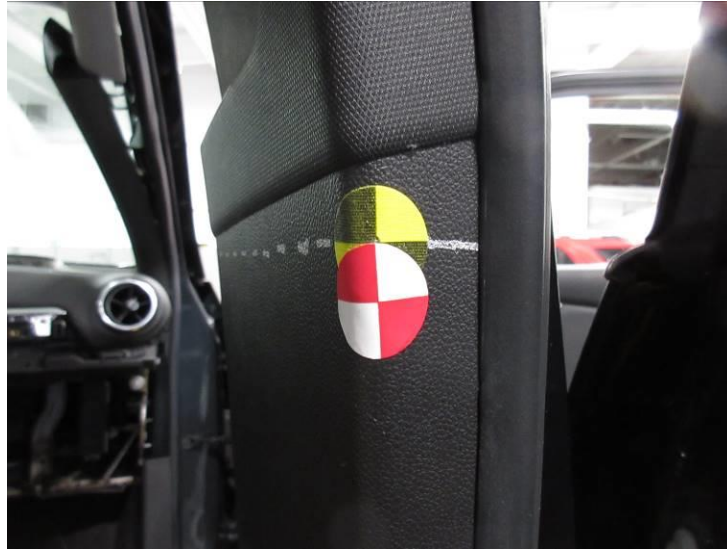
- 9.2.3. Continue to increase the radius in increments of 1 inch (25 mm) until the impact location can achieve first contact with the FMH forehead impact zone at the approach angles determined.

Figure D4. P9-R adjusted (red/white target) to avoid headform contact with an obstruction

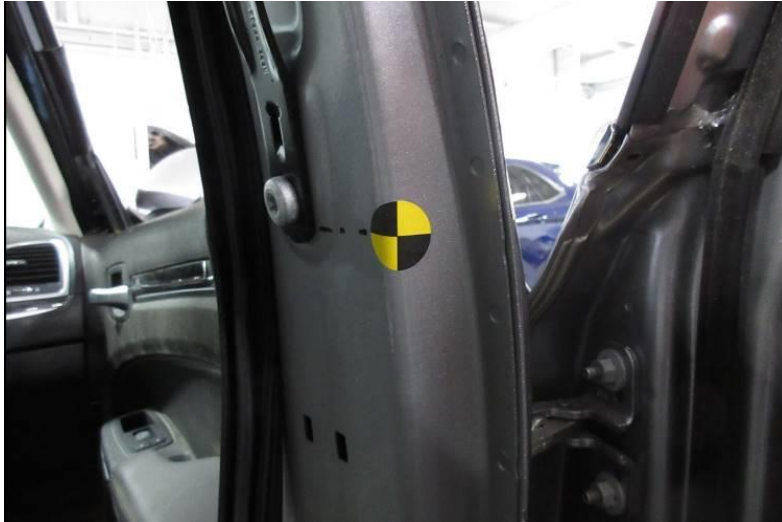
Figure D6. P9-R marked on B-pillar frame

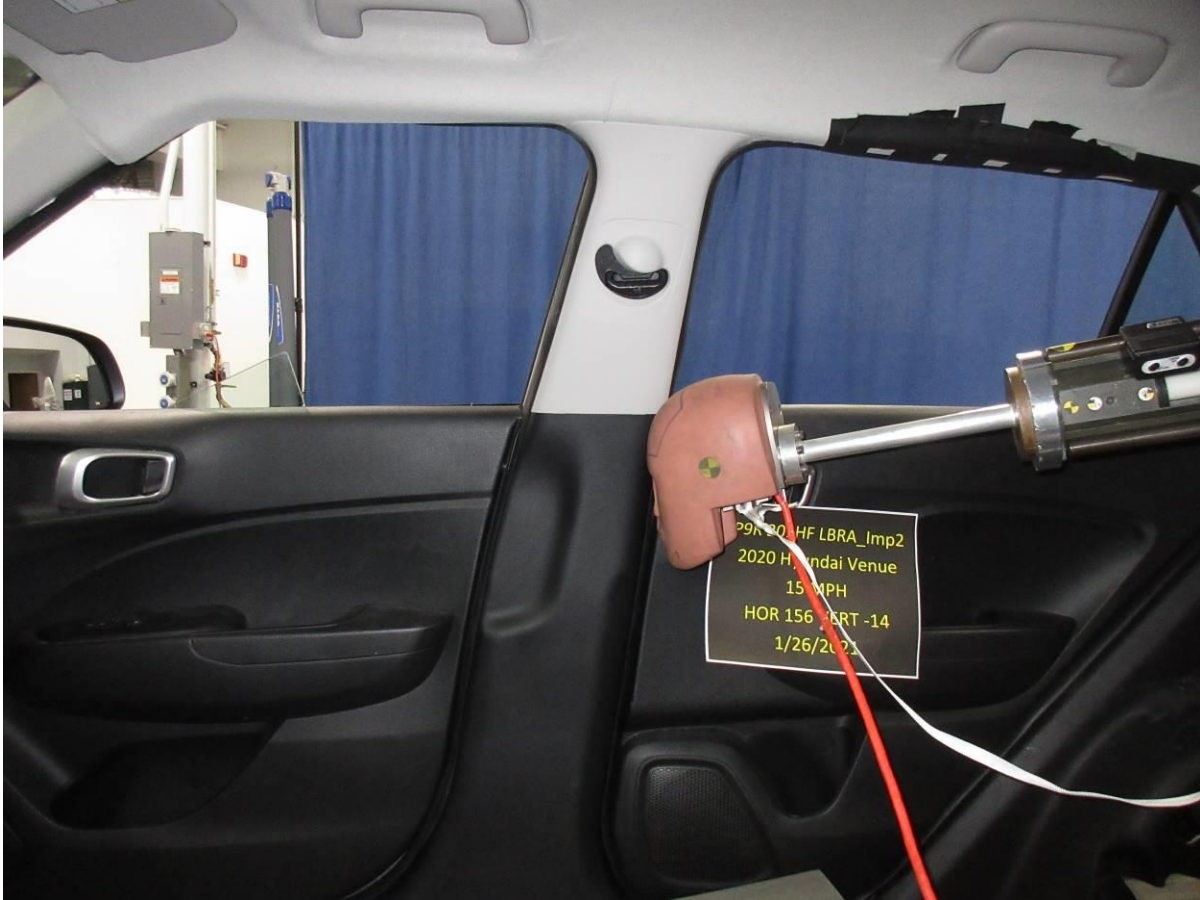
Figure D7. Position impactor to match the vertical and horizontal angles for impact

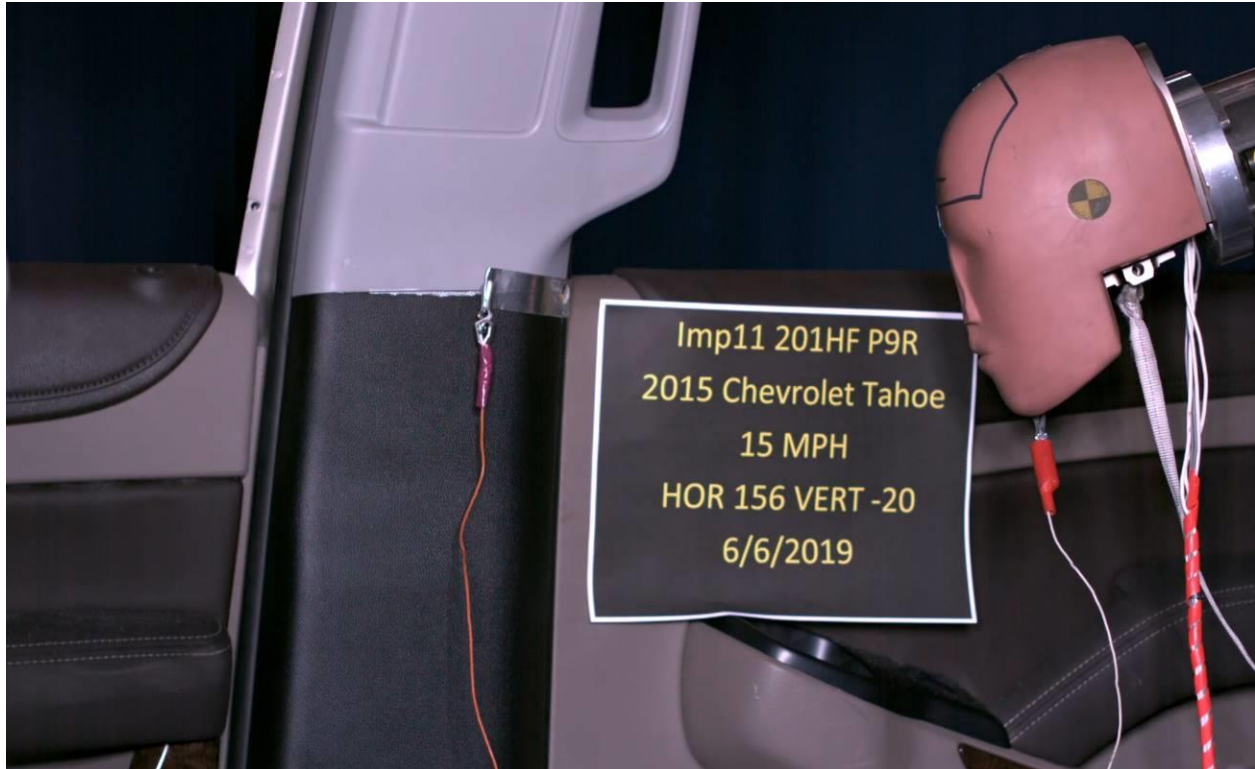
Figure D10. Camera view for lower B-pillar impact
