# Joint Sawing Practices And Effects on Durability

James A. Croveti, Ph.D.  
Marquette University

John T. Kevern, Ph.D., P.E., FACI, LEED AP  
University of Missouri – Kansas City

WisDOT ID no. 0092-16-01

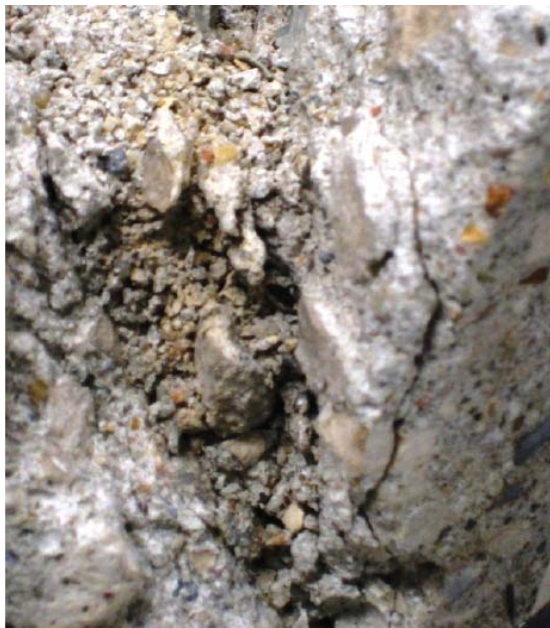
**Figure 1.2.1. Slivers from Freezing and Thawing Cycle (Taylor et al., 2012a)**

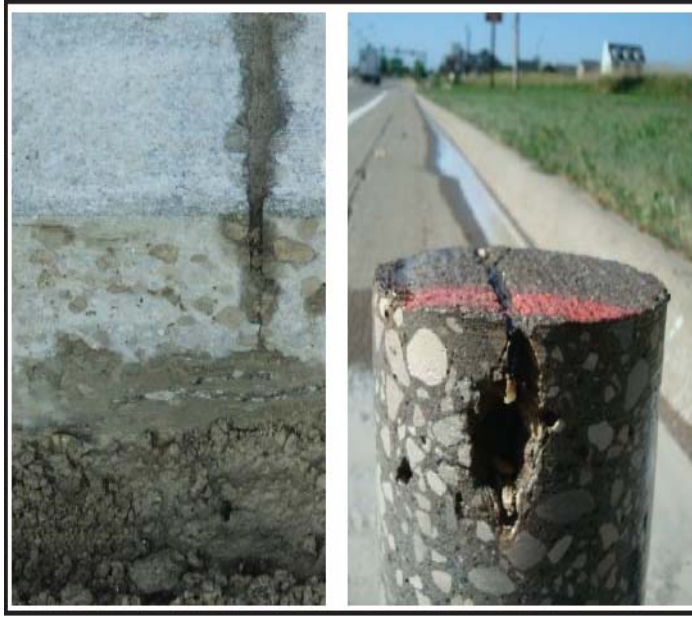
**Figure 1.2.2. Saturated Soils due to Inadequate Drainage and Roadside Irrigation (left) Leading to Joints Showing Frost Damage (right) (Source: Snyder and Associates)**

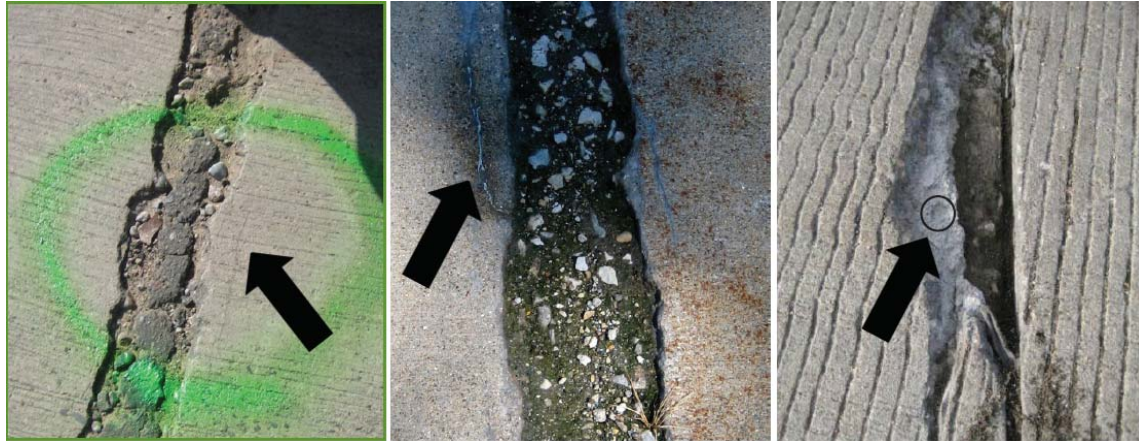
**Figure 1.2.3. Incremental Cracking:** Note (left to right) the crack parallel to the already patched face, the signs of water passing through the crack, and the exposed aggregate remaining in the concrete (Taylor et al., 2012a)

Parallel cracks that form at approximately one inch increments starting from the joint face, known as incremental cracking, is illustrated in Figure 1.2.3. This type of damage also occurs in the paste. This deterioration may be due to exposure of coarse aggregate particles in the interfacial

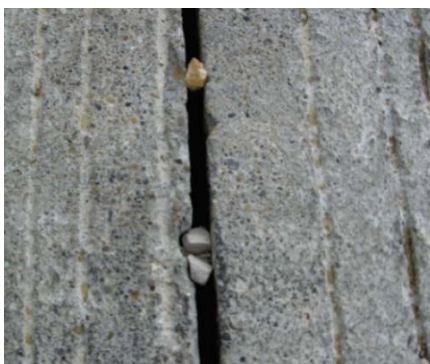
**Figure 1.2.4. Incompressible Materials Causing Mechanical Damage, which can Lead to Further Distress** (Taylor, et al. 2012b)

Incompressible materials like sand, rock and other debris develop localized stress while trapped in the joint and can give rise to mechanical damage, as shown in Figure 1.2.4. Aggregate particles can be dislodged during saw cutting due to the low concrete strength during conventional sawing. This type of spalling type damage is found on the surface and rarely extends through the depth of the slab. Damage during the saw cut may also occur due to worn out bearings or inappropriate blade selection (Taylor et al., 2012). This type of damage is not considered insignificant, as illustrated in Figure 1.2.5.

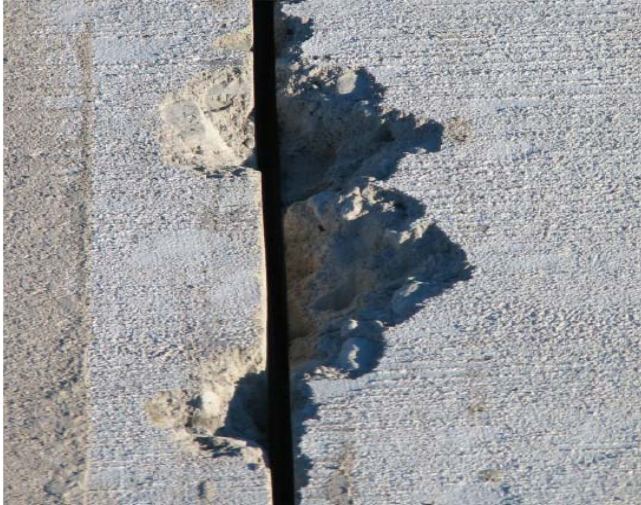
**Figure 1.2.5. Raveling due to Poor Sawing Practice (Source: Iowa Department of Transportation)**

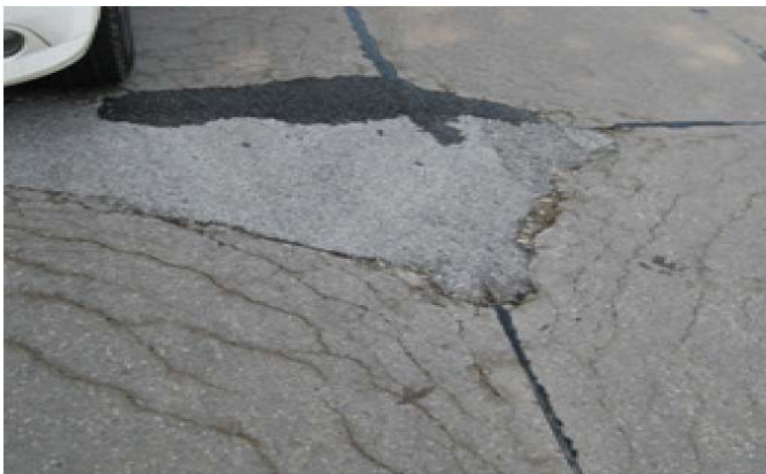
**Figure 1.2.6. D Cracking of High Severity (Source: The Transtec Group)**

Deterioration caused by expansion of frozen water inside some aggregate particles is known as D-cracking, as illustrated in Figure 1.2.6. This distress starts near joints and is typically more severe at the bottom of the slab. The preventive measures suggested by authors include use of aggregate materials that are not susceptible to freeze-thaw action. Furthermore, reducing maximum aggregate size can also prevent this type of deterioration.

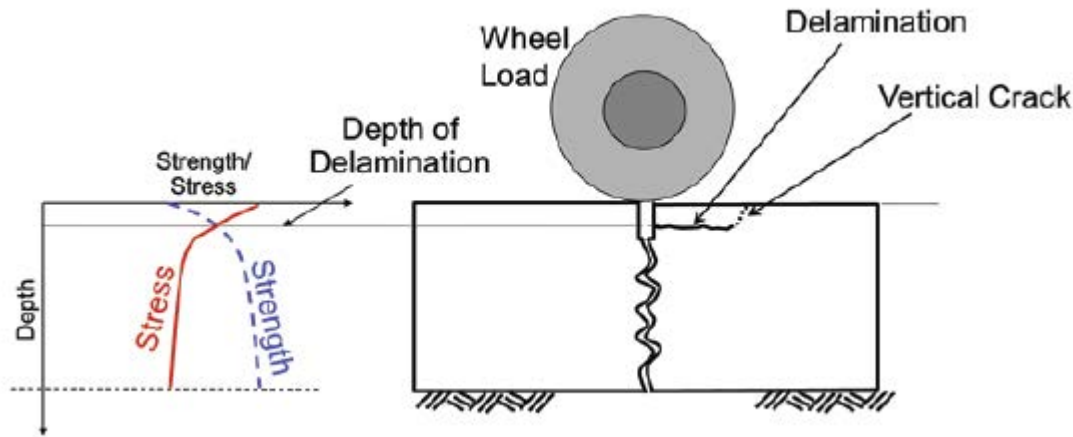
**Figure 1.2.7. Early-Age Drying Stresses (left) and Resulting Vertical Cracking and Delamination Spalling (right) due to High Moisture Loss During Placement (Spragg et al., 2011)**

Differences in moisture content through the depth of the concrete slab may give rise to high stresses, resulting in horizontal cracking as illustrated in Figure 1.2.7. In regions where horizontal

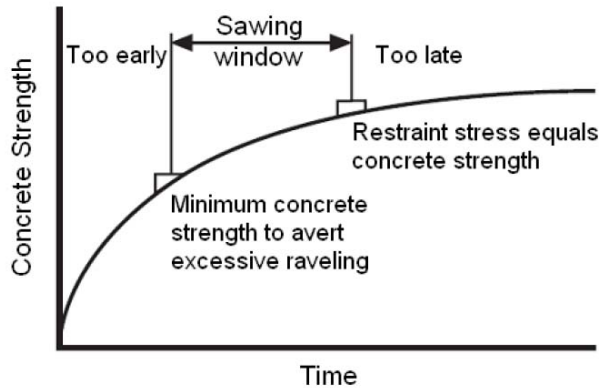
**Figure 1.3.1. Concrete Sawing Window in Terms of Strength vs Time (Okamoto et al., 1994)**

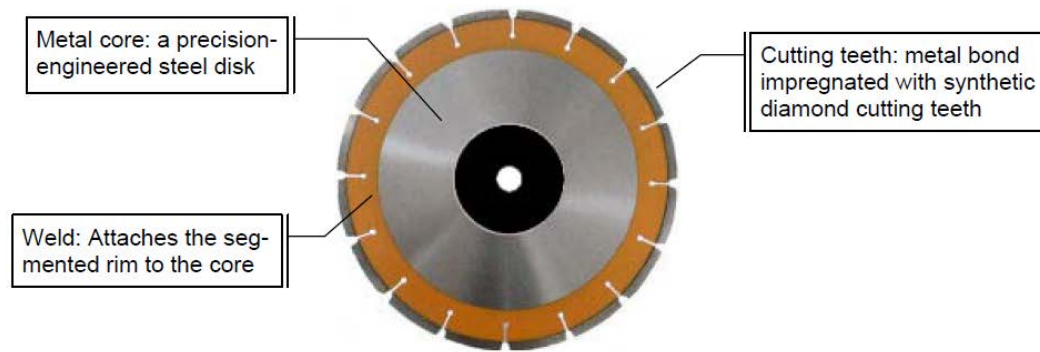
**Figure 1.4.1. Concrete Cutting Saw Blade Diagram (Krstulovich et al., 2011)**

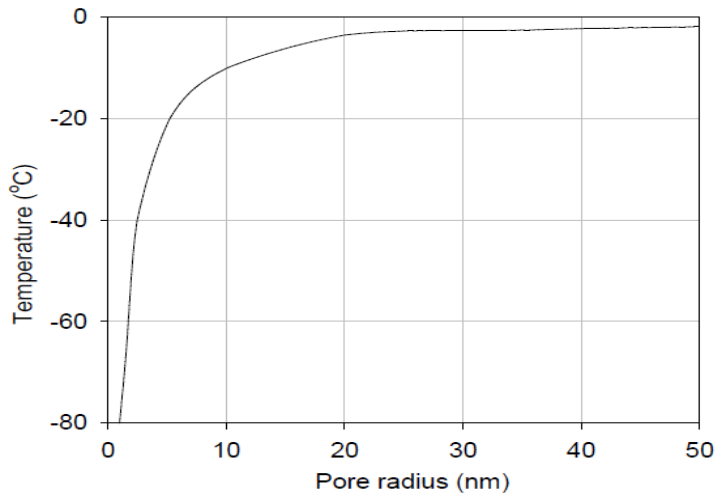
**Figure 1.7.1. Relationship Between Capillary Pore Size and the Freeze Temperature (Zhang, 2013)**

tends to exert pressure on pore walls and a tensile stress is developed. Under normal pressure, freezing temperatures in concrete pores decreases with the pore size, as illustrated in Figure 1.7.1.

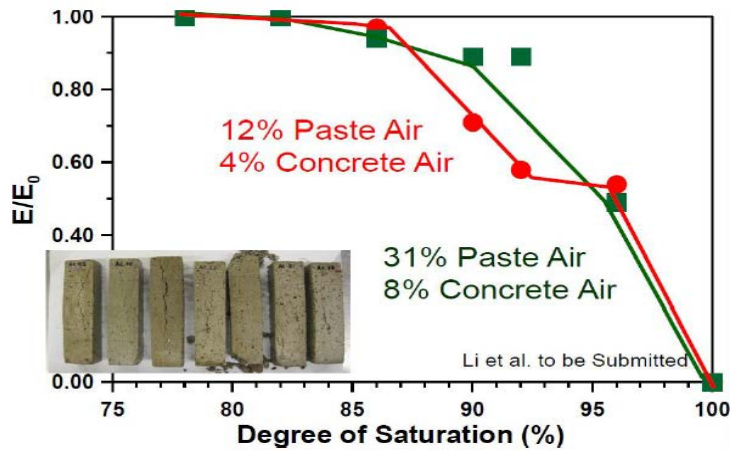
Figure 1.7.2. Relationship Between Degree of Saturation and Freeze-Thaw Durability (Li, et.al, 2012)

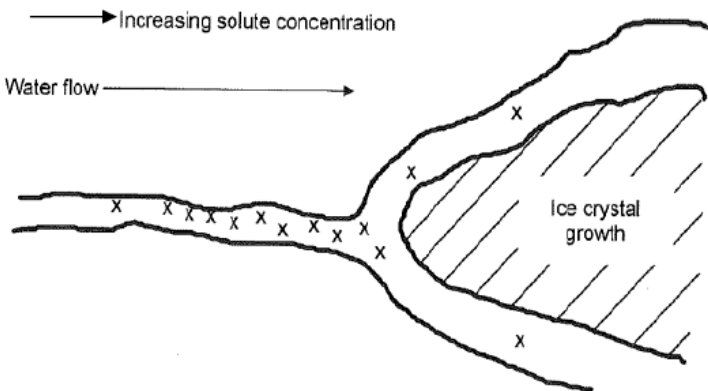
Figure 1.7.3. Conceptual Illustration of the Generation of Osmotic Pressure in Concrete Pores (Zhang, 2013)

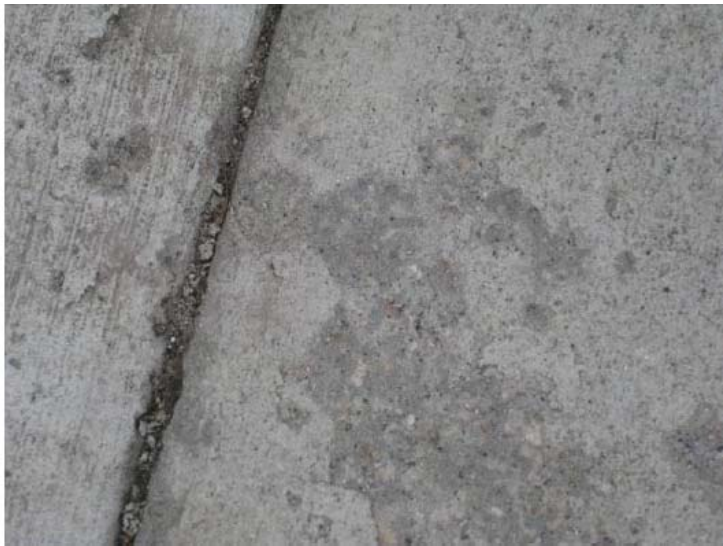
**Figure 1.8.1. Salt Scaled Concrete Surface (Zhang, 2013)**

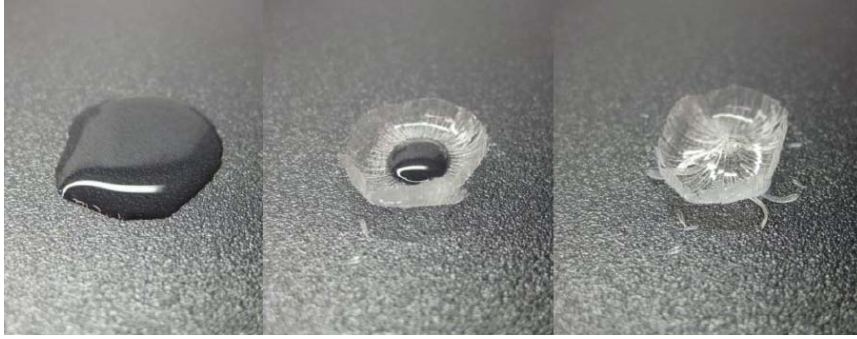
**Figure 1.8.2. Salt Crystallization due to Evaporation of Liquid (Zhang, 2013)**

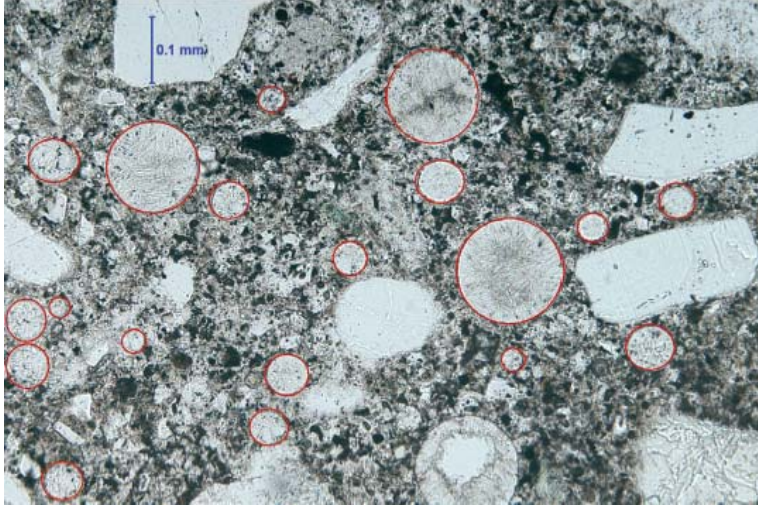
**Figure 1.10.1. Secondary Ettringite Deposits in Air Voids (American Engineering Testing, Inc.)**

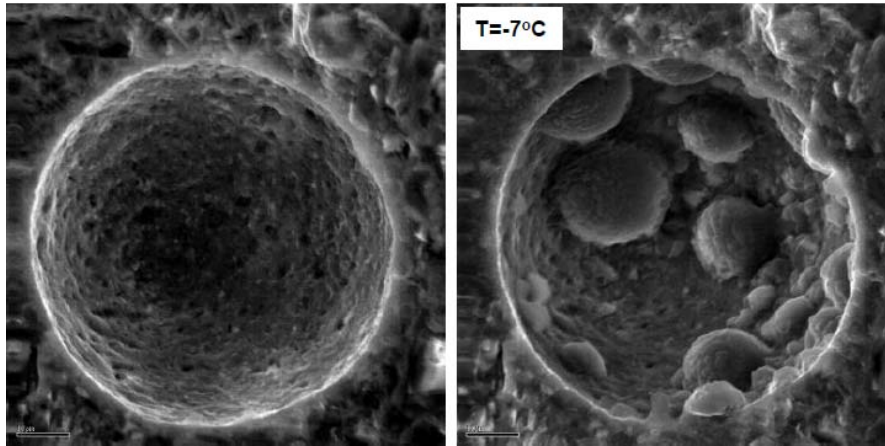
**Figure 1.10.2. SEM Image of Air Void Before and After Freezing Occurs in Concrete (Zhang, 2013)**

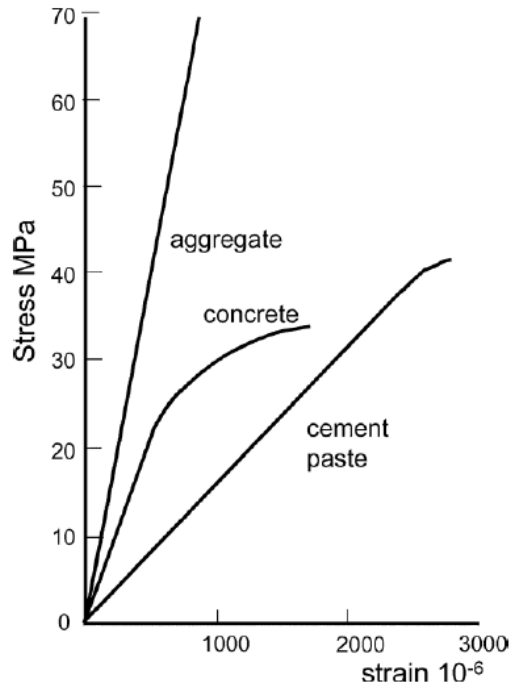
**Figure 1.11.1. Comparative Stress Strain Curves for Aggregate, Paste and Concrete (Zhang, 2013)**

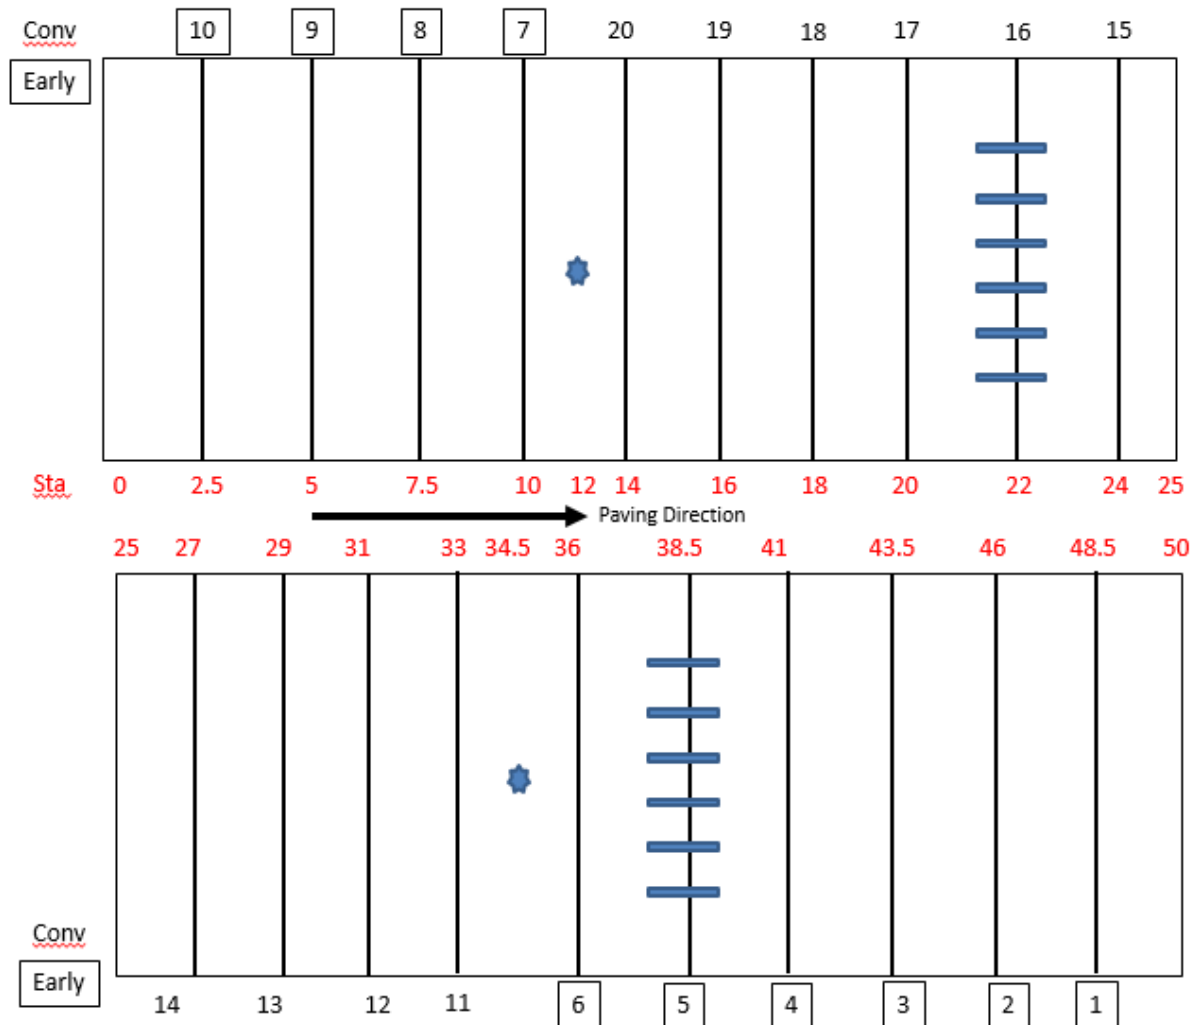
**Figure 2.4.1. Layout Sketch of Saw Cut Joints Within Each Mixture Type**  
(Note: Conv = Conventional Wet Saw Cut)

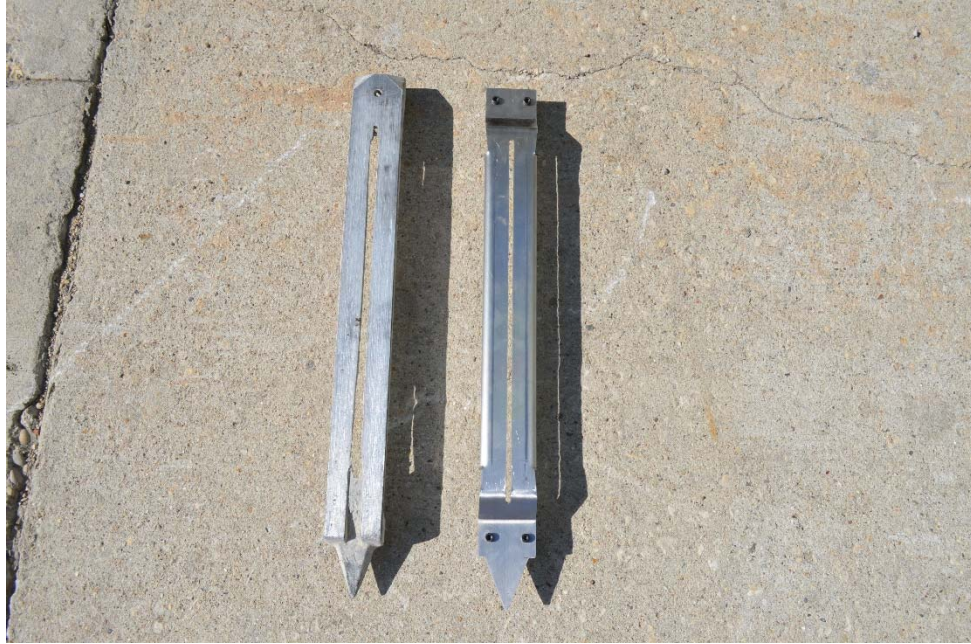
**Figure 2.5.15. Old (Left) and New (Right) Plates Used During Early Entry Sawing**

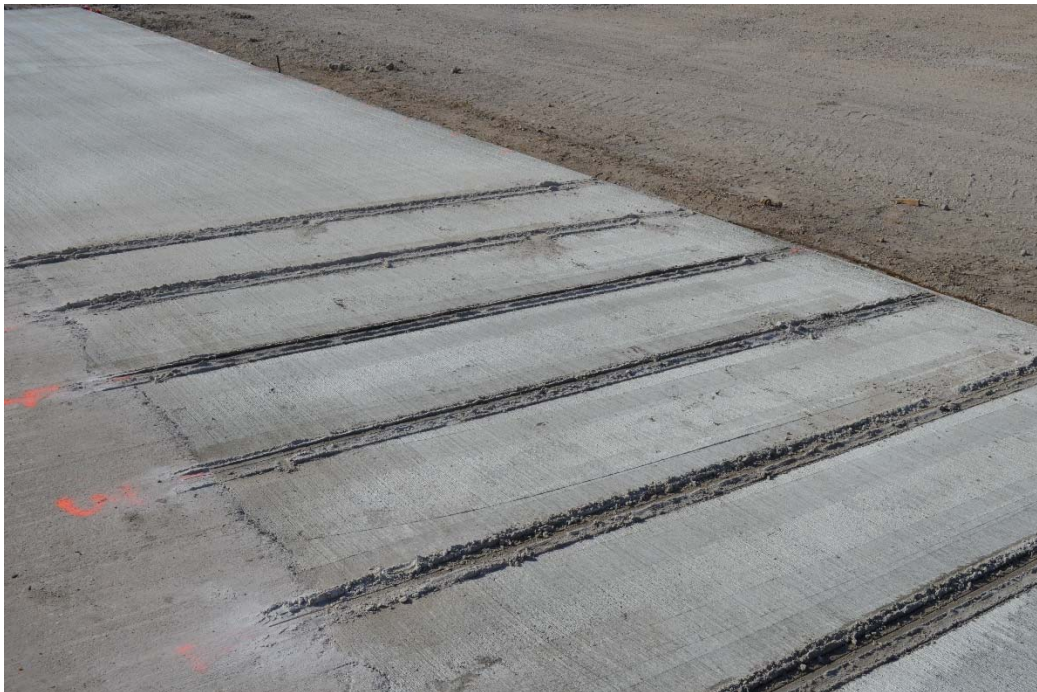
**Figure 2.5.16. First Six Early Entry Saw Cuts in Limestone Mixture**

All early entry saw cuts were produced with a Husqvarna SOFF-CUT 5000 portable saw operated by trained Husqvarna field staff. New saw blades optimized for soft and hard aggregates were used as appropriate for each transverse cut (Tables 2.5.1 & 2.5.2). For the “New” blade conditions (Tables 2.5.1 & 2.5.2), a new shoe was used on the portable saw, which provides optimal restraint for the concrete surface during the upcut operations. For the “Old” blade conditions (Tables 2.5.1 & 2.5.2), a worn shoe with an elongated saw blade portal was used, which provides poor restraint for the concrete surface during the upcut operations. This simulation of “old” blade conditions was deemed by Husqvarna field staff as being more representative of less than optimal contractor quality control during routine saw cutting operations. Figure 2.5.15 provides a side-by-side comparison of the shoes used during early entry saw cutting operations. Figure 2.5.16 provides a representative photo of the first six early entry saw cuts in the Limestone mixture.

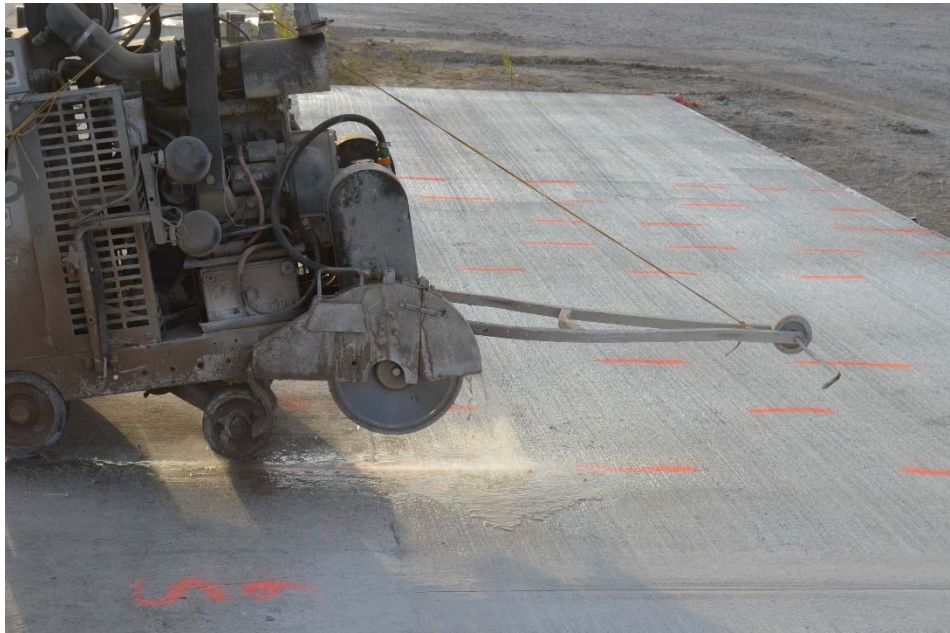
**Figure 2.5.17. Initial Conventional Saw Cut in Limestone Mixture (Joint 11)**

All conventional saw cuts were produced with a conventional portable saw operated by Zignego field staff. Figure 2.5.17 provides a photo of this equipment in preparation for the initial saw cut in the Limestone mixture (Joint 11). New saw blades optimized for soft and hard aggregates were used as appropriate for each transverse cut (Tables 2.5.1 & 2.5.2). For the “Old” blade conditions (Tables 2.5.1 & 2.5.2), the same severely worn saw blade was used for both the Limestone and Gravel mixtures, thus eliminating two transverse saw cut locations in each mixture (Tables 2.5.1 & 2.5.2).

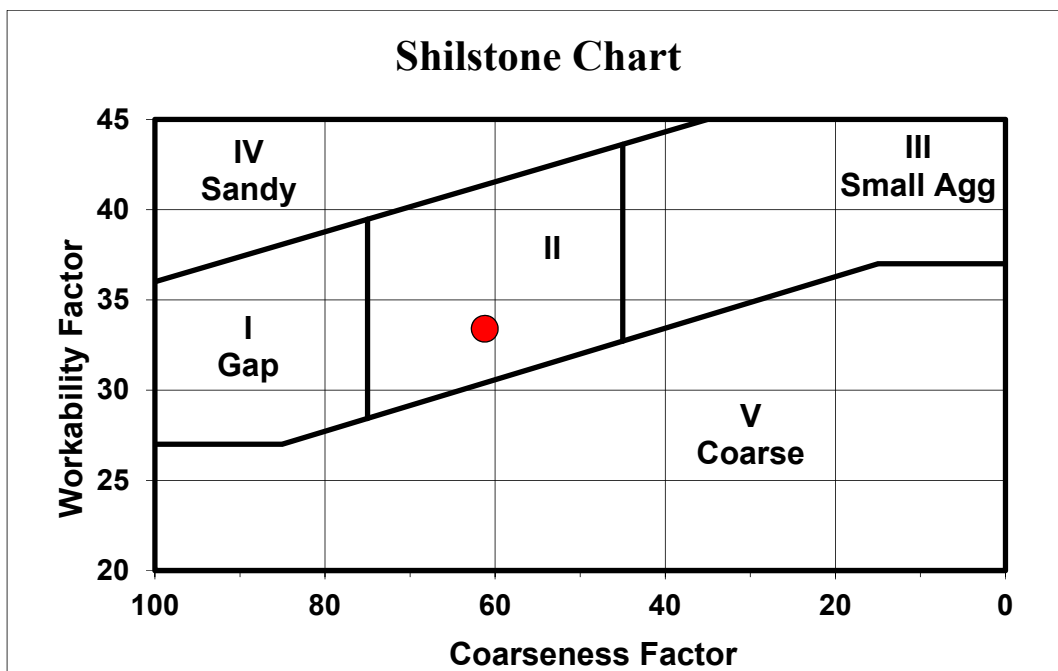
Figure 2.8.3. Coarseness Factor Analysis – CTH KC EB On-Ramp Mixture

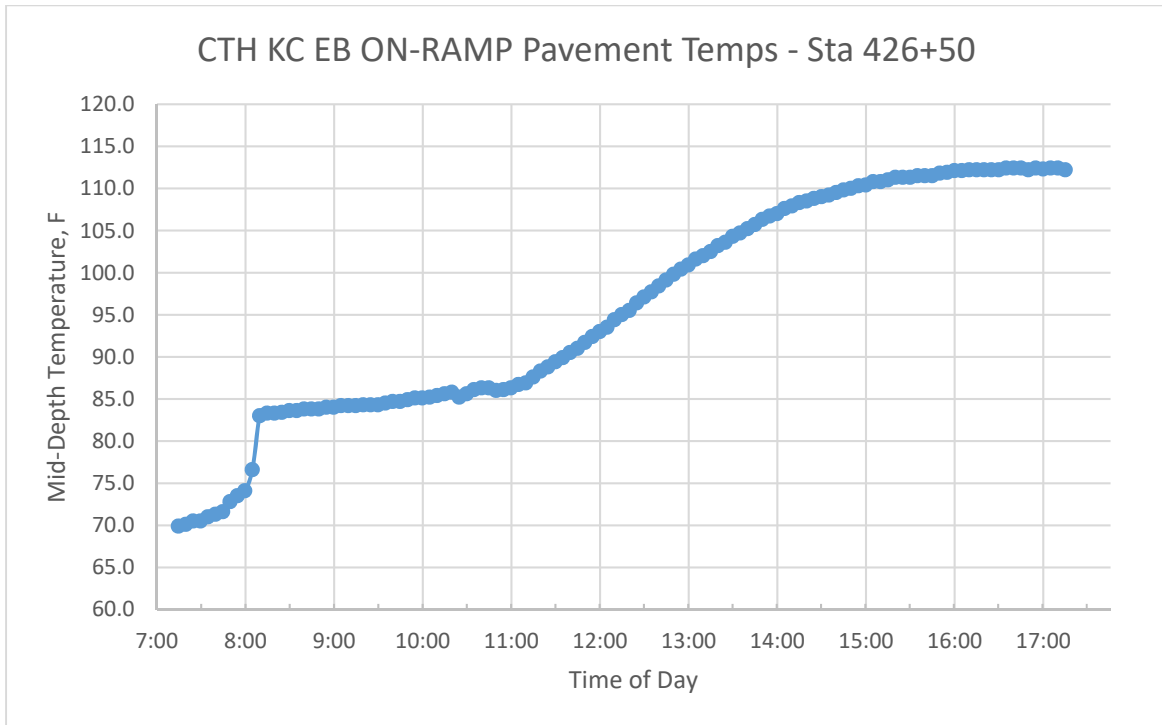
**Figure 2.10.9. Mid-Temp Temperature Probe Readings After Paving**

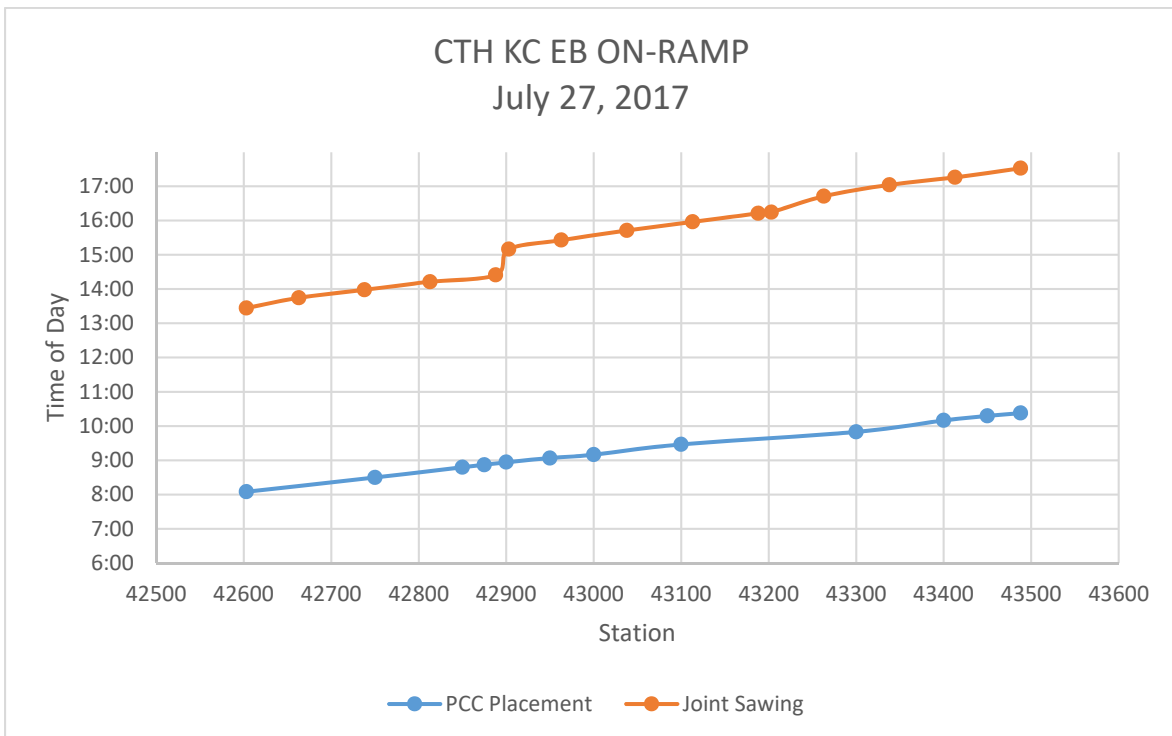
**Figure 2.10.10. PCC Placement and Saw Cut Timing**

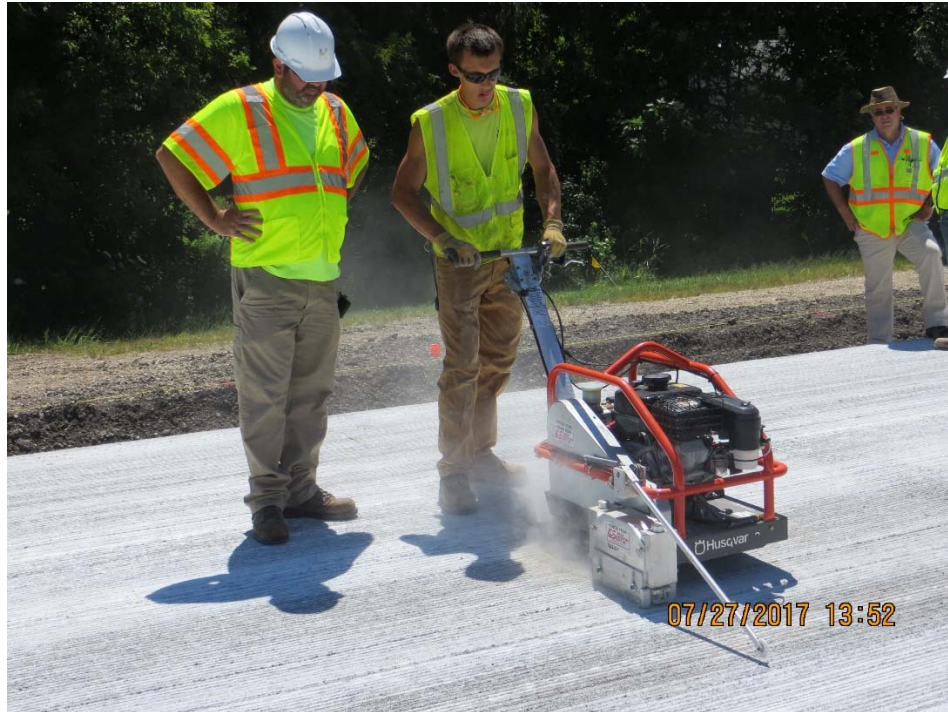
**Figure 2.10.12. Husqvarna SOFF-CUT Model 2000 Early Entry Sawing Operations**

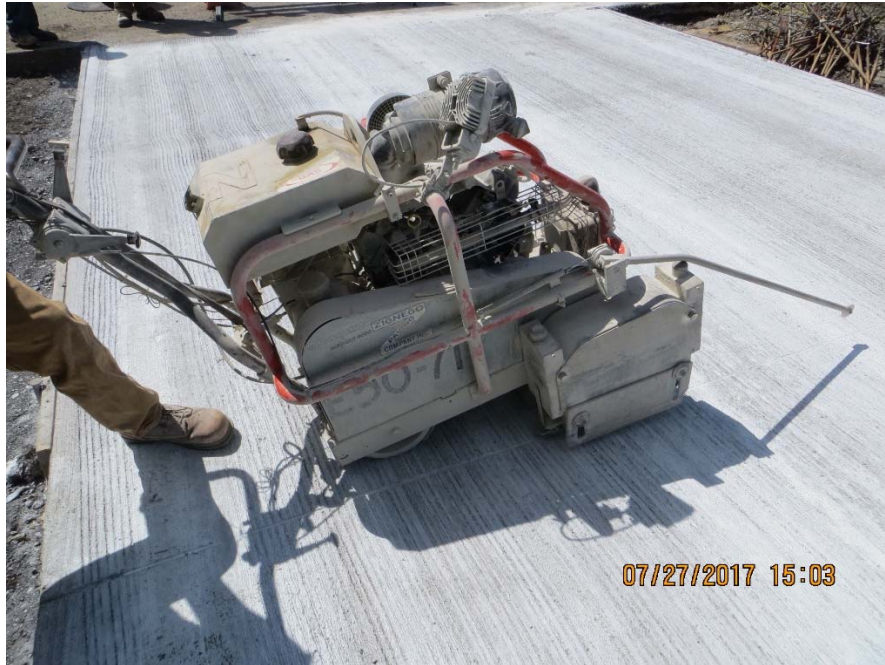
**Figure 2.10.13. Husqvarna SOFF-CUT Model 4000 Early Entry Saw**

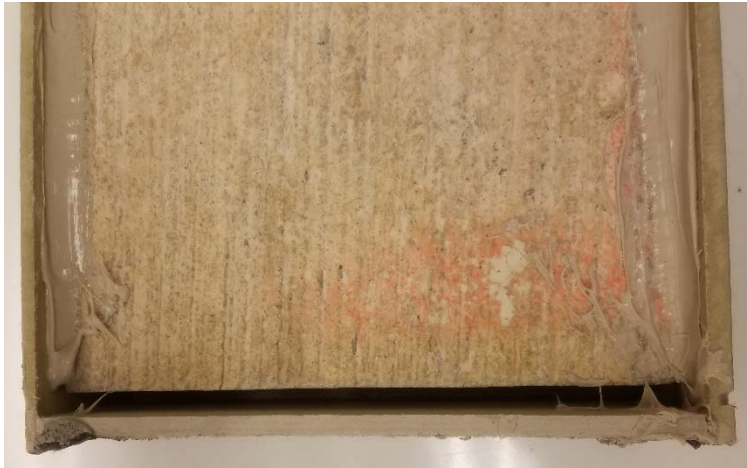
**Figure 3.5.1. Deicer Scaling Sample Showing the Gap Along the Joint to Provide Deicing Solution Access**

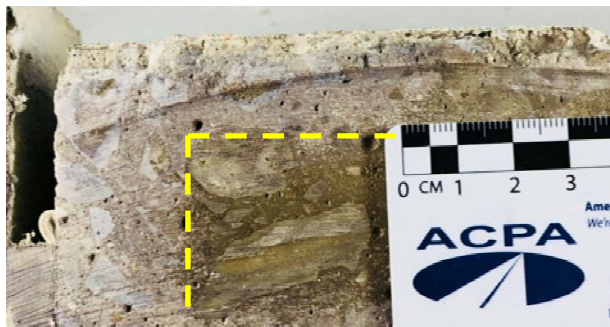
**Figure 3.5.3. Silver Chloride Indication**

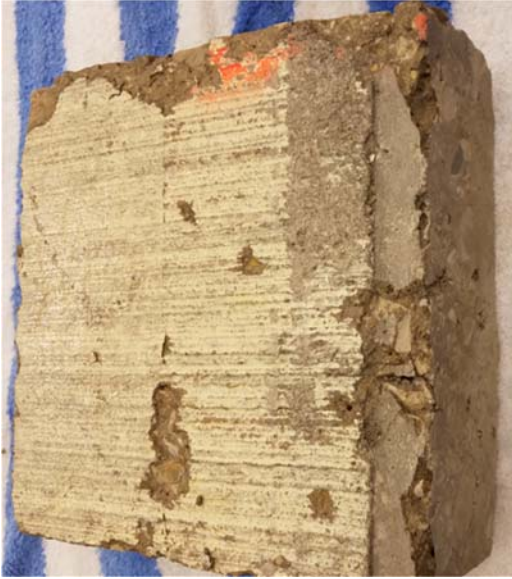
**Figure 4.2.11. Joint Damage Observed for the Early Sawn Limestone Samples**

- Sawing early in the timing window using early entry equipment can cause physical damage to the aggregate and concrete. For limestone aggregate the damage occurred directly underneath the sawing shoe, while for granite aggregate a crack formed immediately outside the shoe.

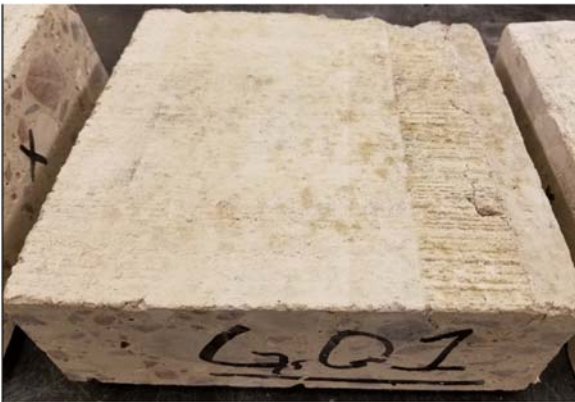
**Figure 4.2.12. Joint Damage Observed for the Early Sawn Granite Samples**

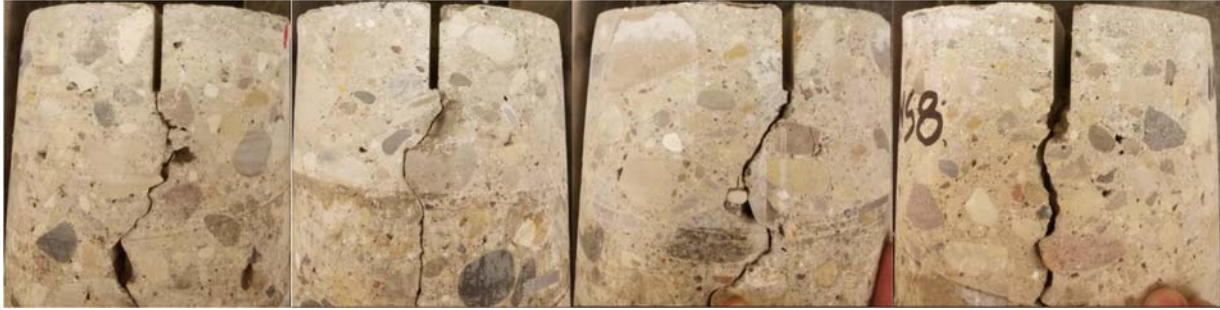
**Figure 4.2.13. Core Samples Sawn to a Depth of 1.5 in.**

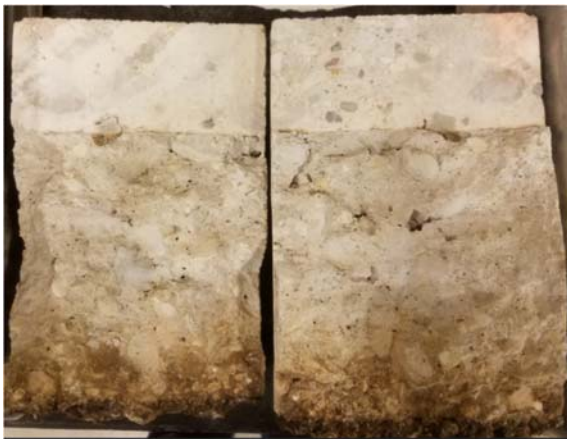
**Figure 4.2.16. Core Samples Sawn to a Depth of 2.0 in. (D/4)**

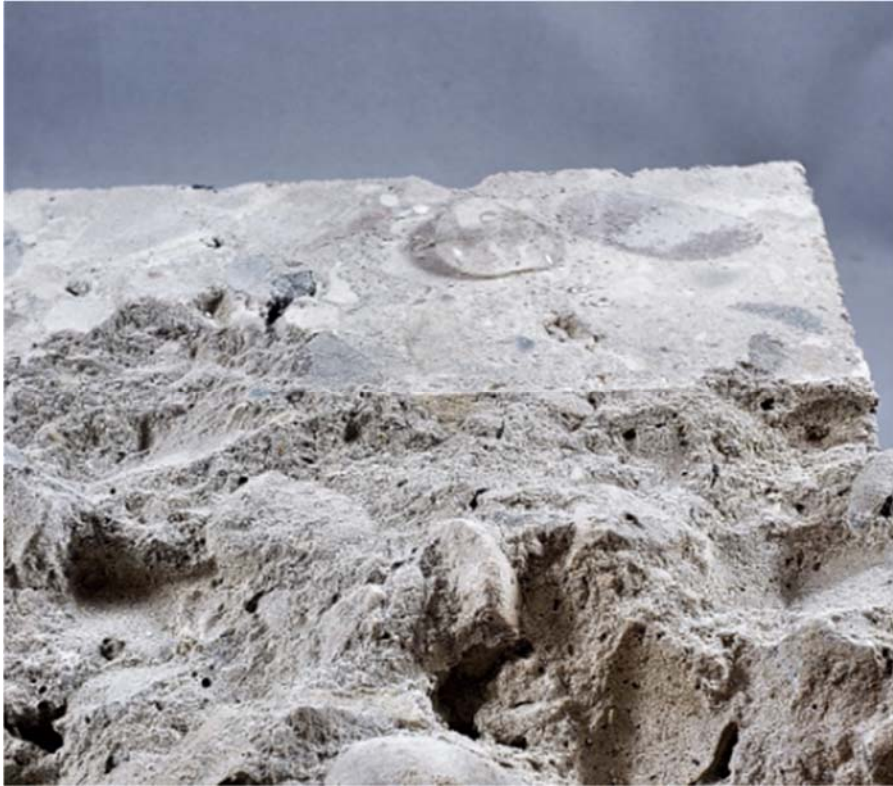
**Figure 4.2.17. Sealed Core Sample Showing Hydrophobic Nature Before Testing**

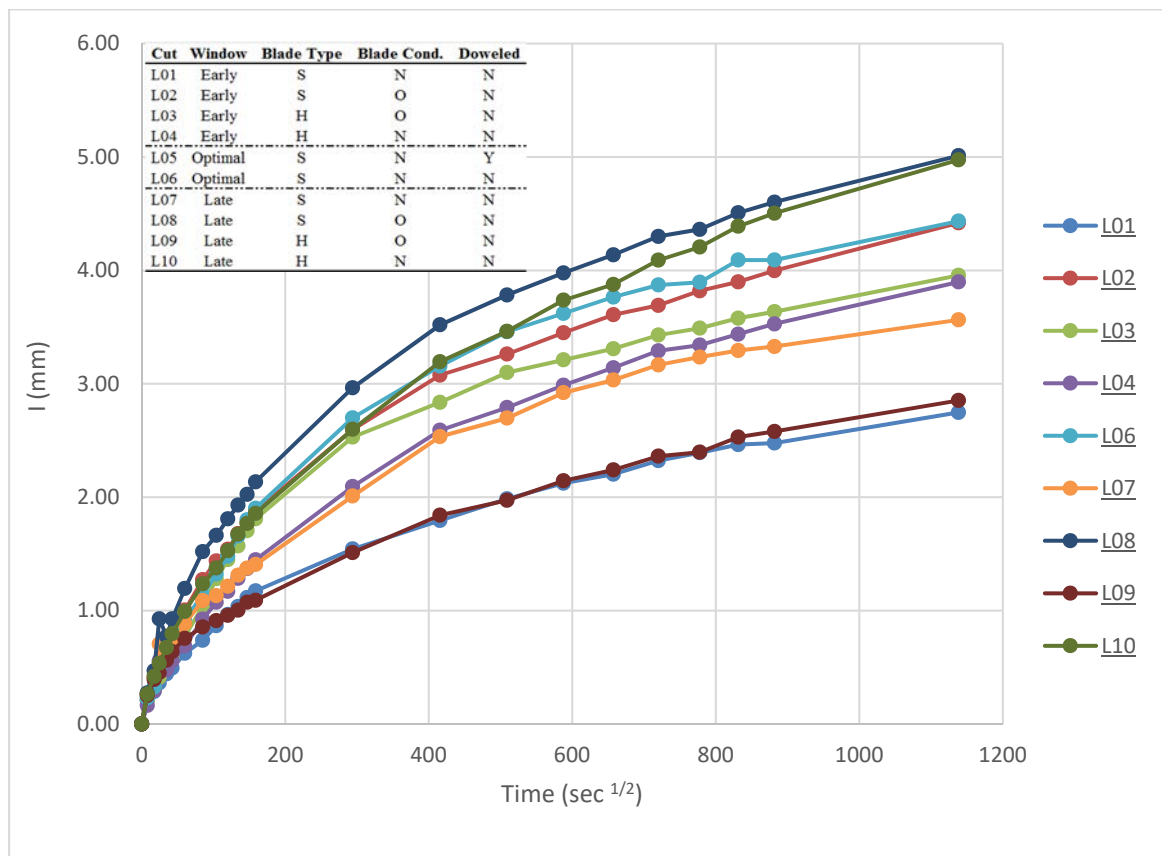
**Figure 4.3.4. Comparison of Results for Soft-Cut Sawing of the Limestone Aggregate Mixture**

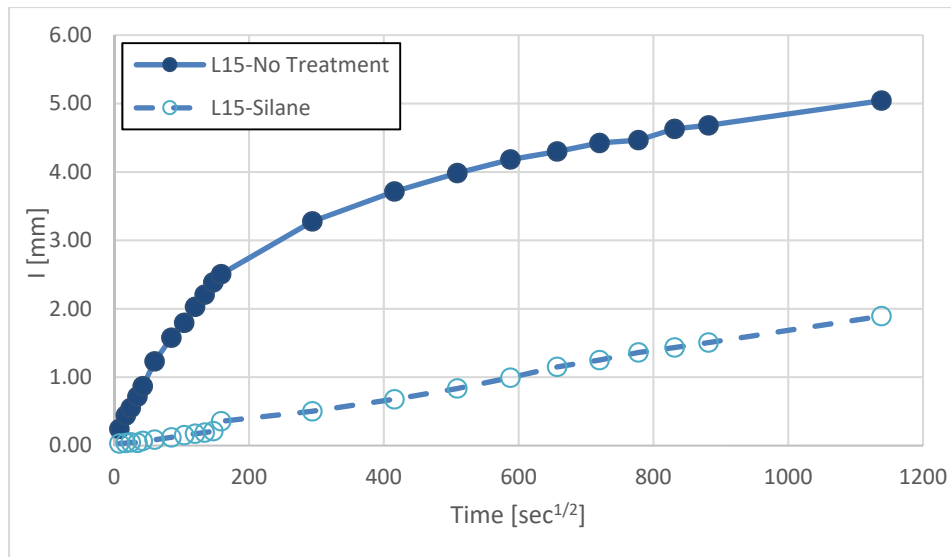
**Figure 4.3.9. Absorption Results for L15 – Conventional Saw, Optimal Sawing Window, New Limestone Blade - Before and After Coating with Silane**

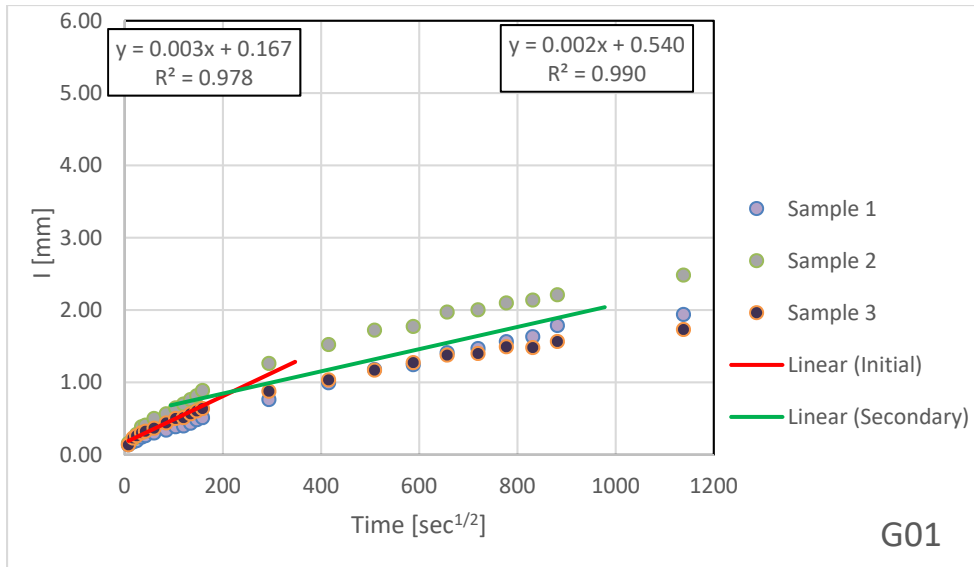
**Figure 4.3.10. Absorption Results for G01 – Soft-Cut Saw, Early Timing Window, New Granite Blade**

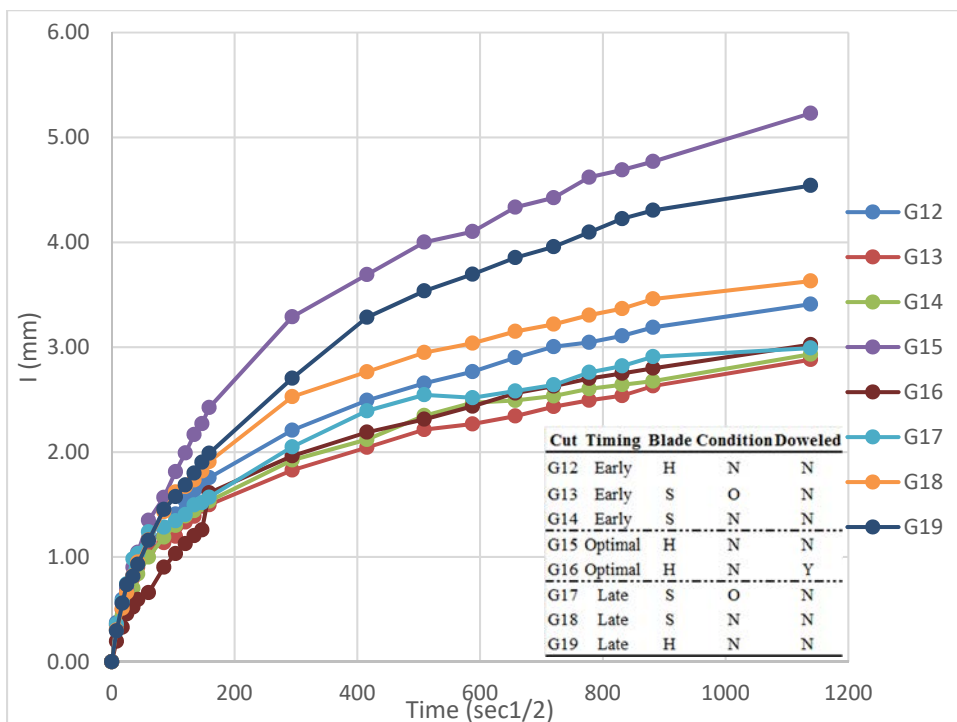
**Figure 4.3.14. Absorption Results for Conventional Sawing of the Granite Aggregate Mixture**

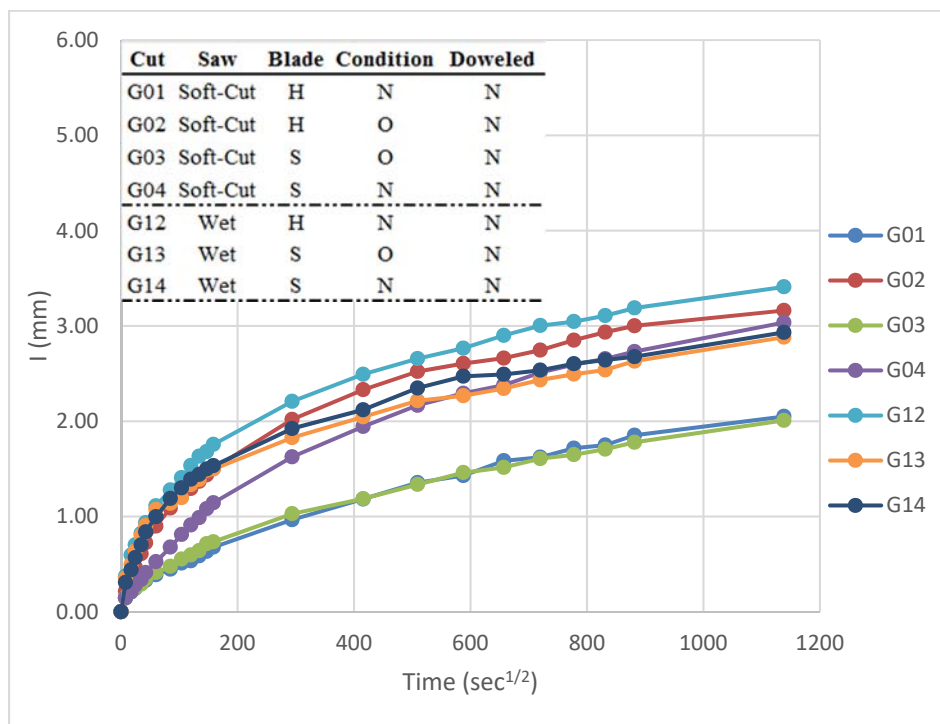
**Figure 4.3.15. Absorption Results for Early Sawing Window for the Granite Aggregate Mixture**

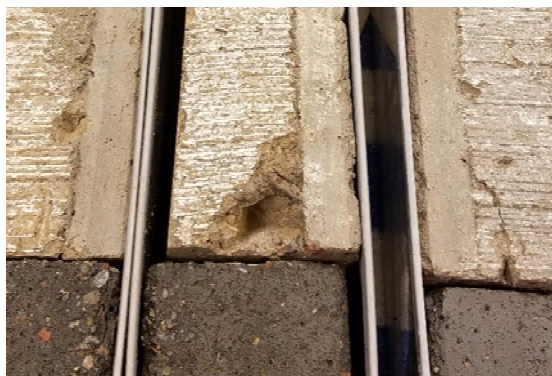
**Figure 4.4.1. Aggregate Pop-Out**

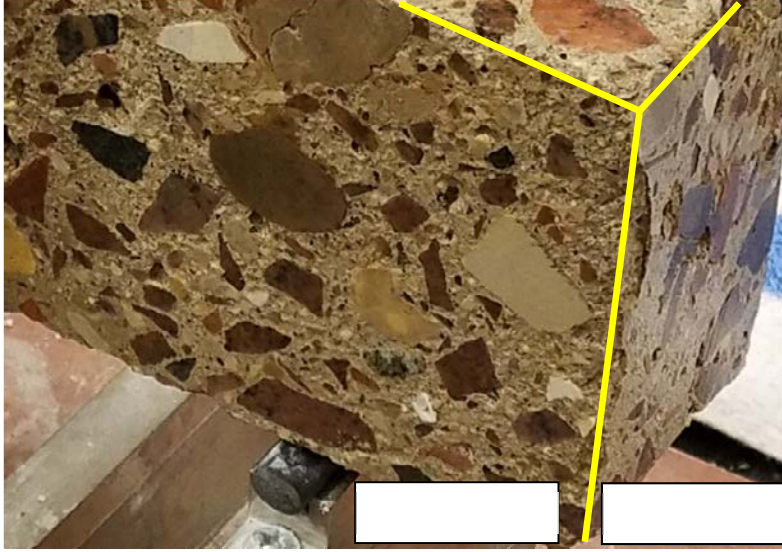
**Figure 4.4.2. Paste Deterioration and Erosion**

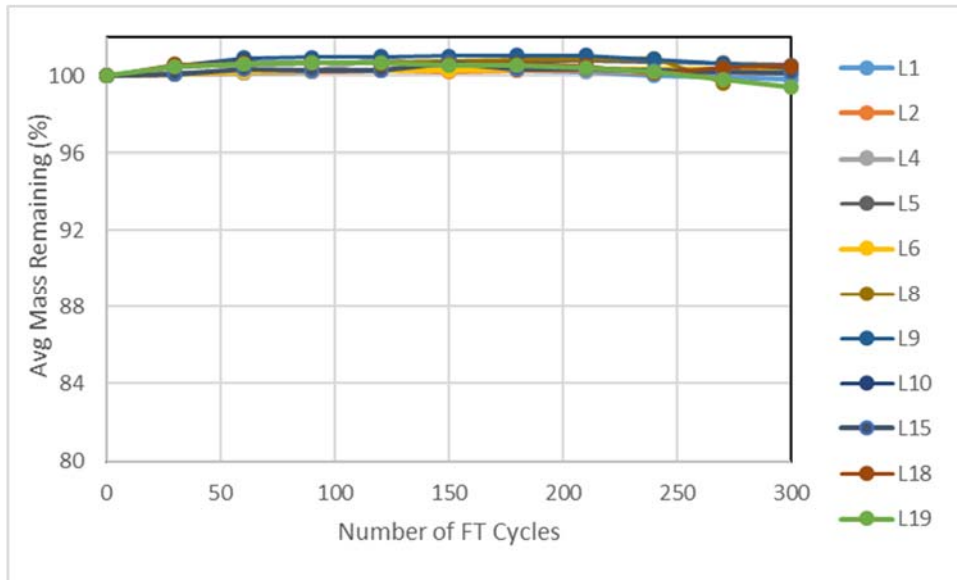
**Figure 4.4.3. Limestone Freeze-Thaw Results Reported for Mass through 300 cycles**

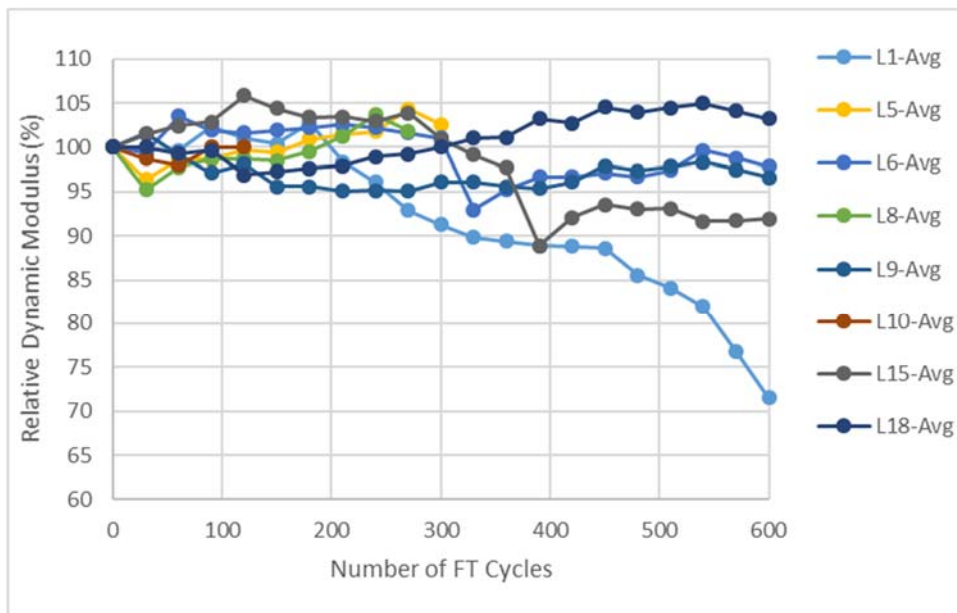
**Figure 4.4.6. Limestone Freeze-Thaw Results Reported for Relative Dynamic Modulus through 600 cycles**

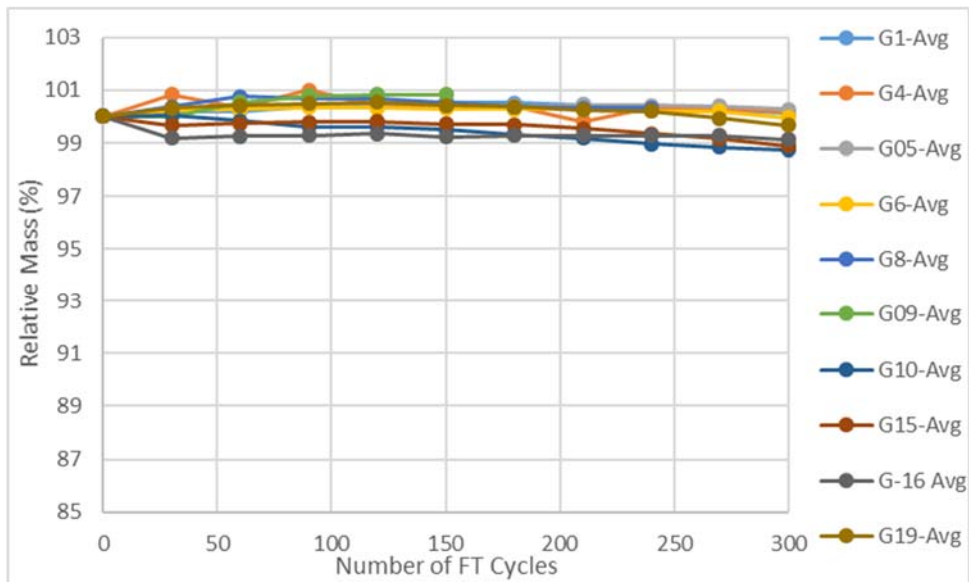
**Figure 4.4.7. Granite Freeze-Thaw Results Reported for Mass through 300 cycles**
