# Joint Sawing Practices And Effects on Durability

James A. Croveti, Ph.D.  
Marquette University

John T. Kevern, Ph.D., P.E., FACI, LEED AP  
University of Missouri – Kansas City

WisDOT ID no. 0092-16-01

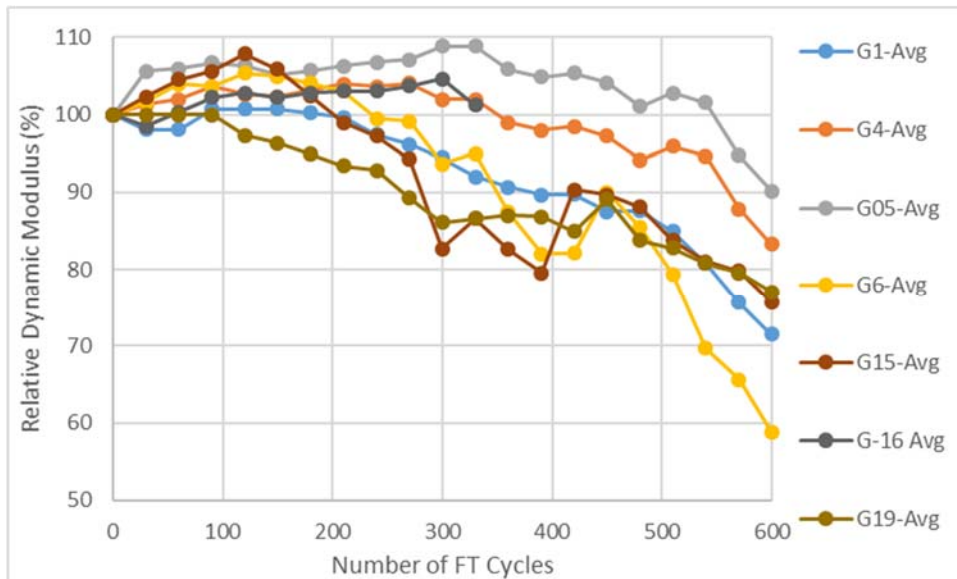
**Figure 4.4.10. Granite Freeze-Thaw Results Reported for Relative Dynamic Modulus Through 600 Cycles**

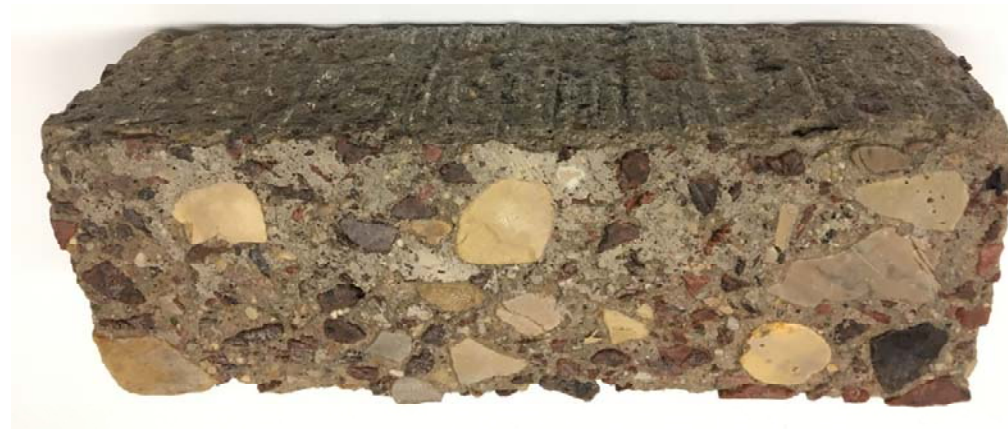
**Figure 4.4.11. Granite Mixture G06 after 600 Freeze-Thaw Cycles**

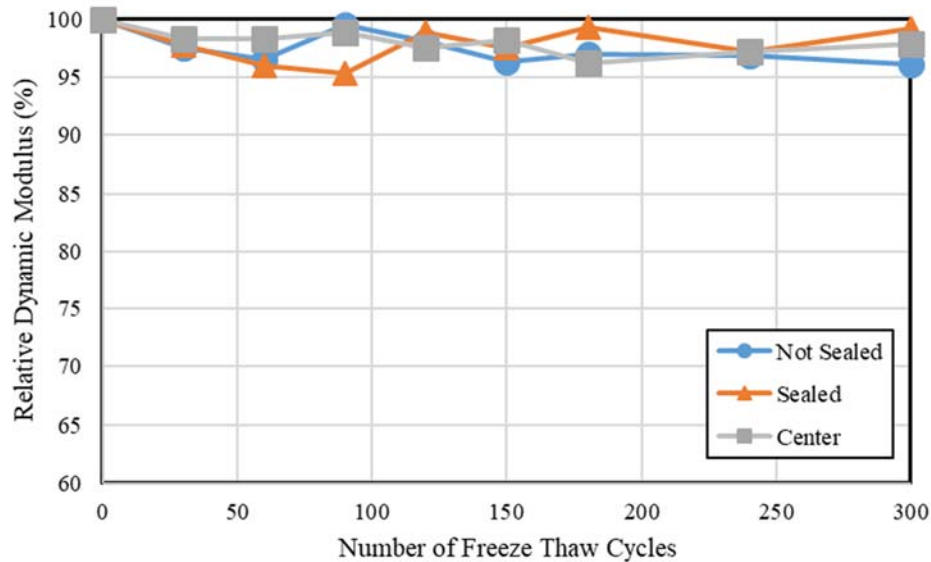
**Figure 4.7.1. Freeze-Thaw Results Grouped by Treatment**

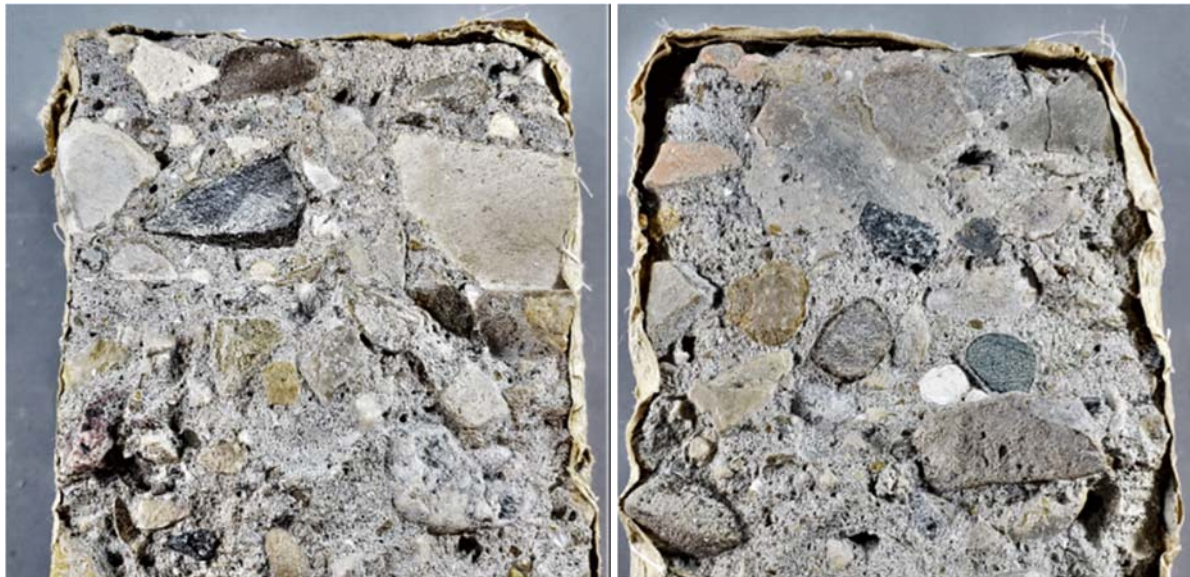
**Figure 4.7.3. Samples with 1.5 in. Sawn Face Unsealed (left) and Sealed (right)**

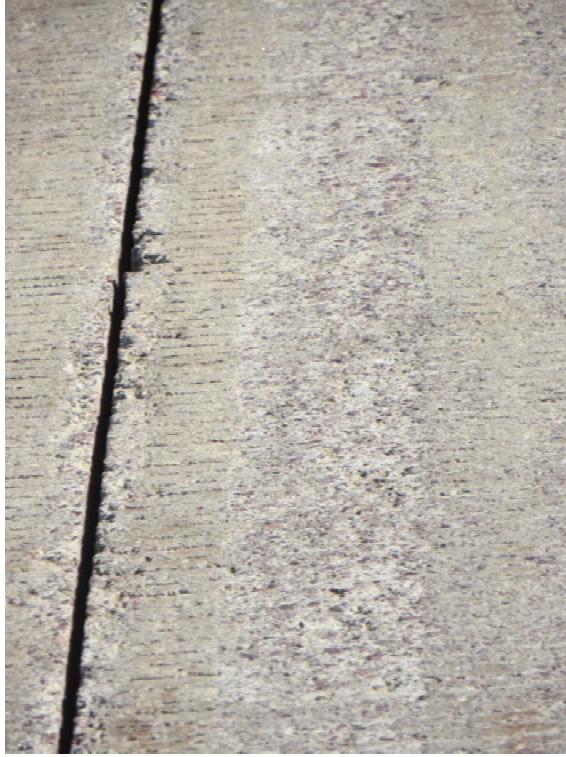
**Figure 5.2.1. Joint Condition Along EB USH 12, November 2015**

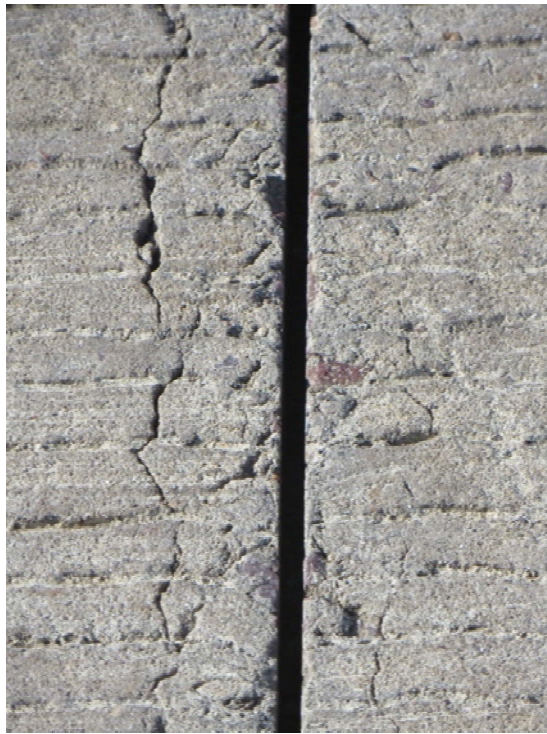
**Figure 5.2.2. Joint Condition Along WB USH 12 On-Ramp, November 2015**

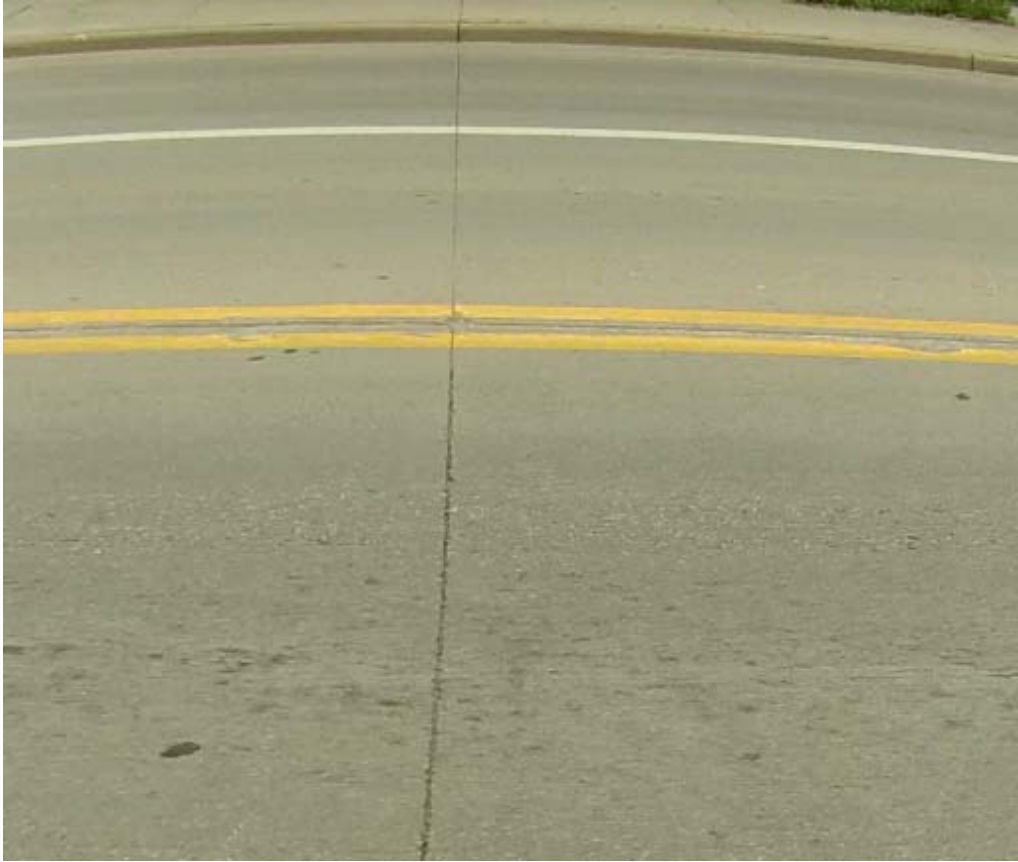
**Figure 5.3.1. Typical Joint Condition Along Birch Street, May 2015**

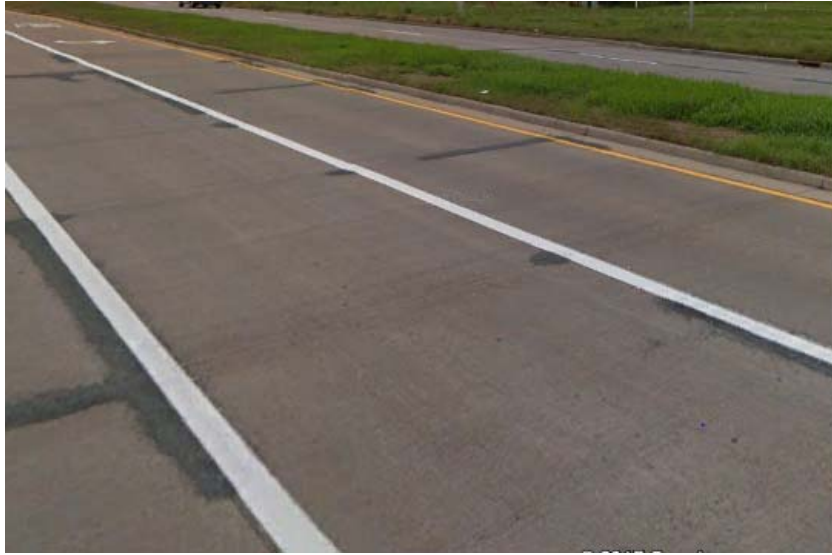
**Figure 5.4.1. Deteriorated Joint Condition Along CTH OO-P2, Just East of STH 124, November 2015**

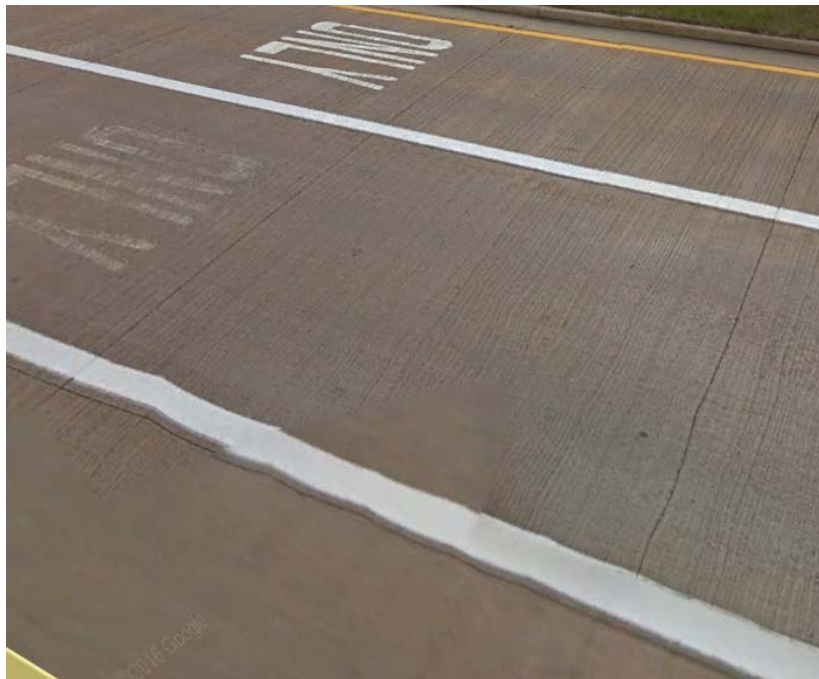
**Figure 5.4.1. Well Performing Joint Conditions Along CTH OO-P1, East of STH 124, November 2015**

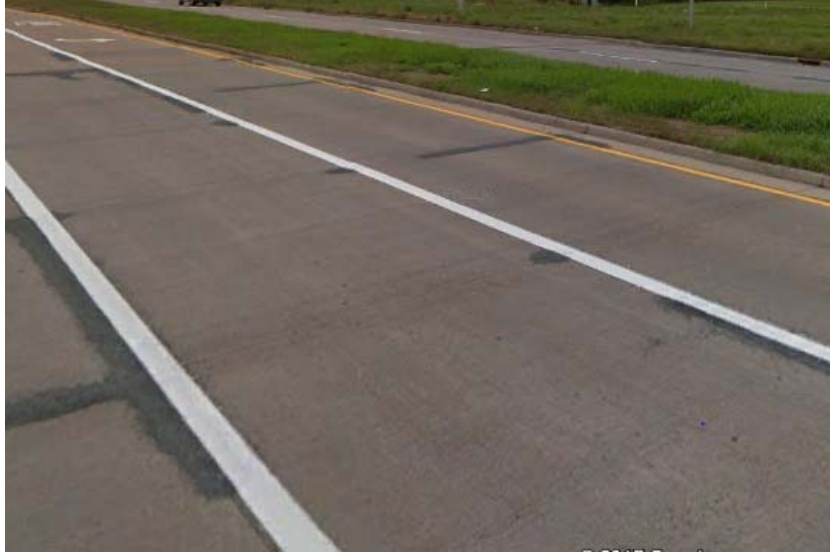
**Figure 5.5.1. Typical Joint Conditions Along WB IH 94, Just West of USH 53, May 2015**

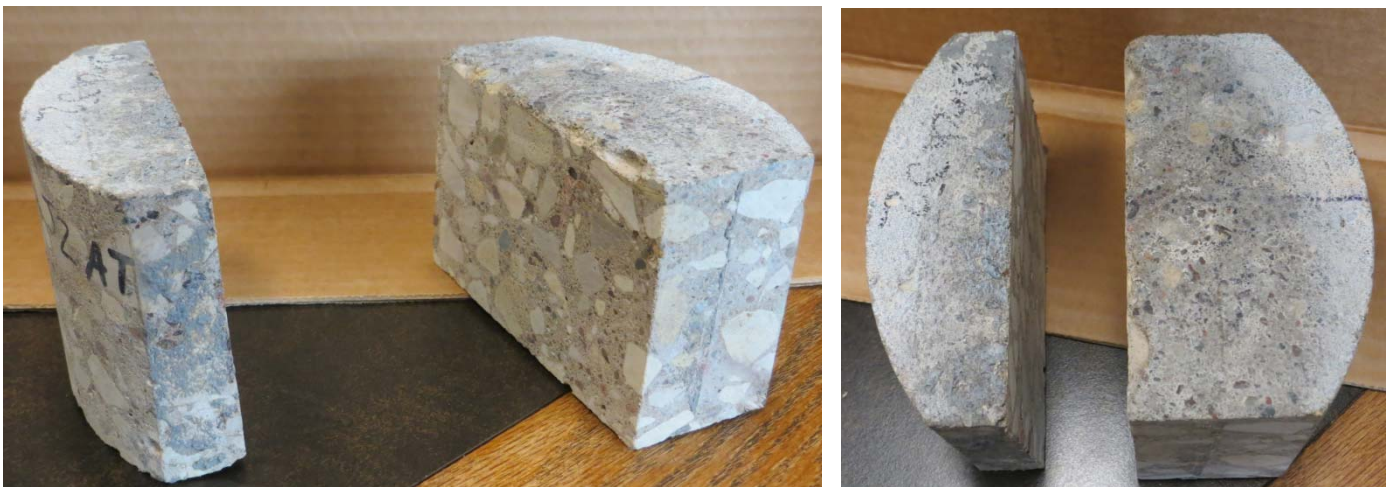
**Figure 5.7.2. Typical Transverse Joint Core Specimens After Trimming (Birch J2A-J2B)**

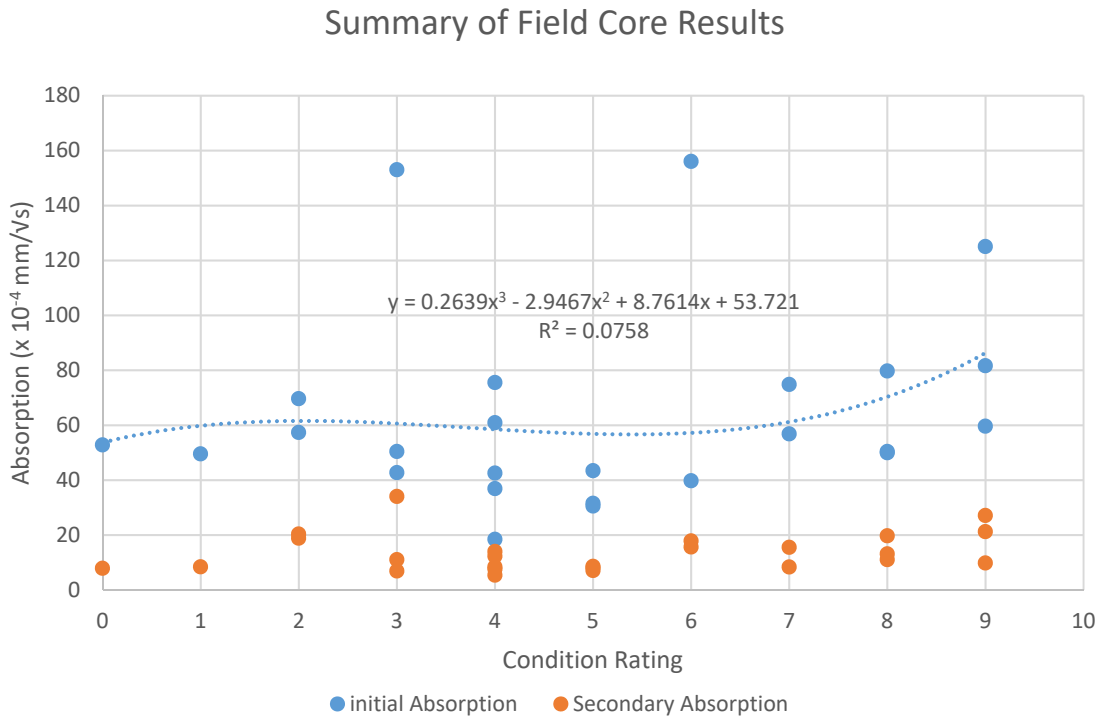
**Figure 5.7.3. Absorption Rates versus Visual Joint Condition Ratings**

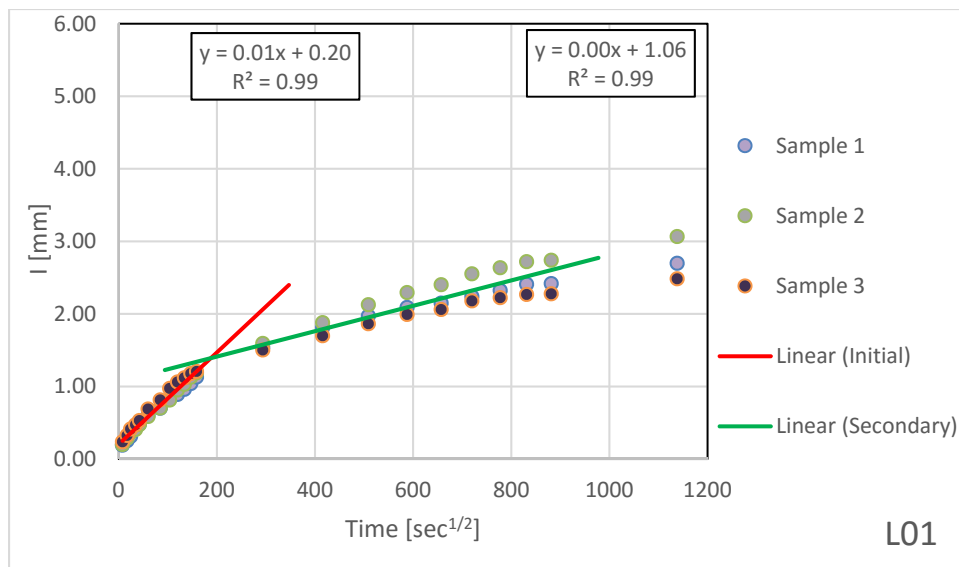
**Figure B.1.1 – Absorption Results for L01**

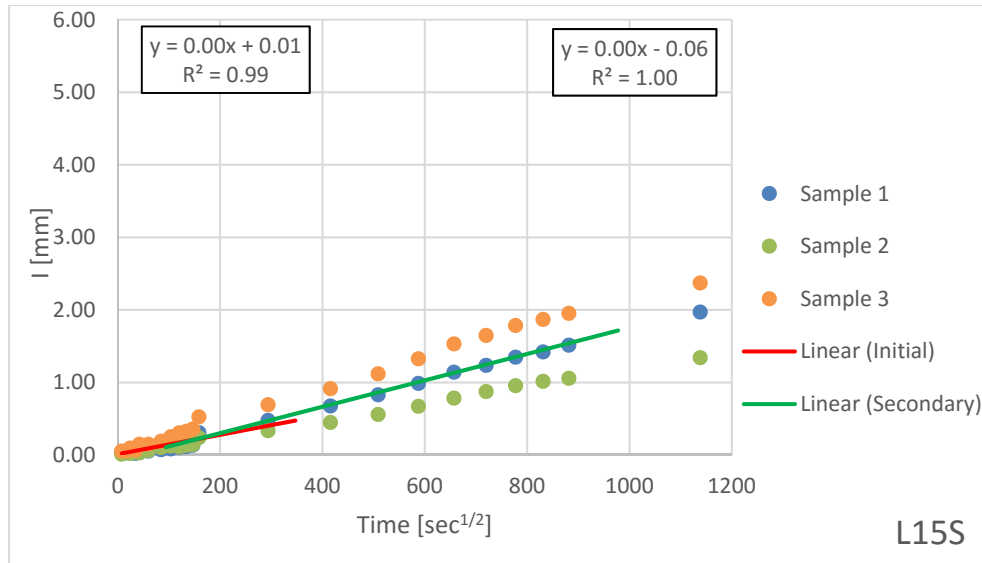
**Figure B.1.19 – Absorption Results for L15 Silane-Coated**

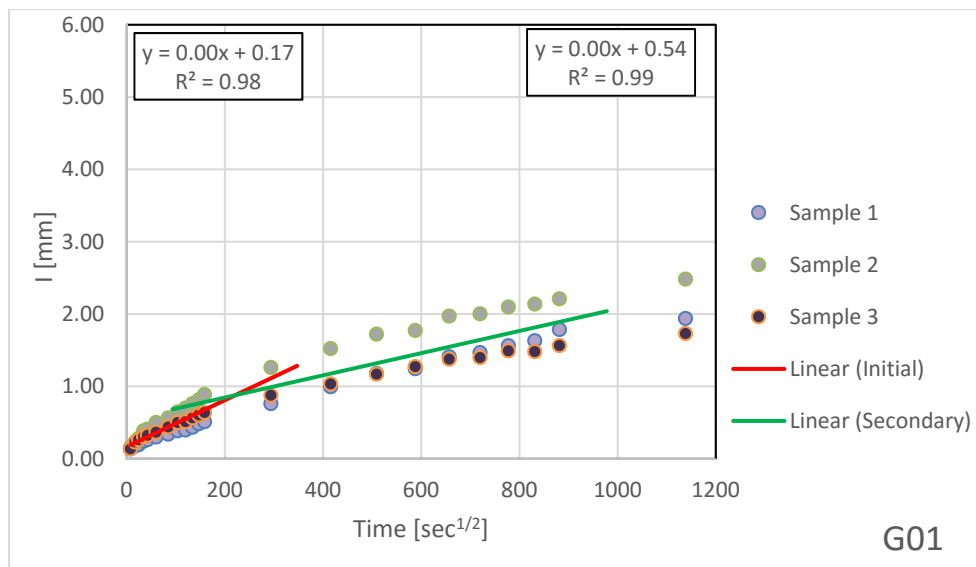
Figure B.1.20 – Absorption Results for G01
