The Effect of Fluorescent Yellow Warning Signs at Hazardous Locations

FY 98-99 Seed Grant Program
Final Report

Kimberly A. Krull, Research Assistant
Joseph E. Hummer, Associate Professor
North Carolina State University
Department of Civil Engineering
Raleigh, NC 27695-7908

July 5th, 2000

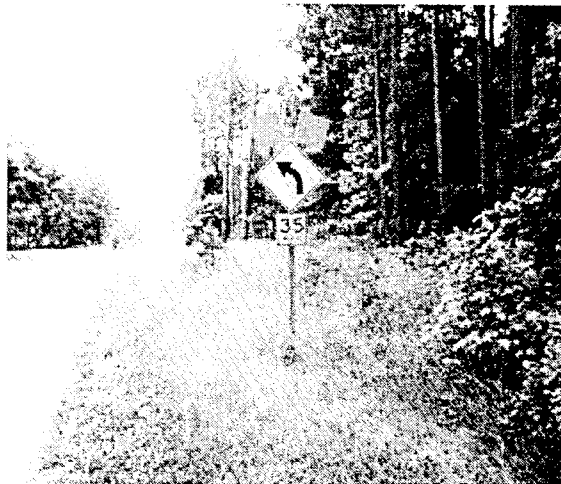
Figure 1-2: Yellow Warning Sign Equipped with Orange Sheetting

about to enter a construction zone. The orange flags used also do not have the ability to retain their color over time. Some traffic engineers have replaced the cloth flags with small square pieces of orange sheeting. This is displayed in Figure 1-2. These signs are not only sending the mixed message with the orange and yellow colors together, but also the effective shape of the sign has been changed from the standard shape required by the MUTCD. These two methods also may create the impression that a sign without orange flags or squares of orange sheeting is of lesser importance.
