Developing a Surface Drainage Rating for Inclusion in TxDOT's Asset Management System: Technical Report

Technical Report 0-6896-R1

TEXAS A&M TRANSPORTATION INSTITUTE
COLLEGE STATION, TEXAS

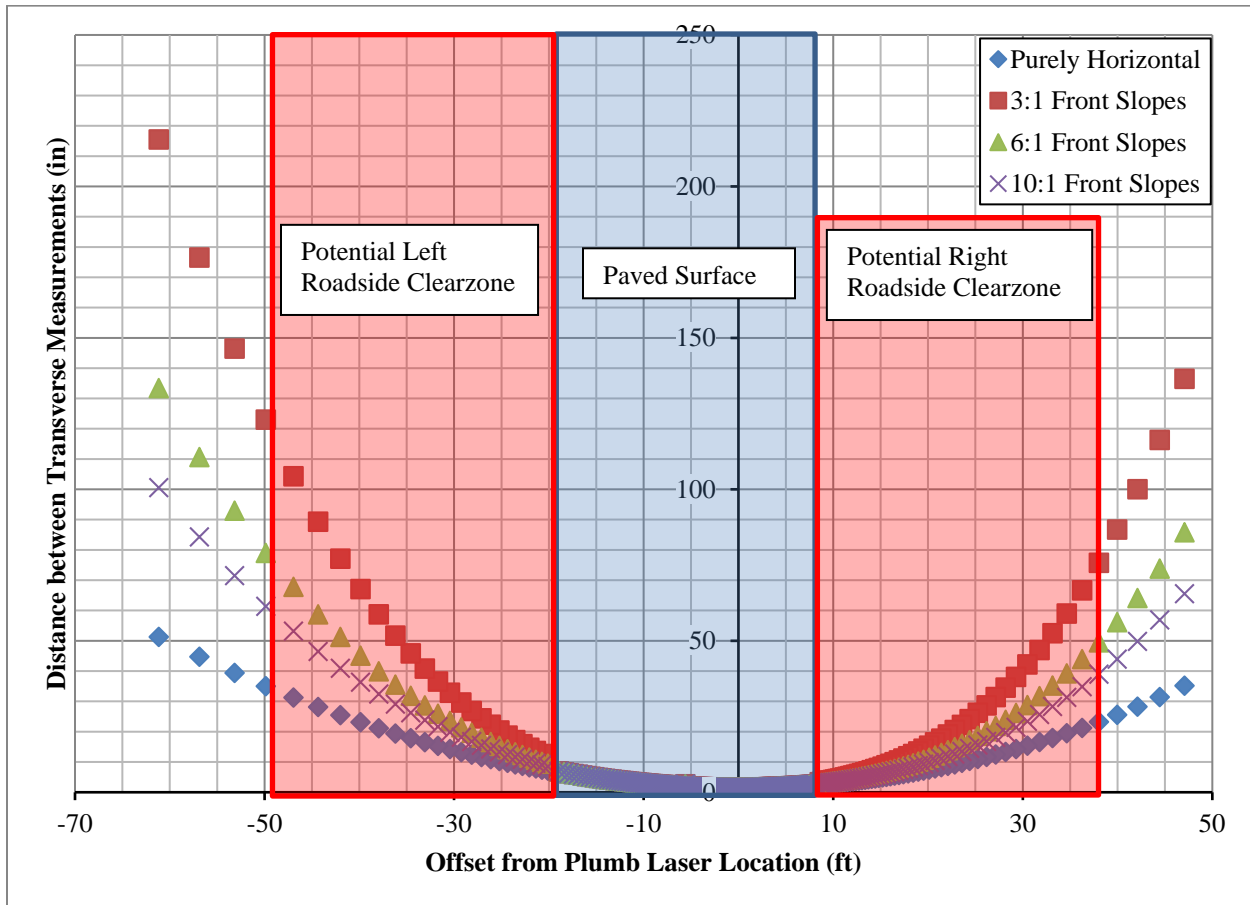
Figure 12. Transverse Spacing for a Two-Lane Roadway.

laser, measurements become farther apart. Figure 12 displays the spacing across a typical two-lane roadway with varying front slopes.

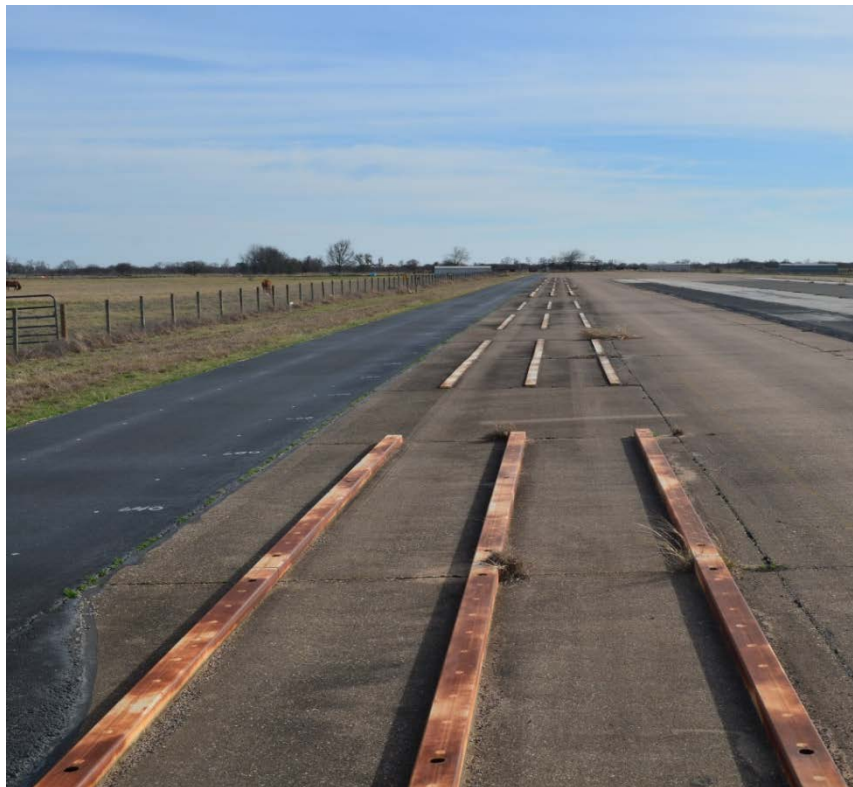
Figure 14. Rut Track Located at Texas A&M RELLIS Campus with Inverted Rut Plates of Known Dimensions.

- In addition to the professionally surveyed ground truth cross-sections, an inverted rut track located at the Texas A&M University RELLIS campus was used to evaluate the accuracy of mobile LiDAR for depth measurements.
- This same inverted rut track was used to analyze area calculations for drainage basins along the roadway. Figure 14 displays the inverted rut track containing steel plates 40-ft (12.2 m) long with 42 in. (1.07 m) between plates.

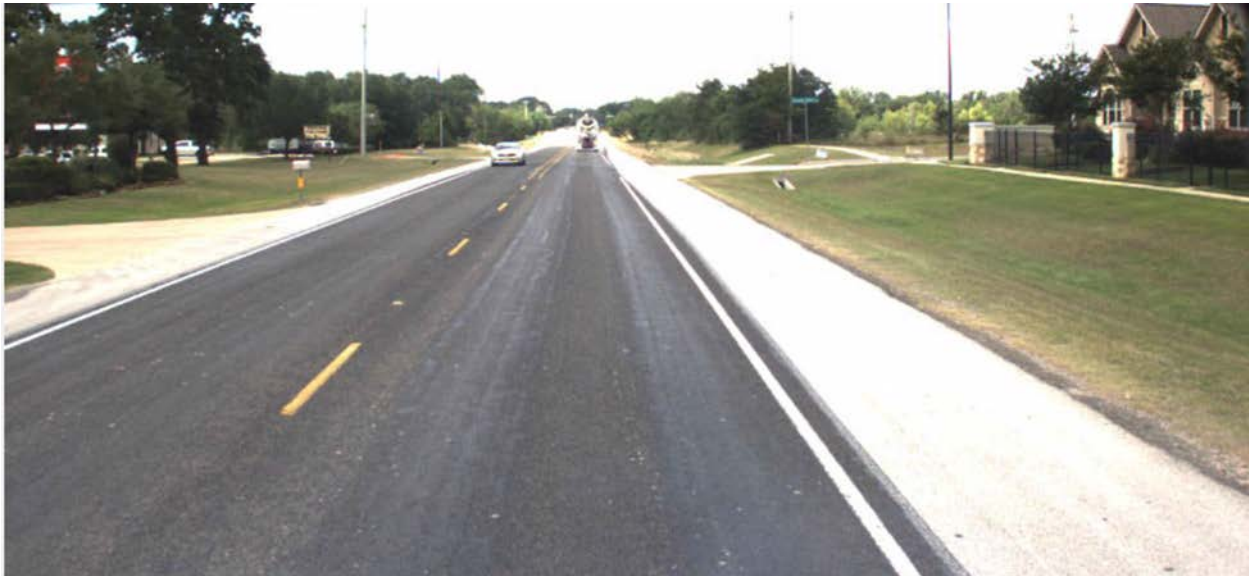
Figure 20. SH 30 on the Day of MLS Data Collection.

Along the right roadside, a finish mowed surface creates a ditch or roadside surface between 1 and 3 in. higher than the actual ground surface. Vegetation also affects the measured slopes of the roadside. For rural areas, vegetation is expected to be higher. Ideally, data collection should occur immediately following the TxDOT mowing cycle. Under Item 730 in TxDOT’s Standard Specifications, roadside mowers should be set to between 5-in. and 7-in. (45).

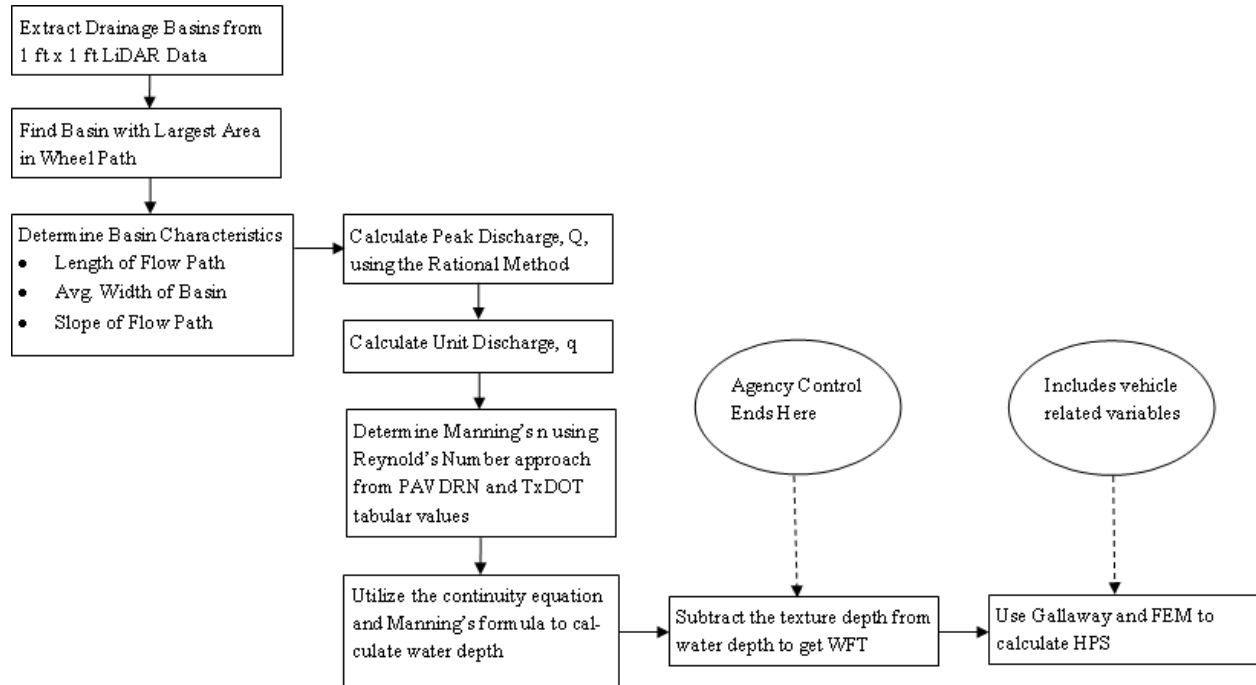
Figure 33. Hydroplaning Calculation Flow Chart.

calculation developed during PAVDRN model work. The PAVDRN model work relies on the Reynold's number calculation (31). Figure 33 is a flow chart of the HPS analysis. Figure 33 is followed by the equations used to calculate water depth on the surface.

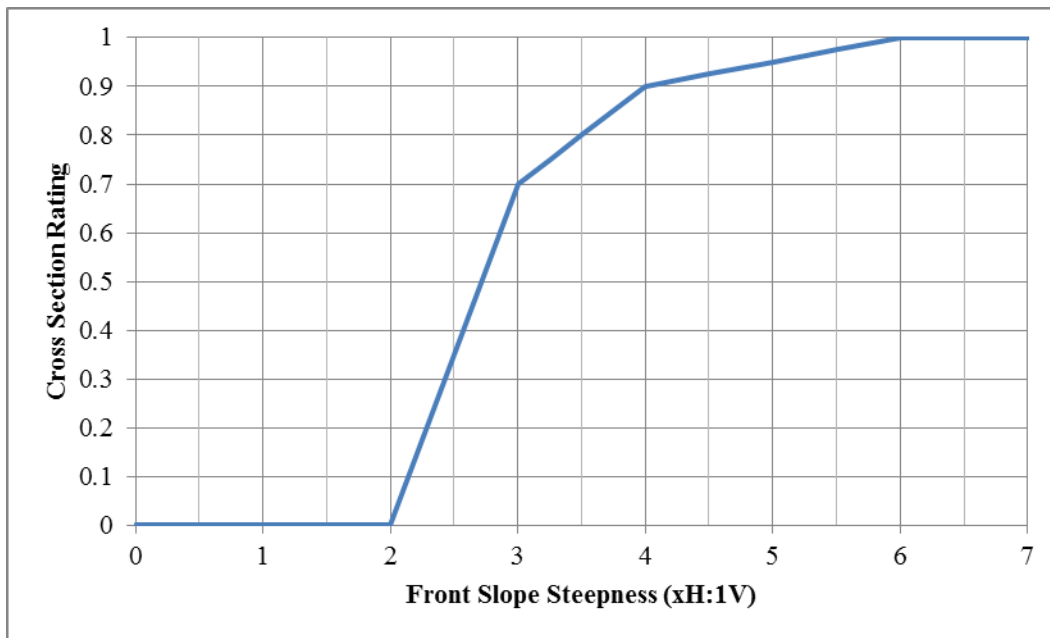
Figure 35. Front Slope Rating Curve.

Researchers rate each cross-section within a data collection section using the curve shown in Figure 35. For sections flatter than 6H:1V, no deduction is made. Many districts specify a 6H:1V front slope steepness as desired. A 10 percent linear deduction takes place from 6H:1V to 4H:1V. A 4H:1V or flatter slope is considered recoverable, so only a small deduction is applied at 4H:1V. Another 20 percent deduction occurs from 4H:1V to 3H:1V as the slope transitions from recoverable to non-recoverable. A front slope steepness of 3H:1V represents the steepest front slope that meets design criteria and receives a rating of 0.7. A linear deduction from a rating of 0.7 to 0.0 occurs between steepness values of 3H:1V and 2H:1V. Anything steeper than 2H:1V receives a rating of 0.0. Not only do slopes steeper than 2H:1V create safety issues, they often cannot be constructed without a stabilization technique such as riprap (40).

Very flat front slopes can create drainage-related issues. However, researchers chose not to select a too flat value to begin deductions. This decision was made not only to acknowledge the safety element associated with flatter roadside but also to avoid double counting. Ditch depth is the next element rated, and shallow ditches receive a poorer rating, essentially capturing very flat roadside front slopes.

Table 24 indicates that many of the sections along FM 31 are defined as out of shape. Because of this result, the rating for many of the sections is driven down into the 70s and below. Section 26, at 75 percent, received the lowest roadside drainage rating. The low roadside rating stems from a shallow and flat ditch. Figure 42 is a screenshot from the mobile LiDAR post-processing software, Road Doctor, displaying the shallow and flat ditch in Section 26. Figure 43 represents a digital rendering of the right roadside of Section 26 along FM 31. Researchers created this rendering using the proof of concept code used to apply the network-level rating to large data sets. With a shallow and flat ditch, the expectation would be that the front slope portion of the roadside rating would be high. For Section 26, the front slope receives a 0.99, indicating a steepness slightly steeper than 6H:1V (for front slope rating, see Figure 35)

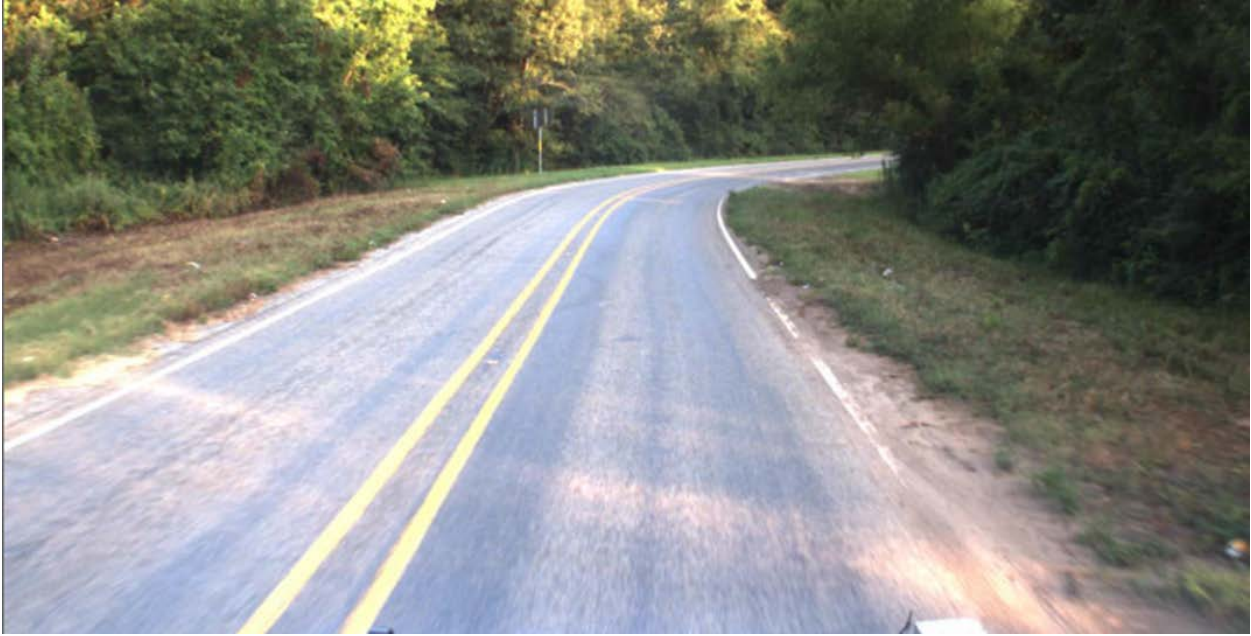
Figure 49. Section 1 on FM 2983.

Table 26 provides a rating not yet seen. Both Section 1 and Section 15 are in shape and part of curves, yet the cross-slope rating is 0.0 for each section. When this rating appears within a curve, it implies that the radius of the curve is shorter than the radius required at a 25-mph speed difference using the posted speed limit friction factor. Using mobile LiDAR data, researchers calculated the radius for Section 1 to be 463 ft and the radius for Section 15 to be 377 ft, with minimum required radii of 507 ft and 490 ft, respectively. From this perspective, the calculated radii are not far from the minimum required for a 25-mph differential, so it would be possible to mitigate the poor cross-slope rating with curve advisory signs and with speed advisory plaques and chevrons. Figure 49 and Figure 50 display each of these curves and show that no advisory signs or chevrons are installed. It is possible that because each section enters and exits a stop condition with stop advisory signs in place that the speed is low enough that chevrons are not needed on these curves. The surface drainage rating allows engineers and managers to drill down into the rating and make engineering decisions such as that one just described.

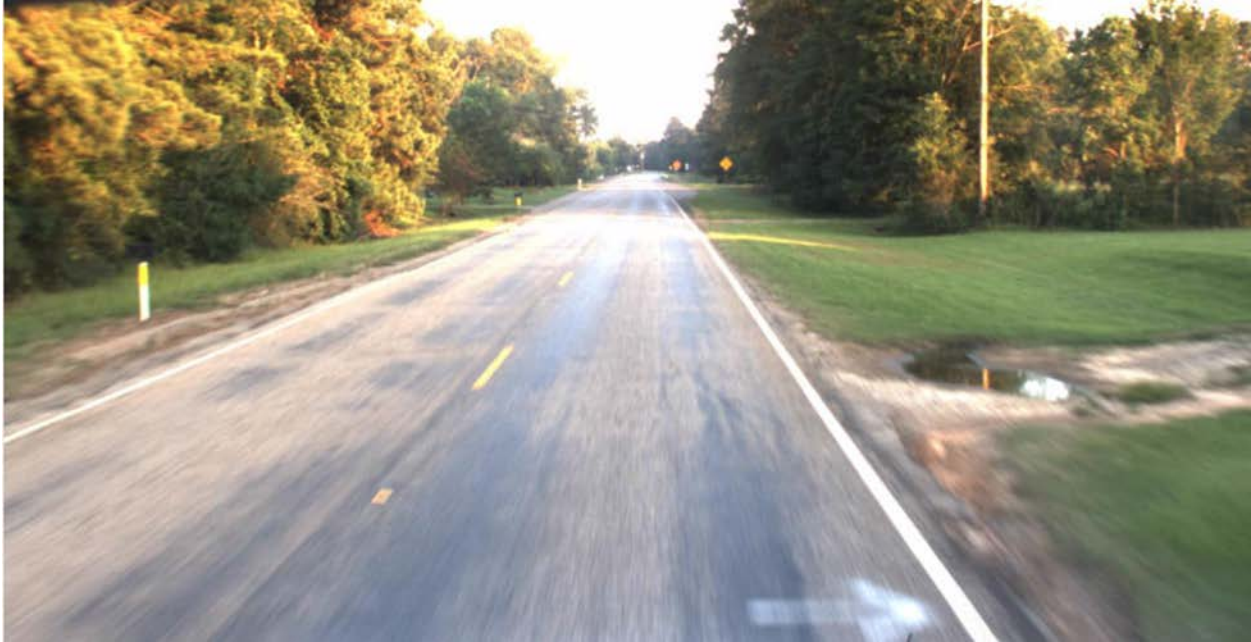
Figure 53. Section 64 on FM 1186.

Figure 53 shows Section 64 along FM 1186. Within Figure 53, the shallow and flat ditch along the right side of the roadway is apparent. The lack of shoulder width speaks to the width rating of 0.70. In fact, the right traveled way width in this section averages 12.04 ft, just wide enough to maintain a passing rating.

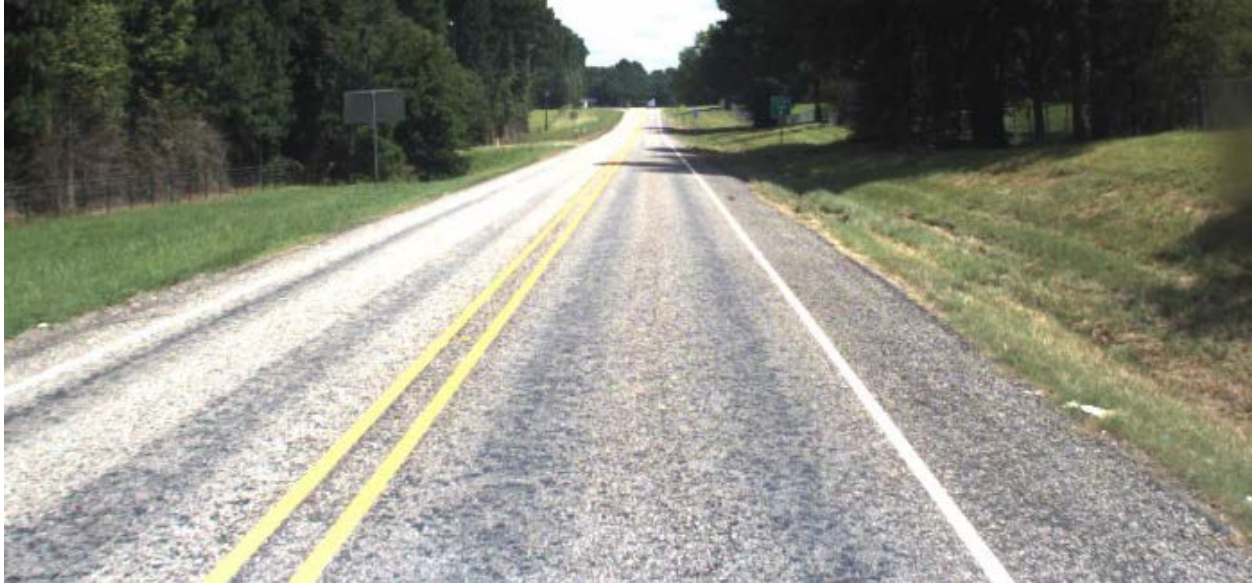
Figure 54. FM 2661 Widened Section North of SH 31.

A consistent reduction in roadway width rating occurs north of the SH 31 intersection. Figure 54 and Figure 55 show the difference in the widened surface north of SH 31, leading to better ratings than south of SH 31. The geometry along FM 2661 appears similar to the geometry on FM roadways in the Atlanta district, yet hydroplaning ratings on FM 2661 are either 0.90 or 1.00. This is not a geometric issue since FM 2661 has sections that are also out of shape; the difference is the posted speed limit. FM 2661 is posted at 60 mph, so while Section 111 has a hydroplaning speed calculation of 54 mph and WFT of 0.22 in., the rating is 0.9 because the comparison of potential hydroplaning speed to posted speed is between 5 mph and 10 mph. In reality, a hydroplaning speed of 54 mph is lower than the 59-mph hydroplaning speed referenced for Section 17 on FM 2625, but Section 17 on FM 2625 receives a lower rating because the posted speed limit is 70 mph. An advantage of the surface drainage rating is the ability to investigate these types of anomalies.

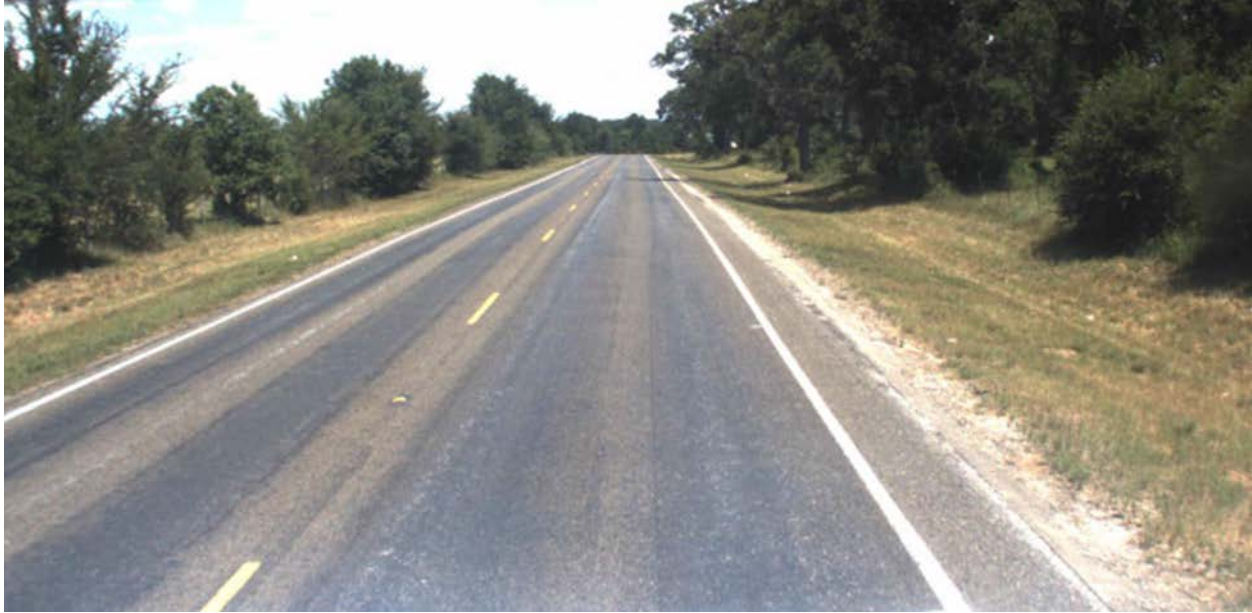
Figure 56. Section 26 on FM 1687.

Section 26 along FM 1687 has the lowest rating of 70. Section 26 is plagued by being out of shape, with a 0.70 hydroplaning rating, and a flat ditch line. The measurements that lead to the rating indicate the roadside slope in Section 26 is approximately 0.6 percent and the hydroplaning speed is 53 mph. Again, the deduction in hydroplaning speed is based on the posted speed limit of 70 mph along FM 1687. Figure 56 displays Section 26.

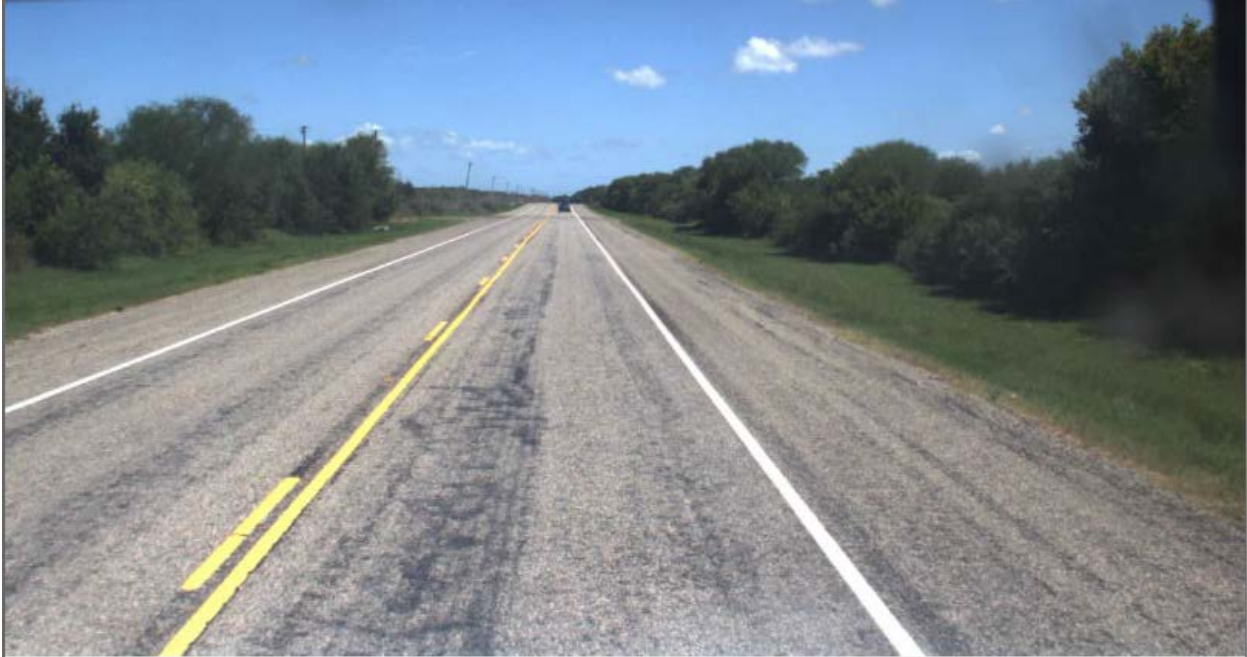
Figure 60. Section 33 along FM 2678 in the Corpus Christi District.

Section 33 on FM 2678 in the Corpus Christi district represents a tangent section with an overall rating of 86. This section has a roadside rating of 1.0 and a paved surface rating of 0.72. The paved surface rating is impacted by reductions in width, cross-slope, and hydroplaning potential ratings. This section is chosen as an example because in reality the width rating should equal 1.0, increasing the overall rating to 0.90. The width rating fails because the algorithm classifies the EOP too close to the edgeline stripe. Seal-coated roadways can create this issue at the network level. FM 2678 consists of a seal-coated surface where the precoated rock has begun to display the aggregate surface below the precoat, as shown in Figure 60. The EOP algorithm looks for reflectivity changes to determine the offset to the pavement's edge, and the exposed aggregate face can trick the algorithm into believing it has reached the EOP. Overall, the algorithm is highly effective at finding the EOP. Width transitions and the effectiveness in capturing these transitions has been previously discussed with FM 31 in the Atlanta District and FM 2661 in the Tyler District. Across 260 seal-coated sections on FM 2661, FM 31, and FM 2678, the algorithm accurately measures the width 234 times, while in only 26 it finds a narrower width than actual field conditions.

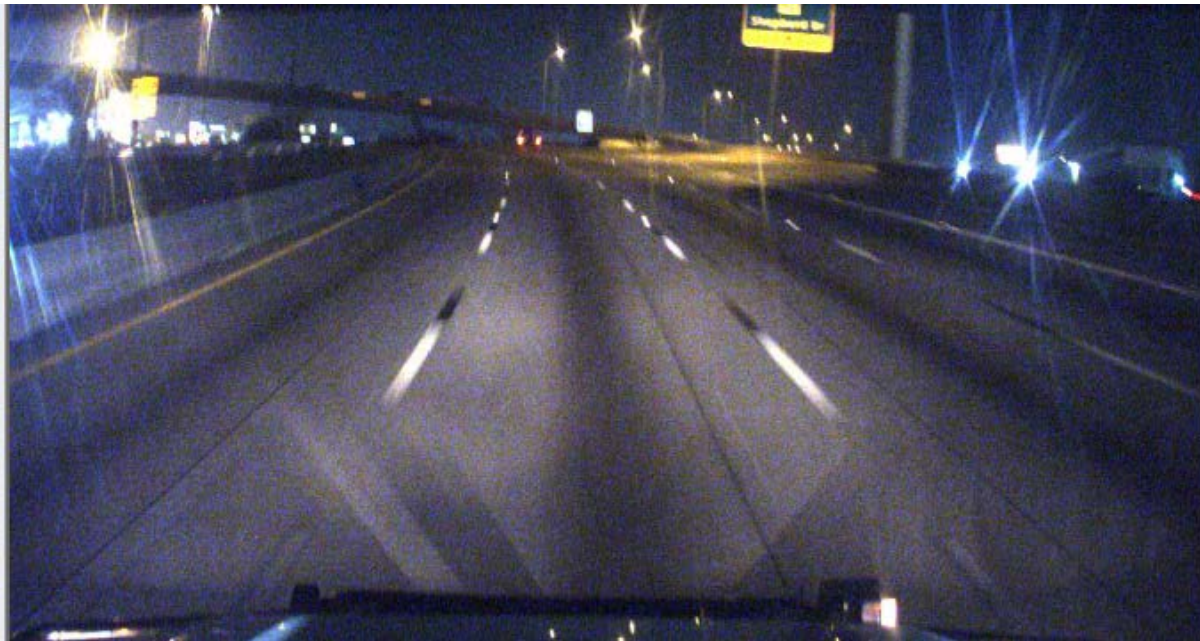
Figure 63. Section 89 along IH 45.

Section 89 along IH 45 consists of a left curve with a radius calculation of 3,634 ft and a superelevation of 2.74 percent falling to the left. Figure 63 displays Section 89 during the data collection.

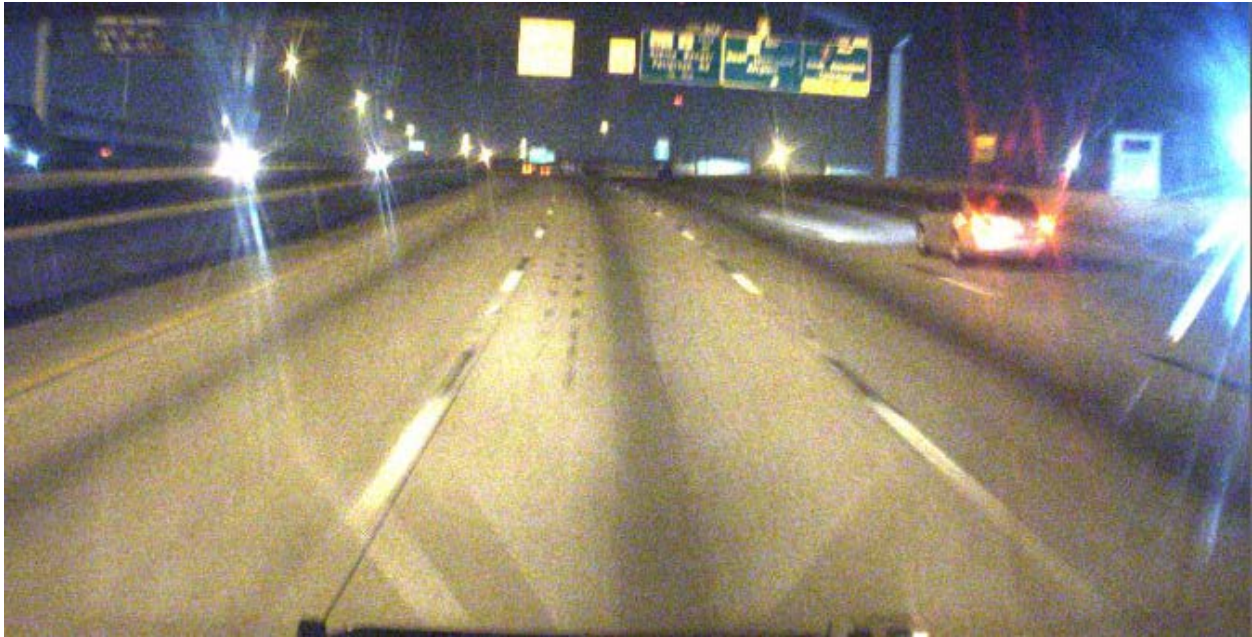
Figure 64. Section 38 along IH 45.

Similarly, Section 38 consists of a left curve with a radius of 6,214 ft with an average superelevation to the left, or inside of IH 45, of 2.82 percent. This dynamic creates a potential hydroplaning speed of 53.6 mph on a roadway with a posted speed limit of 60 mph. This section consists of five southbound lanes approximately 12 ft in width. Figure 64 displays a screen shot from the night of collection, and Figure 65 displays a digital rendering developed with the proof of concept code. The 1-ft \times 1-ft grid discussed in other parts of the report can be seen in the rendering. The elevation information contained in these grids helps in calculating cross-slopes, hydroplaning speed, and other elevation-dependent parameters. However, Figure 65 also shows the challenges associated with data collection on metro sections. Gaps are clearly seen to the far right of the gridded data. This same challenge exists to the far left when collecting data on rural sections, but the larger issue on metro sections is that these gaps occur in the direction of data collection. This discrepancy is one of the primary reasons metro sections should be treated more like project level analysis.

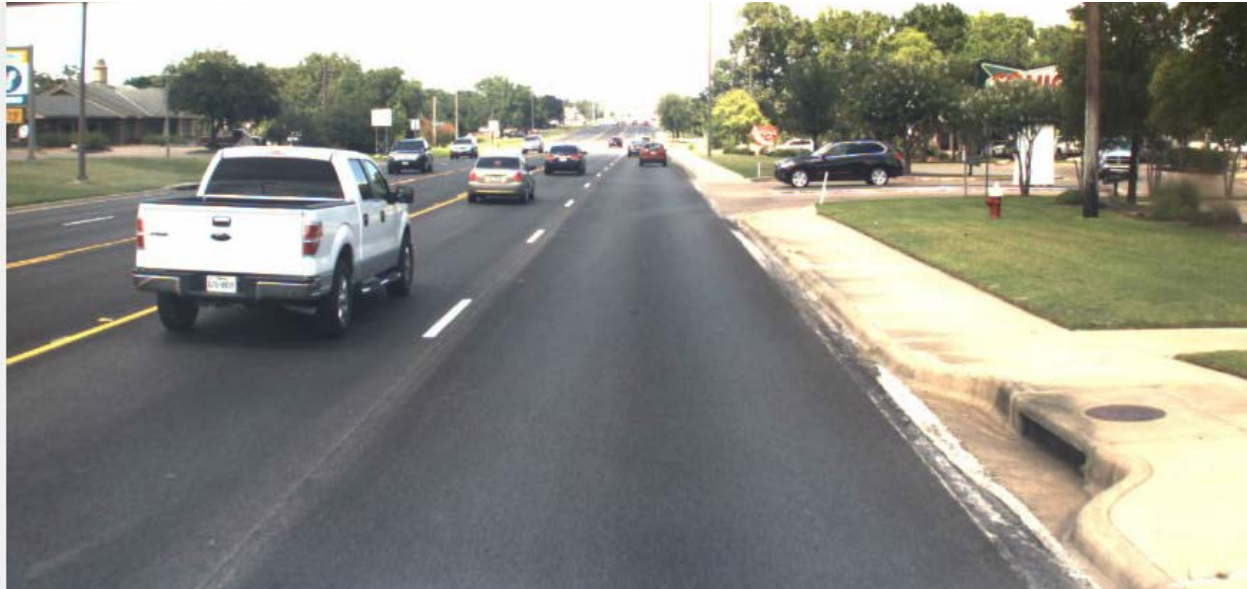
Figure 66. Urban Curb and Gutter Section Example.

Urban curb and gutter sections also present specific points of analysis that are better evaluated from a project level perspective. Figure 66 shows a curb and gutter section along SH 30 (Harvey Rd.) in the Bryan District. Data were collected during daytime hours, and traffic is easily visible in Figure 66. Traffic to the left of the data collection vehicle presents a target for the laser to impact prior to making contact with the roadway surface. Traffic impacts occur during rural data collection as well, but on two-lane facilities the analysis focuses on the data collection lane and the adjacent roadside, limiting the impacts of passing traffic. Also, in the rural environment, the volume of traffic causes fewer problems, and the algorithms used to develop the ratings filters out the erroneous points created by the laser measuring passing vehicles. The filter threshold allows for ratings when 50 percent measurement occurs. Figure 67 consists of the reflectivity data generated in the Road Doctor post-processing software that displays 0.1-mi of data with a truck obscuring a significant amount of data collection to the left of the data collection lane. Figure 67 was created from data collected along SH 30 (Harvey Rd.) in the Bryan District.

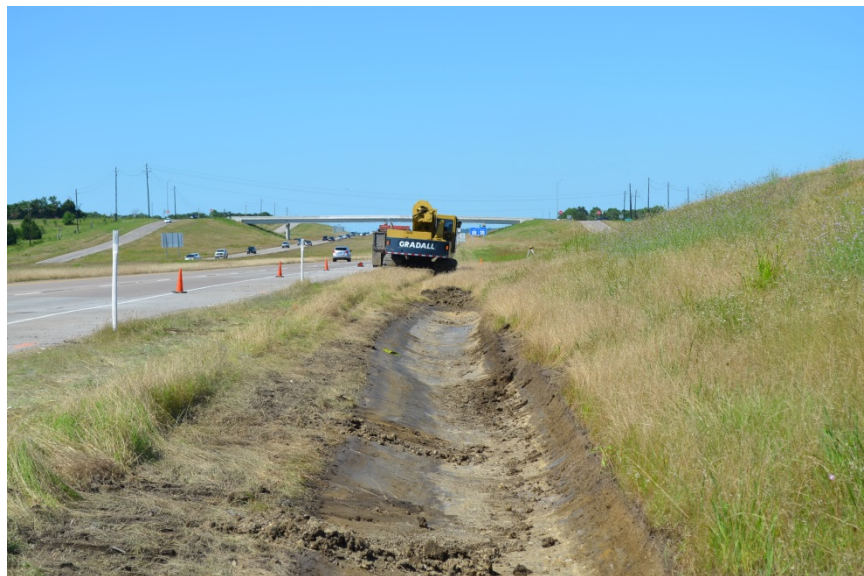
Figure 80. Ditch Grading Work along US 75.

Cut data and preliminary design information were provided to the TxDOT Paris District. TTI personnel met with TxDOT and its ditch grading contractor to perform preliminary ditch cleaning work. This work was deemed advantageous by the district regardless of the ultimate outcome of the rubblization. TTI worked on site with the ditch cleaning contractor and provided specific locations to begin ditch cleaning and estimated cut depths. Several weeks after ditch grading, TxDOT personnel indicated the ditch was still dry, empirically performing better than prior to the ditch cleaning. Figure 80 shows ditch cleaning work.

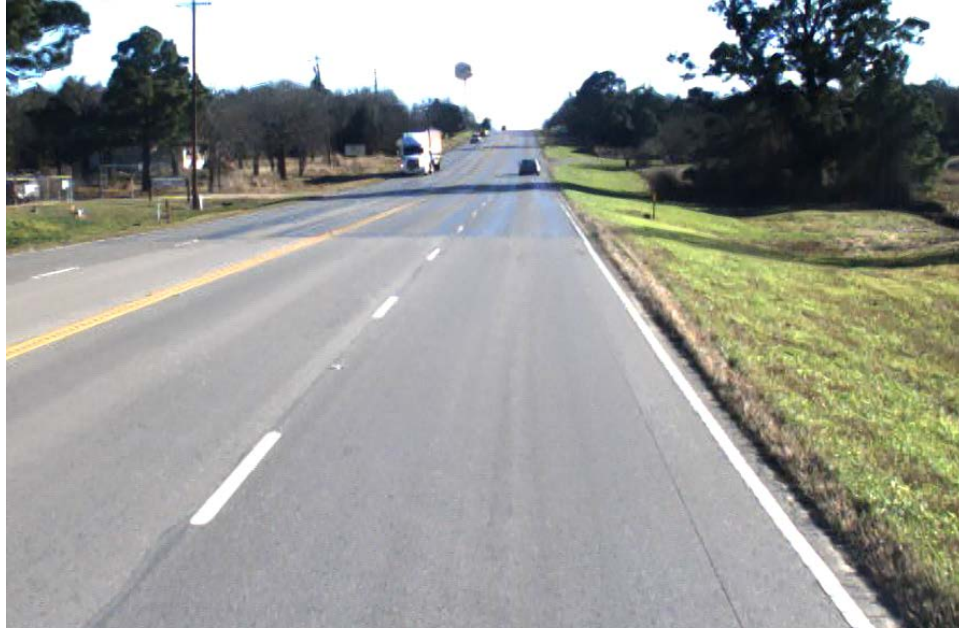
Figure 99. Pavement Used as Reference Point on US 77.

The outside lanes in both directions were evaluated for rutting. All rutting measurements, regardless of direction are referenced from the pavement change near reference marker 476+1.831. At this location, the pavement changes from a recent HMA to seal coat, which is shown in Figure 99. The analysis ends near the county line where US 77 transitions from two lanes in each direction with no median to one lane in each direction, near reference marker 482+0.996.

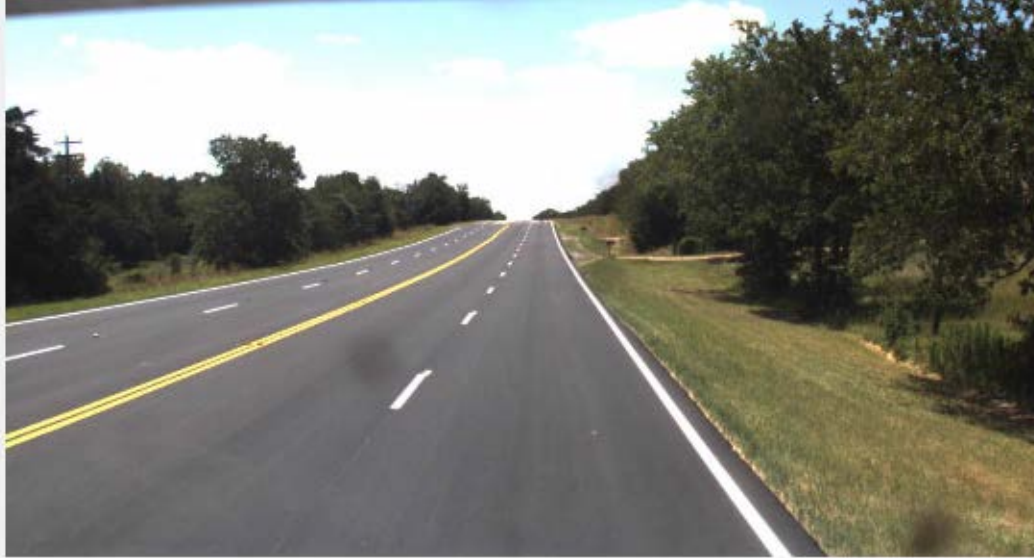
Figure 101. Spot Overlay on US 77.

The rut data generated by mobile LiDAR measurements was used by the district to plan maintenance paving work to mitigate rutting. Spot maintenance overlays were performed in areas with the most significant rutting. Figure 101 shows an example of a spot overlay within the analyzed area. Roadside drainage work has not yet been performed. For this analysis, mobile LiDAR measurements proved beneficial in identifying the most concerning areas in terms of rutting and linking those areas with potential roadside improvements.

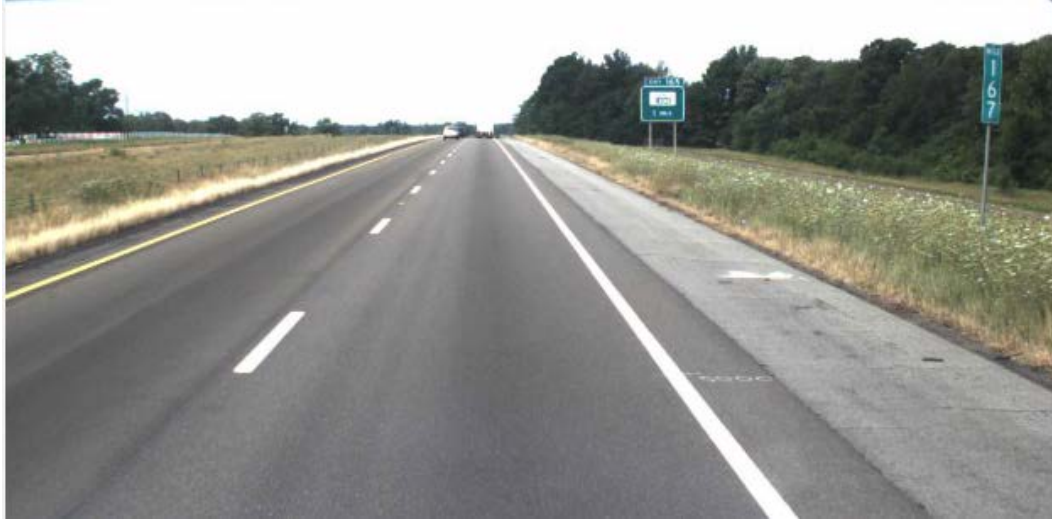
Figure 104. IH 30 Westbound Area with Deep Rutting.

Figure 102, near reference marker 167, depicts rutting in the left wheel path that exceeds 1 in. and approaches 1 in. in the right wheel path. Unfortunately, this rutting occurs in an area of newer construction, as shown in Figure 104.

While Figure 104 does not display visible signs of distress, other areas in the westbound direction experiencing deep rutting also display signs of potential striping. Figure 105 displays an image near reference marker 163 in the westbound direction. Left wheel path rutting in this area begins to exceed 1 in. Figure 105 shows material coming to the surface in both the left and right wheel path, potentially indicating striping.
