JOINT TRANSPORTATION RESEARCH PROGRAM

Warranty Utility Cut Repairs (QC/QA of Utility Cut Repairs)

WARRANTY UTILITY CUT REPAIRS (QC/QA OF UTILITY CUT REPAIRS)

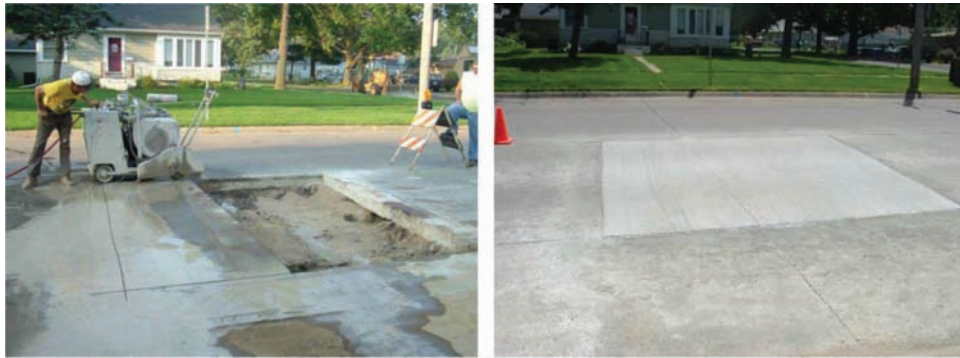
Figure 1.1 Example of a utility cut repair operation on a concrete pavement (Schaefer 2005).

Utility cuts are made to either install, maintain, repair, or replace buried utilities. Upon completion of the work, the cuts are backfilled, compacted, and resurfaced, resulting in a pavement patch (see Figure 1.1). These utility cut repairs are expected to restore pavements to their original condition. However, poor construction techniques often result in settlement of the patches, leading to a reduction in the life of the pavement.

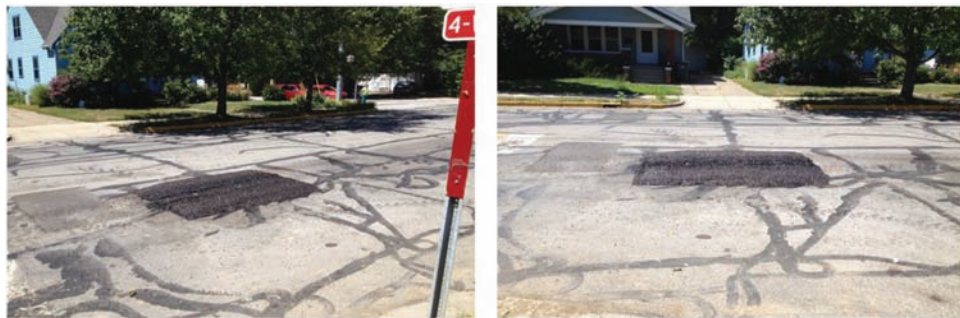
Figure 1.2 Example of a poorly performing utility cut. (Courtesy of Dr. Tommy Nantung and Dr. Jusang Lee, August 2015.)

INDOT personnel have often observed utility cut patching operations similar to those shown in Figure 1.2, where upon completion of utility repairs, contractors 'patch the pavement cut' by merely 'dumping cold mixed

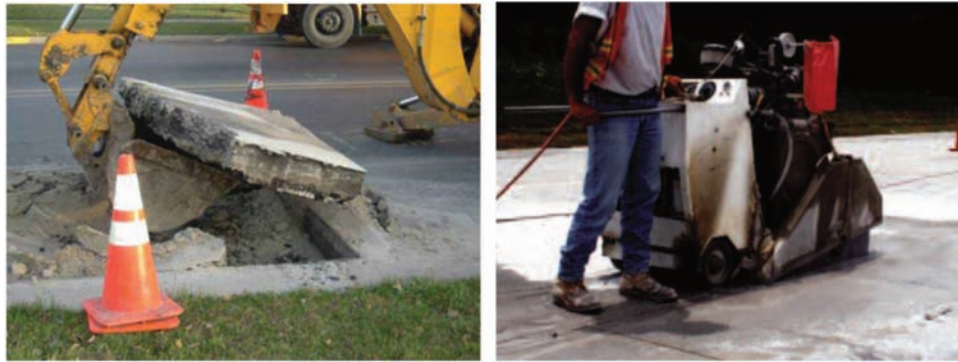
Figure 2.1 Left: asphalt pavement removal (Schaefer et al., 2005); right: saw cutting of a concrete pavement (ACPA, 2009).

A typical utility cut begins with the pavement being saw cut in straight lines separated enough to accommodate trench construction (see Figure 2.1). In the case of small openings, jackhammering is more

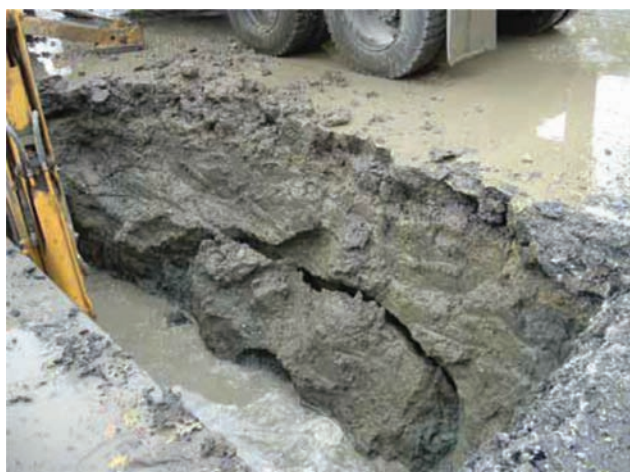
Figure 2.3 Material sloughing off the edges of a trench (Schaefer et al., 2005).

the top of the excavation sloughing off (see Figure 2.3), because excavation for utility repairs creates a weak zone of soil adjacent to the utility patch, which in time, leads to the failure of the patch (Schaefer et al., 2005). A T-section decreases the stresses imposed on the pavement as it incorporates the undisturbed soil surrounding the excavation and provides additional support to the pavement patch (APWA, 1997). This method of patching prevents sloughing off of the material adjacent to the utility excavation. INDOT's specification requires a T-section patch on flexible as well as rigid pavements (INDOT, n.d.).

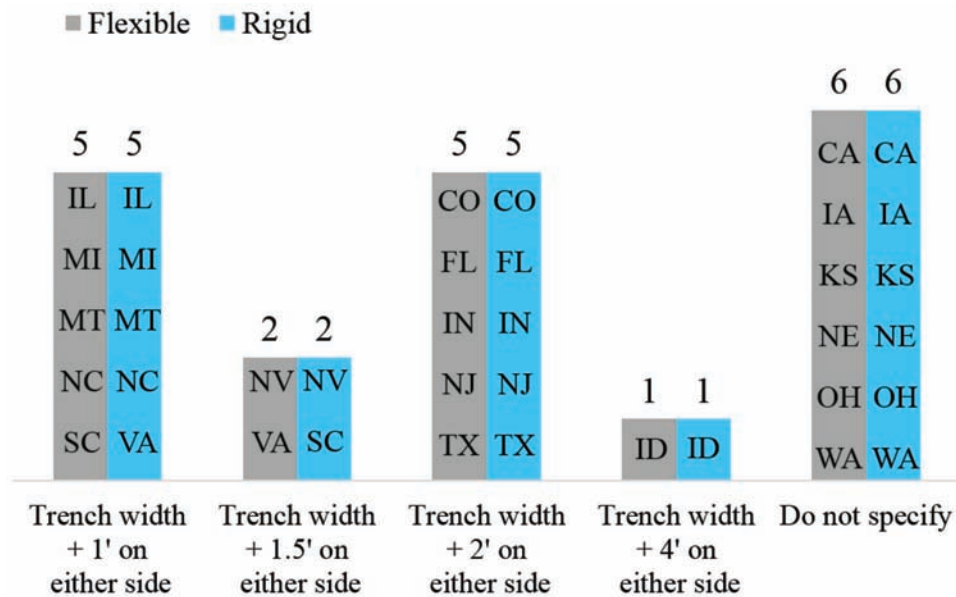
Figure 3.4 Width of pavement surface removal for the reviewed STAs.

A majority of the reviewed STAs (14 out of 19) required an additional cutback of the pavement surface, in order to create a T-section patch (refer to Section 2.2). The extent of the cutback varied from 1 foot to 4 feet on either side of the trench. The reviewed STAs were grouped into five categories based on the specified extent of the additional cutback (see Figure 3.4). In general, the extent of the additional cutback was the same for flexible and rigid pavements. VDOT and SCDOT had different

pavement removal widths for flexible and rigid pavements. A majority of the STAs require between 1' and 2' of additional cutback, on either side of the trench. ITD's minimum required additional cutback was 4' on either side of the trench. IDOT and MDOT require the additional cutback to be 1', whereas INDOT's specification requires an additional cutback of 2' on either side of the trench. Information about T-sections could not be found for Caltrans, Iowa DOT, Nebraska DOT, ODOT, KDOT, or WSDOT.

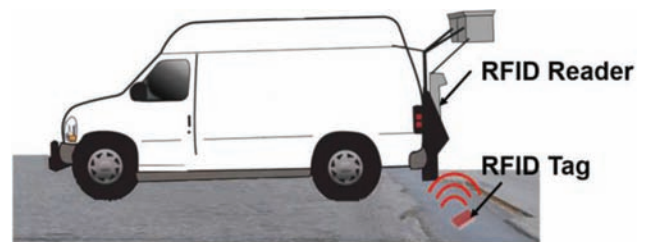
Figure 5.8 Proposed method to install RFID readers on data collection vans.

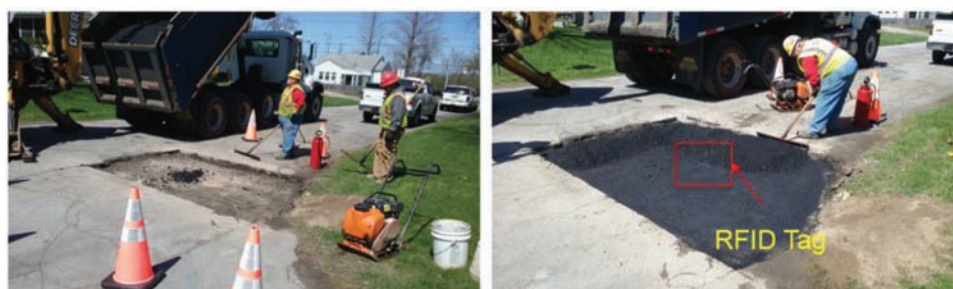
Figure 5.9 RFID tag being installed in a utility cut patch.
