Performance of Wicking Geotextile (H2Ri) to Mitigate Pavement Pumping - Phase 2

July 2022
Final Report

Project number TR202024
MoDOT Research Report number cmr 22-008

Missouri University of Science and Technology

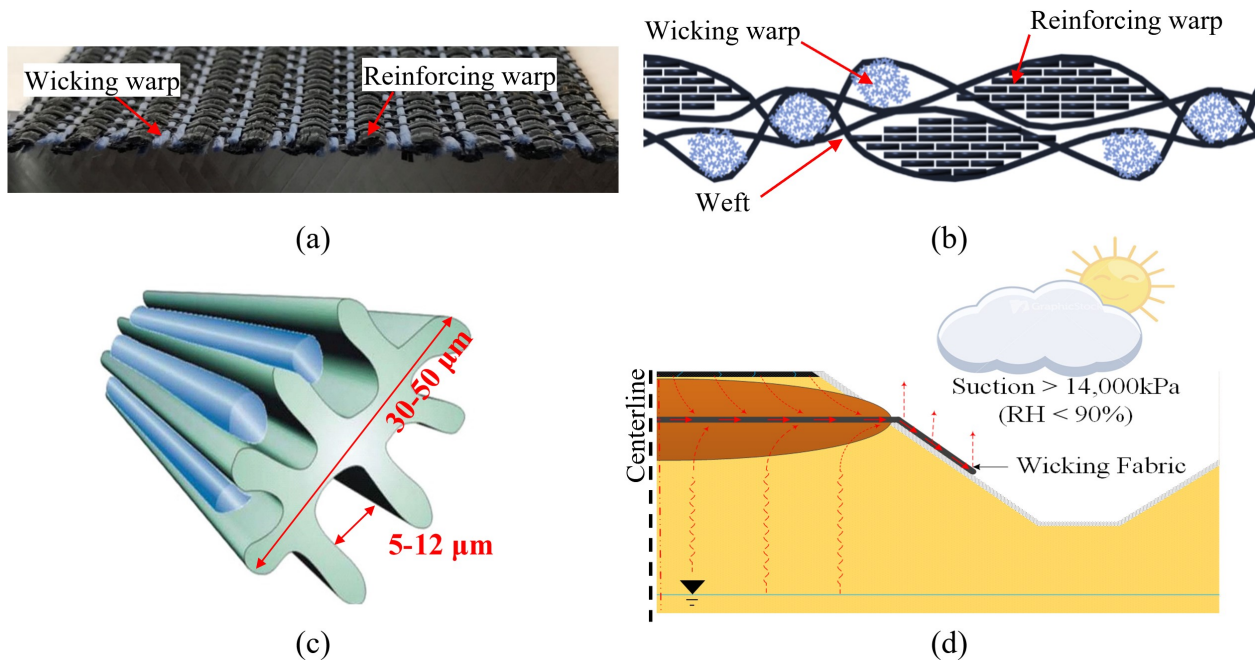
Figure 1.2a shows a picture of the wicking geotextile used in this study. The schematics of the cross-section of the wicking geotextile are illustrated in Figure 1.2b. As depicted in Figures 1.2a-b, the wicking geotextile has two different warp yarns which are weaved by wefts. The reinforcing warp yarn is made of polypropylene with high tensile strength. The unique properties of the wicking geotextile come from its wicking warps that are woven at the top, middle, and bottom of the fabric cross-section. These warps give the wicking geotextile a great potential for maximizing capillary action and water transport in an unsaturated environment. Each wicking warp consists of 144 hydrophilic and hygroscopic nylon wicking fibers (Figure 1.2c) for drainage purposes. These fibers are highly hydrophilic with multichannel cross-sections, which have a high shape factor and

a great number of channels per fiber (specific surface area = $3650 \text{ cm}^2/\text{g}$ ($16039 \text{ in.}^2/\text{oz}$)). Each wicking fiber has an average diameter of $30\text{-}50 \mu\text{m}$ and the opening of the grooves is $5\text{-}12 \mu\text{m}$ (Figure 1.2c). The working mechanism of the wicking geotextile is depicted in Figure 1.2d. The weaving pattern of the wicking geotextile allows it to absorb water from both the top and the bottom sides and transport it along the deep grooved channels. Since the relative humidity of the air is usually less than 90% under most conditions, the suction caused by air at the surface of a pore is very high ($>14 \text{ MPa}$ or 2 ksi). If the end of the wicking geotextile is exposed to the atmosphere, there is a high suction gradient in the wicking geotextile from its buried end in the soil to the exposed end. The suction gradient is the driving force that continuously transports water from the buried end of the wicking geotextile to the exposed end. Water is then vaporized into the surrounding atmosphere at the exposed end and gradually dries the soil.

Figure 1.2 Wicking geotextile: a) fabric photo, b) schematics of fabric cross-section, c) schematics of a single fiber, and d) schematics of wicking geotextile working mechanism (adapted from [33]).

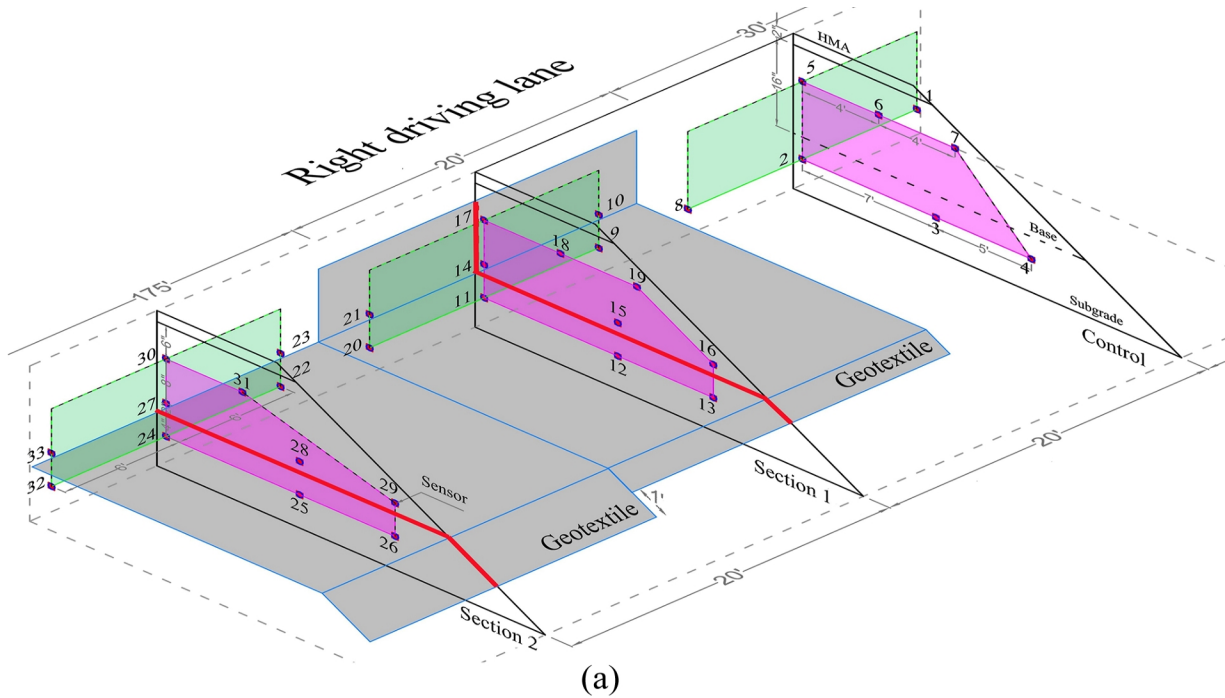
In order to evaluate the performance of the wicking geotextile, a full-scale field test section (Figure 1.3) was constructed and instrumented with the help of the Missouri Department of Transportation (MoDOT). A 225 ft. (68.6 m) -long road shoulder was selected at milepost 117.2 on the eastbound Interstate 44 in Missouri. Three sections, including a 30 ft. (9.1 m) -long control section, a 20 ft. (6.1 m) -long section 1, and a 175 ft. (53.3 m) -long section 2 were constructed (Figure 1.3a). The sections were instrumented with 33 water content reflectometers to measure volumetric water content (hereafter referred to as VWC) and temperature as shown by numbers in Figure 1.3a. For this type of sensor, the VWC measurement range is $0\% \text{ to } 100\% \pm 3\%$, and the temperature measurement range is $-50 \text{ to } +70^\circ\text{C} \pm 0.5^\circ\text{C}$ ($-58 \text{ to } +158^\circ\text{F} \pm 0.9^\circ\text{F}$) [35]. The control section was left untreated without the installation of the wicking geotextile. Section 1 was in the middle with

the installation of a 15 ft. (4.6 m)-wide, topped L-shape wicking geotextile at a depth 18 in. (46 cm) below the road surface at the interface of subgrade and the base course layer, as shown by a solid red line in figure 1.3a. In section 2, the 15 ft. (4.6 m)-wide wicking geotextile was placed horizontally at the interface of the subgrade and the base course layer at a depth 18 in. (46 cm) below the road surface.

Figure 1.3 Field test sections; a) design schematics, b) installation of the wicking geotextile and the second layer of sensors (left), compaction of the base course (right), c) final configuration.

Figures 1.3b shows the construction of the field test sections. The existing road shoulder was first excavated to a depth of 18 in. (46 cm) until the clayey subgrade was exposed. For each sensor installed within the subgrade layer, a hole was dug at a depth of 4 in. (10 cm) below the subgrade (22 in. (56 cm) below the final road surface) to place the sensor and then backfilled with uniform-graded sand. After installation of the sensors in the subgrade, the wicking geotextile was placed over the subgrade in sections 1 and 2. The second group of sensors was then installed right on top of the geotextile after its placement and covered with the sand (Figure 1.3b (left)). Due to the test sections' configuration, the outer edge of the wicking geotextile in section 2 was approximately 1 ft. (0.3 m) beyond that in section 1 as shown in Figures 1.3a and 1.3b. Next, a layer of base course material was placed in one lift and compacted above the subgrade (or the wicking geotextile) with the final height of 16 in. (41 cm) (Figure 1.3b (right)). The shallowest sensors in each section were then installed in the base course at a depth of 8 in. (20 cm) below the final road surface in a similar way as of the sensors in the subgrade. Finally, the base course was covered by a 2 in. (5 cm)-thick hot-mix asphalt (HMA). The construction of the field test sections was completed on September 28, 2018. The solid pink lines in Figure 1.3c show the vertical cross-section locations of the three test sections. Soil moisture and temperature in all test sections were monitored by the installed sensors right after the construction of test sections on September 28, 2018, at an interval of every 15 minutes. The results were then averaged into hourly readings and stored in the data logger for further analysis.

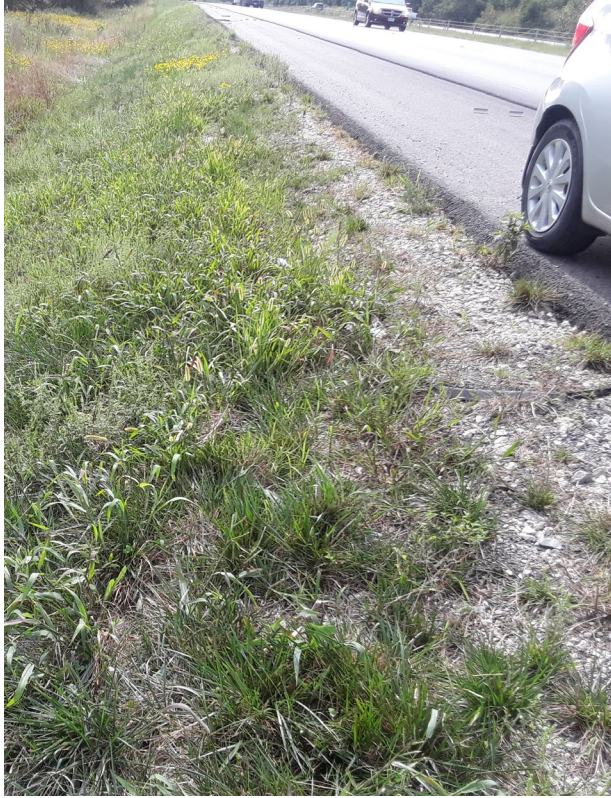
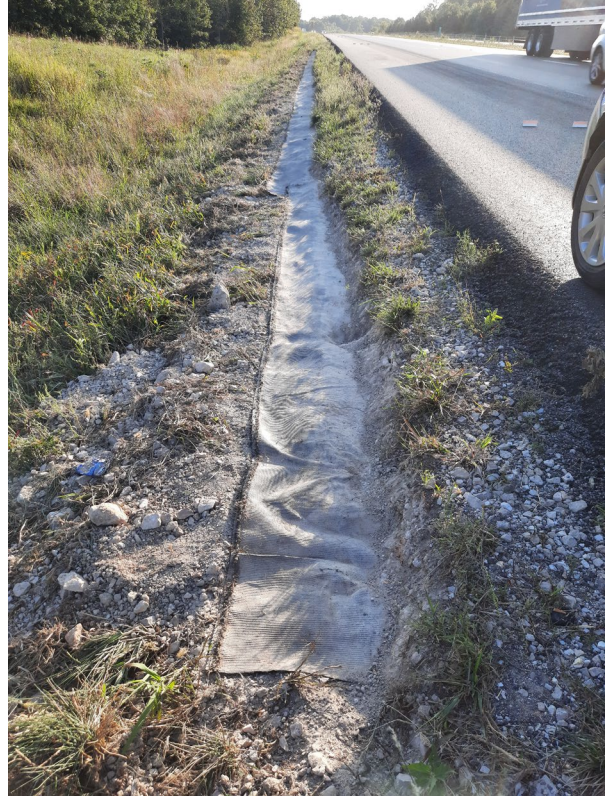
Figure 3.2 a) Field test section situation on 9/13/2020 before exposing the end of the wicking geotextile, and b) Field test section situation on 9/23/2020 after exposing the end of the wicking geotextile.

As mentioned in the preliminary report, the whole width of the wicking geotextiles in sections 1 and 2 was completely covered by the base course layer when the construction of the field test section was completed. Later, on 2/9/2019 soils at the shoulders of test sections, 1 and 2 were removed to expose the wicking geotextile to air to facilitate the drainage (Figure 3.1). The exposed length of the wicking geotextile in sections 1 and 2 was at least 12 in. along the whole length of the corresponding sections. During a visit on 9/13/2020, it was found that the wicking geotextile in test section 1 was completely covered by the collapsed base course soils and grass, while in test section 2, most of the wicking geotextile was covered. 10 days later on 9/23/200, an additional trip was made to the field test section. In this trip, the collapsed soils and grass were removed to expose the wicking geotextiles in both sections 1 and 2 (Figure 3.2).

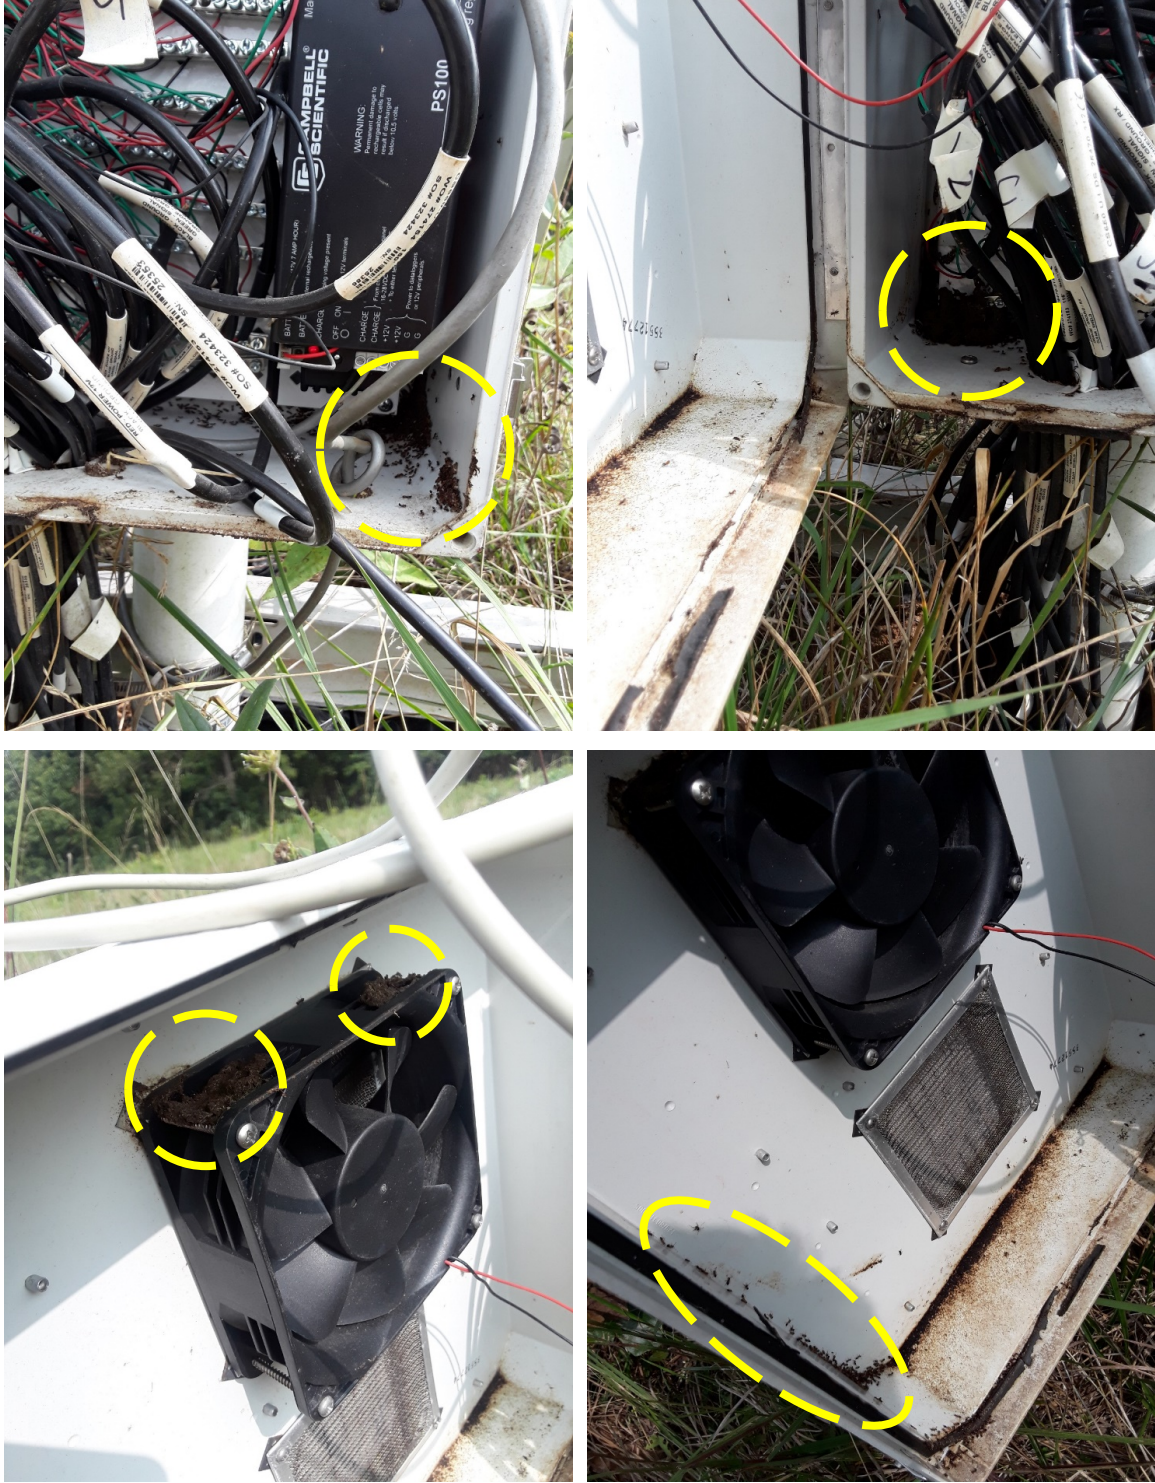
During a visit to the field test on 9/13/2020, several ant nests were found inside the datalogger chamber (Figure 3.3). One of these nests was located on the circuit board connecting the sensors to the datalogger unit. It was then discovered that the nest had caused a short circuit in the sensor connections. As a result, data related to several sensors had not been collected since 5/5/2020. In addition, a few sensors were permanently damaged as a result of this problem. During the next visit on 9/23/2020, the chamber was cleaned, and the disconnected sensors were reconnected to the datalogger. More information on the damaged sensors will be presented later in this report.

Figure 3.3 Ant nests inside the datalogger chamber

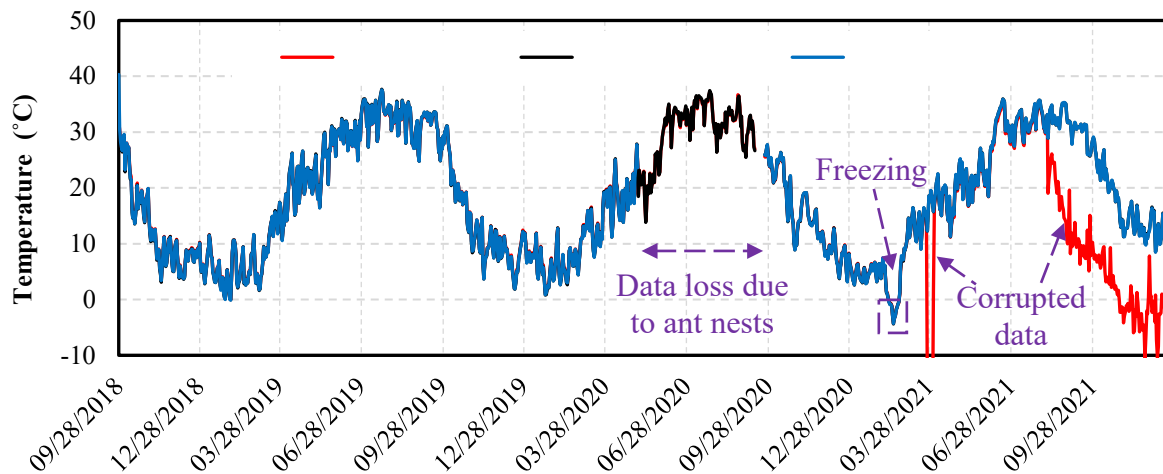
Figure 3.4 shows the temperature variation in sensors 5, 17, 30, located at depth 8 in. below the shoulder surface in the control section, section 1, and section 2, respectively. It can be seen that the temperature variations in different years are very consistent. In summer, the temperature rose to around 35°C (95°F) and it dropped to around 5°C (41°F) during wintertime. Except for a short period in early 2021, the base layer did not experience subfreezing temperature. Noting that these sensors are located near the top of the base layer, soil freezing is unlikely to occur in the field test section.

Figure 3.4 Temperature variation near the top of the base layer in the control section, section 1, and section 2

As mentioned before, Ants nesting caused some data loss between 5/5/200-9/23/2020. During this period the data related to some of the sensors, like sensor 30, was not recorded. This period is shown by the green dashed double arrow in Figure 3.4. In addition, sensor 5 shows false temperature readings for the most part in 2021. This problem might have been caused by mechanical damage or other unpredicted issues.

Since the temperature in other locations in the base layer and the subgrade was very similar to what has been presented in Figure 3.4, the soil temperature is not discussed further.

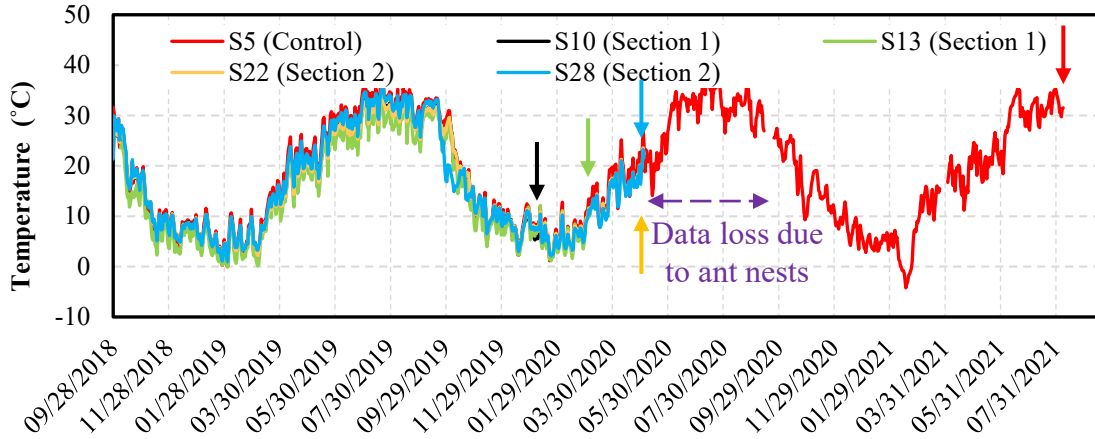
Similar to sensor 5, sensors 10, 13, 22, and 28 have also stopped working at some time during the monitoring period. The temperature readings in these sensors have been removed from the analyzed data. The time at which each of these sensors stopped working is displayed in Figure 3.5. The arrows in Figure 3.5 show the time when each sensor stopped reading valid temperature. Since most of the sensors stopped working is within a few months before the data loss as a result of ant nests, it is believed that ants inside the datalogger chamber might have caused electrical short-circuit in these sensors and caused permanent damage to them. It should be noted that the permanent damage mainly affected the temperature measurement circuit in these sensors. As it will be shown later, the soil moisture measurement of these sensors was used in the analysis despite their false temperature measurements.

Figure 3.5 Temperature variation in corrupted sensors.

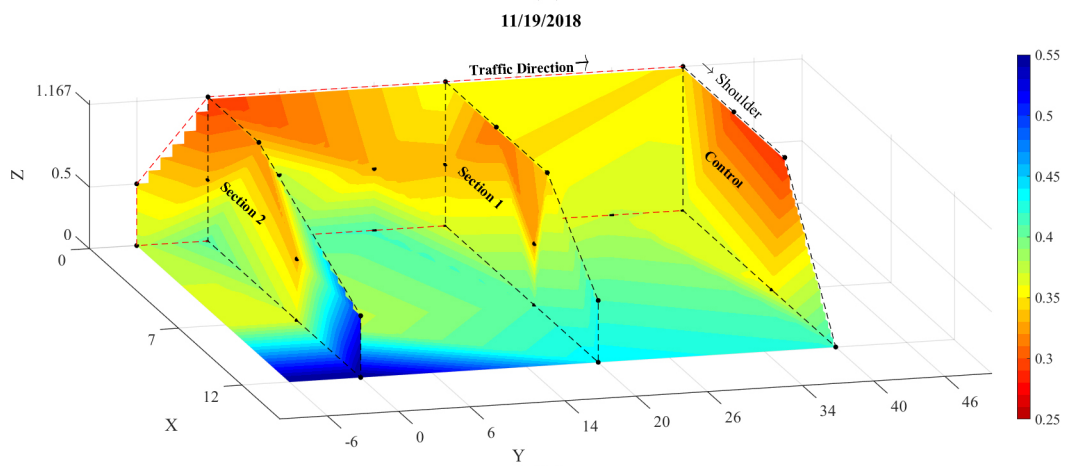
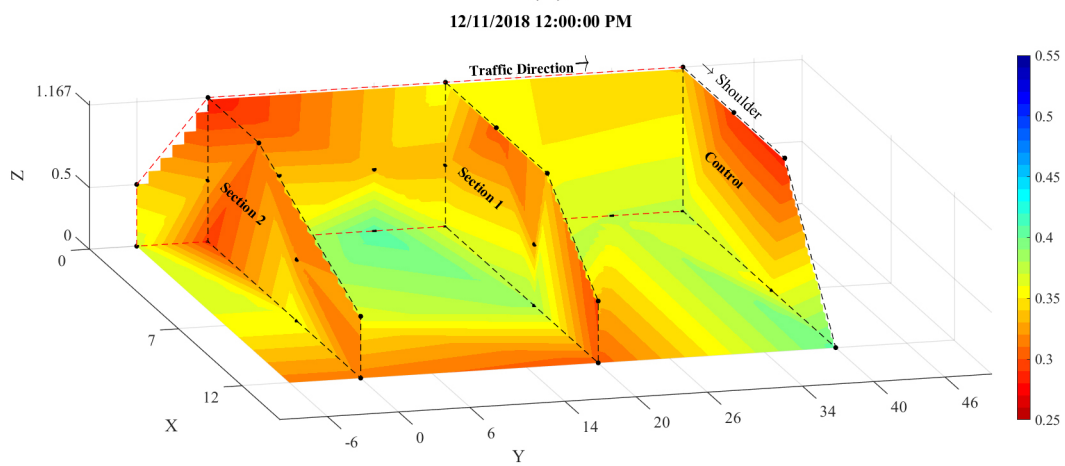
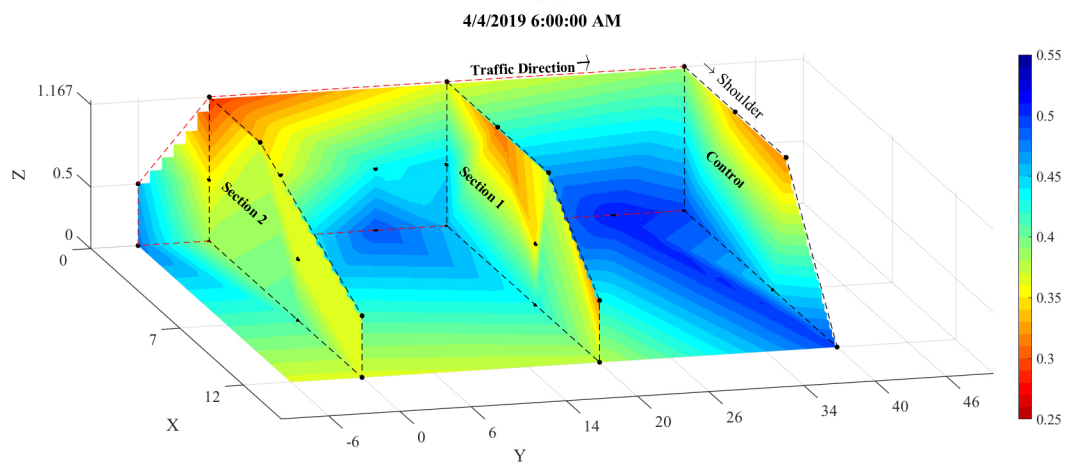
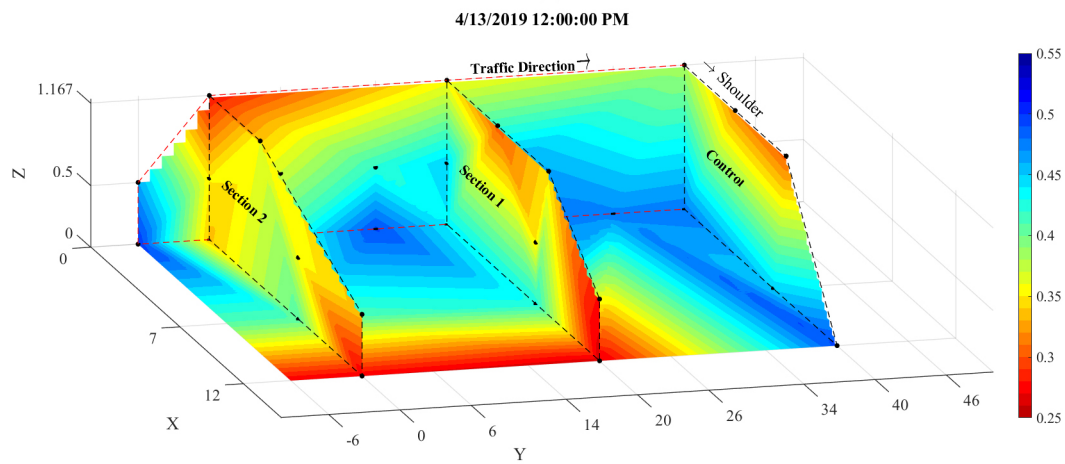
To better understand the effect of installing the wicking geotextile in reducing water content in the paved shoulder, the spatial distribution of the VWC was plotted at moments of before, during, and after a specific rainfall, as shown in Figure 3.7. Figure 3.7a shows the distribution of VWC on 11/12/2018, which is 7 days before the rainfall of 11/19/2018. At least one week had passed since the last rainfall and all test sections were relatively dry. Section 2 was the driest among all sections. The driest location in section 2 is at the upper part of the interface between the driving lane and the shoulder, which indicated superior performance since if the soil at that point were dry, it is unlikely for the pumping to occur.

Figure 3.7 VWC at different times before exposing the tip of the wicking geotextile at section 1: a) before rainfall on 11/12/2018, b) during rainfall on 11/19/2018, c) after rainfall on 12/11/2018, and after exposing the tip of the wicking geotextile at section 1: d) before rainfall on 4/2/2019, e) during rainfall on 4/4/2019, f) after rainfall on 4/13/2019.

Figure 3.7b shows the spatial distribution of the VWC during a rainfall event of 11/19/2018. The VWCs in all three sections increased in general, although the increases at the side slope portion were larger than that inside the shoulder. In addition, a noticeable increase in VWC at the inner edge of section 2 was observed. The VWC change in section 1 was between the increase in control and section 2. Figure 3.7c shows the distribution of VWCs in all sections after one week of no rainfall. Compared with Figure 3.7b, it was found that larger changes in VWC occurred in soils near the surface than those inside the road shoulder, and the largest VWC changes occurred in section 2 at the lower part of the interface between the driving lane and the shoulder. At similar locations in section 1, there were no visible changes in VWC, while in the control section, there was a slight increase in the VWC. Note that these readings took place before exposing the edge of the wicking geotextile.

A comparison of the same phenomenon after exposing the edge of the wicking geotextile in section 1 is shown in Figures 3.7d through 3.7f. Figure 3.7d shows the distribution of VWC on 4/2/2019, a few days after the last rainfall when the pavement was relatively dry. The overall VWC was higher than that shown in Figure 3.7a, indicating that the VWC increased during the spring of 2019. Section 2 was the driest section and section 1 was drier than the control section. During the rainfall on 4/4/2019 (Figure 3.7e), the VWC increased in all sections. The increase in VWC in subgrade at the inner edge of the pavement was much more compared to the upper layers. After eight days (Figure 3.7f), sections 1 and 2 noticeably dried compared to the control section, specifically at the outer edge of the pavement. Similar to what has been observed in Figures 3.7a through 9c, the superior performance of the improved sections is obvious.
