GEORGIA DOT RESEARCH PROJECT 17-19

**CRITICAL ASSESSMENT OF HFST'S LONG-TERM
PERFORMANCE IN GEORGIA UNDER
DIFFERENT ROADWAY CONDITIONS**

April 2022

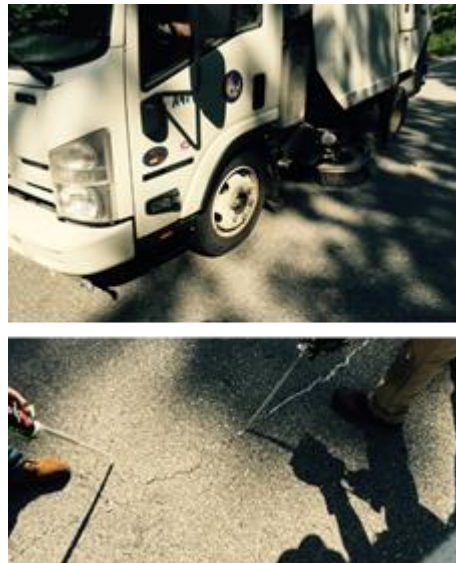
Figure 4 – Pictures. Surface cleaning (top) and cracks sealing with epoxy (bottom).

pavement surface. The pavement surface must be clean, dry, and free from ice, frost, loose aggregate, oil, grease, road salt, and other loose matter likely to interfere with the bonding between the binder materials to the surface. This is accomplished using mechanical sweepers, high pressure air, and/or other methods approved by the transportation agency or the engineer. Drainage structures, curbs, and other utility services must be protected to prevent them from being clogged with epoxy and aggregates. Inadequately filled joints and cracks are to be filled with resin binder and allowed to gel. Figure 4 shows a) cleaning of an existing road surface using a scrubber and b) sealing of cracks.

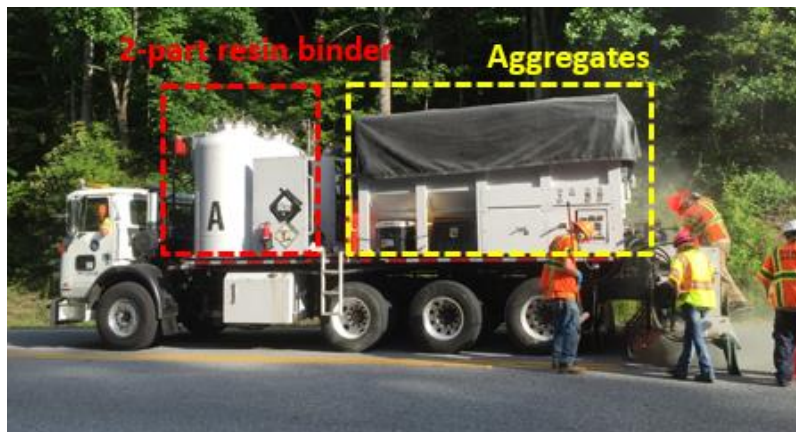
Figure 5 – Picture. Designated truck in operation, automatically placing HFST binder and aggregates.

methods and placed uniformly over the original surface as per the specified in-place thickness (GDOT specifies 60 mils). The aggregates are then placed on the binder at a specified rate (GDOT specification: 13 pounds per square yard) before the binder reaches its gel time. Complete coverage of the binder with aggregates is necessary to achieve a uniform surface. HFST placement can be done manually or automatically; Figure 5 shows the automatic placement using a designated truck. Figure 6 shows the binder and aggregates placement operation closely. The binder is spread evenly on the pavement and the aggregates are dropped uniformly within 5 seconds.

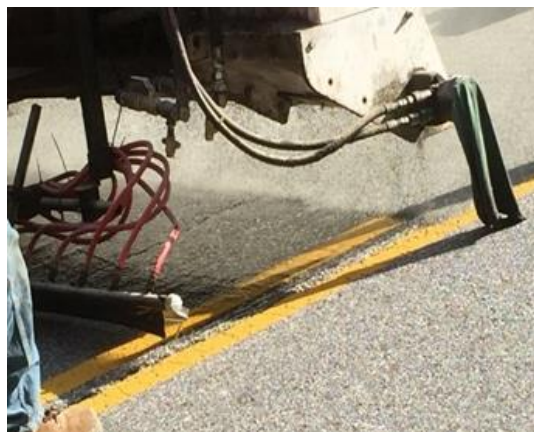
Figure 6 – Picture. Close up of automatic binder and aggregates placement.

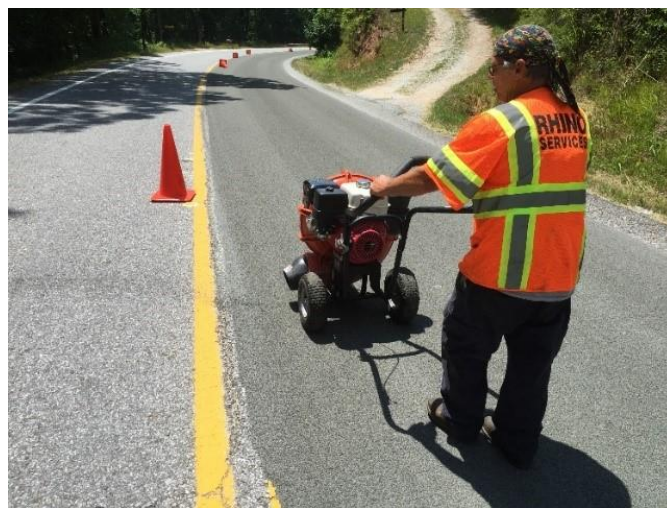
Figure 7 – Picture. Excess aggregate removal with mechanical blower.

The HFST is allowed to cure for approximately three hours without any traffic intervention. Finally, all excess aggregate should be removed using either hand brooms, mechanical sweeping, or suction methods. After all operations are complete and excess aggregate is removed after curing, the treated surface is opened for traffic. Figure 7 shows excess aggregate removal with a mechanical blower.

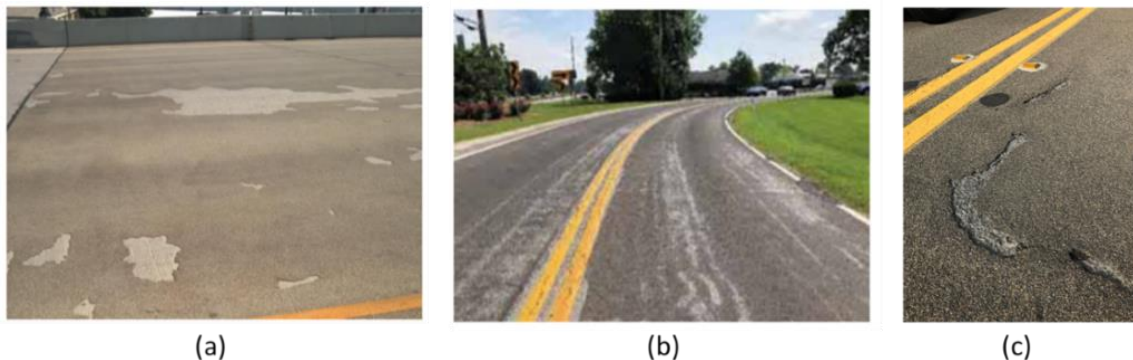
Figure 10 – Pictures. Examples of different HFST distresses: (a) HFST delamination (FDOT, 2019), (b) HFST aggregate loss (Courtesy of KYTC), and (c) Pavement pop-off with attached HFST (photographed by author).

Based on the National Survey, the most common distresses observed by DOTs in the premature failure cases are excessive HFST delamination, HFST aggregate loss, and pavement pop-off with attached HFST. Figure 10 shows an example of these common distresses. According to DOTs, the top-three causes for HFST premature failures are the following: 1) inadequate surface preparation, such as not filling the cracks, clearing the dust, etc., 2) moist pavement during HFST application, and 3) incorrect HFST binder thickness.

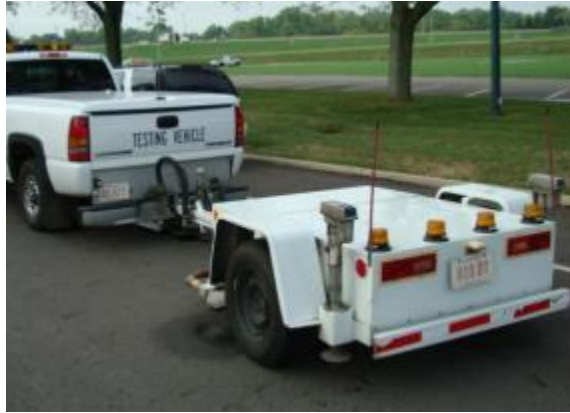
Figure 11 – Picture. Locked Wheel Skid Test Device (Source: Moravec, M. 2013).

A locked wheel device (LWD), as shown in Figure 11, is the most common friction measurement device used by state DOTs. ASTM E274 governs the method for measuring the skid resistance of paved surfaces with a locked wheel device. This test method utilizes a measurement representing the steady-state friction force on a locked test wheel as it is dragged over a wet pavement surface under constant load and at a constant speed (standard test speed is 40 mph). Skid testing is conducted using a smooth tire (ASTM E524) or a ribbed tire (ASTM E501). The primary advantage of this method is that no traffic control is required, and the friction is measured while the vehicle is moving. The output is a skid number (SN), which is the force required to slide the locked test tire at the stated speed divided by the effective wheel load and averaged over the testing area. SN values range from 0-100.

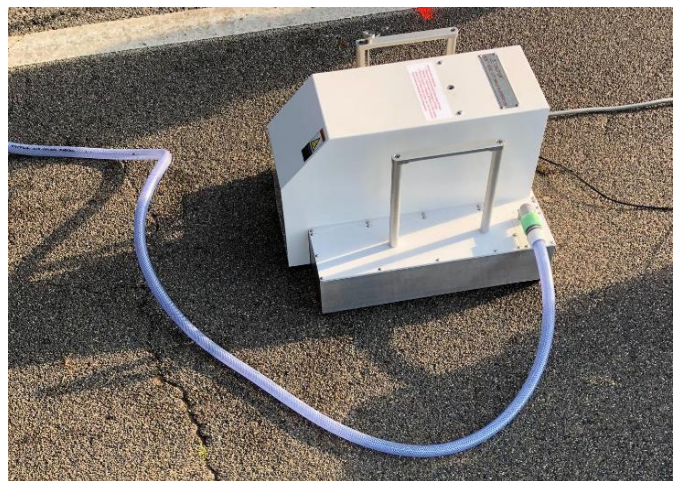
Figure 12 – Picture. Dynamic Friction Tester.

ASTM E1911 covers the standard method for measuring the surface friction using the DFT. This method provides a measure of surface friction as a function of sliding speed. DFT measurement is a static measurement and requires traffic control to let the engineers place the device on the road and collect the measurements. The output is a friction coefficient (0-1) that is used to indicate the surface friction. Figure 12 shows a DFT.

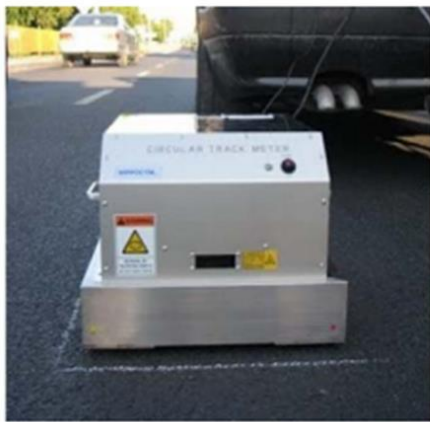
track having a diameter of 284 mm and the vertical displacement of the laser along the path is measured. The CTM is designed to measure the same circular track that is measured by the dynamic friction tester and report the mean profile depth (MPD) of the macrotexture profiles. ASTM E2157 covers the standards macrotexture measurement using the CTM and ASTM E1845-15 covers the standard practice for calculating pavement macrotexture MPD.

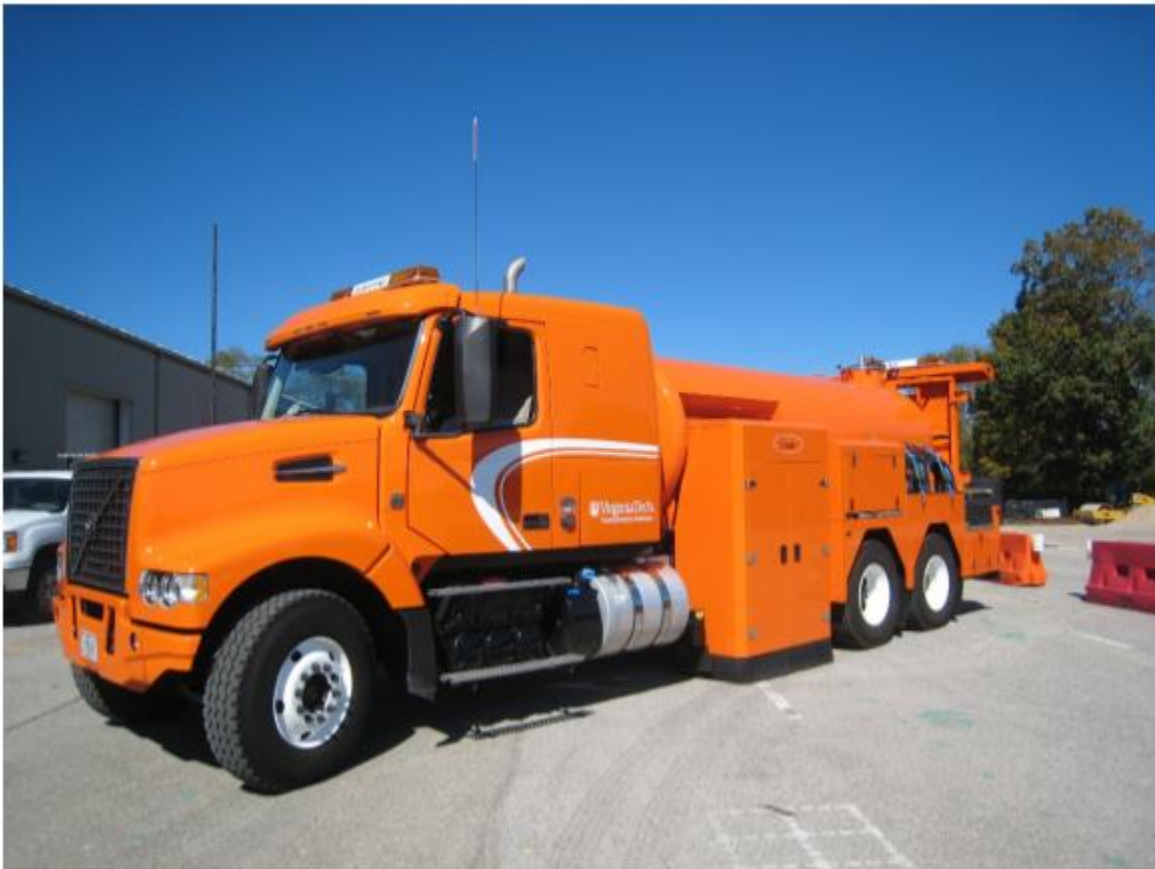
Figure 14 – Picture. Sideway-force Coefficient Routine Investigation Machine (SCRIM). (Image source: VTTI).

evaluation (by FHWA and Virginia Tech Transportation Institute) uses a high-speed laser device to measure macrotexture, especially mean profile depth (MPD), road geometry (grade, cross slope, and horizontal curvature), and temperature (pavement, tire, and air) in 1- and 10-meter averages. The SCRIM has an operating speed between 15 and 55 mph, and a range of 150 miles per 2,200-gal tank of water. Data from the SCRIM are geolocated to enable integration with other data sets (Izeppi et. al., 2019). Currently, the specifications for deploying the SCRIM are being developed by AASHTO. Figure 14 shows an image of a SCRIM device.

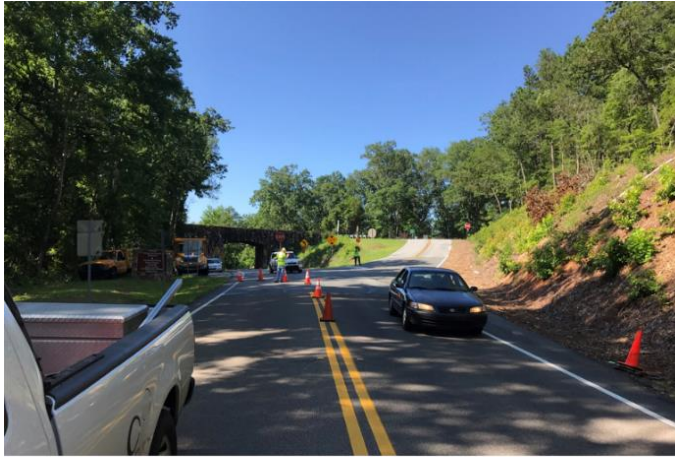
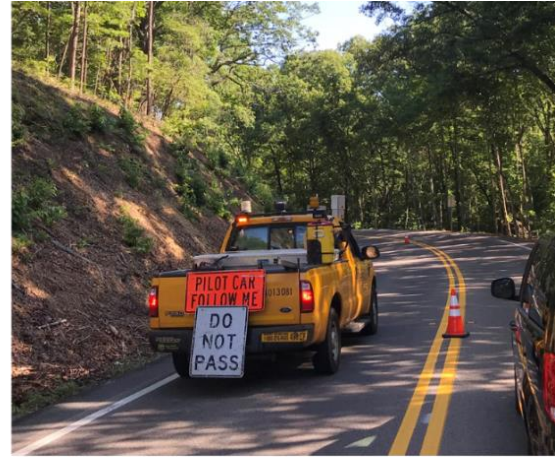
either direction. Figure 18a-b shows the traffic control of the curve site for the data collection.

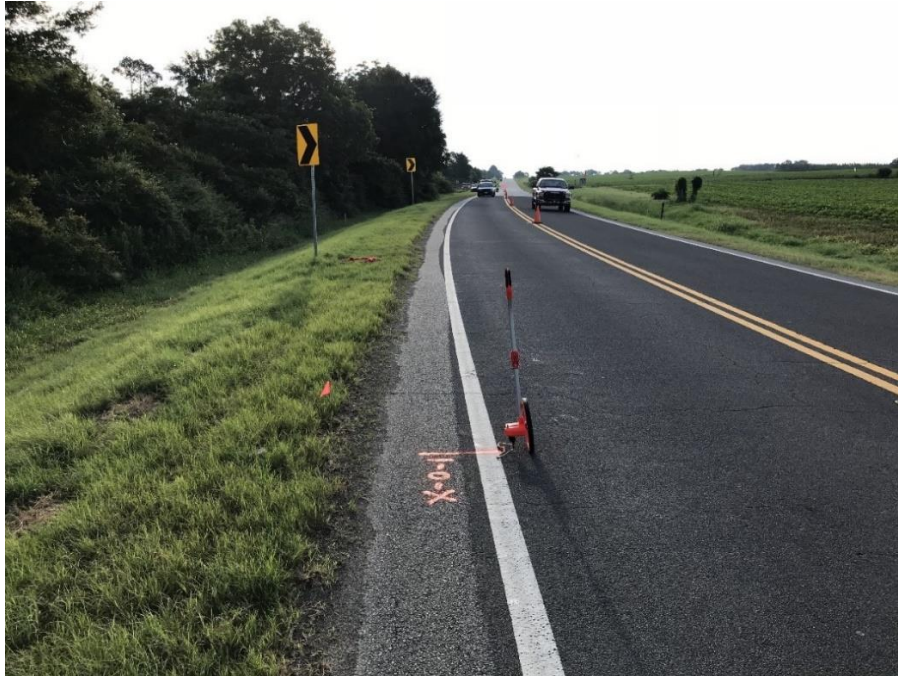
Figure 19 – Picture. Identification of spots in the middle of the curve site using a measuring wheel and a marking on the shoulder indicating the spot to collect data, I - Left wheel path, O - Right wheel path, X - non-wheel path.

In the field, the PC point is located with the help of GPS and a visual survey. The rest of the spots are located with respect to the PC point using a measuring wheel. Once the spots are located, markings are made with paint on the side of the shoulder to identify the same spot for the next data collection round (as shown in Figure 19). At each round, the marking on the shoulder was repainted so it would be visible for the subsequent round of data collection.

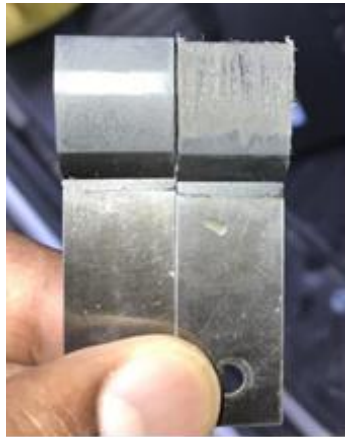
Figure 21 – Picture. Comparison of a new DFT rubber pad with the worn out DFT rubber pad after four measurements on calcined bauxite HFST.

4. Measure the 3D scan of the spot (using an LS-40 high resolution scanner) in such a manner that it captures a homogeneous surface of the spot (avoid cracks, oil spills, other contaminations, etc.).
5. Record the pavement temperature using the infrared thermometer placed roughly 2 feet above the pavement.
6. Measure the DFT readings on the testing spot. If the recorded friction measurement is not smooth at different speeds (fluctuating widely), slightly move the DFT (by less than an inch) and repeat the measurement. Replace the DFT rubber slider after 3-5 measurements when it becomes worn-out. Figure 21 shows an example of a new DFT rubber slider and a worn-out rubber slider; it can be clearly seen the worn-out rubber slider is flat and has several cuts across it.

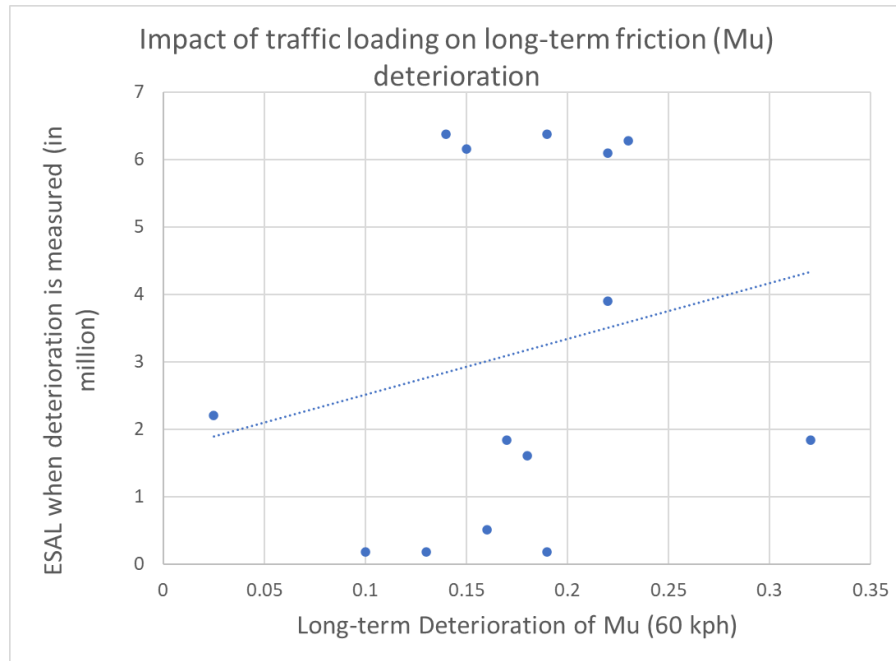
Figure 34 – Graph. Long-term friction deterioration vs. ESALs for calcined bauxite HFST.

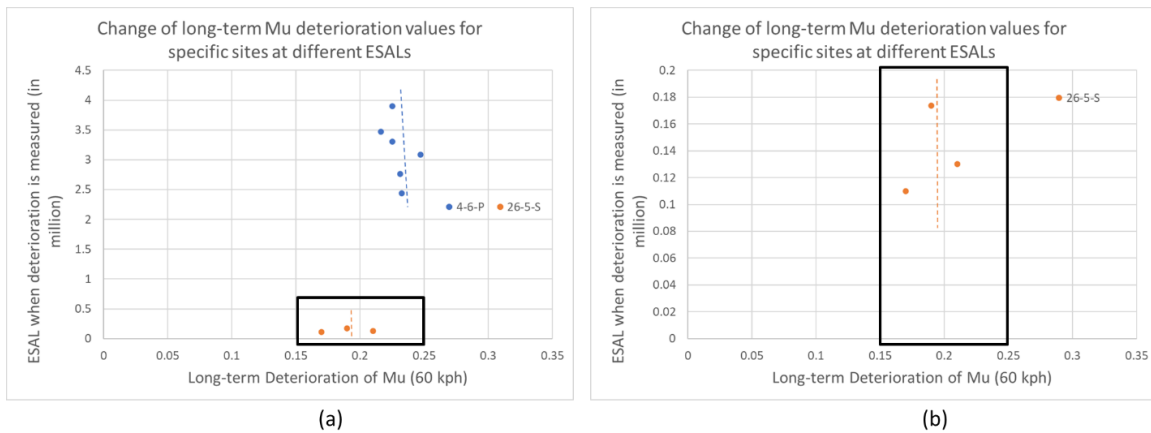
Figure 35 – Graph. Long-term friction deterioration values for two calcined bauxite HFST (4-6-P and 26-5-S) at different ESALs of loading.

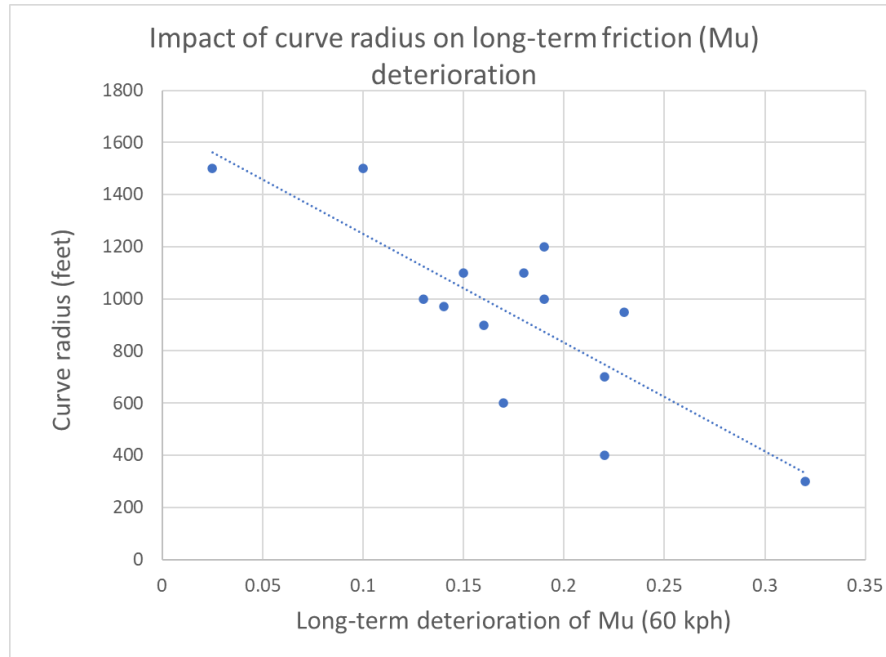
Figure 36 – Graph. Long-term friction deterioration vs. curve radius for calcined bauxite HFST.

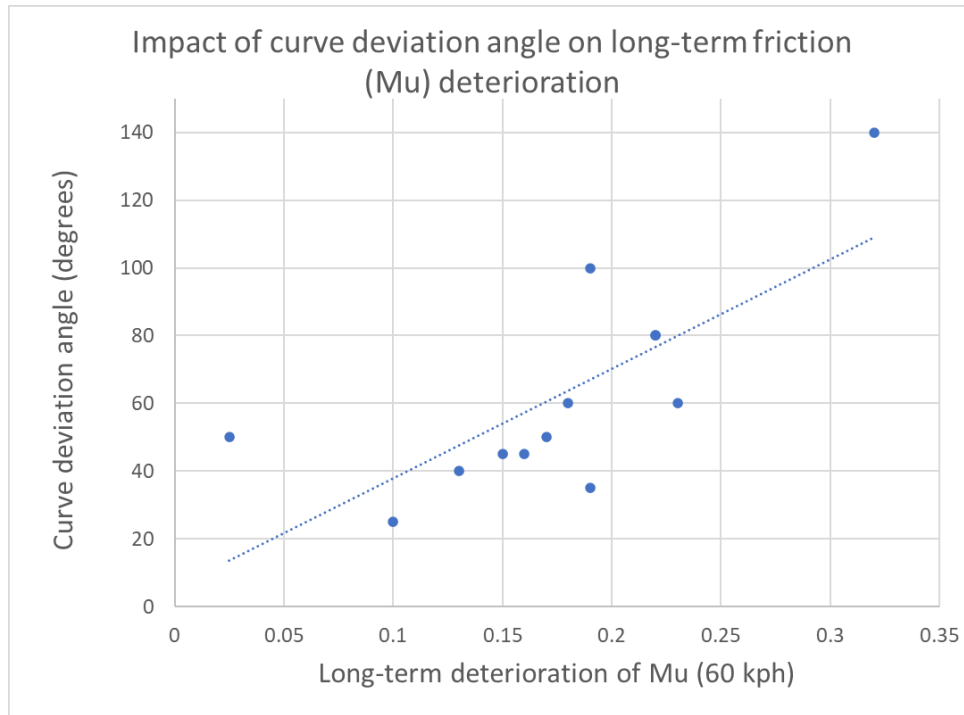
Figure 38 – Graph. Long-term friction deterioration vs. curve deviation angle for calcined bauxite HFST.

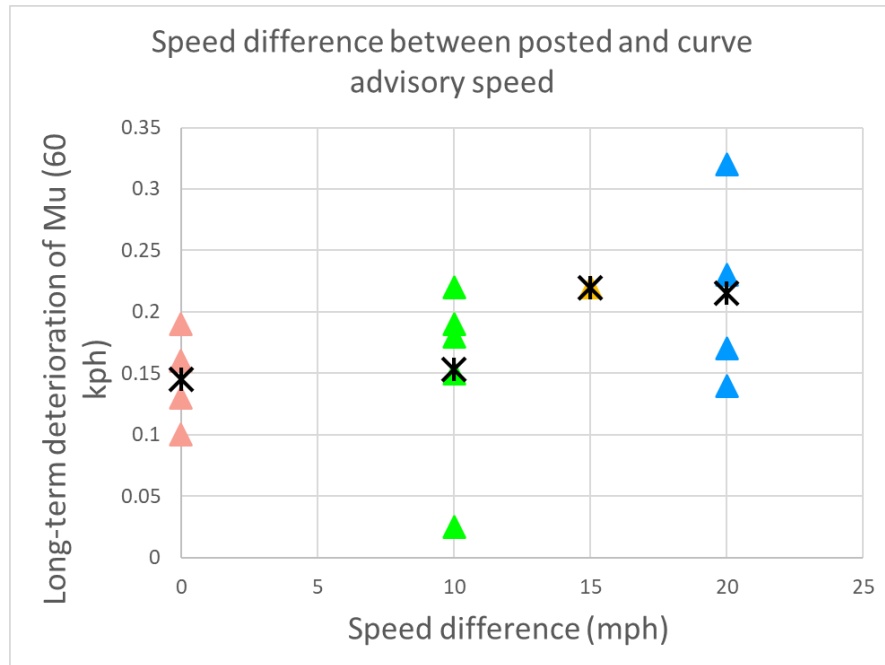
Figure 39 – Graph. Long-term friction deterioration comparison for 0, 10, 15, and 20 mph speed difference at the calcined bauxite HFST curves.

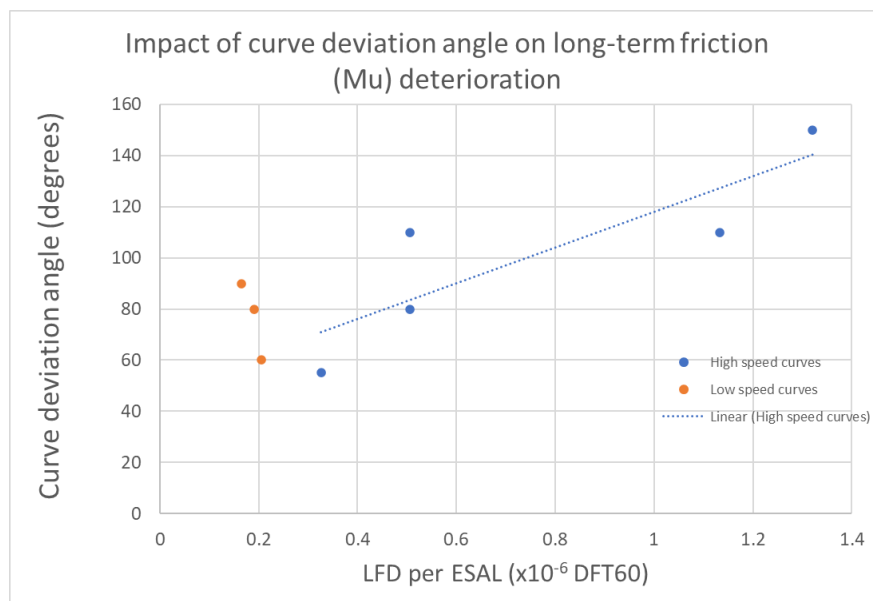
Figure 43 – Graph. Long-term friction deterioration vs. curve deviation angle for phonolite TPO.

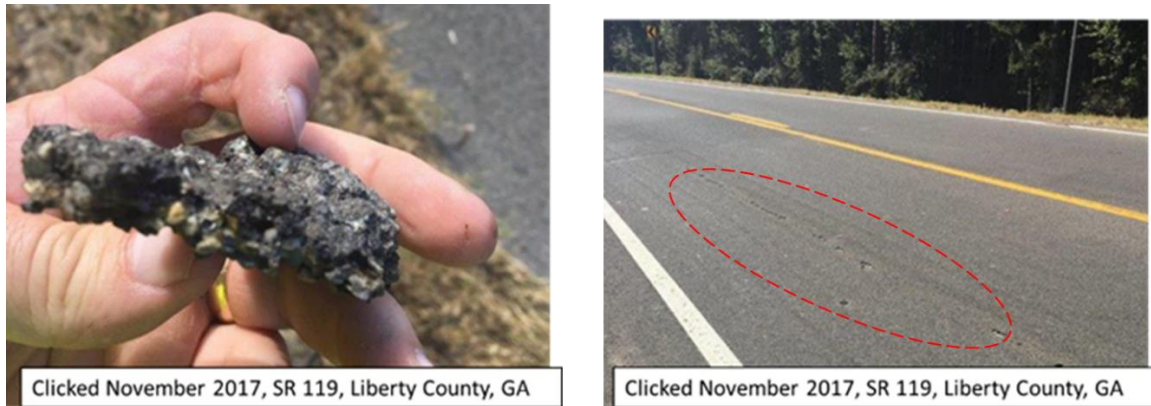
Figure 54 – Pictures. Asphalt pavement pop-off along with HFST layer in SR 119, Liberty County, GA. (this site has been replaced).

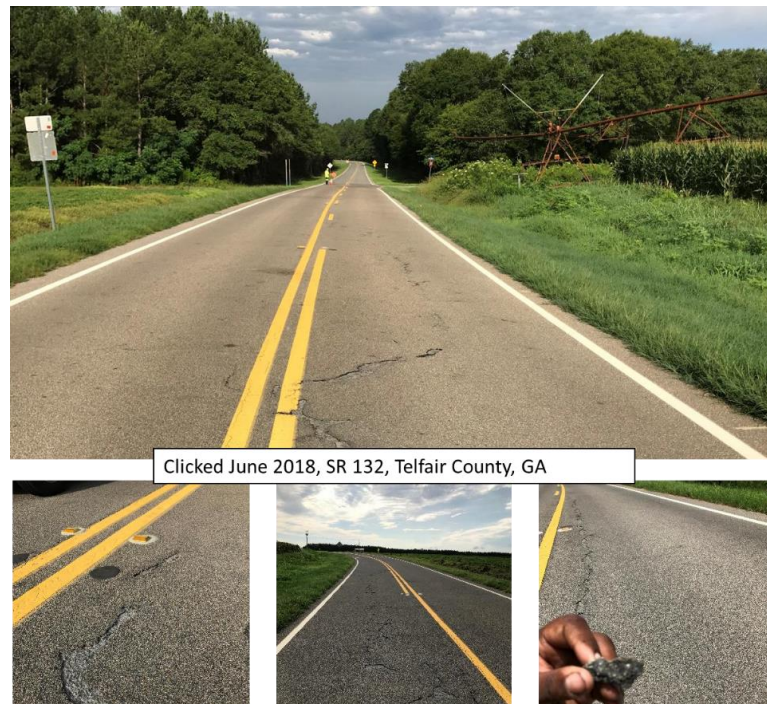
Figure 55 – Pictures. Asphalt pavement pop-off along with HFST layer in SR 132, Telfair County, GA.

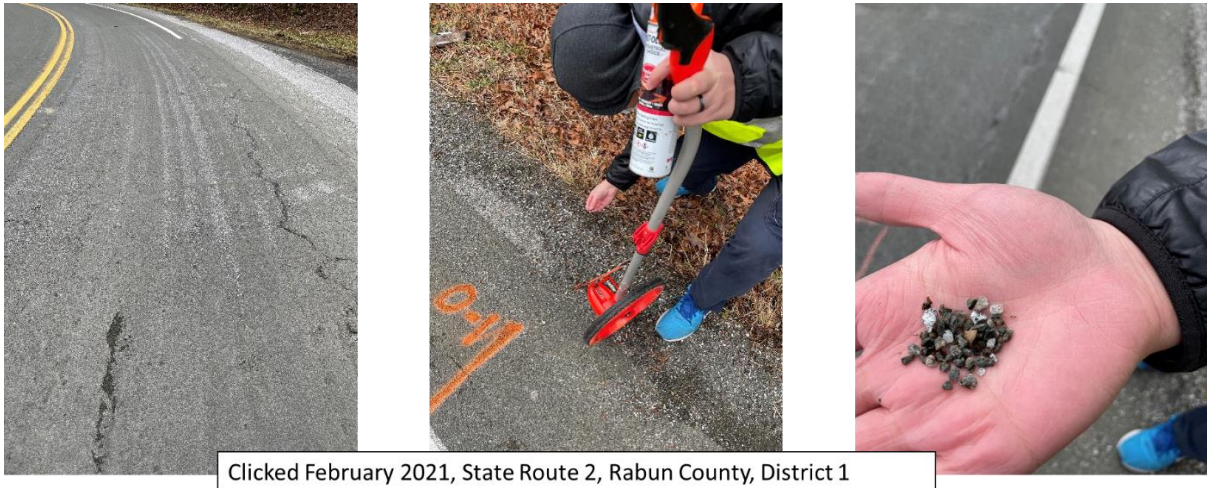
Figure 57 – Pictures. Aggregate loss on the wheel path as well as dislodged aggregates on the shoulder.

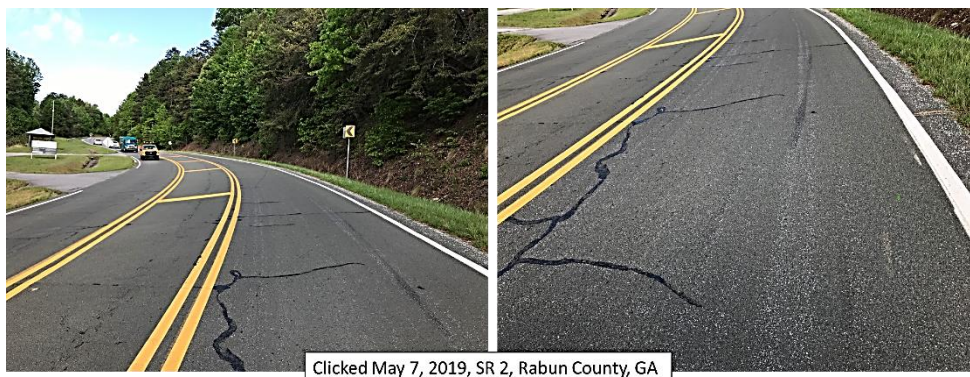
Figure 58 – Pictures. Wheel path aggregate loss without a strong pattern, SR 2, Rabun County, GA.
