RESEARCH REPORT

Assessment of Asbestos Containing Materials in Idaho Bridges

RP 283

May 2021

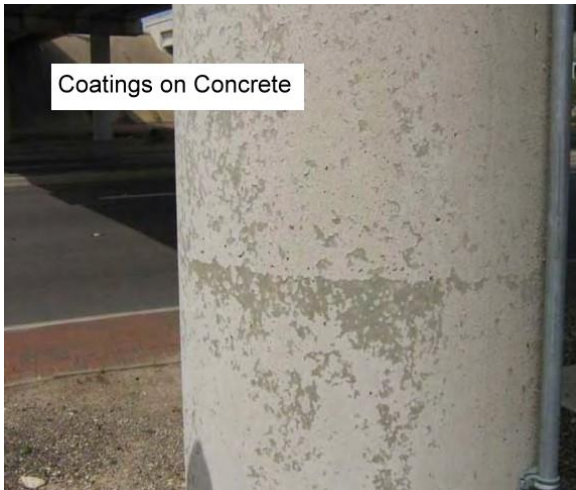
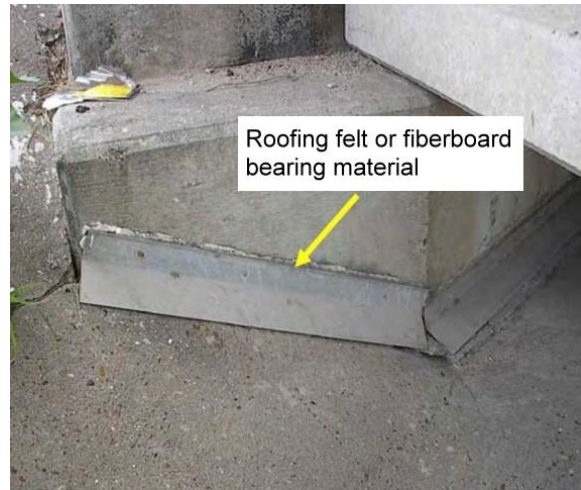
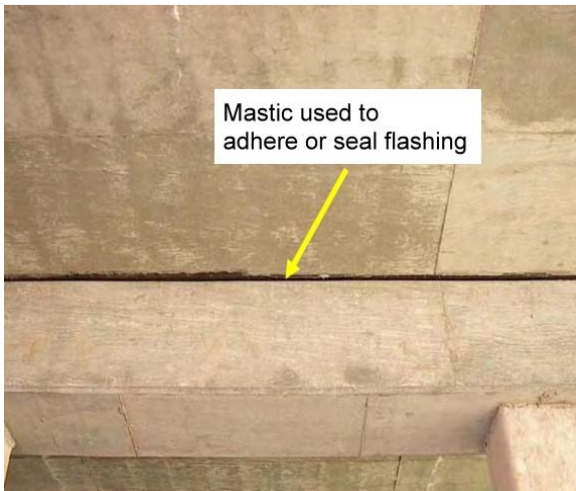
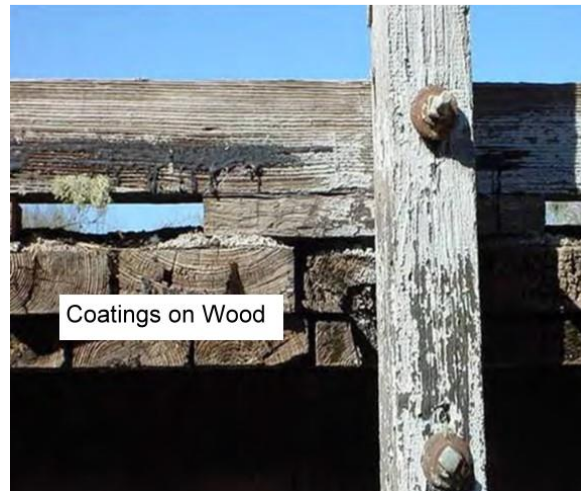
Figure 2.1 Common sources of Asbestos found in bridges (Morse, et al. 2008). (a) shows potential asbestos coating on concrete, (b) photo shows use of felt or fiberboard bearing material which may contain asbestos, (c) shows location of adhesive mastic with possible asbestos, and (d) photo shows possible use of coatings with ACMS on wood.

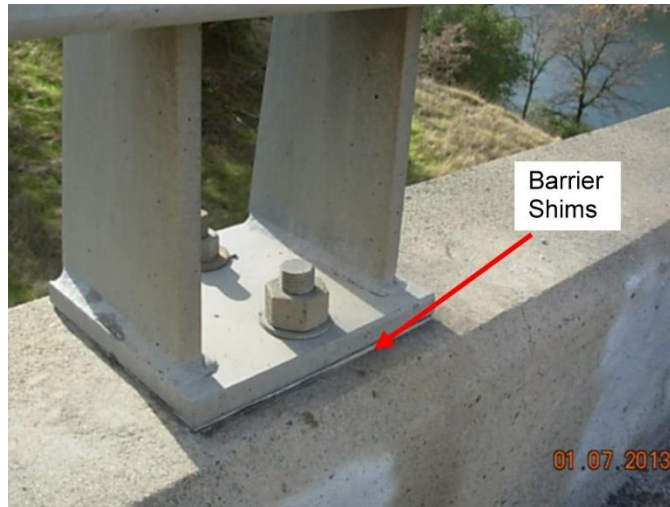
Figure 2.2 Barrier rail shims with ACM (Caltrans 2013)

The California Department of Transportation (Caltrans) produced an asbestos and lead containing paint survey report for the Tuolumne River Bridge (Caltrans 2013). The project focused on collecting bulk samples for chemical analysis. Six representative samples were selected from the bridge pads, concrete, and barrier rail shims (sheet packing). Laboratory analysis indicated 70 percent of chrysotile asbestos in the barrier rail shims. Figure 2.2 shows the location of these barrier shims, which are used to separate the rail baseplate from the concrete barrier. Interestingly, NESHAP did not require the removal of the asbestos containing barrier shims prior to renovations.

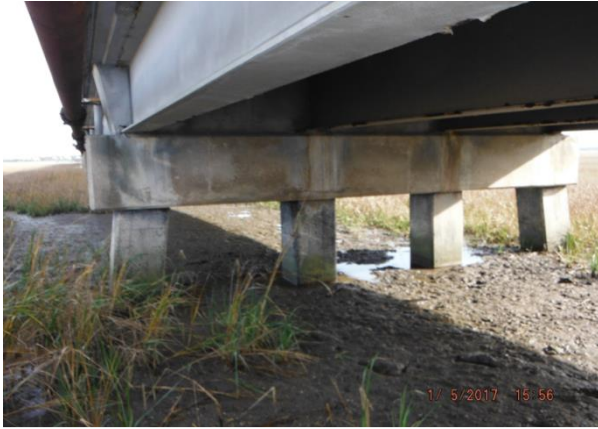
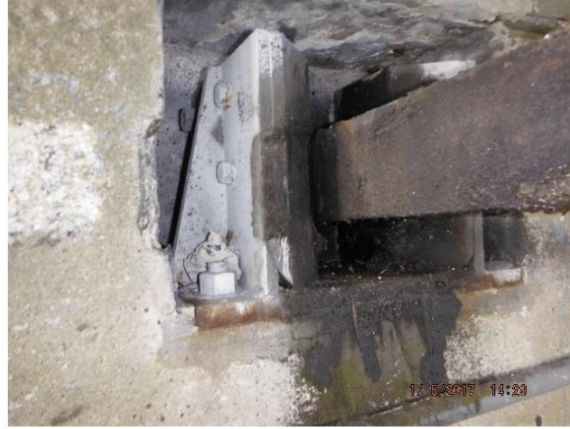
Figure 2.4 US-21 Sea Island Parkway Bridge over the Harbor River (F&ME Consultants 2017).
(a) bridge bents with joint-filler, and (b) swing braking parts

Figure 2.4 shows some of these locations. The figure on the left shows one of the bridge bents where the inspectors collected gray expansion joint like-materials. The figure in the right shows the swing part braking pad, where samples were not collected as the material did not appear to contain asbestos.
