# **MASH TL-3 EVALUATION OF THE TxDOT TL-3 LOW-PROFILE BARRIER FOR HIGH SPEED APPLICATIONS**

**Test Report 0-6968-R1**

**TEXAS A&M TRANSPORTATION INSTITUTE**

**TEXAS DEPARTMENT OF TRANSPORTATION**

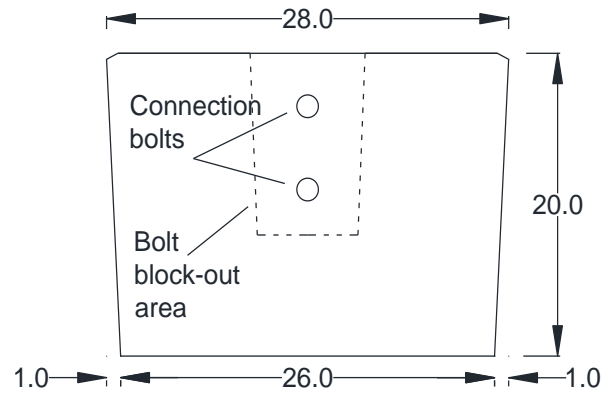
**Figure 1.1. 20-Inch Tall Low-Profile Barrier.**

To address this sight-distance problem while still shielding errant vehicles from various work zone hazards, researchers at the Texas A&M Transportation Institute (TTI) developed a 20-inch tall low-profile PCB (Figure 1.1) for use in low-speed work zones (2). This 20-inch tall low-profile barrier was designed with a negative 1:20 vertical slope on the face, which reduces the vertical climb of the vehicle during an impact. The 20-ft long segments and connection tolerance allow the system to accommodate both vertical and horizontal roadway curvature. Full-

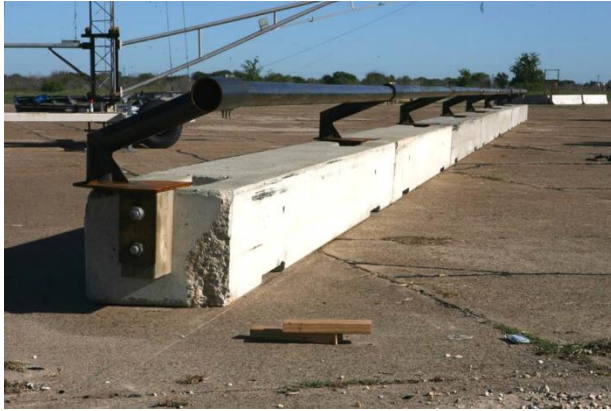
**Figure 1.2. Roadside Application.**

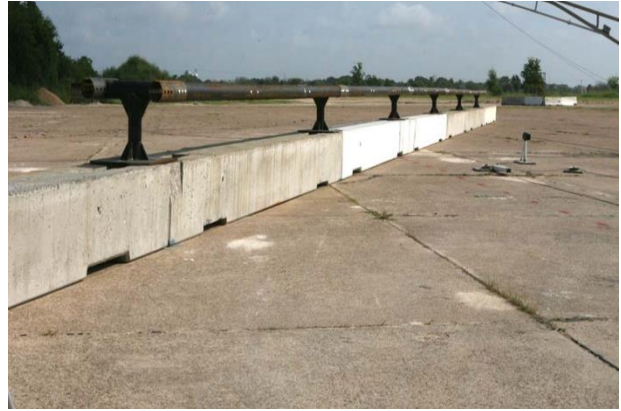
**Figure 1.3. Median Application.**

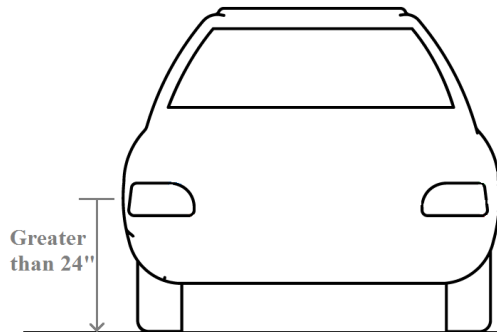
**Figure 2.1. Requirement of Vehicle Lens Mounting Height.**

In 1991, Guidry and Beason conducted a random survey of 100 vehicles to establish the range of typical headlight heights and found most cars at that time had headlight mounting heights between 24 and 28 inches (2). Simplified geometric analyses were conducted to study the sight-distance problem. It was found that the cross-traffic driver’s sight-distance is unlimited as long as the barrier height is less than 24 inches (minimum headlight mounting height) for constant slope and sag vertical curves. In the case of crest vertical curves, it was found that the

cross-traffic driver's sight-distance is significantly increased by using barrier heights of less than 24 inches.

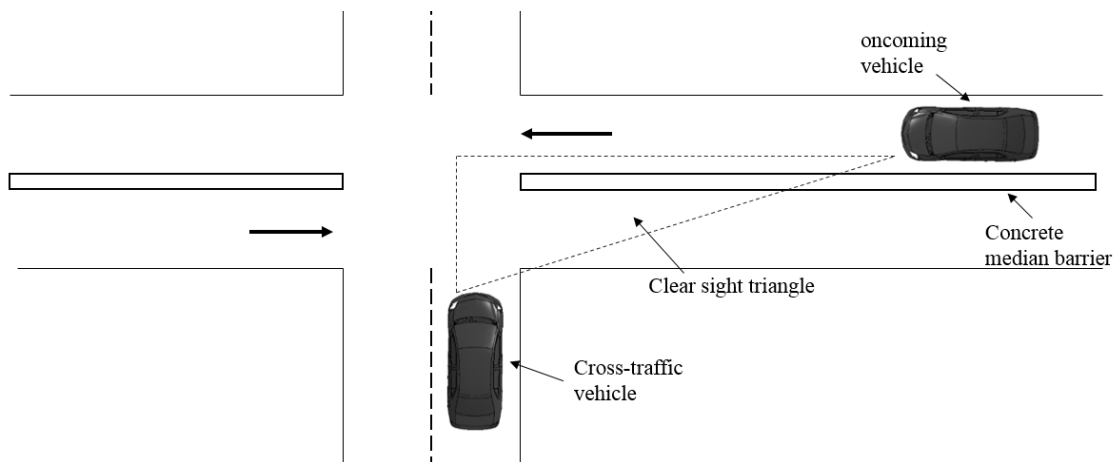
**Figure 2.2. Sight Obstruction (Median Barrier Application).**

Intersections can have issues with sight-distance obstruction. Each quadrant of an intersection should contain a triangular area free of obstructions that might block an approaching driver's view of potentially conflicting vehicles. Figures 2.2 and 2.3 illustrate the geometry of the sight obstruction problem of median and roadside barriers at intersections.

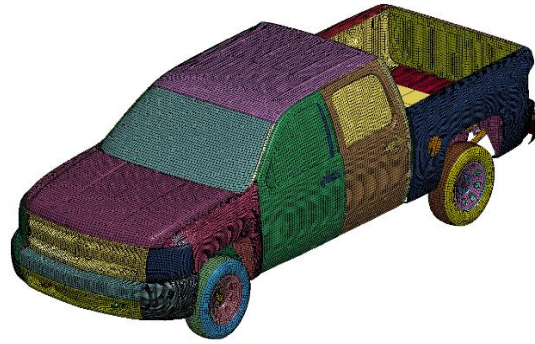
**Figure 2.7. Available MASH 2270P Pickup Truck FE Model (10).**

Test conditions of *MASH* Test 3-11 were replicated with a pickup truck model representing the *MASH* vehicle 2270P (Figure 2.7), impacting the PCB system at *MASH* TL-3 nominal conditions of 62 mi/h speed and 25° angle (10).

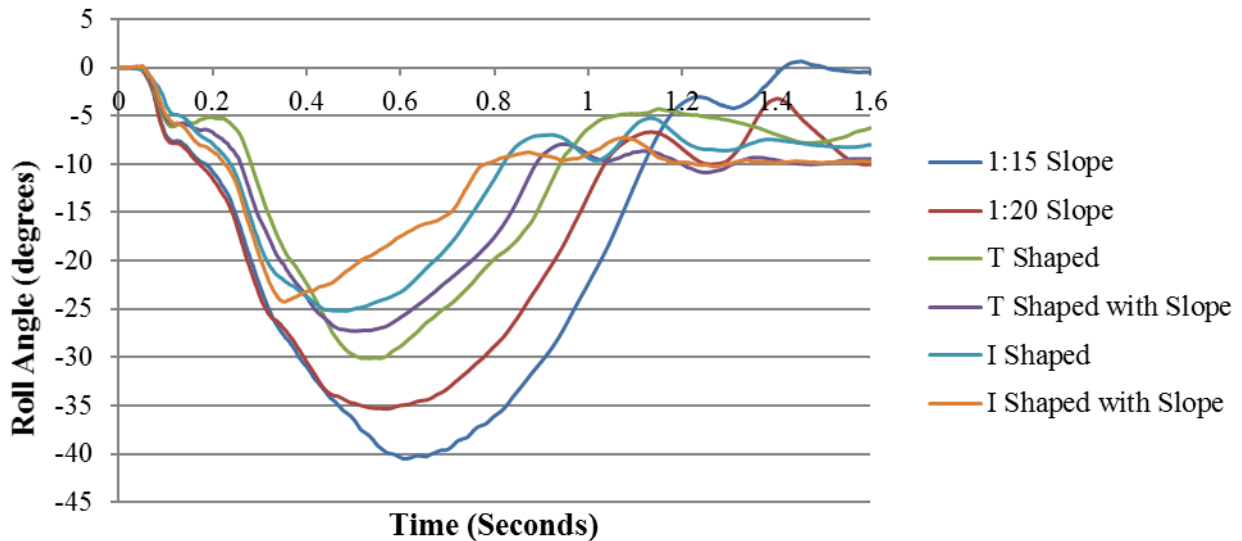
**Figure 2.9. Roll Angle Comparison of 26-Inch Tall Barrier Concepts with Impact Tire Disengagement.**

Figure 2.9 summarizes the vehicle roll angular displacements recorded during the impacts for those simulations that were modeled with impact tire disengagement. Figure 2.10 summarizes the vehicle roll angular displacements recorded during the impacts for those simulations that were modeled without impact tire disengagement.

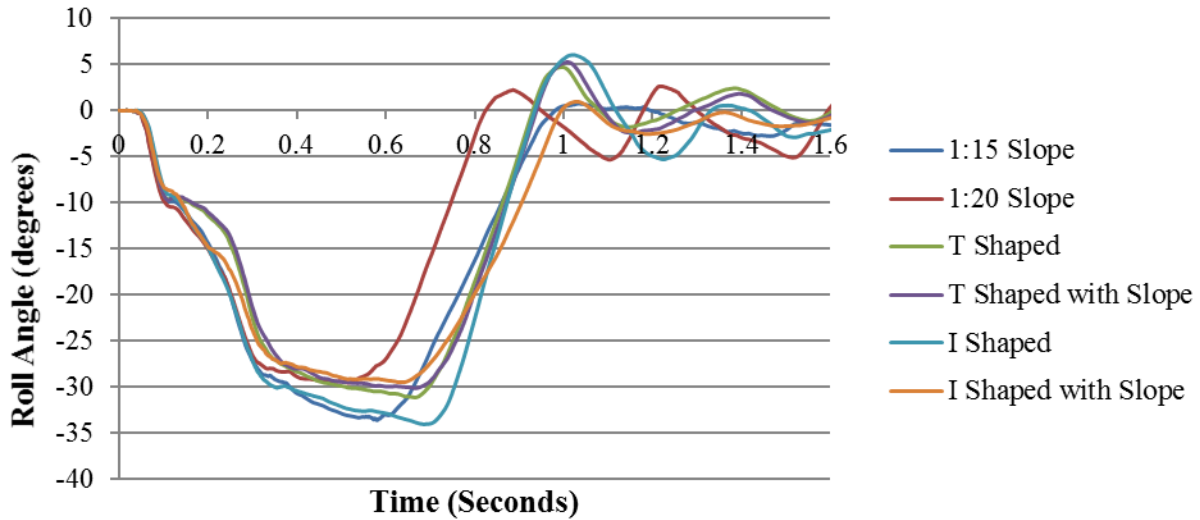
**Figure 2.10. Roll Angle Comparison of 26-Inch Tall Barriers without Impact Tire Disengagement.**

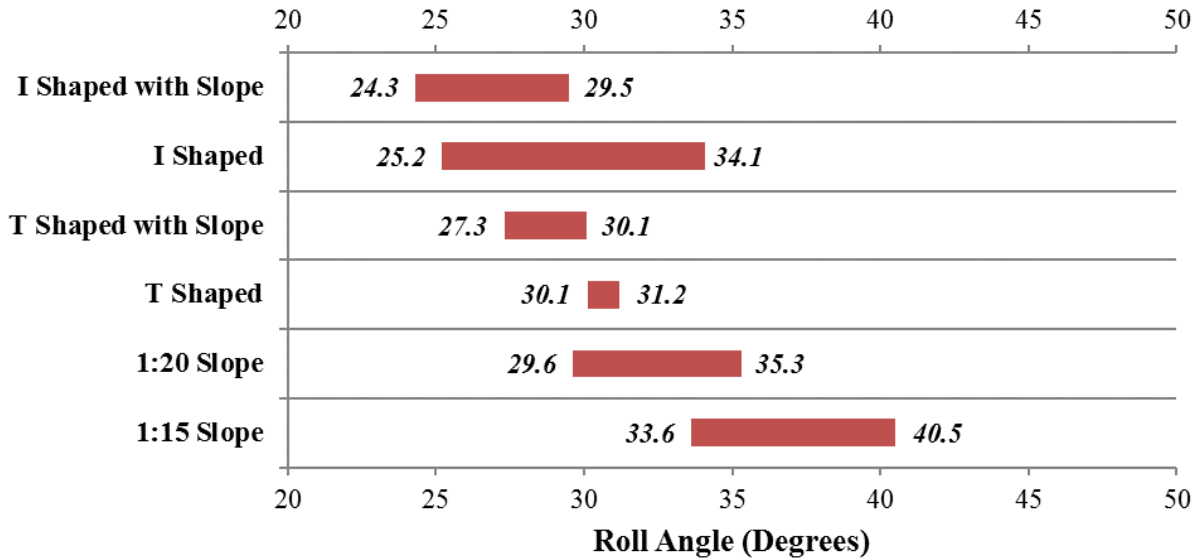
**Figure 2.11. Range of Maximum Roll Angles for 26-Inch Tall Barrier Concepts.**

The conducted preliminary simulations on the 26-inch tall PCB systems suggest that a 26 inches height is adequate to contain and redirect the 2270P vehicle within the *MASH* stability criteria. Therefore, it was decided to explore barriers with a height of 24 inches.

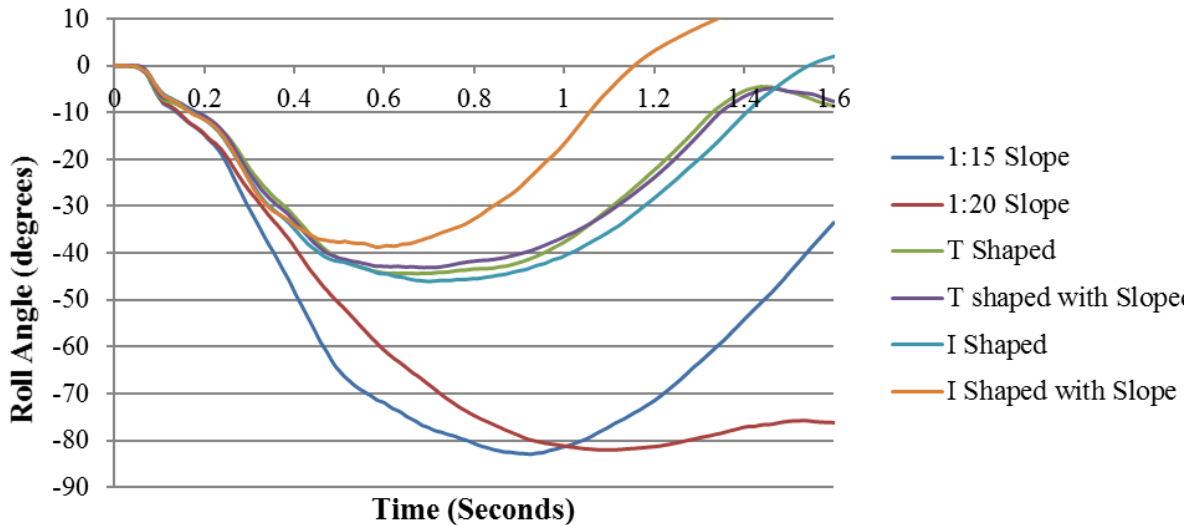
**Figure 2.12. Roll Angle Comparison of 24-Inch Tall Barrier Concepts with Impact Tire Disengagement.**

Simulations were conducted with the pickup truck vehicle impacting the PCB system at a speed of 62 mi/h and an impact angle of 25°. Impact location was the one-third point of the 120-ft long, 24-inch tall concrete rigid block. Evaluated PCB systems included proposed PCB profile concepts of 1:15 negative slope, 1:20 negative slope, T-shaped, T-shaped with a 1:20 negative slope, I-shaped, I-shaped with a 1:20 negative slope. The 2270P vehicle was contained and redirected by all the 24-inch tall PCB systems. Figure 2.12 summarizes the vehicle roll angular displacements for the simulations modeled with impact tire disengagement. Figure 2.13 summarizes the vehicle roll angular displacements for the simulations modeled without impact tire disengagement.

During the impact events against the 1:15 and 1:20 slope profiles (with impact tire disengagement), the 2270P vehicle was unstable and had unacceptable behavior. In both cases, the recorded maximum roll angular displacements were above the required *MASH* limits, failing the *MASH* requirements for vehicle stability. Figure 2.12 suggests that vehicle stability was acceptable during the impact events against the T-shaped and I-shaped low-profile PCBs with impact tire disengagement. For these cases, the vehicle roll angular displacement ranged between roughly 39° and 46°. When the tire disengagement option is not applied (Figure 2.13), the recorded maximum roll angular displacements were all below 38°.

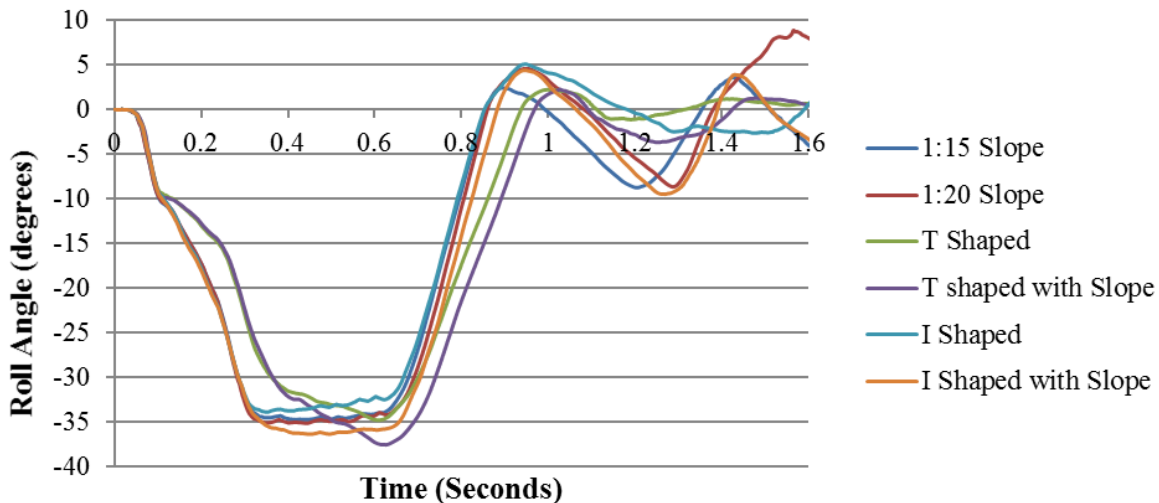
**Figure 2.13. Roll Angle Comparison of 24-Inch Tall Barriers without Impact Tire Disengagement.**

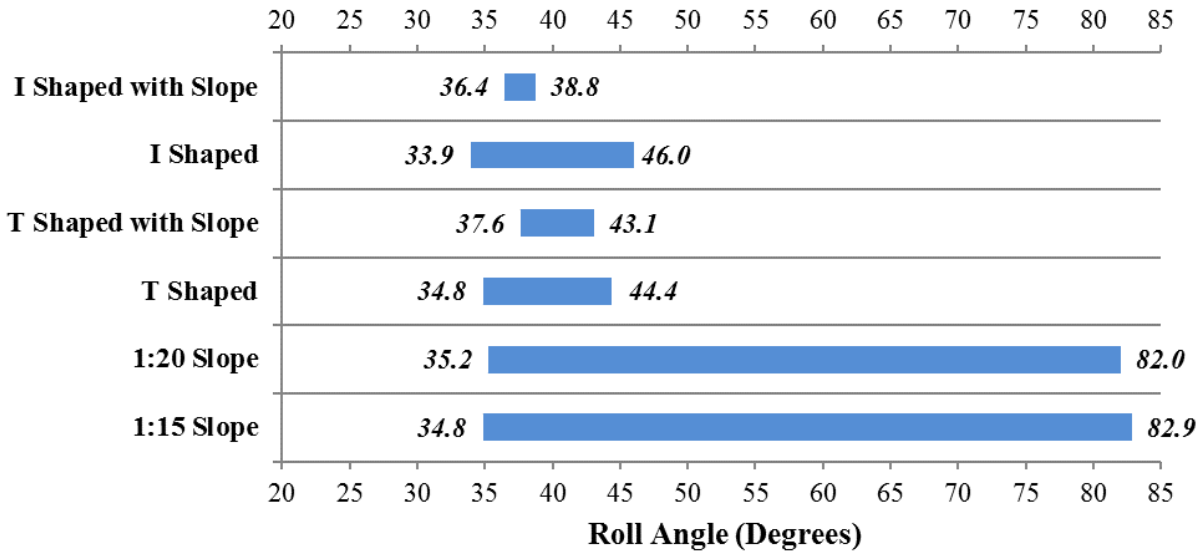
**Figure 2.14. Range of Maximum Roll Angles for 24-Inch Tall Barrier Concepts.**

The preliminary simulations conducted on the 24-inch tall PCB systems suggest that not all the proposed barrier profiles would be able to adequately contain and redirect the impacting 2270P vehicle within *MASH* stability criteria. For the case of the sloped profiles (1:15 and 1:20), the 2270P vehicle has a high probability of rollover.

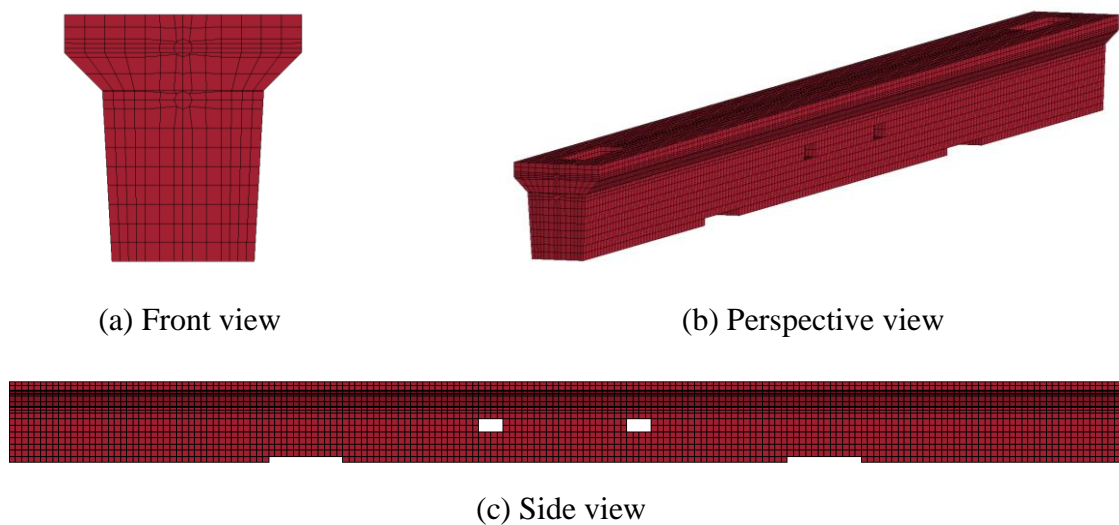
**Figure 2.15. Detailed FE Model of 26-Inch Tall T-Shaped Low-Profile PCB Segment.**

The detailed FE model of the T-shaped low-profile PCB included barrier segment length, drainage scuppers, and segment connection details, such as steel rods, plate washers, washers, and nuts. The detailed PCB full system model is comprised of six 26-inch tall and 30-ft long barrier segments, for a total system length of 180 ft. The length of the barrier segment was discussed and approved by TxDOT based on horizontal curvature application needs. No concrete failure options were implemented in the detailed FE model. Therefore, the developed model does not have the ability to predict fracture or even spalling of concrete, which might be likely to be experienced during the full-scale crash test. Figure 2.15 shows the detailed FE model of a barrier segment. Figure 2.16 illustrates the modeled connection details between two barrier segments. The barrier system was modeled as free-standing.

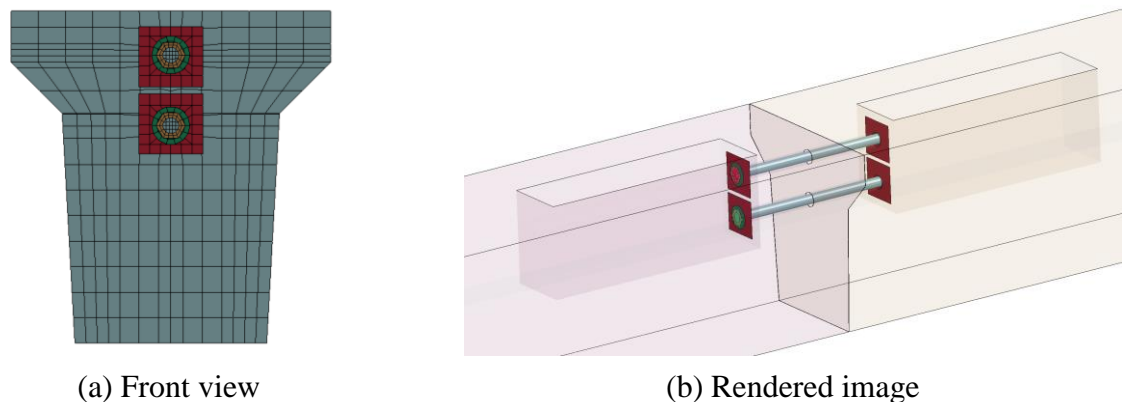
**Figure 2.16. Detailed FE Model of Barrier Segments Connections.**

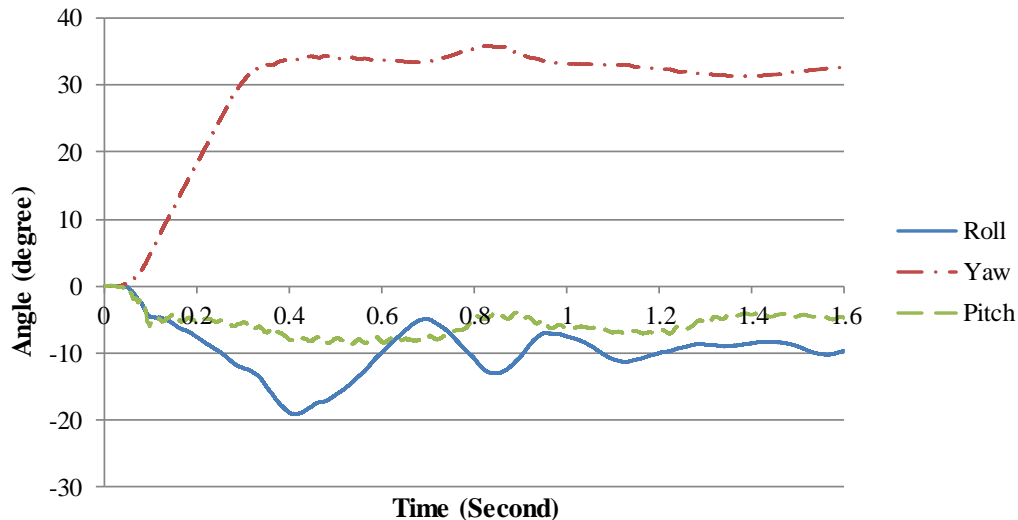
**Figure 2.17. Angular Displacements for Tire Disengagement Detailed Simulation Case.**

The modeled 2270P vehicle remained upright during and after the impact event. Figure 2.17 shows vehicle roll, pitch, and yaw angles throughout the impact event against the 26-inch tall low-profile PCB. Maximum roll, pitch, and yaw angles were  $-19.2^\circ$ ,  $-8.8^\circ$ , and  $35.9^\circ$ , respectively, which satisfied *MASH* stability criteria.

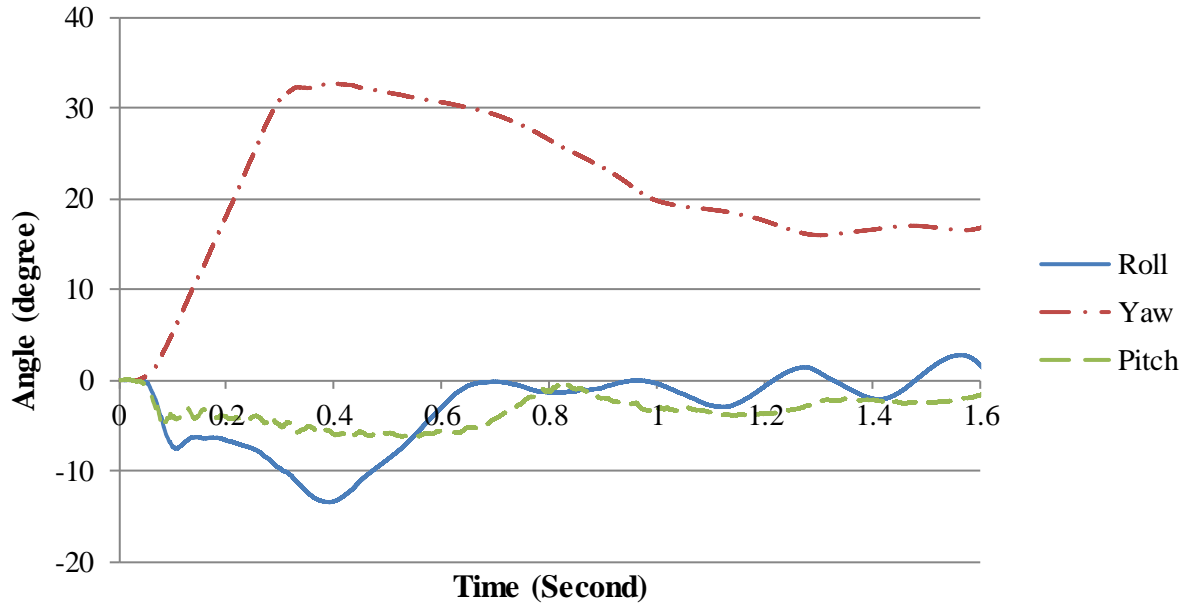
**Figure 2.18. Angular Displacements for No-Tire Disengagement Detailed Simulation Case.**

The modeled 2270P vehicle remained upright during and after the modeled collision event. Figure 2.18 shows vehicle roll, pitch, and yaw angles throughout the impact event against the 26-inch tall low-profile PCB. Maximum roll, pitch, and yaw angles were  $-13.5^\circ$ ,  $-6.3^\circ$ , and  $32.7^\circ$ , respectively, which met *MASH* stability criteria.

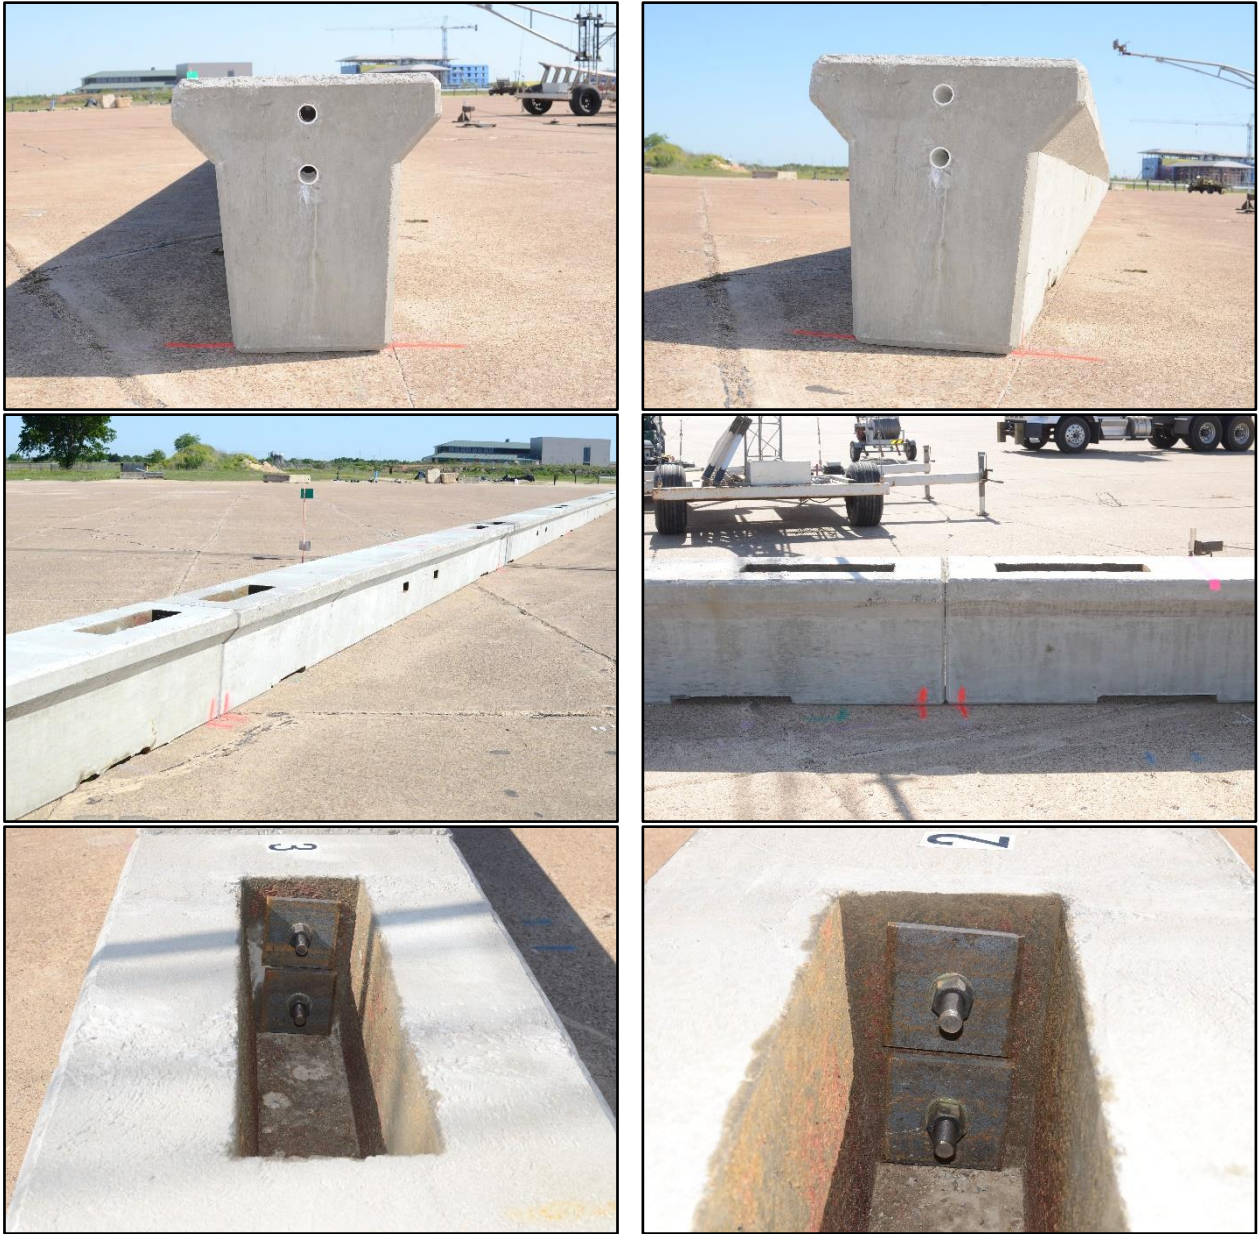
**Figure 3.2. TL-3 Low-Profile Barrier prior to Testing.**

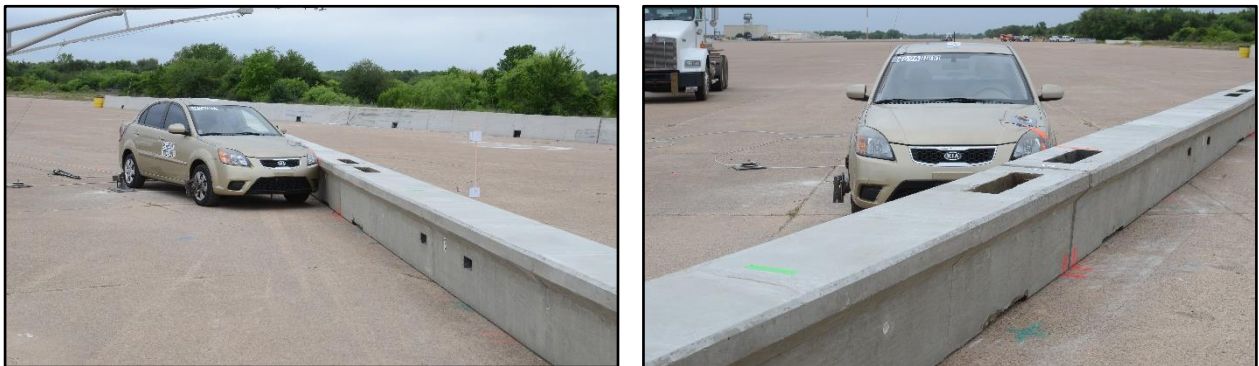
**Figure 6.1. TL-3 Low-Profile Barrier/Test Vehicle Geometrics for Test No. 469688-1-1.**

Figures 6.1 and 6.2 show the 2011 Kia Rio used for the crash test. The vehicle's test inertia weight was 2423 lb, and its gross static weight was 2588 lb. The height to the lower edge of the vehicle bumper was 7.75 inches, and height to the upper edge of the bumper was 21.5 inches. Tables C.1 and C.2 in Appendix C1 give additional dimensions and information on the vehicle. The vehicle was directed into the installation using a cable reverse tow and guidance system, and was released to be freewheeling and unrestrained just prior to impact.

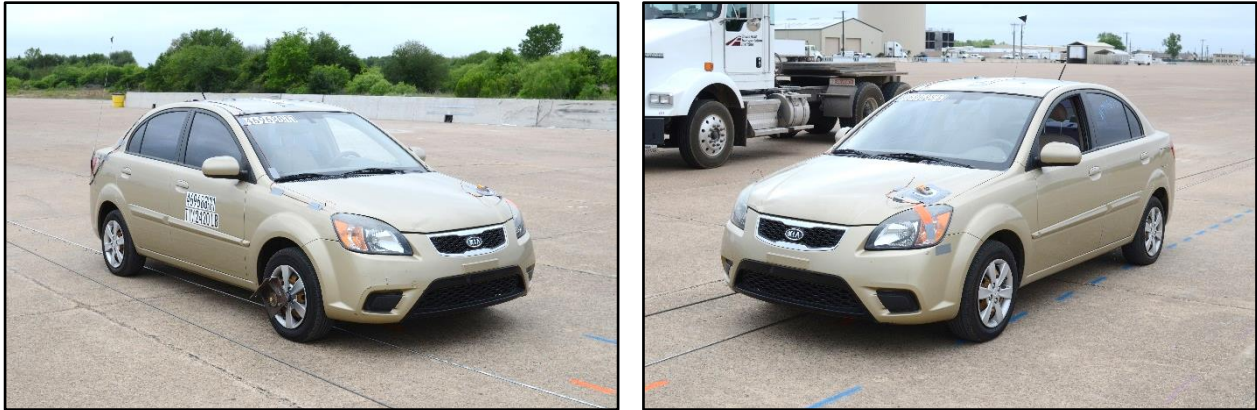
**Figure 6.2. Test Vehicle before Test No. 469688-1-1.**

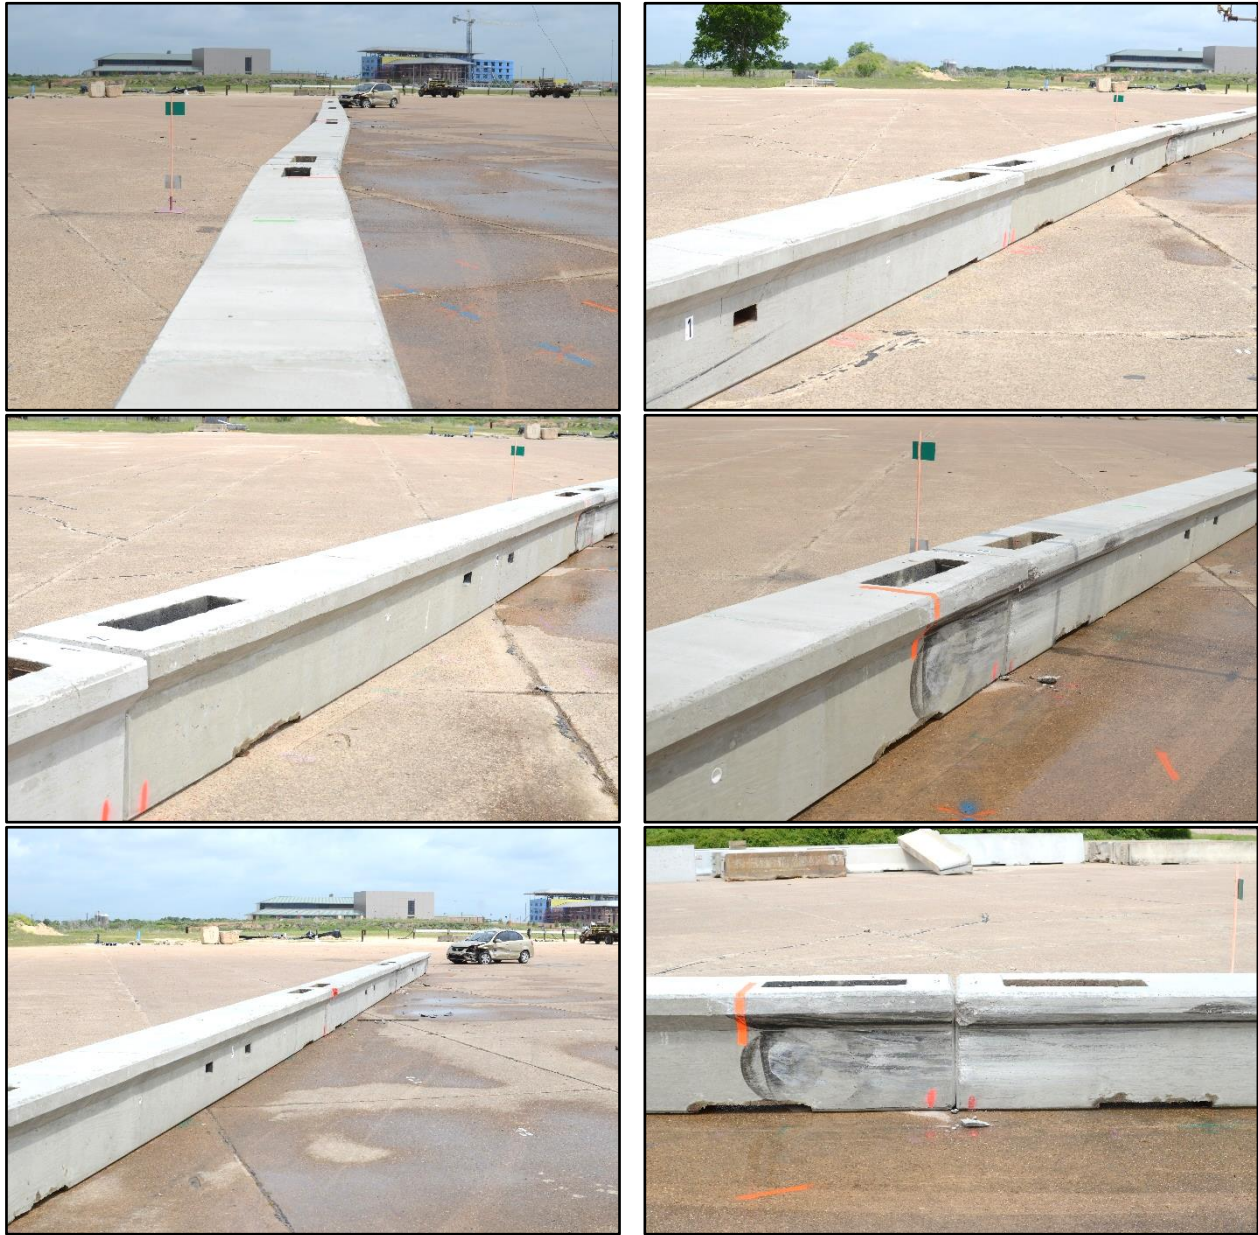
**Figure 6.3. TL-3 Low-Profile Barrier after Test No. 469688-1-1.**

width was 38.5 inches, and the height of maximum working width was 26.0 inches. Maximum dynamic deflection during the test was 13.2 inches, and maximum permanent deformation was 13.0 inches.

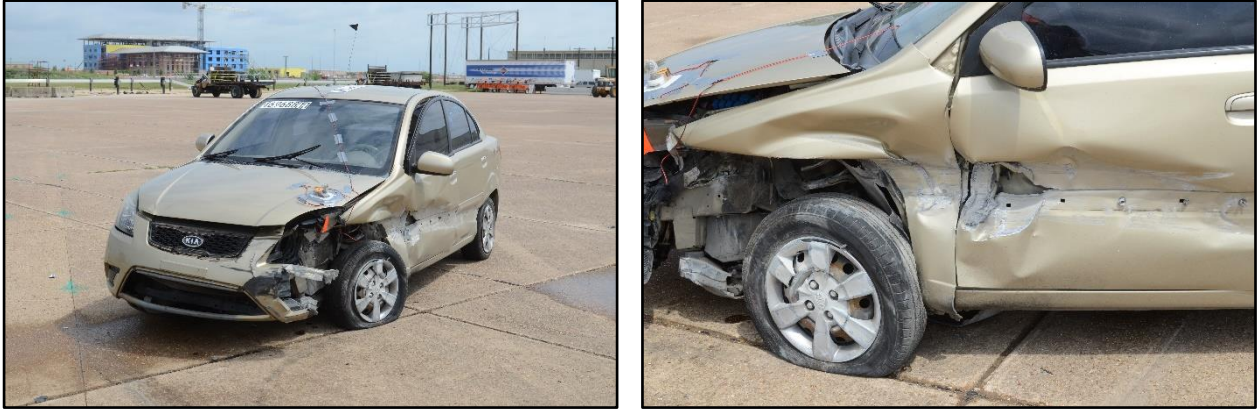
**Figure 6.4. Test Vehicle after Test No. 469688-1-1.**

rear doors, left rear rim, and rear bumper were damaged. The windshield sustained stress cracks in the left lower corner. Maximum exterior crush to the vehicle was 12.0 inches in the side plane at the left front corner at bumper height. Maximum occupant compartment deformation was 1.0 inch in the left kick panel area. Figure 6.5 shows the interior of the vehicle. Tables C.2 and C.3 in Appendix C1 provide exterior crush and occupant compartment measurements.

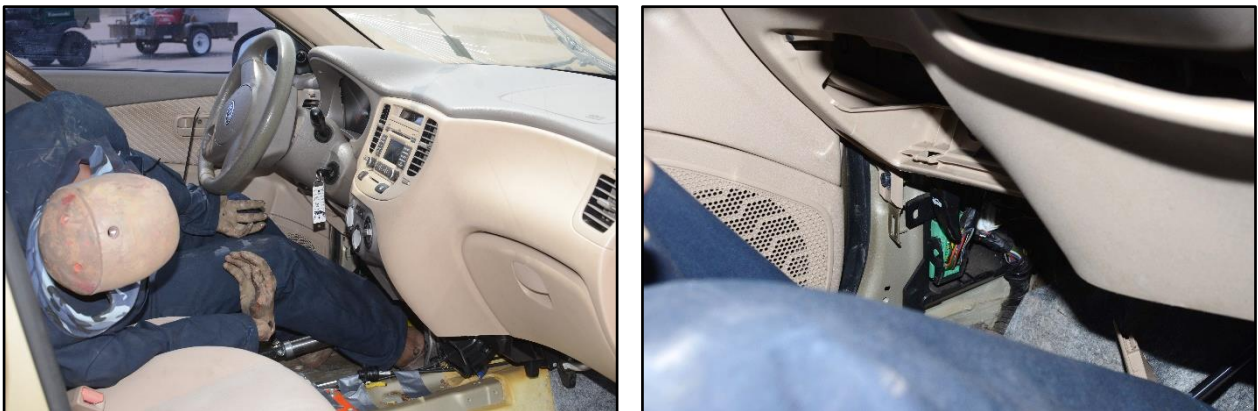
**Figure 6.5. Interior of Test Vehicle after Test No. 469688-1-1.**

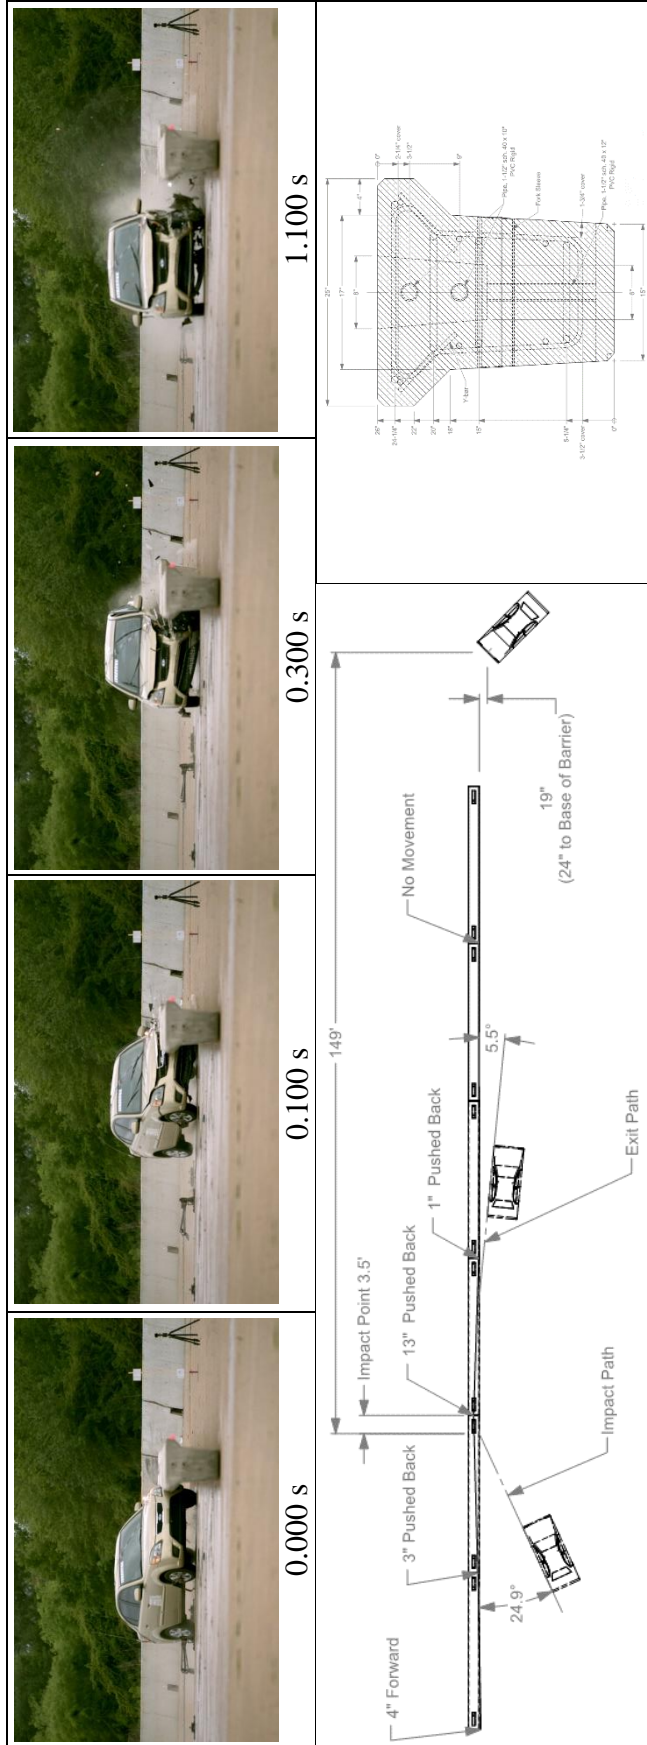
<b>General Information</b>		Texas A&M Transportation Institute (TTI)
Test Agency.....	MASH Test 3-10	
Test Standard Test No.....	469688-1-1	
TTI Test No.....	2018-04-18	
Test Date.....		
<b>Test Article</b>		
Type.....	Portable Concrete Barrier	
Name.....	TL-3 Low-Profile Barrier	
Installation Length.....	180 ft	
Material or Key Elements...	T-shaped concrete barrier 15 inches wide at base, 25 inches wide at top, 26 inches tall	
<b>Soil Type and Condition</b>		Placed on concrete surface, damp
<b>Test Vehicle</b>		
Type/Designation.....	1100C	
Make and Model.....	2011 Kia Rio	
Curb.....	2443 lb	
Test Inertial.....	2423 lb	
Dummy.....	165 lb	
Gross Static.....	2588 lb	
<b>Impact Conditions</b>		
Speed.....	63.4 mi/h	
Angle.....	24.9°	
Location/Orientation.....	3.6 ft upstream of joint 2&3	
<b>Exit Conditions</b>		
Speed.....	62 kip-ft	
Angle.....	46.0 mi/h	
<b>Occupant Risk Values</b>		
Longitudinal OIV.....	23.0 ft/s

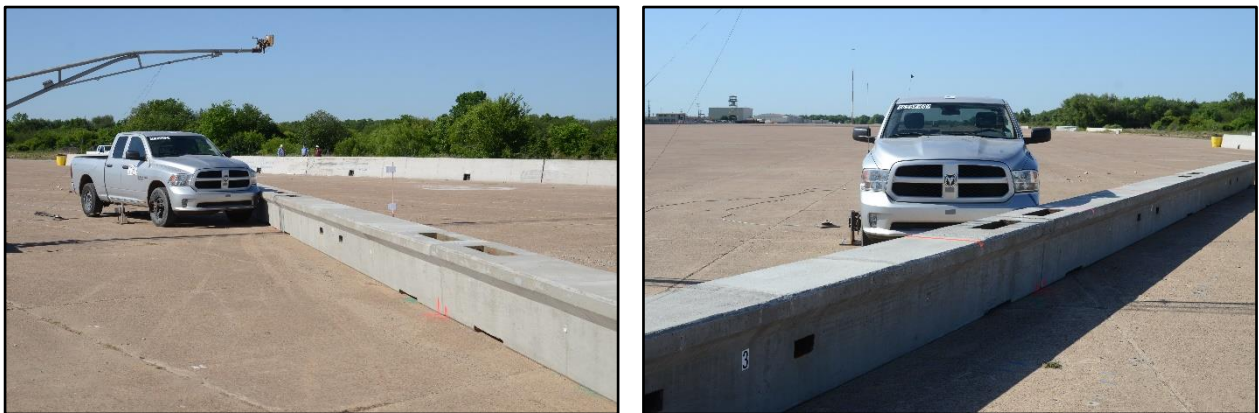
**Figure 7.1. TL-3 Low-Profile Barrier/Test Vehicle Geometrics for Test No. 469688-1-2.**

Figures 7.1 and 7.2 show the 2013 Dodge RAM 1500 pickup truck used for the crash test. The vehicle's test inertia weight was 5012 lb, and its gross static weight was 5012 lb. The height to the lower edge of the vehicle bumper was 11.75 inches, and height to the upper edge of the bumper was 27.0 inches. The height to the vehicle's center of gravity was 29.0 inches. Tables D.1 and D.2 in Appendix D.1 give additional dimensions and information on the vehicle. The vehicle was directed into the installation using the cable reverse tow and guidance system, and was released to be freewheeling and unrestrained just prior to impact.

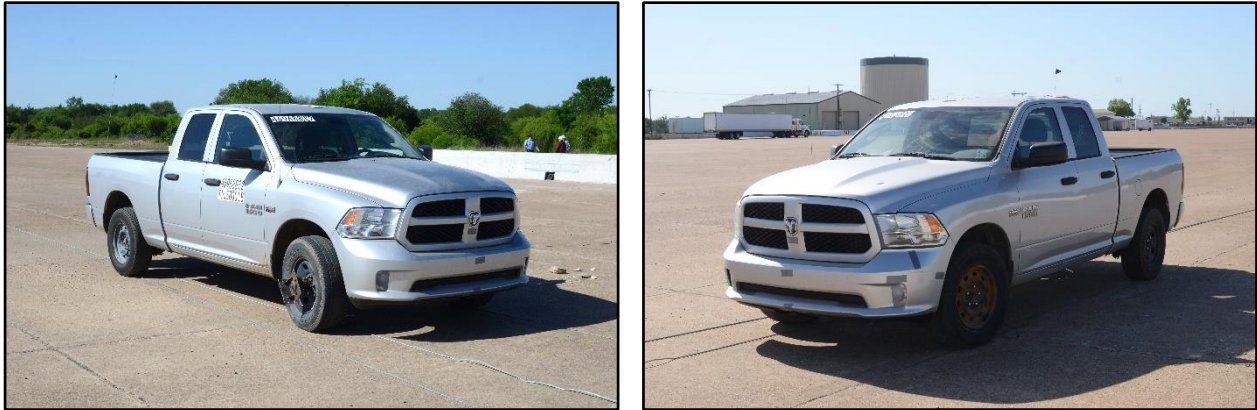
**Figure 7.2. Test Vehicle before Test No. 469688-1-2.**

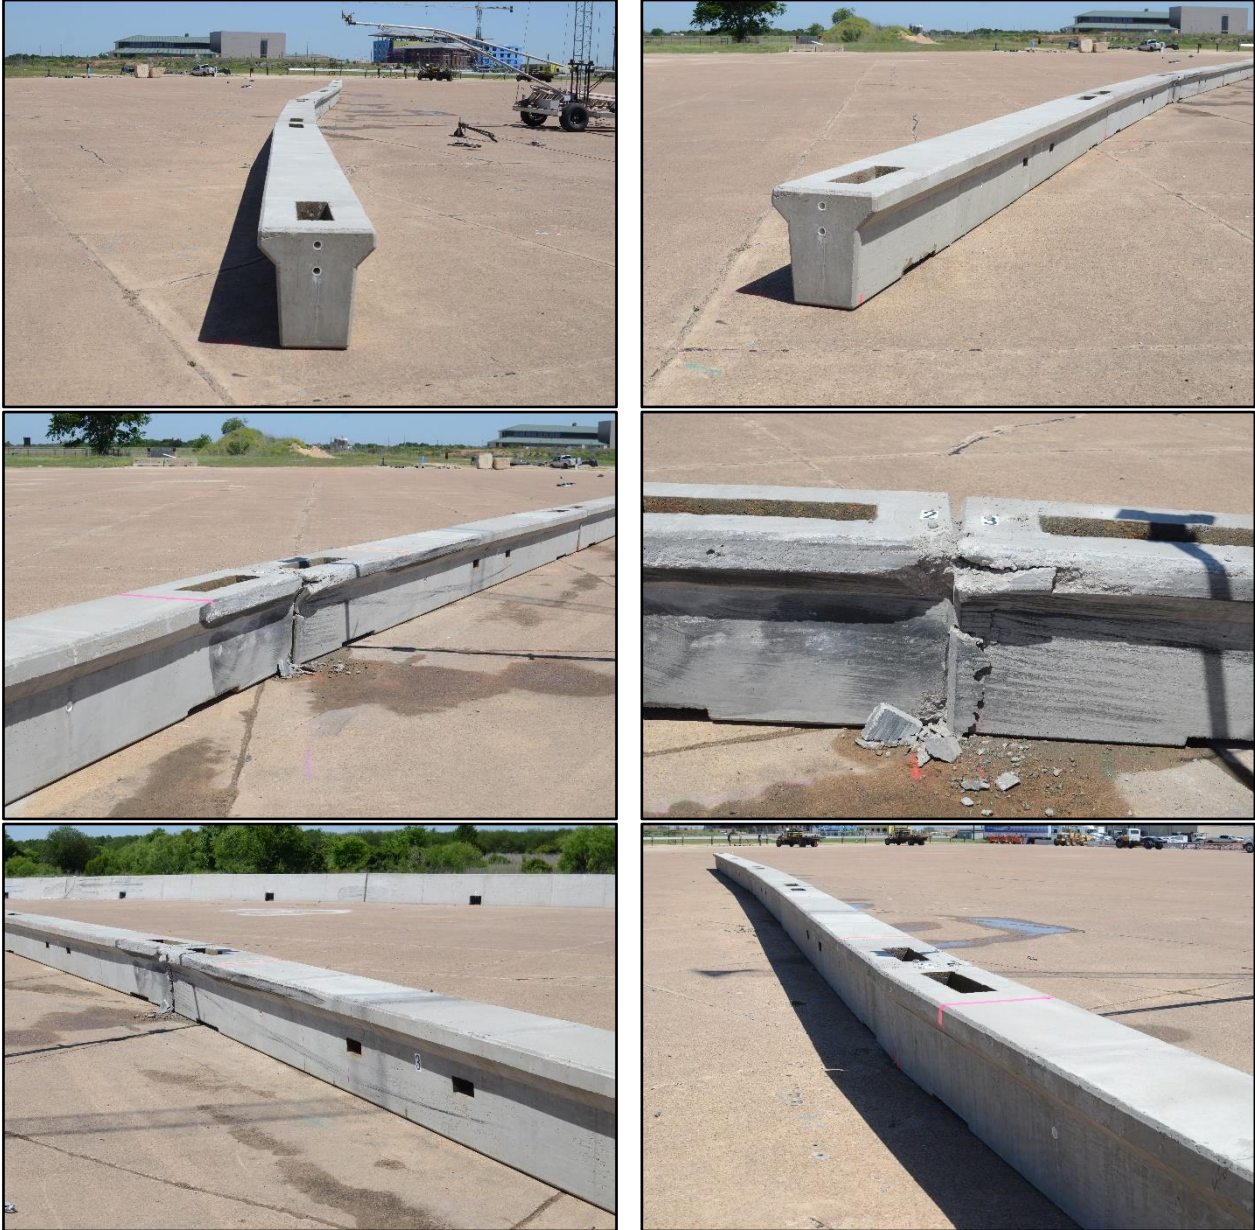
**Figure 7.3. TL-3 Low-Profile Barrier after Test No. 469688-1-2.**

side, and joint 3-4 was displaced 12.0 inches toward the field side. No lateral movement was noted at the downstream end of segment 4. Working width was 50.6 inches, and the height of maximum working width was 26.0 inches. Maximum dynamic deflection during the test was 25.0 inches, and maximum permanent deformation was 25.0 inches.

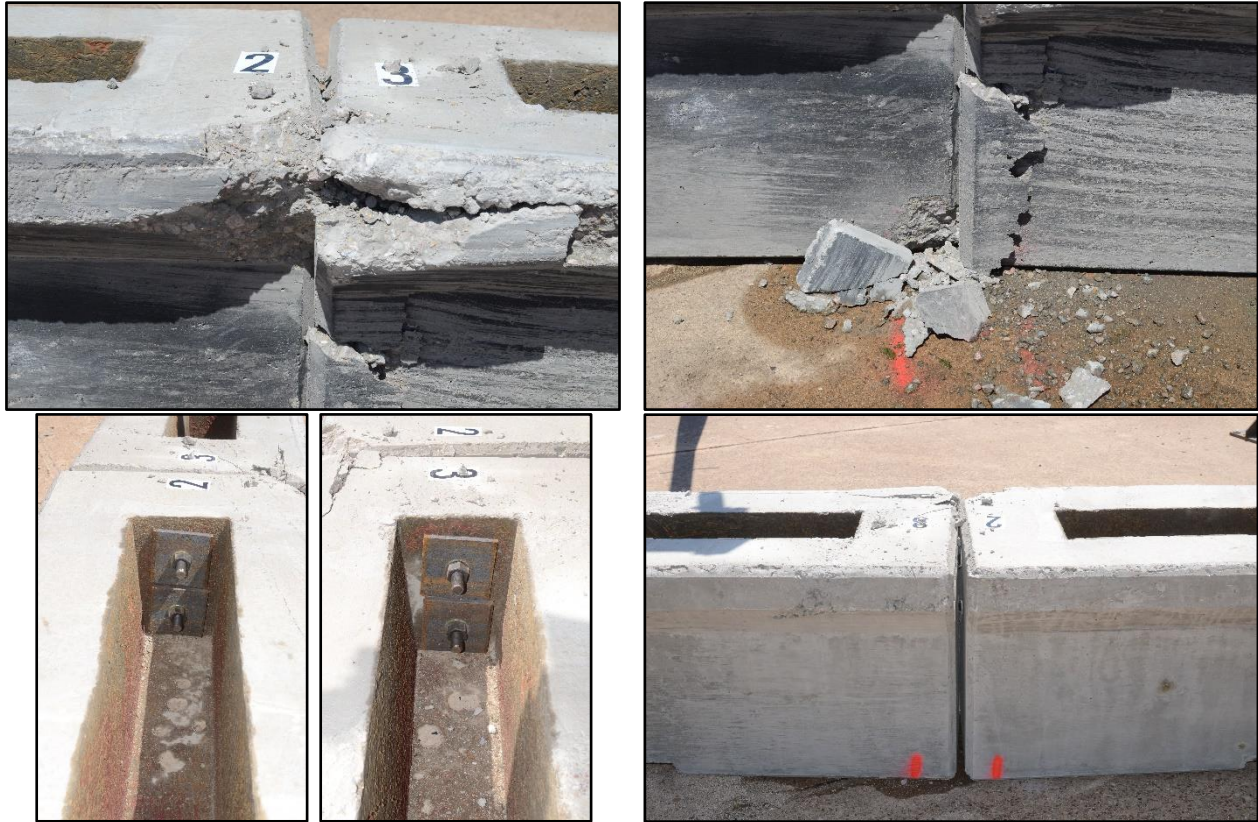
**Figure 7.4. Damage at Joint 2-3 after Test No. 469688-1-2.**

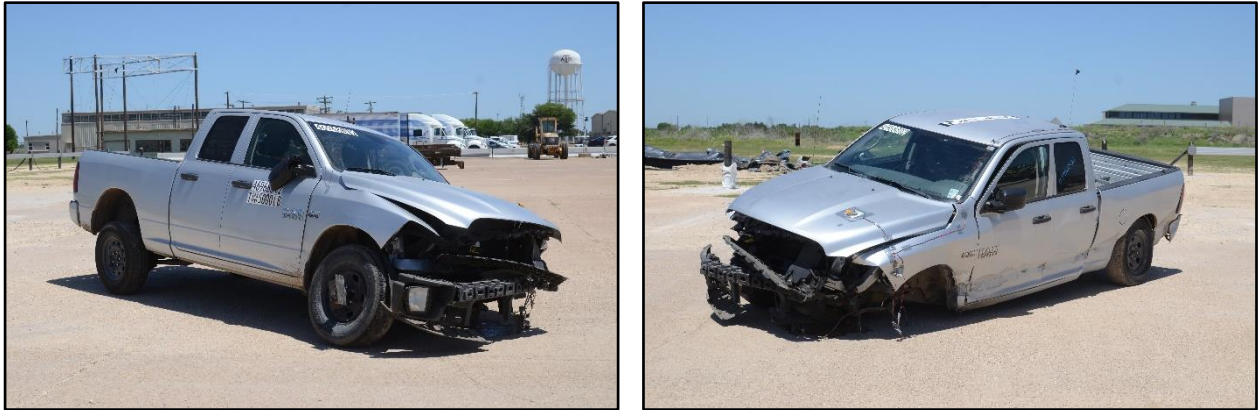
**Figure 7.5. Test Vehicle after Test No. 469688-1-2.**

Figure 7.4 shows the damage sustained by the vehicle. The front bumper, left frame rail, hood, grill, radiator and support, left front fender, left front tire and rim, left front upper and lower A-arms, left front upper and lower ball joints, front sway bar, tie rod ends, left front and rear doors, left rear cab corner, left rear exterior bed, left rear rim, and bumper were damaged. The windshield sustained a stress crack in the left lower corner radiating upward. Maximum exterior crush to the vehicle was 10.0 inches in the horizontal plane at the front bumper at bumper height. Maximum occupant compartment deformation was 2.0 inches in the driver side floor from the firewall to the driver seat. Figure 7.5 shows the interior of the vehicle. Tables D.3 and D.4 in Appendix D.1 provide exterior crush and occupant compartment measurements.

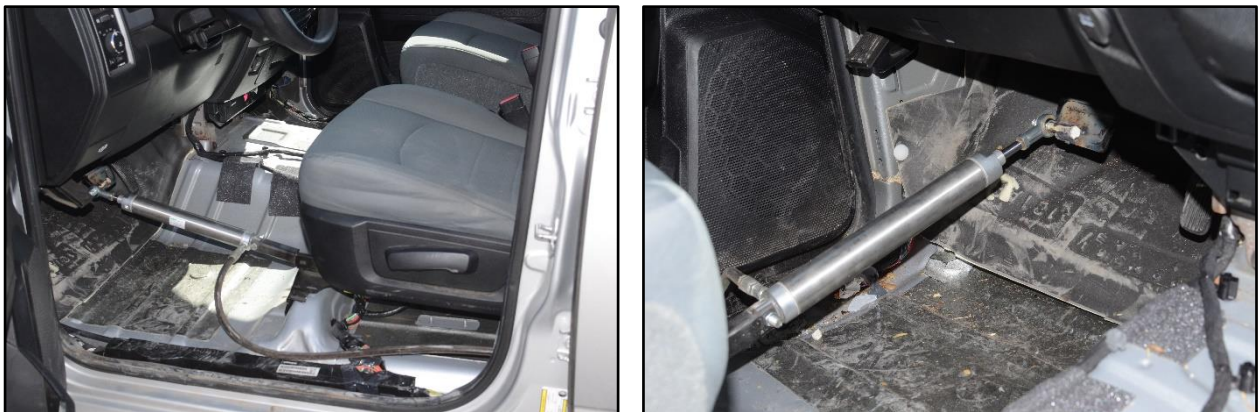
Before Test

After Test
