# **MASH TL-3 EVALUATION OF THE TxDOT TL-3 LOW-PROFILE BARRIER FOR HIGH SPEED APPLICATIONS**

**Test Report 0-6968-R1**

**TEXAS A&M TRANSPORTATION INSTITUTE**

**TEXAS DEPARTMENT OF TRANSPORTATION**

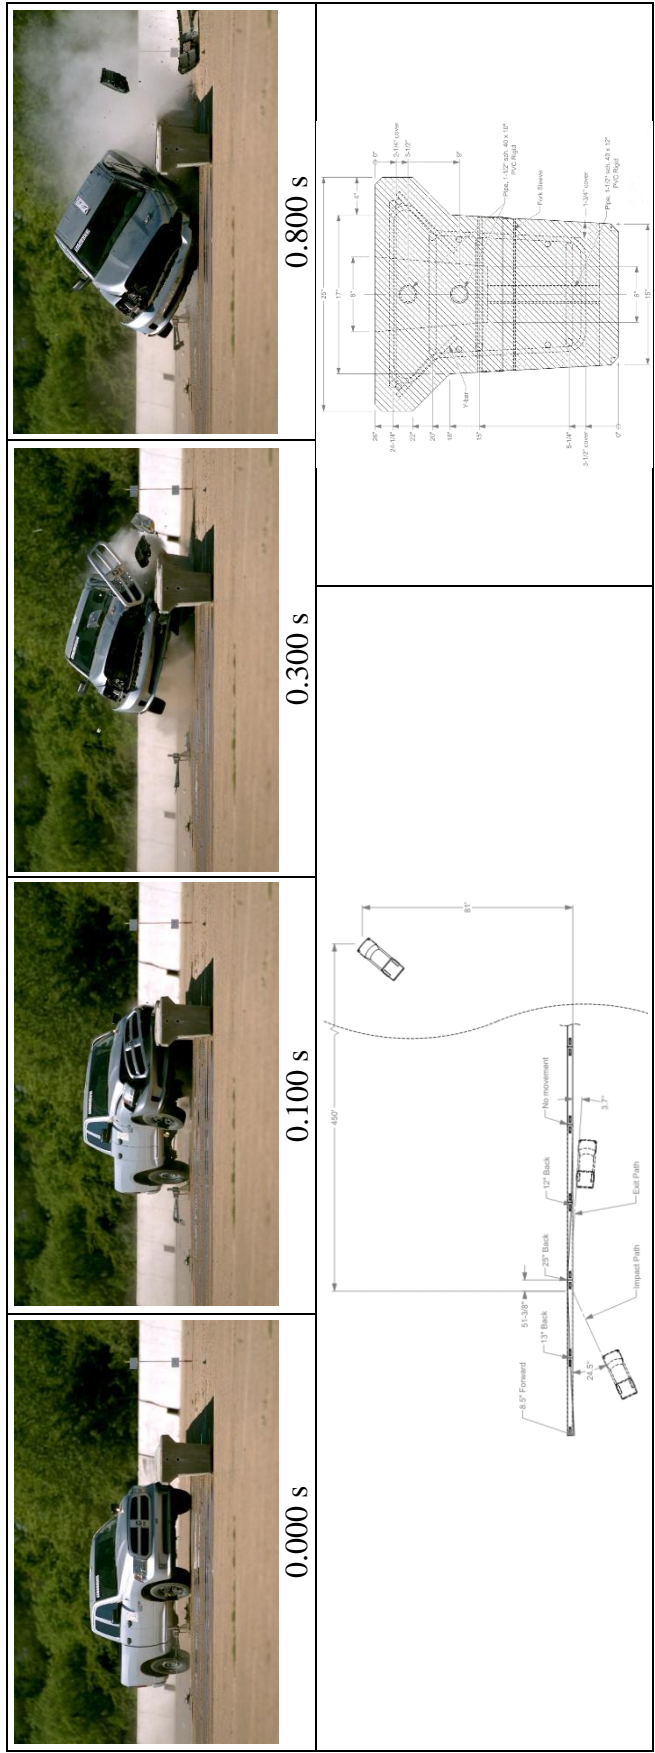
<b>General Information</b>		<b>Impact Conditions</b>		<b>Post-Impact Trajectory</b>	
Test Agency .....	Texas A&M Transportation Institute (TTI)	Speed .....	62.4 mi/h	Stopping Distance .....	431 ft downstream
Test Standard Test No. ....	MASH Test 3-11	Angle .....	24.5°		81 ft twd field side
TTI Test No. ....	469688-1-2	Location/Orientation .....	4.3 ft upstream of joint 2&3	<b>Vehicle Stability</b>	
Test Date .....	2018-04-16	<b>Exit Conditions</b>		Maximum Roll Angle .....	40°
<b>Test Article</b>		Speed .....	111.6 kip-ft	Maximum Pitch Angle .....	10°
Type .....	Portable Concrete Barrier	Angle .....	3.7°	Vehicle Snagging .....	No
Name .....	TL-3 Low-Profile Barrier	<b>Occupant Risk Values</b>		Vehicle Pocketing .....	No
Installation Length .....	180 ft	Longitudinal OIV .....	19.4 ft/s	<b>Test Article Deflections</b>	
Material or Key Elements ...	T-shaped concrete barrier 15 inches wide at base, 25 inches wide at top, 26 inches tall	Lateral OIV .....	20.7 ft/s	Dynamic .....	25.0 inches

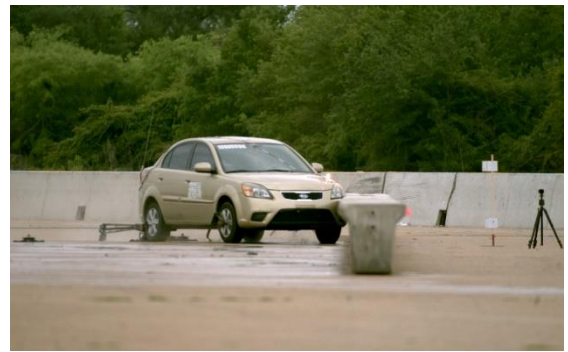
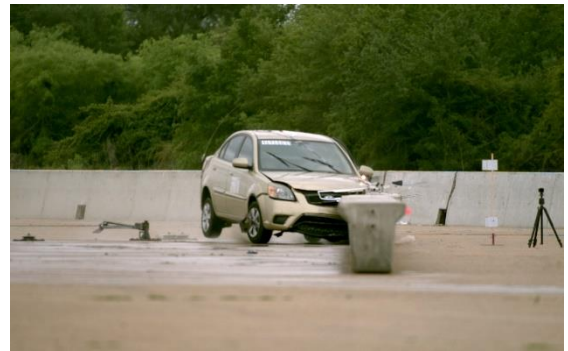
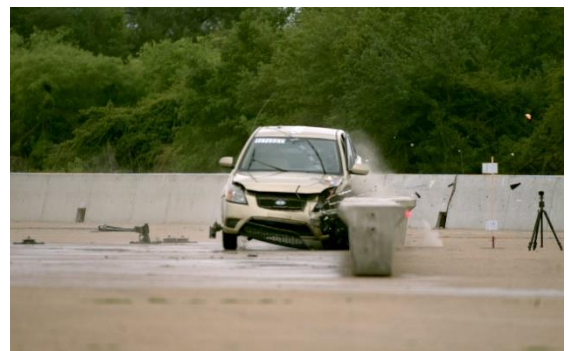
**Figure C.1. Sequential Photographs for Test No. 469688-1-1 (Overhead and Gut Views).**

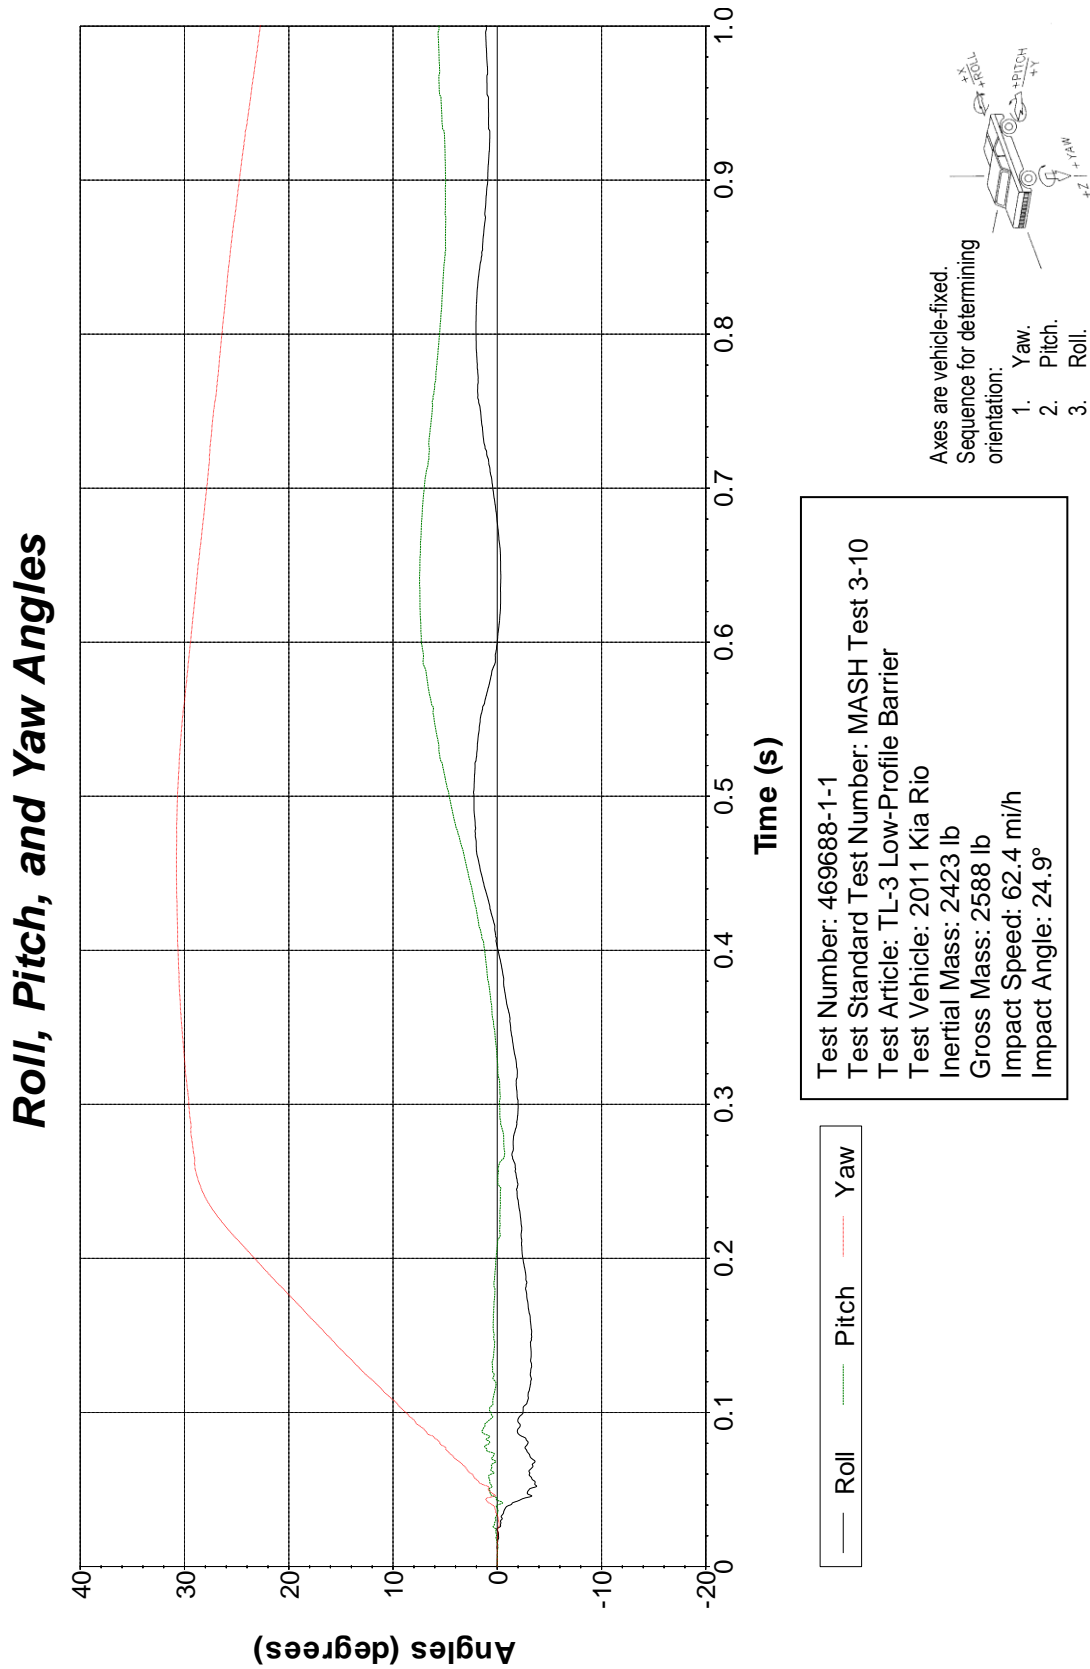
**Figure C.3. Vehicle Angular Displacements for Test No. 469688-1-1.**

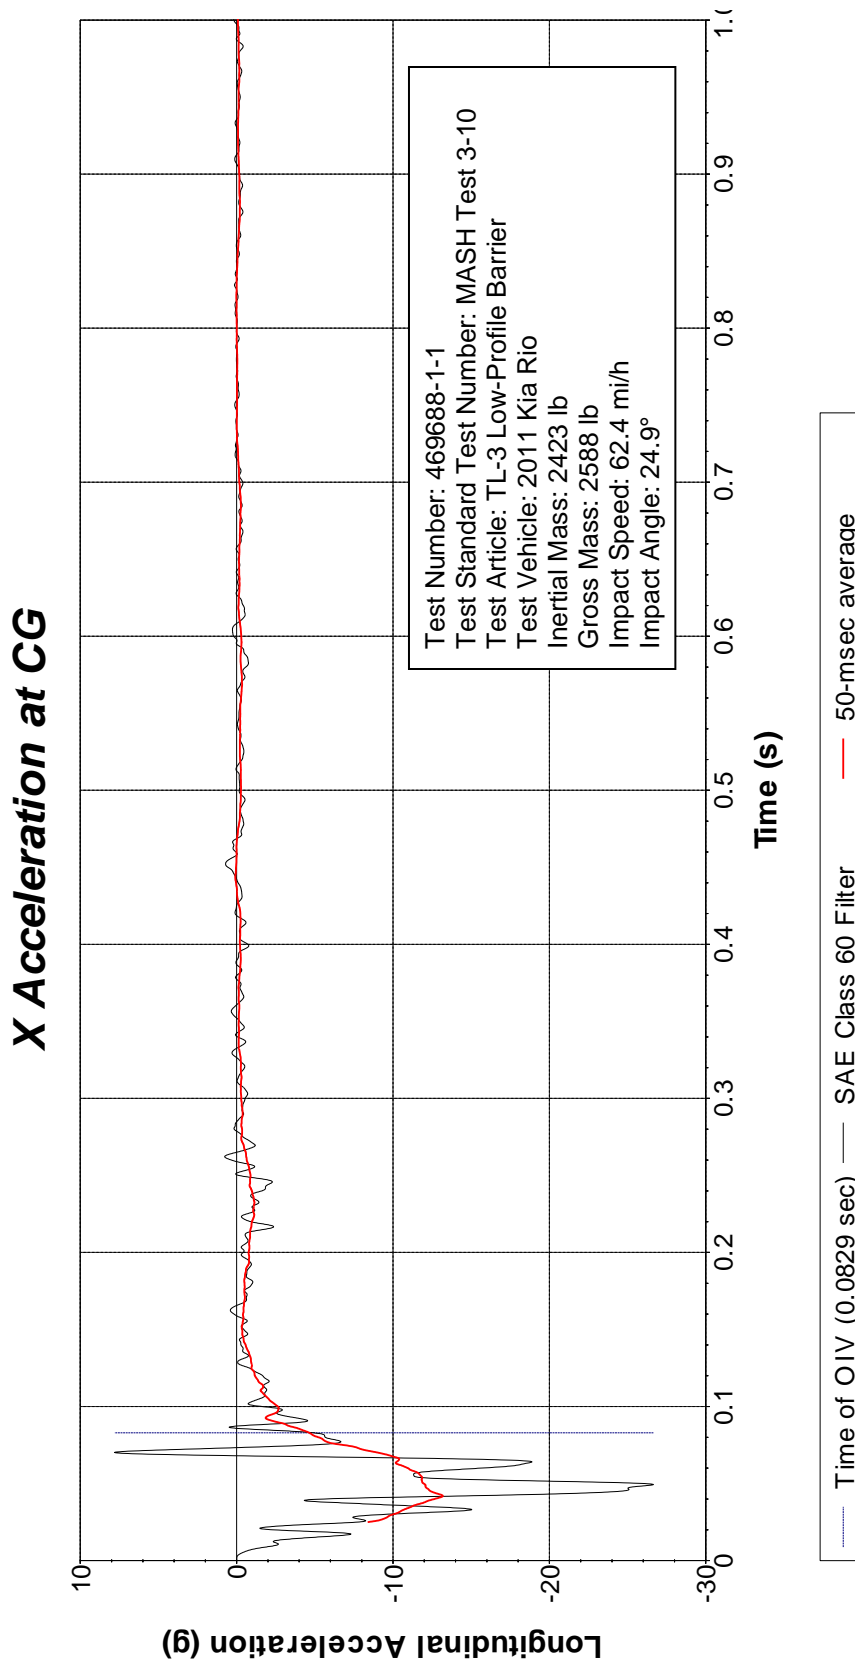
**Figure C.4. Vehicle Longitudinal Accelerometer Trace for Test No. 469688-1-1 (Accelerometer Located at Center of Gravity).**

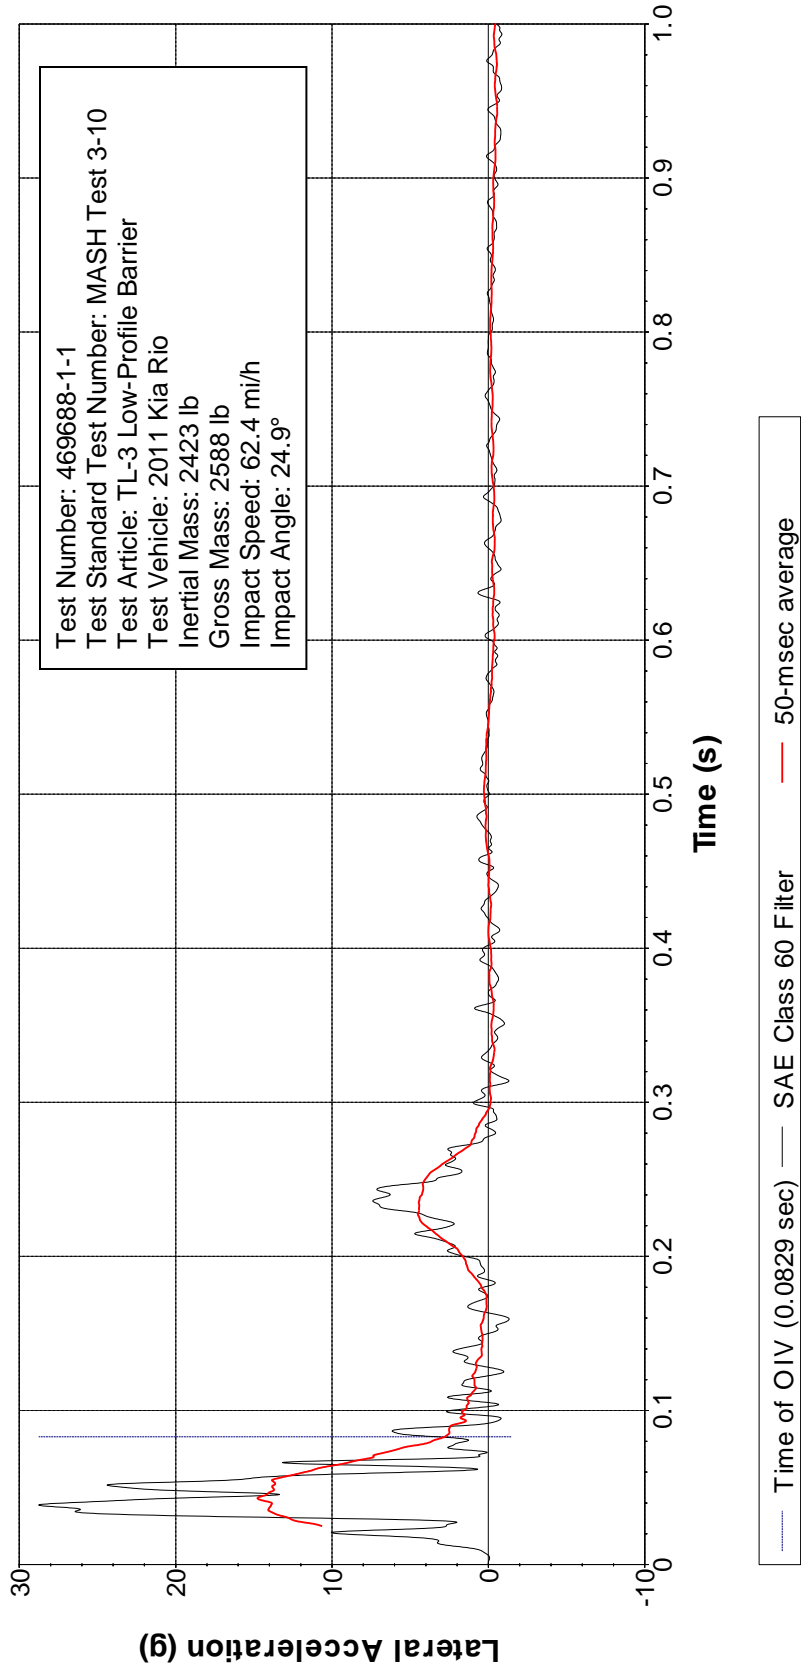
**Figure C.5. Vehicle Lateral Accelerometer Trace for Test No. 469688-1-1 (Accelerometer Located at Center of Gravity).**

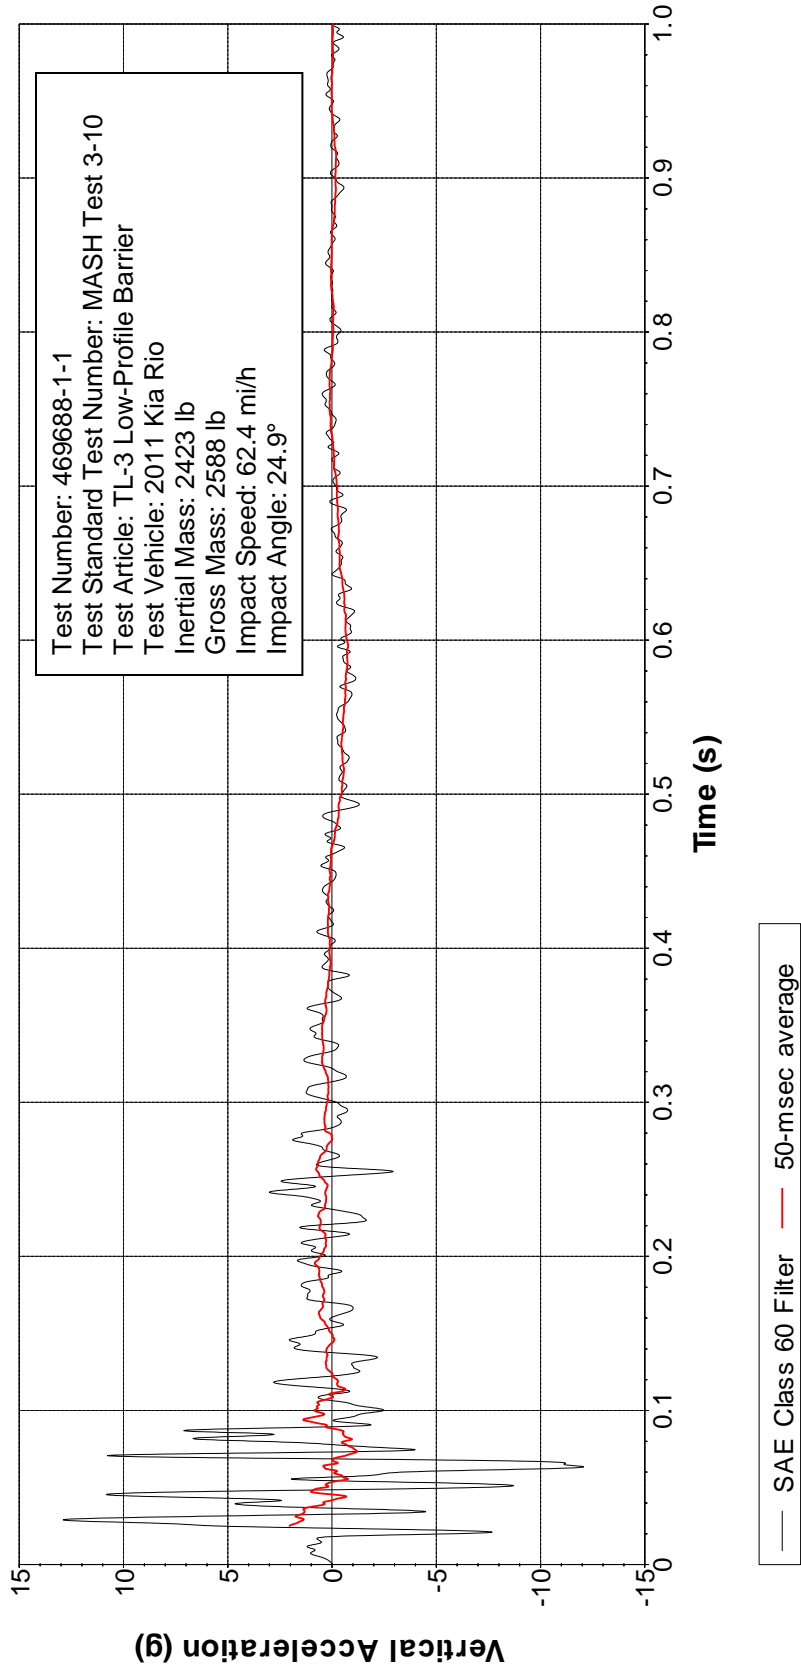
**Figure C.6. Vehicle Vertical Accelerometer Trace for Test No. 469688-1-1  
(Accelerometer Located at Center of Gravity).**

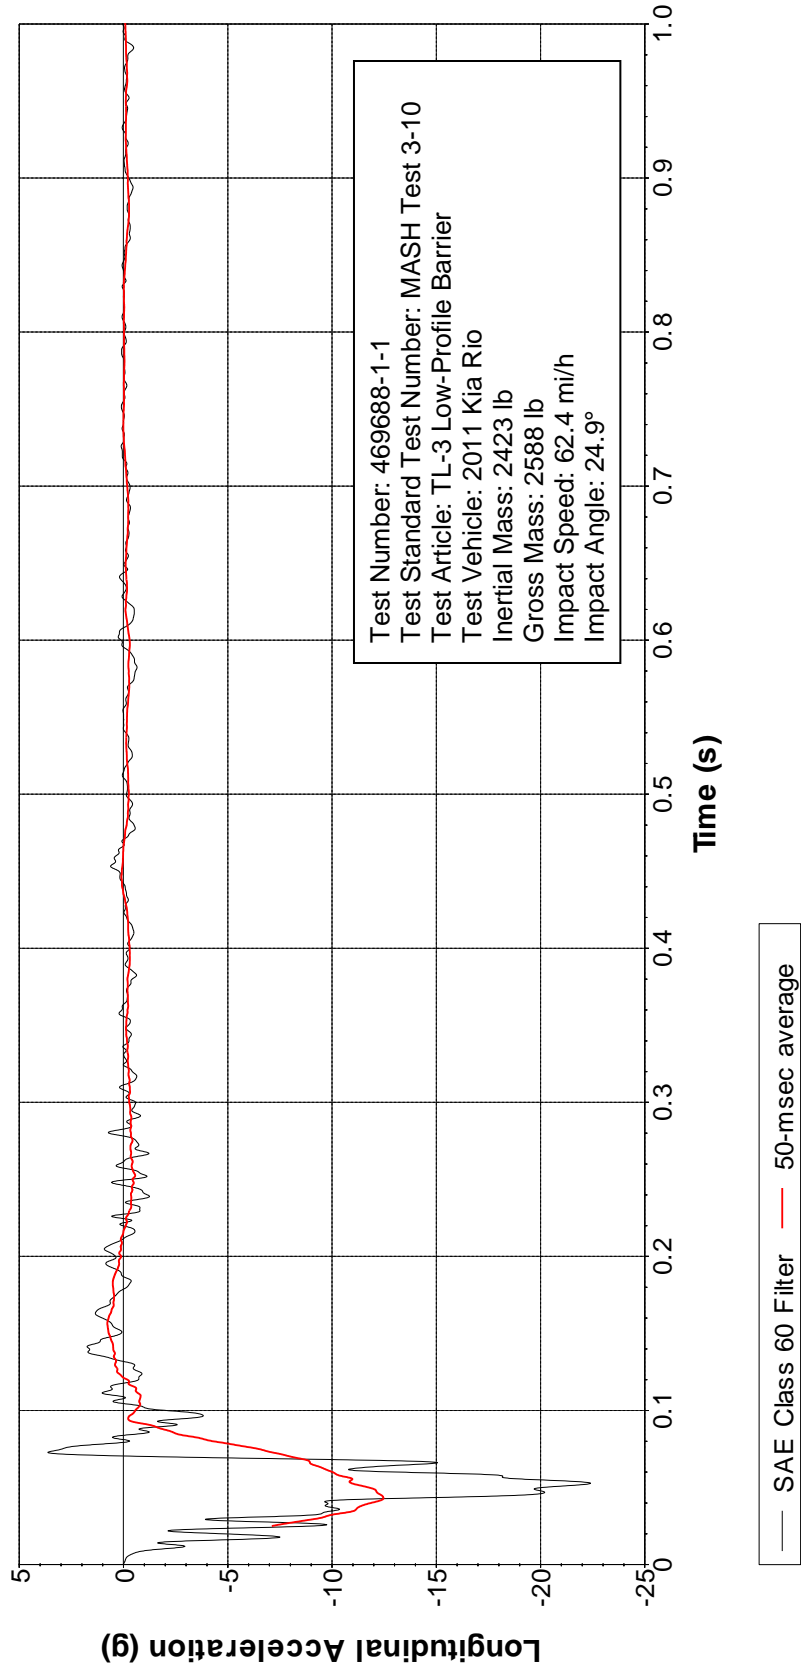
**Figure C.7. Vehicle Longitudinal Accelerometer Trace for Test No. 469688-1-1 (Accelerometer Located Rear of Center of Gravity).**

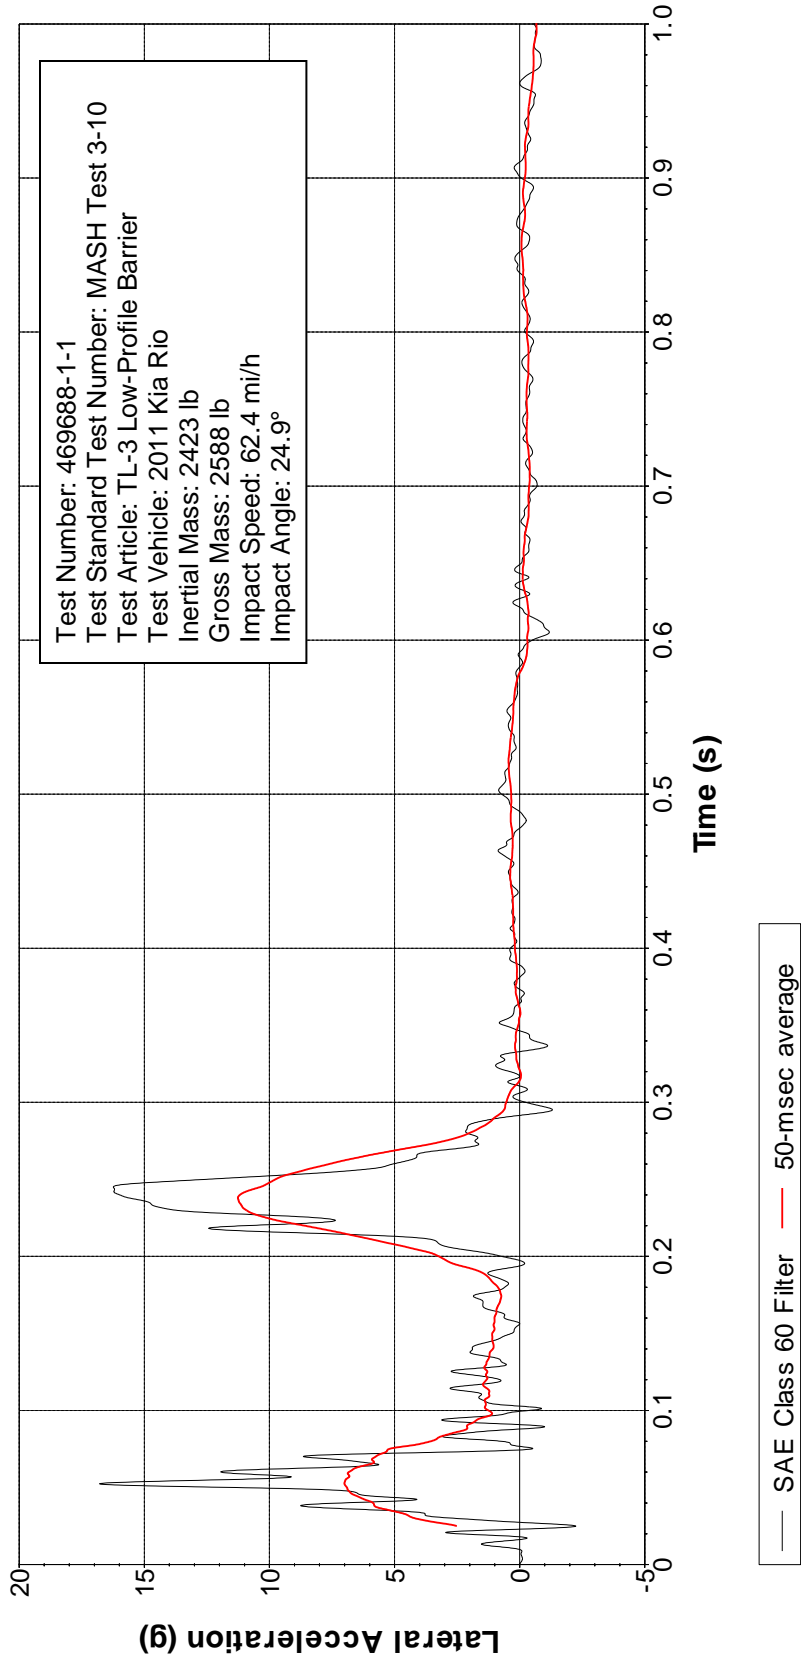
**Figure C.8. Vehicle Lateral Accelerometer Trace for Test No. 469688-1-1 (Accelerometer Located Rear of Center of Gravity).**

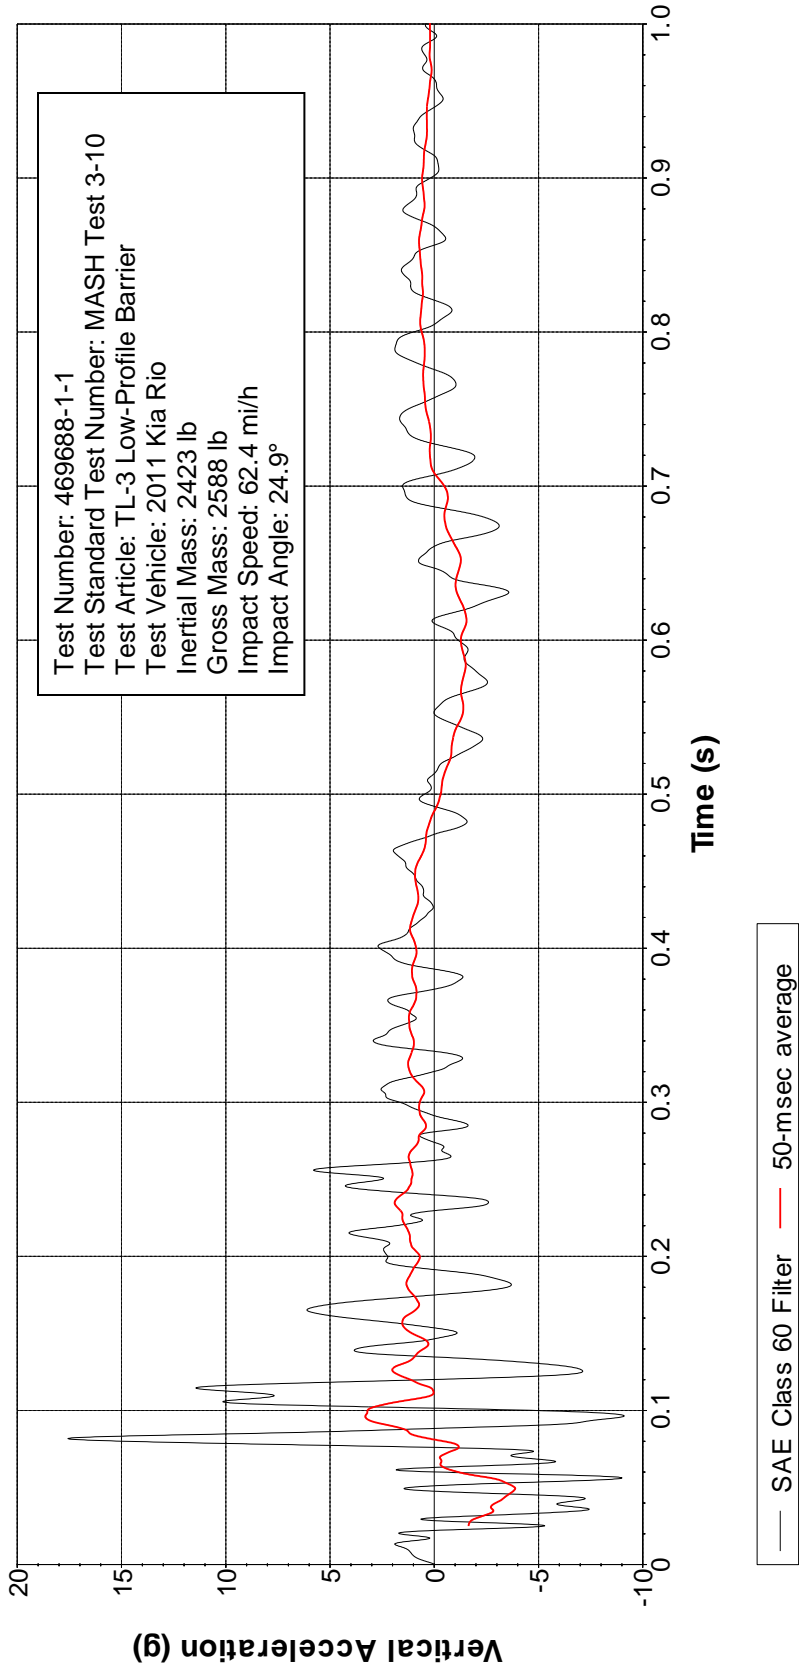
**Figure C.9. Vehicle Vertical Accelerometer Trace for Test No. 469688-1-1 (Accelerometer Located Rear of Center of Gravity).**

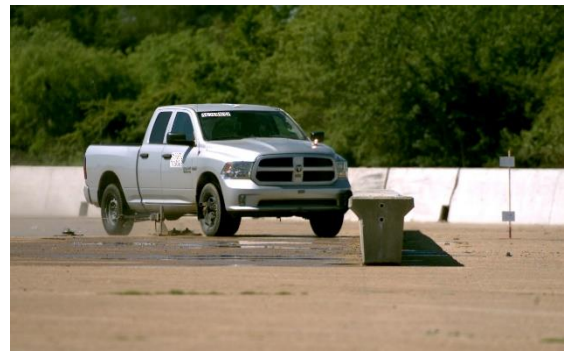
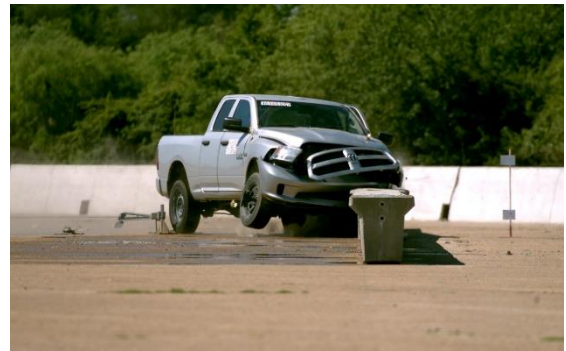
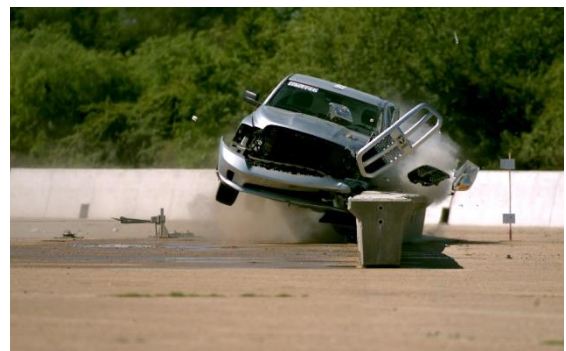
**Figure D.1. Sequential Photographs for Test No. 469688-1-2 (Overhead and Gut Views).**

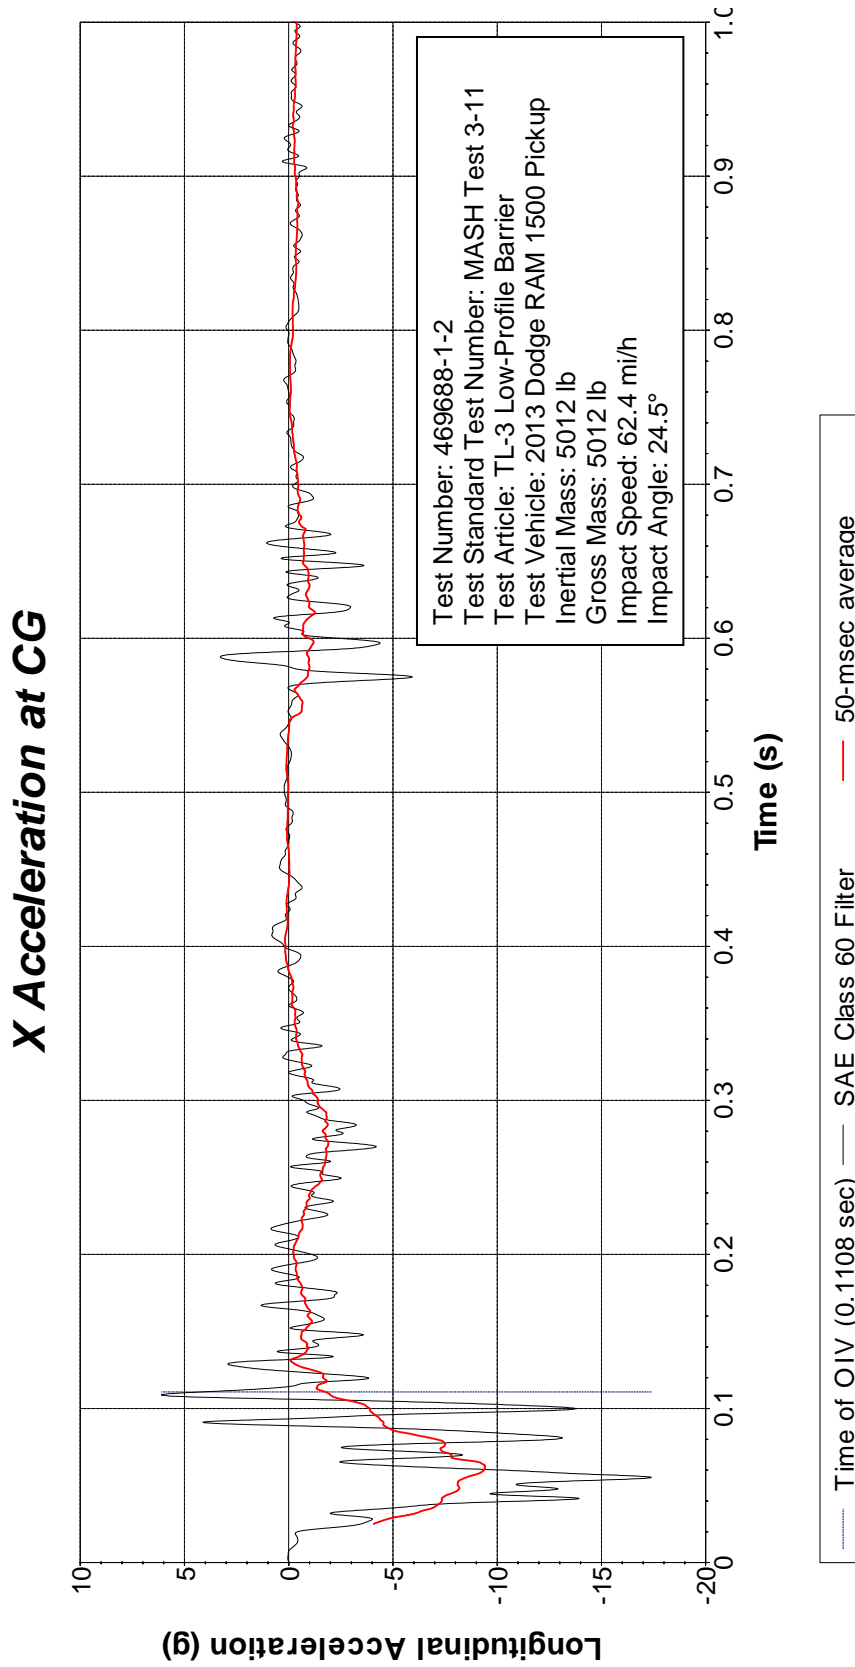
**Figure D.4. Vehicle Longitudinal Accelerometer Trace for Test No. 469688-1-2  
(Accelerometer Located at Center of Gravity).**

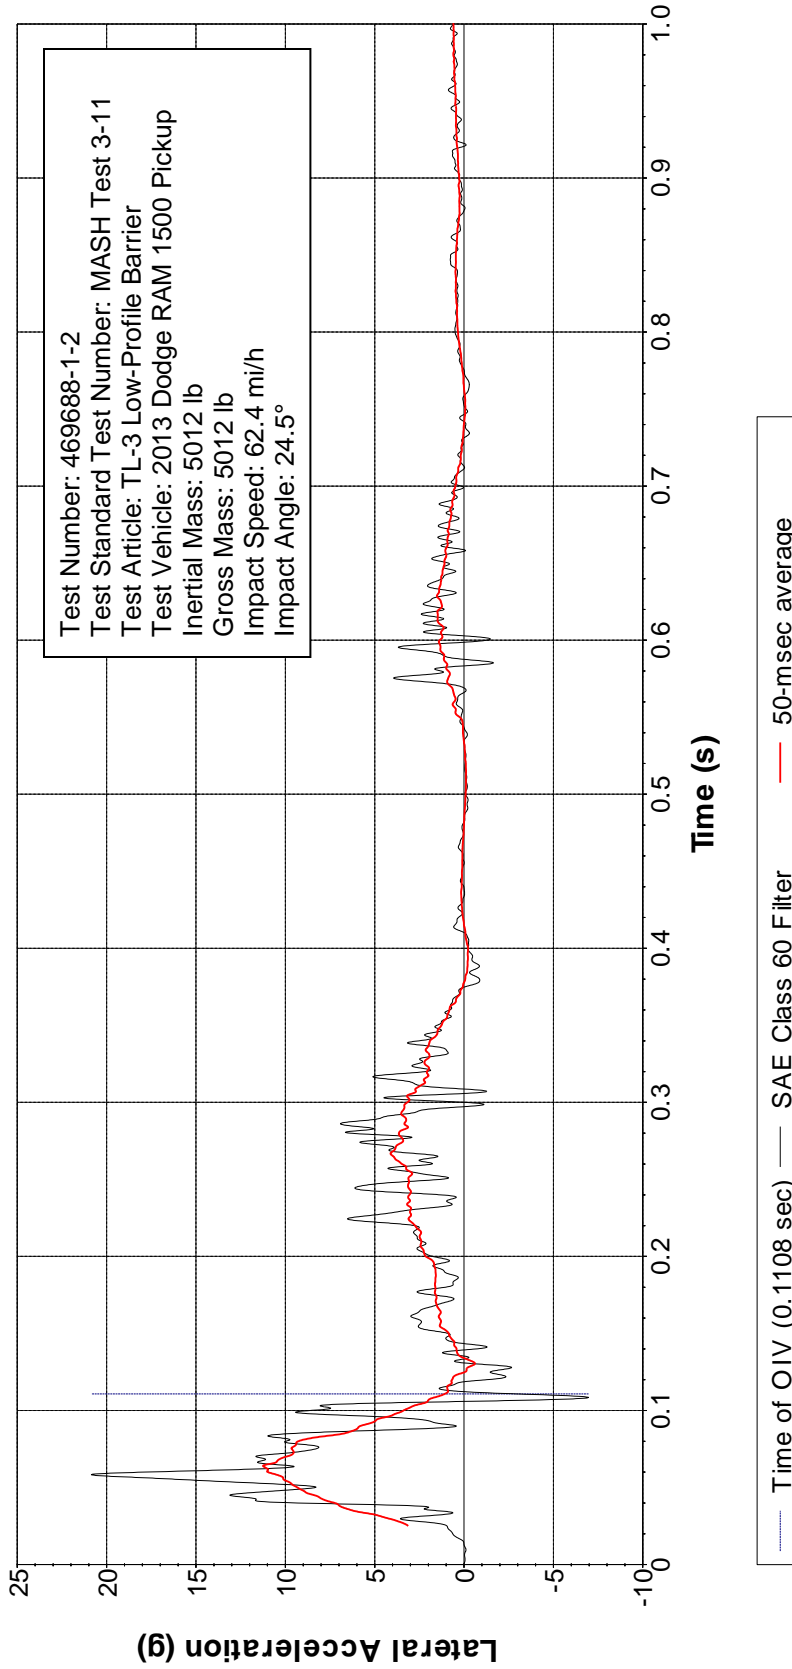
**Figure D.5. Vehicle Lateral Accelerometer Trace for Test No. 469688-1-2 (Accelerometer Located at Center of Gravity).**

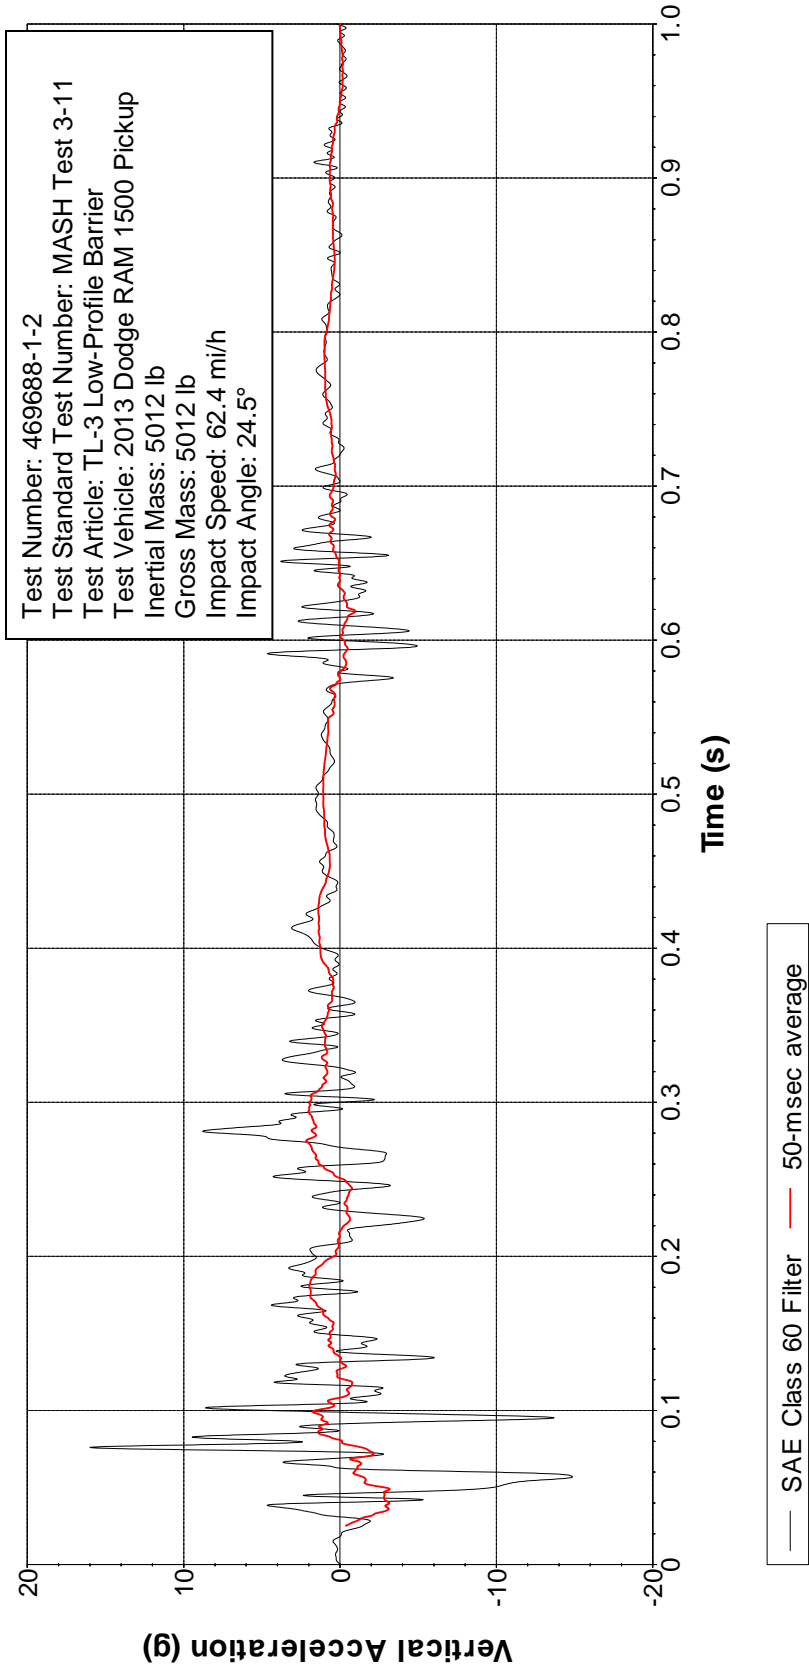
**Figure D.6. Vehicle Vertical Accelerometer Trace for Test No. 469688-1-2  
(Accelerometer Located at Center of Gravity).**

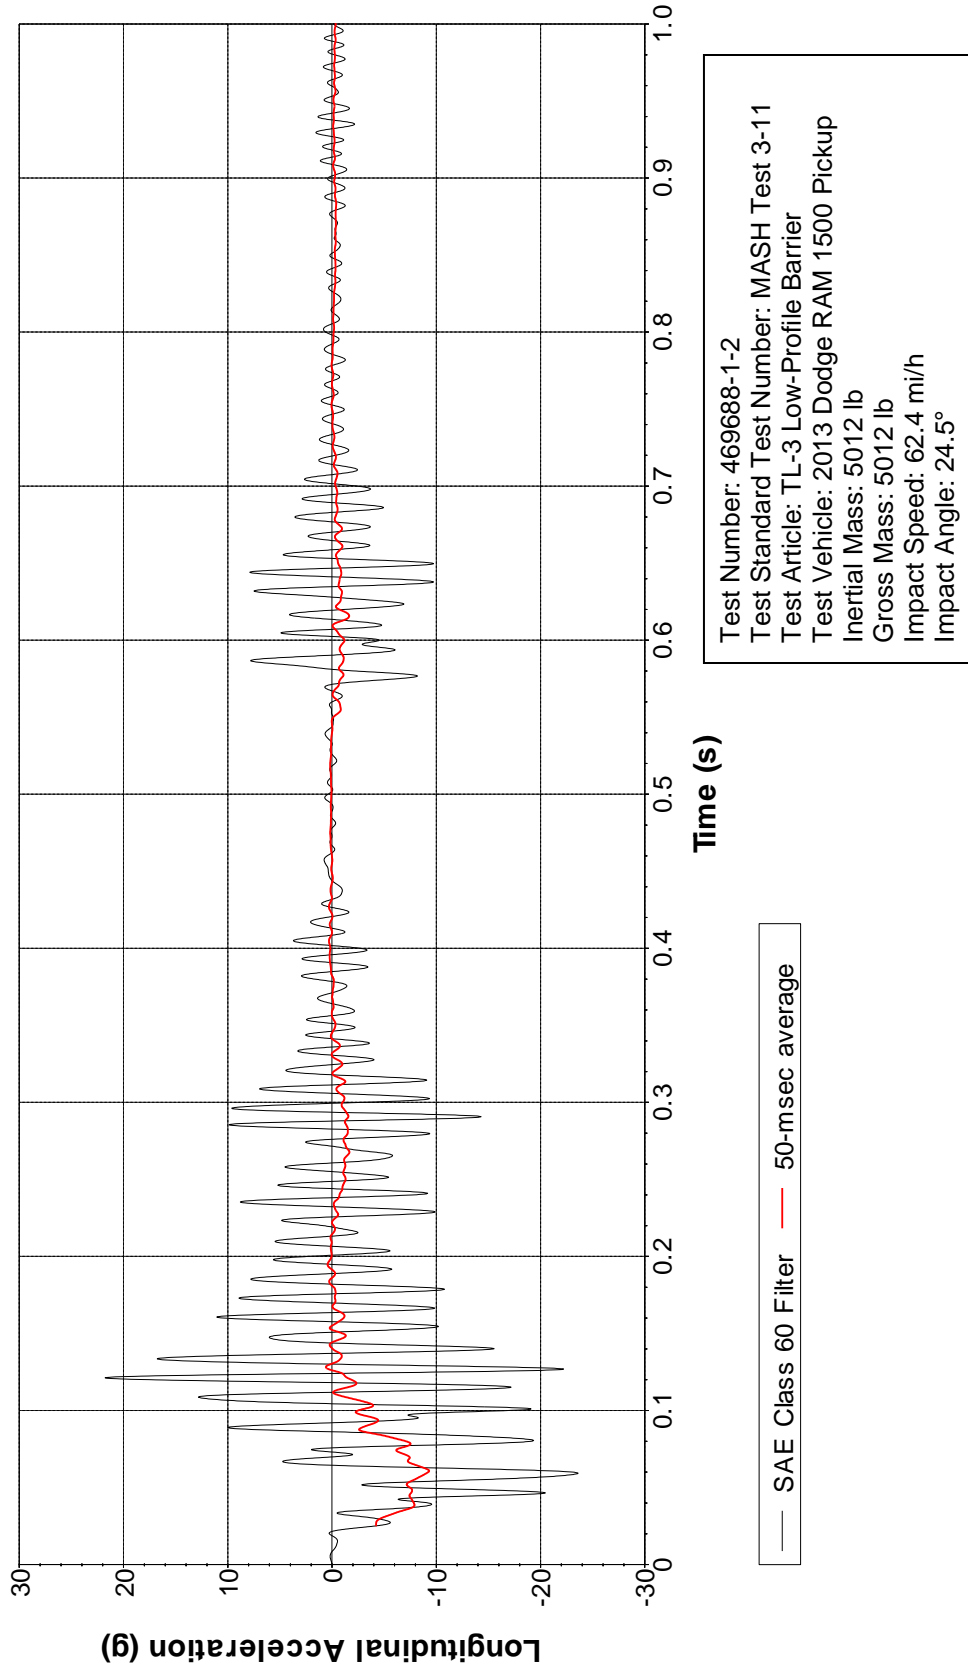
**Figure D.7. Vehicle Longitudinal Accelerometer Trace for Test No. 469688-1-2 (Accelerometer Located Rear of Center of Gravity).**

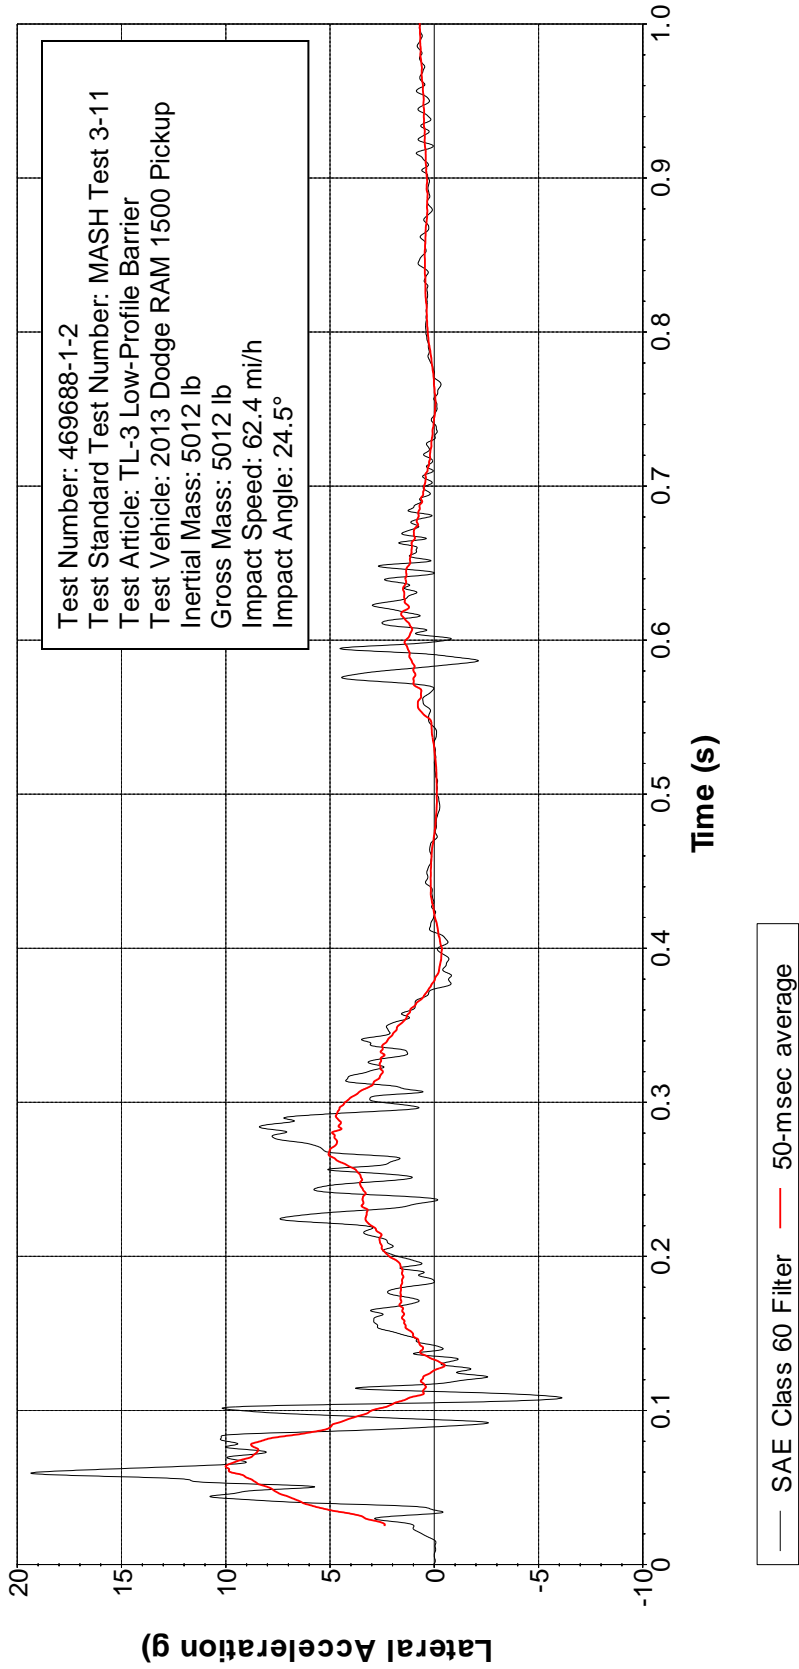
Figure D.8. Vehicle Lateral Accelerometer Trace for Test No. 469688-1-2 (Accelerometer Located Rear of Center of Gravity).

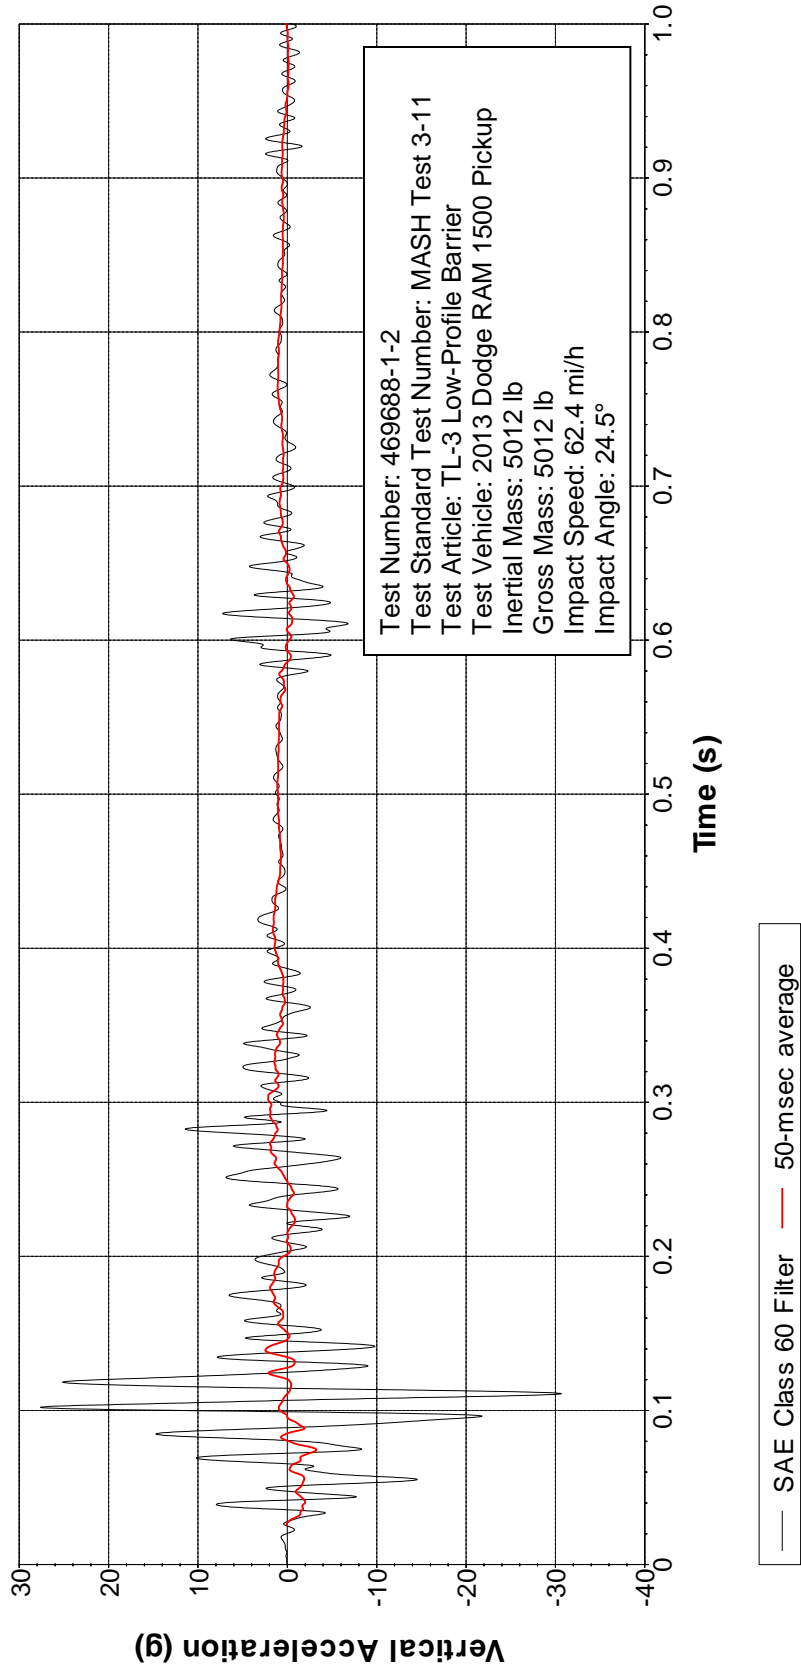
**Figure D.9. Vehicle Vertical Accelerometer Trace for Test No. 469688-1-2 (Accelerometer Located Rear of Center of Gravity).**
